Phase 2 Archaeological Investigations at Skuifraam, Franschhoek Berg River Dam

**Prepared for
Trans Caledon Tunnel Authority
June 2005**

Mary Patrick & Harriet Clift
Cape Archaeological Survey cc
19 Dawlish Road, Plumstead
7800

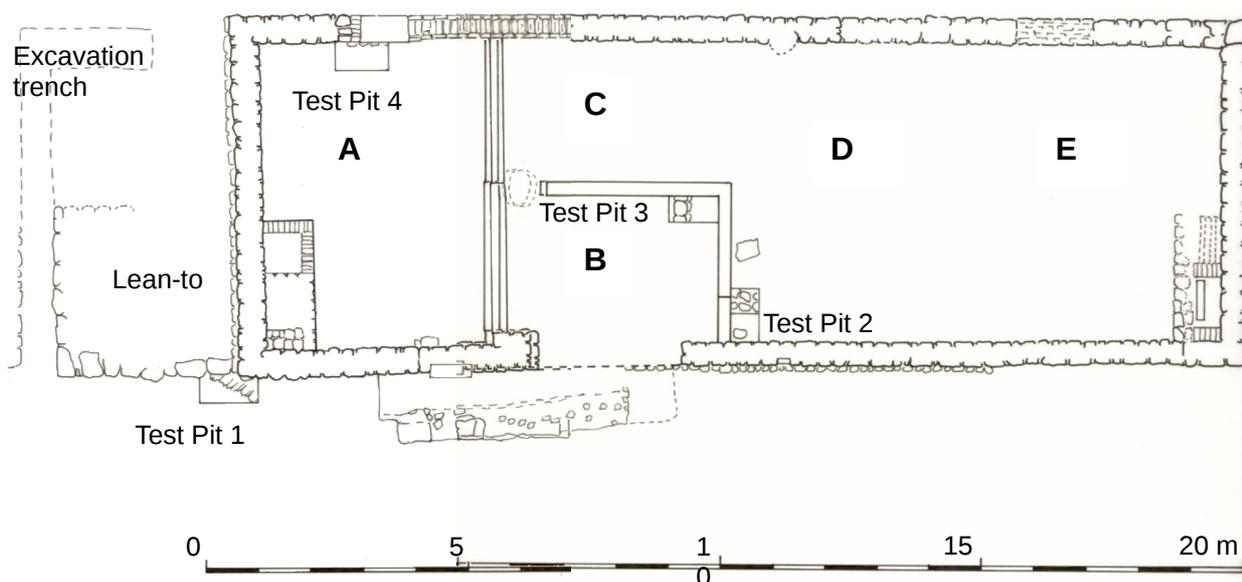
Figure 4: Floor plan of Skuifraam-1 drawn facing east. Letters A-E indicate possible rooms. The walls between Rooms C, D and E have not been preserved.

In addition to uncovering the ground plan of the structures, four test pits were excavated in the interior of Skuifraam-1 (Figure 4). These test pits clearly show that at least two building episodes had taken place. A rubble layer rich in charcoal also confirmed that the structure was badly damaged by fire at some point during its history. In January 1931 a veld fire near Skuifraam was documented in the forestry records. This fire destroyed about 260 acres of land⁶. It is possible that the charcoal layers found in the deposits correspond to this event.

The existing interior walls are 19-23cm thick and are associated with the early 20th century reuse of the building. These walls do not have a stone footing, and sit on top of a clay plaster floor surface. The rooms formed by these walls have been indicated on Figure 4 as A, B, C, D and E, running from north to south.

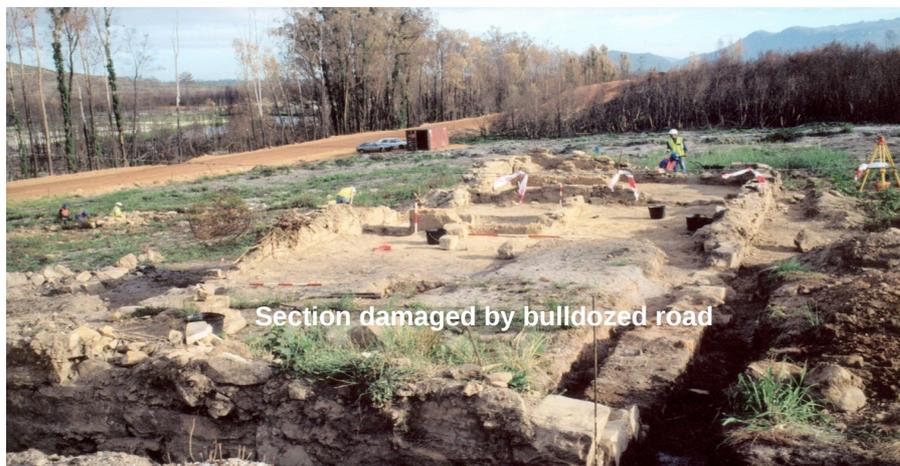
Plate 2: View of SKuifraam-1, looking north.

The foundations of Skuifraam-1 are largely intact, with the exception of the southern end, where the bulldozed road cut through it (Plate 2). The main section of the building is 19.5m long and 6.5 – 7m wide (it is slightly wider on the northern end). A lean-to had been added along the northern edge of the building, adding another 3m to the length of the building. The foundations and large parts of the existing outer walls of Skuifraam-1 are constructed with stone. The stone is neatly dressed and evidence of lime plaster as well as a later cement plaster has been found intact in various places. The exterior walls are on average 50cm wide.

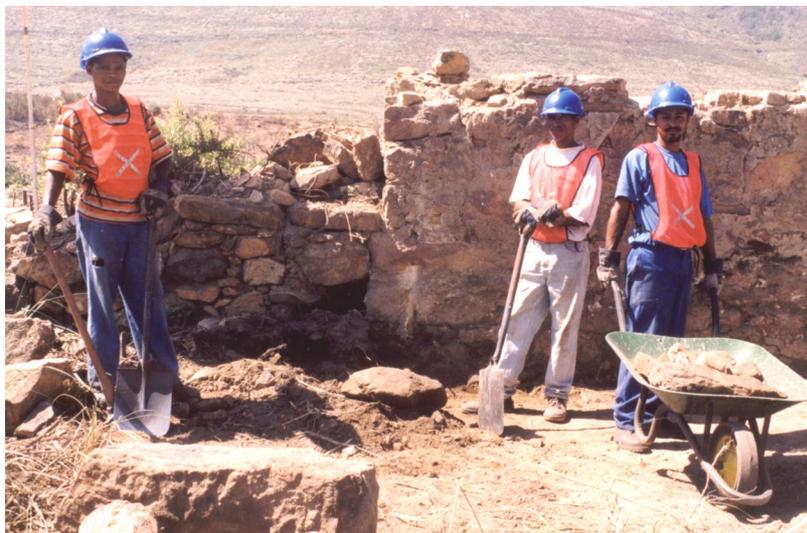
Plate 3: Daniel Steenbok, Johan Cilliers and Jonathan Williams clearing rubble away from the western wall. Note the change in stonework at the junction of the house and the lean-to.

The stone foundation of the lean-to is less substantial than that of the main section (Plate 3) and on its northern side could only be traced for a length of 3m. The north-eastern corner of the lean-to was not found. No plaster, lime or cement, has been found intact on the stonewalling of the lean-to.

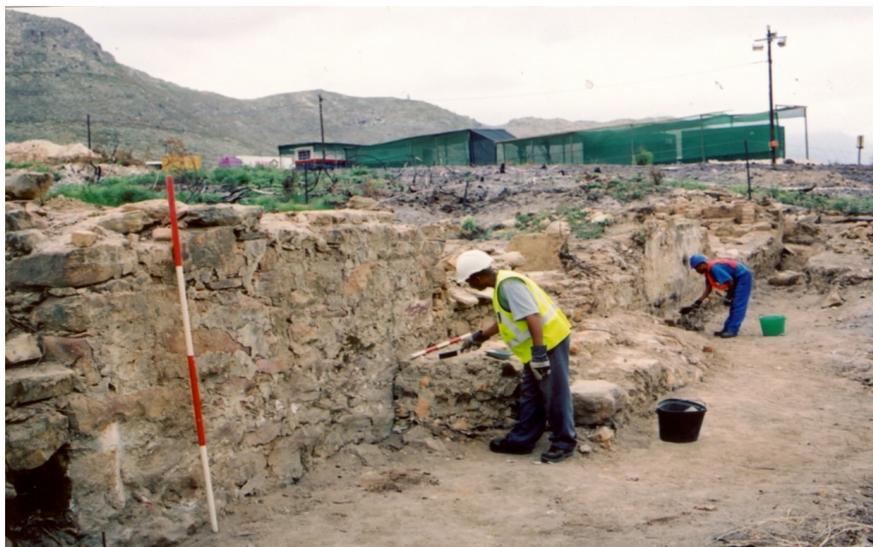
Plate 4: Western wall. Derrick Hartnick is cleaning what was initially thought to be the remains of a stoep, but seems to be rubble as exterior plaster extends behind it. Note the change in level of the plinth sloping upwards towards the southern end of the building. Elton Haas (with the red vest) is showing the original level of the surface of the ground.

The plinth along the south-western portion of this wall clearly shows the natural slope of the land at the time that the structure was built (Plate 4).

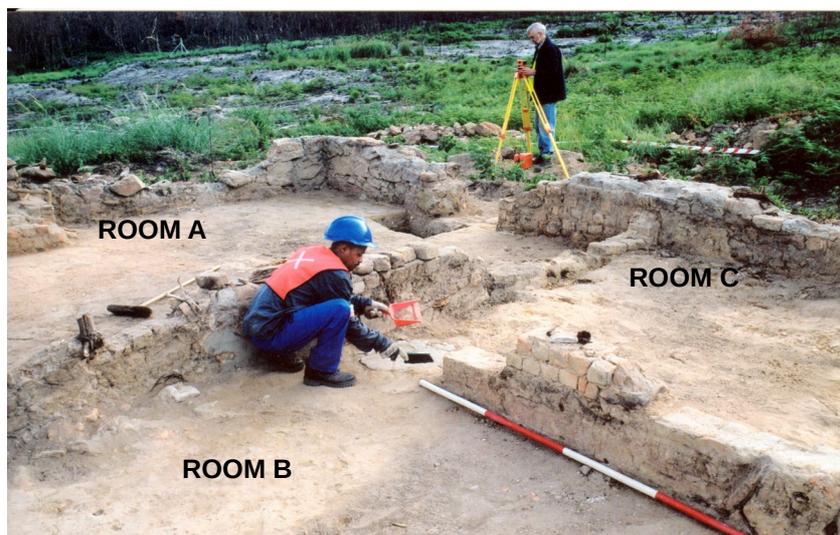
Plate 5: Note portion of eastern wall constructed of brick. Jonathan Williams is cleaning part of a preserved cement floor dating to the early 20th century

There is evidence that the remainder of the eastern wall above the footing was constructed with sun-dried or raw brick (Plate 5). The bricks are soft, extremely vulnerable to the elements and tend very rarely to survive.

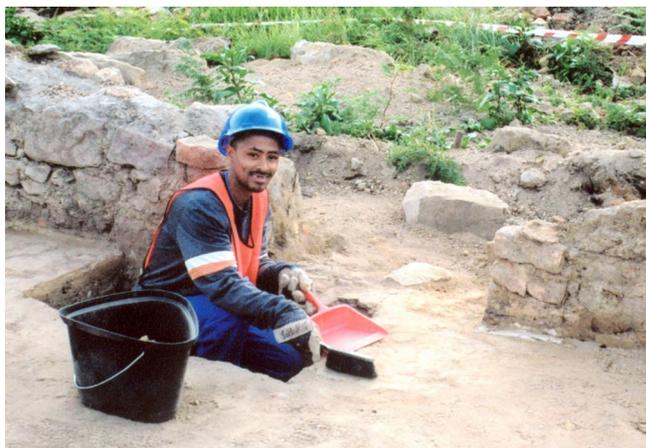
Plate 6: Exterior doorway in Room A. Note the change in building material (stone vs brick) as well as the compacted clay which formed the base for a 20th century cement floor.

Room A measures roughly 4x5m. An exterior doorway is evident in the eastern wall of this room, and the 20th century floor level is indicated by a cement plaster (Plate 6). Floor surfaces have been preserved in two places in Room A; a cement one at the eastern doorway and in the south-western corner of the room, measuring 143cm and 135cm below datum respectively.

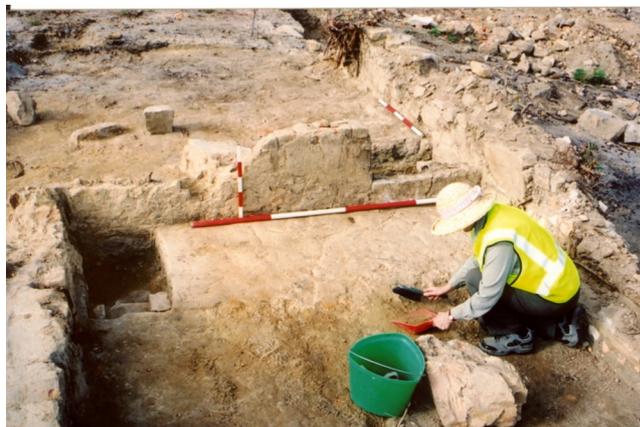
Plate 7: Mary Patrick cleaning the compacted clay floor in Room B. Note the cement step from Room D. Test Pit 3 is in the centre left.

Room B is a small room measuring 4x2m. Access into this room was via doorways from Room C and Room D. Cement and clay floor surfaces have been preserved in both these doorways. The floor surface from Room D drops by 18cm (via a cement plastered step) to a clay floor surface in Room B, which measures 130cm below datum. A cement floor surface is preserved in the doorway between Room B and Room C (Plate 5). The level of this floor measures 124cm below datum.

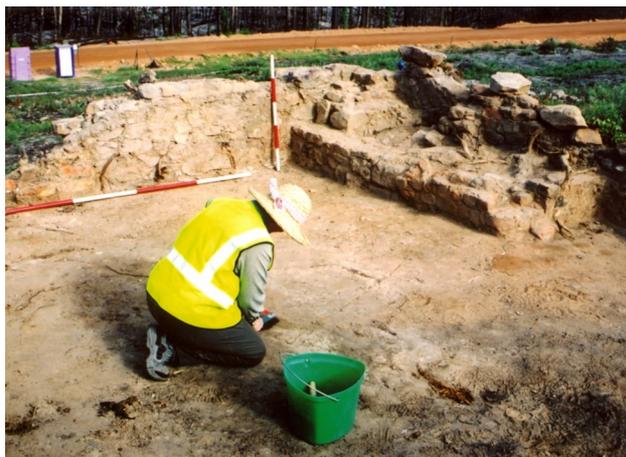
Plate 8: Hearth in Room A. Note the later brick addition, making it a double hearth.

The hearth in Room A consists of two parts; the part in the north-western corner is built of stone and measures 107cm below datum. The hearth at some point was enlarged and this section is built with brick and measures 105cm below datum (Plate 7). A portion of cement plaster suggests that this feature was still in use during the 20th century reuse of the building.

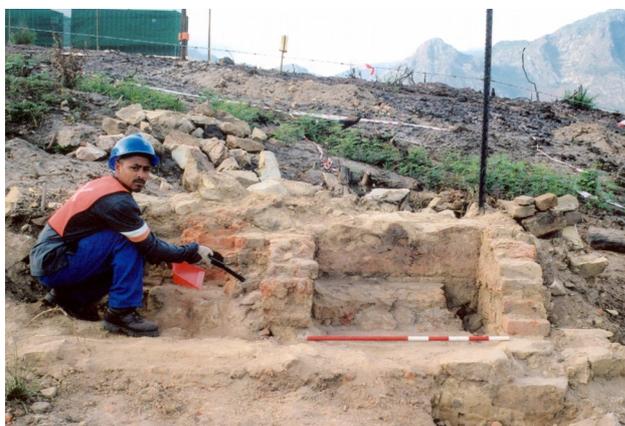
Plate 9: Hearth in Room E. This hearth is entirely build of brick and dates to the forestry period.

The hearth in Room E is a later addition; it is built with later bricks and is flush with the stone exterior wall. It is a double hearth similar to the one in Room A (Plate 8). The position of a metal plate in one half of the hearth is marked by the metre stick.

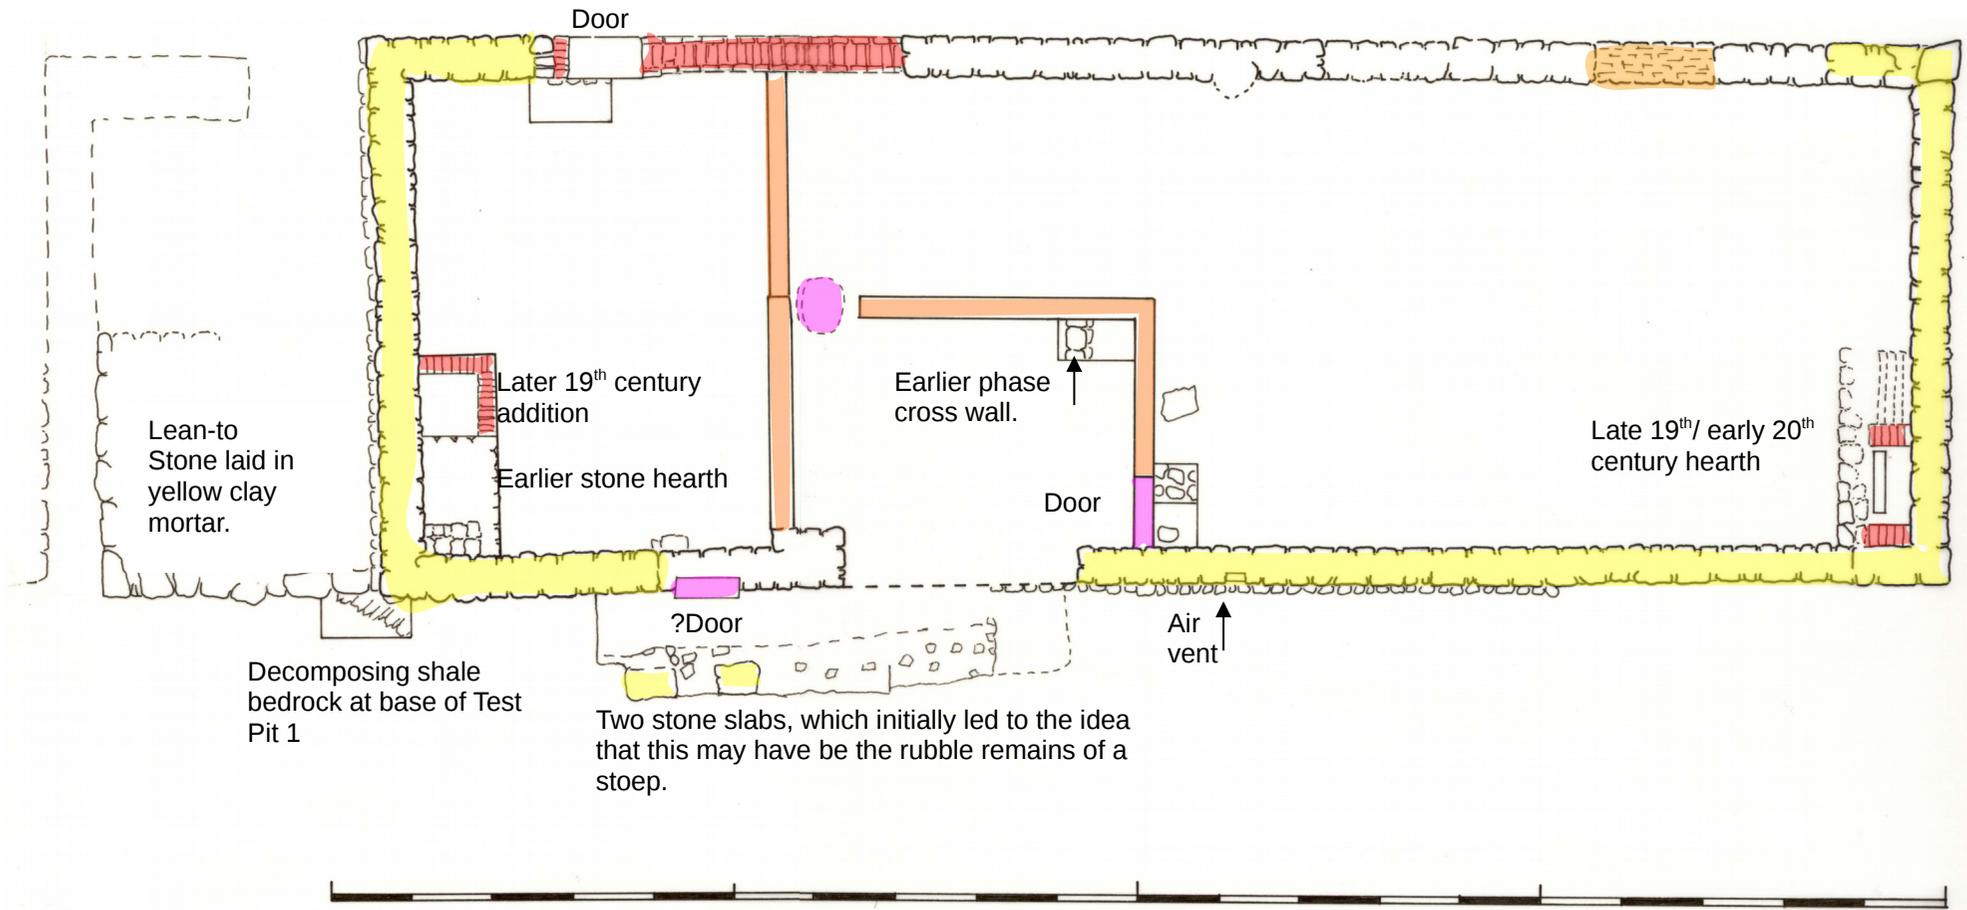
- KEY:**
- Dressed sandstone
 - Raw brick and clay mortar
 - Fired brick
 - Cement

Figure 5: Skuifraam-1. Annotated floor plan, showing the use of raw materials.

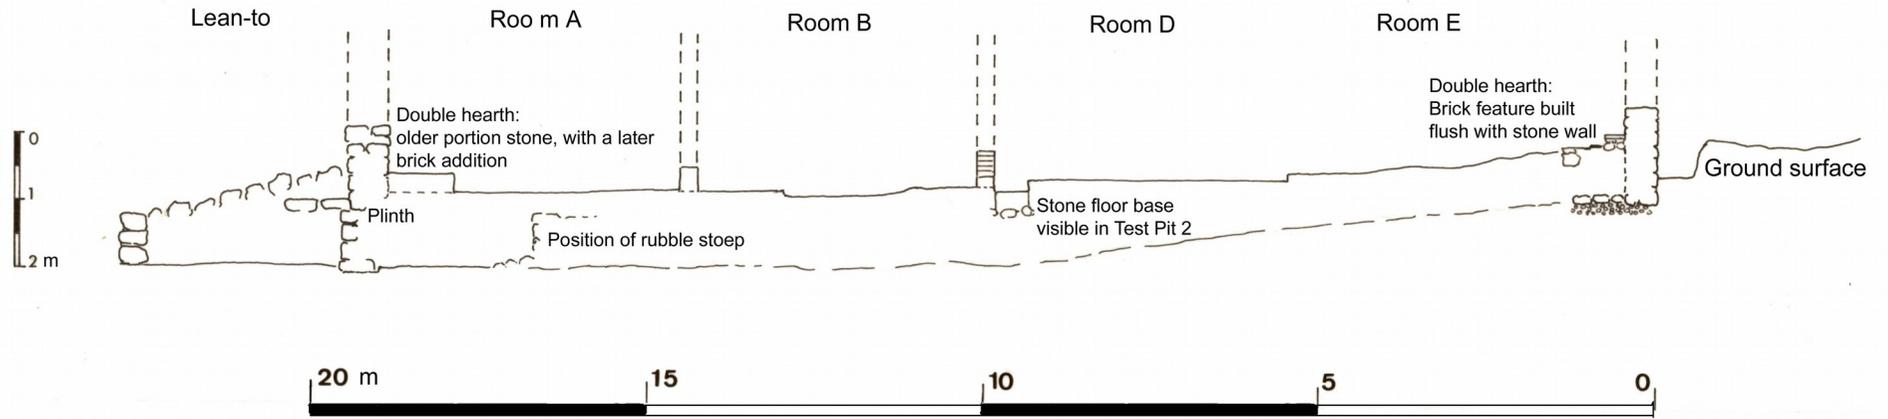
Figure.6: Skuifraam-1. Elevation of the western façade, drawn facing eastward.

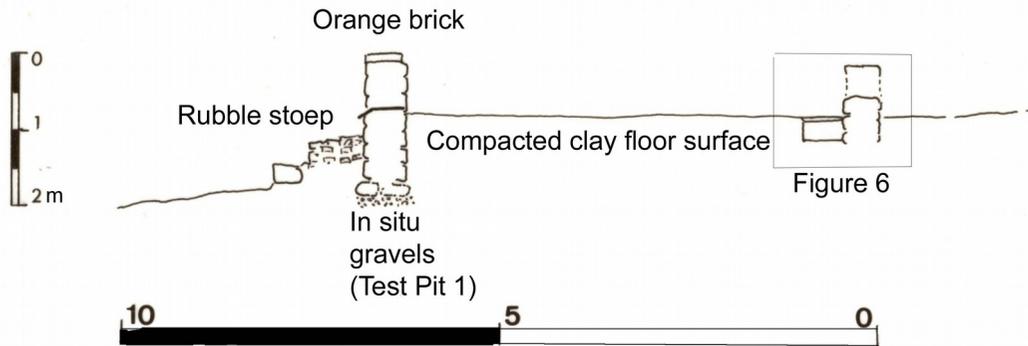
Figure.7: Skuifraam-1. Cross-section of Room A, drawn looking northwards. (Correction: Detail marked Figure 6, should read Figure 9)

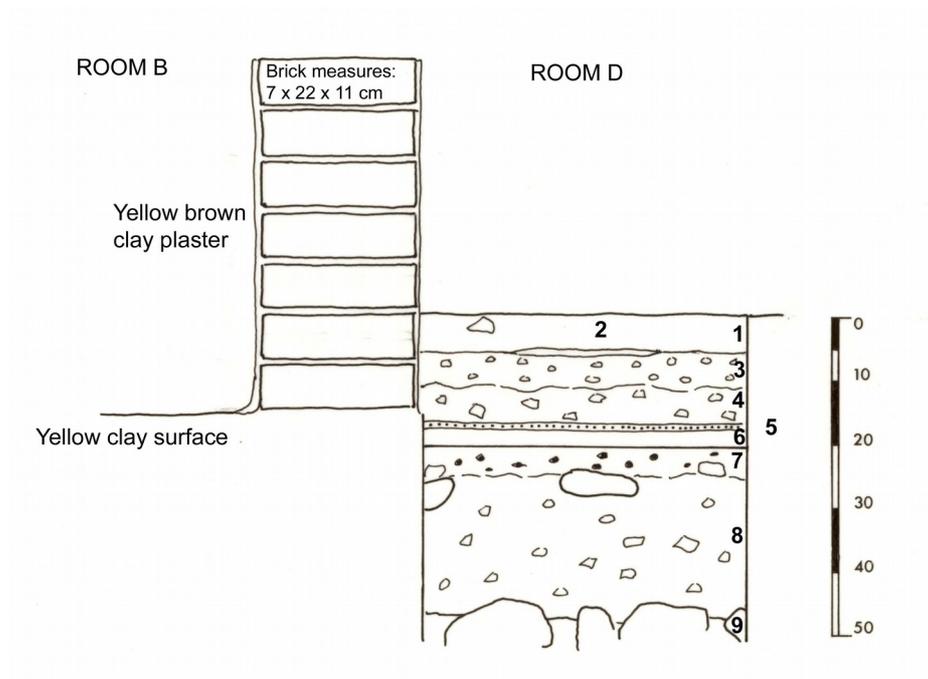
Key to layers:

- 1 YELLOW COARSE CLAY FLOOR with bits of lime and brick rubble
- 2 LENS OF WOOD (possible flooring remnant)
- 3 COMPACTED CLAY BRICK RUBBLE, light cream in colour
- 4 BROWN GREY FILL, RUBBLE & SOOT
- 5 FINE CLAYEY-SAND FLOOR, dark brownish in colour
- 6 YELLOW CLAY FLOOR – sterile
- 7 RUBBLE FILL, fine matrix with charcoal specs
- 8 RUBBLE FILL, with brown soil and orange brick specs
- 9 BEDDING STONES possibly forming base for raised floor surface

Figure 8:Skuifraam-1. Eastern section of Test Pit 2, Room D.

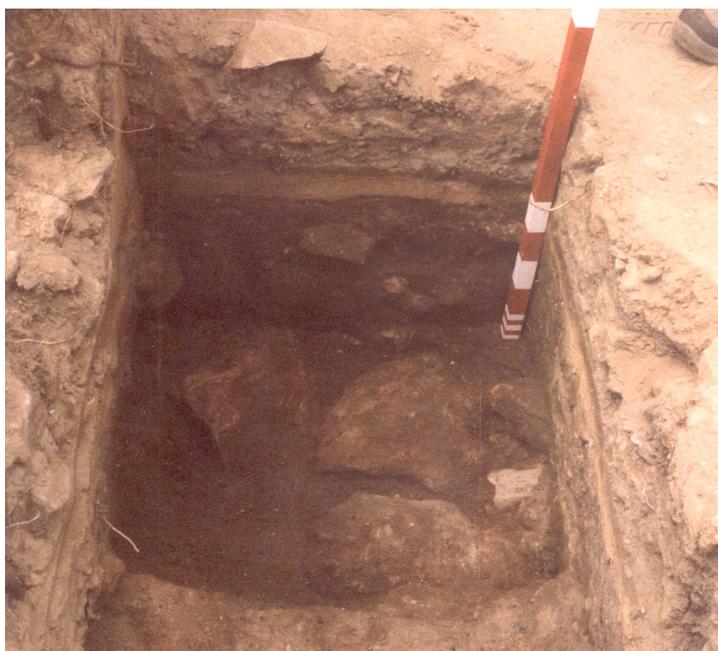
Plate 10: Skuifraam-1. Eastern section of Test Pit 2.

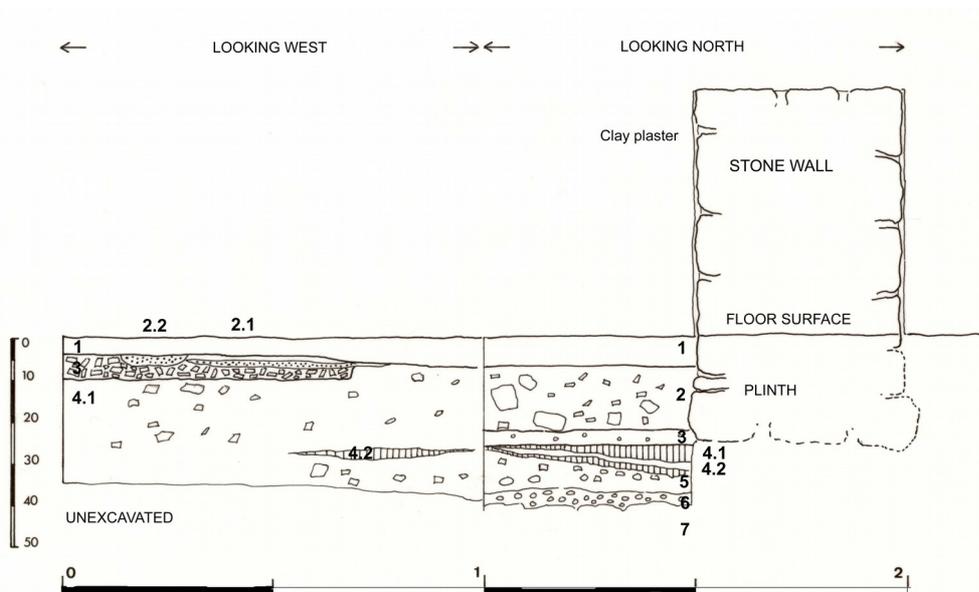
Key to layers:

LOOKING WEST

- 1 YELLOW CLAY FLOOR
- 2 LENSES OF DARK BROWN SOIL
- 3 FLOOR OF HARD LIME PLASTER
- 4.1 RUBBLE FILL with brick pieces, orange specs & yellow clay
- 4.2 DARK BLACK LAYER – burnt material

- 1 YELLOW CLAY FLOOR
- 2 FILL of light cream, brick pieces & specs, lime plaster – indicates earlier building phase
- 3 DARKISH BROWN SOIL with specs orange brick
- 4.1 DARK BLACK LAYER – burnt materi
- 5 LENS WATERLAIN SOIL, light brown colour
RUBBLE FILL of yellow/orange clay and brick pieces
- 6 GREYSIH GRAVEL, with small pebbles
- 7 GRAVEL, associated with paleo-river system

Figure 9: Skuifraam-1. Western and northern section of Test Pit 4, Room A.

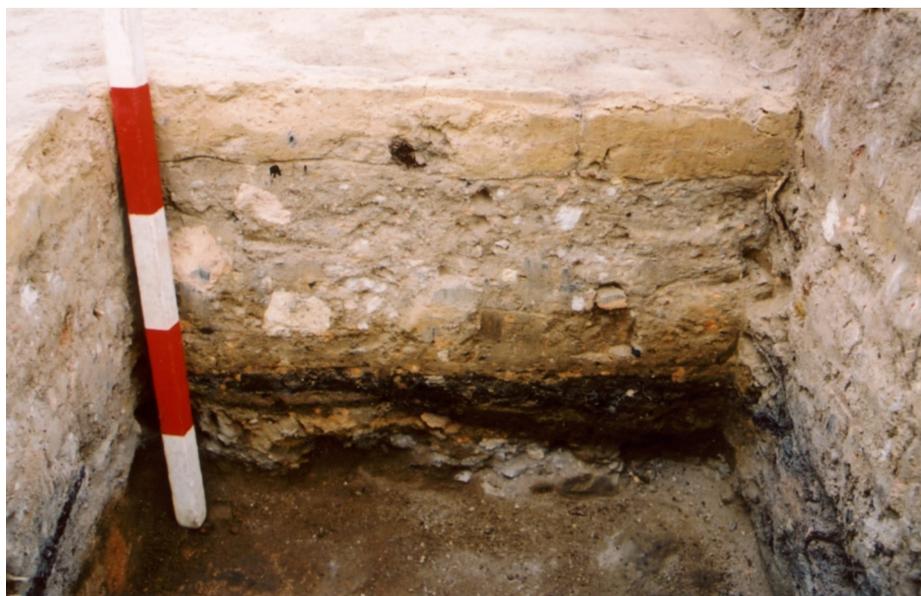
Plate 11: Skuifraam-1. Northern section of Test Pit 4.

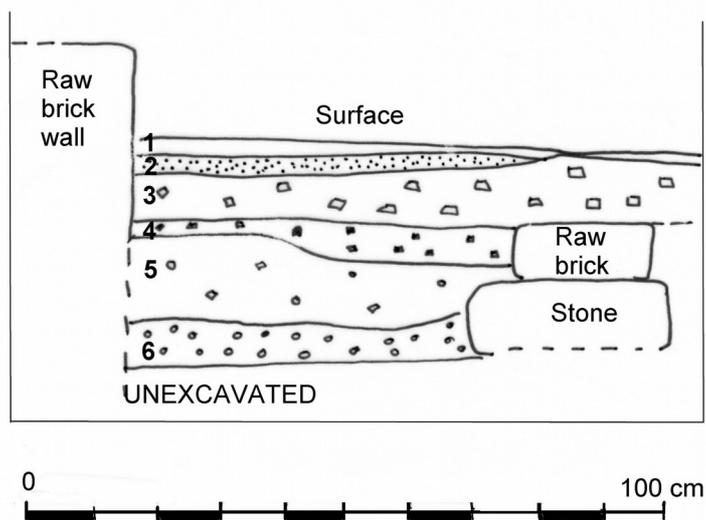
Key to layers

- 1 YELLOW CLAY FLOOR
- 2 FILL, plaster and cement
- 3 RUBBLE, red brick, plaster and charcoal specks
- 4 RUBBLE, raw brick, plaster and charcoal specks
- 5 RUBBLE, compact and gravelly with plaster specks
- 6 RUBBLE, compact and gravelly with plaster specks

Figure 10: Skuifraam-1. Western section of Test Pit 3, Room B.

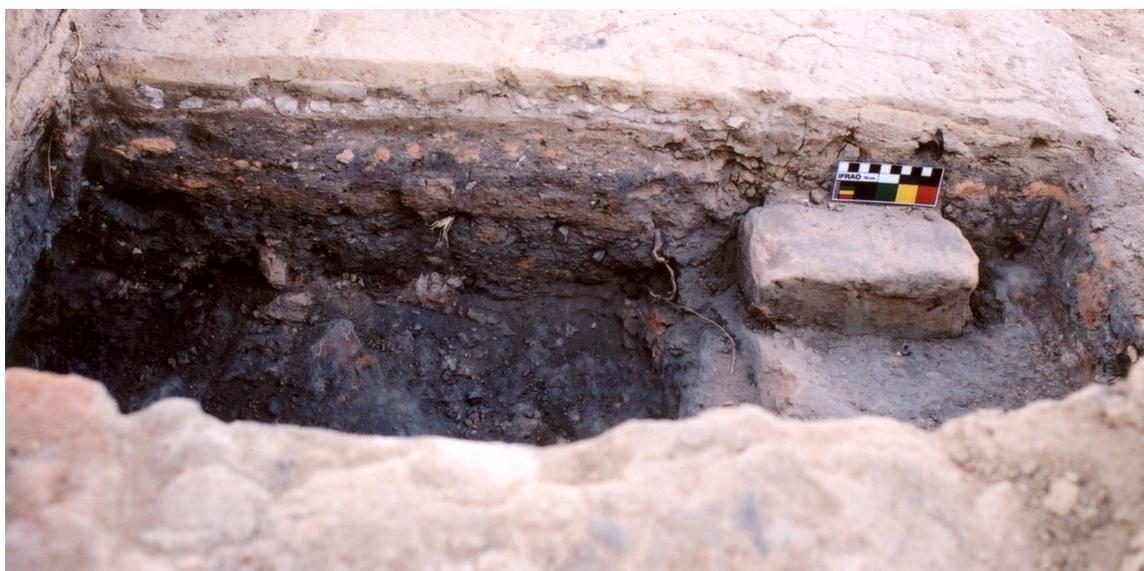
Plate 12: Western section of Test Pit 3, Room B.

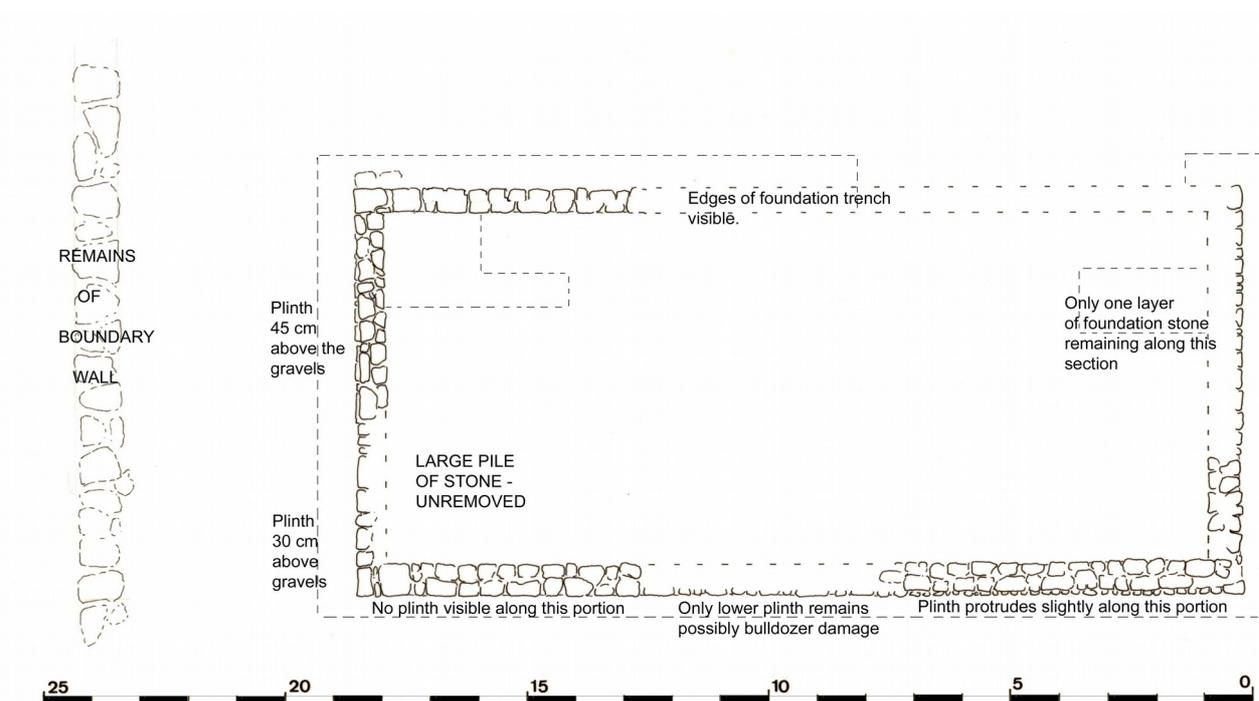
Figure 11. Skuifraam-2: Annotated floor plan of the structure. All surviving walls are of dressed stone and have plinths. (Scale in m).

The northern wall of Skuifraam-2 has a substantial stepped plinth. Along the eastern side, no stone walling was found in tact, in fact the only evidence of a wall was found in the change in soil colour indicating the foundation trench. Along the southern wall, the remaining plinth is only one stone deep, and is buried under nearly 1.8m of sandy deposit. The southern footing cuts into the natural white/yellow clay. This wall does not seem to be as solidly built as its northern counterpart and in some places resembles smallish chunks held together with clay mortar. The western wall of Skuifraam-2 appears to be partially built of stone and sits on top of a stone plinth. The middle part of the wall has not survived. One gets the impression that a bulldozer may have driven through the middle of this structure at some point. It also seems as if stones from this structure were removed and used in the rebuilding of Skuifraam-1.

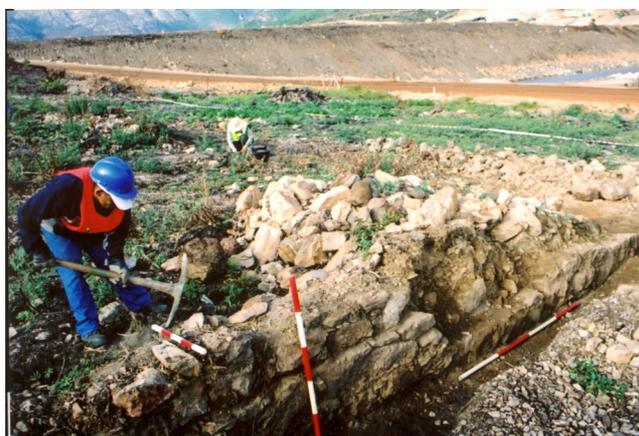
Plate 13: North wall. Note the very fine stepped plinth.

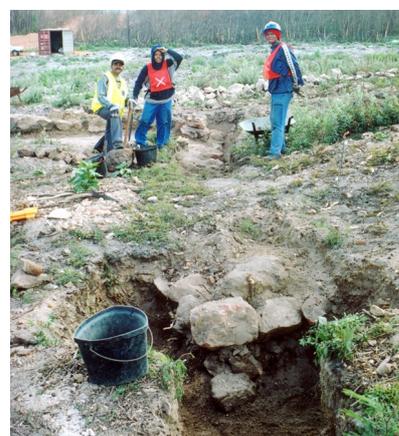
Plate 14: East wall, which was only partially preserved.

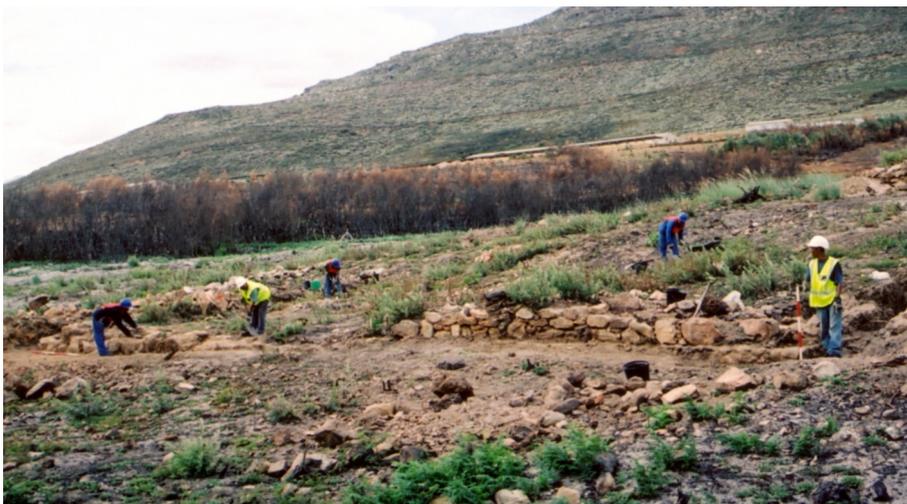
Plate 15: West wall. This wall is fairly well preserved, but the middle portion only retained the plinth. It is possible that this is also damaged caused by a bulldozer.

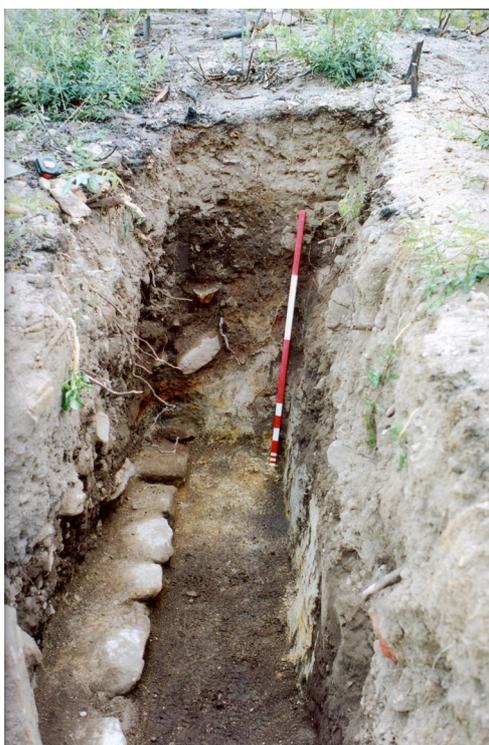
Plate 16: South wall. The foundation of this wall cut into the underlying natural clays. Only the plinth has survived.

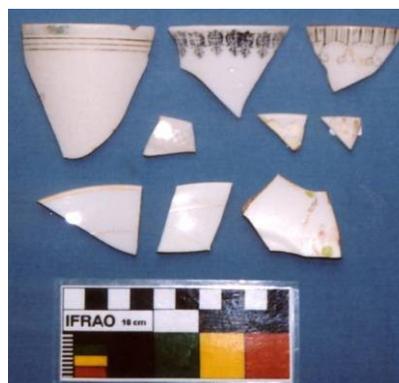
Plate 18: British porcelain, typical of 20th century.

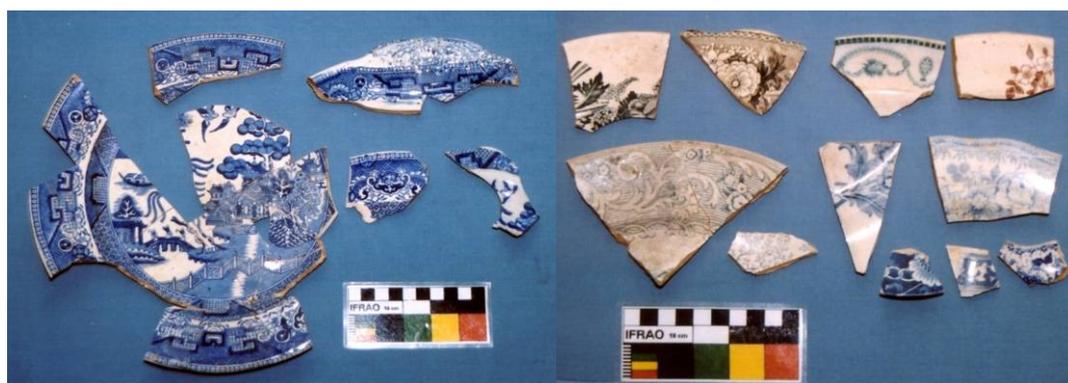
Plate 19: Transfer printed refined earthenware (REW); Willow pattern on the left and a selection of single colour transfer printed on the right. The fragment of Willow pattern to the top right of the scale is on British porcelain.

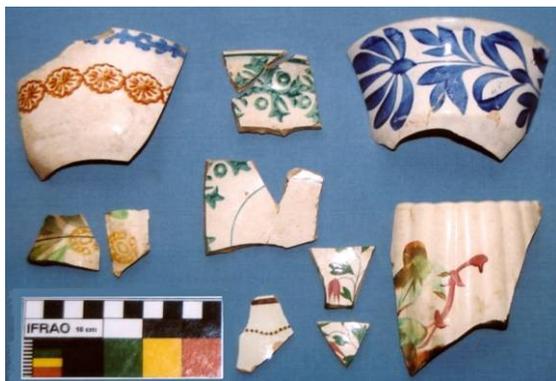
Plate 20: Hand painted and sponged decoration on REW.

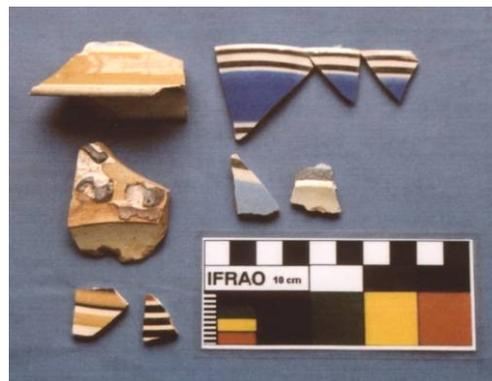
Plate 21: Industrial slipware

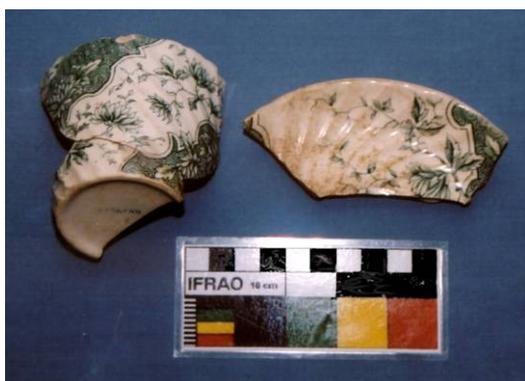
Plate 22: Vitrified REW/Ironstone

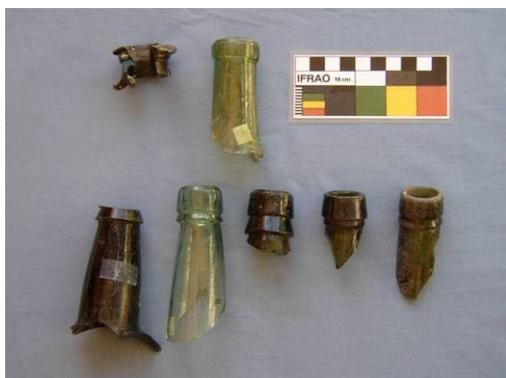
Plate 23: The flared lip on the top left is from an earlier style casement bottle. The remaining examples have no seams on either neck nor lip, indicating that they were handblown with the lip laid on by hand c1830.

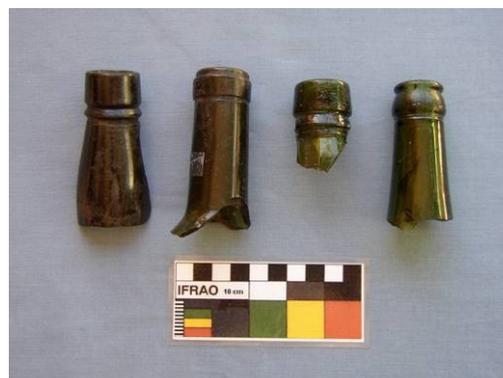
Plate 24: The bottle on the left has a seam on the neck, but not on the lip, indicating that it was manufactured 1810-1880. The two bottles in the centre were manufactured between 1881 and 1920. The bottle on the right (crown top) were manufactured from 1903 onwards.

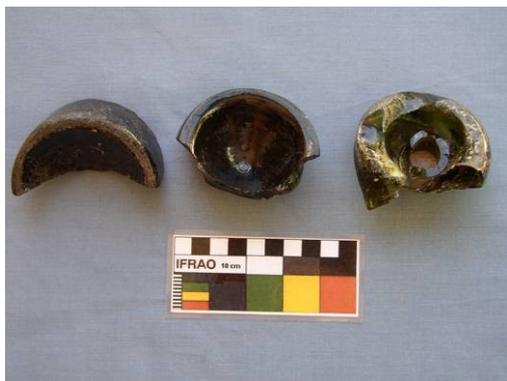
Plate 25: Pontil scars indicate that the bottle was manufactured prior to 1860.

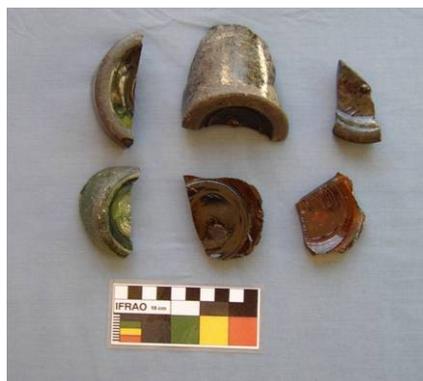
Plate 26: Mould blown bottles post 1860 and modern machine made bottles on the right.

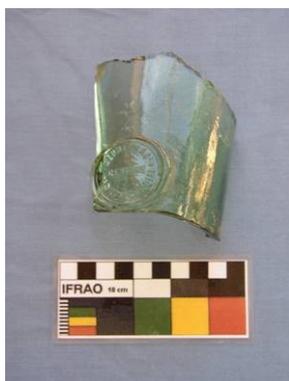
Plate 27: Bernard & Co Old Tom Cordial, post 1875.

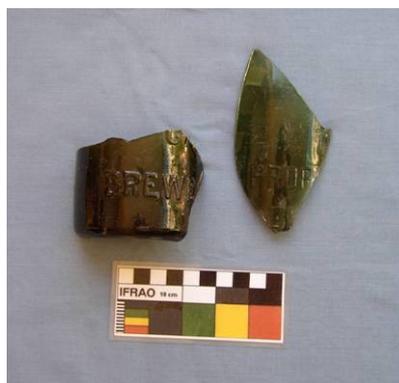
Plate 28: Markings of Ohlson's Cape Brewery beer bottles. The one on the left may be a South African Brewery.

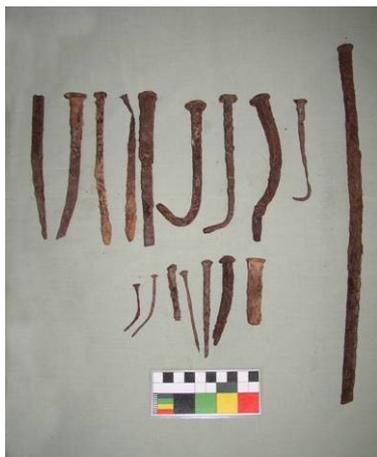
Plate 32: Selection of roofing nails on top row. Small nails on bottom left are horse shoe nails.

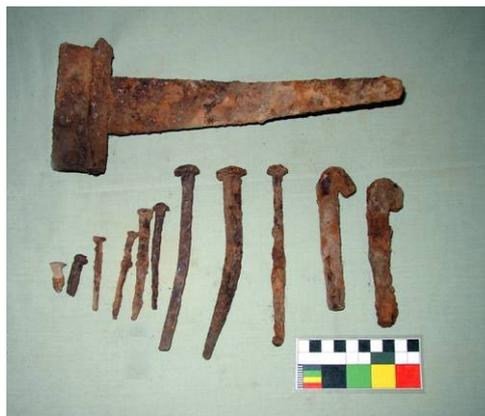
Plate 33: Gate hinge and roofing nails.

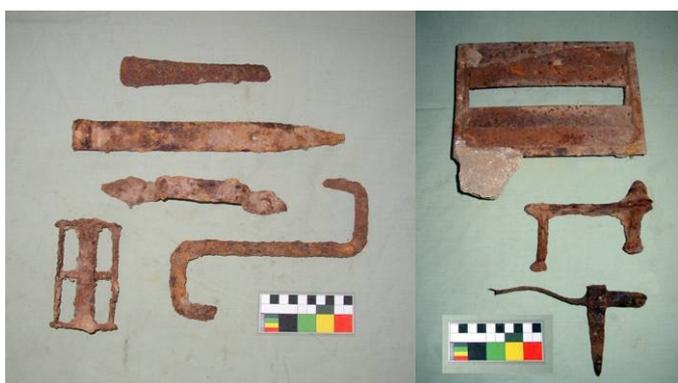
Plate 34: Bicycle parts on the left and building hardware on the right.

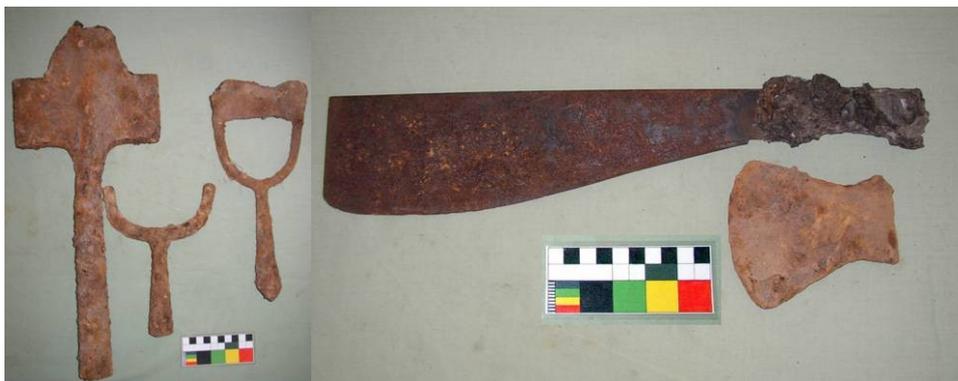
Plate 36: Digging implements on the left, hoe and shovel and wood cutting implements on the right. The Panga is post c1960, dated by the introduction of plastic handles which replaced wooden handles.

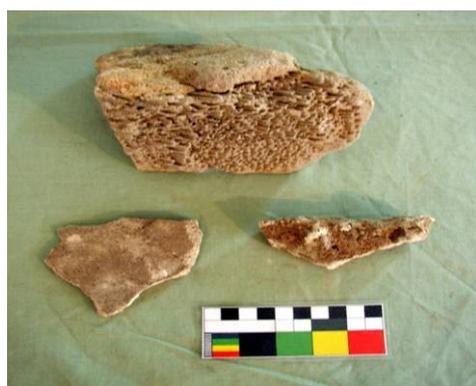
Plate 37: Roofing Plaster which showing that Skuifraam 1 had a thatched roof

The building material recovered from site falls into four categories. Namely, brick, plaster, and dressed stone manufactured by a mason, roofing nails, bolts and gate hinges. The average brick measures 220 x105 mm, and is made from sun-dried orange clay. Plaster is distinguished by colour and roofing plaster varies from the plaster used to cement bricks walls.

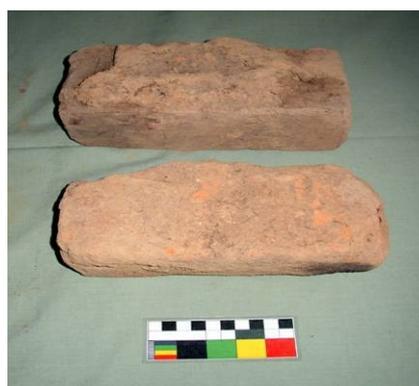
Plate 38: Sun-dried clay bricks

still holds: sun-dried clay bricks are indicative of an earlier date: Nineteenth century bricks tend to be ‘softer’ with a more orange colour and are often used together with a yellowish clay mortar. The relative dating of bricks are complicated by the wide variety in quality to be found in the same batch. Twentieth century bricks have a redder colour and are usually harder.
