**PETROSA – PROPOSED BYPASS PIPELINES AND REPOSITIONING OF SINGLE-
POINT MOORING (SPM) BUOY
MOSSEL BAY,
SOUTH AFRICA**

UNDERWATER HERITAGE IMPACT ASSESSMENT

Report #: 2022/WC/002
Status: Final
Revision #: 2
Date: 26 October 2022

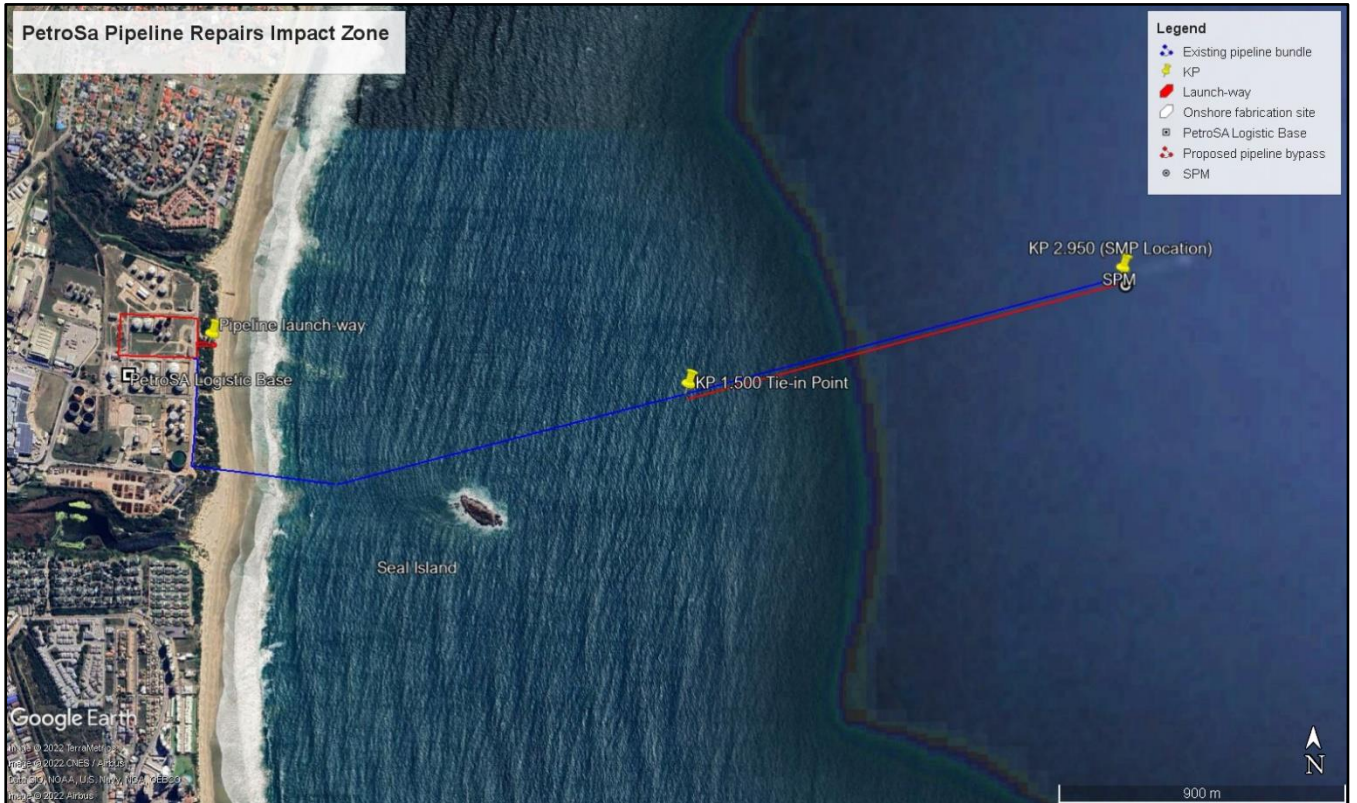
Figure 1: PetroSA existing pipeline (blue) and proposed bypass pipelines (red)

This project is the repair / modification of the existing SPM pipeline infrastructure from the PetroSA Tank Farm (Figure 1; Figure 2) by installing two new ~1.4 km long bypass steel pipelines (12" and 14"), connected to the existing SPM infrastructure, to bypass the corroded section. The new pipes will be fabricated and assembled at the Onshore Fabrication Yard within the PetroSA Tank Farm – 400 m to the north of the existing pipeline. Thereafter it will be towed to the installation route. The pipelines are towed using buoyancy tanks and ballast weights to ensure the pipes are kept off the seabed. They are then parked while awaiting a suitable weather window for installation (Figure 2: A1-A2). The new pipeline section will be installed parallel to and 15 m away from the corroded section (Figure 2: A3-L3). The bypass pipeline will be jetted below the seabed and allowed to backfill naturally (CONSUB Doc. No: C-0022-PLI-PHI-001). Several hydrographic surveys will be undertaken during the execution of the work.

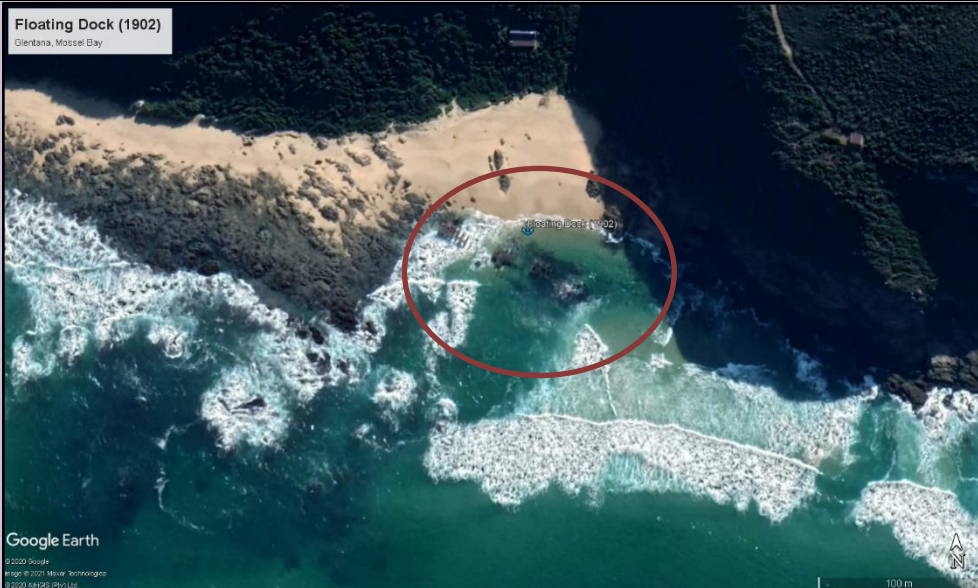
<p>Figure 13: Visible remains of the wreck of the Floating Dock (1902) (Google Earth 2020)</p>	
13	<i>Galatea</i>	Aground, wrecked	Britain	1846-10-10	Wood brig	<p>This 223-ton vessel was built in 1829 at Chepstow, U.K. Under Captain T. Owen, she was anchored at Mossel Bay and parted her cables during a south-easterly gale. The vessel was wrecked on the rocks at 2 in the morning and four people drowned. (Turner 1988; van den Bosch 2009). According to Levine (1989), she was wrecked at "Danger Point", and her bell was recovered in 1970.</p>	Danger Point
14	<i>Galera</i>	Aground, wrecked	Norway	1892-08-25	Wood barque	<p>This vessel of 446 tons was built in 1873. Under Captain J.M. Abrahamsen, on a voyage from the Friendly Isles (present day Tonga, Polynesia) to France, with a cargo of copra, she was in Mossel Bay when a south-easterly gale sprung up. She was "wrecked in the big gully on the west side of Danger Point, Mossel Bay ... 34° 10.30 S 22° 08.00 E" (Turner 1988: 179). Apparently, Turner dived on the site in 1983 but not much was visible due to sand.</p> <p>The co-ordinates in Turner (1988) are often incorrect, as Turner was trying to keep certain wreck locations secret from other salvors. However, his co-ordinates are in the general vicinity of what Scheffler (1990) names Danger Point, near the old whaling station. No historical maps record this name.</p>	Danger Point

12	<i>Floating Dock</i>	Aground, wrecked	South Africa	1902	Steel Floating dock	Durban port ordered a large floating dock, it measured 122 x 24 m, it was capable of lifting vessels of 4 000 tons. The dock was in tow from Tyne (United Kingdom) however, a gale was blowing when the vessel broke tow from the <i>Baralong</i> . A tug and a steam trawler tried to save the dock, but the seas were too big. The dock was washed high on the beach at Glentana. The iron hulk is still visible (Figure 13). Her iron railings were repurposed outside the Anglican Church in George and a flight of iron steps was used at a house in York Street, George (Green 1969)	Glentana Beach
