## **9. HISTORIC OVERVIEW OF OTHER FEATURES FROM WITHIN THE STUDY AREA**

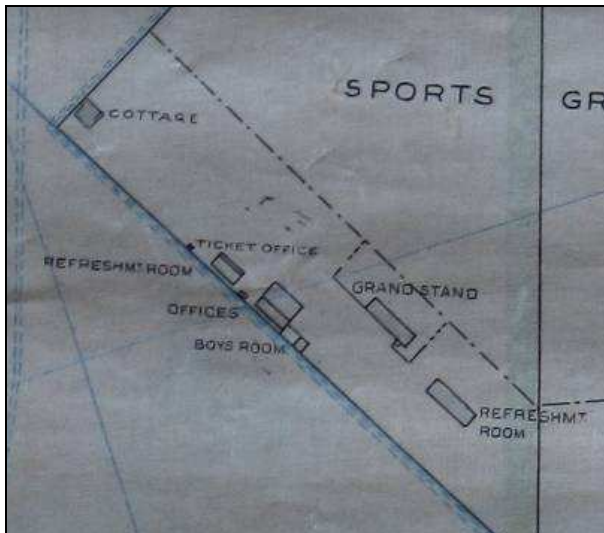
Figure 18

Enlarged section of the map titled 'General surface Plan of the New Comet Gold Mine'. Although the map was surveyed on 30 June 1907, it was revised annually for the subsequent three years. The last revision was undertaken on 30 June 1910. It shows the sports field with all its associated buildings as it existed at the time. The north-eastern corner of the old married quarters provides a reference for the position of the sports field as a whole. A further enlargement of the section containing the buildings associated with the sports field is depicted on the left.

The next important information comes from a map titled 'General surface Plan of the New Comet Gold Mine'. Although the map was surveyed on 30 June 1907, it was revised annually for the subsequent three years. The last revision was undertaken on 30 June 1910. The map shows the sports field with all its associated buildings, including a grand stand, two refreshment rooms, a ticket office, offices, 'boys room' and cottage.

On the revised map dated to 30 June 1910 (see Figures 16 & 18) no roads are depicted within the study area. The two roads from the previous map located directly to the west of the study area have been replaced by a single road known as Main Reef Road which runs along the north-south axis through the eastern end of the old married quarters.

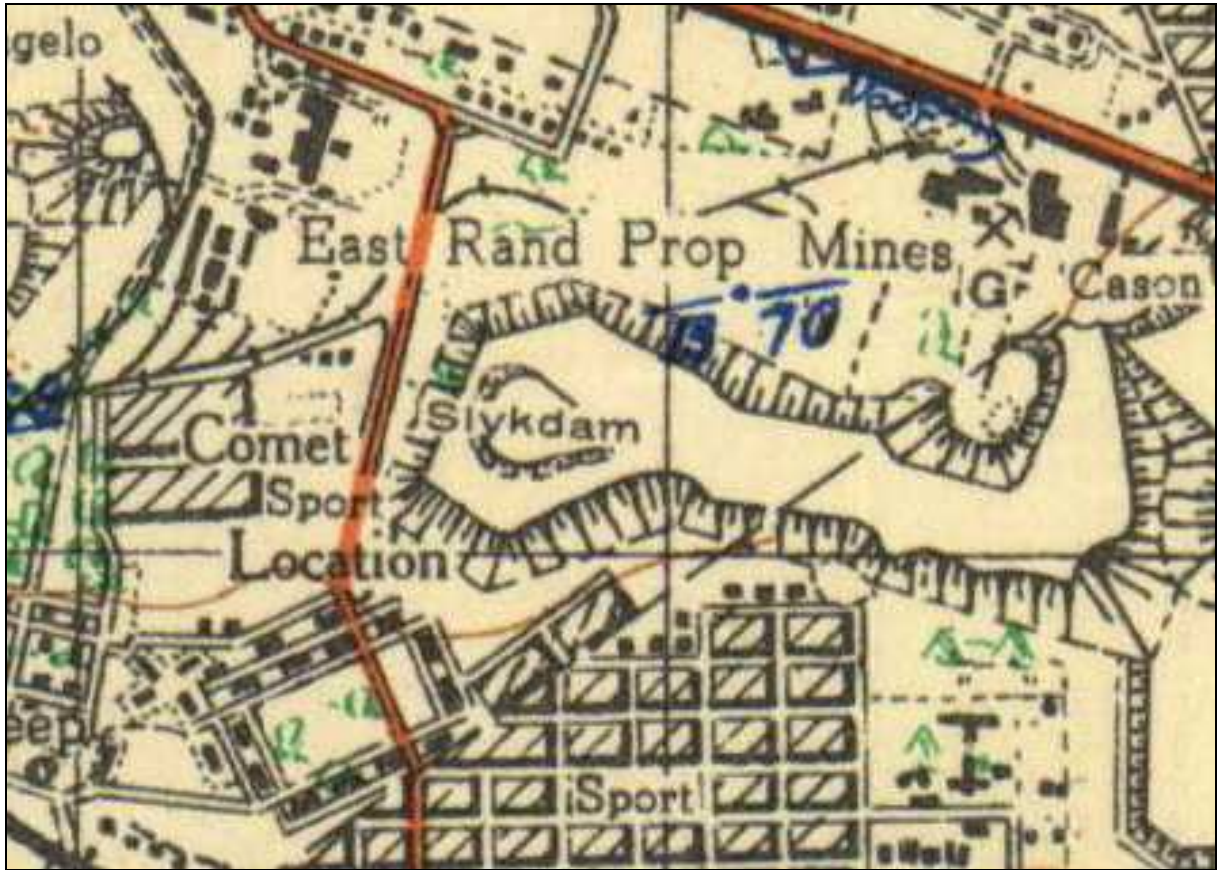
Figure 19 Enlarged section of the Second Edition of the 2628AA Johannesburg sheet of the 1:50 000 topographical map series. This map was surveyed in 1939, and printed in 1945. It represents the earliest available map which depicts the slimes dams within the study area.

The next available image of relevance is the 1939 topographical sheet. For the first time it shows roads associated with the old and new married quarters. This said it is important to note that these roads were likely built at the same time (or shortly after) the married quarters were constructed. Roads are shown on the inside and outside of the old married quarters. Although not clearly shown on the map, the aerial photograph from this time (see Figure 23) shows Maple Avenue from the Vogelfontein Plantation suburb linking up with the inner road from the old married quarters and thereby providing access for the residents of the latter suburb to Main Reef Road. Furthermore a road is shown going around the four terrace buildings associated with the new married quarters and another one linking the four terraces with the Vogelfontein Plantation area by connecting with Pine Street. This latter road splits the four terrace buildings into two clusters containing two terrace buildings each. The road going around the four terrace buildings are presently named Forest Street and the road linking up with Pine Street is also named Pine Street.

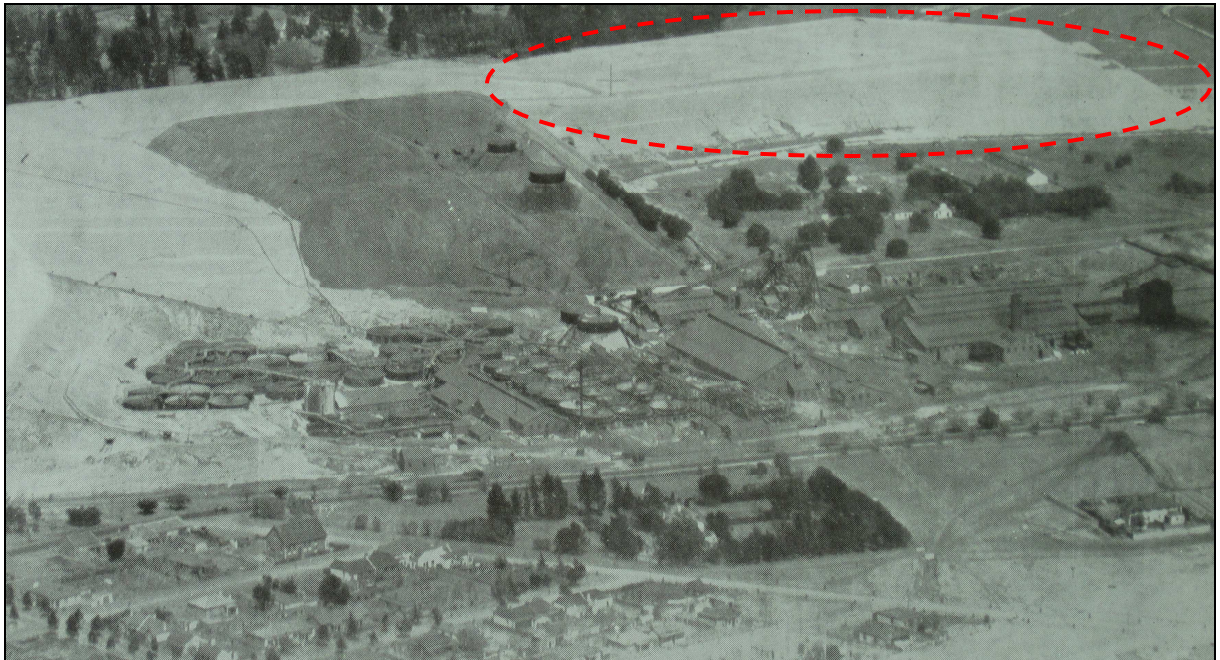
Figure 20 Historic photograph of the Cason Slimes Dams as seen from the north-east. The photograph appeared in a book titled *Boksburg: Mining and Industrial Activity* which was published in 1937. The section of the slimes dam that was located within the present study area is marked.

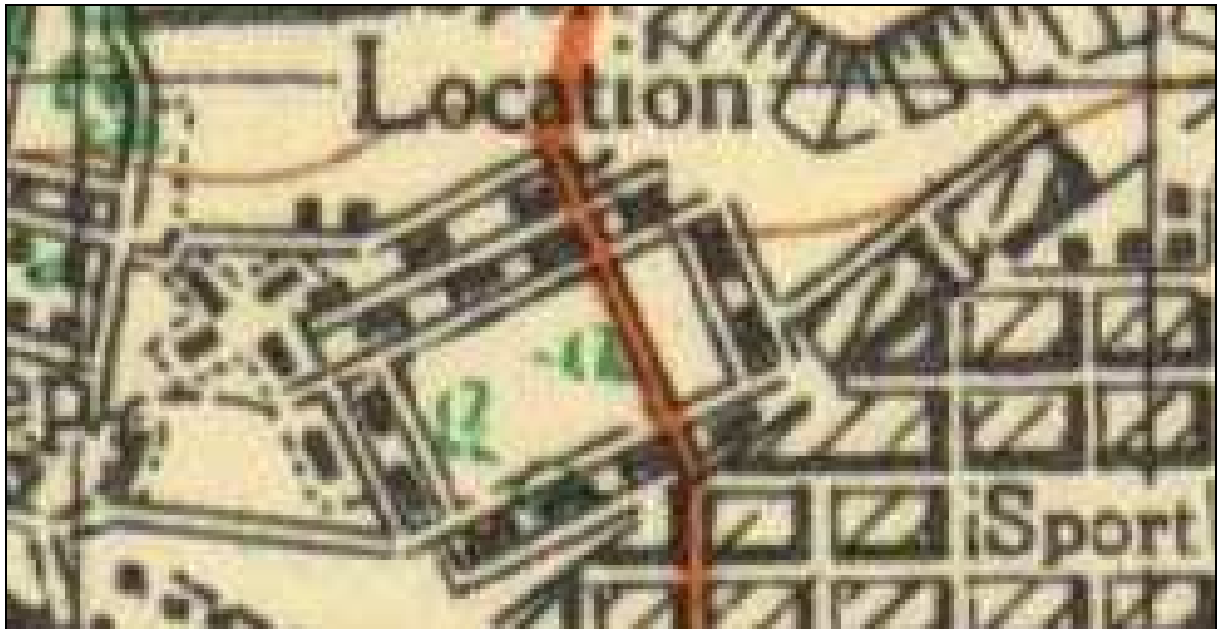
Figure 21 Enlarged section of the topographical sheet was surveyed in 1939 and printed in 1945. The road network located within the study area and associated with the old and new married quarters can clearly be seen.

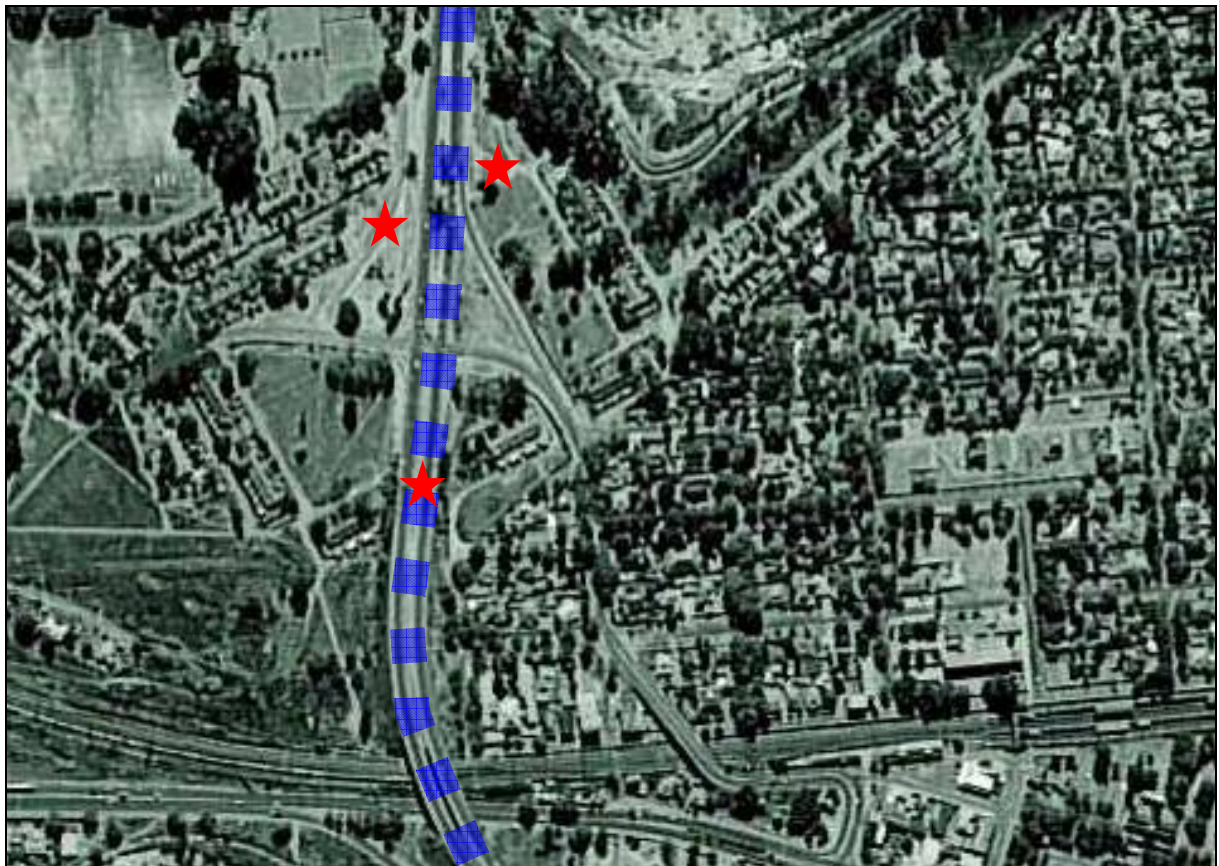
Figure 23 This aerial photograph was taken in 2002. Rondebult Road is marked in blue, whereas the three buildings from the old married quarters that were demolished as part of its development is indicated with red stars.

The last observation to be made about the chronology of the roads from within the study area and its direct surroundings is that a short time before 2002 the Gauteng Provincial Roads Department and the Boksburg City Council extended Rondebult Road over the railway line east of East Rand Station to join Rietfontein Road in Boksburg North crossing over ERPM property in the process (Wood, n.d.). This road development resulted in the demolishing of three buildings from the old married quarters, two of which was located within the study area. South and outside of the study area a blockhouse from the South African War (1899-1902) was also destroyed.

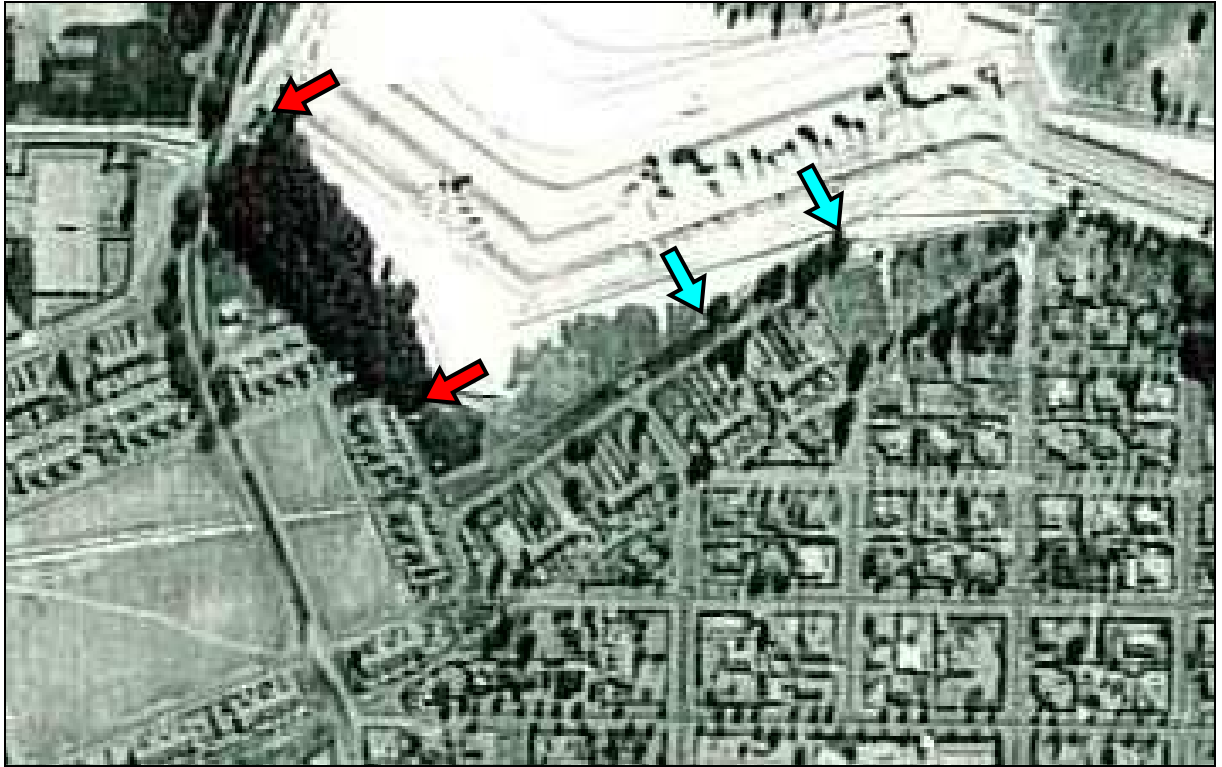
Figure 24 Section of an aerial photograph taken in 1939. The trees located at the south-western end of the slimes dam and the trees along the drainage line south of the slimes dam are marked with red and blue arrows respectively.

A large number of trees are located all along the drainage line or watercourse south of the slimes dam. These are mostly eucalyptus trees. None of the maps from before the construction of the slimes dam depict any trees in this area. The earliest indication of trees in this area is on the 1939 aerial map. At the time only a few can be seen towards the east of the study area. The 1984 aerial photograph shows a marked increase in the numbers of trees in this area of the study area.

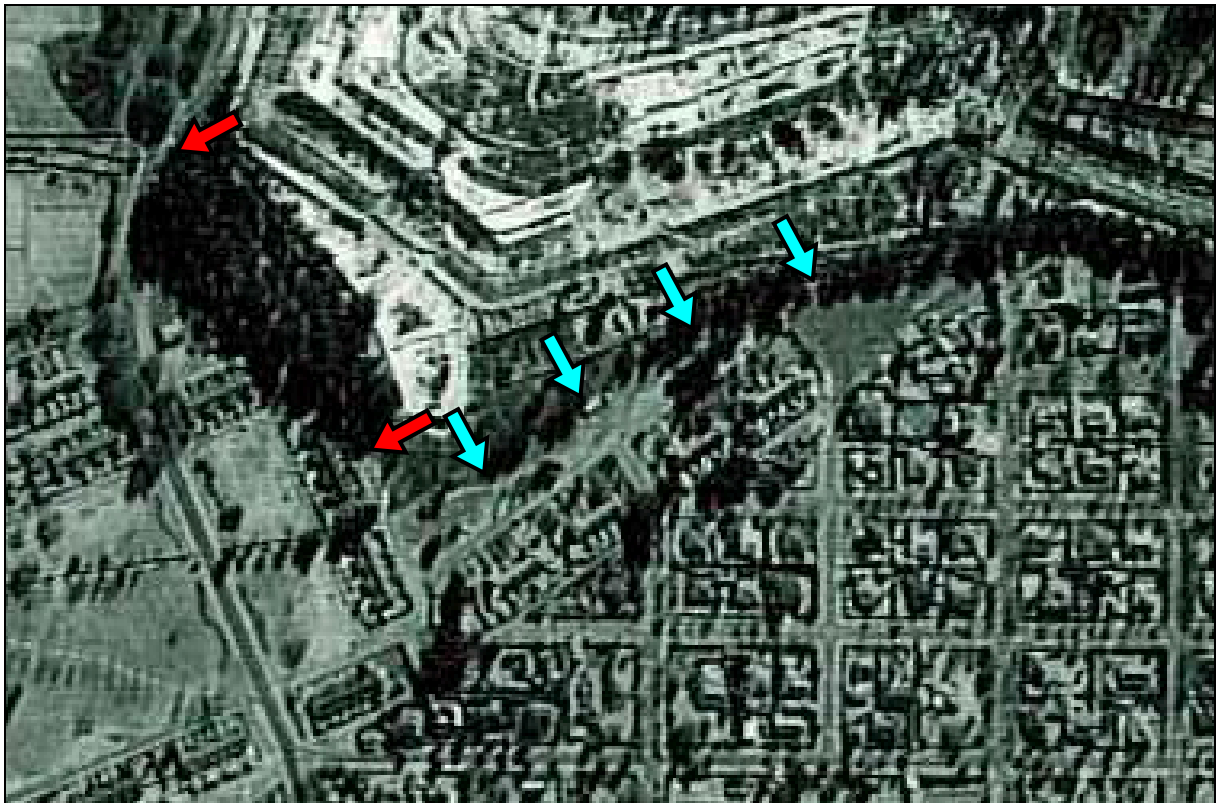
Figure 25 Section of an aerial photograph taken in 1984. The trees located at the south-western end of the slimes dam and the trees along the drainage line south of the slimes dam are marked with red and blue arrows respectively.

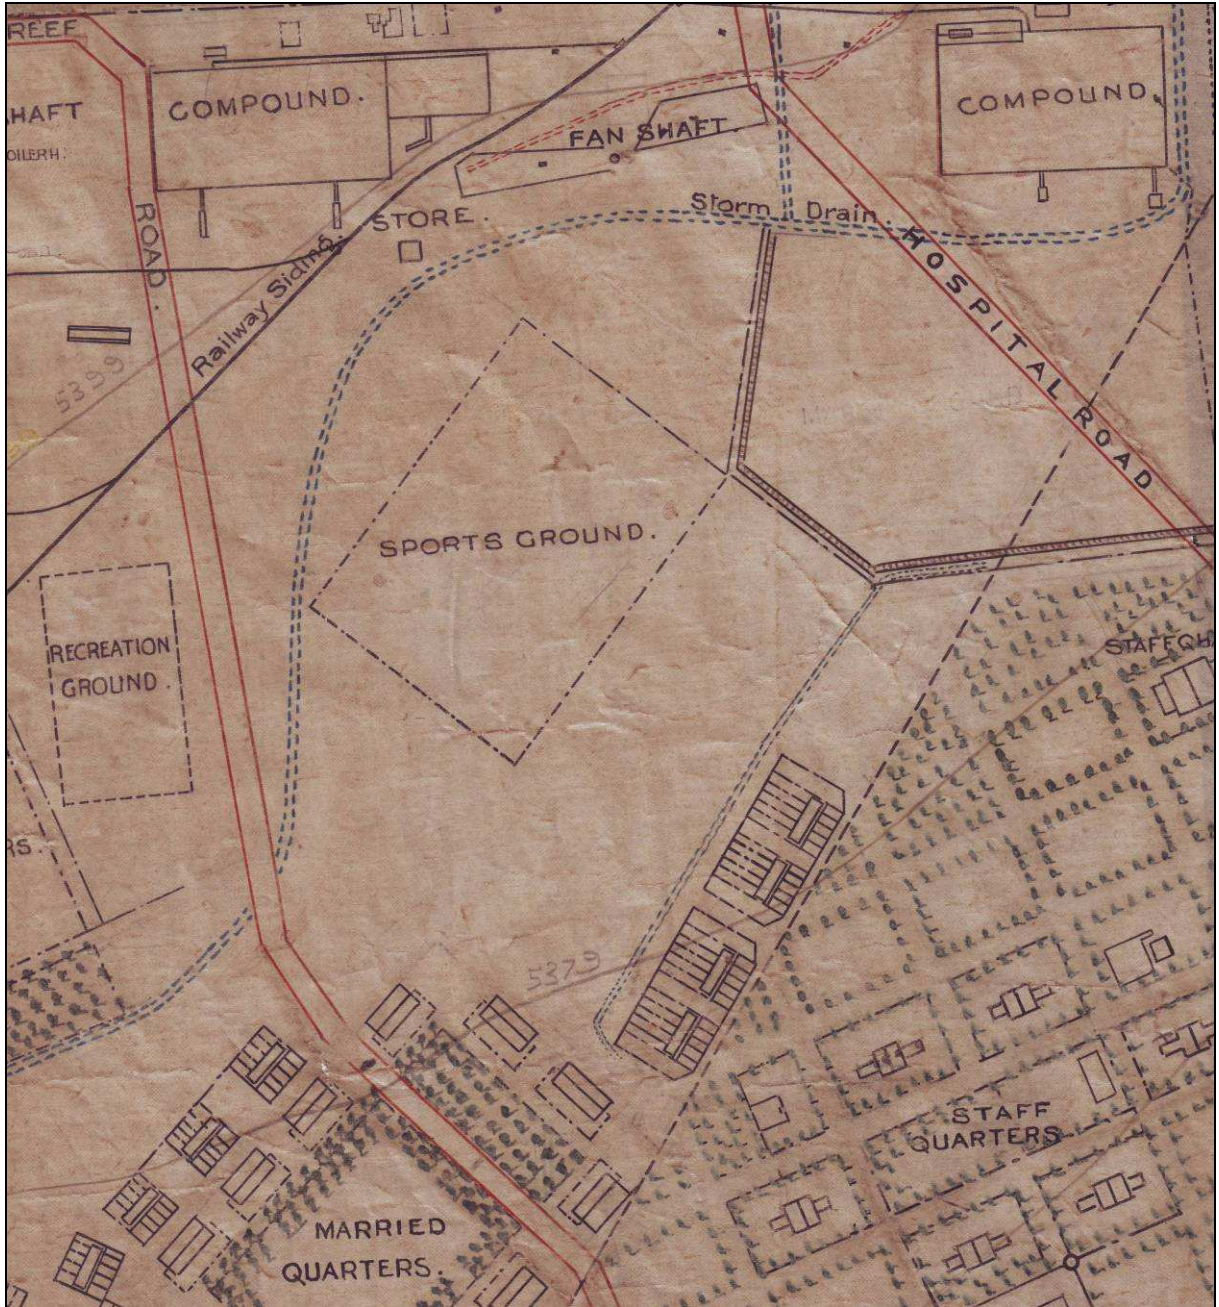
Figure 27 Enlarged section of a map dating from between 1911 and 1915. It clearly shows the storm drain discussed in the text.

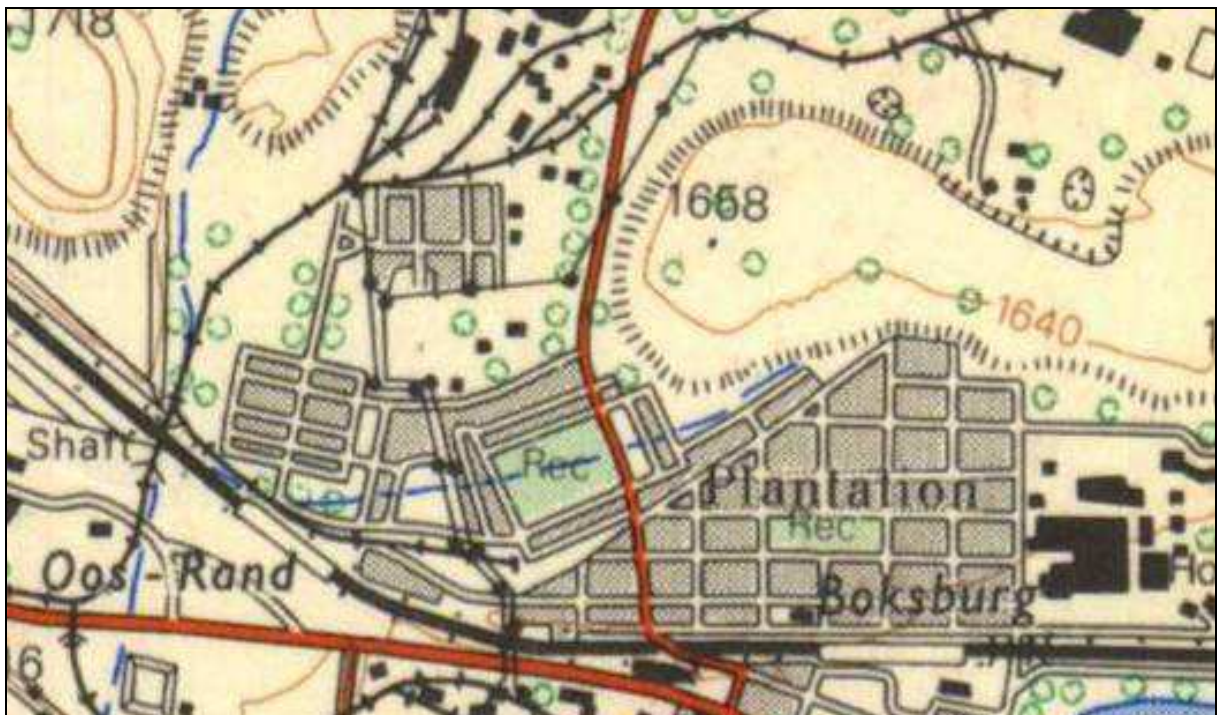
Figure 29 Enlarged section of the Fifth Edition of the 2628AA Topographical Sheet that was compiled during 1975 and printed during 1980. It shows a storm drain, drainage line or watercourse to the south of the slimes dam in exactly the same position as the one depicted on the 1958 map.

The final map relevant to this section is the Fifth Edition of the 2628AA Topographical Sheet that was compiled in 1975. It also shows only one watercourse or drainage line within the study area, namely the one located to the south of the slimes dam.

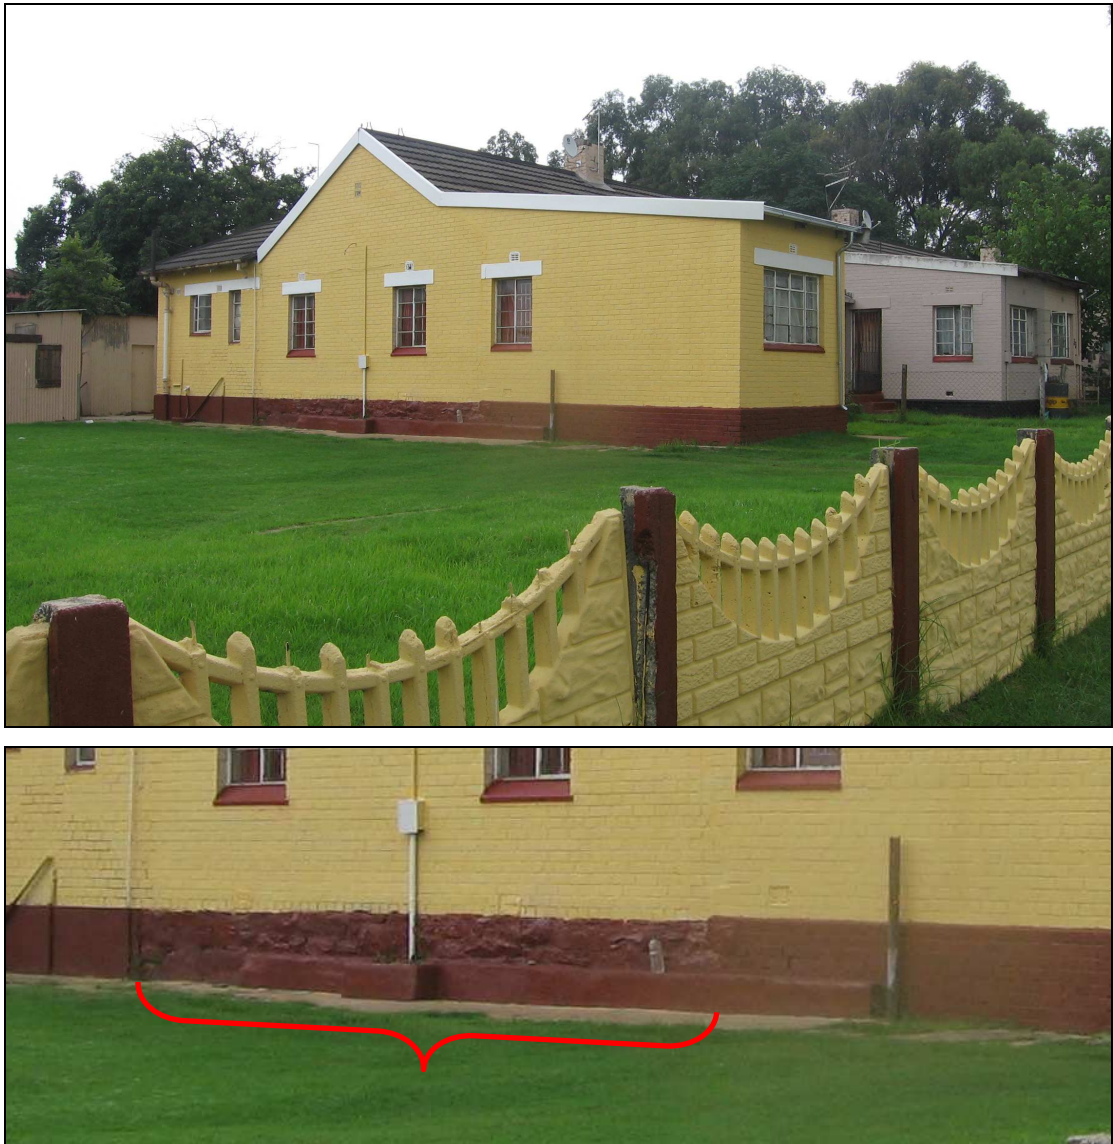
Plate 9 Side elevation of one of the existing buildings from the old married quarters. The enlarged image (bottom) clearly shows the original stone foundation. The stone foundation is marked in red.

The original units had stone foundations with a plinth elevated to a height of about 500-600mm above the ground and were probably not painted at first. During the later extensions the same architectural solution was discarded in favour of more commercial foundations that were subterranean.

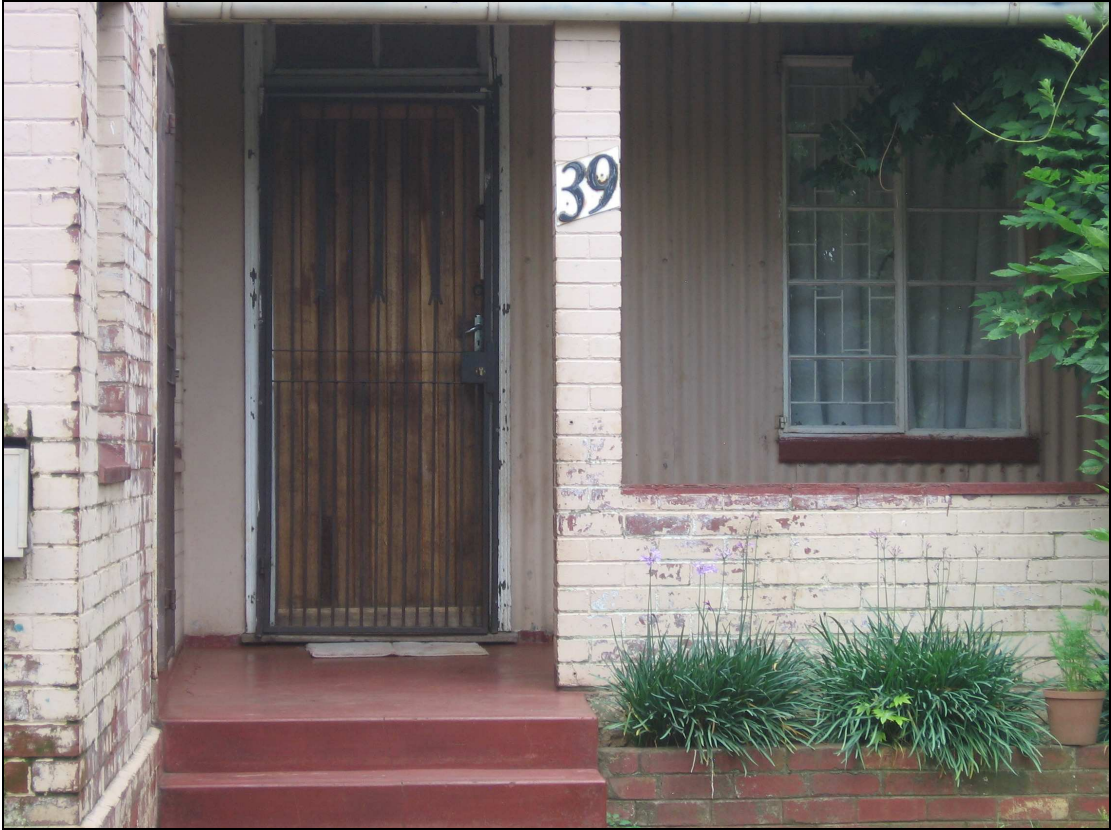
Plate 12 The front veranda of one of the existing units from the old married quarters. This unit is number 39. The corrugated iron sheeting on the walling next to the door can clearly be seen. As discussed elsewhere the corrugated sheeting must have formed part of the original structure.

Some of the units found to the west of Rondebult Road still have corrugated sheets on its walls. The use of corrugated iron at first is supported by an archival map which depicts the old married quarters as brick-lined iron buildings. At a later stage the walls of the dwellings were constructed with face brick and left unpainted. This rule of thumb was altered over time and all the buildings were covered with paint without plastering the original brick exterior walling.

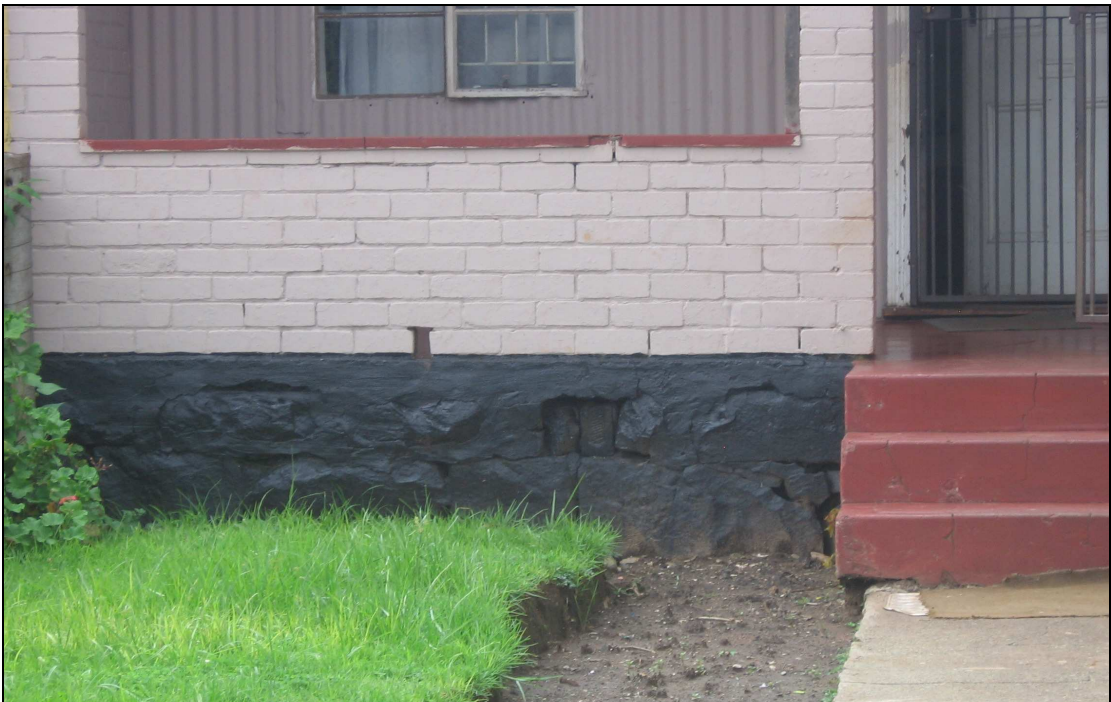
Plate 13 A section of the front elevation of another existing unit from the old married quarters. The original structure's corrugated iron sheeting and stone foundation can clearly be seen.

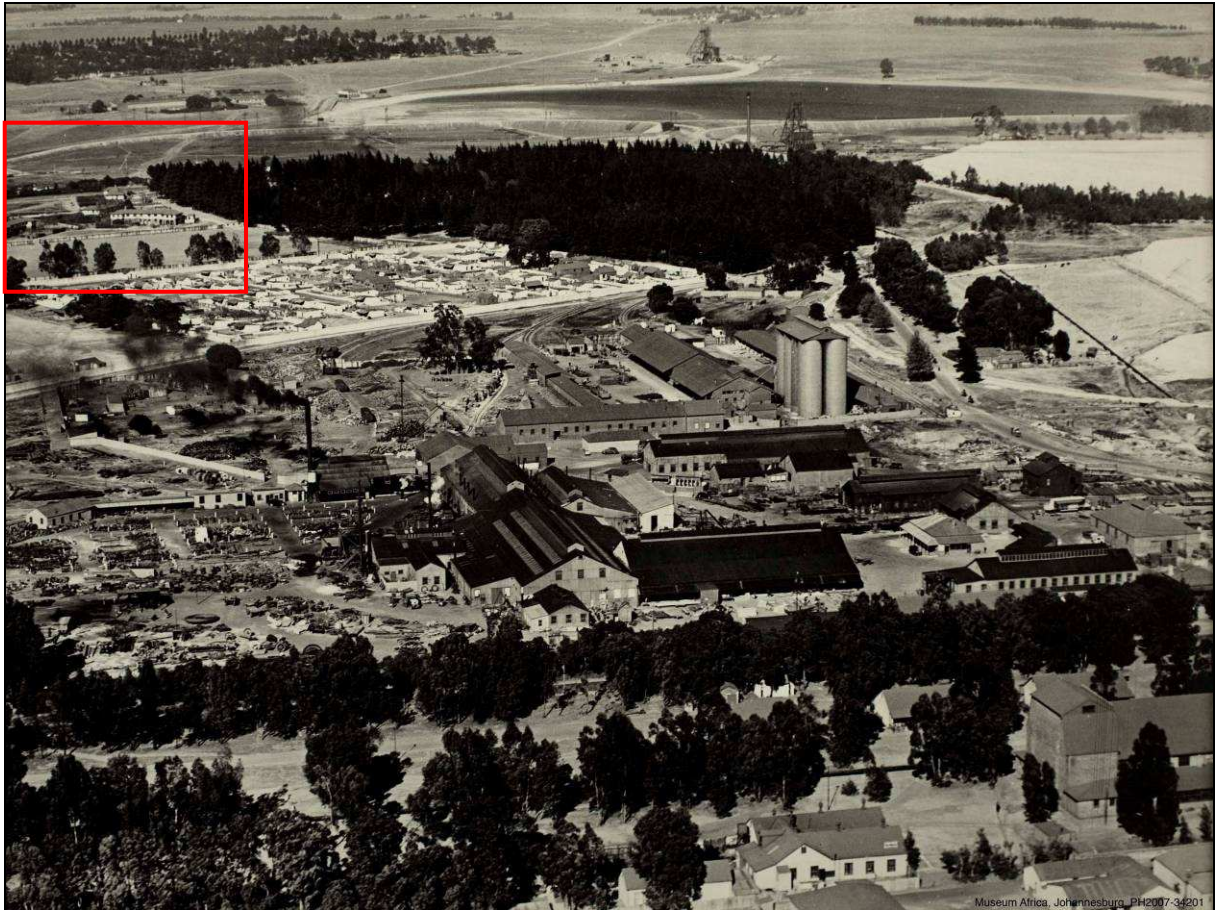
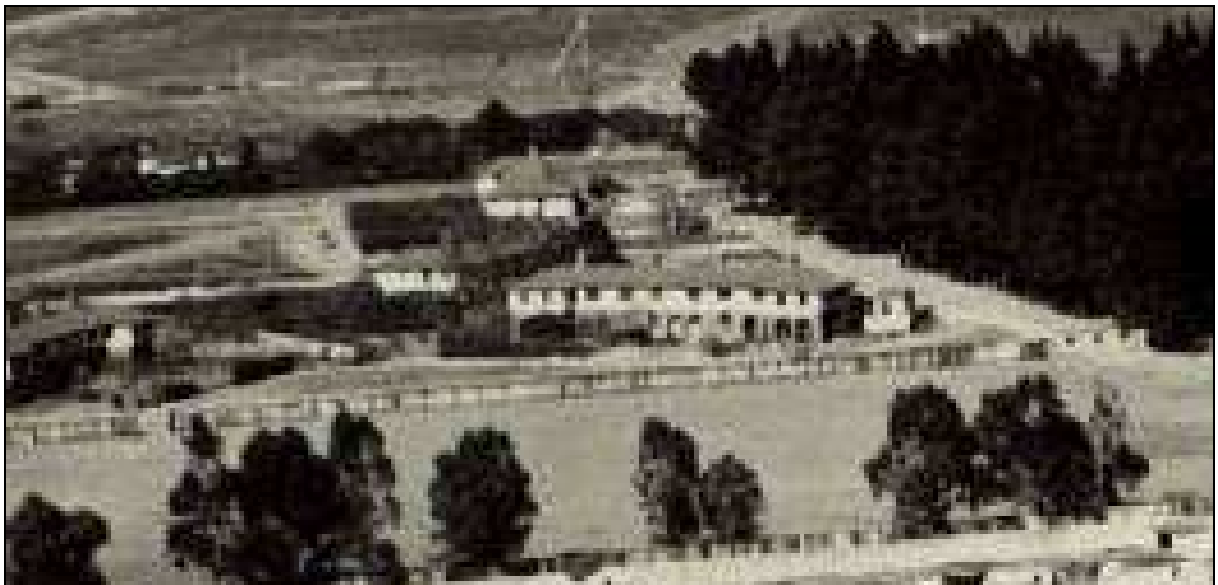
Figure 35 Historic image of the East Rand Proprietary Mines' workshops. Although the photograph is not dated, a number of motor vehicles can be seen amongst the buildings in the foreground which suggest that the photograph was taken during the 1920s or 1930s. In the top left hand corner (see enlarged photograph below) three of the terrace houses designed by Sir Herbert Baker can be seen. Although these fall to the west and outside of the study area, they would have been exactly the same as the four from within the study area. As such, this image provides a valuable glimpse into the general appearance of the terrace houses in the way Baker designed them and before they were modified and altered in later years.

A photograph was located in the images collection of Museum Africa in Johannesburg (Museum Africa, Images Collection, PH2007-34201) which provides one with at least some idea of what the original terrace houses designed by Herbert Baker would have looked like before all of the abovementioned alterations and changes were put in place. While this image (refer Figure 35) is in actual fact of the ERPM Central Workshops, and enlargement of a section of the background clearly shows a number of the terrace buildings located to the west of the present study area. While this photograph is undated, motor vehicles parked amongst the buildings allow one to suggest that the photograph was taken during the 1920s or 1930s.

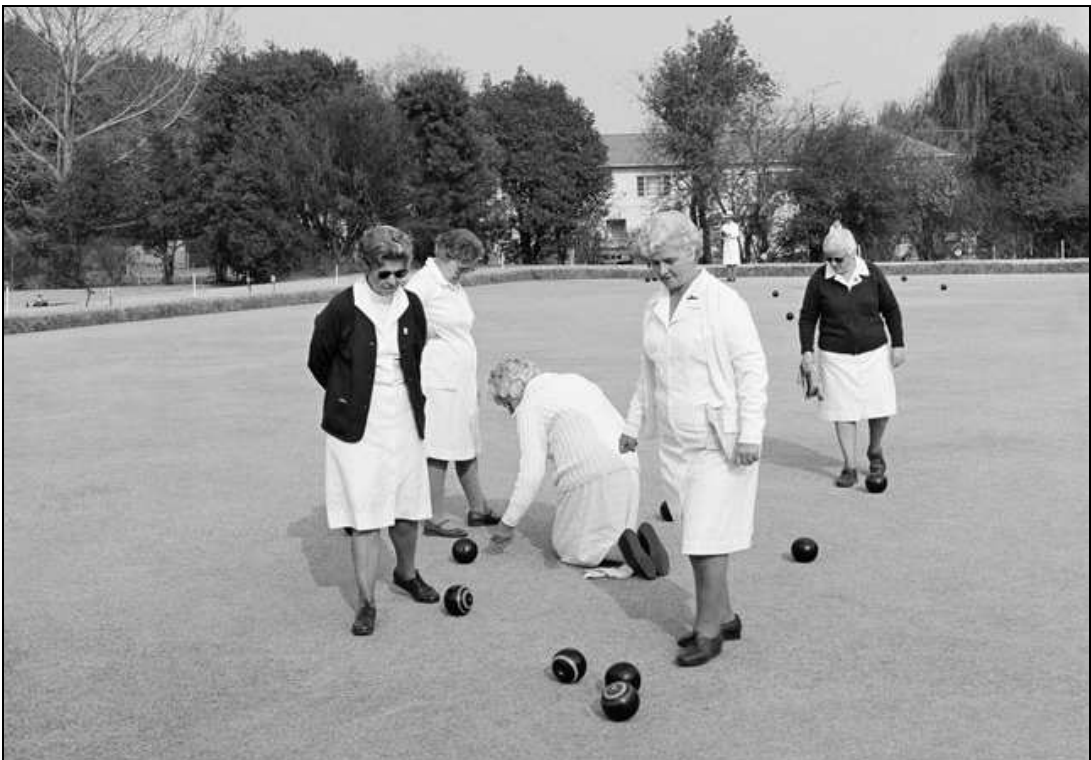
Figure 36 This photograph of ladies playing bowls at the E.R.P.M. Bowling Club was taken by David Goldblatt during 1979/1980 ([www.michaelstevenson.com](http://www.michaelstevenson.com)). One of the terrace buildings is visible in the background. Closer inspection of this image shows that the appearance of the terrace buildings during 1979/1980 was very much the same as it is today.

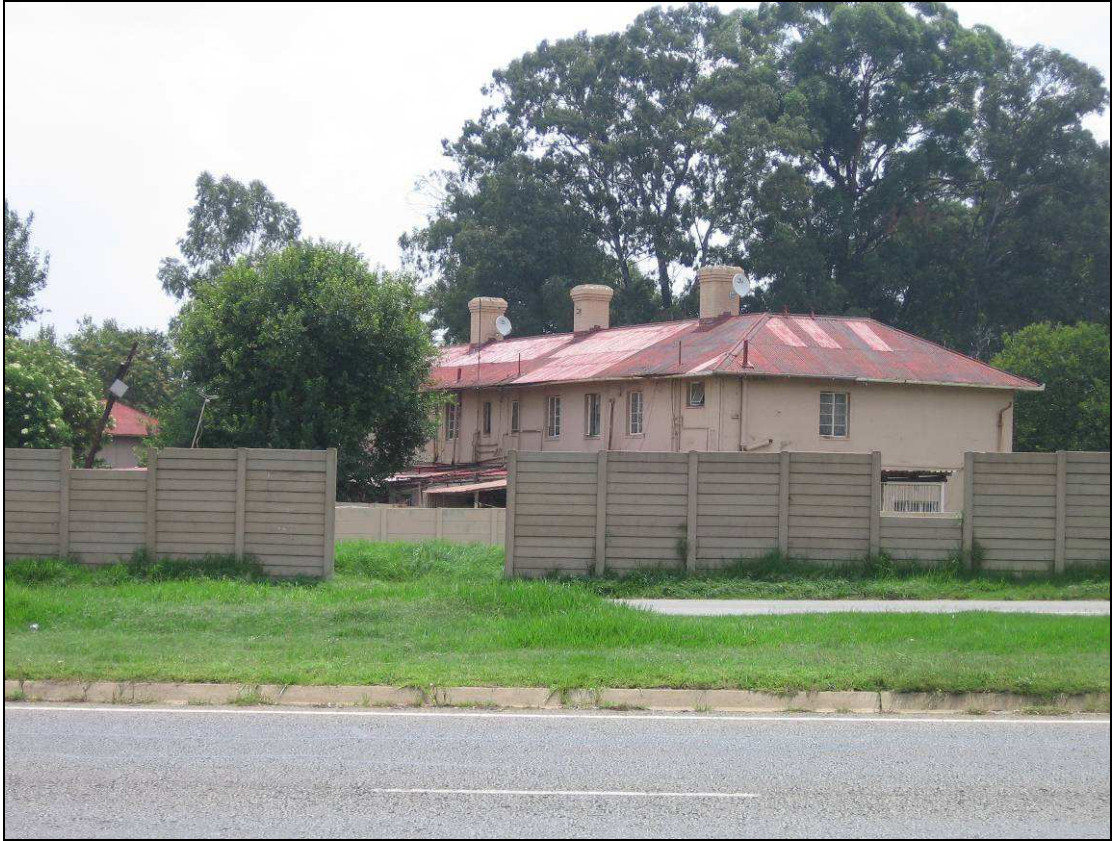
Plate 14 View from Rondebult Road towards the southern elevation (back elevation) of one of terrace buildings located to the west of the aforementioned road.

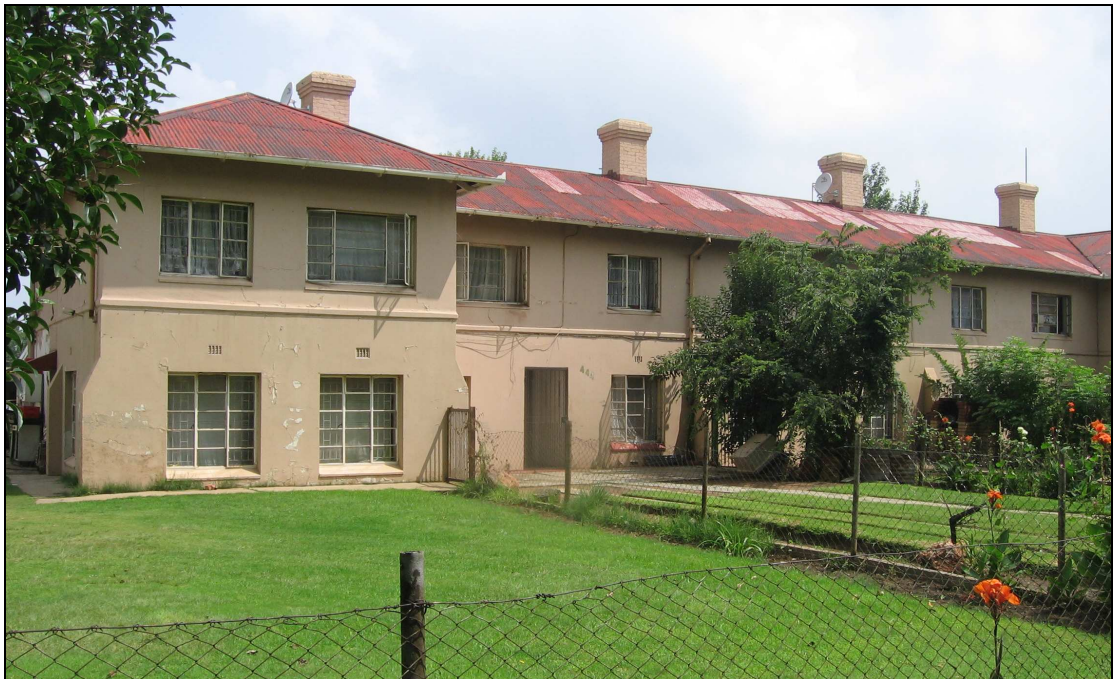
Plate 15 General view of the northern elevation of one of the units indicating the new steel frame windows that replaced the casement windows of Baker.

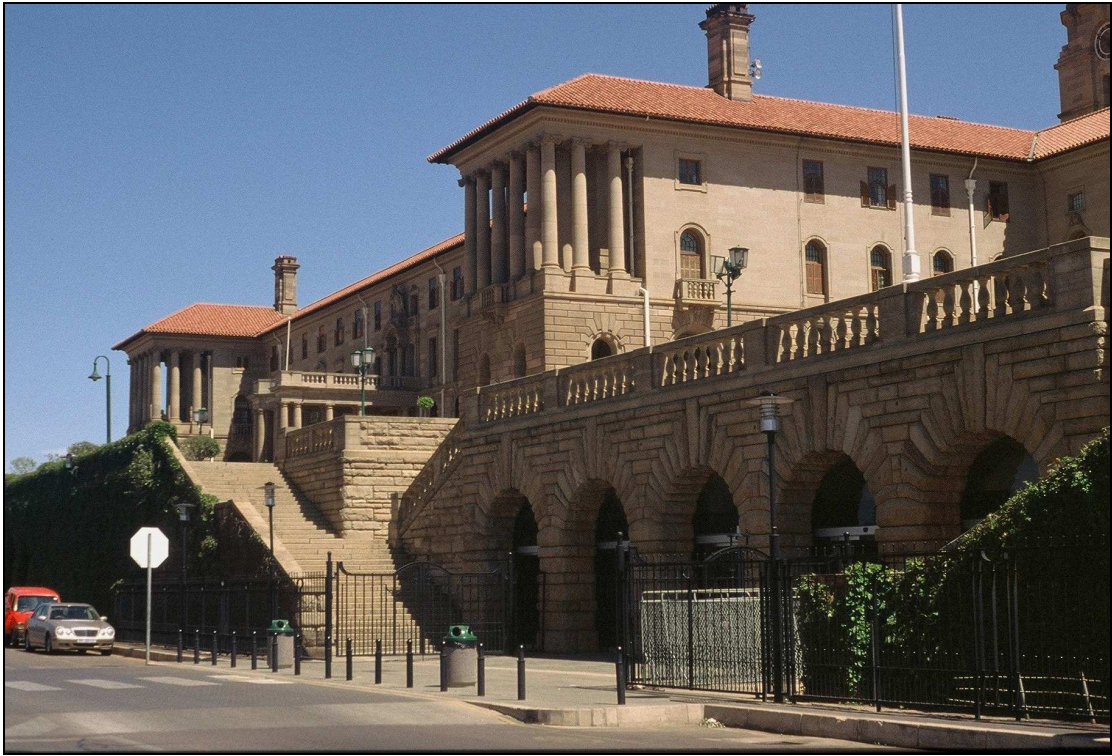
Plate 16 A similar pattern emerges in Baker's work with the simple rectangular floor plan pushed backwards by adding a pavilion at each side of the front elevation - here applied at the Union Buildings but also applied at the ERPM housing units in minute scale.

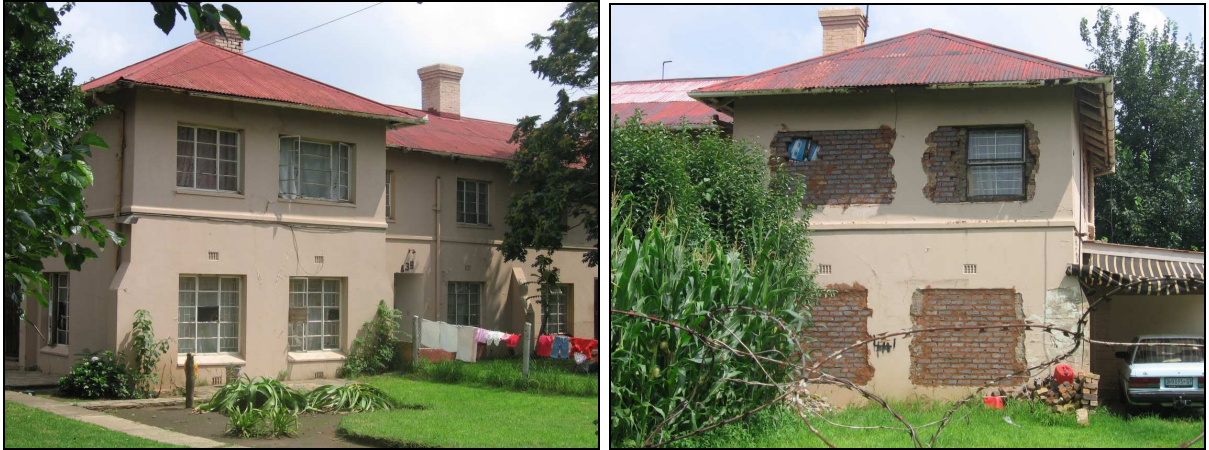
Plates 17 & 18

Second generation steel frame windows (left) are replaced by the current residents or owners (right).

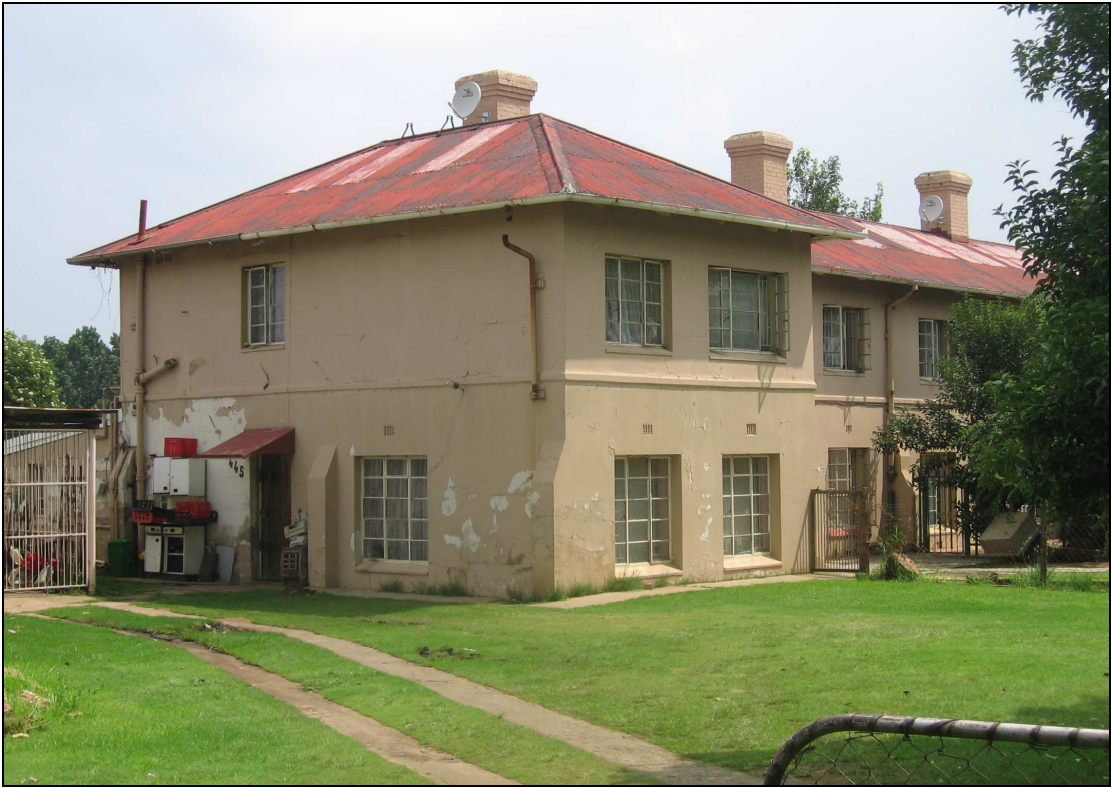
Plate 19 Corner elevation of one of the terrace buildings at ERPM with a slightly protruding pavilion and small buttressing element at its corner.

Two other elements typical of Bakers work was the use of buttresses and arches. The buttresses were used to reinforce the walls while also serve as an aesthetic detail as it would break-up the flat surfaces of the walls visually, thus providing some variety. At ERPM, buttresses were introduced at the corners of the main facades almost to ceiling height but they do not dictate or dominate the general appearance of the facades

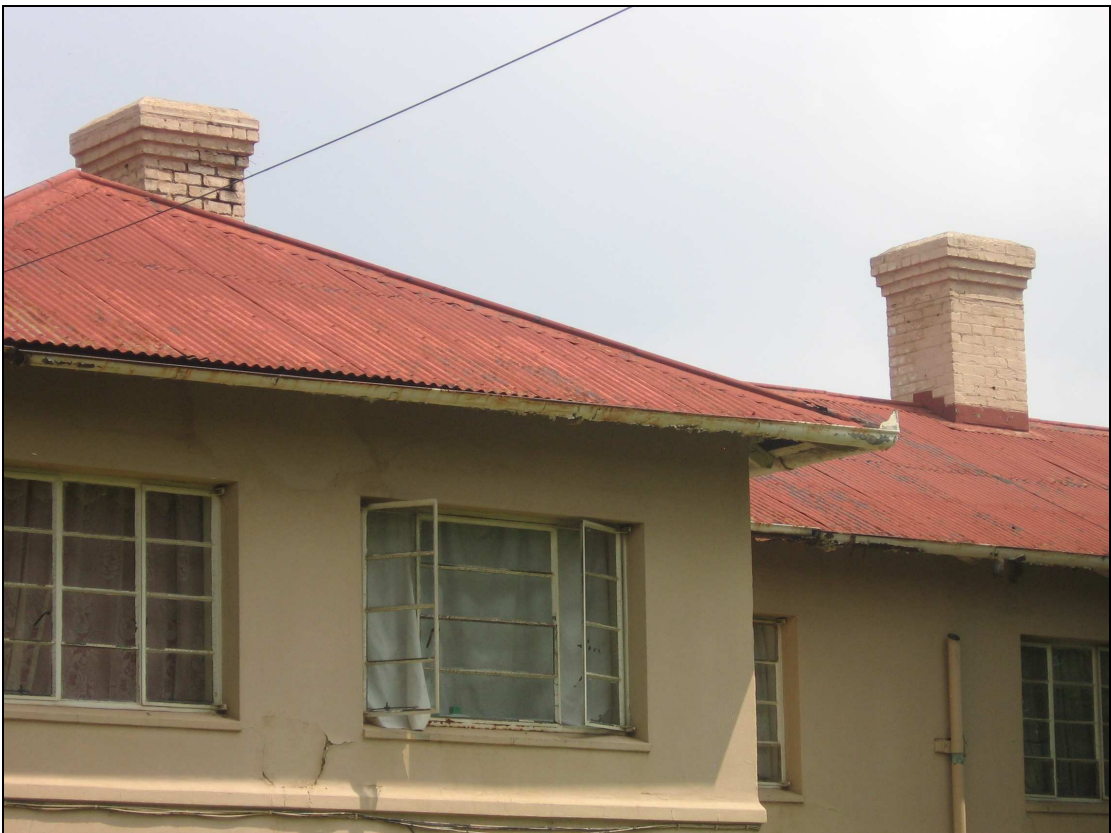
Plate 20 Simple though stylish chimneys as seen at the terrace housing from ERPM are typical of the design of the architectural firm of Baker & Masey.

Radford also mentioned the occurrence of the chimneys as they tend to be a trademark element on the terrace and single storey units. They were used both as functional and aesthetic elements in order to fit the balance and symmetry of the design and to add some aesthetic value to an otherwise functional element.
