## **9. HISTORIC OVERVIEW OF OTHER FEATURES FROM WITHIN THE STUDY AREA**

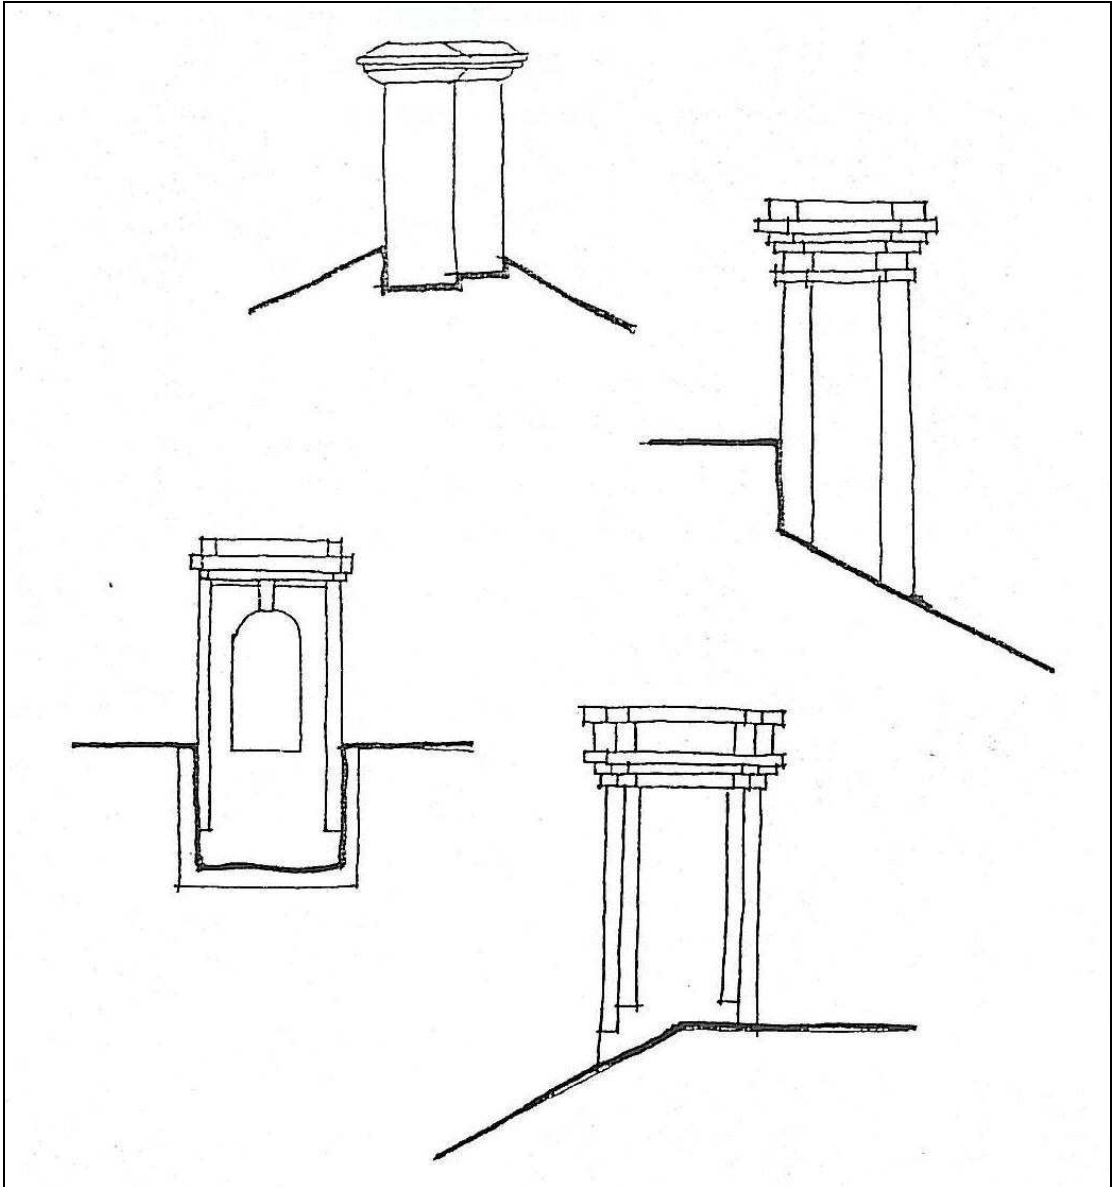
Figure 39 Typology of chimneys favoured by Baker's firm and used in the design of mining housing complexes (Radford 1990).

Radford also mentioned the occurrence of the chimneys as they tend to be a trademark element on the terrace and single storey units. They were used both as functional and aesthetic elements in order to fit the balance and symmetry of the design and to add some aesthetic value to an otherwise functional element.

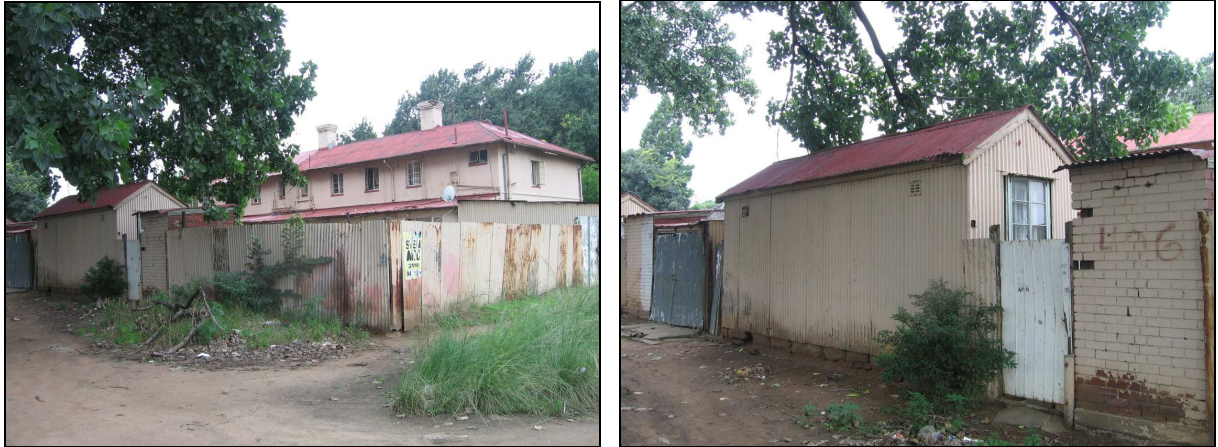
Plates 21 & 22 Exterior of backyard walling and small timber and iron outbuilding.

Another aspect of mining housing complexes is the treatment of spatial elements such as the backyards. At ERPM ample backyards were allowed behind the terrace housing and services and amenities such as toilets and showers were accommodated in the corrugated iron outbuildings located on the extreme periphery away from the backdoors. Wooden doors and windows were also installed in these buildings although most of these have since been replaced with steel frame windows. Some original windows were discovered in isolated outbuildings giving some indication of the type, style and form of these windows.

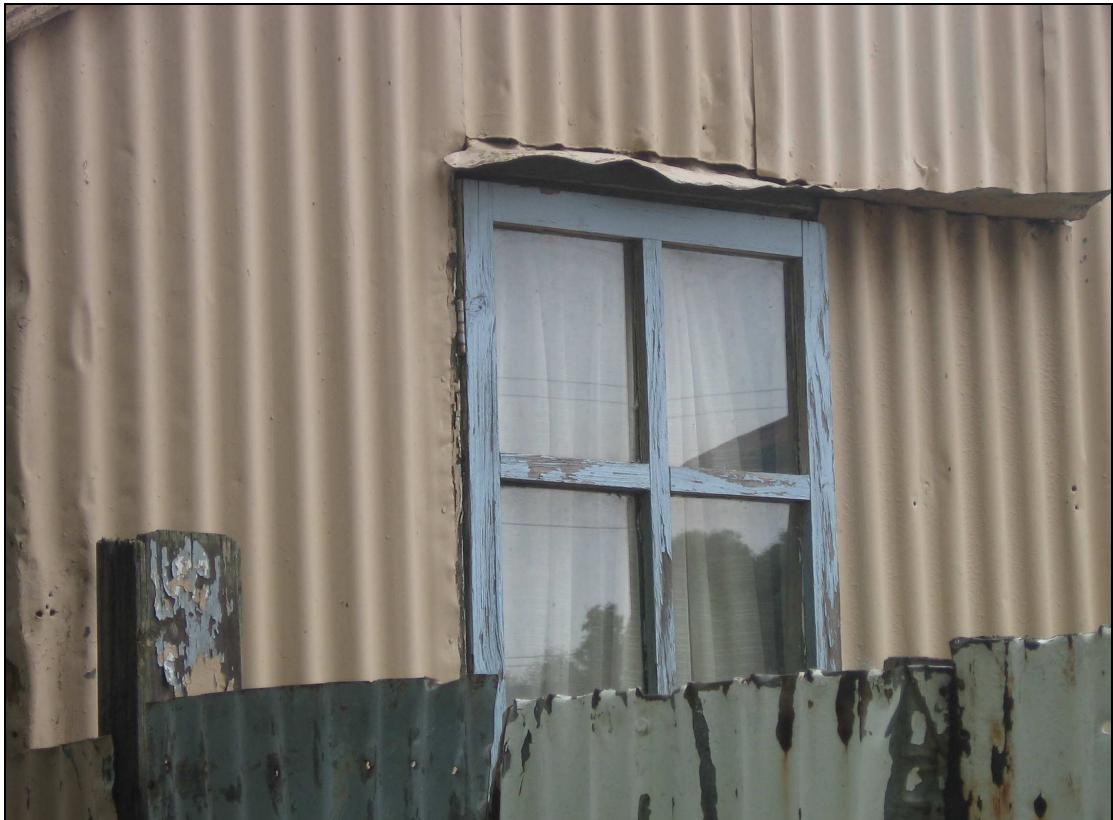
Plate 23 The original wooden window from an old corrugated iron outbuilding.

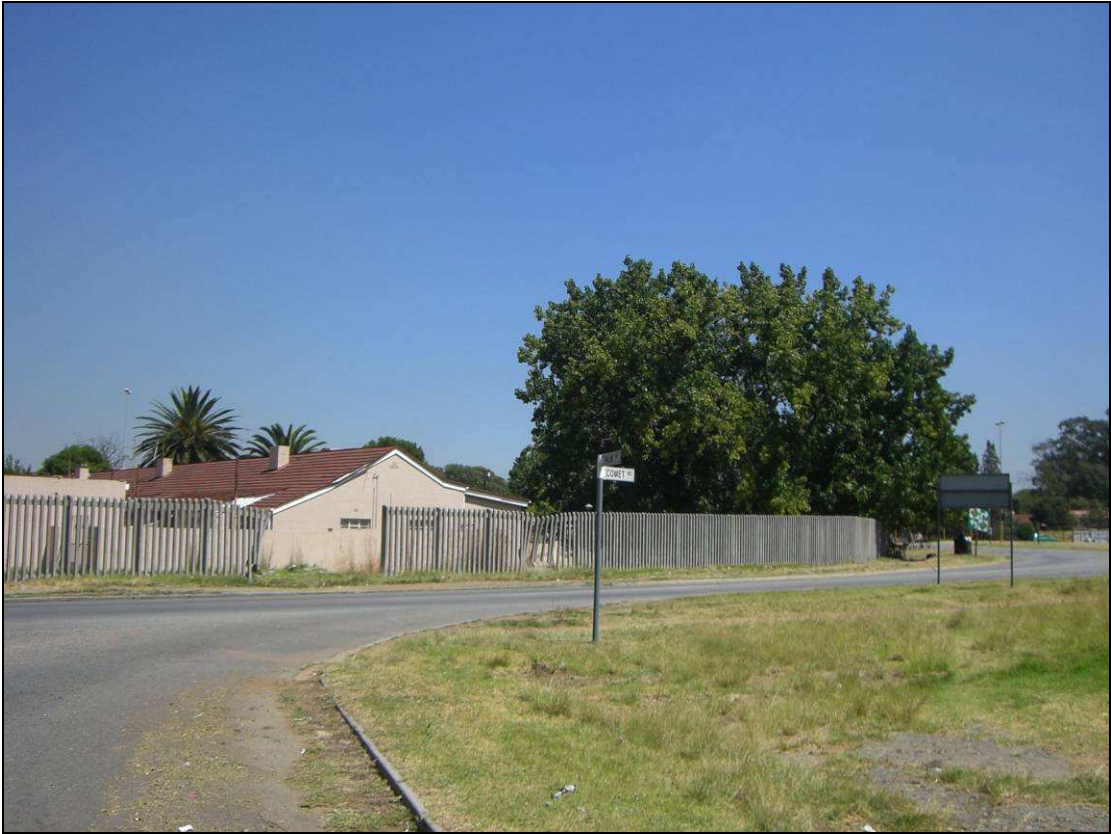
Plate 24 This image taken before or during 2007 appears to show the old married quarters known in this report as Building 1. The view is from the east.

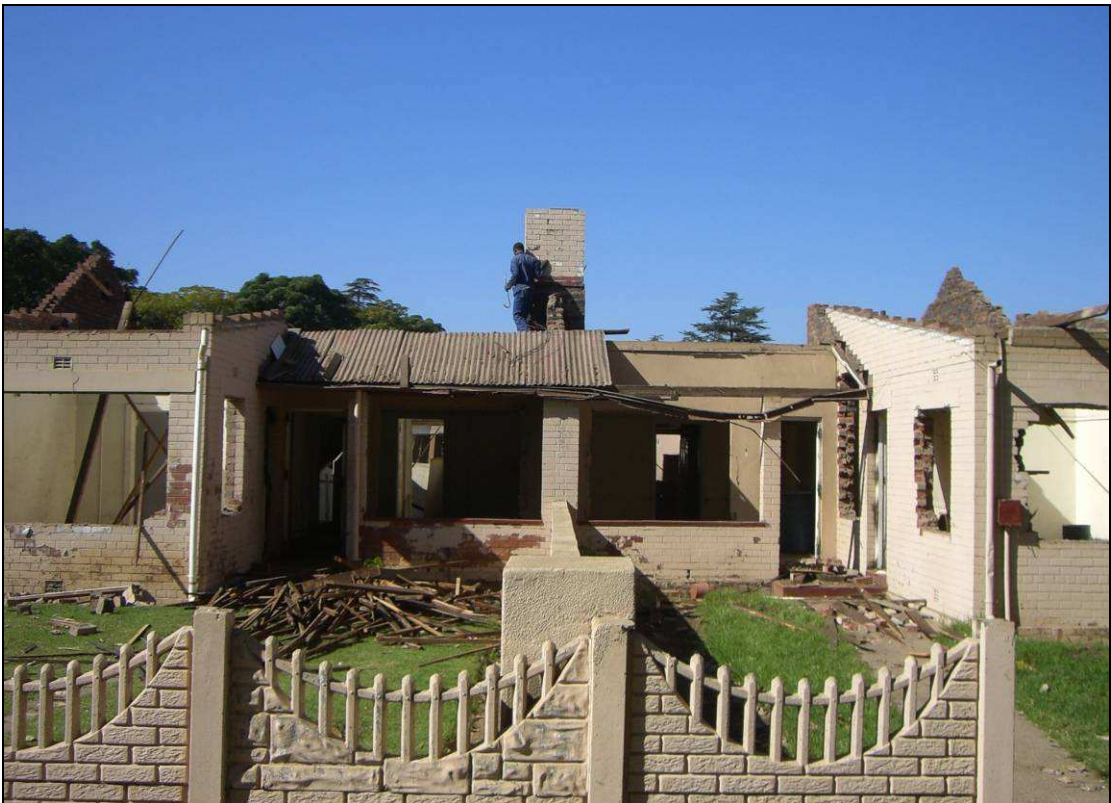
Plate 25 This image taken before or during 2007 appears to show a section of the old married quarters known in this report as Building 1.

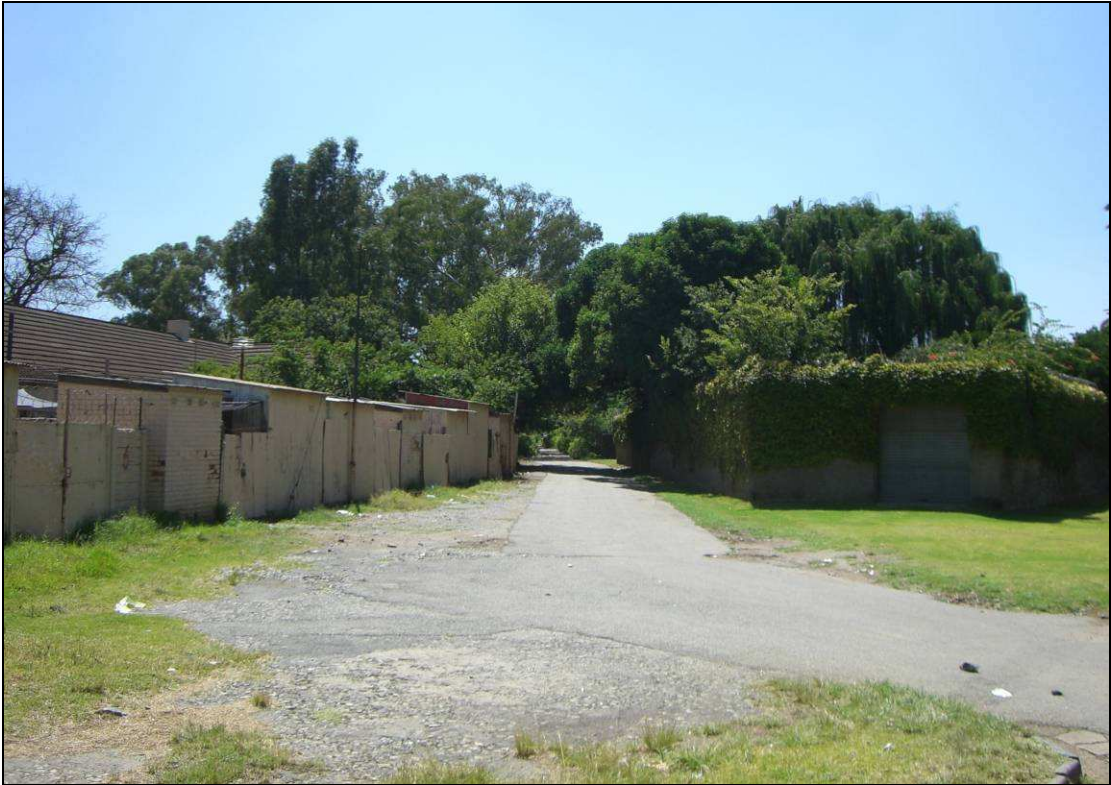
Plate 26 The outside buildings as well as a section of the roof from Building 2 can be seen on the left of this photograph taken before or during 2007. The access road from Palm Avenue can be seen in the centre.

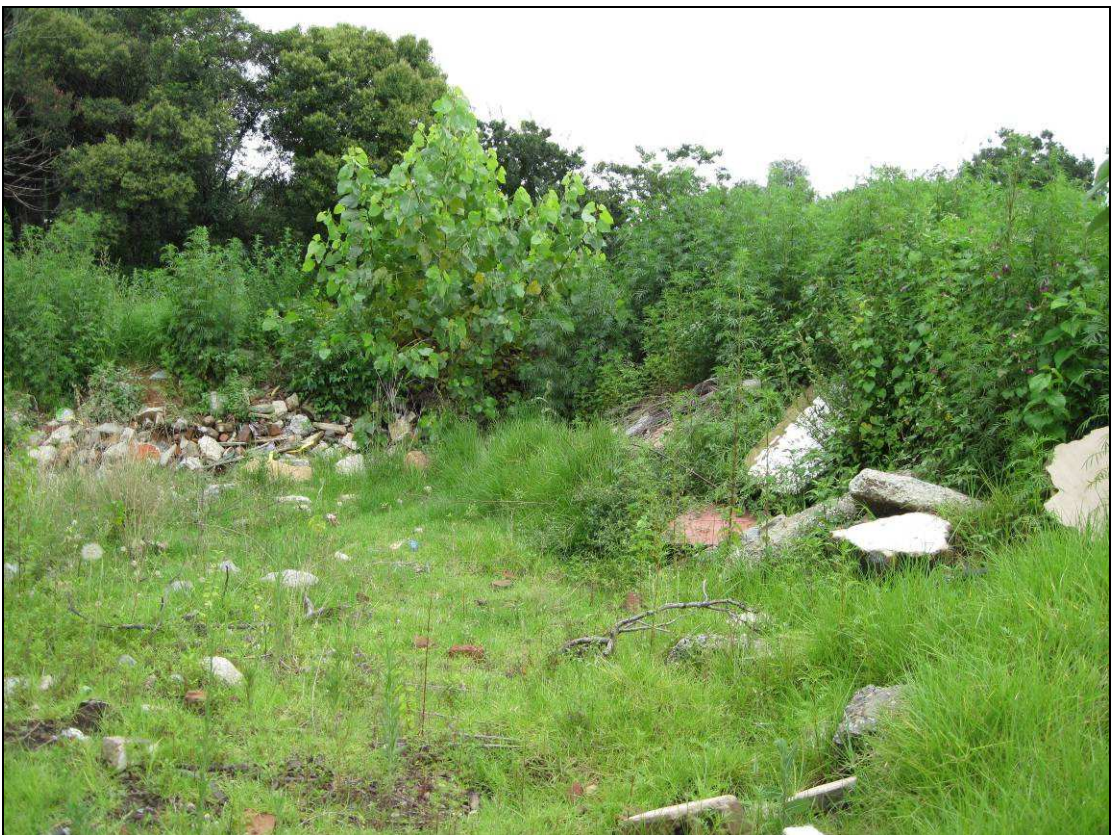
Plate 27 All that remains of what used to be the old married quarters known in this report as Building 2.

The only remains of the former buildings were large middens of building rubble – overgrown with grass and weeds. The rubble indicated that the buildings must have been pushed over with a front-end-loader. The doors, windows, corrugated iron, floor boards and other fixtures and fittings must have been removed prior to the demolition as no evidence of these could be found on any of the sites. After the buildings were gutted the shells were probably pushed over and the rubble neatly dumped on the spot where each building existed.

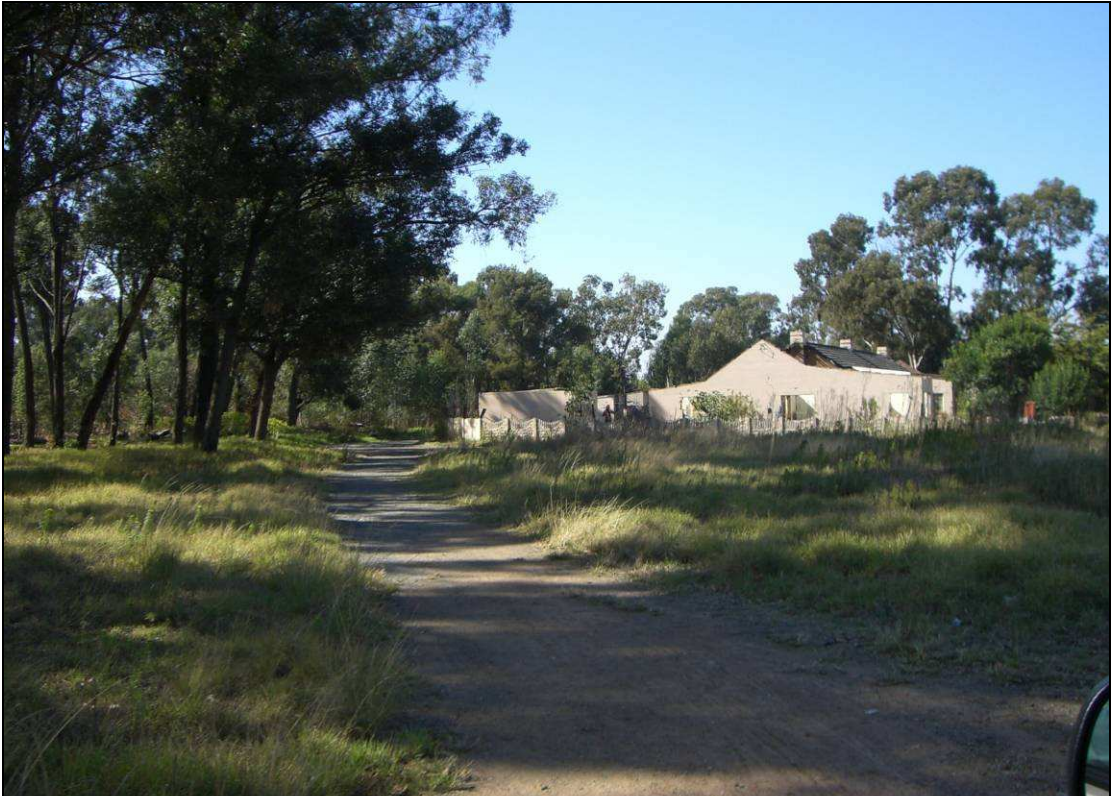
Plate 28 This image taken before or during 2007 appears to show the old married quarters known in this report as Building 4. The view is from the northwest.

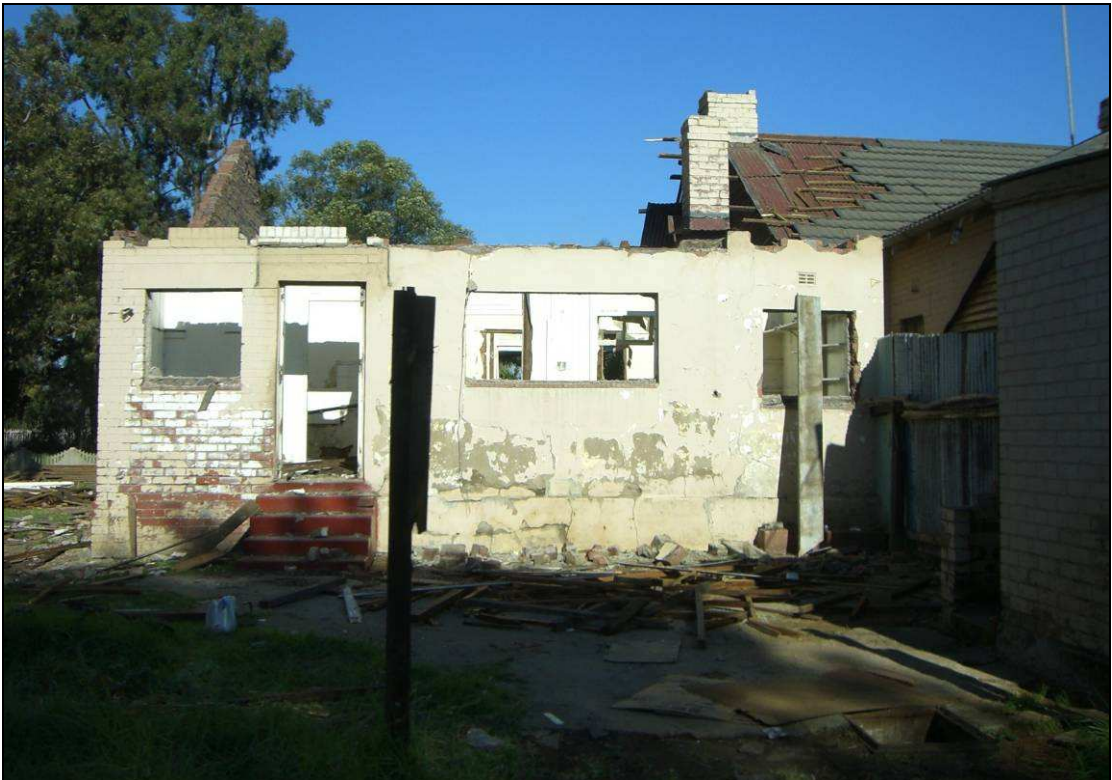
Plate 29 This image taken before or during 2007 appears to show a section of the old married quarters known in this report as Building 4. The fact that demolition had already started when this photograph was taken is evident.

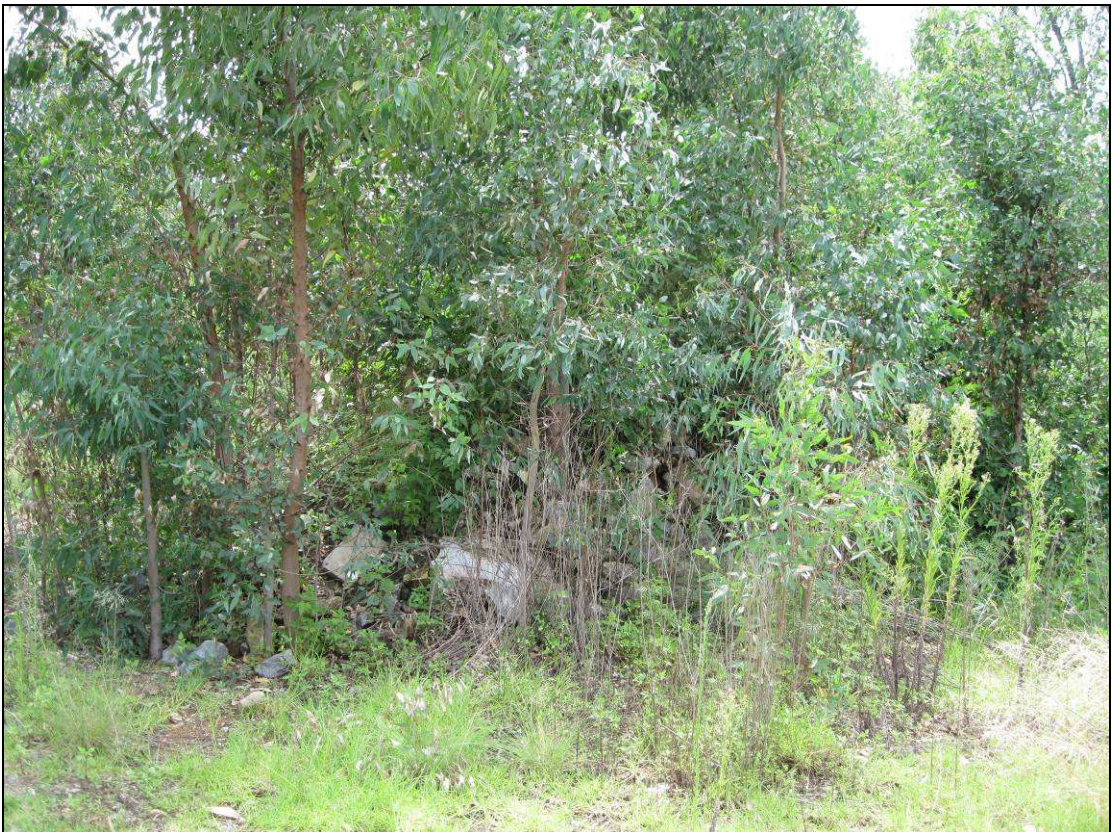
Plate 33 All that remain of Building 4 is this mound of rubble.

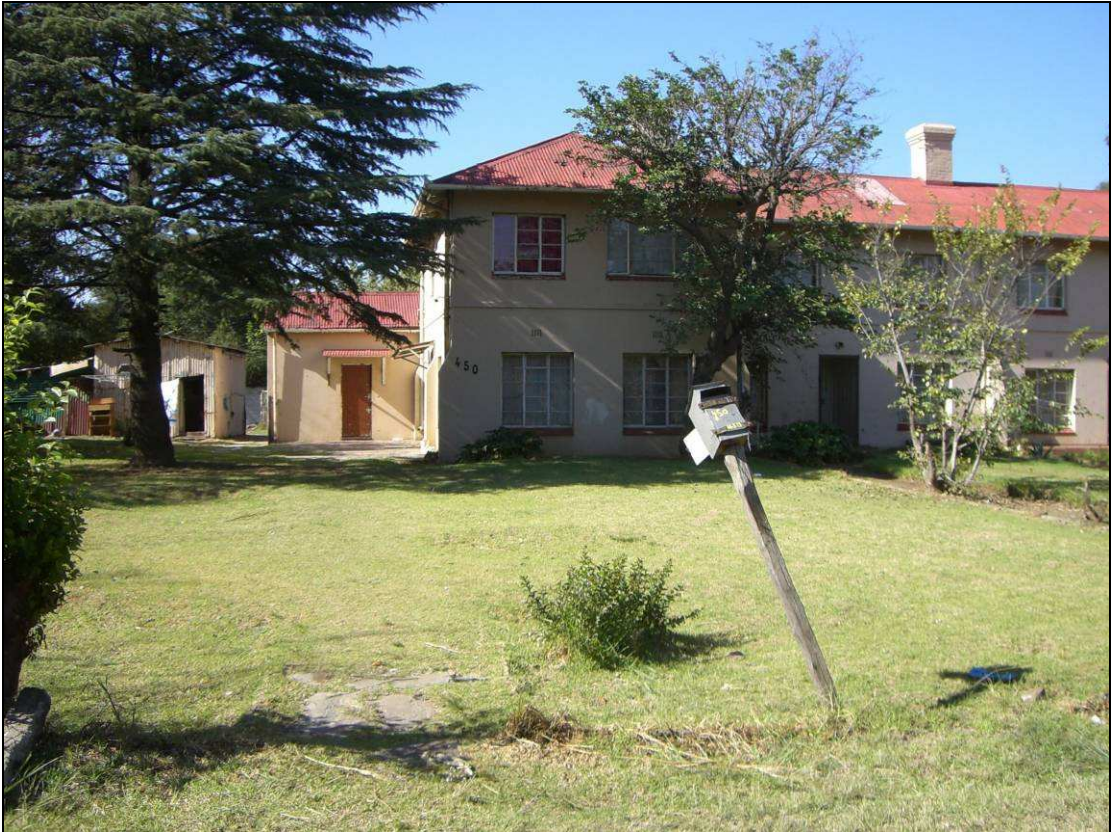
Plate 36 This image taken before or during 2007 appears to show the new married quarters building known in this report as Building 5.

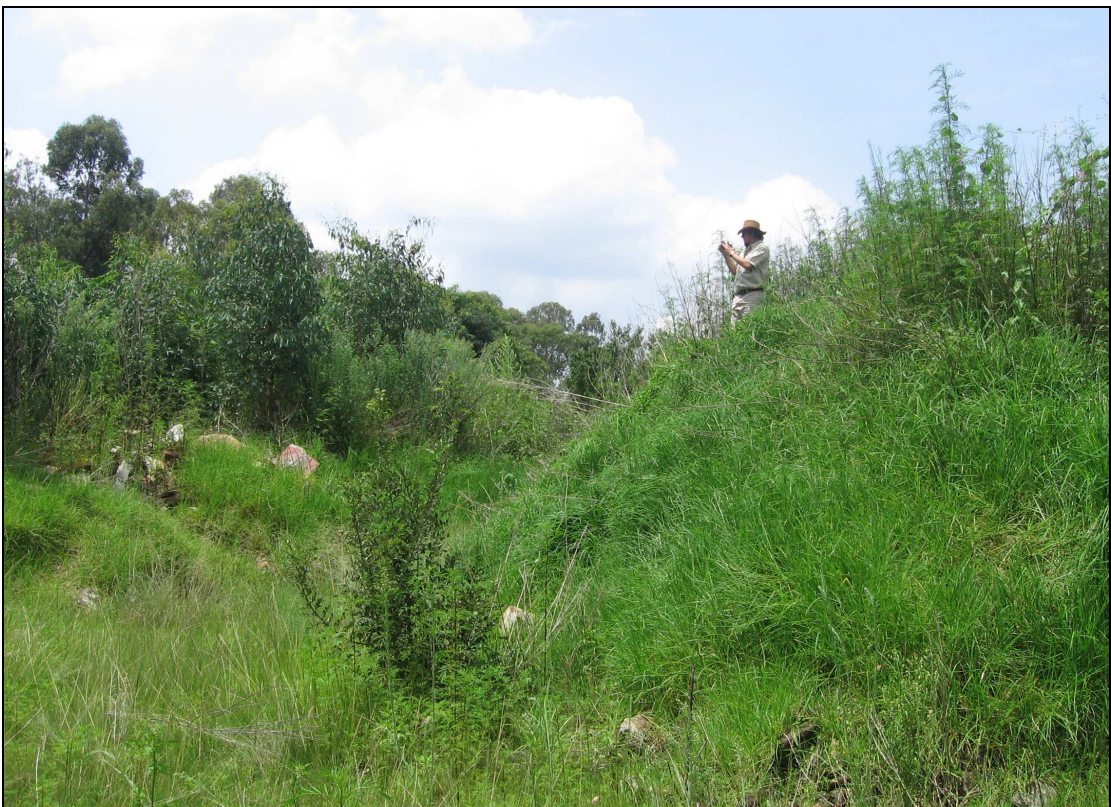
Plate 37 All that remains of what used to be the new married quarters known in this report as Building 5 is a large mound of rubble.

As was the case with the old married quarters, the only remains of the former Baker houses were large middens of building rubble. The rubble indicated that the buildings must have been pushed over with a front-end-loader. The doors, windows, corrugated iron, floor boards and other fixtures and fittings must have been removed prior to the demolition as no evidence of these could be found on any of the sites. After the buildings were gutted the shells were probably pushed over and the rubble neatly dumped on the spot where each building existed. This said, some building elements such as concrete lintels and sections of walls that were not completely crushed during demolition were still found. A few chunks of sandstone occur in scattered finds on the rubble and some selective examples of red Kirkness face bricks were also identified. Kirkness bricks were common at the time but have also become one of Bakers trademarks as these bricks

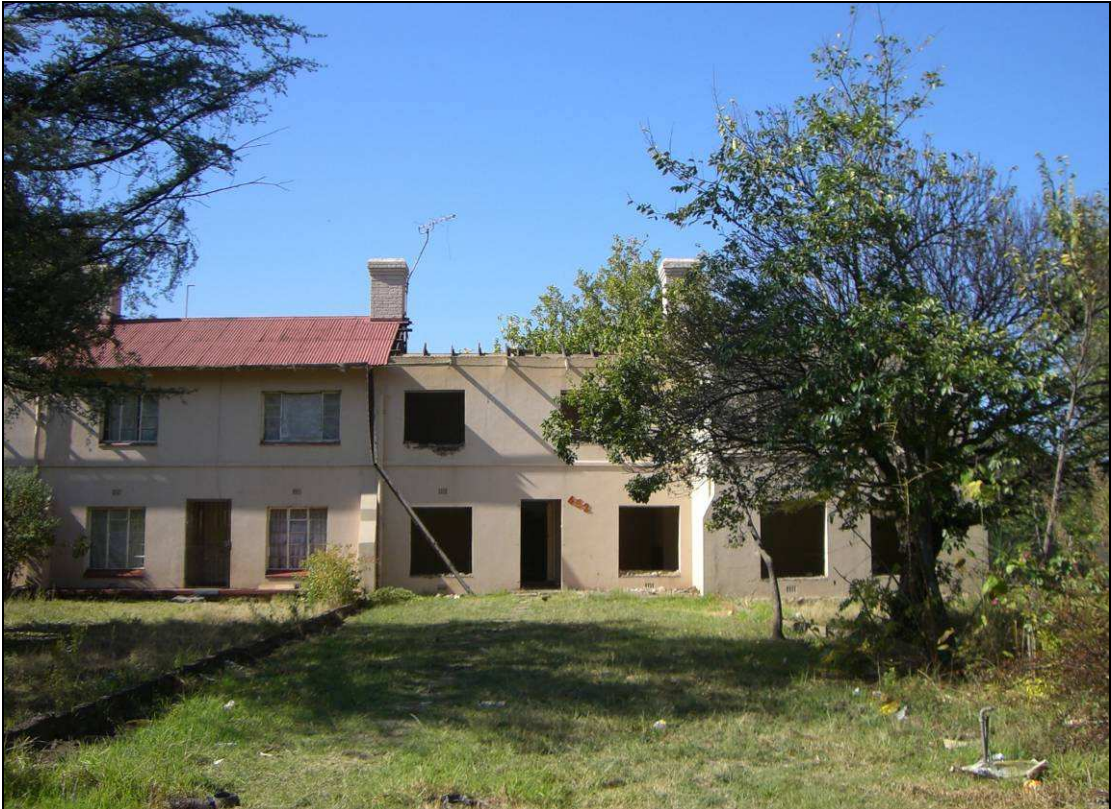
Plate 38 This image taken before or during 2007 appears to show the new married quarters building known in this report as Building 6.

Although all four buildings are still depicted on the available Google Earth Image which dates from May 2007, they all bear evidence that demolition activities had already commenced. The building known for the purposes of this report as Building 6 shows the most damage.

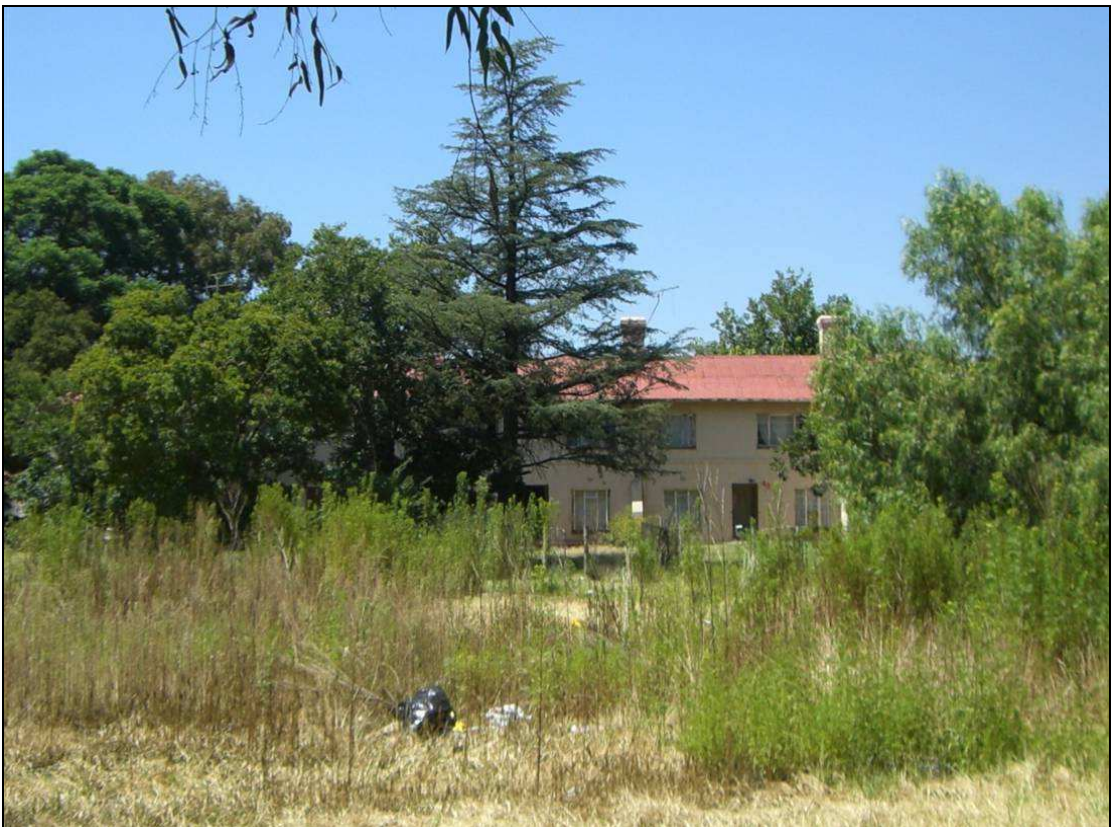
Plate 39 This image taken before or during 2007 appears to show a section of Building 6 within its landscape. The view is from the north.

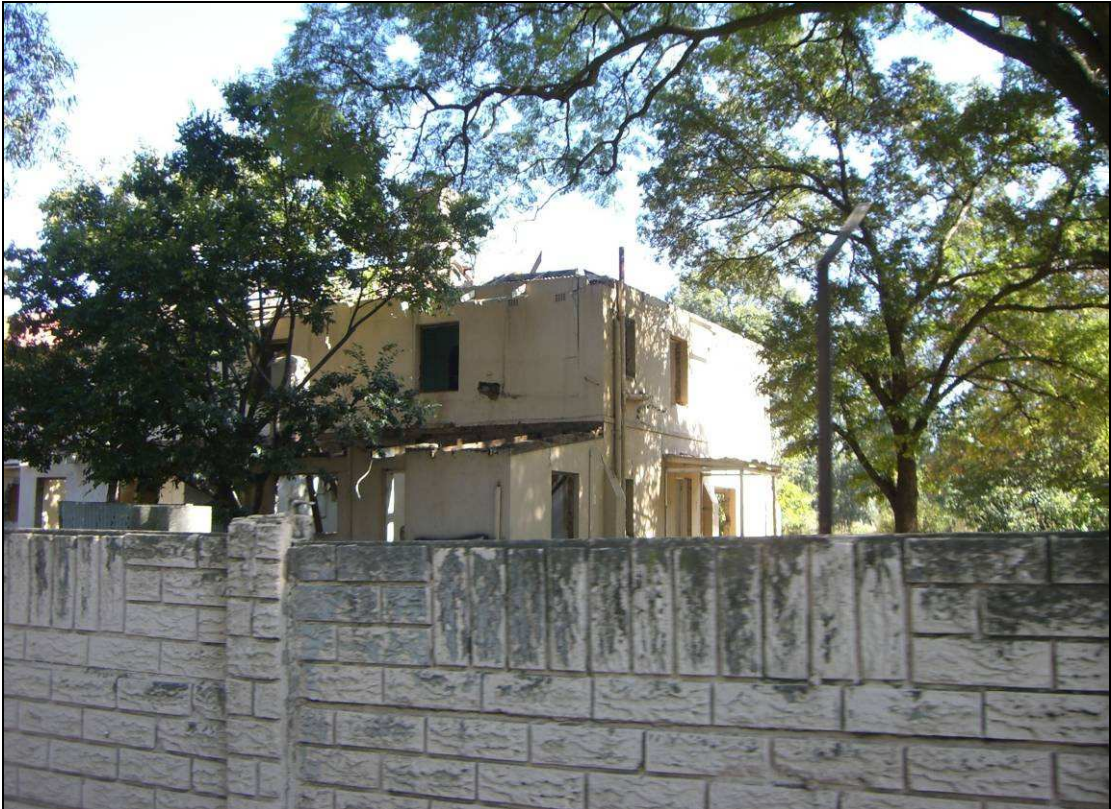
Plate 40 This image taken before or during 2007 appears to show a section of the back elevation of Building 6. The view is from the south-east.

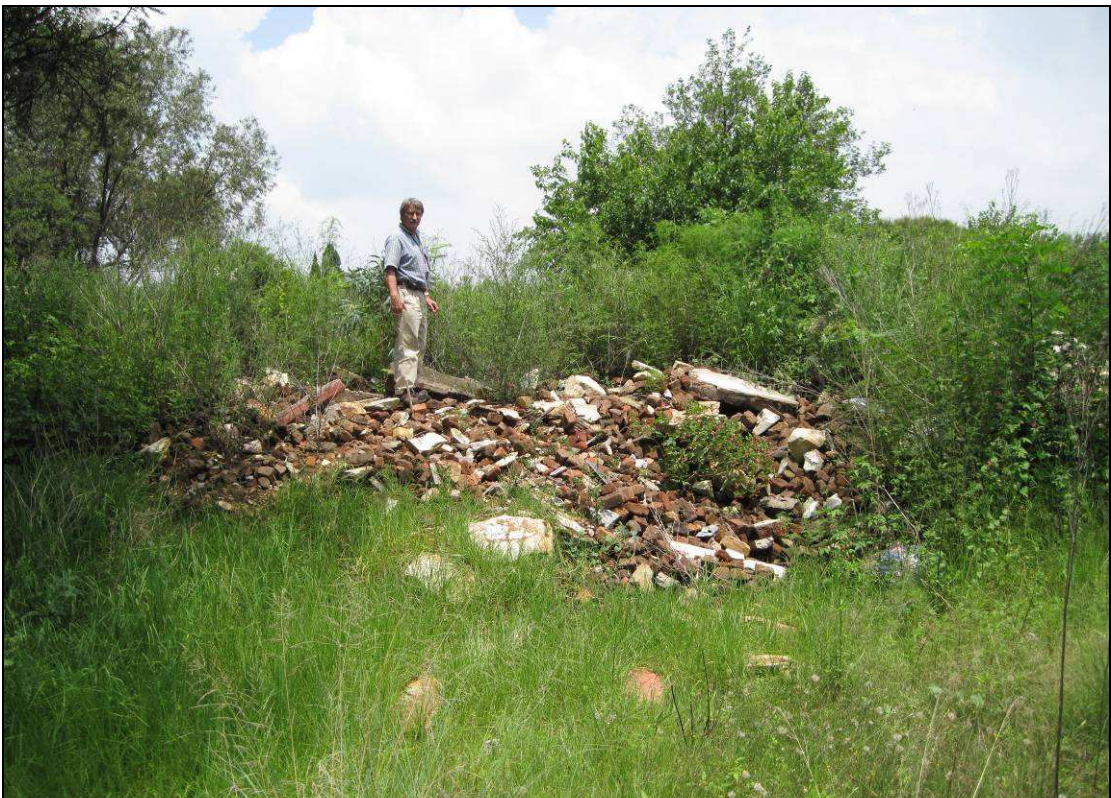
Plate 41 All that remains of what used to be the new married quarters known in this report as Building 6. The Kirkness brick alluded to in the report was observed here.
