S.S. Karin

Shipwreck Report

Durban Harbour Entrance Widening
Kwazulu-Natal
South Africa
June 2010

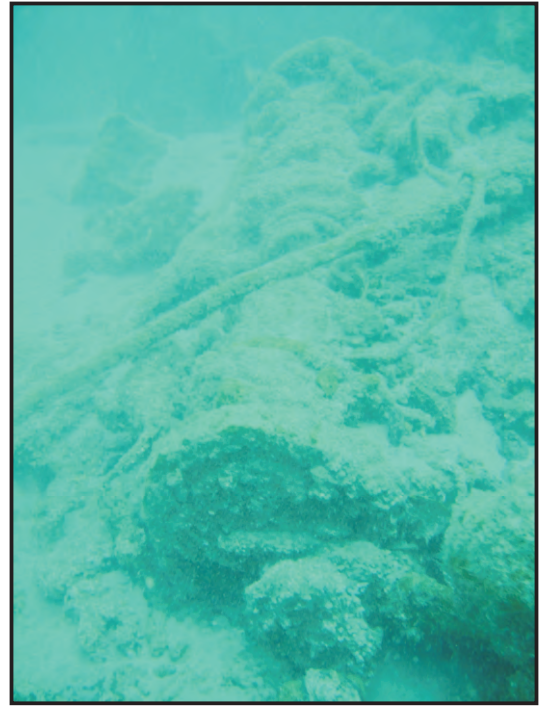
Figure 14: Conglomerated wreck of the *Karin* (Photo: Subtech)

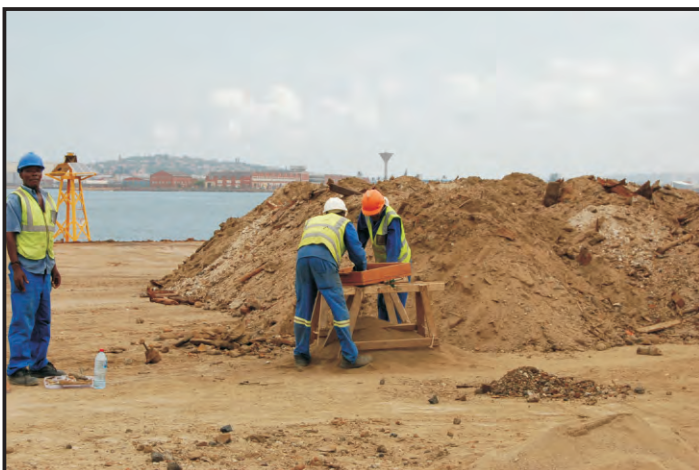
Figure 23: A sample of approximately 1 ton was sifted through a 3mm mesh sieve. However, the cost/benefit of this exercise made it unviable (Photo: Maitland)

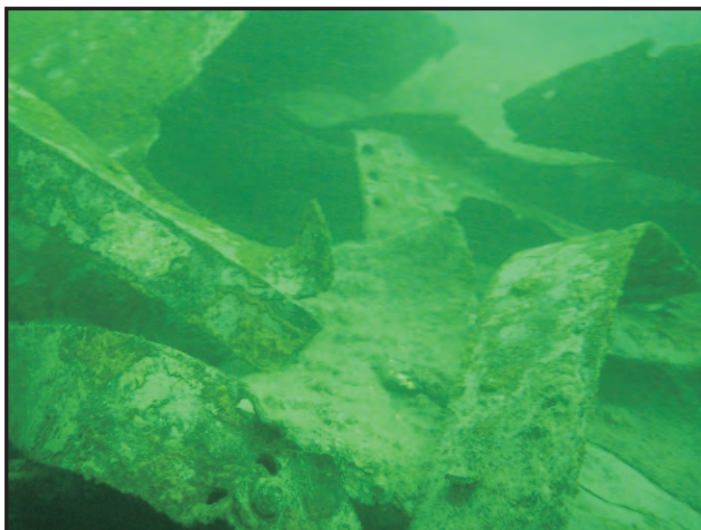
Figure 27: In-situ hull plating (Photo: Subtech)

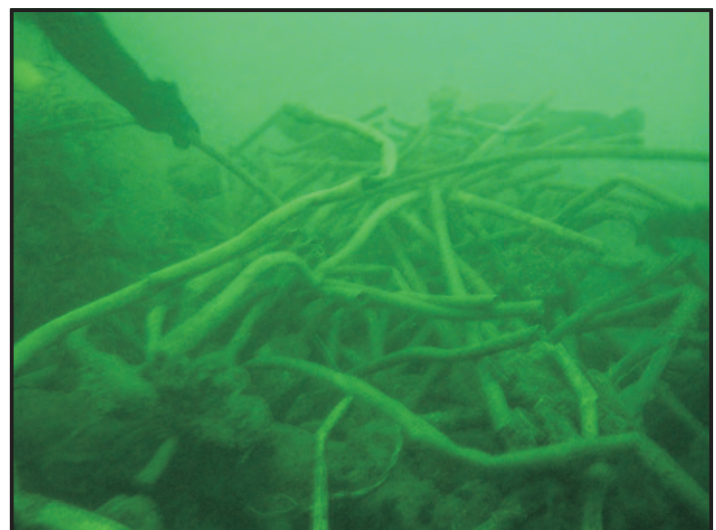
Figure 28: In-situ hull plating and boiler pipes (Photo: Subtech)

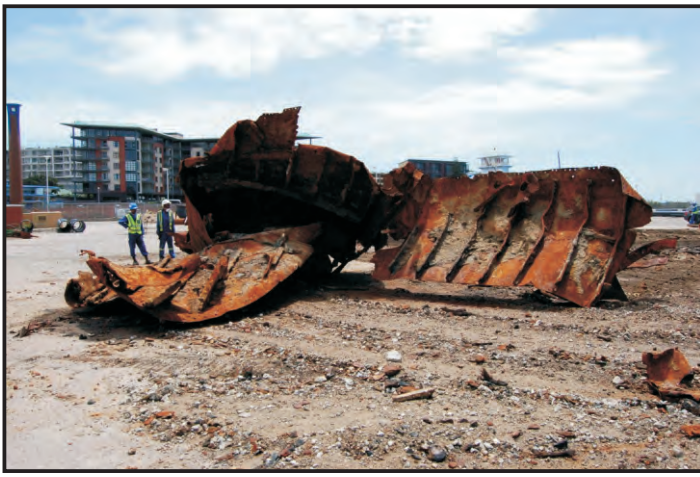
Figure 29: The largest section of hull plating removed intact, showing frames and stringers (Photo: Maitland)

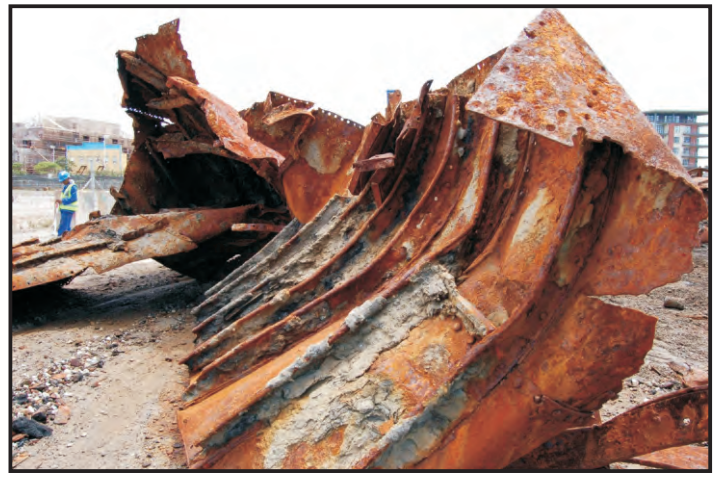
Figure 30: Close-up of the hull plating and the turn of the bilge (Photo: Maitland)

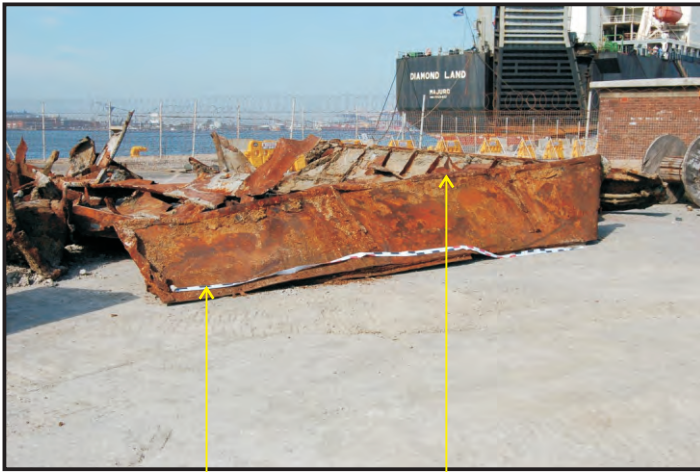
Sheerstrake Rubbing strake

Figure 31: External sheerstrake with the rubbing strake. The rubbing strake is placed on the outside of the gunwale and strengthens the join between the sheerstrake and the bulwark (Photo: Maitland)

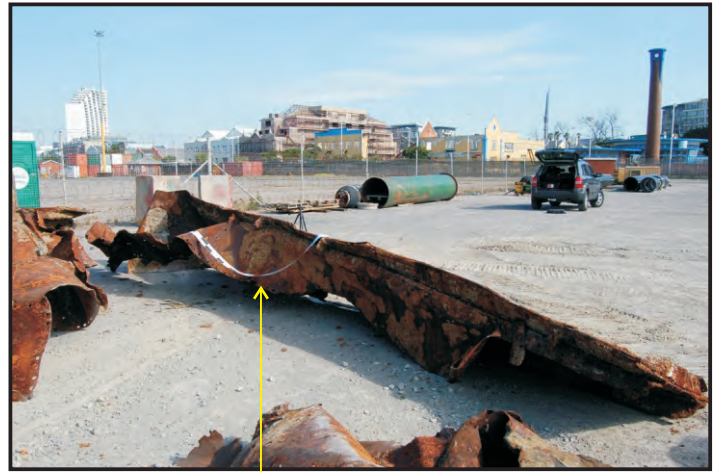
Figure 32: Internal view of the sheerstrake showing the steel deck plating (Photo: Maitland)

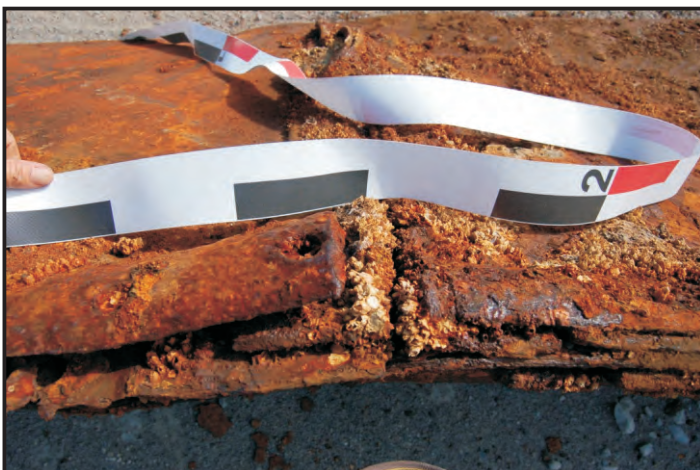
Figure 33: Close-up of the rubbing strake (Photo: Maitland)

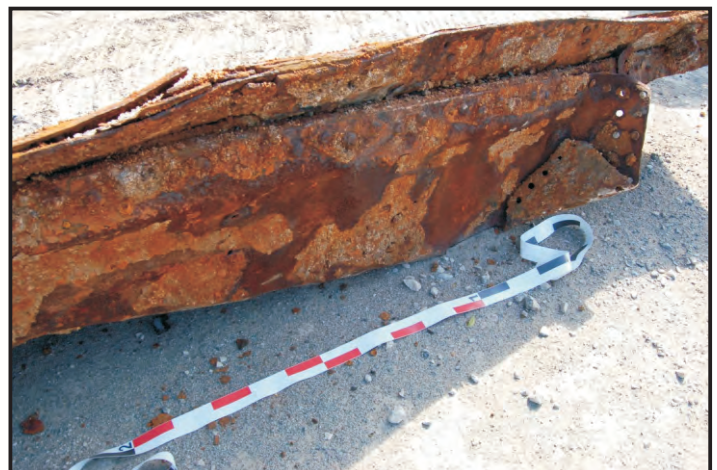
Figure 34: Close-up of the gunwale, where the sheerstrake, bulwark and deck intersect (Photo: Maitland)

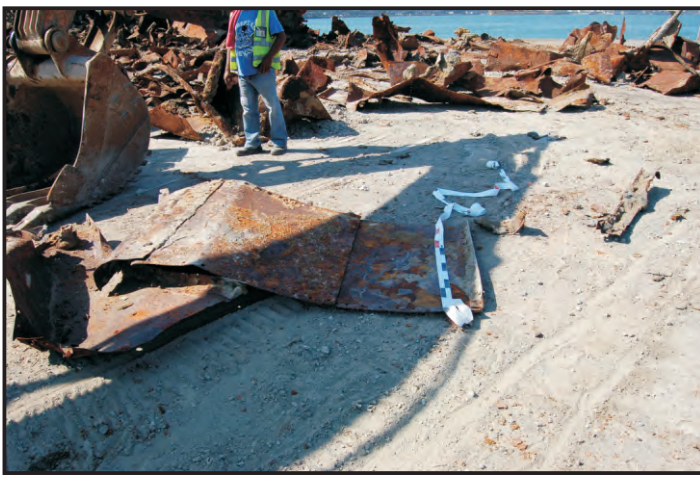
Figure 35: Joggled plating, this method of constructing the side plating did not require liners and was cheaper and lighter than previous methods (Pursey 1950: 82; Photo: Maitland)

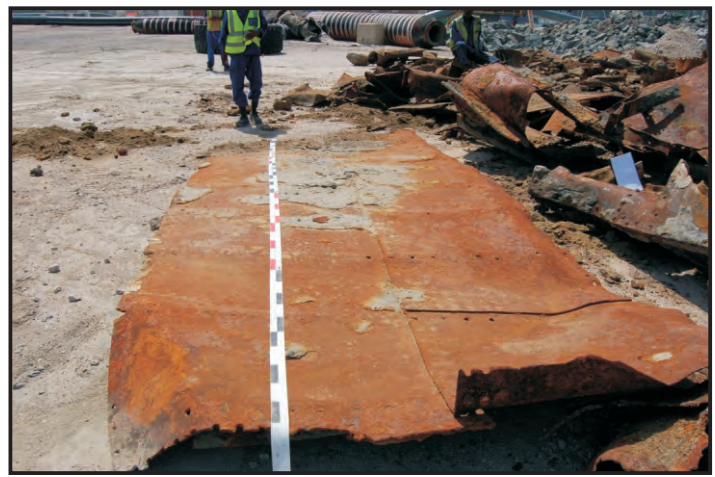
Figure 36: Long section of hull plating, the *Karin* hull was severely distorted due to post-depositional damage (Photo: Maitland)

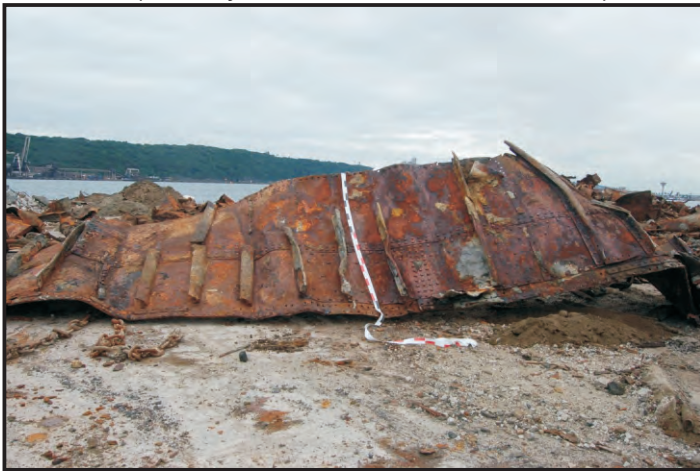
Figure 37: Internal view of the hull plating showing frames (Photo: Maitland)

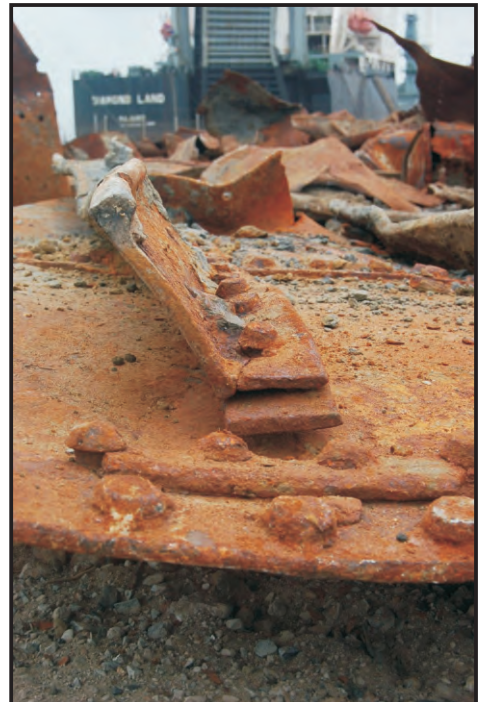
Figure 38: Close-up of bulb angle frames, they are stronger than frame-and-reverse, corrode less and require less riveting, they are also more suitable for joggled plates (Pursey 1950: 50; Photo: Maitland)

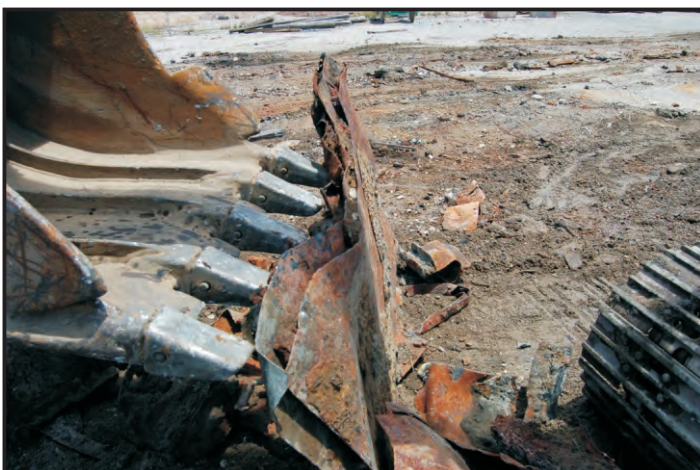
Figure 39: Triple steel plates, thinner than the hull plating (Photo: Maitland)

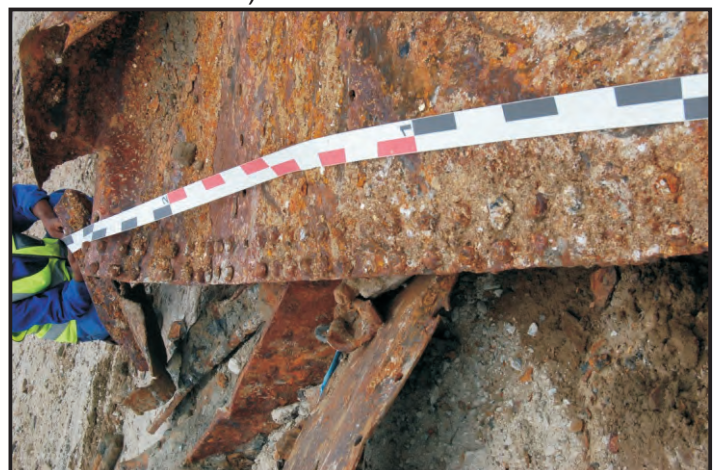
Figure 40: Hull plating with double riveting (Photo: Maitland)

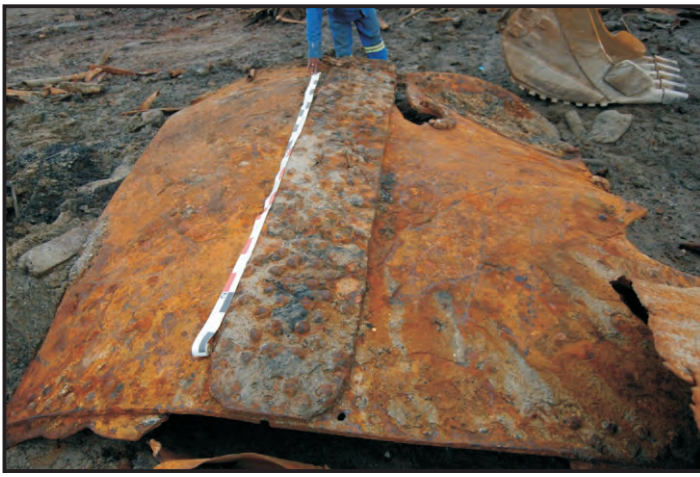
Figure 41: Hull plating with double riveted butt strap (Photo: Maitland)

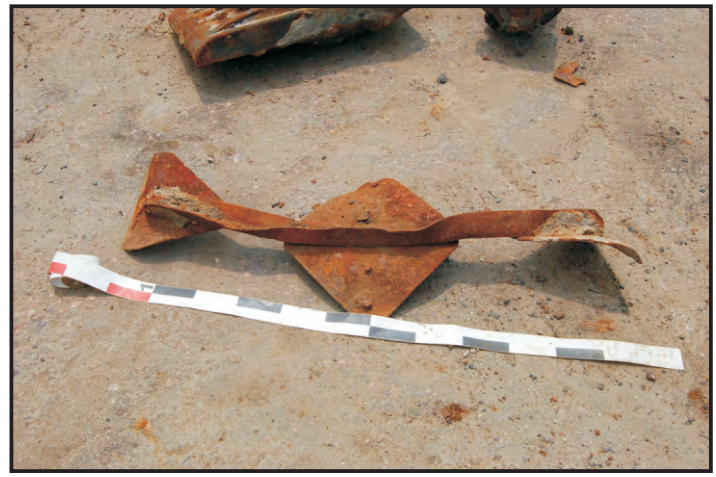
Figure 42: Diamond plate, used to connect the face bars of web frames and stringers (Pursey 1950: 10; Photo: Maitland)

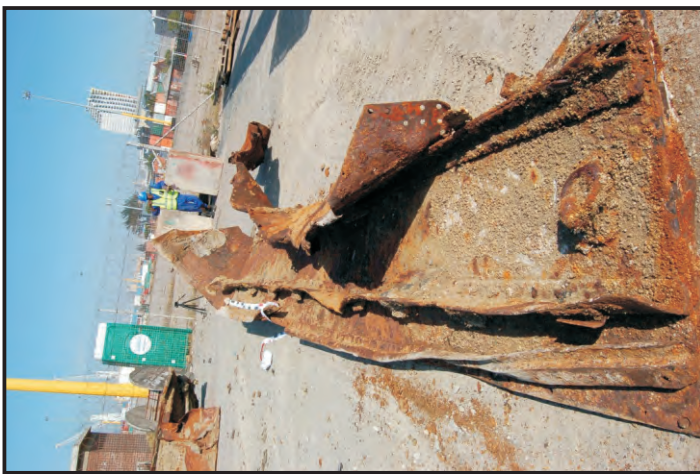
Figure 43: Internal view of hull plating with a portion of the steel deck and a scuttle (Photo: Maitland)

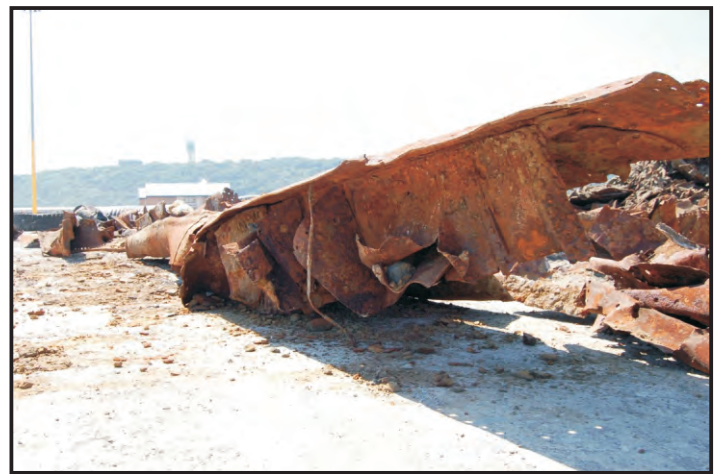
Figure 44: Hull plating with large support structures, possibly from the engine room (Photo: Maitland)

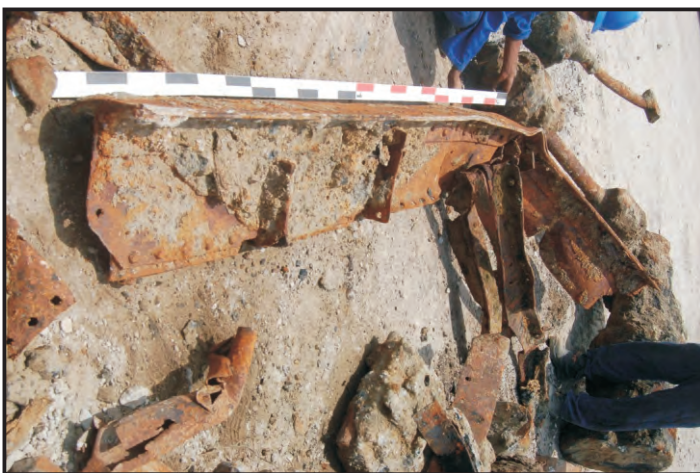
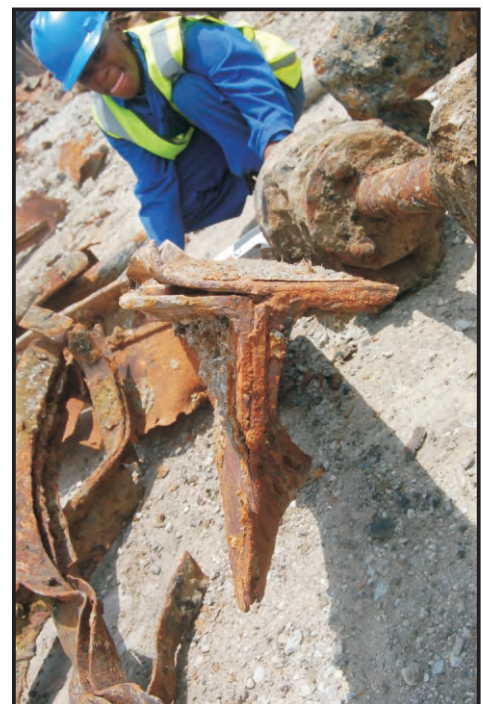
Figures 45 - 46: Double angle bar beam, possibly a deck support structure (Photo: Maitland)

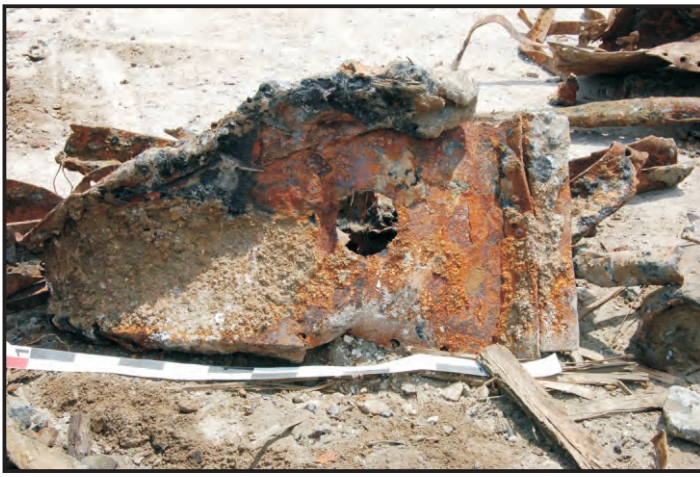
Figure 47: Possible beam knee, a deck support (Photo: Maitland)

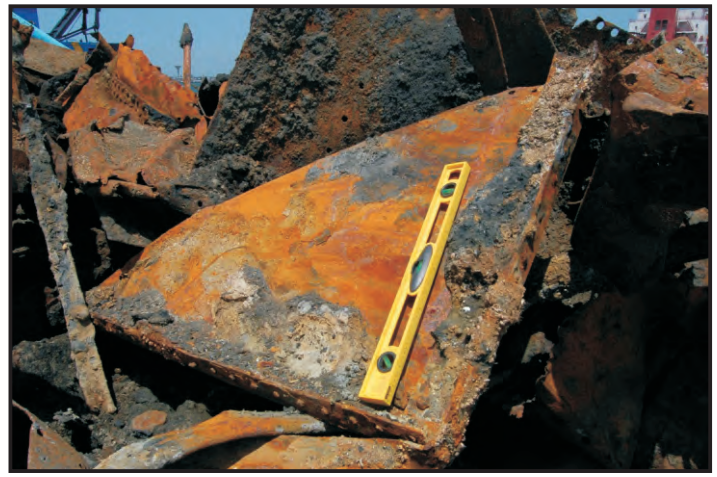
Figure 48: Deck bracket knee (Photo: Maitland)

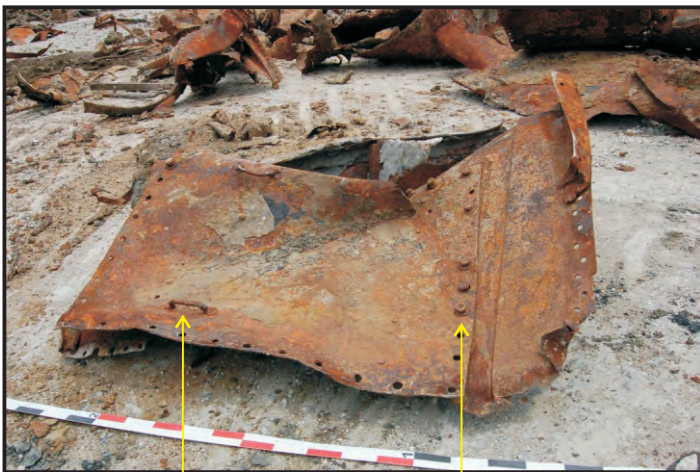
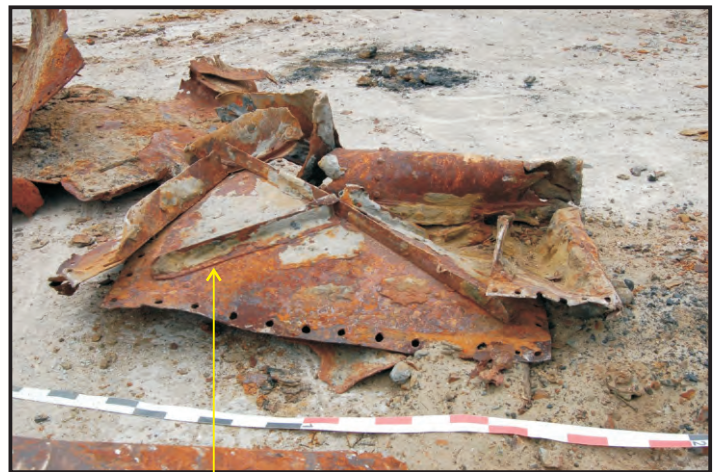
Handle

Bolts

Diagonal tie plates

Figures 49 - 50: Front and back of an access hatchway, these were placed throughout the vessel. This has two handles and was bolted shut (Photo: Maitland)

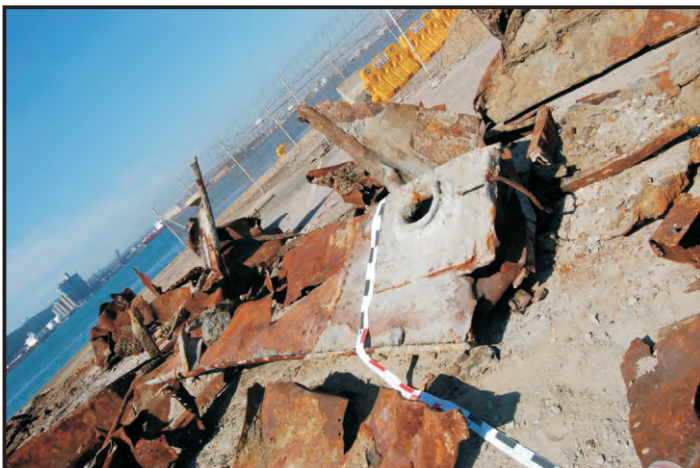
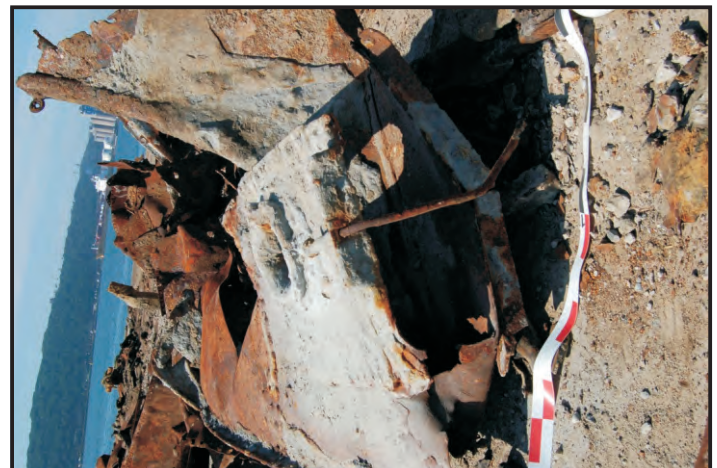
One anchor hawsehole can be seen on the starboard side on the blueprint, it must have been mirrored on the port side.

Figures 51 - 52: Top and side view of the bow hawsehole, there is an extra reinforcing plate around it (Photos: Maitland)

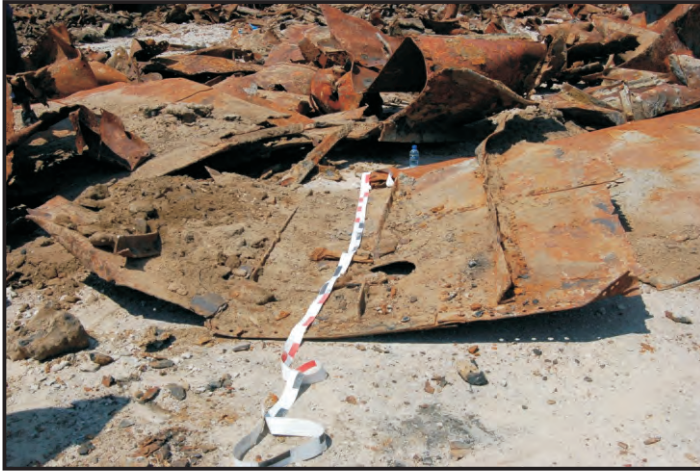
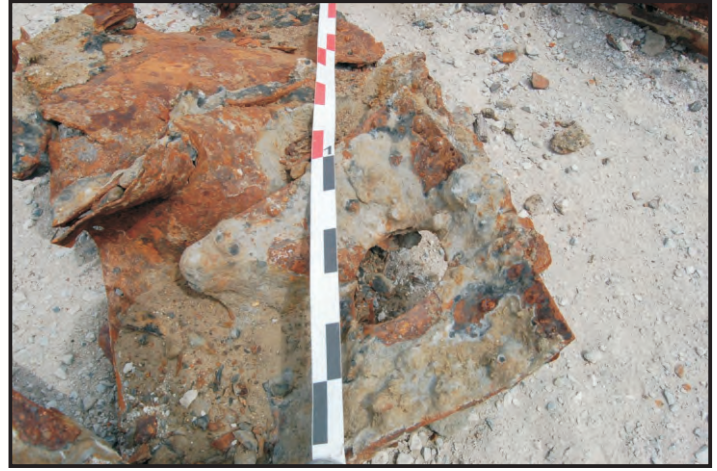
Figures 53 - 54: Internal and external view of porthole, note the strengthening plate on the external side (Photos: Maitland)

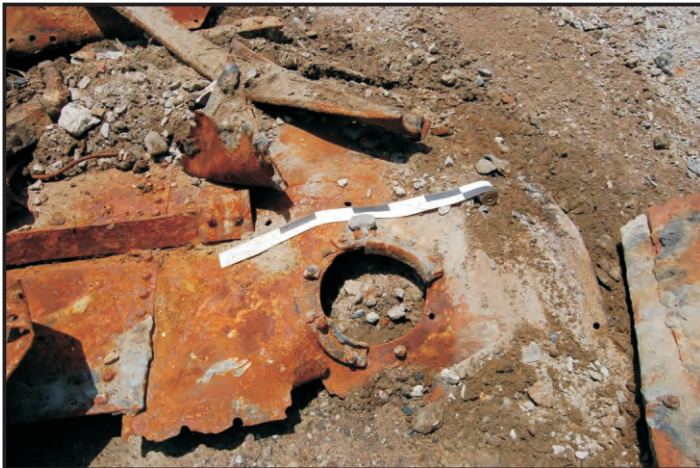
Figure 55: Porthole frame (Photo: Maitland)

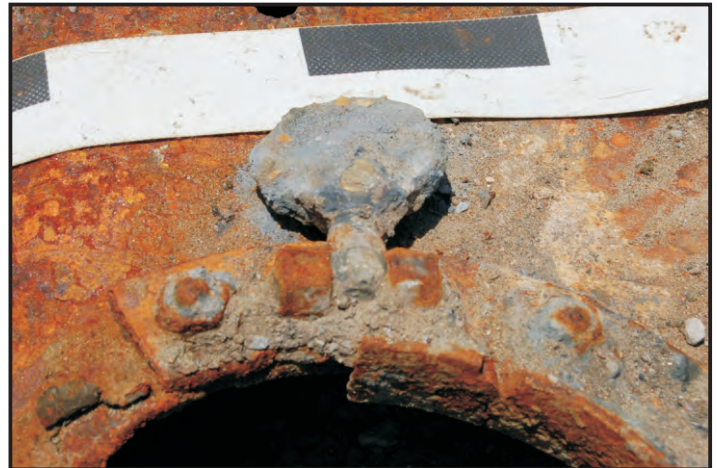
Figure 56: Brass porthole securing clip (Photo: Maitland)

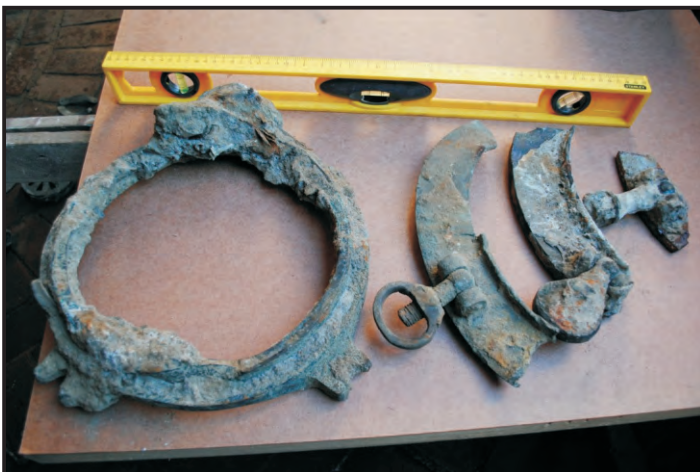
Figure 57: Complete porthole frame with intact rubber seal, broken sections with porthole clips (Photo: Maitland)

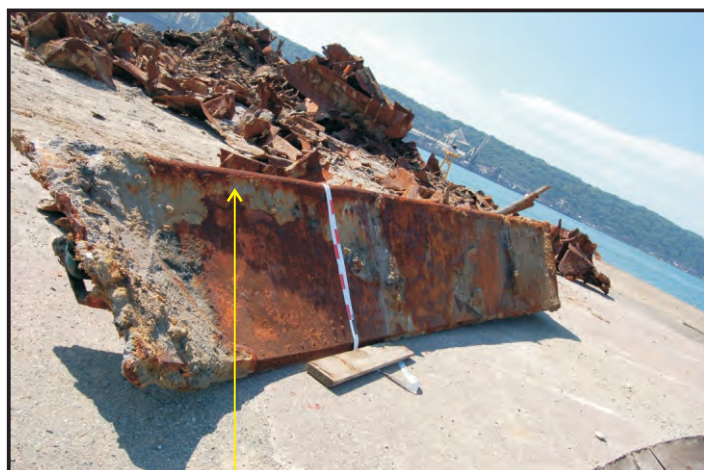
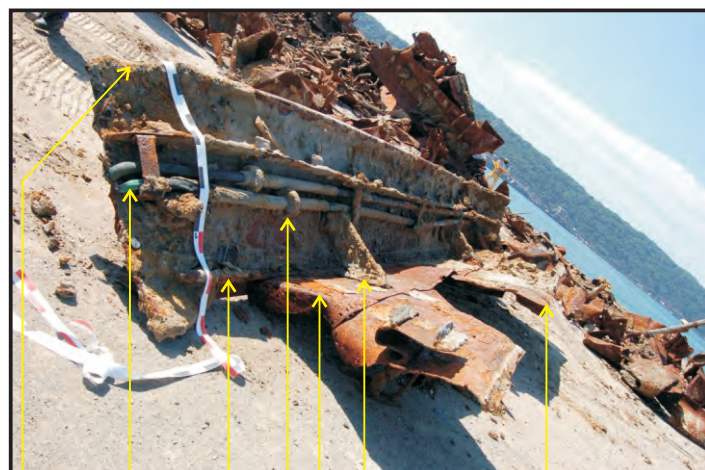
Main rail

Main rail
Bulwark piping
Deck stringer plate
Coupling flange
Gunwale angle bar
Bulwark stay
Deck plating

Figures 58 - 59: External and internal view of the bulwarks, showing various features (Paasch 1890: ; Photos: Maitland)

The *Karin* was a well deck ship, that is she had a raised quarter deck and bridge combined and a forecastle, the deepening between these structures formed a 'well' (Paasch 1890: 3). The plated bulwarks as opposed to railings may have contributed to her inability to shed the large amount of water that washed onto her deck, which led to her sinking.

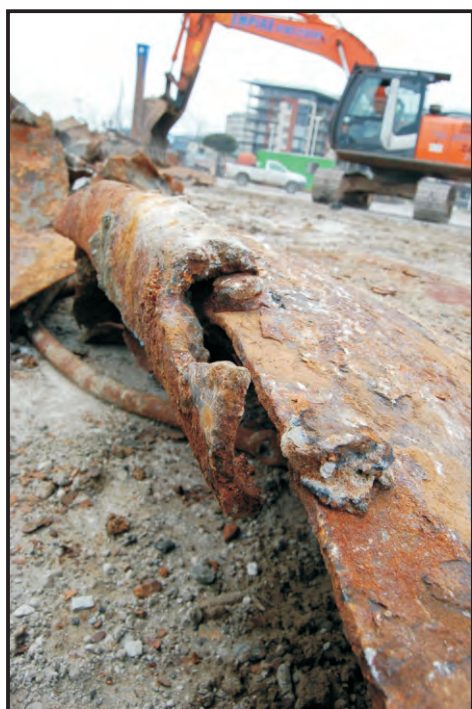
Figure 60: Close-up of the bulwark main rail (Photo: Maitland)

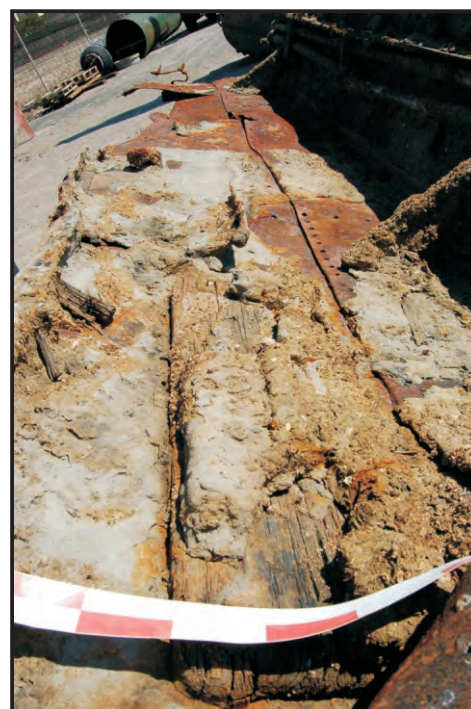
Figure 61: Section of deck plating near the bulwark with wood planks, the wood may have served as a base for deck equipment (Photo: Maitland)

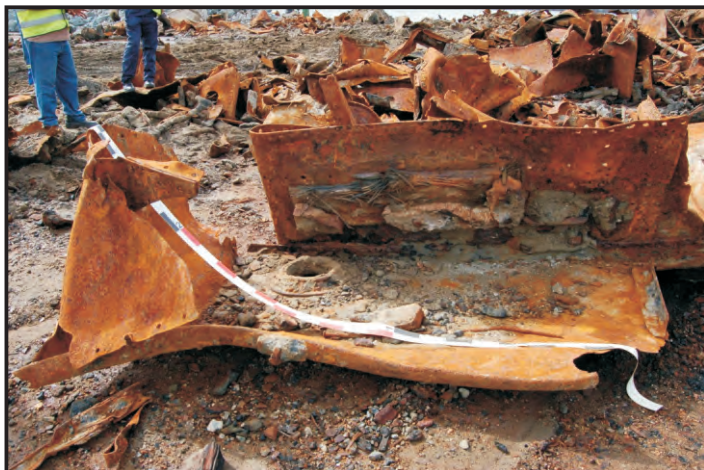
Figure 62: Bulwark with mooring pipe and deck plating with wooden base plate, the proximity of these items indicates bollards may have been attached to the base plate (Photo: Maitland)

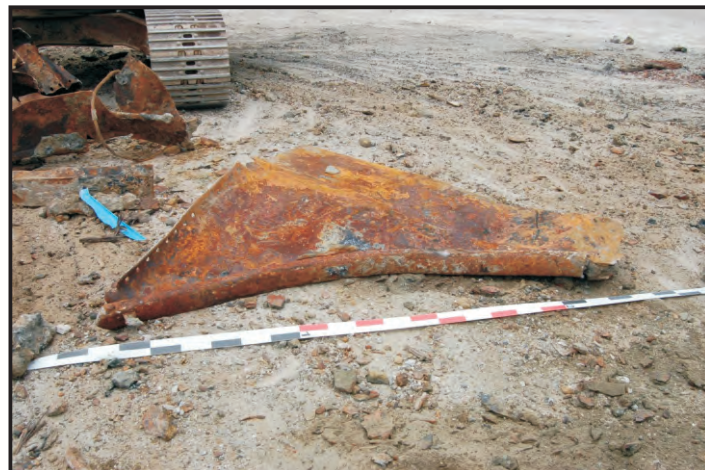
Figure 63: Section of bulwark showing the curve of the well deck (Photo: Maitland)

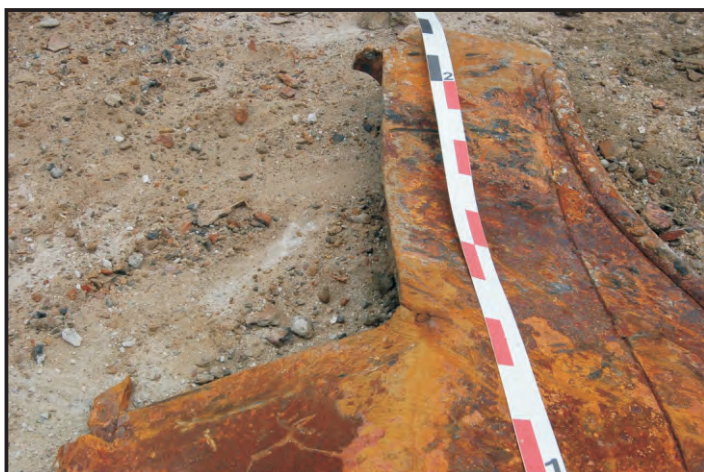
Figure 64: External view of a washport, the curve of the well deck bulwark is also visible (Photo: Maitland)

There was a lot of discussion in the Court of Inquiry regarding whether the washports were sufficient to release the water on deck. P.B. sale, the mate of the *Karin* states that the washports measured 2' 6" x 18", which tallies with the pictures below. McNaughton, the *Karin's* chief engineer stated that the washports opened "by a hinge, a special patent," (Appendix A: 26,84). According to Pursey (1950: 92) the regulations regarding washports are "Bars, spaced not more than 9 inches apart, must be fitted across the port. Where hinged flaps are fitted, they are to have brass pins and must not have any fittings for keeping them closed." The depth of the washports on the *Karin* was 18" and there was one bar across the port.

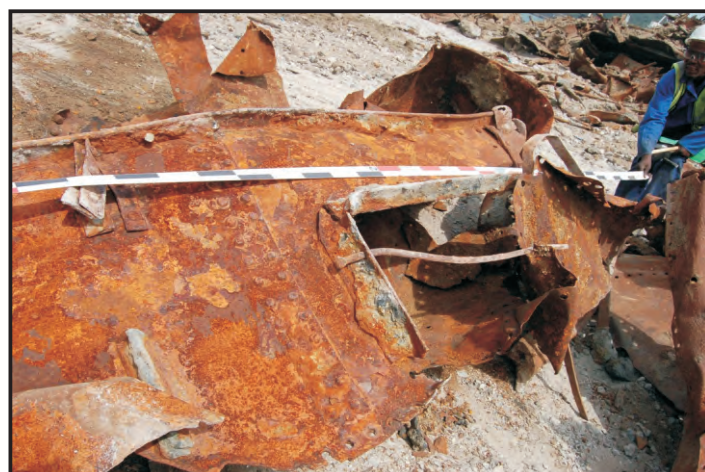
Figure 65: Internal view of a washport, the strengthening frame and cross bar is visible (Photo: Maitland)

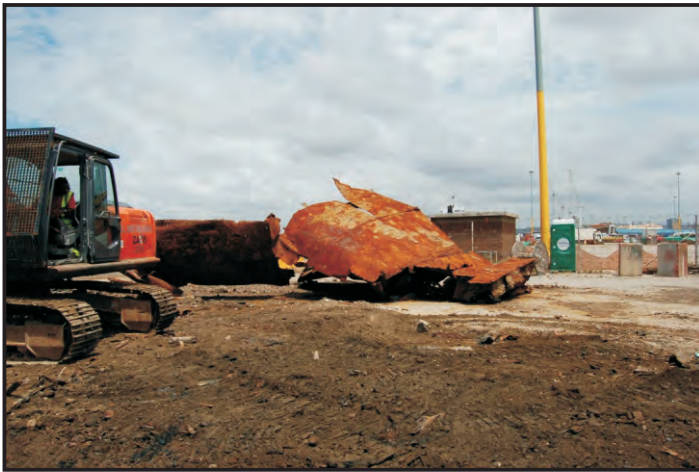
Figure 67: Keel and plating, probably the forward section where the vessel narrows towards the bow (Photo: Maitland)

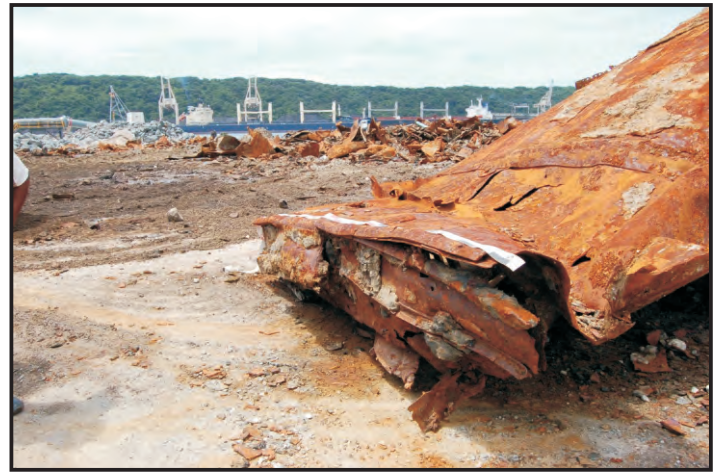
Figure 68: Close-up showing part of the centre keelson (Photo: Maitland)

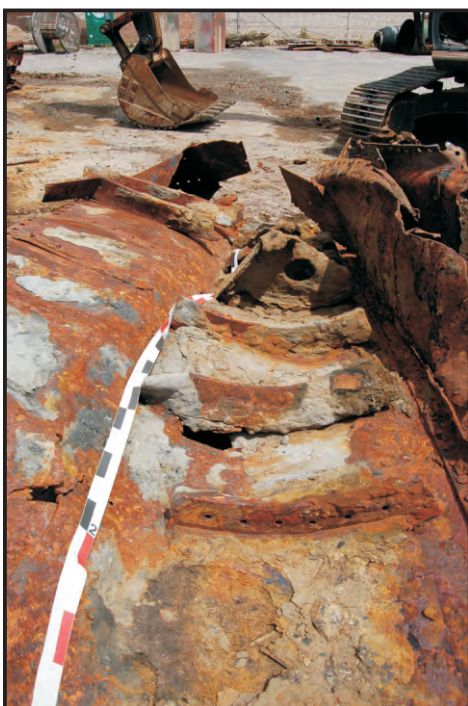
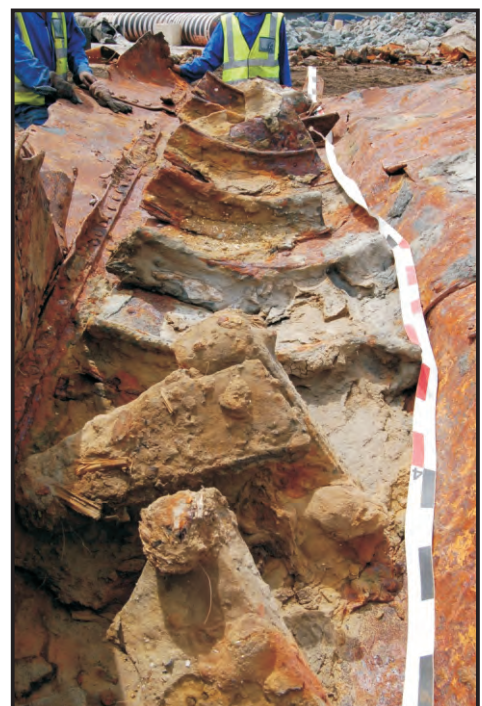
Figures 69 - 70: Two views of the keel, probably forward of midships, these frames are at the turn of the bilge, also bracket frames are visible (Photos: Maitland)

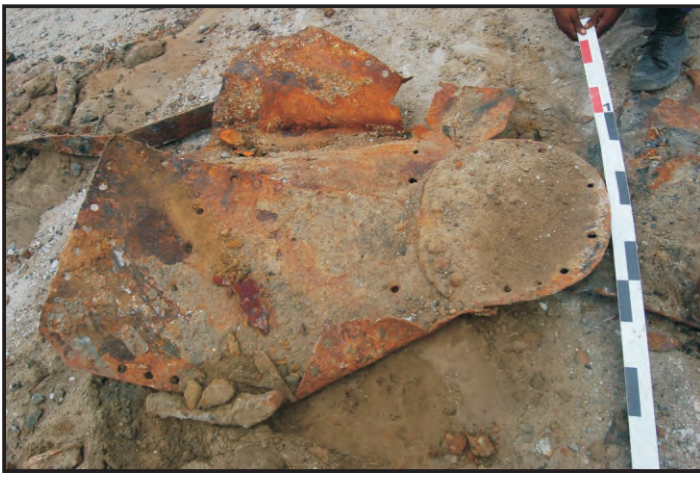
Figure 71: Manhole cover (Paasch 1890: Plate 20; Photo: Maitland)

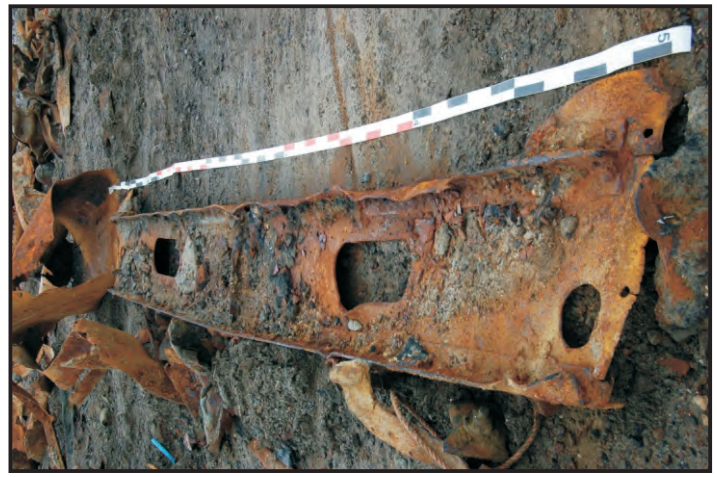
Figure 72: Floor girder (Photo: Maitland)

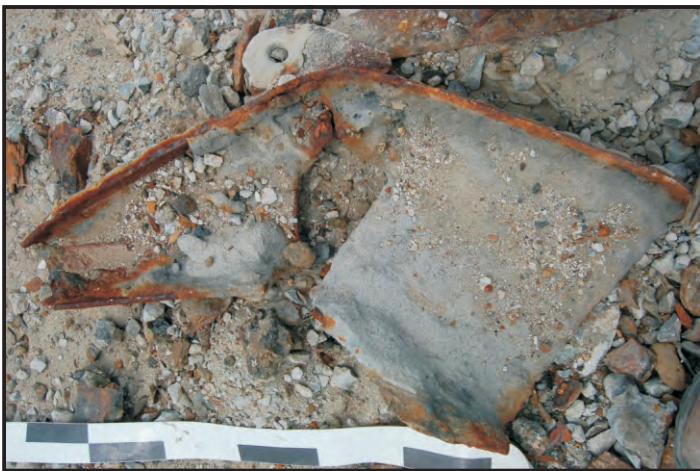
Figure 73: Bracket frame with water course (Photo: Maitland)

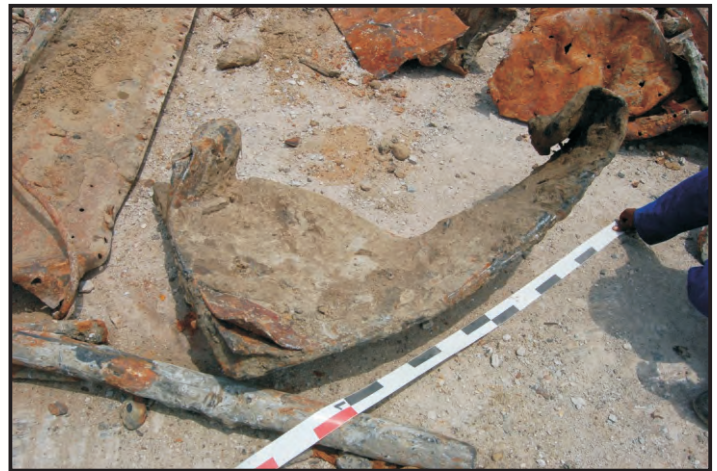
Figure 74: Breasthook or crutch depending on whether it is from the bow or the stern; a plate that strengthens these areas (Photo: Maitland)

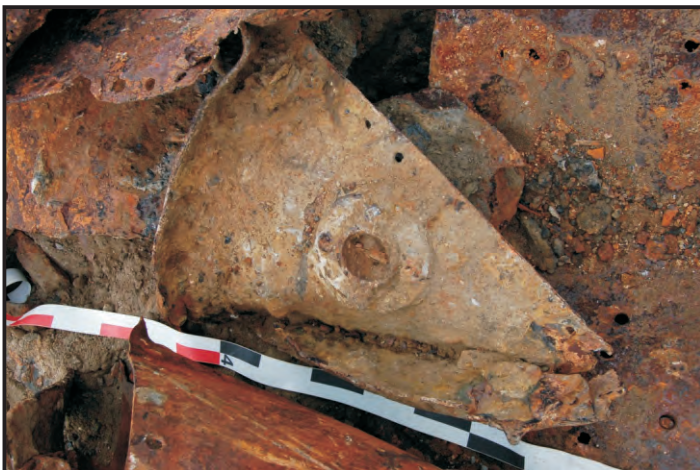
Figure 75: Web frame with pipe flange coupling (Photo: Maitland)

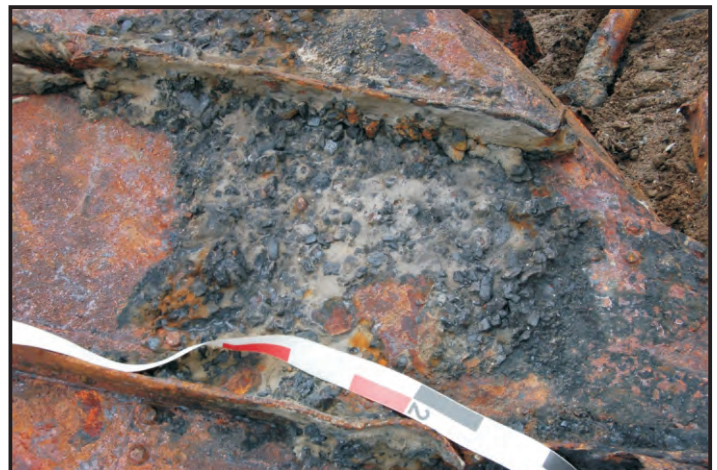
Figure 76: Plating with coal embedded in the corrosion, this section of plating is probably part of the coal bunkers, the *Karin* carried 85 tons of bunker coal (Appendix A: 3; Photo: Maitland)

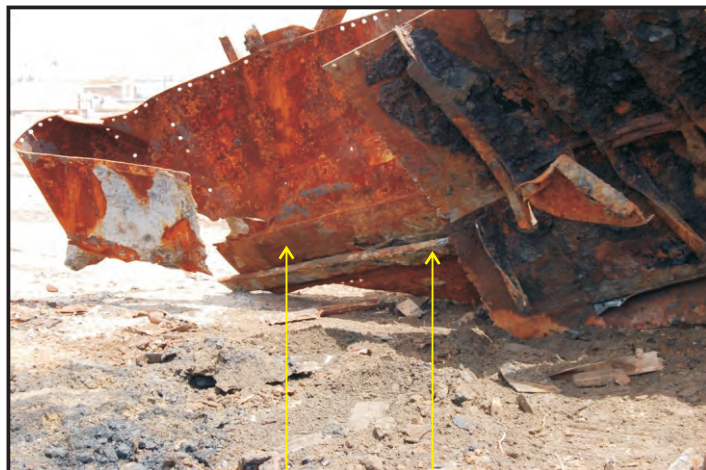
Strengthening plates

False keel

Figure 77: A fixed keel was probably fitted to protect the vessel against damage if running aground (Paasch 1890: 15; Photo: Maitland)

P.B. Sale, the mate of the *Karin*, mentions that he allowed an inch less on the loading lines due to the “putting on a fixed keel” (Appendix A: 41). This implies that the fixed keel had been attached to the vessel after her last Lloyd’s survey, otherwise the plimsoll mark would have been changed. This tallies with the welding found on the fixed keel, the rest of the vessel is connected with rivets.

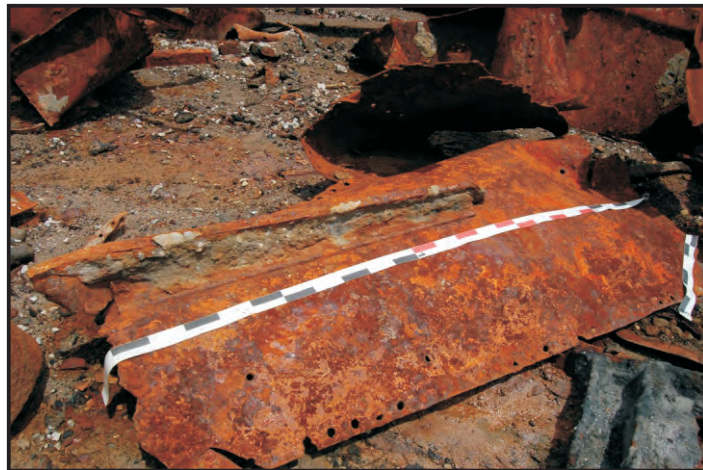
Figure 78: The aft or forward end of the fixed keel (Photo: Maitland)

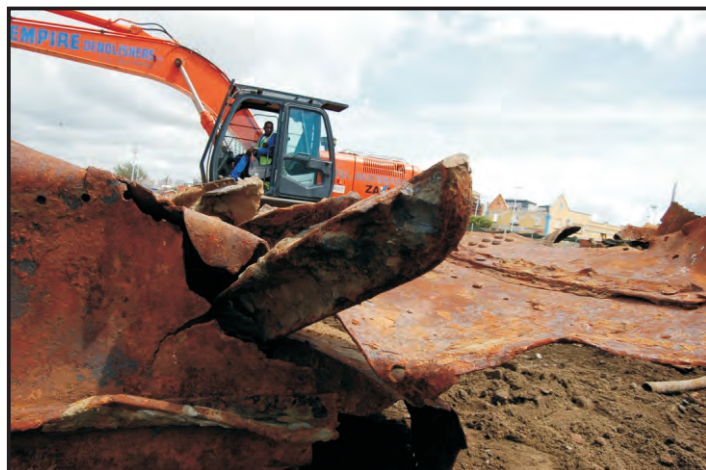
Figure 79: The aft or forward end of the fixed keel (Photo: Maitland)

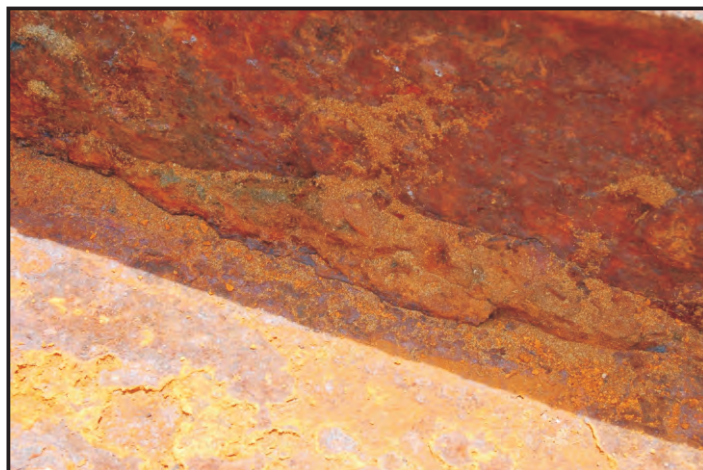
Figure 80: Close-up of the fixed keel - this is the only welding on the vessel (Photo: Maitland)

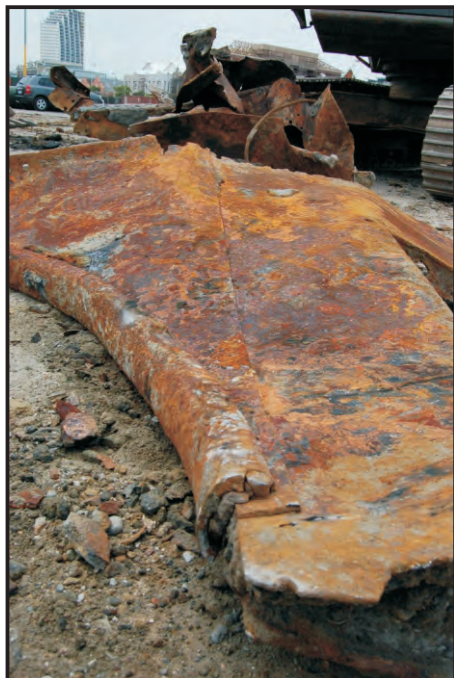
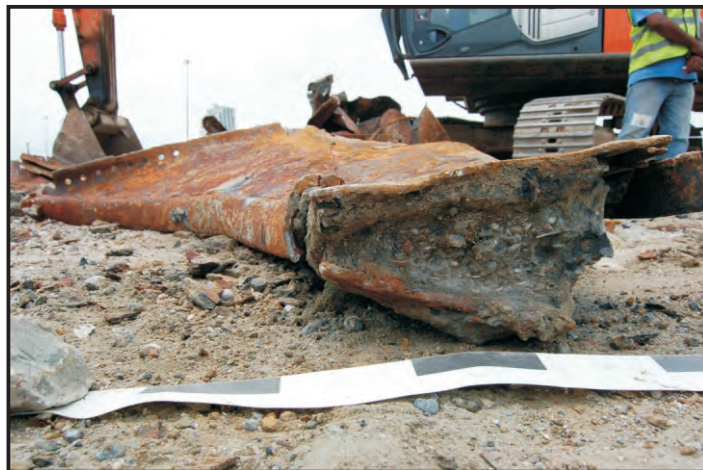
Figures 81 - 82: Top and cross-section view of the bow, it has a reinforcing stem (Photos: Maitland)

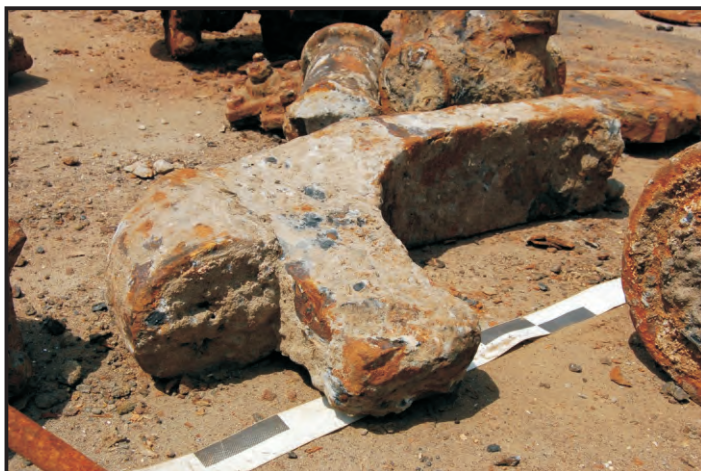
Figure 84: Sole piece of stern frame (Photo: Maitland)

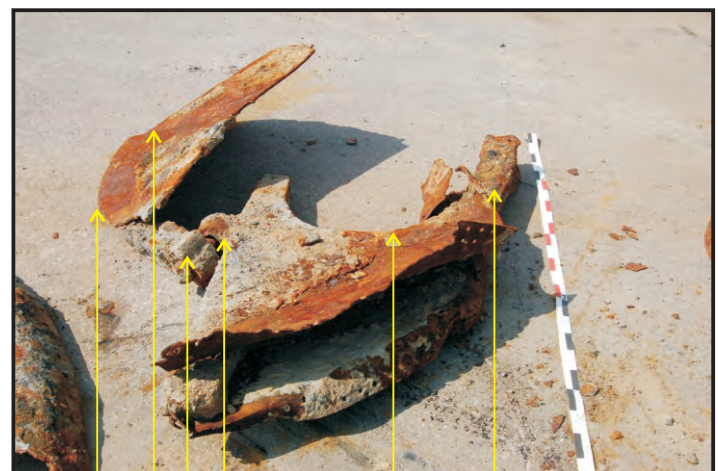
- Rudder
Rudder brace
Rudder pintle
Arch
Propellor post

Figure 85: Arch piece of stern frame with remains of the rudder (Photo: Maitland)

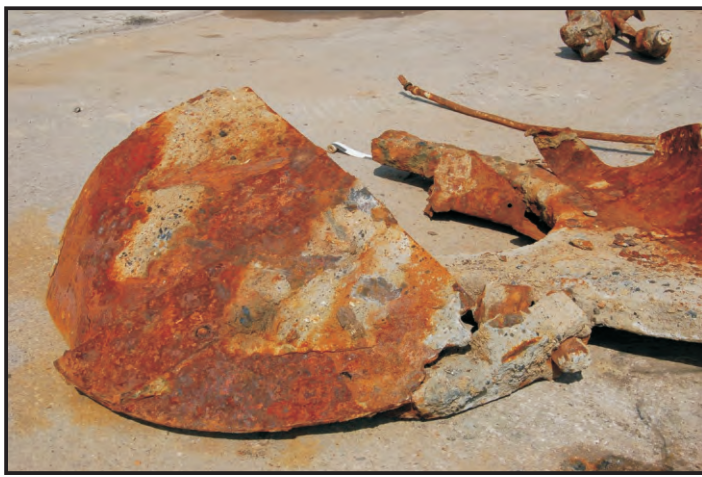
Figure 86: Close-up of the remains of the rudder, the arm is more visible in this view (Photo: Maitland)

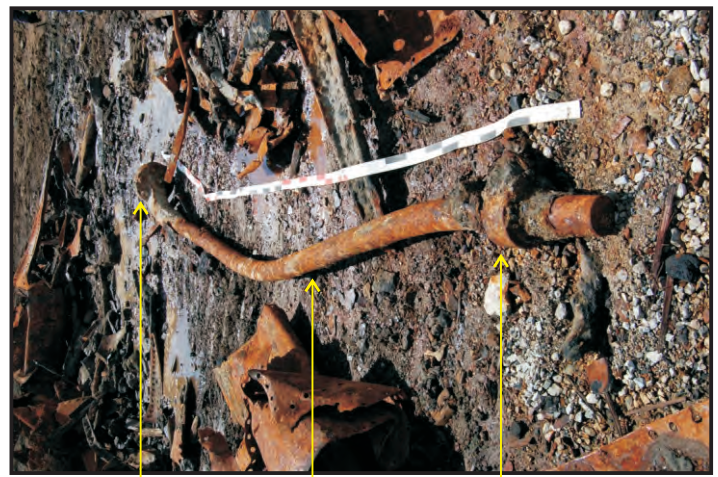
Horizontal coupling Rudder stock Steering connection

Figure 87: Upper part of the rudder stock. The horizontal coupling connects the two parts of the stock, allowing disconnection when necessary (Brown 1931: 465; Photo: Maitland)

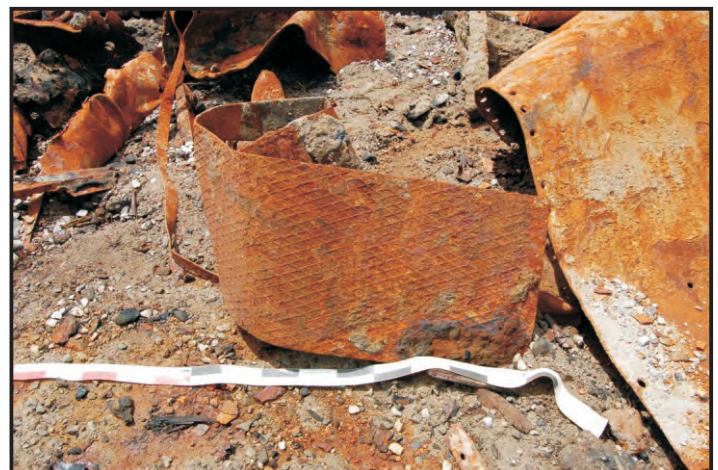
Figure 91: Non-slip sheeting, this would be attached on gangways etc. (Photo: Maitland)
