S.S. Karin

Shipwreck Report

Durban Harbour Entrance Widening
Kwazulu-Natal
South Africa
June 2010

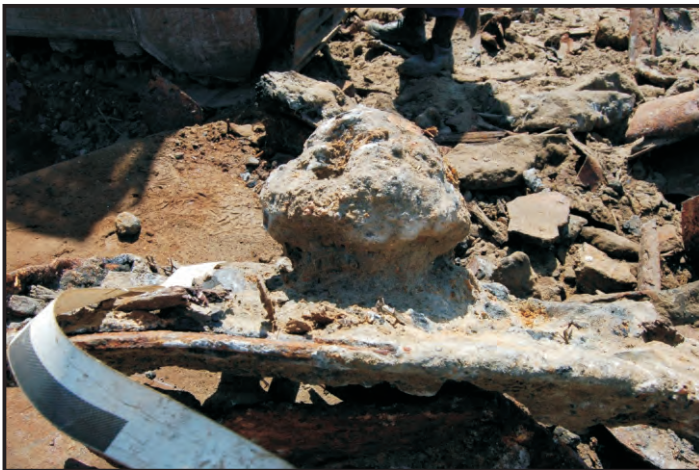
Figure 94 -95: Two deck capstan rollers, the first is still attached to the deck plating (Renda 2010; Photo: Maitland)

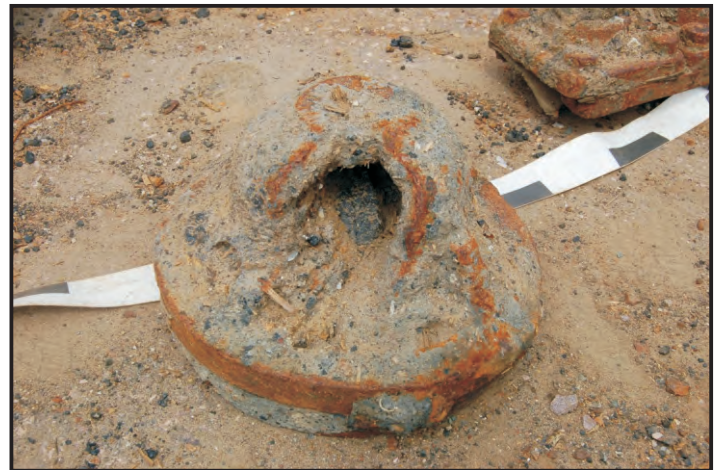
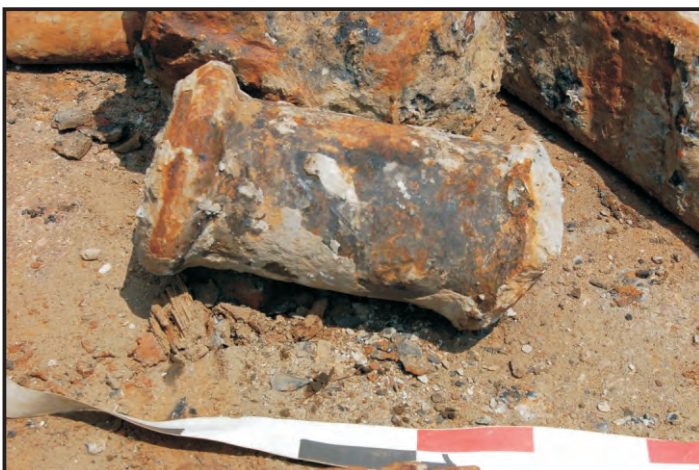
Figure 96: Bollard. According to the blueprint, the *Karin* had at least 20 bollards and capstan rollers on her deck (Photo: Maitland)

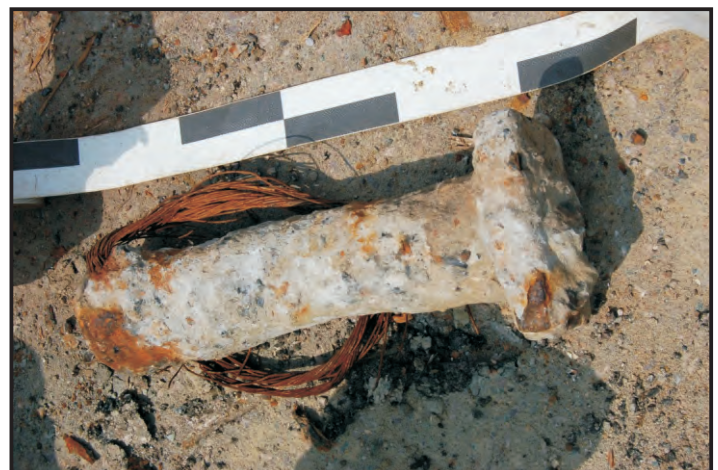
Figure 97: Deck bitt with concreted cable (Photo: Maitland)

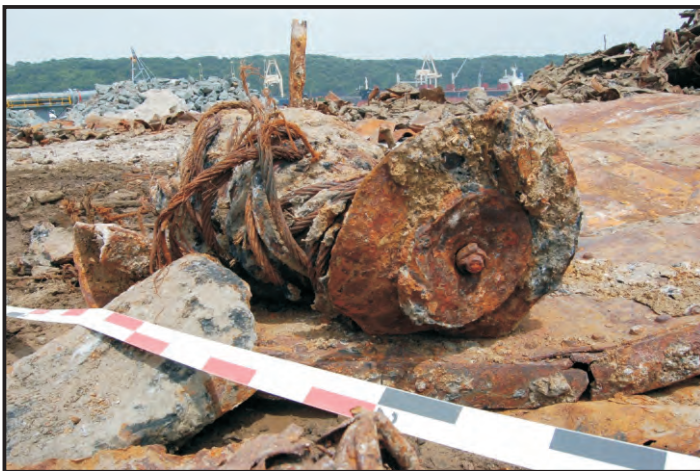
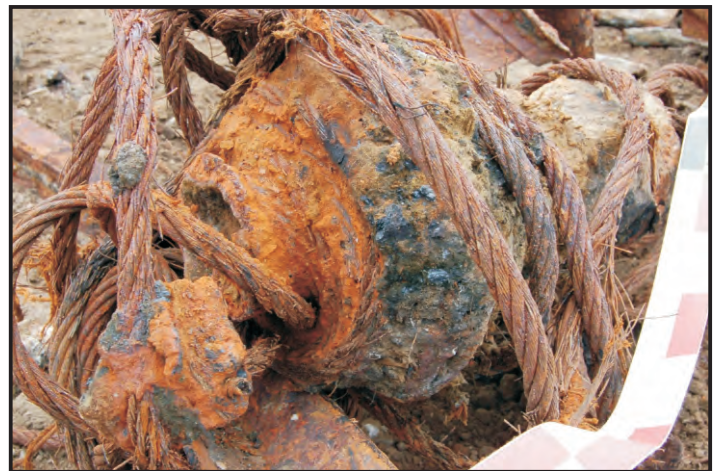
Figures 99 - 100: Steam windlass. According to the Lloyd's Survey of 1921, the *Karin* had a steam windlass. This was usually placed on the upper fore-castle deck and was used for hauling up bower anchors (Appendix A: 3; Paasch 1890: 156; Photos: Maitland)

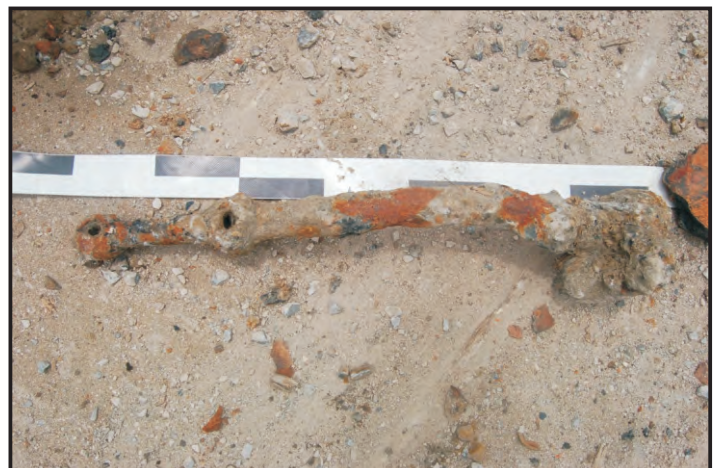
Figure 102: Possible deck railing. The *Karin* had railings fore and aft (Photo: Maitland)

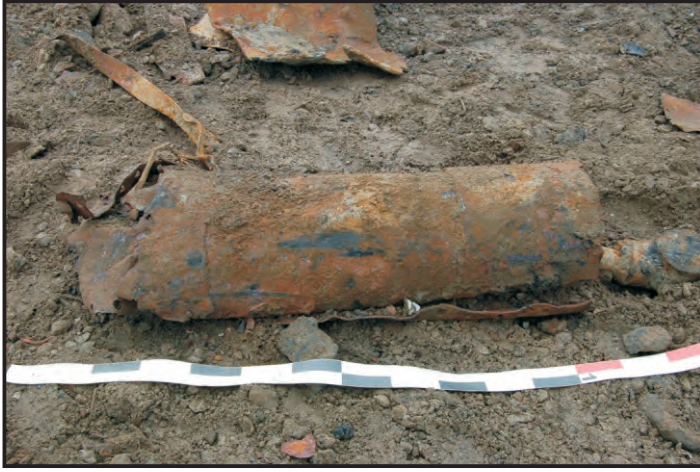
Figure 103: Section of mast constructed of two plates on the round, although the mizzen mast was apparently washed away during the wreck, sections would still have remained (Pursey 1950: 144; Photo: Maitland)

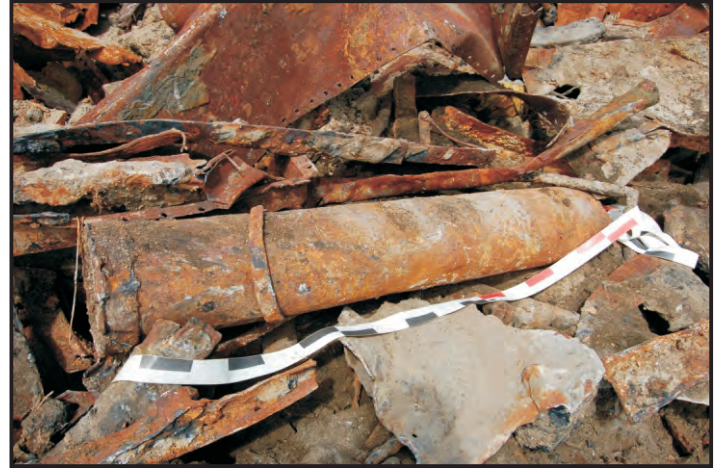
Figure 104: Section of mast, the flange where it was stepped onto the vessel is on the left end (Photo: Maitland)

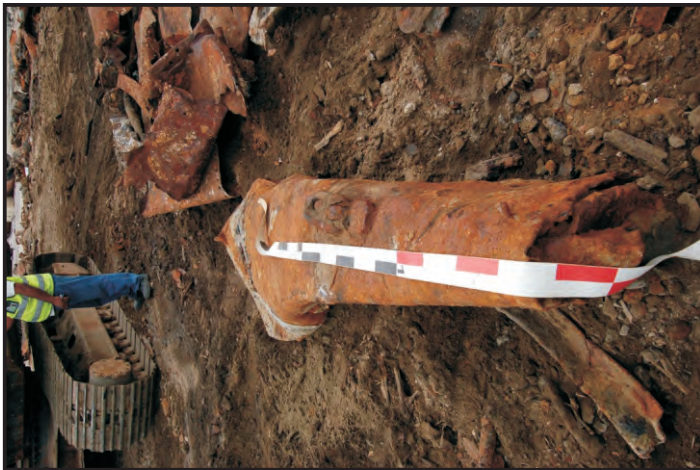
Figure 105: Section of mast with a rigging shackle (Photo: Maitland)

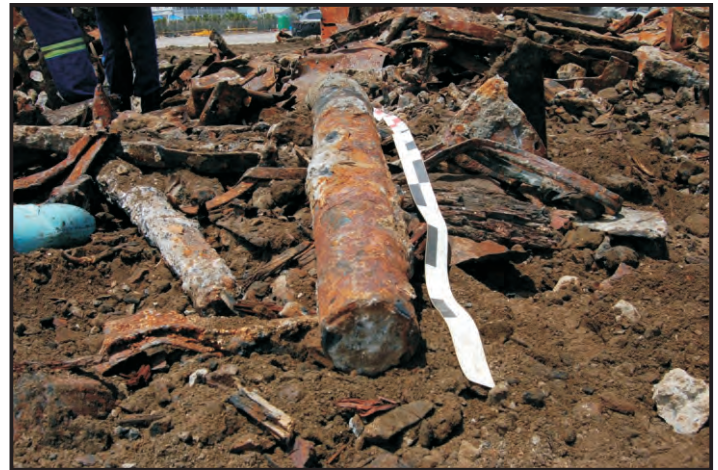
Figure 106: This 'mast' is constructed of solid steel therefore may actually be the eduction pipe from the condenser (Photo: Maitland)

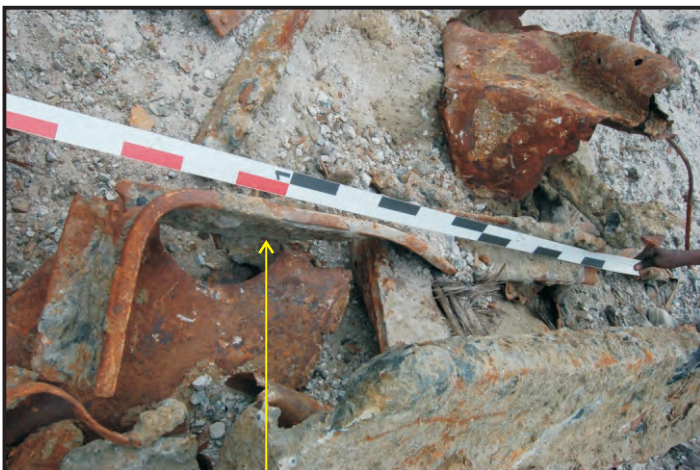
Figure 107: Frame from a watertight door (Manual of Seamanship 1951:47; Photo: Maitland)

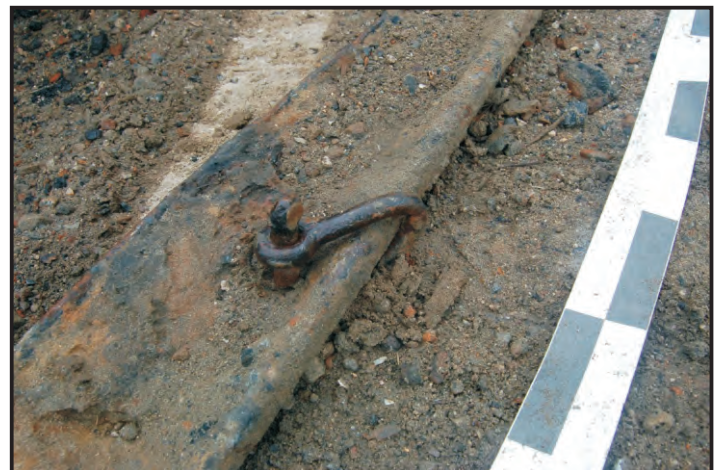
Figure 108: Securing clip on the frame of a watertight door (Photo: Maitland)

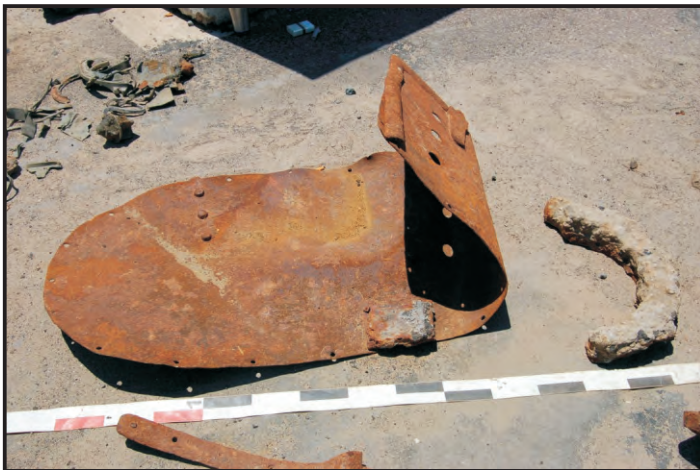
Figure 111: Inside of cabin door with lock (Photo: Maitland)

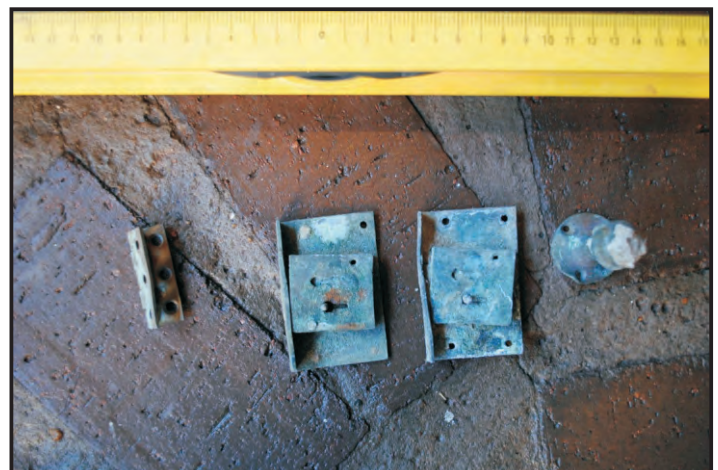
Figure 114: Cupboard hinge, locks and door knob (Photo: Maitland)

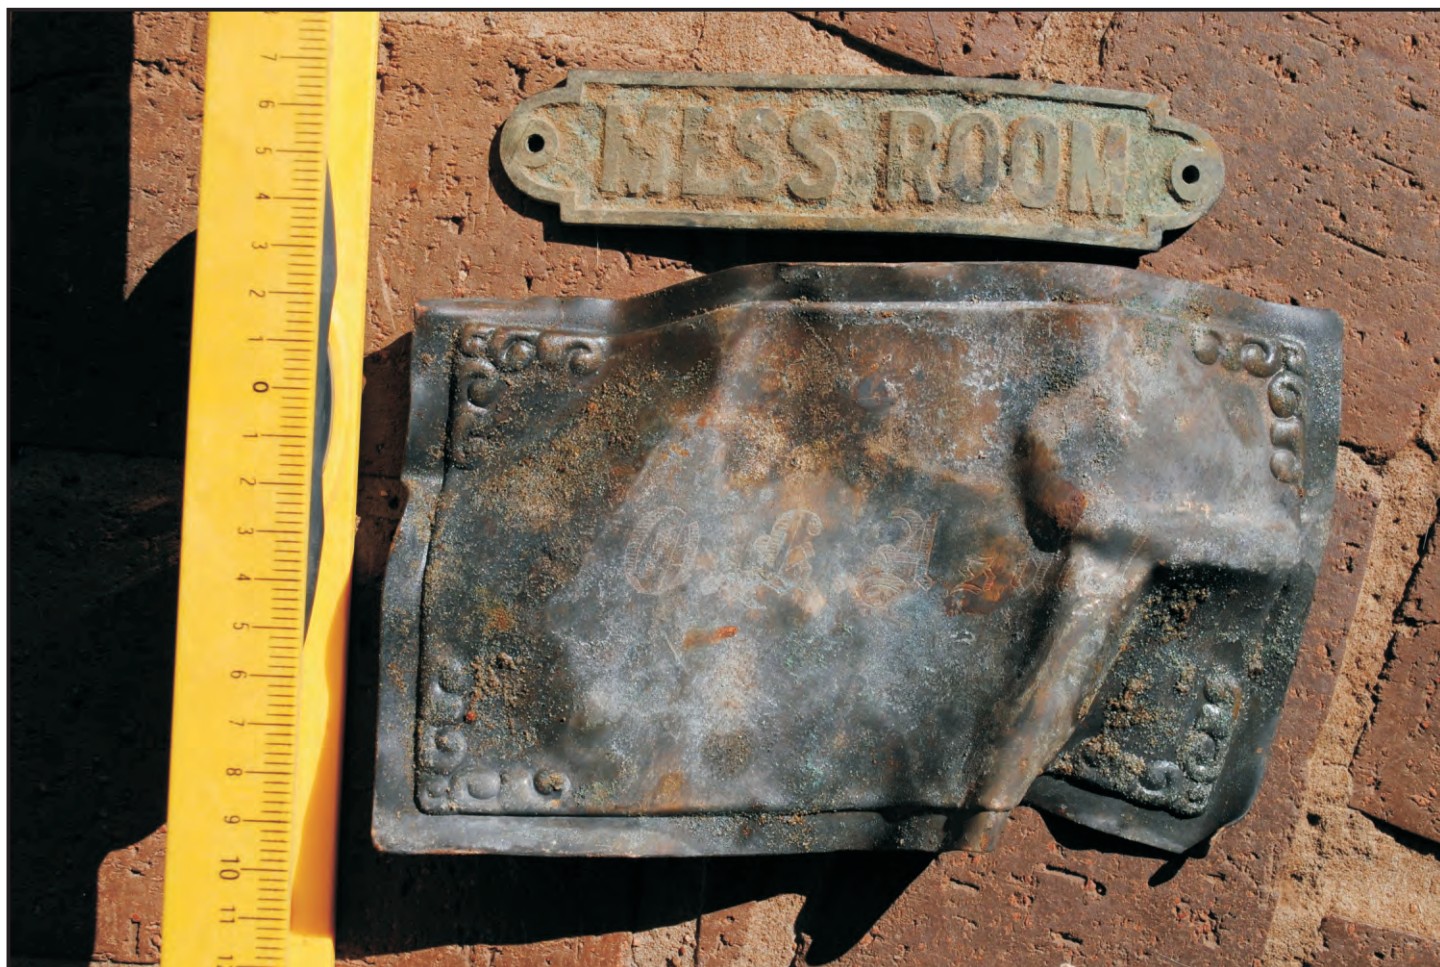
Figure 116: Door plates from the mess room and cabin. If I had any doubt as to my identification of the wreck as the *Karin*, this artefact removed them. The name on the plate is O.C. Asdal, who was the master of the *Karin* (Photo: Maitland)

I then went to the newspaper archives at the Central Durban Library, the articles there further reinforced the idea that 'Anomaly 27' was the *Karin*. Further research at the Pretoria Archive Repository uncovered all the files dealing with the wreck of the *Karin* and her dispersal and I was confident of my identification of 'Anomaly 27' as the remains of the S.S. *Karin*. However, towards the end of my report, I found the cabin name plate of O.C. Asdal, the proverbial smoking gun.

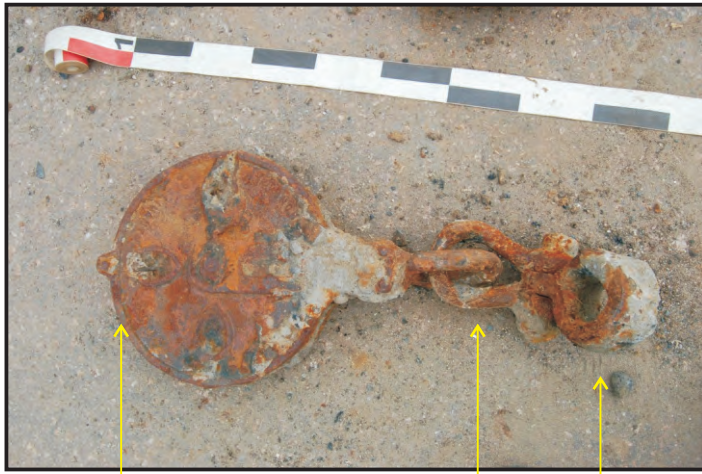
Cargo block Bow with forelock shackle Spar ring

Figure 117: Two cargo blocks were recovered, the one pictured was stamped—BULLIVANTS LONDON HONI31; the other was stamped TO (L?)_ _ T SINGLE TEST 2 W1. Bullivants & Co., from Millwall, London produced a wide range of deck and hull equipment in the early 20th century (www.naval-history.net; Photo: Maitland)

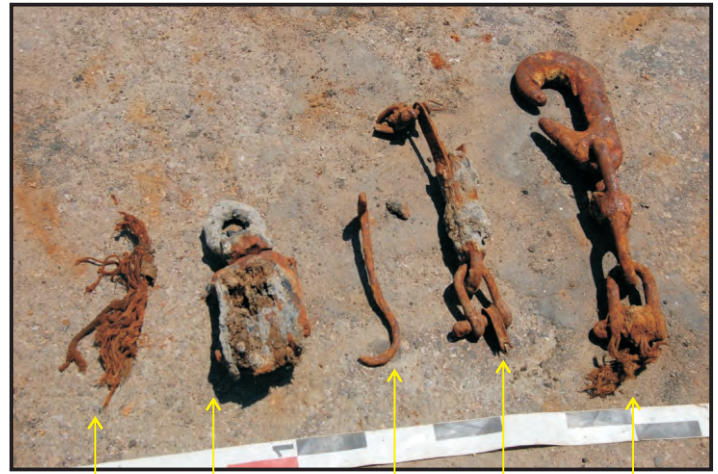
Rope Stevedore's hand hook Cargo hook
Internal bound block

Thimbles and straight screw shackle

Figure 118: Various rigging items (McLeod 1977; 110; Manual of Seamanship 1951: 142 - 150; Photo: Maitland)

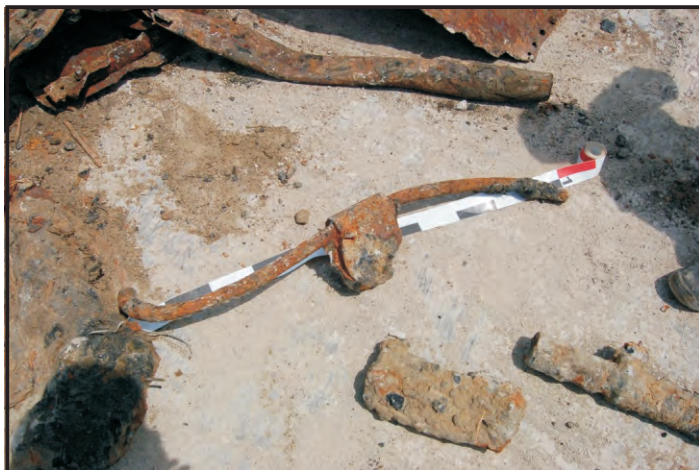
Figure 119: Running pulley, probably part of the derrick (Photo: Maitland)

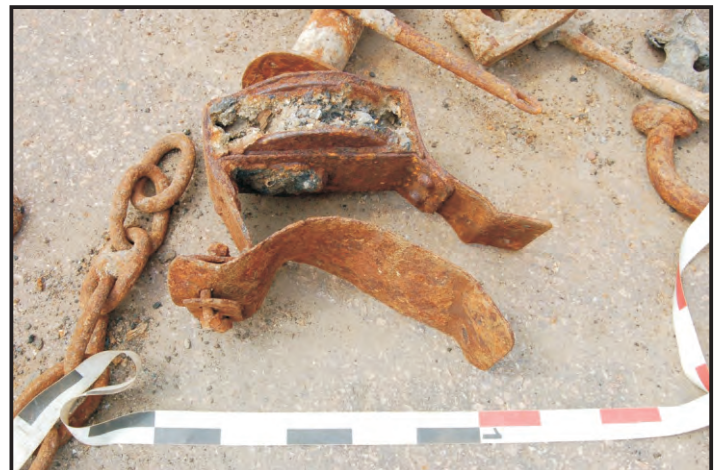
Figure 120: Derrick sheave with a guard (Carpenter 1917: 550)

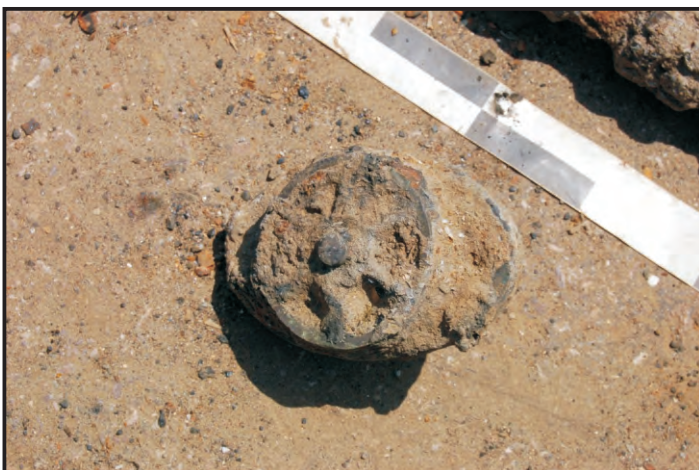
Figure 121: Deck guide sheave (Renda 2010; Photo: Maitland)

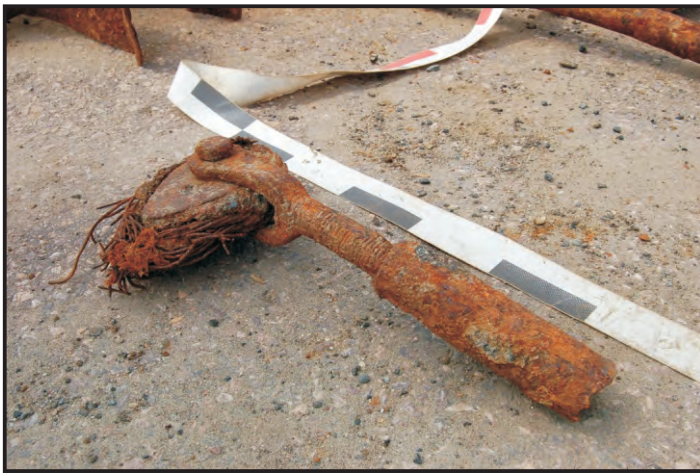
Figure 122: Turning-in screw with thimble, these are used to break in a wire rope (Manual of Seamanship 1951: 147; Photo: Maitland)

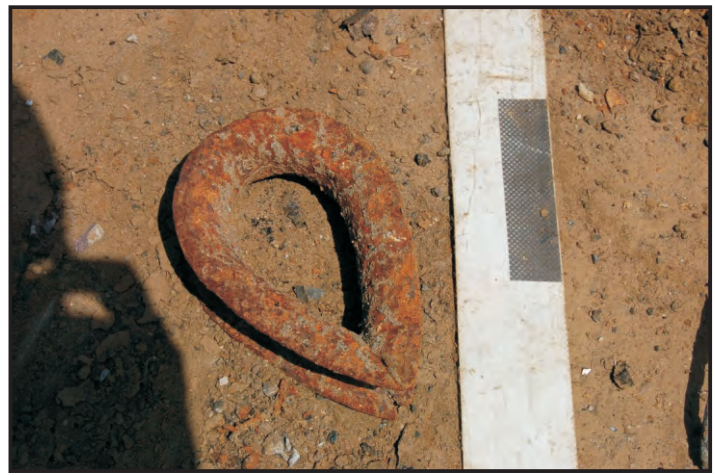
Figure 123: Heart-shaped open thimble (Manual of Seamanship 1951: 169; Photo: Maitland)

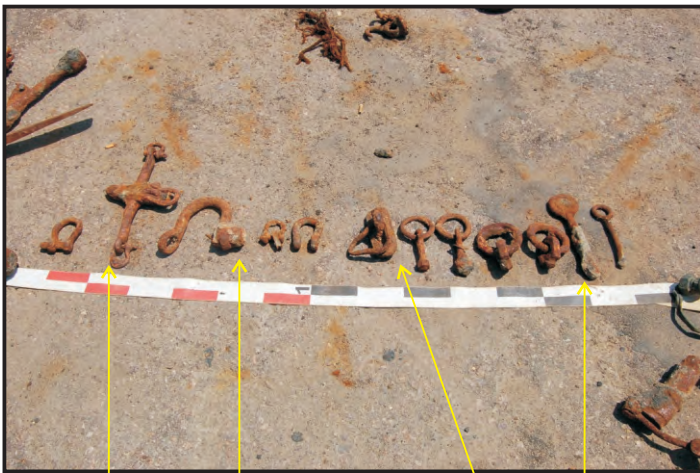
Different sized shackles Eyeplate Ring bolts
Driven eyebolts with shackles

Figure 124: Various rigging fittings (Photo: Maitland)

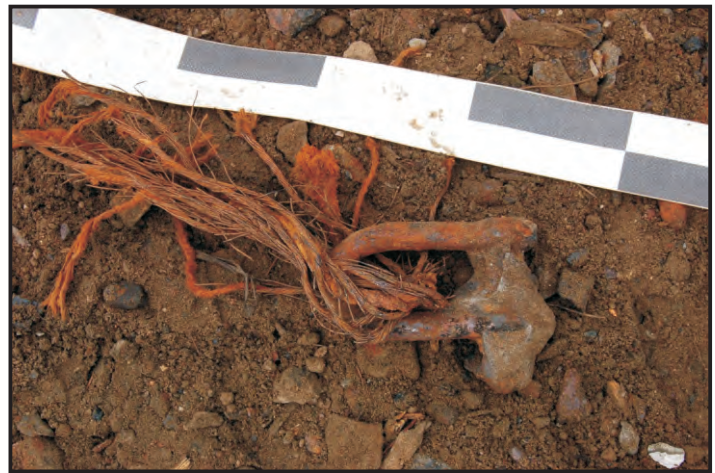
Figure 125: Straight screw shackle with rope still attached (Photo: Maitland)

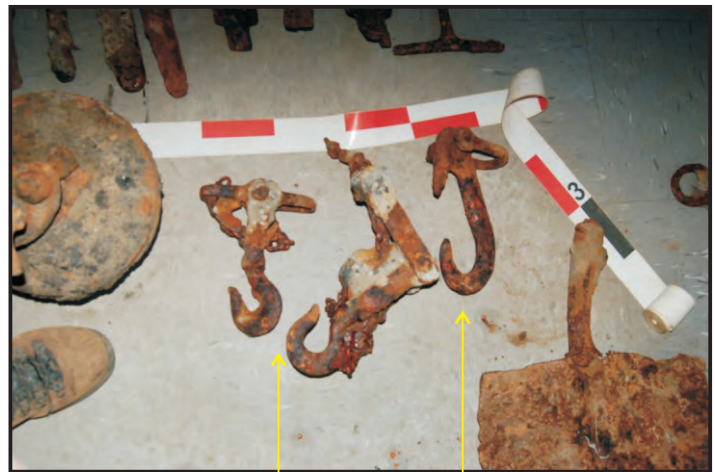
Hoist hooks

Snap hook

Figure 127: Various hooks (Photo: Maitland)

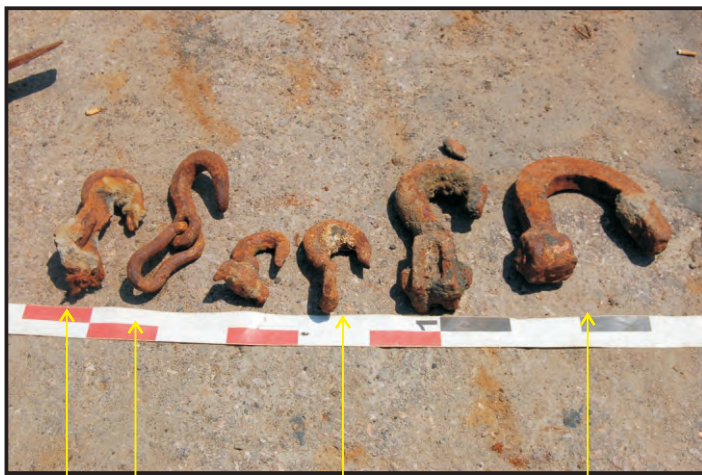
Hooks broken off from blocks
 Hook with link
 Hook with thimble
 Unknown

Figure 128: Selection of hooks (Photo: Maitland)

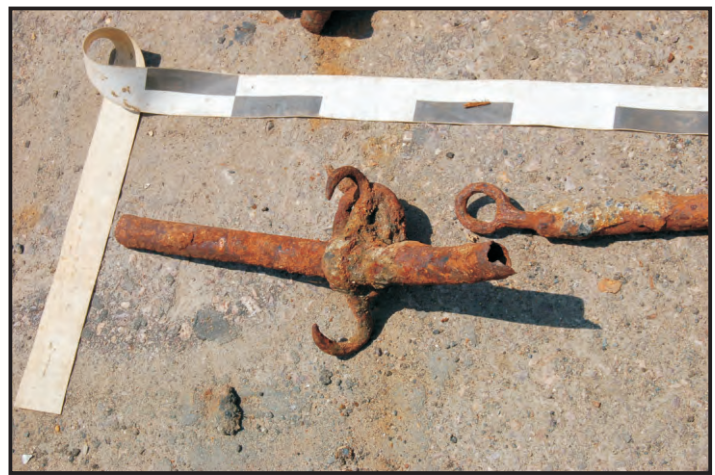
Figure 129: Double hook attached to a pipe clamp, there is a link on the obverse side and a short length of small chain (Photo: Maitland)

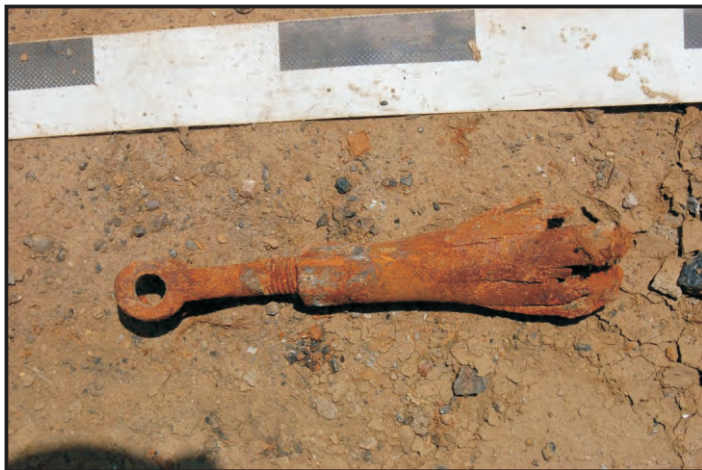
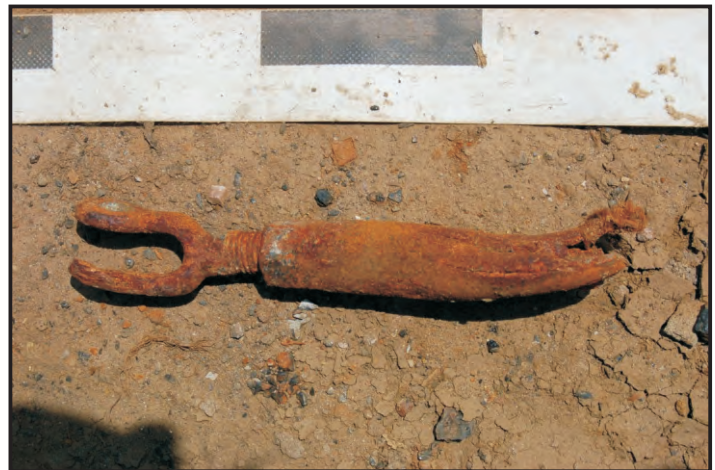
Figures 130 - 131: The opposing ends of a turnbuckle, the first is a fixed eye on the end of a screw and the second is a shackle on the end of a screw. These were used to adjust the tension or length of rigging wires (Manual of Seamanship 1951; Photo: Maitland)

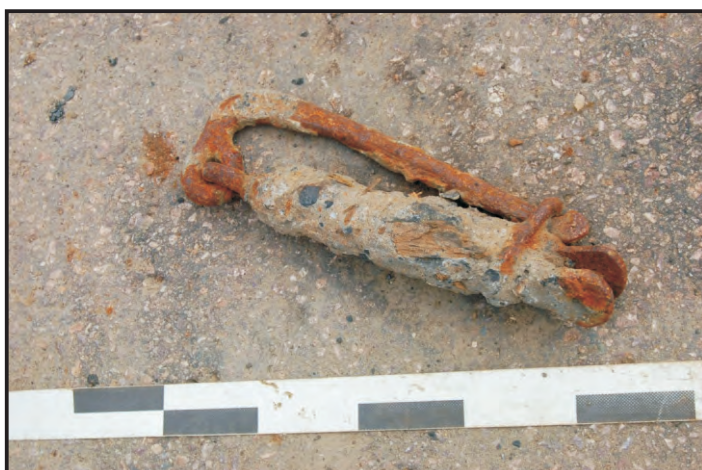
Figure 132: Blake slip (House 2004: 91; Photo: Maitland)

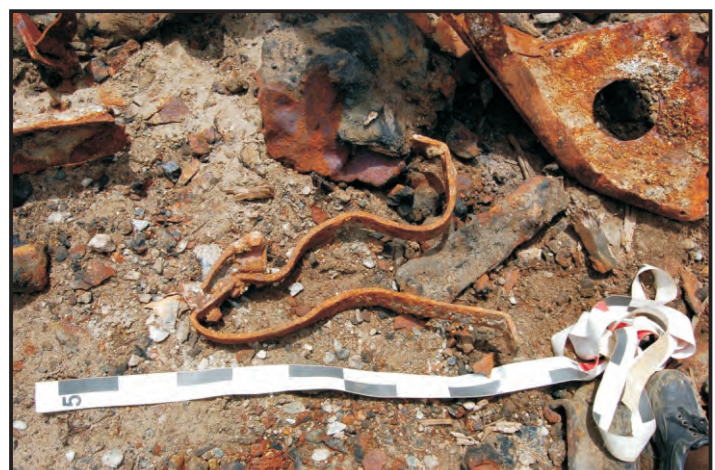
Figure 133: Band clamp (Donald 2010; Photo: Maitland)

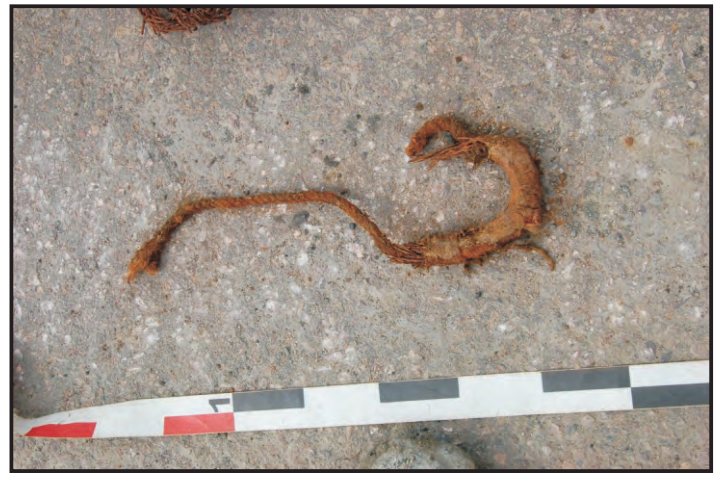
Figure 135: Remains of wire cable with a hemp core that was spliced to form a hawser eye (Manual of Seamanship 1951: 95 - 96; Photo: Maitland)

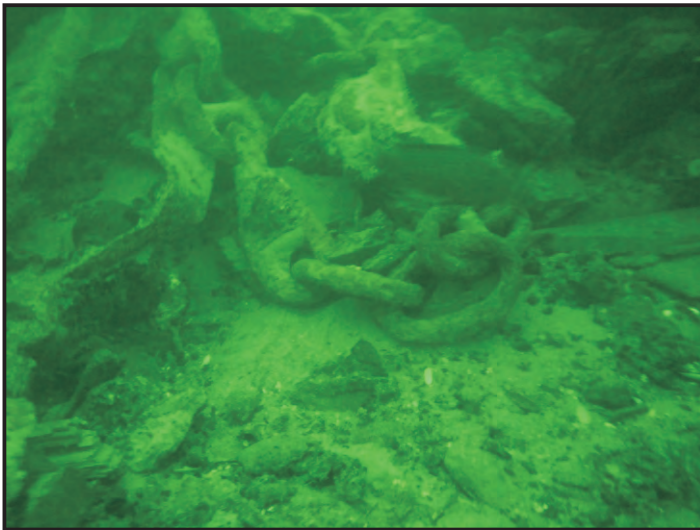
Figure 136: In-situ stud link chain (Photo: Maitland)

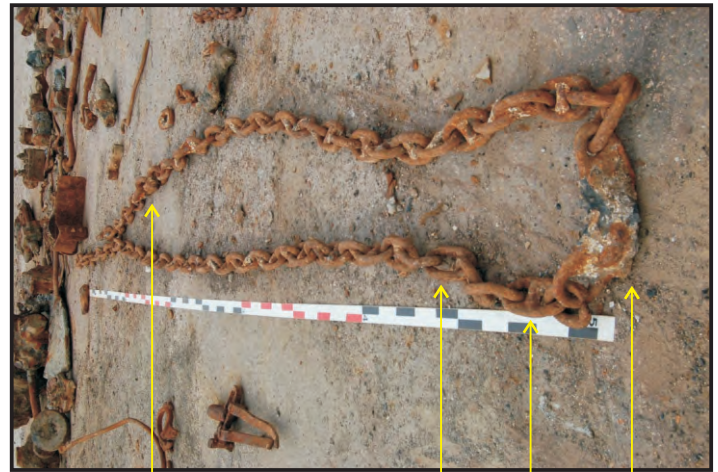
Figure 137: About 10 meters of stud link anchor cable (Paasch 1890: Plate 65; Photo: Maitland)

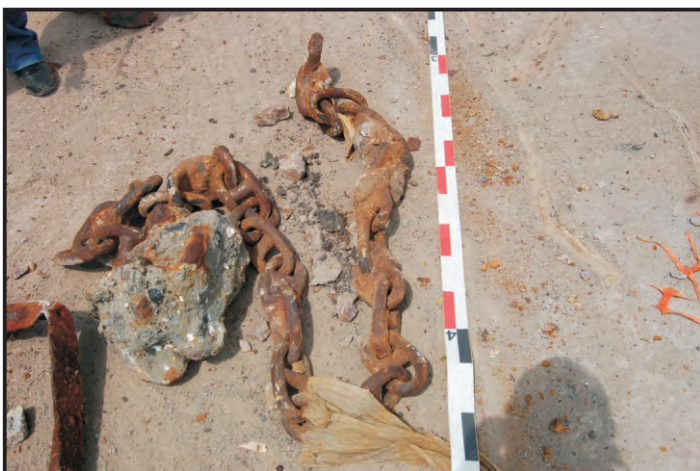
Figure 138: Length of stud link chain, the conglomerrated section is probably the cable clench from the chain locker (Manual of Seamanship 1951:205; Photo: Maitland)

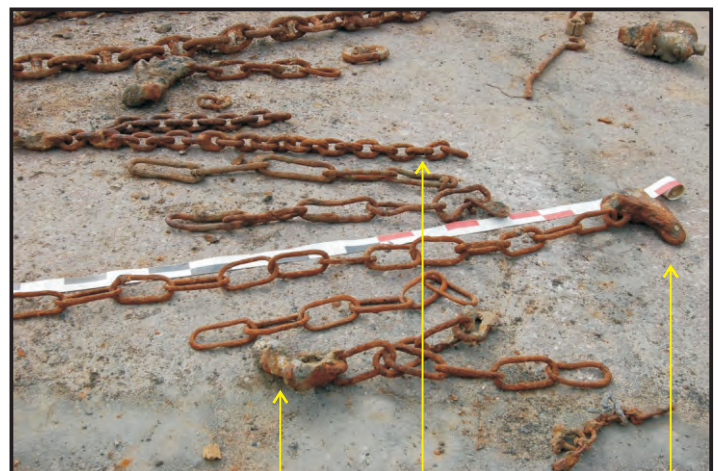
Figure 139: Stud-link, common straight link and open link chains of various sizes and gauges (Carpenter 1917: 600; Manual of Seamanship 1951: 147; Photo: Maitland)

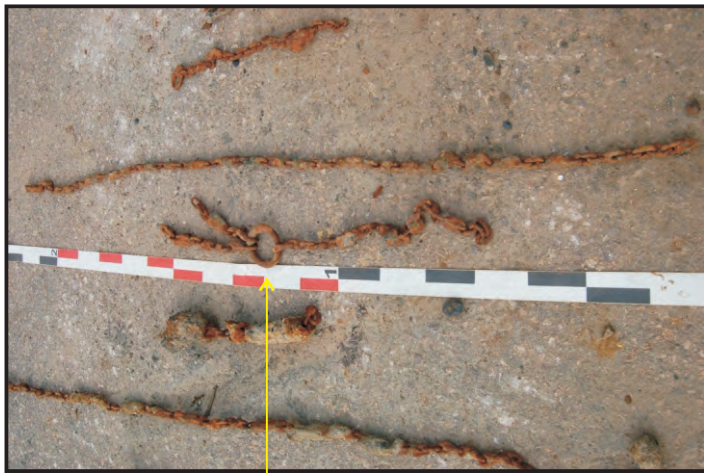
Chain ring

Figure 140: Different chain sizes and gauges (Photo: Maitland)

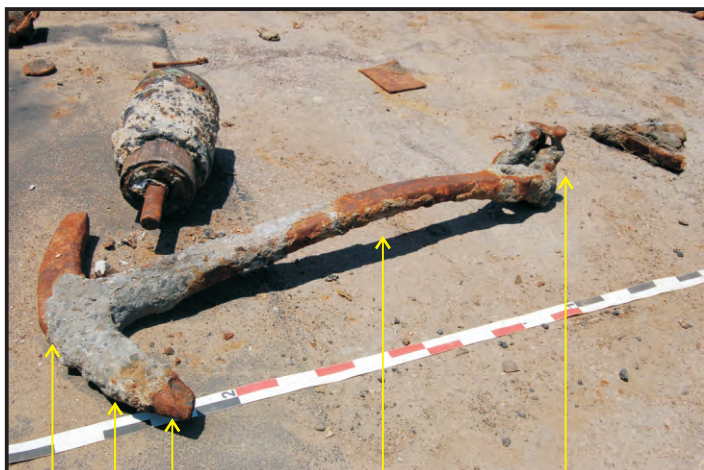
Anchors were usually marked with a maker's name, progressive number and weight on the crown. This anchor was too corroded to see these. All steamers, except very small ones, carried two bower anchors, one spare bower and a steam anchor (Brown 1931: 115).

Crown Arm Fluke Shank Shackle

Figure 141: Stockless anchor (Miller 1884: 14; Photo: Maitland)

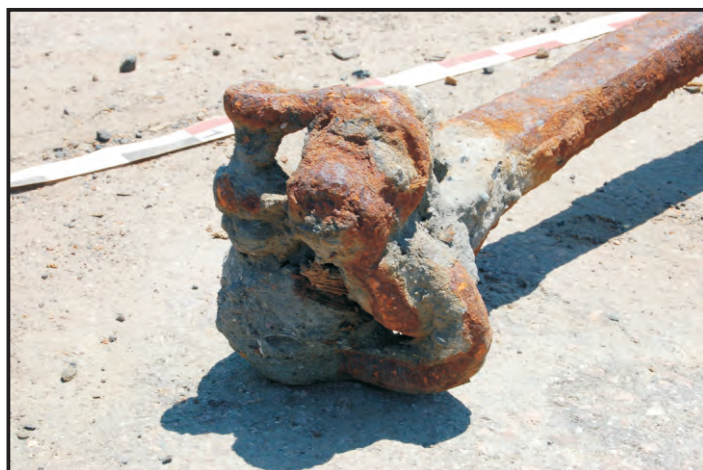
Figure 142: Close-up of the anchor shackle (Photo: Maitland)
