# RUSSELL HIGH SCHOOL PIETERMARITZBURG

Robert J W Brusse – Architect.

# RUSSELL HIGH SCHOOL PIETERMRITZBURG

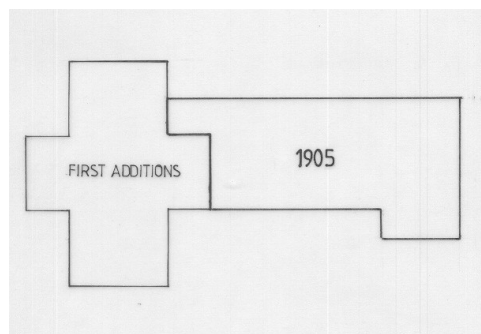
In 1905 new classrooms and an assembly hall were added as a new three storied building to the south-west of the current library. This Edwardian building was designed in the best traditions of the Arts and Crafts tradition, then fashionable both in Britain and her colonies.

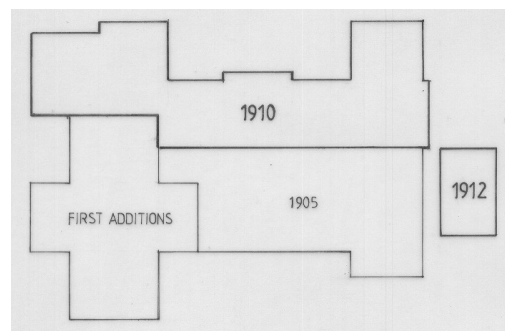
Five years later a new block was added to the complex, facing onto Hoosen Hafejee Street. This extension consisted of a new main entrance, the Principal's office and a series of classrooms on two levels with staircases on either end of the building. The contract drawings show that these proposals were approved by the Department of Public Work's Chief Engineer, J. F. F. Barnes in February 1910, and the contract signed on 4<sup>th</sup> April that same year.
