THE STELLENBOSCH HOTEL EXTENSION (SHE) PROJECT

A CHRONOLOGICAL OUTLINE OF THE EVOLUTION OF A COLONIAL STRUCTURE AND ITS FEATURES ON PLOT 1298

H.N. VOS AND S.SCHOEMAN
JULY 1990

HISTORICAL ARCHAEOLOGY REPORT
RESEARCH CENTRE FOR HISTORICAL ARCHAEOLOGY
STELLENBOSCH MUSEUM

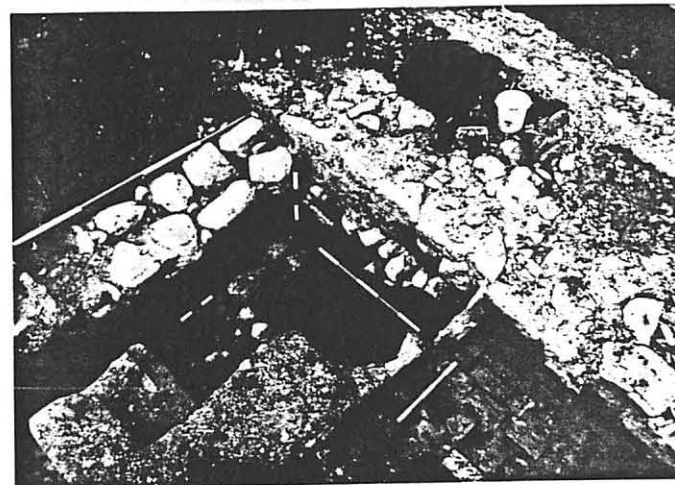
11 The use of the variety of measuring scales are indicated in this archaeological section with its complicated stratigraphy.

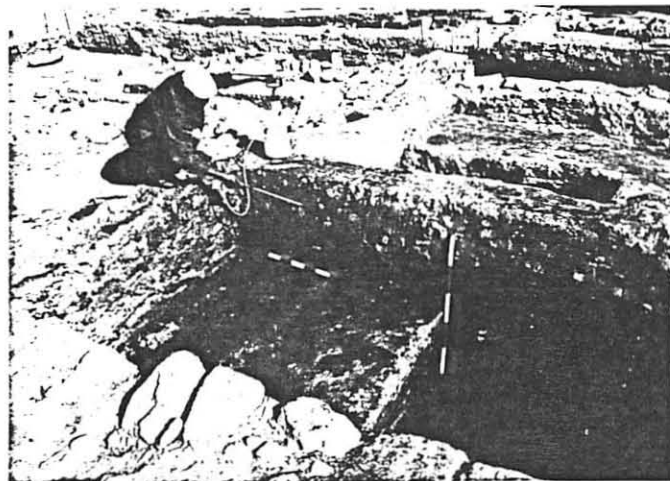
16 The stratigraphic sections of the baulks are sprayed evenly with a fine mist for drawing and photographic purposes.

In order to keep control of the features and artefacts associated with the stratigraphic layers, the rooms of the house were subdivided in crosslike baulks. These baulks constitute the upright, thin strips (40-50 cm wide) between the excavated sections, providing this time vertical standard reference points for deeper excavations. They were also very helpful in serving as communication pathways for all personnel on site, as well as for transporting soil by means of barrows and buckets. Three such baulks were planned on a north-south axis, running through the centre of the rooms for the full length of the house and into the backyard. Two similar stratigraphic baulks extending from west to east, would respectively run through the house rooms and the backyard.

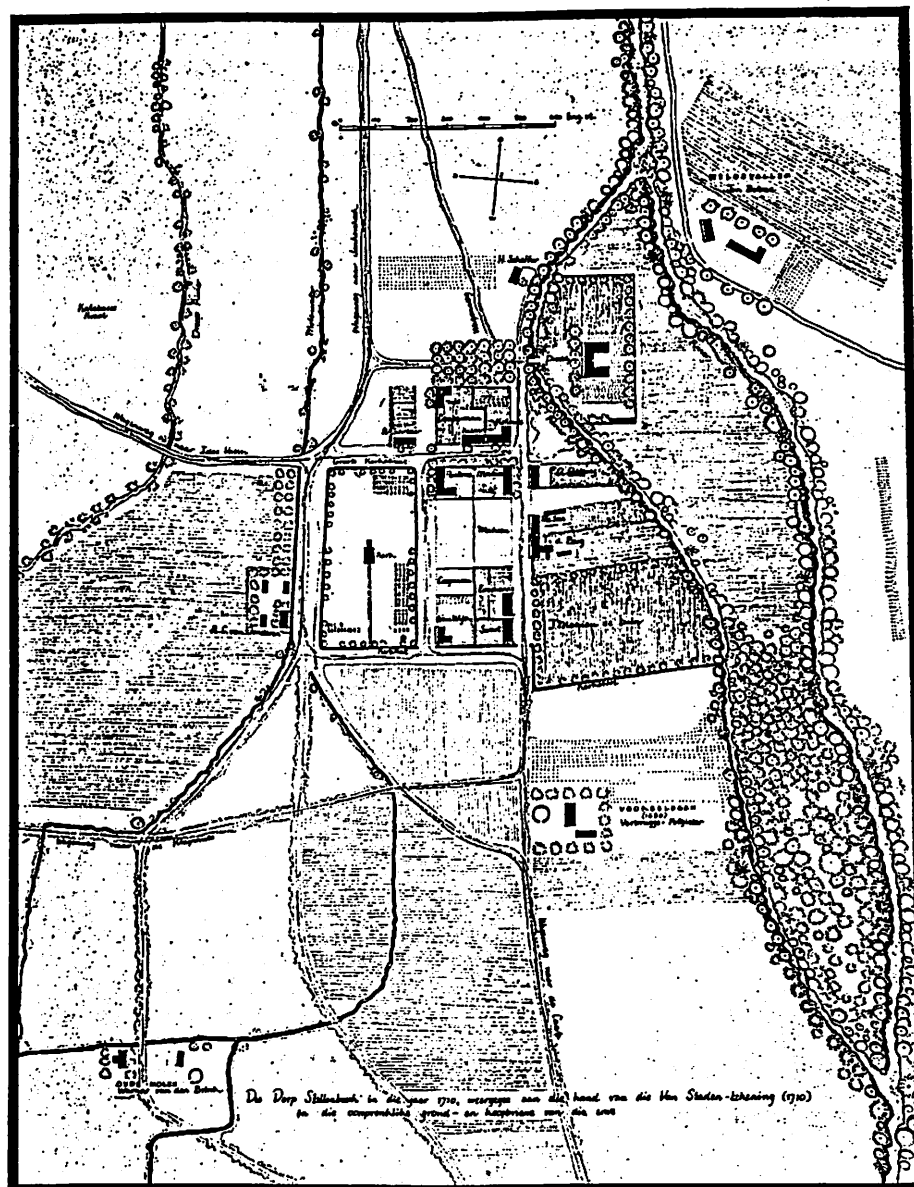
Fig.7.1 Groundplan of Stellenbosch in 1710, based on E.V. Stade's drawing (Smuts 1979:50).

The town block bounded by Church, Andringa, Dorp and Ryneveld Streets constituted a major part of the old historic core of Stellenbosch. By the end of the first decade of the 18th century, a homestead occupied each of the four corners of the block (Fig. 7.1) (Hugo & Van der Byl 1963: 32). The oldest grants of 1693 were to the Colonie of Stellenbosch on plots a and b (Fig. 7.2) (Van der Byl 1963: 13A,20A).

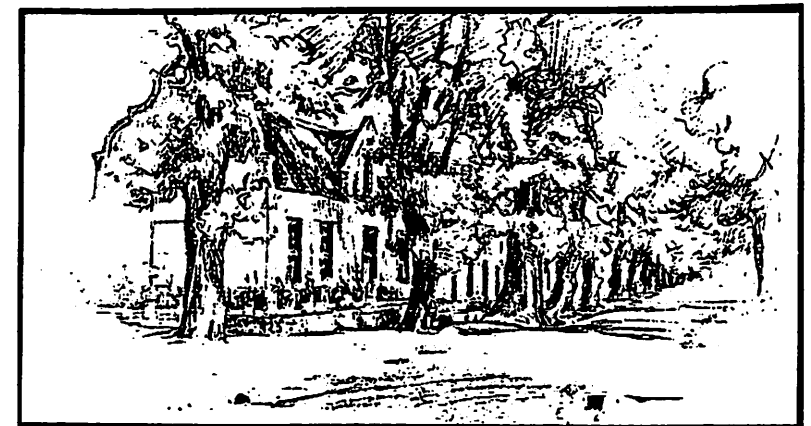
Fig.7.3 Hofmeyer House was situated on plot b, one of the first grants in 1693. It is drawn by A.F. Trotter at the turn of the last century. The SHE homestead probably looked very similar (Smuts 1979:6).

The structure on corner b was modified over the years and still existed by c.1900 (Fig. 7.3). Note the impressive avenue of oak trees lining Church Street.

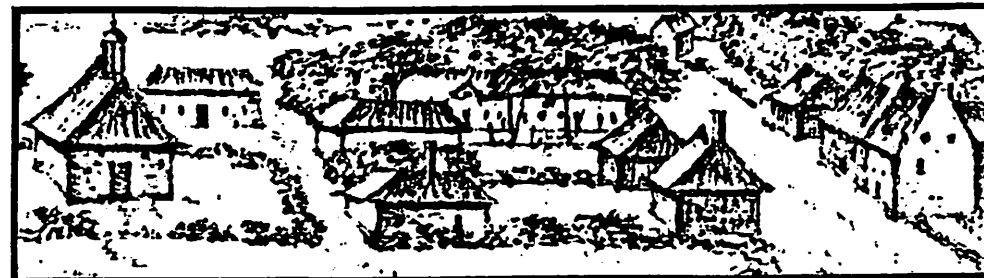
Fig.7.4 In the Stade drawing of 1710, Van Wyk's home looks very unpretentious, with its low thatch, high chimney and two small window openings (Fransen 1979:80).

Van Wyk was married to Cornelia Helm in 1693 and they had 9 children, all born by 1709 (Malherbe 1966). He is also the progenitor of the Van Wyks in South Africa. He previously farmed at Kulken Vellei (now Rathby) (1699 - 1705) and afterward at Bonte Vellei (Sept. 1711 - 1734) (Van der Byl 1963: 58A, 56A). He is remembered because he was occupying one of the houses which E V Stade depicted in his drawing of Stellenbosch on 15.2.1710 (Fig. 7.4).

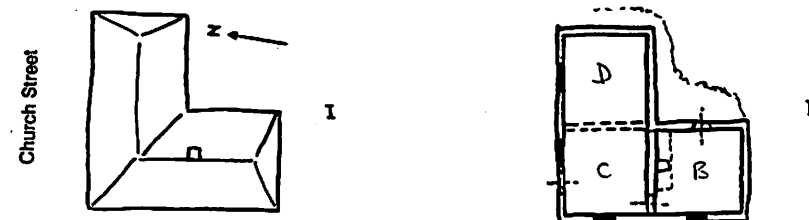
Fig.7.5 The roof structure as it probably looked like (I) and a possible room interpretation (II), based on the Stade drawing and archaeological evidence.

From the above picture the following architectural interpretation is given (Fig. 7.5).

There is little doubt that according to the chimney, the placement of the kitchen was within room B facing Andringa Street. The accuracy of the Stade drawing is confirmed when one notes that the chimney correctly abuts the interior wall. The order of the inventoried items do not agree with the order of the functional room interpretation of the actual house. In addition it is not sure whether there was any division between the rooms (C & D) facing Church Street (see also Fig.1).

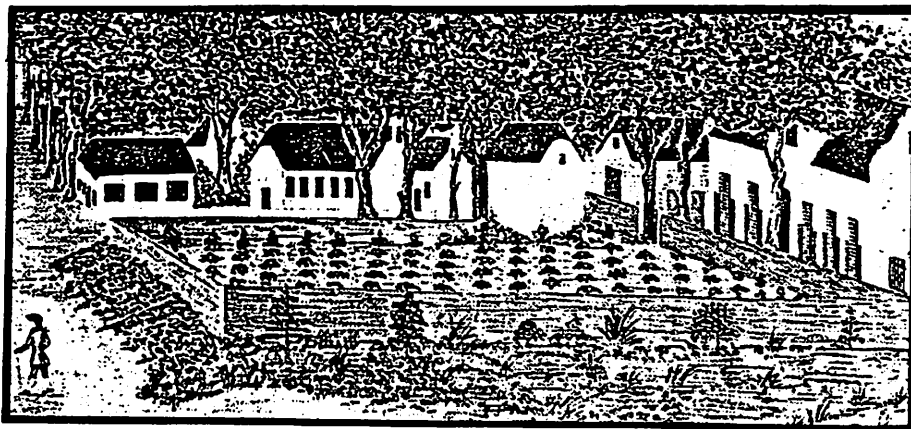
Fig.7.7 The Mader painting of 1757 is the most important historic document of the dwelling during the mid 18th century (Fransen 1979:82).

During Wium's occupation, we are given a view of the house as it appeared in 1757, as depicted on the Mader painting (Stellenbosch Museum) (Fig. 7.7).

Spatial dimensions seemed to stress square or rectangular units, strung together as desired or necessitated, but with no idea toward symmetry. Notice for example the window and door placements of the long room E/J in the Mader watercolour (Fig. 7.7). Communal activities formed part of the general lifestyle, where eating and drinking, work, play and sleeping were all conducted in one or two rooms. Inventories of the period where the contents of the rooms were individually specified, confirm such multi-purpose rooms. Most of the inventories, as the two traced of this house, lumped the goods and chattels all together in one long list, which was typical of how things were done generally.

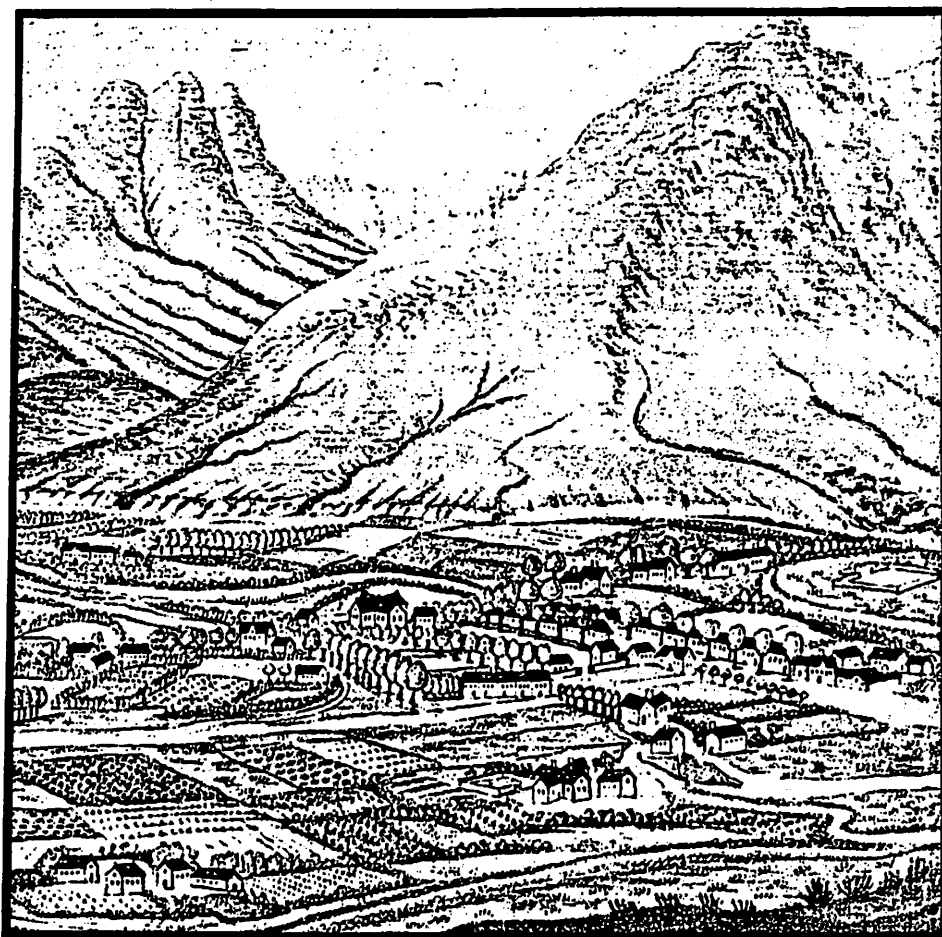
Fig.7.9 The Schumacher aquarelle of 1776 of Stellenbosch town depicts the dwelling of J.G. John in rather vague detail.

The panorama of Stellenbosch village (Fig.7.9) as drawn by Johannes Schumacher is picturesque, but not a great deal of faith can be put in it when it comes to detail. Some of his buildings are not accurately placed, all exhibit the same general appearance with very little variation in window or door placement, or of gables. From his drawing, only a vague idea can be gained of the house which shows 3 doors towards Andringa Street.

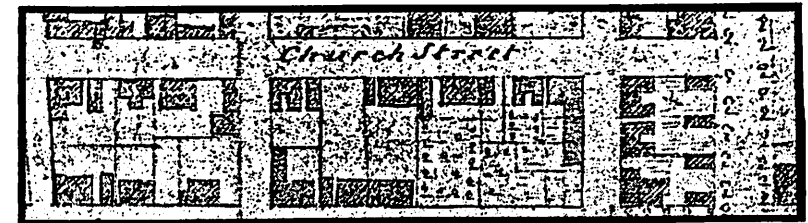
Fig.7.11.1 Map of c.1830 by surveyor H. Kuys showing a U-shaped building (Hugo and Van der Byl 1963:206; Smuts 1979:54).

Kriel enjoyed one of the longest ownerships of the plot, viz. for 17 years. Just across the street on the north-west of Church and Andringa Street, he also owned a property from 1806 - 1821 (ibid. p.17). Another view of the building is given by the Kuys map (Fig.7.11.1).

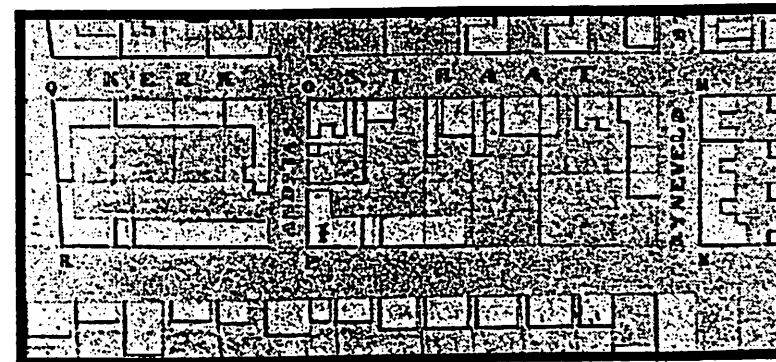
Fig. 7.12 On the Hager map of 1859 the additional new structure, interpreted as a coach-house, is shown (Stellenbosch Museum).

It was during the ownership of Beukes that the Hager map of the town of 1859 was drawn (Fig. 7.12), detailing this building as practically unaltered in outward shape. The small, rectangular outbuilding is now prominently depicted. On the Church Street side on plot N a building has been erected, flush against the eastern outbuilding. According to the transfer deed Beukes became insolvent.

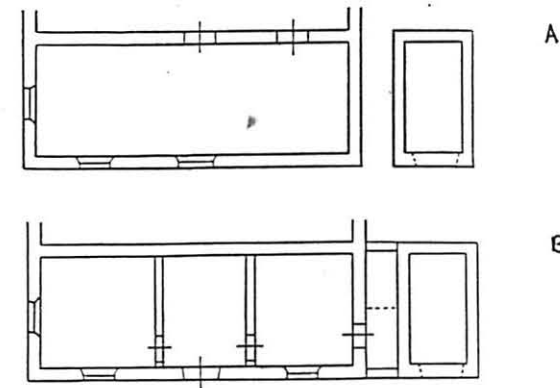
Fig. 7.16 A re-interpretation of the c.1910 plan is given, by separating it into two periods, i.e. before (A) and after (B) the alterations.

In Fig. 7.16 the structural subdivisions of the rooms are separated into two periods.

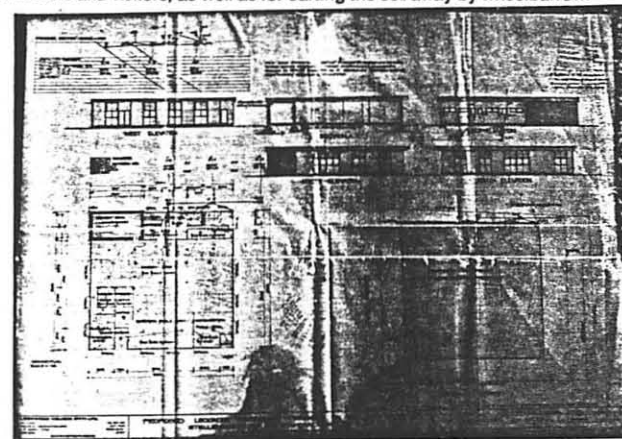
Fig.7.21 Plan of 1970 for the erection of the temporary premises of the Standard Bank of S.A. Ltd. (Stellenbosch Municipality).

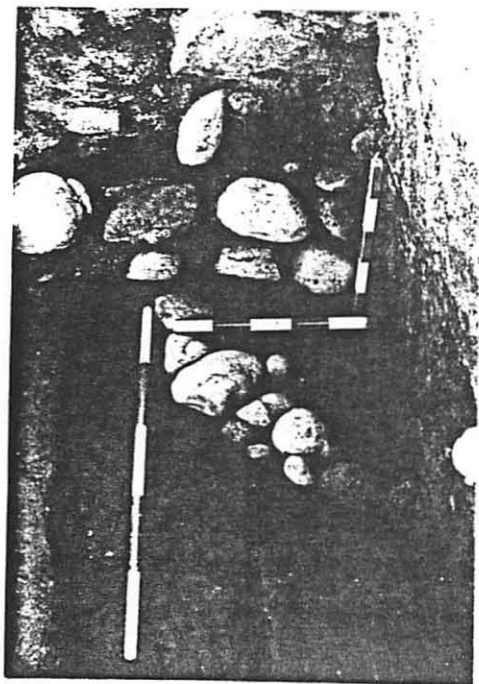
22 A scattering of random stones with incidental artefacts, indicate an area prior to the site being built (wall A3).

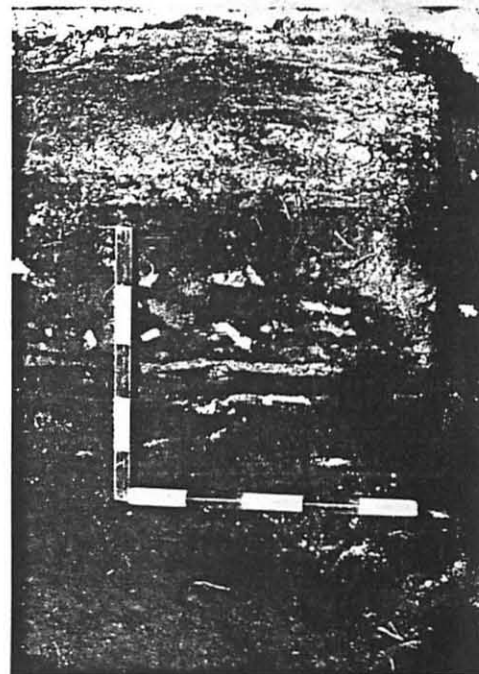
23 A section of riverstones were packed in a semi-circle at the deepest level excavated in room B (wall B1).

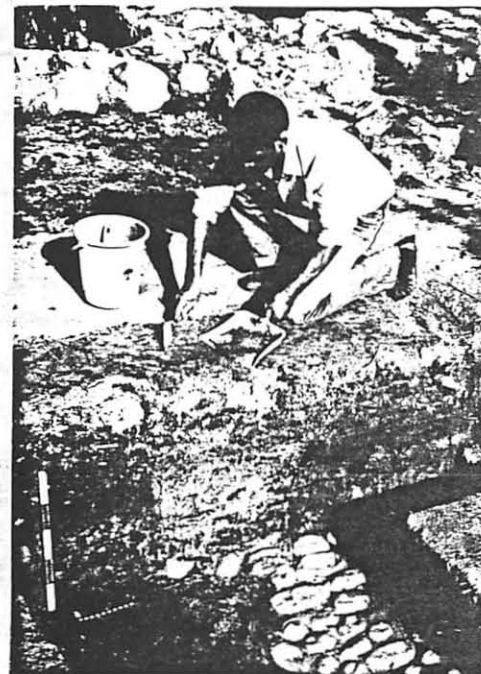
24 Very little of the effects of the 1710 fire were found, except for the ash and burnt clays found in room D.

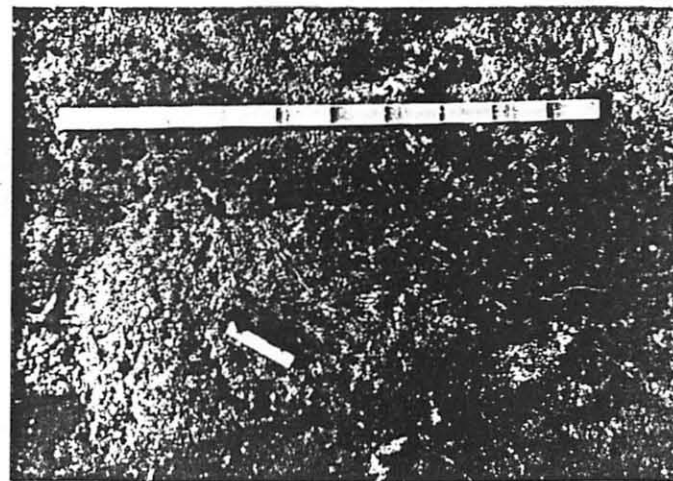
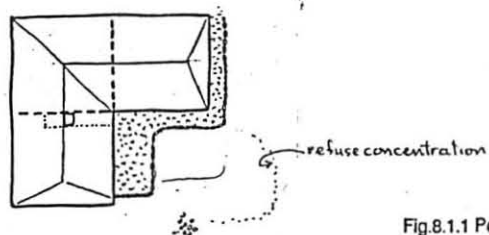
25 The cobbled surface adjacent to wall D3, was covered with black ash and carbonized thatch, with a concentrated area just eastward of it (detail 26).

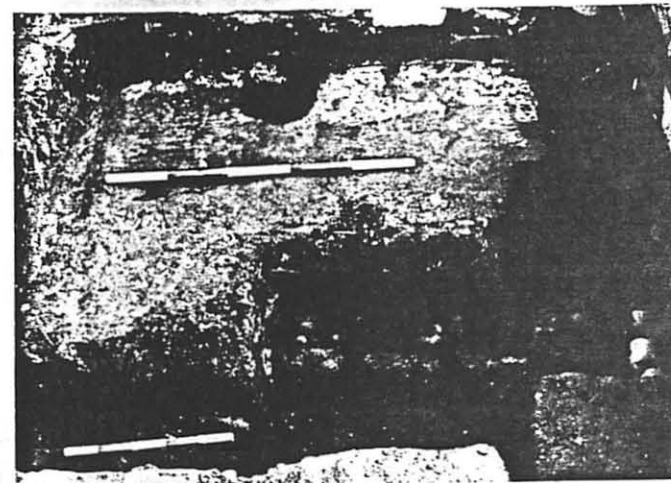
27 The extent of the earlier cobbled stoep is detailed (room E), as well as the edge of linear cobbles at the bottom (28) (room F) and the area that was enlarged (29) (room H).

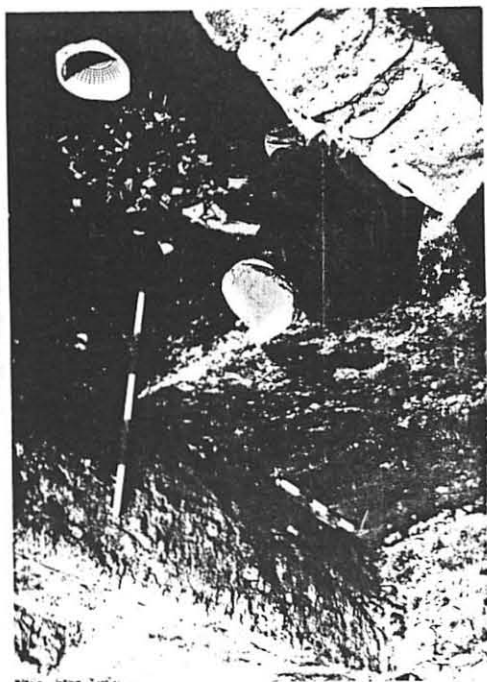
32 In room G, within levels 8 and deeper, the refuse was scattered over an extensive area, of which a select section was excavated.

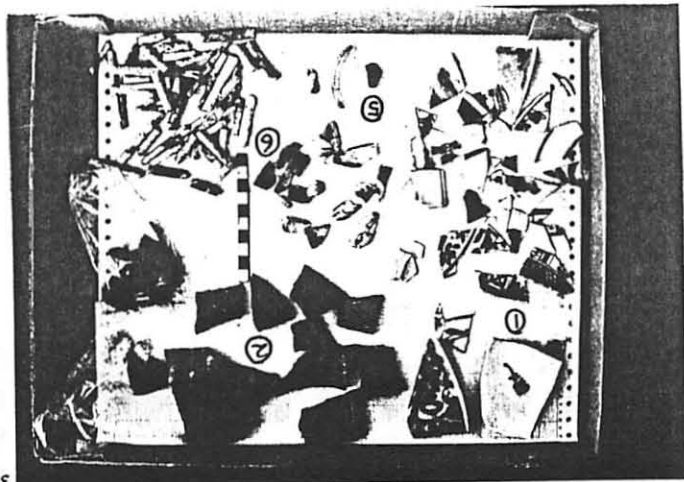
34

33-34 Samples of the artefacts dating to the period of the first quarter of the 18th century. Items include: 1. Blue-and-white Chinese porcelain (plates, bowls, saucers, cups) 2. Earthenware 3. Bottleglass 4. Window glass 5. Drinking glass 6. Smoking pipes (bowls and stems) 7. Very fragile animal bones.

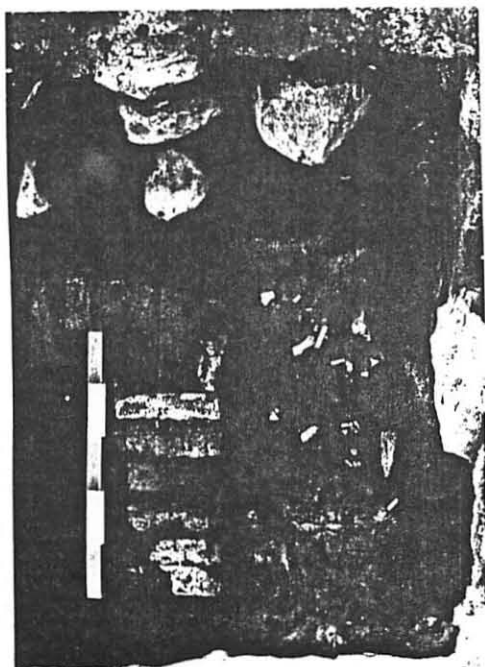
30 A close-up of the corner section of the bricklined stoep. Note the scattering of small artefacts which were found in fine water-laid sediments.

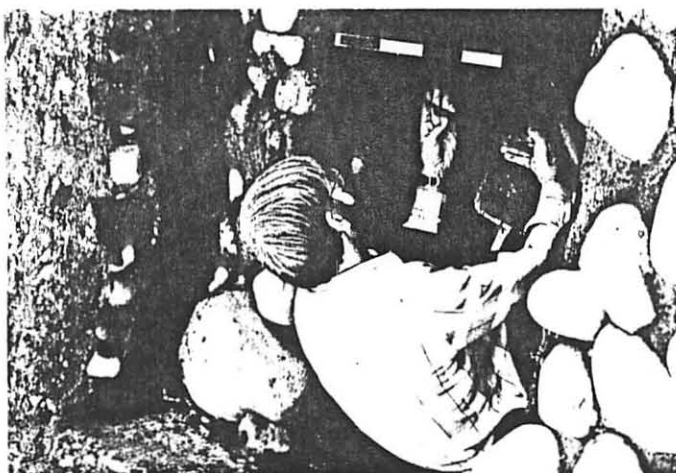
31 In room F a long metal (brasslike) strip was found at a similar level as the artefacts in no. 30.

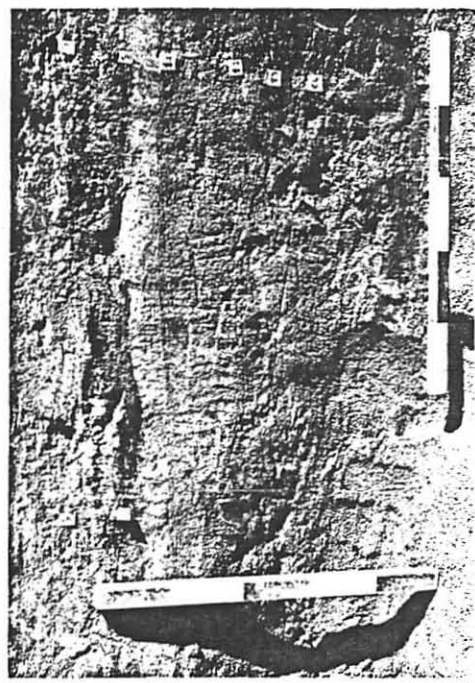
35 A portion of the clayed-up wall (built upon riverstones), forming part of the outbuilding erected by c.1720. Note the soft sand-plastered clay floor.

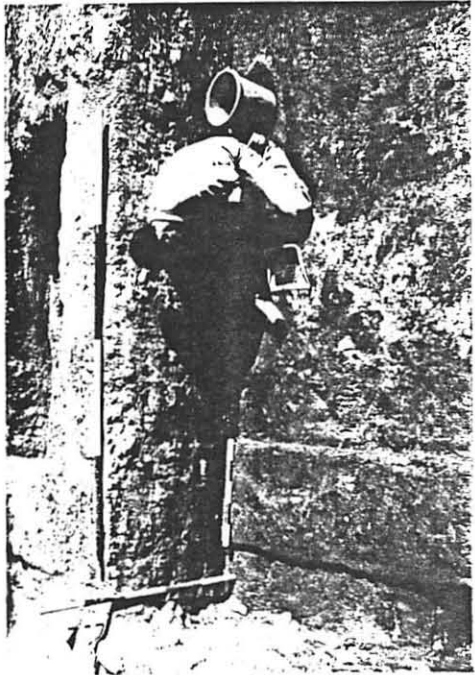
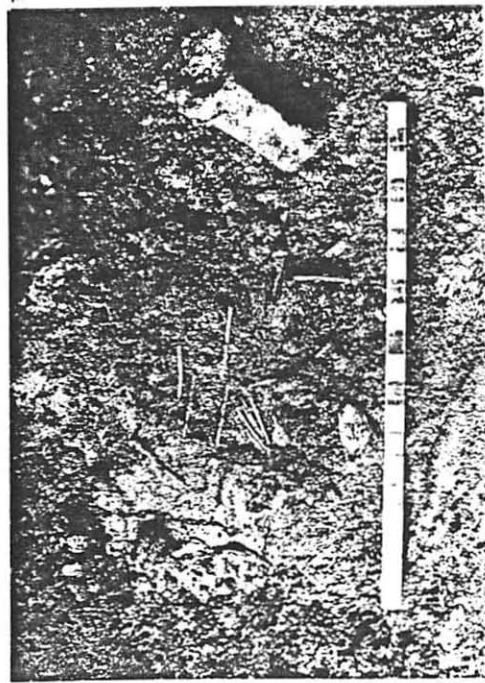
36 Layer 8 represents the flattish, long mudbricks, which formed the base of the floor of the outbuilding. It is built over the soils containing the artefacts.

37 On top of the mudbricks and plaster, ash deposits with small artefacts like bone and fish remains were found.

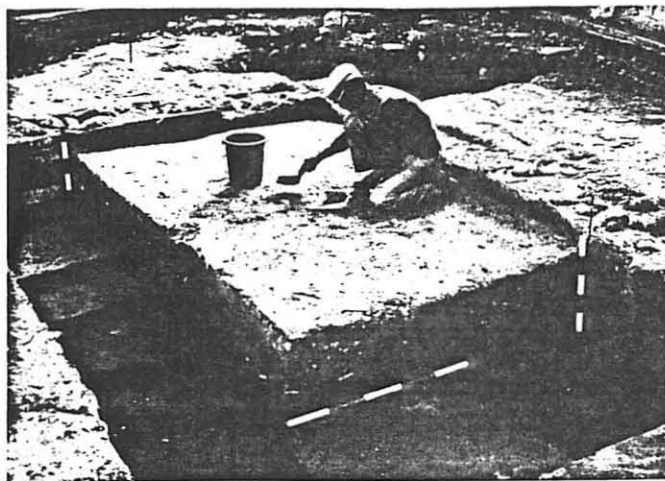
38 In room C the lower levels of dark clay floors have been exposed. Layers 11 and 12 represent surfaces after 1710, with small artefacts (mainly smoking pipe fragments) on top of them (39).

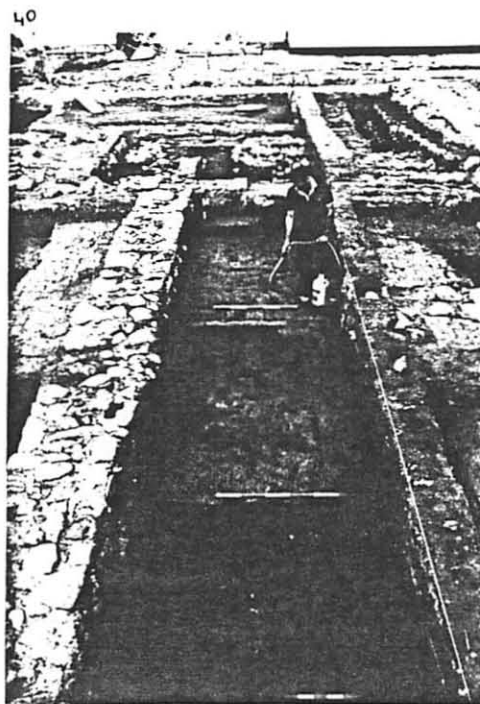
40 In rooms H/I a variety of old clay floors were encountered. The one indicated with an arrow shows signs of the impressions of riverstones on its surface.

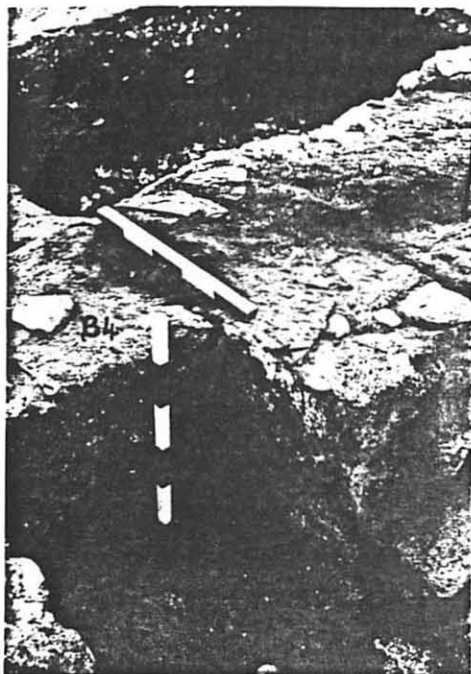
41 The corner section of wall C 3/4 shows clearly how the white-washed plaster bypasses the later wall B4.

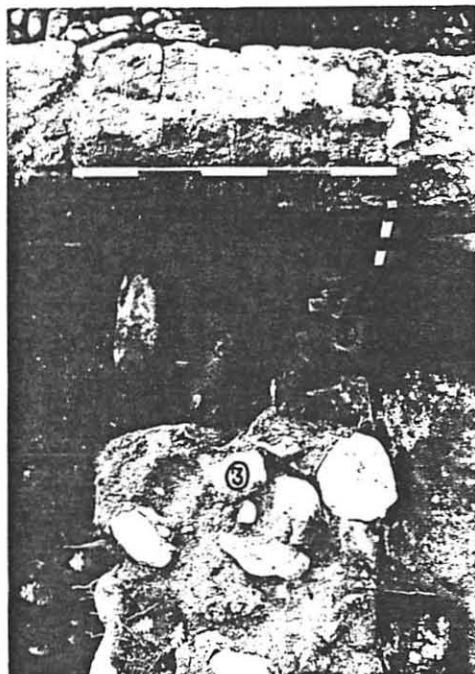
42 A section of the old wall foundation (1) of the rectangular building that was not demolished. The 1810 foundation (2) was built partially on top of it.

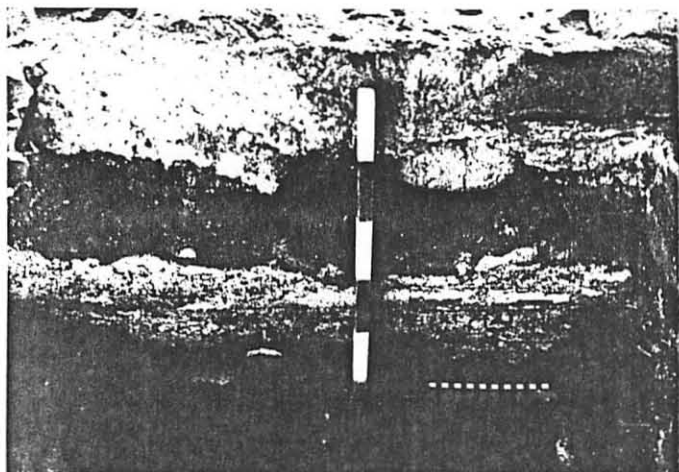
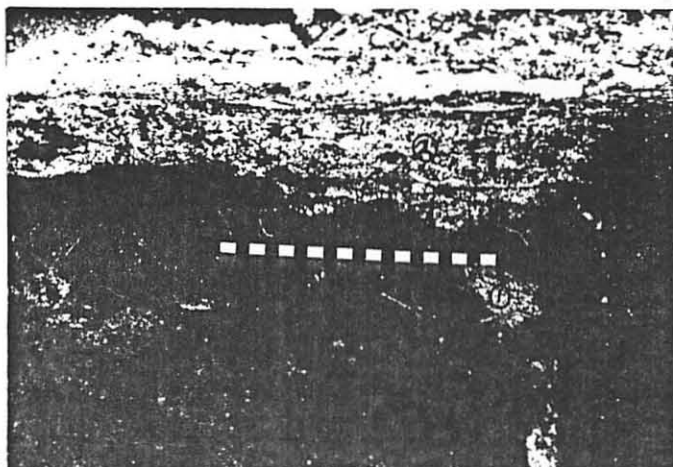
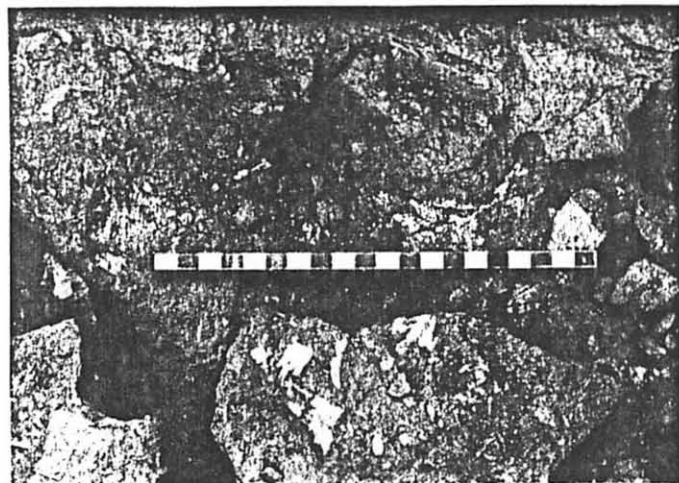
44 On the original clay floor (layer 10) of the stone built house, the limeplaster (1) has survived selectively (detail 45). Note the white-washed wall plasters (2), reaching unto the granite plinth (3).

46 The clay floor was extra-ordinarily hard and when it was broken up by pick, the scant remains and impressions of organic material were visible.

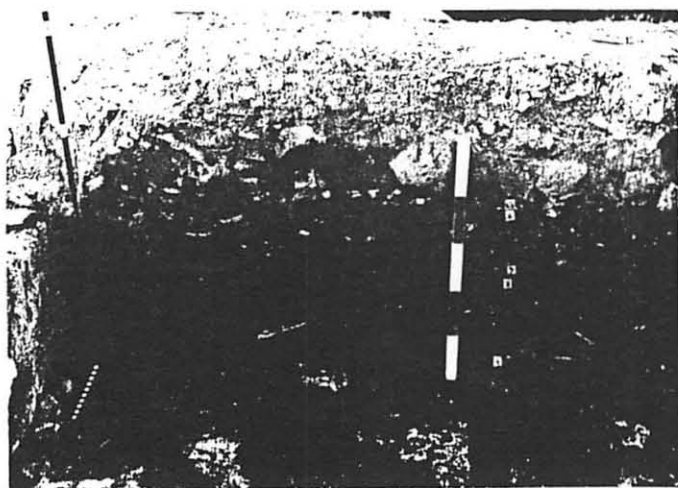
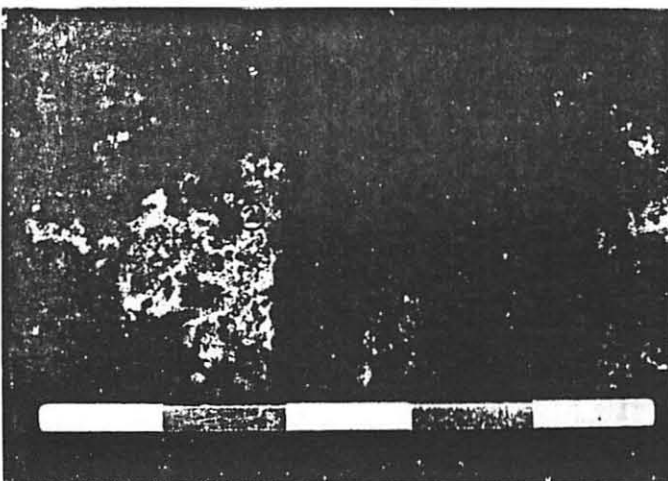
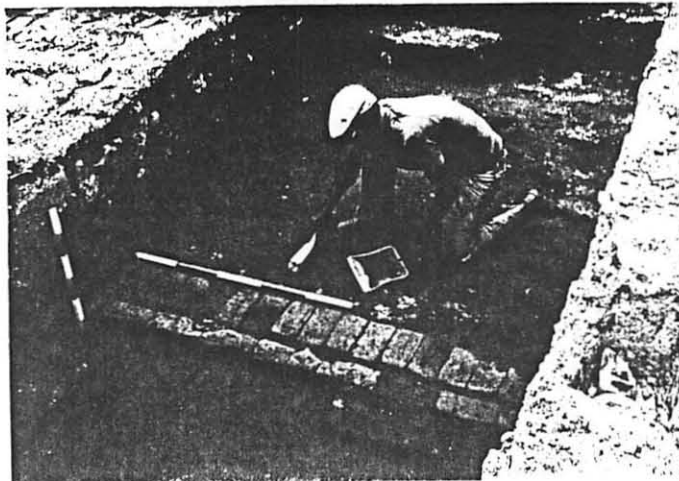
47 The hard clay floor (layer 9) within room I was dark brown and gritty (1), as if burnt. Afterward it was coated with a limeplaster layer (2) (detail 48).

49 In room H dark clay floors were exposed. The dividing wall of orange brick was demolished flush with the last floor surface.

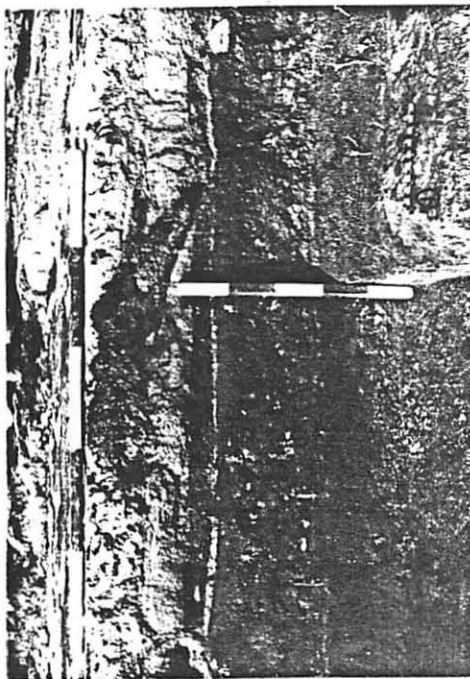
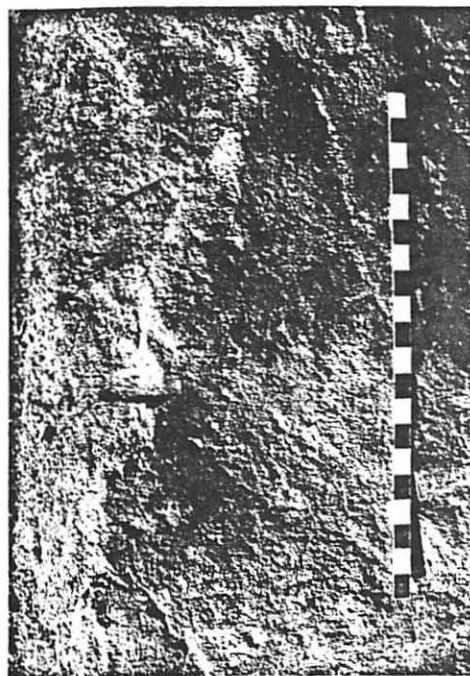
50.1

50 In room A select portions of an orange clay floor (1) were found intact (detail 50.1).

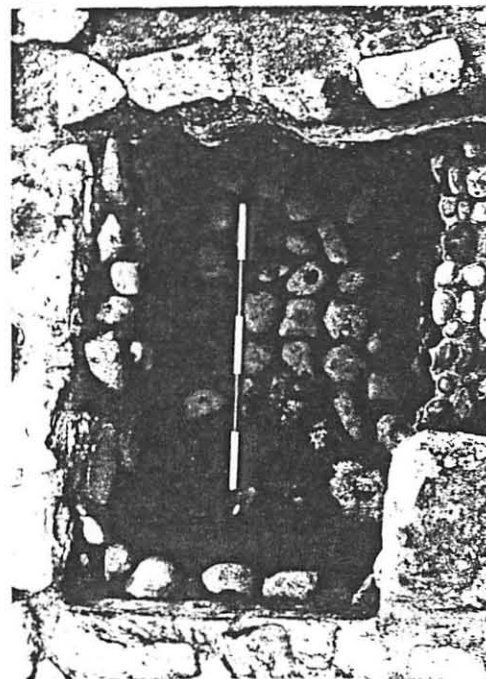
51 Between the foundations of later buildings at 75 cm BSL, the eastern cobble surface was discovered. It consisted of riverstone and granite, displaying a neat pattern of being laid in rows.

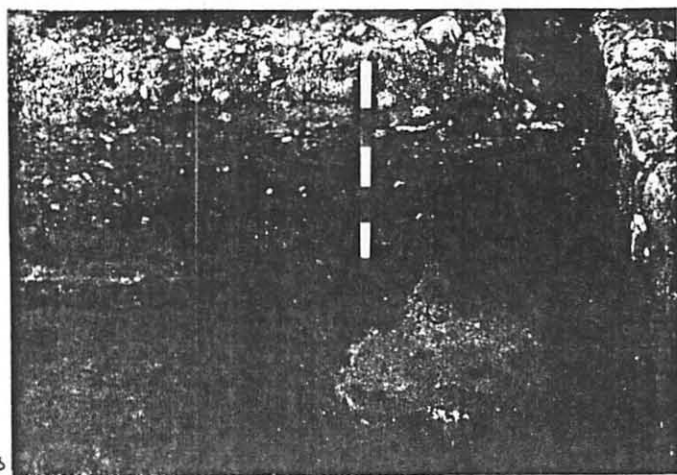
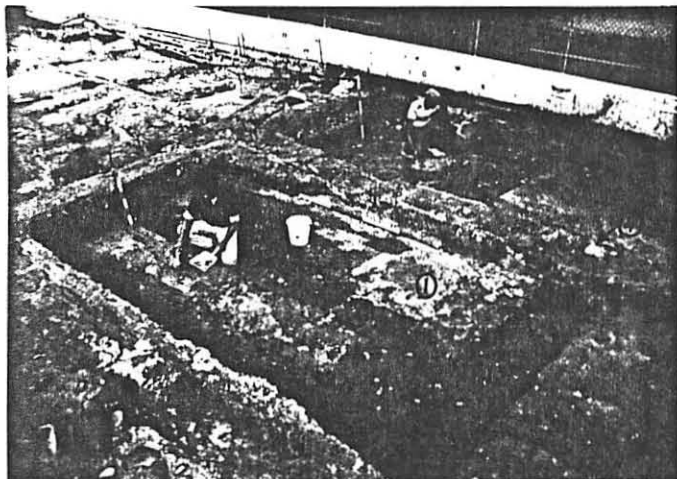
52 53

52 In room D, above the thin orange dust layer (1), a hard, dark clay surface (2) was exposed. At the entrance of the house a hard lime patch (3) filled the worn surface (detail 53).

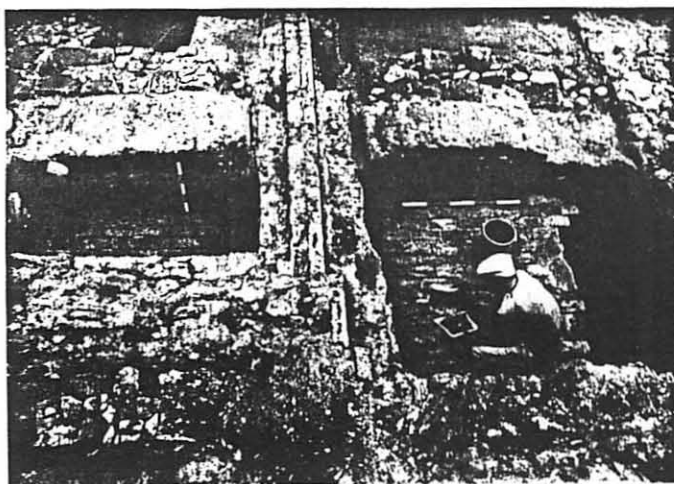
54 In room A fairly large areas of a coarse, cream-grey plaster (1) were still intact. An old trench (2) cut through it and the floor stopped against the old foundation wall A1, which has been demolished and robbed of its upper stones (3). Note the re-use of granite, with earlier, white plaster adhering to it (4).

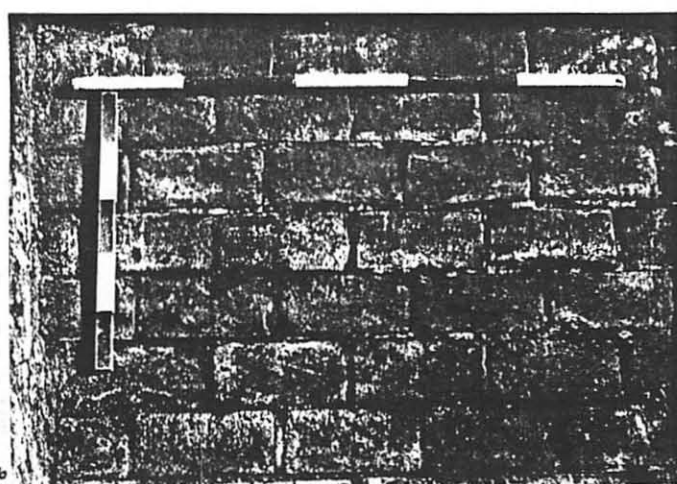
55 56

55 The eastern end of the long room E, was neatly paved with bricks in a staggered fashion, and pointed with lime (detail 56).

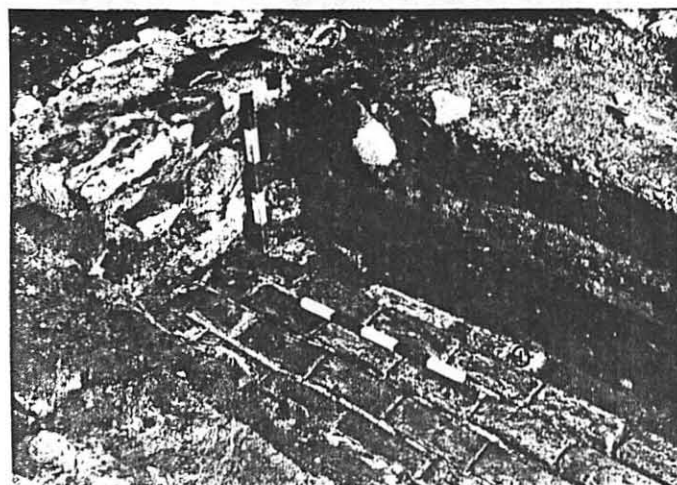
57 Note the small exposed area immediately adjacent to the brick of a cream plaster (1) on top of a clay surface (2), which formed the rest of the floor of room E (see Fig.8.10).

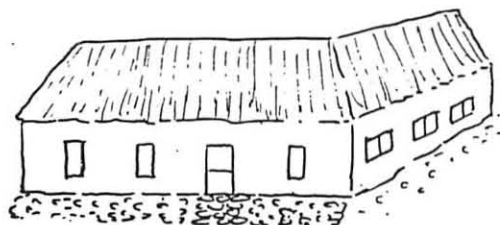
Fig.8.9 A conjectural view of the facade facing Church Street by c.1750, according to the Mader drawing of 1757.

A central entrance in room D can be inferred by a much thicker, harder and coarser lime surface, where one would expect much more wear at an entrance. The entrance could also be confirmed in the fact that the opening was neatly blocked up with granite with a different mortar (yellowish) and built directly upon the plaster layer. A full length cobblestone stoep adorned the Church Street facade (at 64 cm BSL), having had a width of at least two metres. Confirmation of a central doorway was again found in the pattern displayed by the cobbles. While a smaller stone was used for the most of the stoep, large flat cobbles and granite paved the way to the doorway (Fig. 8.9).

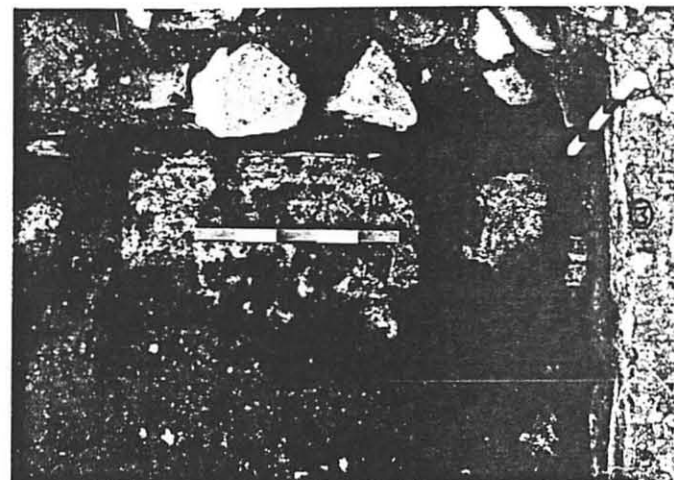
58 A limeplaster surface (1) [at the same height of 60 cm BSL as that of (1) in photo 57], about the divisional wall E4. Note the impressions of sleepers (2) which were laid afterwards above the lime floors. The later foundations (3) cut through the floor, leaving a small trench (4). The earliest white-washed plaster (5) stretched beyond the c.1750 surface (detail 58.1).

Another surprise was the finding of at least 3 regularly spaced cuttings (running east-west) within floor 7.1/7.2. They represent the impressions of sleepers (6 x 5 cm) for a wooden floor, laid practically on top of the lime surface.

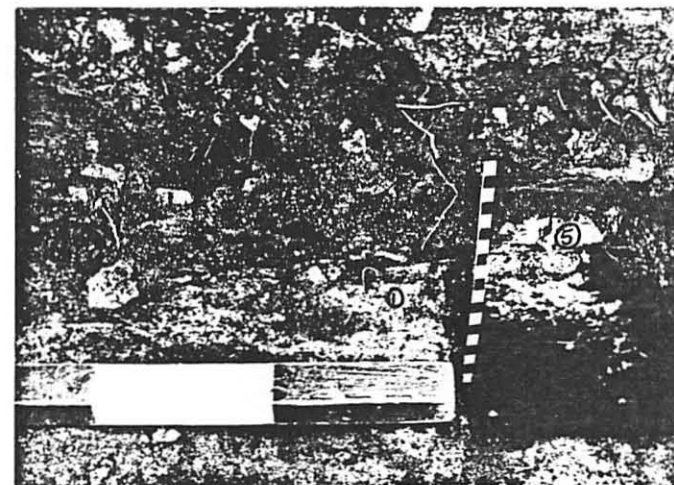
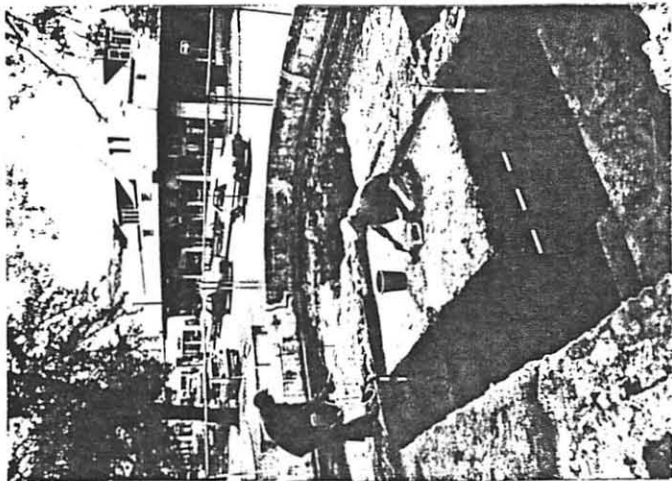
59 In this orientation view of room C, the topmost clay floor (1) is detailed (60). The lower part of the old wall plaster remains (2), but the rest has been demolished with only the c.1780 plaster (3) above, which was burnt in the 1803 fire. The clay floor was once again coated with a thin layer of lime (4) (detail 61).

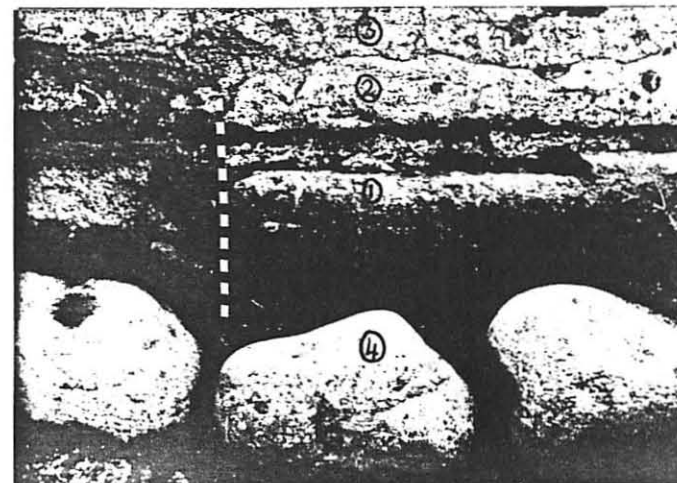
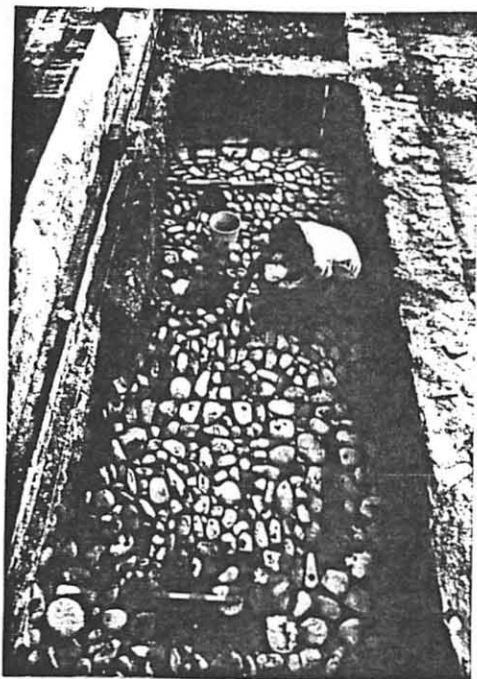
65 The cobble stoep (western area) facing Church Street was beautifully laid. Note the position of at least three post-holes.

66 The eastern area of the cobble stoep was more disturbed. Note the large cobbles toward the old entrance (1) and the blocked-up openings of brick of a later period (2).

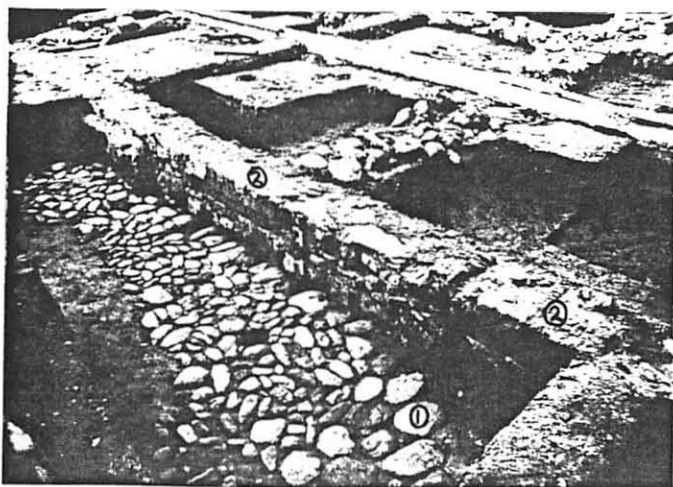
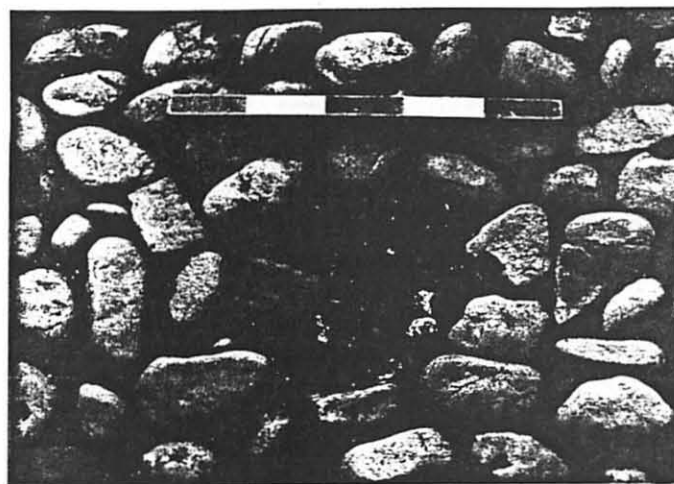
67 Close-up of one of the post-holes, filled with 18th century brick.

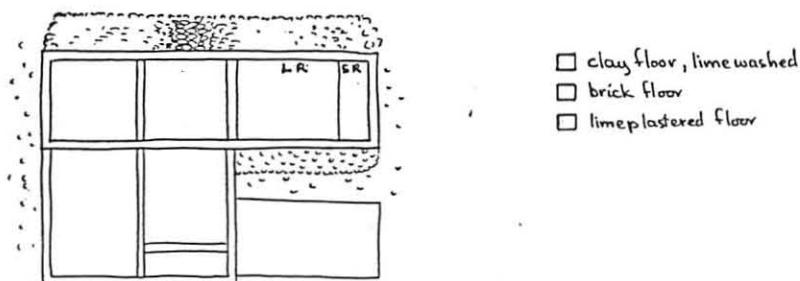
Fig.8.10 Groundplan of the dwelling by c.1750 with an extension towards the back.

The space immediately behind (i.e. south of) room E, still formed a small courtyard with large, flat cobbles. On the eastern exterior, a cobble strip for the dripline of the thatch may date to this period or later (Fig. 8.10).

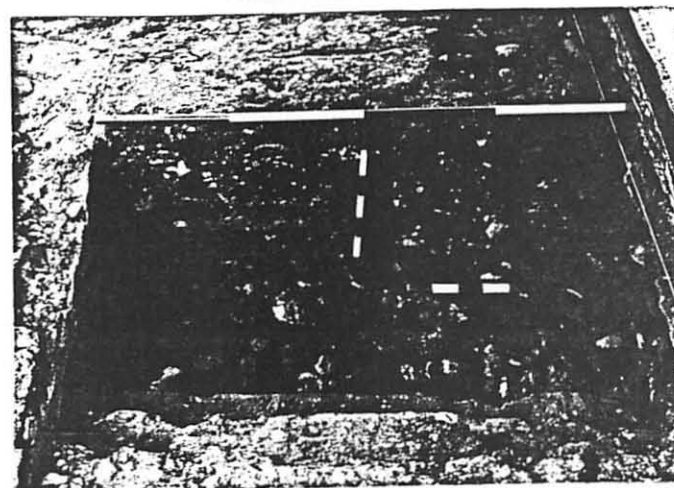
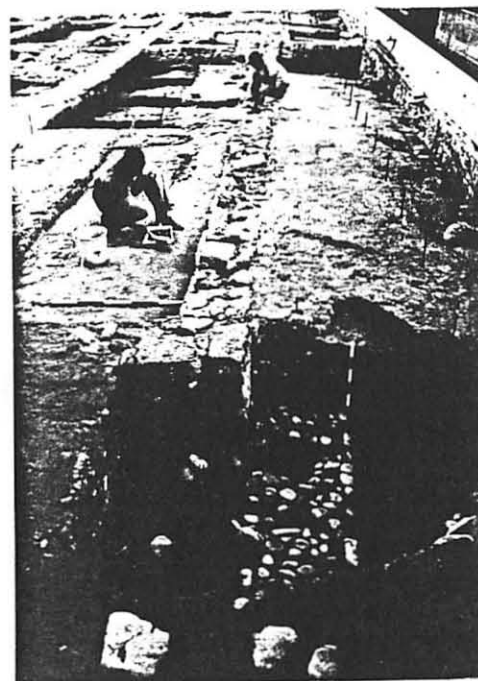
69 The cobble stoep was later filled in with much rubble to a higher level.

70 An earlier wall about the corner end of the house (room C), but it was completely demolished except for its lower parts.

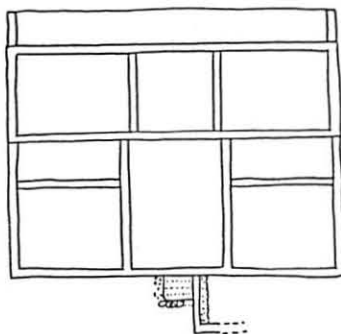
Fig.8.11 The houseform was significantly altered by c.1770, becoming more symmetrical in layout.

The house underwent major reconstruction during the third quarter of the 18th century (Fig. 8.11). Unfortunately much of the elements of this time period were destroyed about 20 years later when the floor levels were drastically altered and also after the 1803 disaster, when many of the interior foundations were re-excavated and rebuilt. Vast amounts of building rubble were used to raise all the floor levels, by at least 20-30cm. The fill is typical of the 18th century, containing rawbrick, soft-burnt orange brick, wall limeplasters (white-washed), and roof lime plasters with thatch impressions.

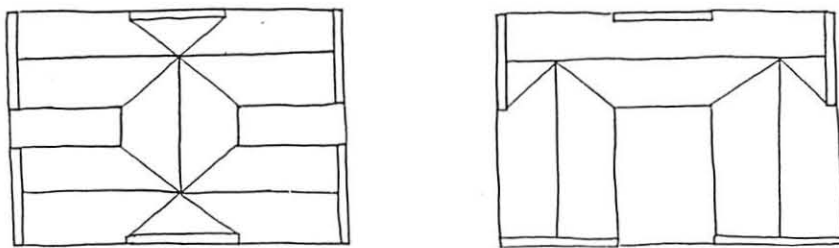
Fig.8.12 Possible types of roof structure at this period.

New walls/foundations were dug or rebuilt to change the configuration of the house into a rectangular structure (type of enclosed H or more likely, a U-shape with possibly a central flat roof) (Fig. 8.12). Room G (position of the lean-to), was finally demolished (if not at an earlier date) and its rawbrick filled in above the 80cm BSL floor (room G) till about 50cm BSL. The wallplaster against wall G4 continued for at least 40cm BSL.

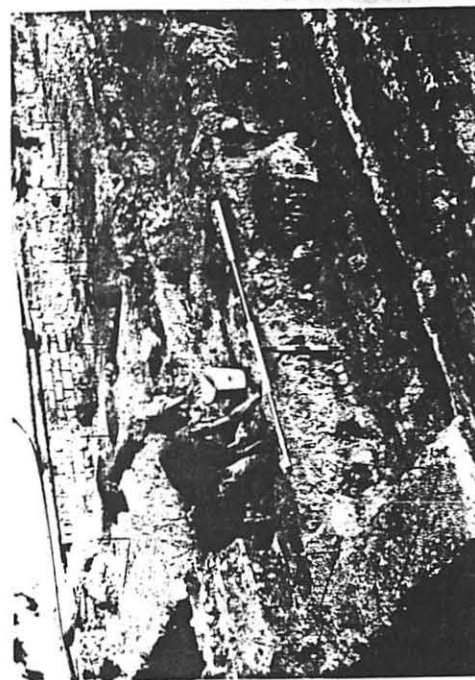
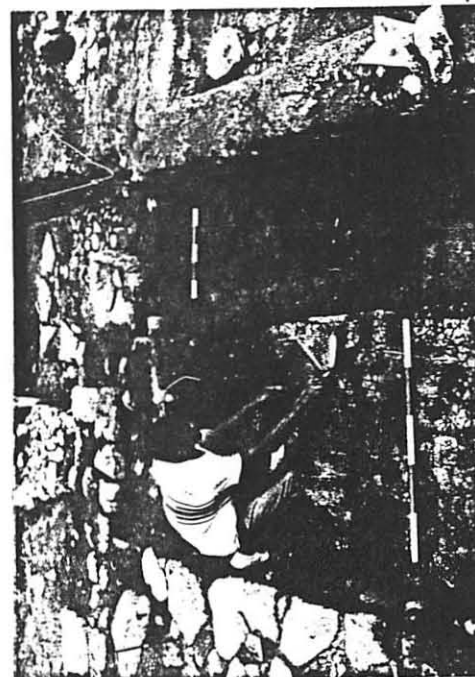
71 72

71 In rooms H/I a layer of fine orange brick was again found. Mr Karel Julius is cleaning the base layer of the c.1780 tiled floor.

72 The floor layers in rooms A and B were practically all destroyed by trenches dug during the demolition of the 1970 bank.
