THE STELLENBOSCH HOTEL EXTENSION (SHE) PROJECT

A CHRONOLOGICAL OUTLINE OF THE EVOLUTION OF A COLONIAL STRUCTURE AND ITS FEATURES ON PLOT 1298

H.N. VOS AND S.SCHOEMAN
JULY 1990

HISTORICAL ARCHAEOLOGY REPORT
RESEARCH CENTRE FOR HISTORICAL ARCHAEOLOGY
STELLENBOSCH MUSEUM

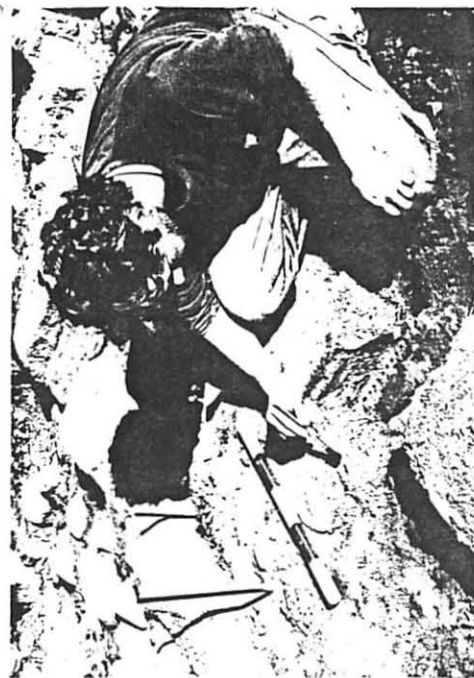
74 The new foundations of the backings were built primarily of granite and shale. The interior (north-south) walls were practically all destroyed. Only where they bonded into the back wall, were two small but important sections left intact.

75 This was carefully excavated by Mr Gawaine Ziman, to determine the depth of the previous floor levels.

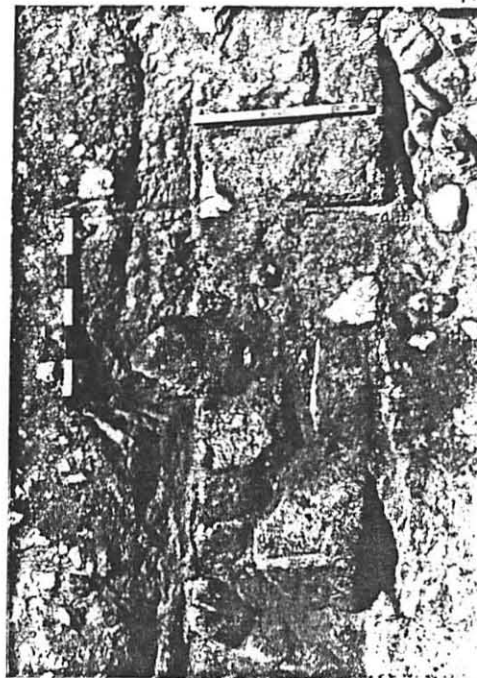
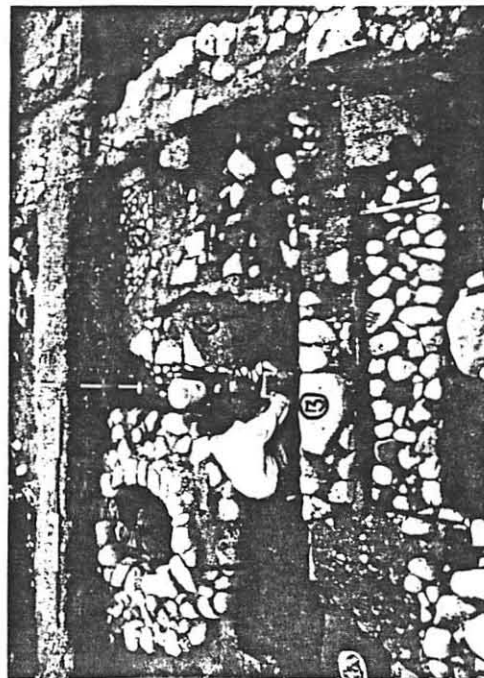
76 In the backyard an addition of steps (1), cobbled surfaces (2) and a dividing wall (3) were erected. The pit feature dates to a century later.

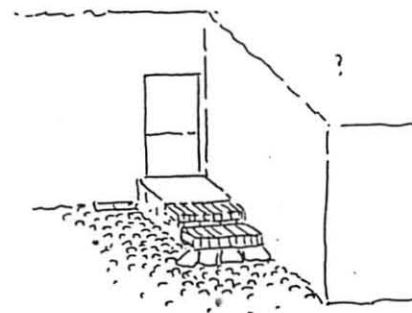
Fig.8.13 An impression of how the backstep may have looked by the mid 18th century.

During the 3rd quarter of the 18th century or later, a wall with foundations was built at the back, apparently to form a room eastward of it. Yet, a belt of cobblestone about it, indicating an exterior surface. At some later date, the wall (with larger dimensions) was extended 90 degrees eastward. Due to the many disturbances in this area, no satisfactory explanation can be postulated at present. Westward of the wall, granite and brick steps gave access to a back door. Only the impressions of the brick in the limeplaster have survived at the lowest step (Fig. 8.13).

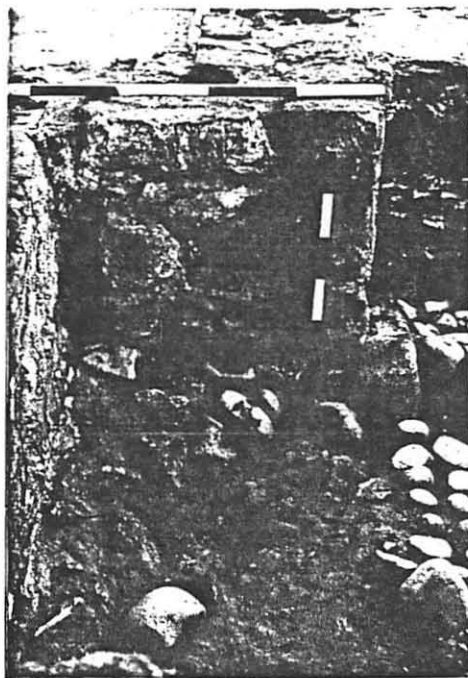
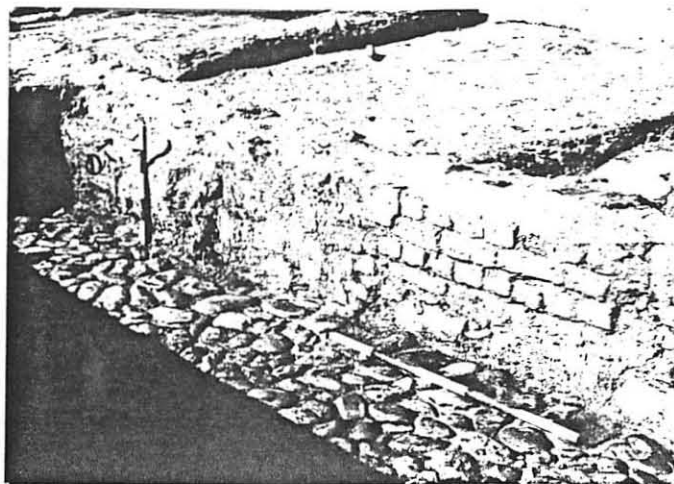
77 The foundations of the Church Street facade were rebuilt in yellow mortars (1), directly on top of the old building (2) (exterior corner, room C).

78 On the exterior of room E the wall openings were also blocked up. On the left (1) a small section of the height of the stoep was found intact.

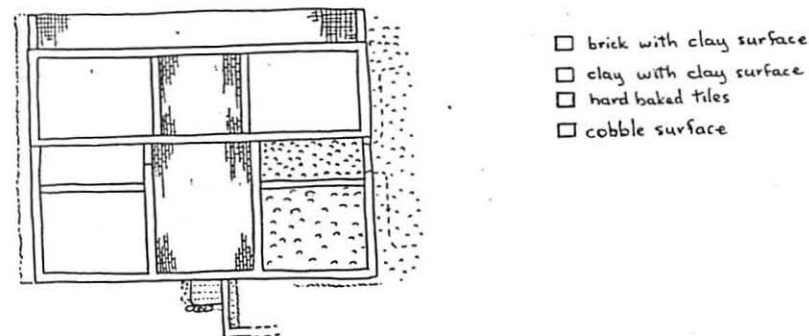
Fig.8.14 The groundplan of the house with its floor types as it was by c.1800, prior to the fire.

The most clearly defined levels of the structure can all be dated to the last two decades of the 18th century, when the floor level was raised for the last time before the 1803 fire. The overall layout of the house was still similar to the previous phase, viz. a thatched H-shaped dwelling, with large sash-windows (Fig. 8.14).

10. A startling discovery was that a cobbled coach-house could have formed an integral part of the main dwelling by c.1790 (Fig.8.14). Coach-houses, therefore, were not necessarily separated from the main structure.

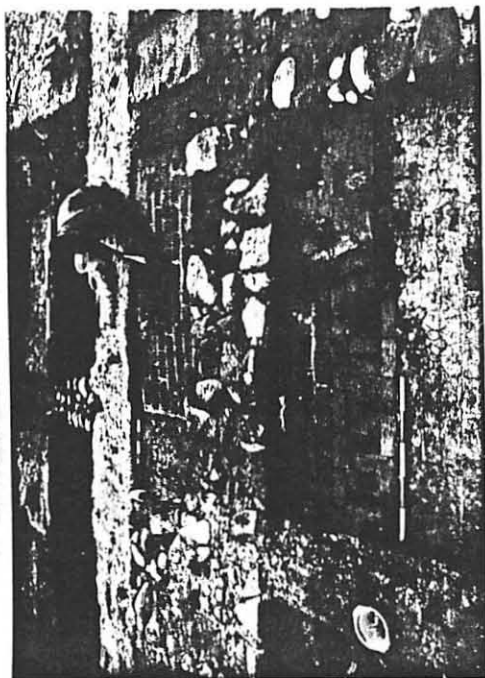
82 In room B the walls of the old foundations were left partially in situ. A brick-lined wall (1) and a threshold of a door can be discerned.

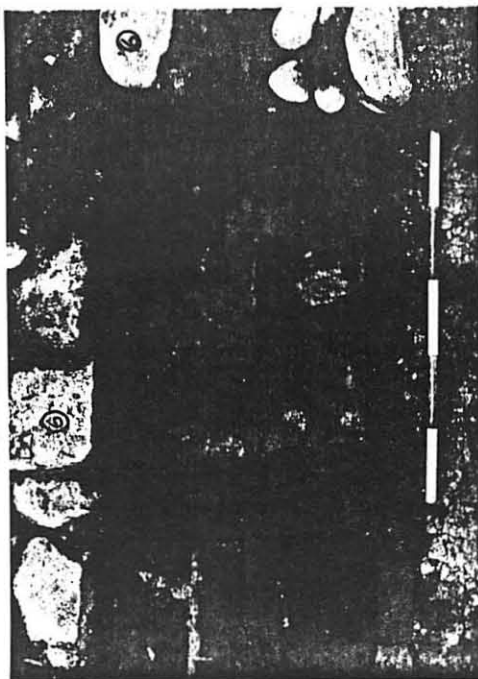
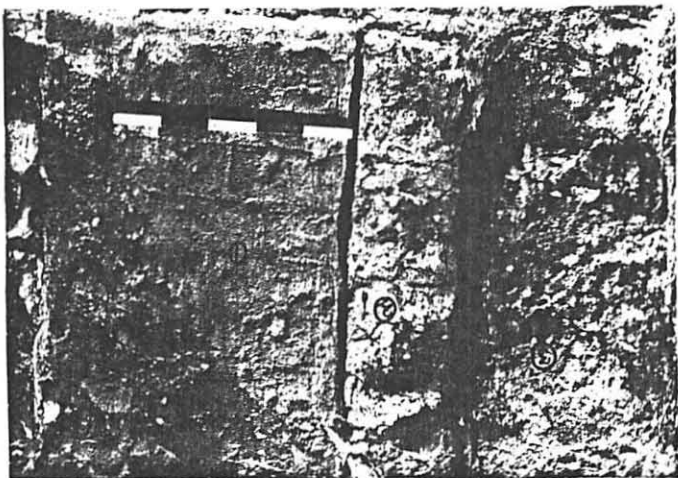
83 Detail of the door area: 1. Brick wall
2. Brick plastered floor 3. Lime plaster patches 4. Charred threshold with some wood intact 5. Filled-up post-hole 6. Post-1810 foundations.

81 A section in room D shows the brick (1), the plaster layer on top (2), the rubble and charcoal of the 1803 fire (3) and later fill-in (4).

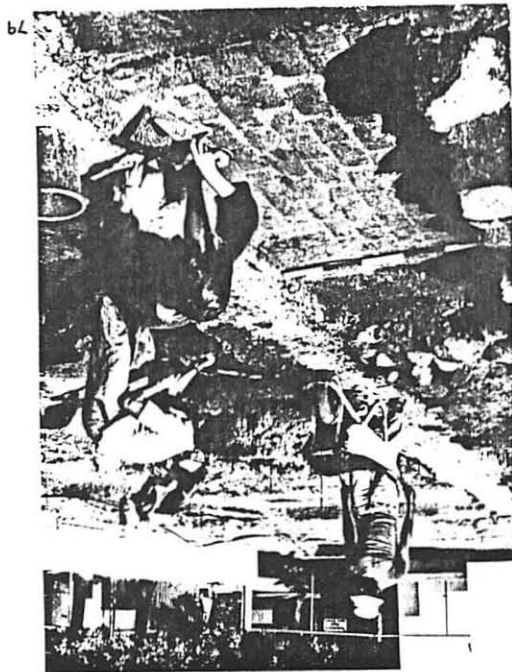
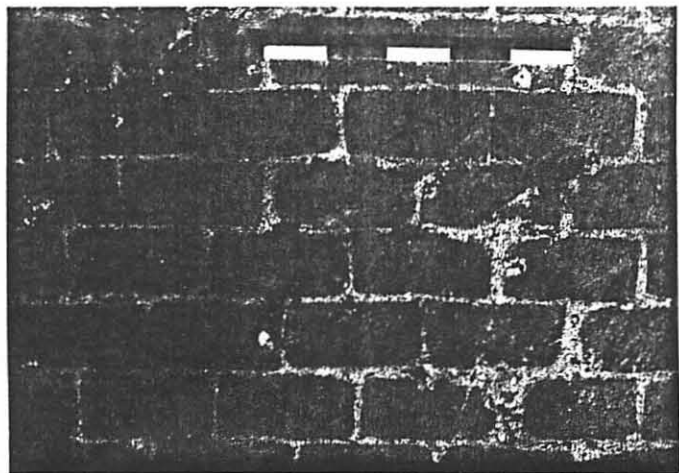
81

79 In room B the yellow, mustard-coloured clay bricks were stripped of their upper plaster coating to expose them fully (80).

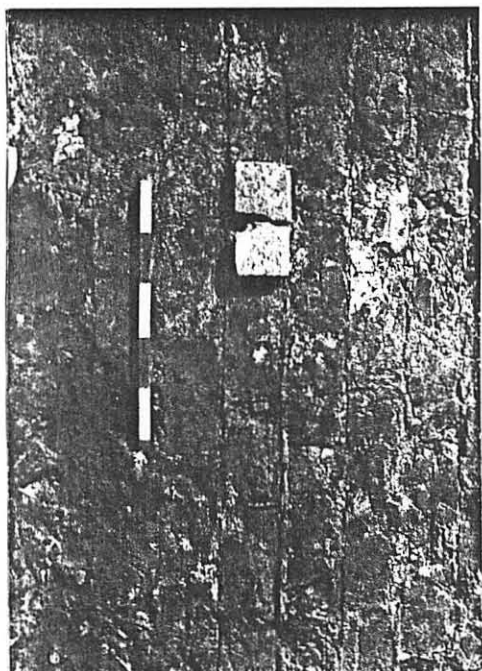
84 Remnant sections of the c.1810 tiled floor were found within room D, but much disturbed.
85 Broken pieces of the brick-sized tiles were discovered and are here placed on the lime plastered base with its impressions of the staggered tiles.

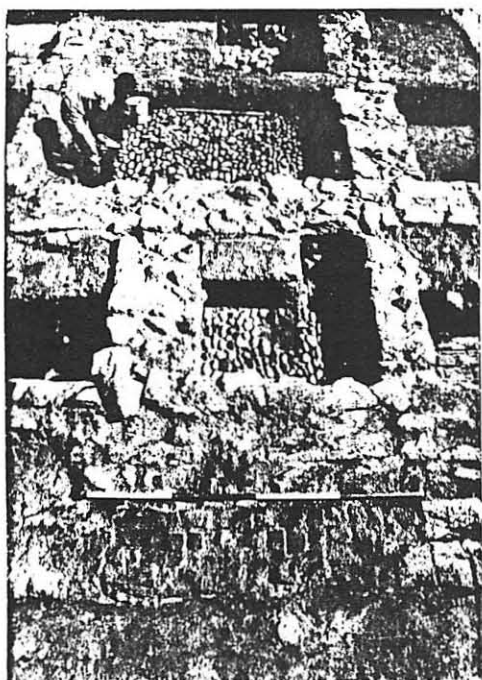
86 The dimensions of the old coach-house with its cobble surface, can be discerned amidst all the later additions.
1. Demolished foundations
2. 1970 bank foundations
3. Nineteenth century foundations
4. Old entrance blocked up with brick after 1810.

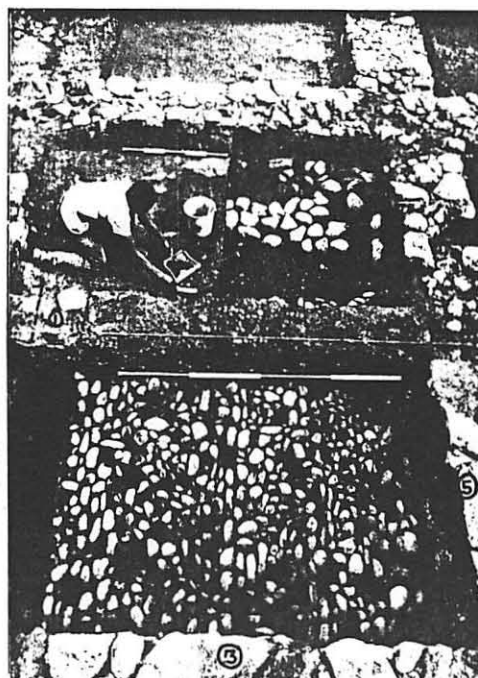
87 Much blackened ash and reeds were found on top of the cobbles, which are neatly laid between regular rows of stone. The early 18th century granite foundations (5) are also visible.

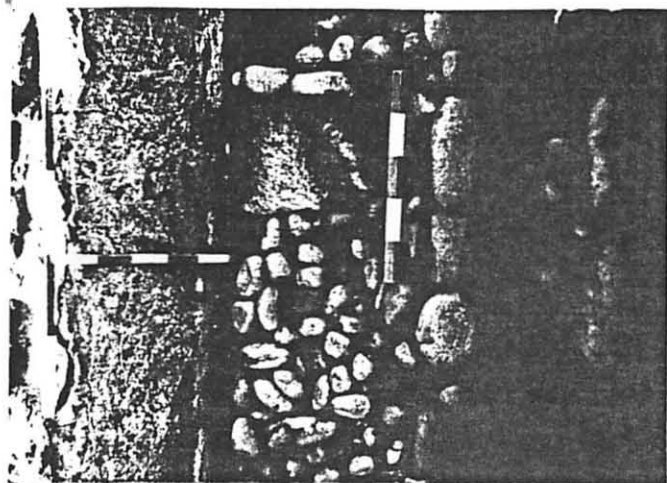
90 A drip-line of cobbles was provided on the western and southern sides of the building. At this external point (room B/C) an anomaly in stones were found, possibly indicating an earlier step or entrance.

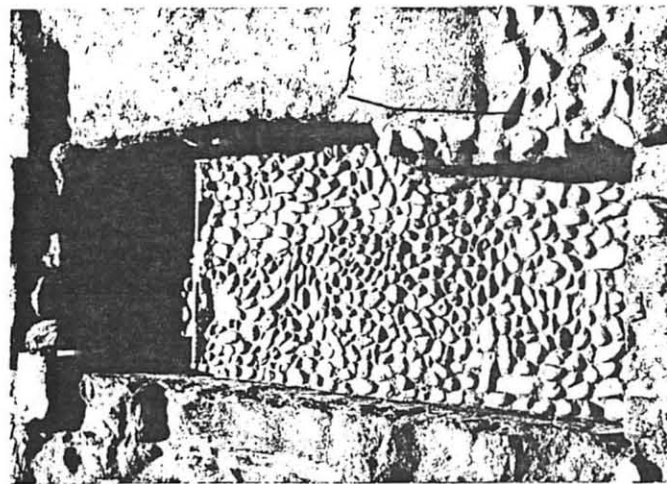
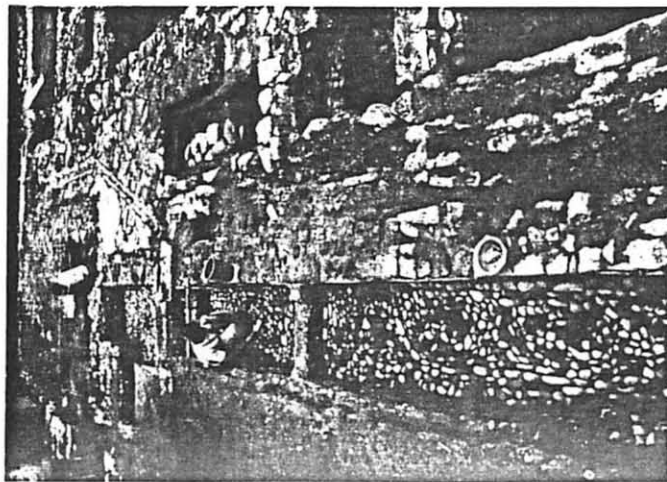
88 The eastern cobbled yard was partially exposed, revealing also shallow furrows within it. In room O (89), a close-up shows how tightly the stones were packed.

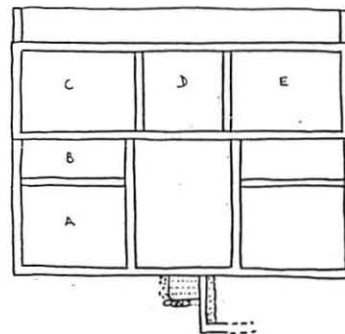
Fig.8.16 The rooms facing the street facades were all painted in a powder blue (c.1800).

In contrast to the previous rooms, room E was provided with a yellowish clay floor 4-5cm thick. Areas of it were heavily patched with a variety of clays, but all blending together. Areas were surely worn out by much trampling and needed to be filled up, a common practice, especially in kitchens, where there was continuous traffic. It should be noted that wallplaster painted in powder blue was still found in situ within rooms A, B, C, D and E. Some demolished plasters also had pink bands painted over the blue (Fig. 8.16).

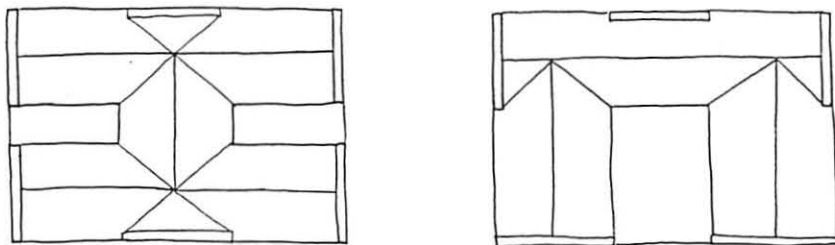
Fig.8.19 The configuration of the roofstructure may have been either U-shaped with a central flatroof (A), or H-shaped with flat roofs between the legs (B) (post-1810).

On the Andringa Street side, the strip of stone cobbling continued to be exposed to the elements, providing a dripline for the thatched roof. The configuration of the roof could have taken two forms (Fig. 8.19).

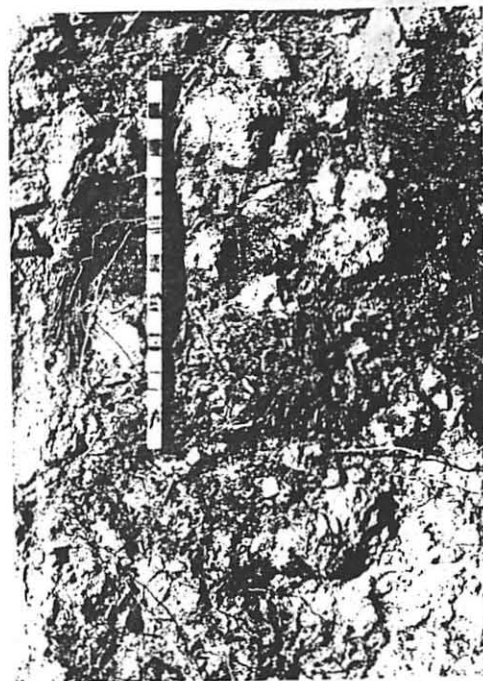
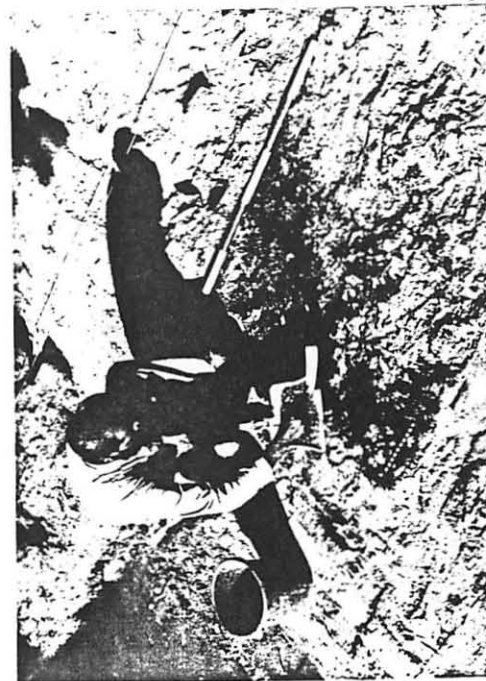
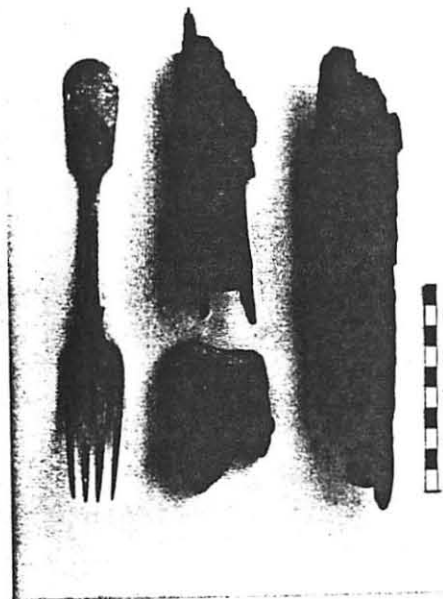
91 The 1803 fire devastated the house completely. In room C an area was located where the carbonized thatch was heavily concentrated (detail 92).

93 These charred wooden pieces came from room I in a compacted rubble layer. The fork probably dates to the late 19th century.

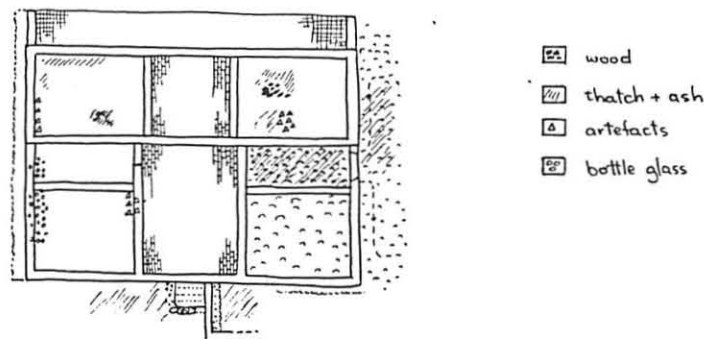
Fig.8.20 Groundplan of the house and site, showing the areas where large or conspicuous concentrations of carbonized thatch, wood and artefacts were encountered (1803-1810).

The archaeological investigations provides more details of interest. No attempt was immediately made after 1803 to restore the old house. Many of the clays, bricks and plasters showed signs of blending as they were exposed to water action over a prolonged period of time. Building rubble continued to topple onto the floors, compacted over many seasons. The blackened floor layers and the numerous carbonized thatch particles and concentrations, acted as important chronological indicators of the contemporaneous parts of the house, which have been described in Phase IV. Certain areas showed differential concentrations of either ash, thatch, plasters, brick, or artefacts (Fig. 8.20).

What followed, was also quite surprising. The house lay waste for about six years and was then completely rebuilt in the same form, but to smaller dimensions (compare Fig.8.20 with Fig.8.21). A new outbuilding took shape on the eastern line of the old foundations. Large portions of the granite foundations were re-excavated and re-used. It has never been realised that such drastic alterations could be effected on an existing site. Nothing but an area excavation would have revealed these structural alterations.

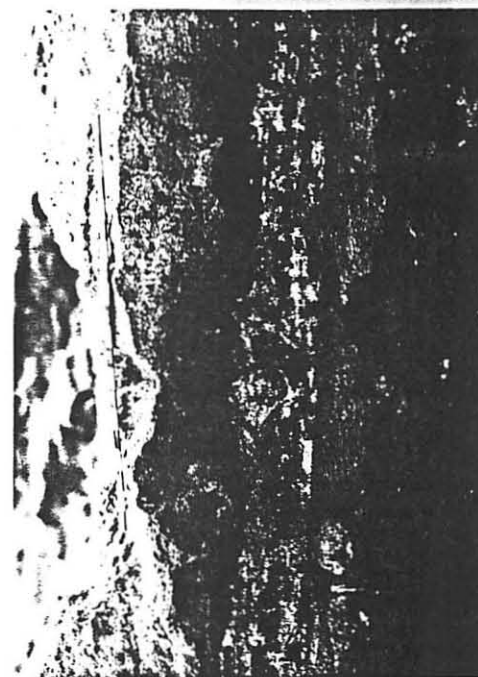
94 Signs of the 1803 fire were quite obvious in room C.

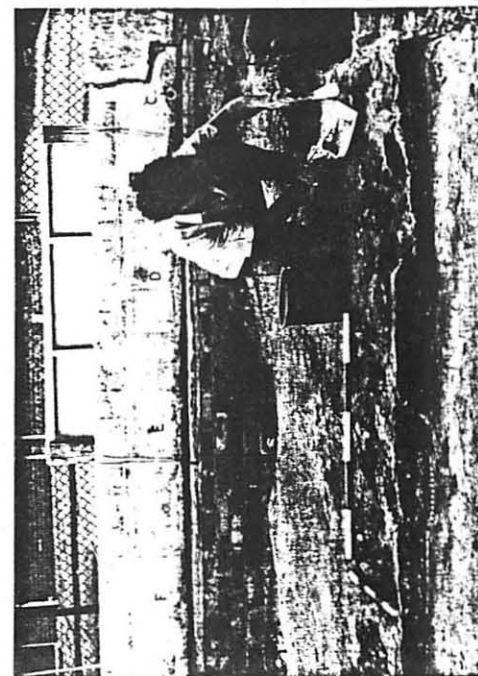
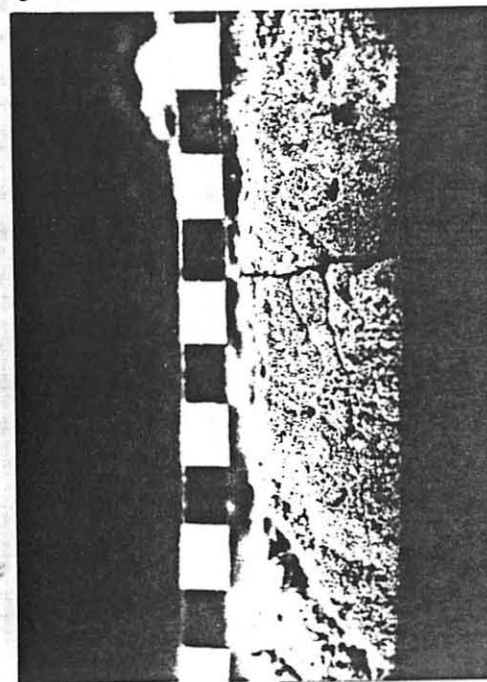
95 A close-up clearly shows the blue colour the walls were painted at the time. Rubble filled the floor for 2 to 3 cm and then the fire blackened the walls beyond that.

96 A close-up view of the plaster from above, indicates how the limeplaster discoloured to a light brown during the extreme heat.

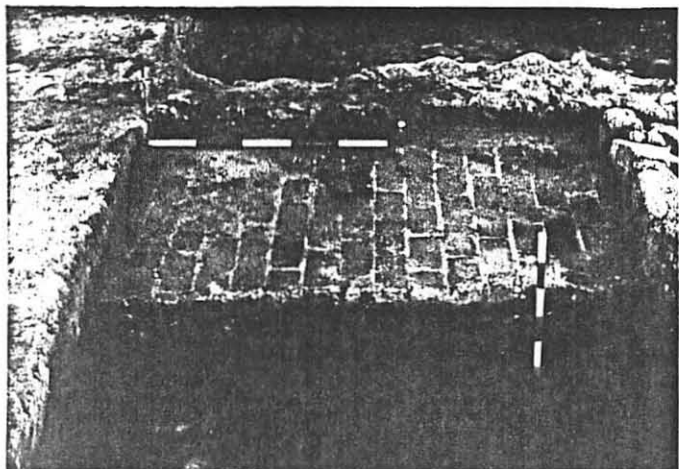
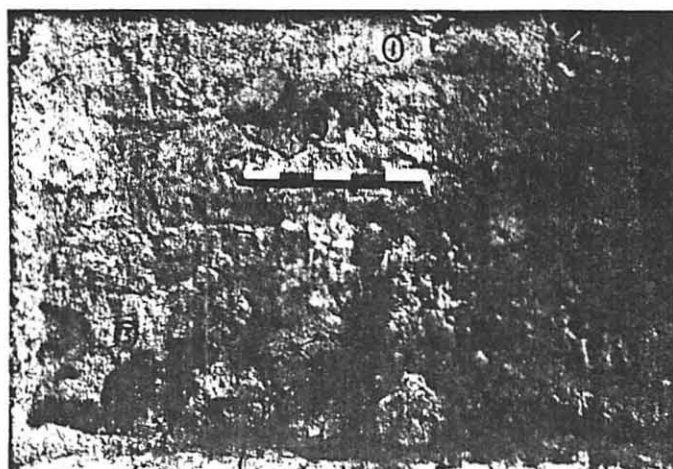
97 98

97 The effect of the fire was even felt beyond the limeplastered floor covering, right into the yellow brick (room C).

98 The floor of room E consisted of a thick yellow clay layer (1), with various patches of clay to fill worn-out areas (2). Charred boards (presumably from the ceiling) (3), were discovered amidst the rubble overlying the floor.

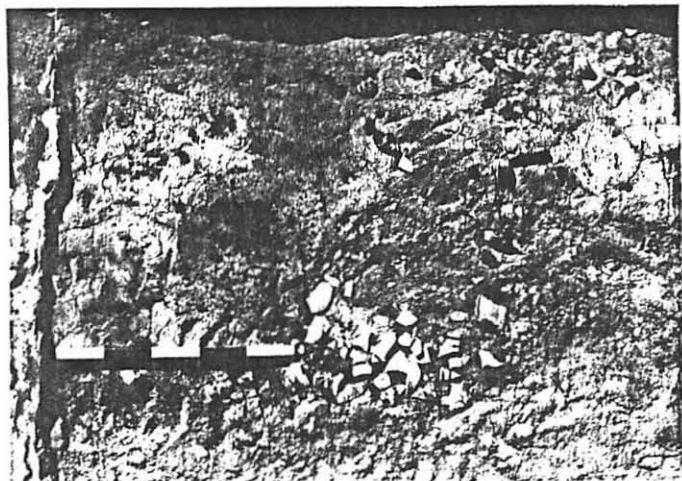
99 In the southernmost area of room E, signs of a thin, blackened plaster layer were found on top of the clay floor. Ceramics and glass artefacts were found in situ on the floor surface (see 100-103).

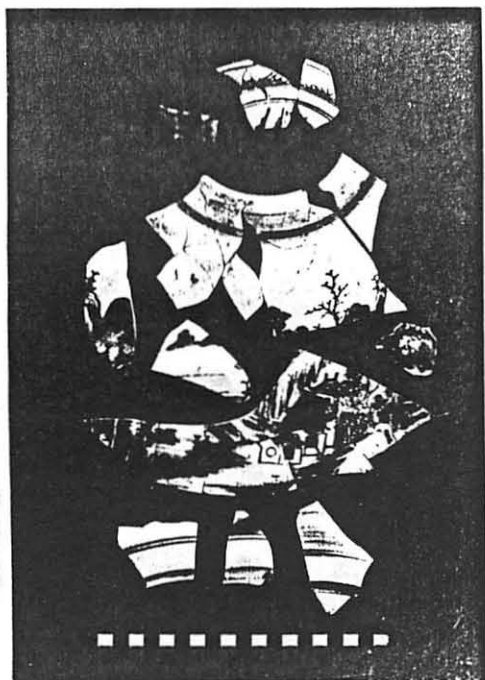
100 Artefacts from room E gutted in the 1803 fire included a Chinese porcelain ginger jar (scale : 20 cm).

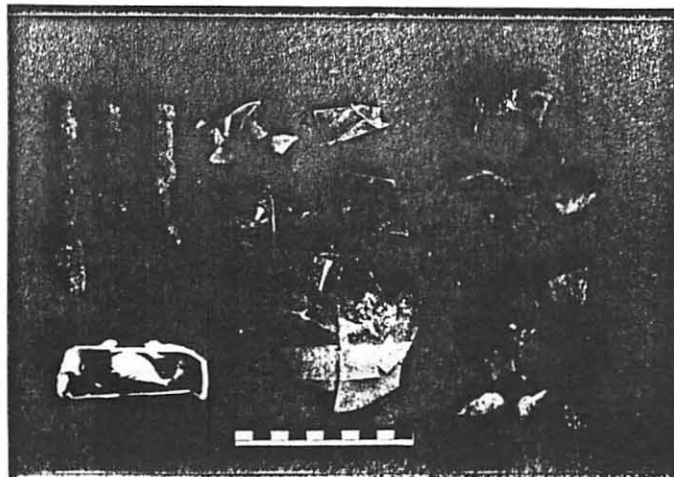
- 101 1.Nails 2.Windowglass (some warped)
3.Bowl base with kilin design
4.Upper portion of a marteveen storage jar
5.Bottle glass

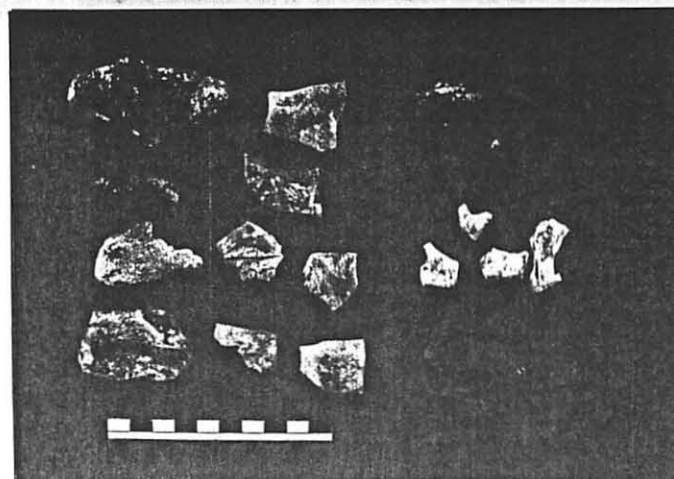
- 102 1.Molten leaded glassware 2.Bottle tops
3.Drinking glasses (distorted)
4.Pharmaceutical glass? (distorted)

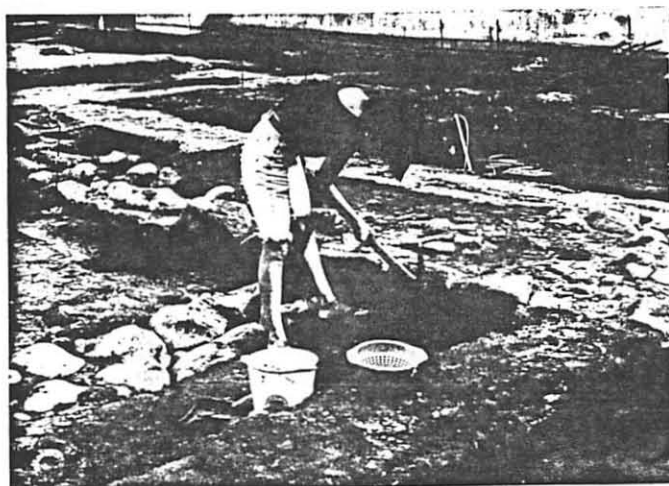
103 A concentration of Chinese porcelain was to be found in this particular area (room H), filled-in after the foundations were robbed of their stone in c.1810.

104 Fragments included plates (1), a bowl (2) and a vase (3).

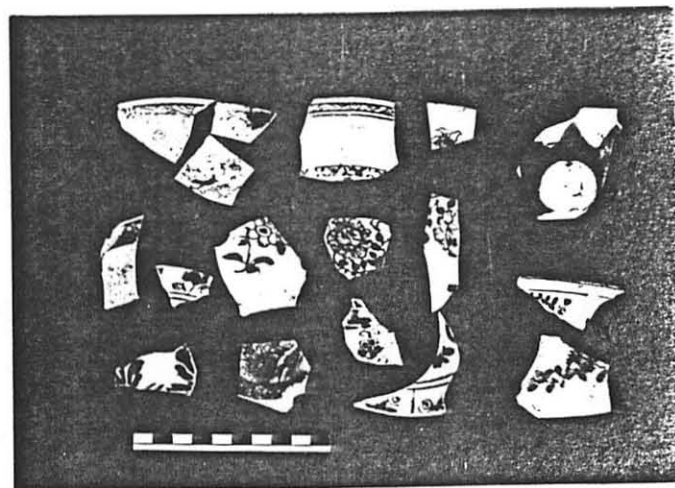
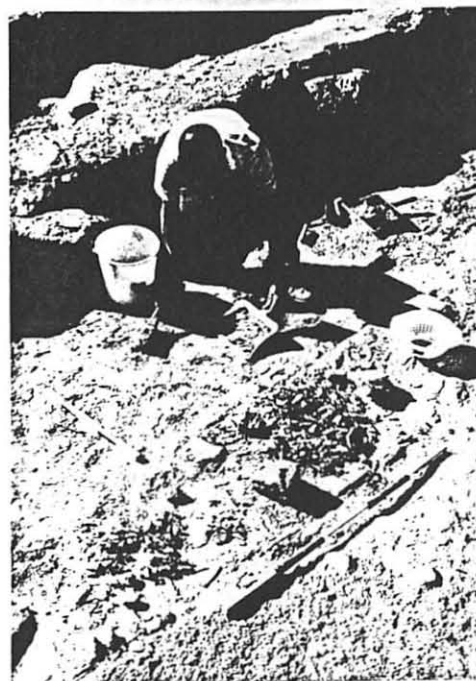
105 On the eastern sides of rooms A and B a vast amount of small fragmented bottle glass pieces were found within the later fill. Originally they would have lain on the floor surface, as was found to be the case where small intact sections of the floor were excavated.

106 Beyond the filled-in foundation B3, sherds of ceramics and glass were discarded with the rubble.

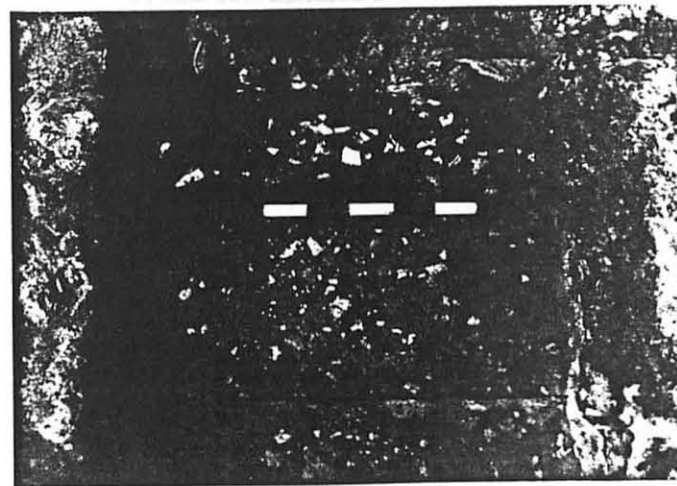
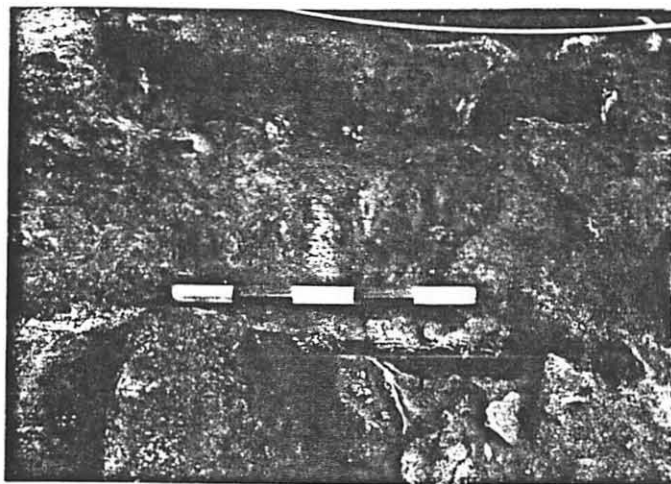
107 Room B was also painted in blue, as a small section indicated, where the post-1810 foundation abut it (see detail 107.1).

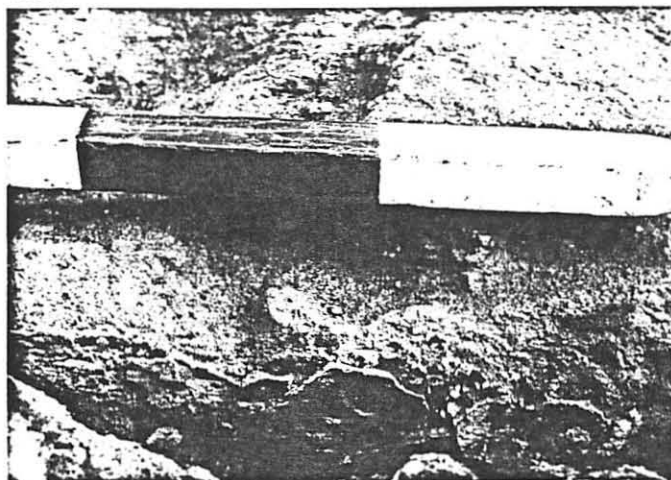
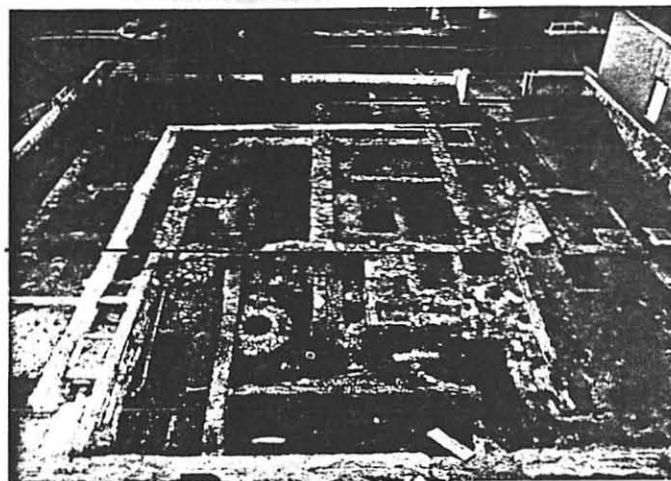
108 Aerial view of the site, indicating how the configuration of the buildings changed after 1810 into the main dwelling westward and the outbuilding eastward.

109 Against wall B2, two lines of riverstone were found, though heavily disturbed to give a false impression of a circular feature. They rested on the c.1780 clay floor with charcoal and artefacts (1803) below and between them. It could be a feature associated with a hearth of post-1810.

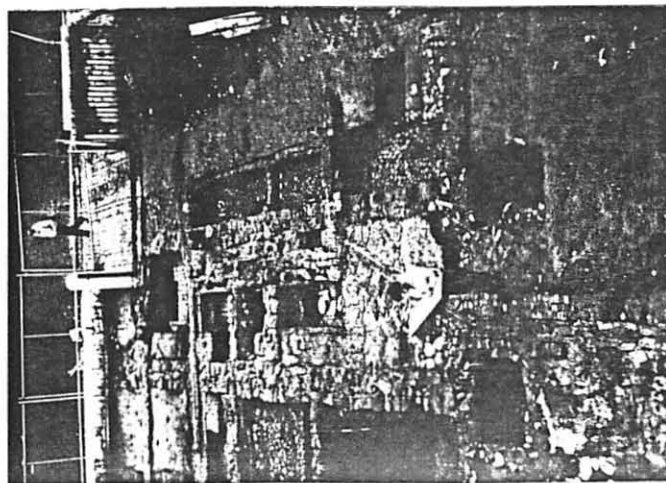
110 The eastern foundation of the old house, was now turned into the western foundation of the newly erected outbuilding. The cobbled yard was filled-in.

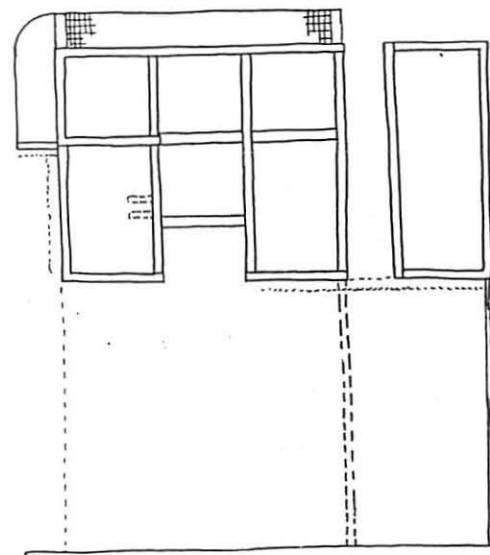
Fig.8.21 Groundplan of the house as it was rebuilt after c.1810, creating two structures.

As has been suggested in the historical outline of the site, the dwelling was probably not rebuilt till the ownership of Willem Wium in 1810. In the light of the complete chaos and ruin of the house, he conceived a completely new plan of the plot and its structures. Historically there is evidence that the plot was divided into two portions by 1808. All the rubble was conveniently deposited into the rooms and their floor surfaces were leveled and raised in height by at least 50 - 60 cm. Consequently, practically nothing of the floor surfaces of this period or anything afterward could be recovered, as they were all razed in the c. 1960 demolition of the house. Even all traces of the post - 1810 walls disappeared, as well as the upper portions of the foundations (Fig.8.21).

114 On the Andringa Street side, a new set of steps were built on top of the dripline (looking north) (see Fig.8.21).

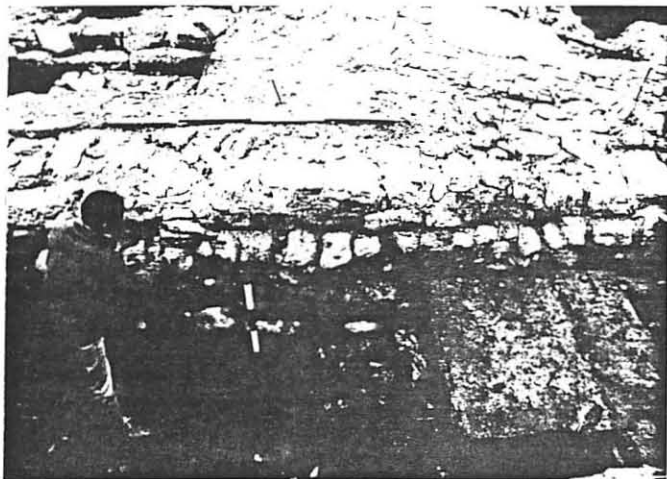
113 The post-1810 foundations of re-used granite, riverstones and shale were quite deep, as exposed in this section in room G, wall 2.

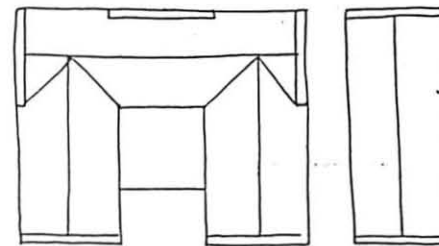
Fig.8.22 Probable configuration of the roofplan of the house, as indicated by the Hertzog map of 1817.

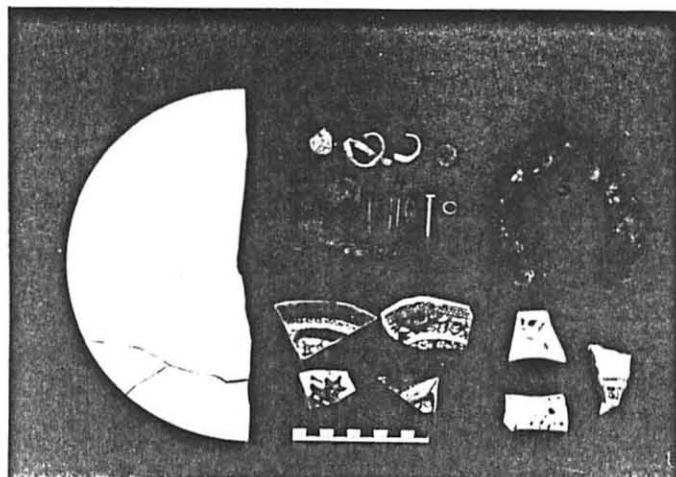
116 Amongst this kitchen rubbish (> 1810) the following was found:

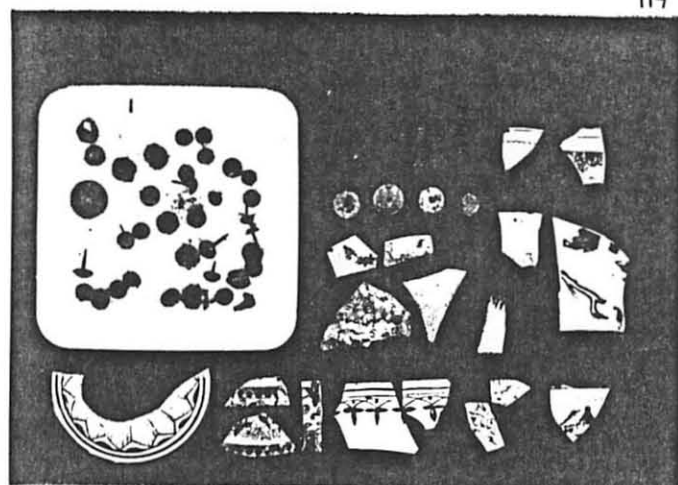
- 117 1. Brass tacks 2. Brass objects 3. Iron nail
4. Bone button backs (3) 5. Brass button with cloth 6. Window glass 7. English porcelain 8. Chinese porcelain.

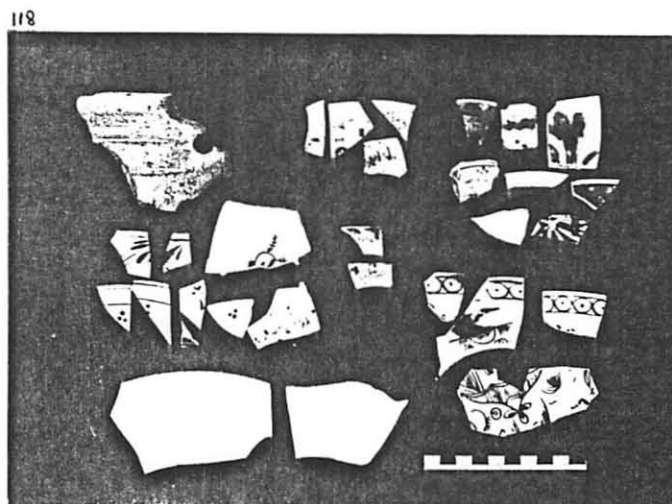
118 Similar period articles were filled in within room F where the foundations were robbed of stone (118-121). 1. Earthenware 2. Variety of English porcelain 3. Chinese porcelain

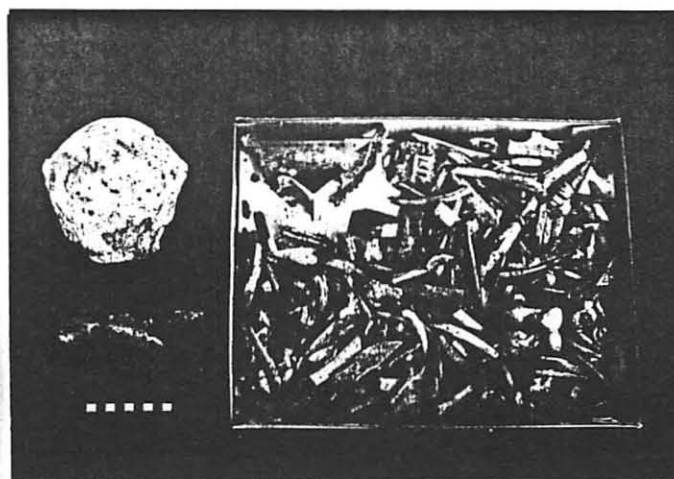
119 1. Fish remains, 2. Shell, 3. Ostrich eggshell (scale 2cm).

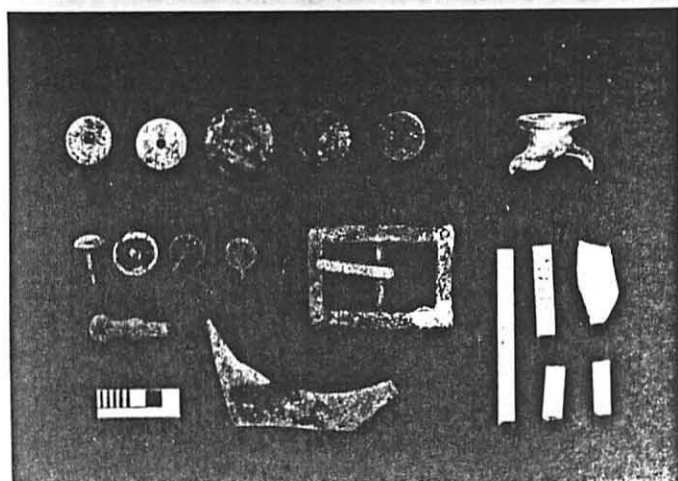
121 1. Bone button backs 2. Brass buttons 3. Brass drawing pins 4. Brass buckle 5. Brass objects 6. Pharmaceutical glass bottle top 7. Kaolin smoking pipe fragments

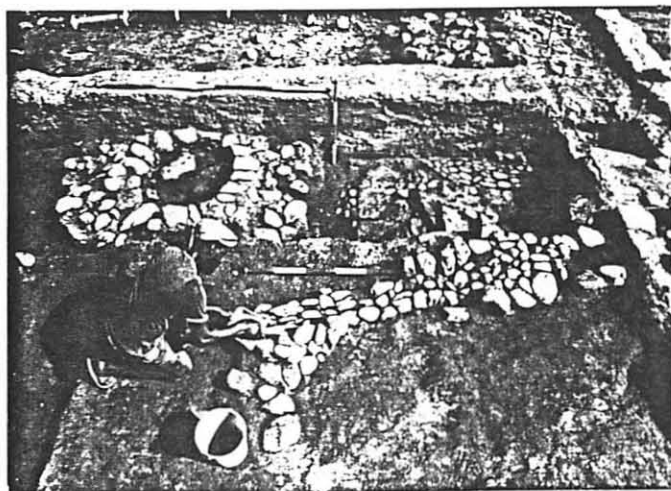
123 In the backyard a cobbled furrow (> 1870 ?) for transporting rainwater from the roof, was neatly excavated.

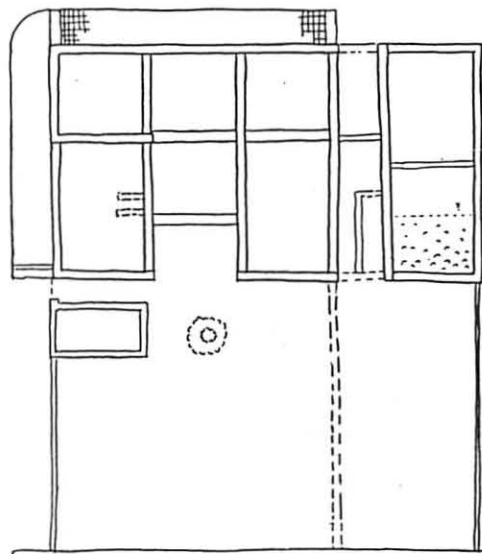
Fig.8.23 Groundplan of the structures and the site, as they could have looked by the mid 19th century.

Details of the development of the plot and house plan are rather limited because practically nothing remains of the upper portions of the building. A combination of historical and archaeological information does, however, provide a more balanced interpretation of the site (Fig. 8.23).

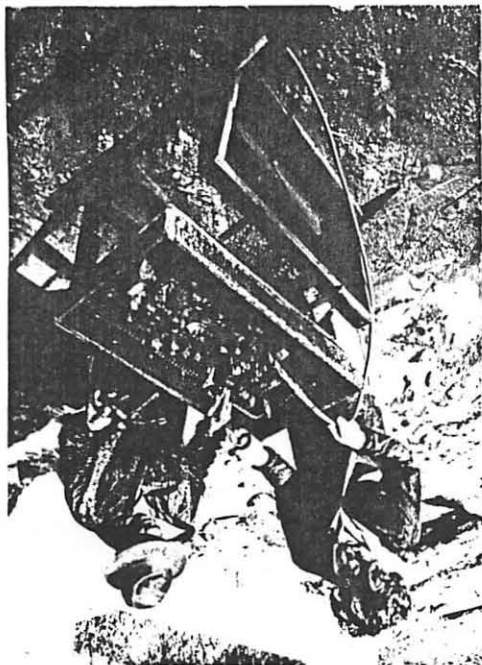
128.1 Primarily rubble and stones were taken out of the pit, but a few artefacts like bucket handles were recovered during the wet-screen process.

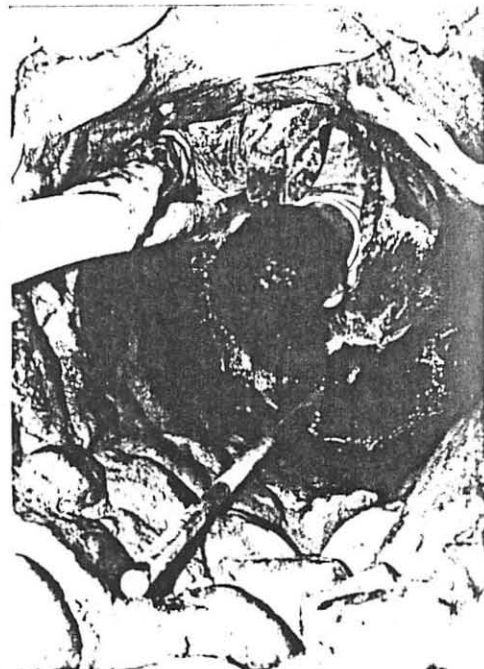
127 The excavation and recording of the pit posed its own problems. The water table was quite high within the 2 m pit and the water and slush had to be pumped out (128).

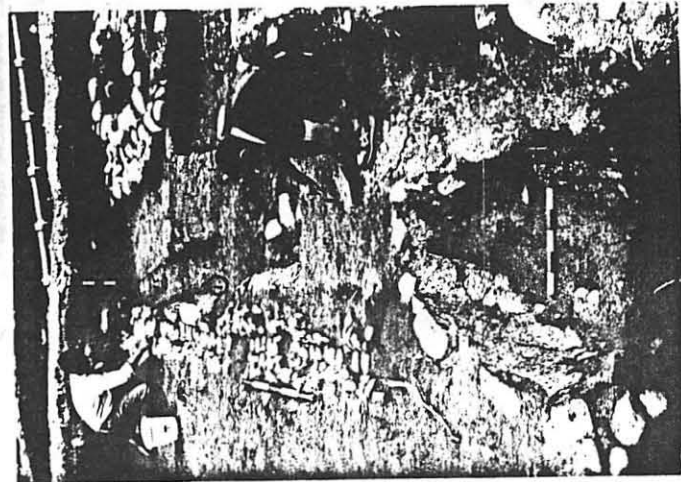
129 A cobbled furrow (1) was opened up, which was partially destroyed by the later rubbish pit I c.1900, lined with stones and iron sheeting (2).

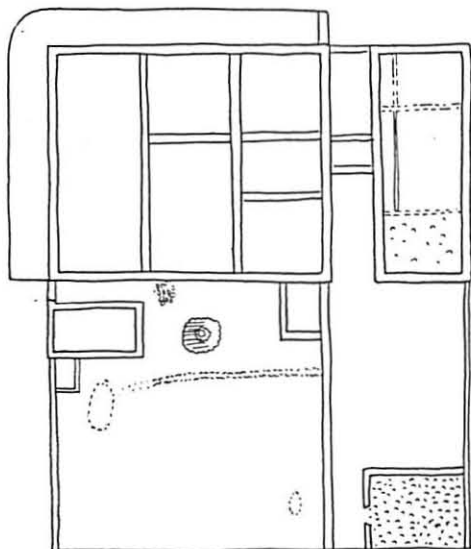
Fig.8.24 Groundplan of the structures and the site by the late 19th century.

The 1882 survey plan by Rowan provides general details of the constructions and features and especially of the back portions of the erf. The position of the southernmost furrow fell within an area that was heavily disturbed with stone (granite and river-stones) and brick rubble. Consequently no attempt was made to relocate it. Another cobbled furrow was located approximately within square X, along its west to east axis. Only a small portion of it was encountered at square X 18. A localised rubbish deposit of mainly broken bottle glass was excavated in square DD/EE 18. It was situated directly below the c. 1900 rubbish dump II. The features like the pit at the back, fell into disuse during this period and disturbances increased. The divisional walls within rooms A,B and C were also demolished (Fig. 8.24).

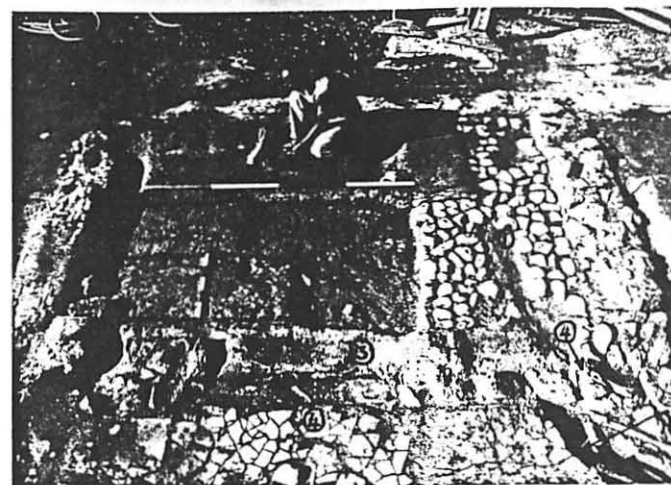
132 In the eastern outbuilding, cobbles (1) formed a surface within room O. Directly below them, sleepers (2) for a wooden floor (c.1900) were recovered, which would be contemporaneous with the wooden threshold (3). Lead pipes were also found (4).

Immediately above the late 19th century cobbles in room O, a yellow clay layer was found, with indications of wooden sleepers to support a wooden floor. A brass penny or two (illegibly corroded) that had slipped through the floorboards, were also found. The interior division of the building (rooms N and P), was subdivided by a north-south brick wall with a foundation of small river-stones. Unfortunately all the surfaces above this were destroyed.

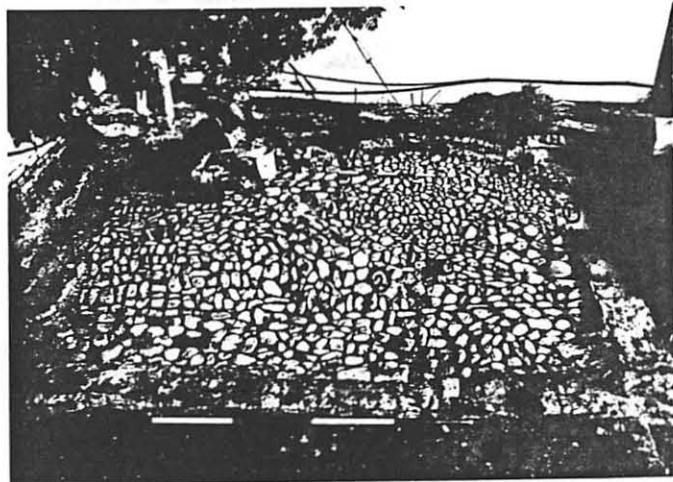
138 The stable with its large area of cobbles, was well preserved. Note the entrance (1) and shallow furrow (2).

In the south-eastern corner of the plot the remains of an interesting, rectangular structure were discovered. The structure's position, size and well-laid cobble floor with a shallow furrow, suggests that it was used as a stable. A few horse shoes which were found in the backyard confirm this conclusion. It had a narrow entrance on its eastern side. Access to the eastern plot was also gained from the Andringa Street side by a long and narrow passage, which was still in existence by 1985. At present the passage forms part of the 1985 Stellenbosch Hotel.

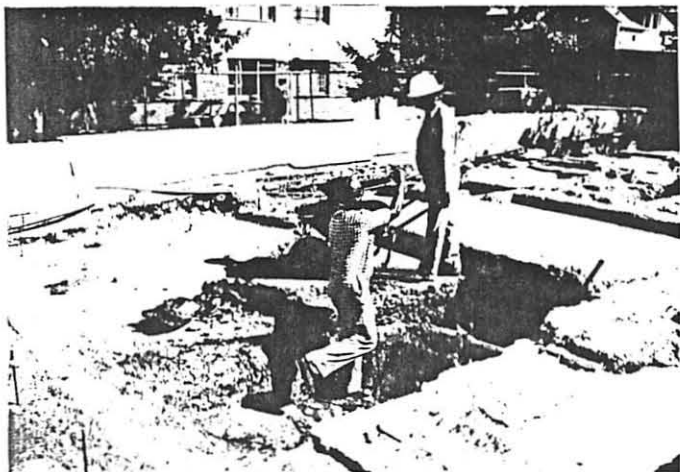
141 Rubbish pit III, (c.1900) was hld directly below the concrete floors of the garage. A variety of objects were recovered (142-145).

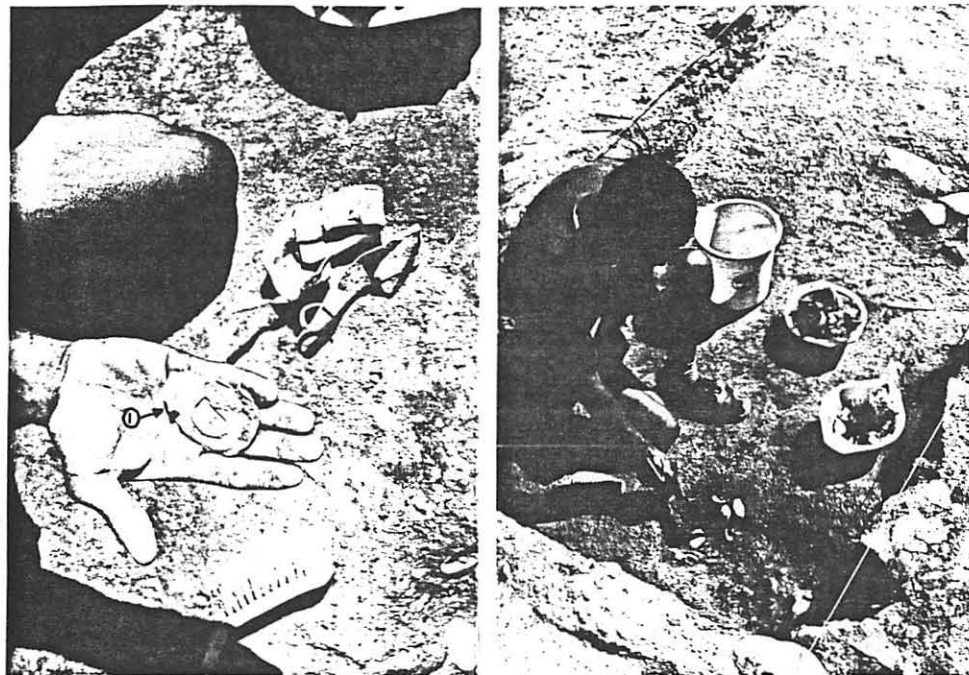
146 In rubbish area IV (c.1900), a reversed lead seal (1) was recovered (see Fig.8.25), as well as strips of lead (see also no. 149).

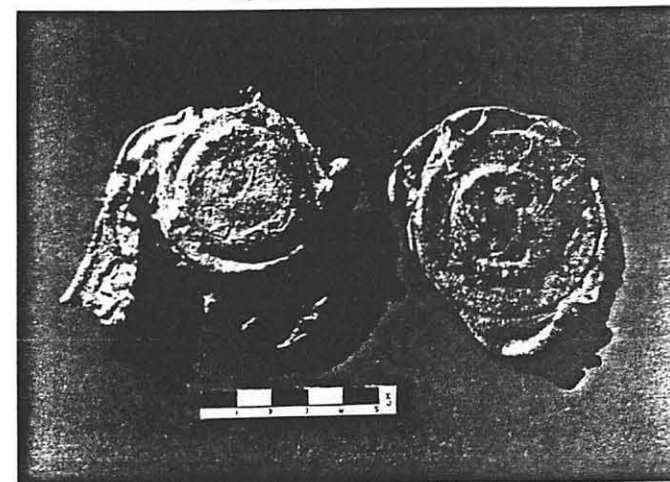
149 The lead seal (1) from area IV was compared to a circular lead object (2) from room D, layer 4 (19th century).
