THE STELLENBOSCH HOTEL EXTENSION (SHE) PROJECT

A CHRONOLOGICAL OUTLINE OF THE EVOLUTION OF A COLONIAL STRUCTURE AND ITS FEATURES ON PLOT 1298

H.N. VOS AND S.SCHOEMAN
JULY 1990

HISTORICAL ARCHAEOLOGY REPORT
RESEARCH CENTRE FOR HISTORICAL ARCHAEOLOGY
STELLENBOSCH MUSEUM

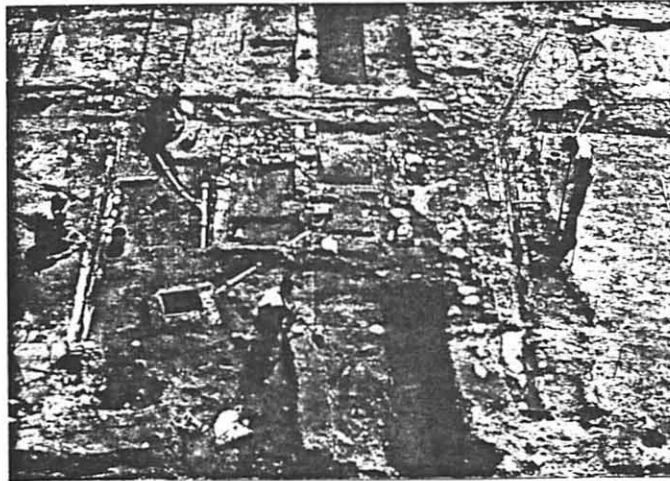
140 The foundation walls of the outroom and toilet facilities are outlined (see Fig.8.26).

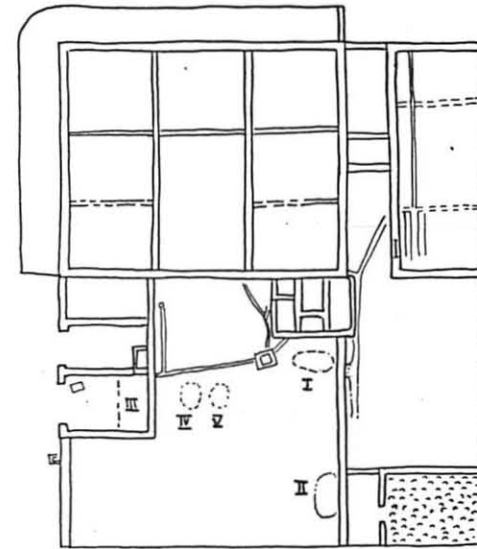
Fig.8.25 Groundplan of the structures, and features on the site by the early 20th century.

Major alterations were the creation of more subdivisions within the main house and the demolition of the coach-house to make way for two cement garages with thick concrete floors. A section was dug through the concrete floor where it was already disturbed. Only one wall (II.AA1) of the coach-house could be exposed (Fig. 8.25).

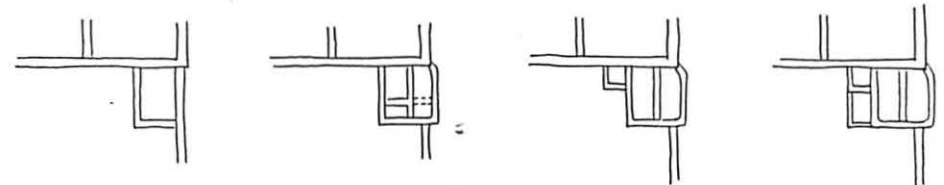
Fig.8.26 Possible development of the constructions of the later washing and toilet facilities (late 19th to early 20th century).

More emphasis was being placed on hygiene and the lean-to against the southeastern end contained ablution and toilet facilities. The consecutive development of these small rooms is not definite but a possible outline is presented (Fig. 8.26).

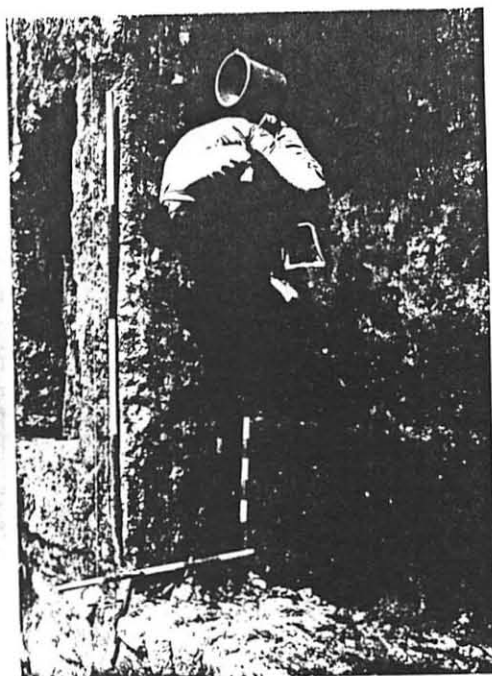
- 1.1 Corner section with raised walls of granite and shale. Represents the oldest corner of the dwelling, and of this town-block (period c.1700).
- 1.2 Corner section indicating where the post-1720 dwelling ended.
- 1.3 Blocked-up openings of doors/windows in the front facade. They represent the only openings that were positively identified in the exterior of the building (period late 18th/early 19th century).
- 1.4 The only remains of brick walling that have survived with signs of an entrance door adjacent (north) of it (period c.1790).
- 1.5 The earliest divisional wall of the front portion that has remained (post-1720) overlain by the post-1803 foundation stones.
- 1.6 The rest of the foundations and stone walls are in a fair condition.
- 1.7 The only clay wall that was encountered, was built with a base of cobble stones (c.1720).

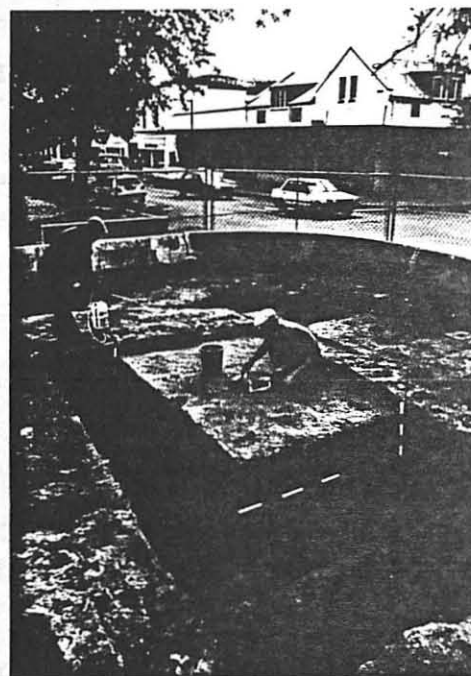
- 2.1 A variety of very interesting clay floors are visible, all dating from the 18th century. Unfortunately, the oldest ones are situated at very low levels, making preservation or accessibility to view quite difficult. The moist conditions are advantageous to fungal growth and quickly affects such exposures adversely.

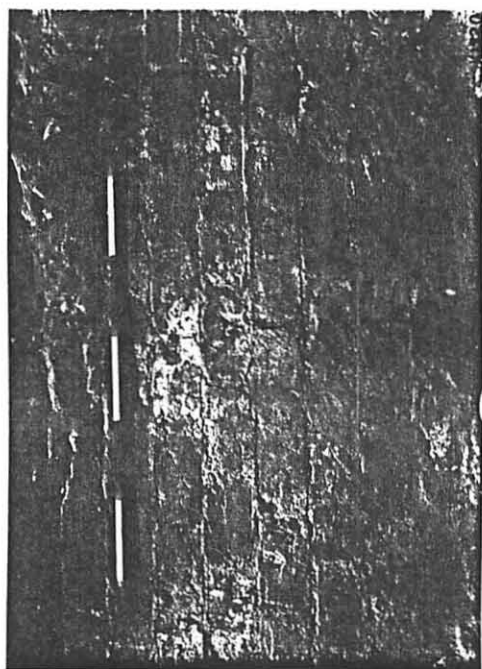
- 2.6 A neat and extensive cobbled floor, which probably served as stabling quarters, is situated in the south-east corner of the plot (mid to late 19th century).

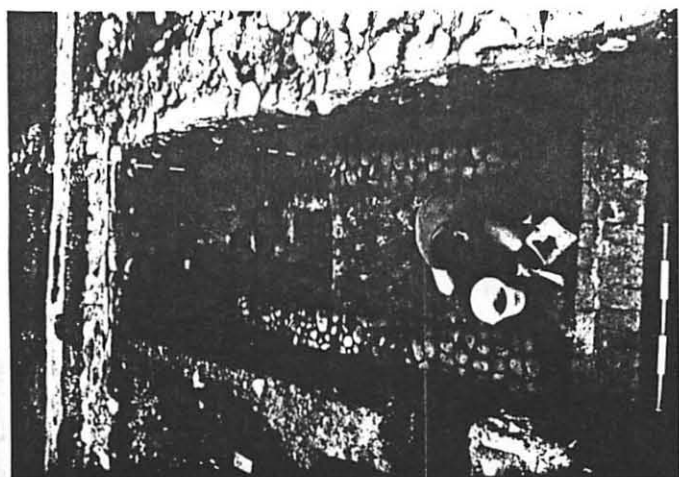
- 3.6 Cobbling, forming part of an extensive stoep covers a large area, with a later stone surface built over it (18th century).
- 3.7 A section of the stoep cobbles of circa 1705 with signs of the 1710 fire directly adjacent to it. This represents portions of the earliest dwelling and should be treated with the utmost care.
