David Styles

Vegetation Surveys, Advice and Consulting

9 August 2014

ASSESSMENT OF VEGETATION WITHIN AND SURROUNDING THE FOOTPRINT OF A PROPOSED PEDESTRIAN BRIDGE BETWEEN UMLAZI AND EMANSOMINI

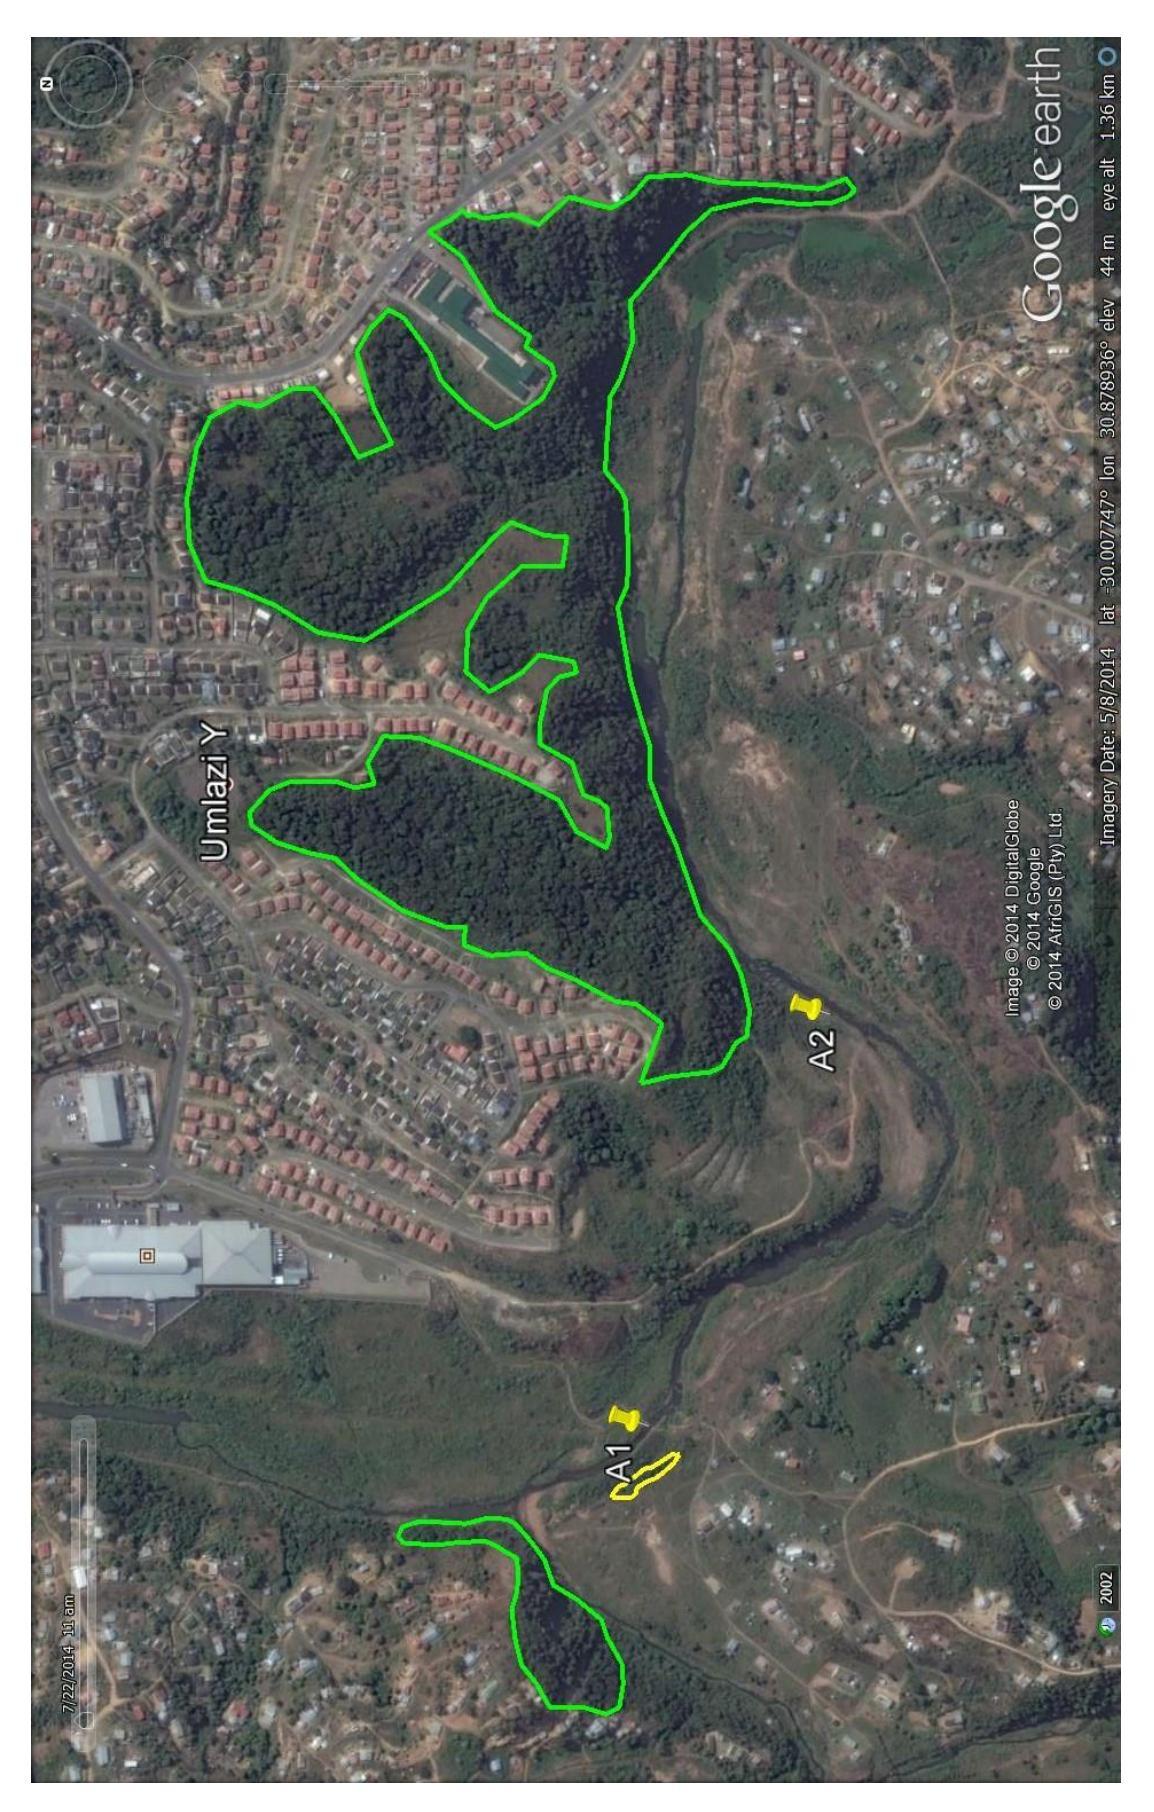
APPENDIX 1: Vegetation map

A1 – Western alternative for pedestrian bridge

A2 – Eastern alternative for pedestrian bridge

Yellow polygon – patch of woody vegetation in which *Millettia grandis* (Umzimbeet) occurs, trees being felled for poles or firewood.

Small green polygon – Scarp Forest near the western alternative

Large green polygon – Scarp Forest, much in good condition, near the eastern alternative

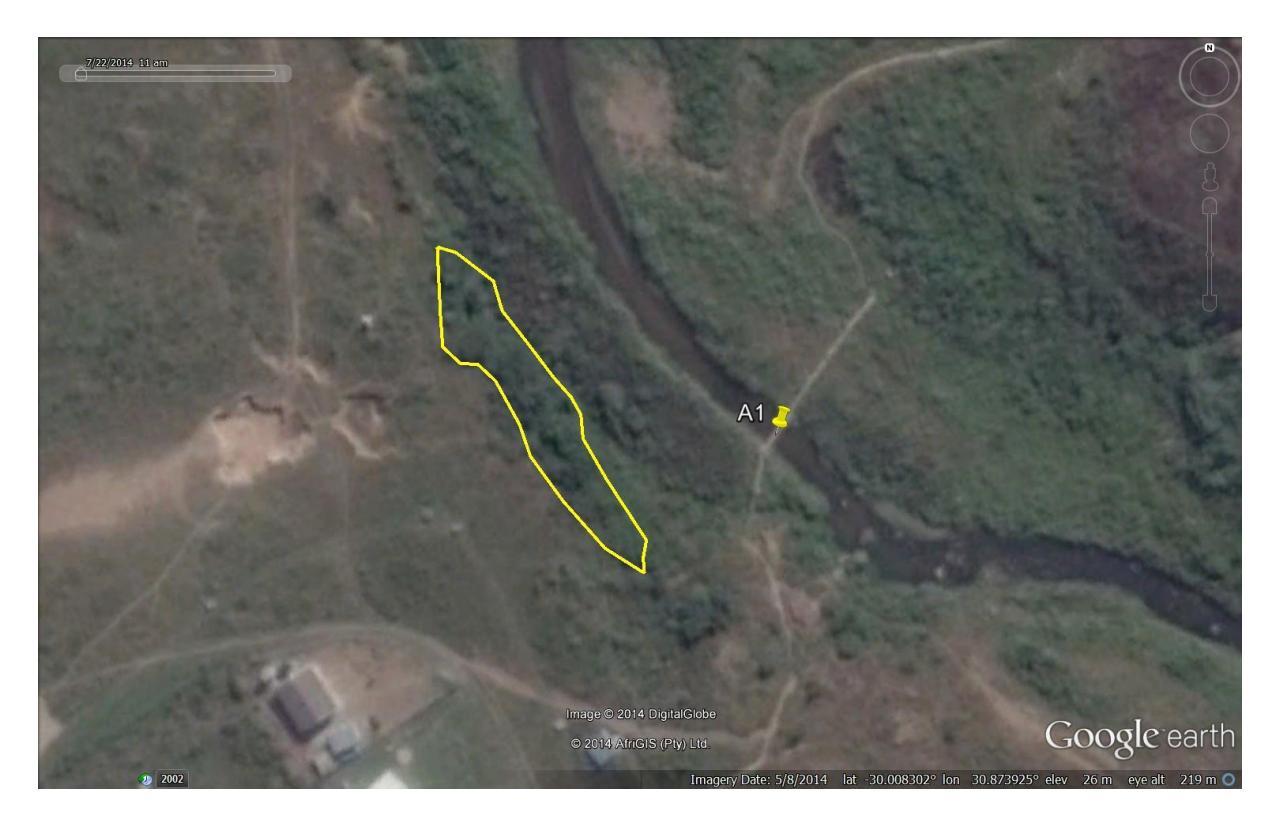
Closer view of the woody patch in which Millettia grandis (Umzimbeet) trees occur

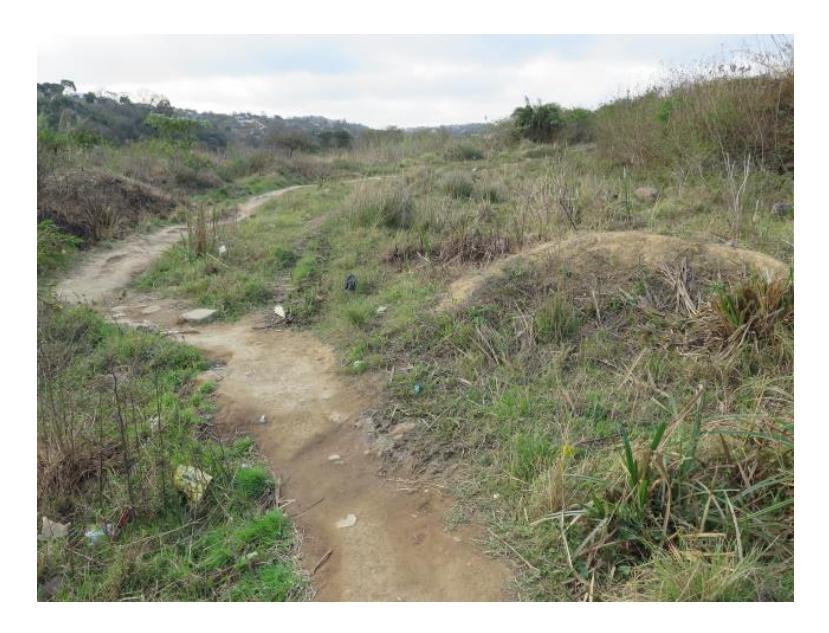
Top: View of path down to the western crossing, comprising secondary grassland, weeds of disturbance and some sedges (*Cyperus dives*) cropped low from grazing.

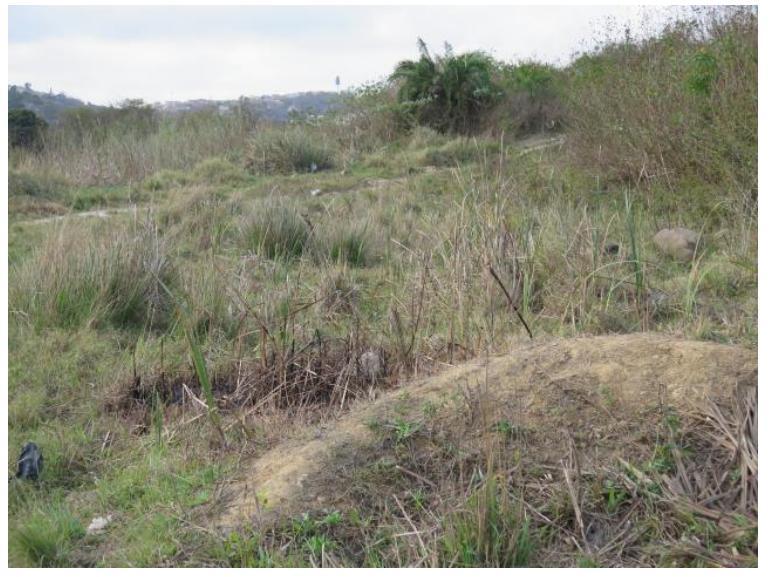
Middle: View of the same, with some *Typha capensis* emerging in the middle ground. It appears that in addition to grazing, vegetation was burned earlier in the season.

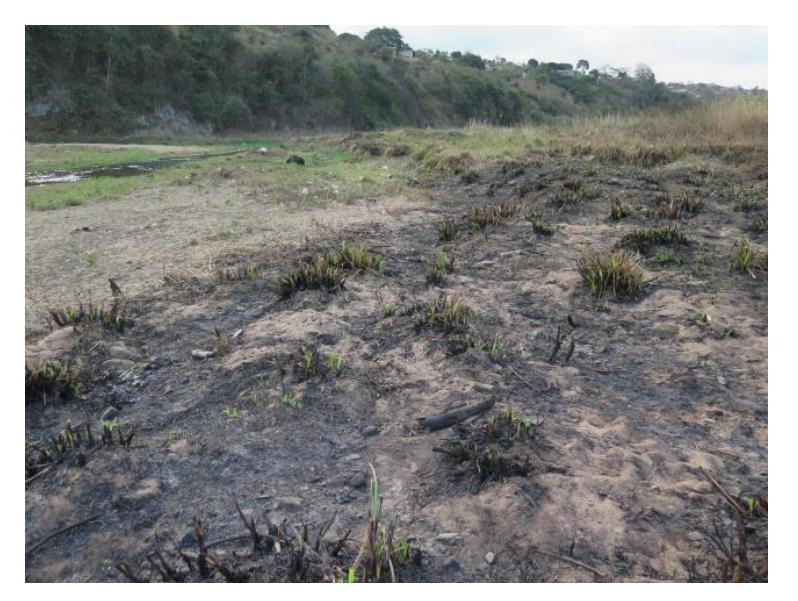
Bottom: Banks close to the crossing point, which has been recently burned. Grasslike plants are in fact the sedge *Cyperus dives*, nearly unrecognizable after the burn.

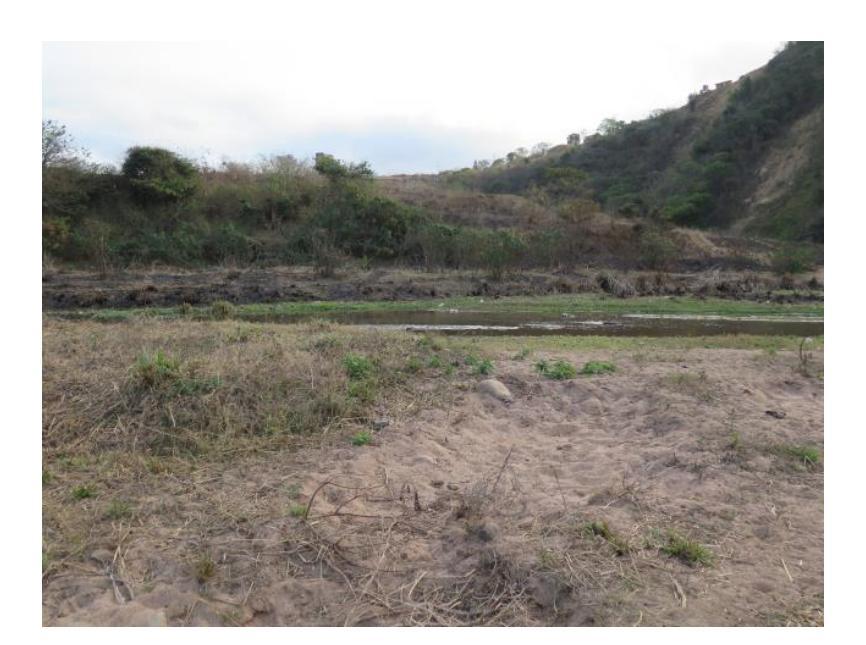
Top: View of river banks close to the crossing, with ground churned by trampling by cattle. On the far side of the bank is part of the patch of tattered woody vegetation that includes protected *Millettia grandis* (Umzimbeet) trees that are being cut down, apparently for poles or firewood.

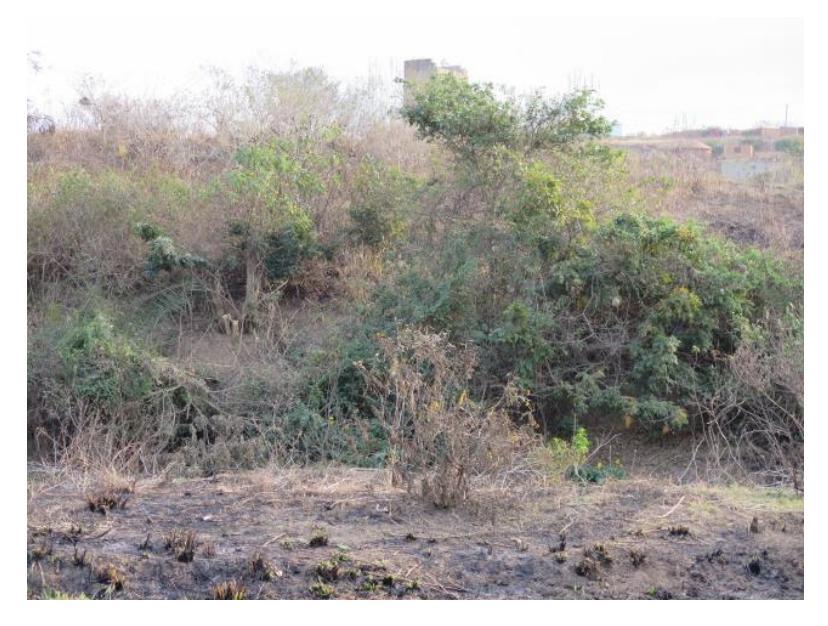
Middle: Closer view of the patch, showing one of the *Millettia grandis* trees cut to stumps, mixed with alien vegetation. This patch was probably more closed with more indigenous trees but has been reduced by felling over time.

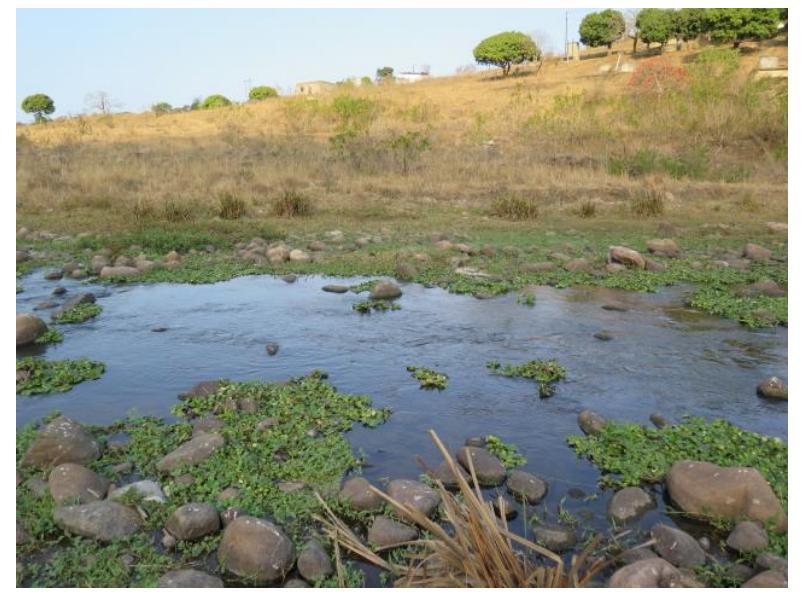
Bottom: View of the river close to the eastern crossing point, with more informal settlement and mango trees on the south bank, a band of grassy vegetation infiltrated by alien plants (here mainly Tecoma stans, Chromolaena odorata, Lantana camara and Senna didymobotrya. This then leads to the bank on which there are Cyperus dives sedges cropped by grazing. In the water are the alien aquatics/hydrophytes Eichhornia crassipes (Water Hyacinth) and Nasturtium officinale (Watercress).

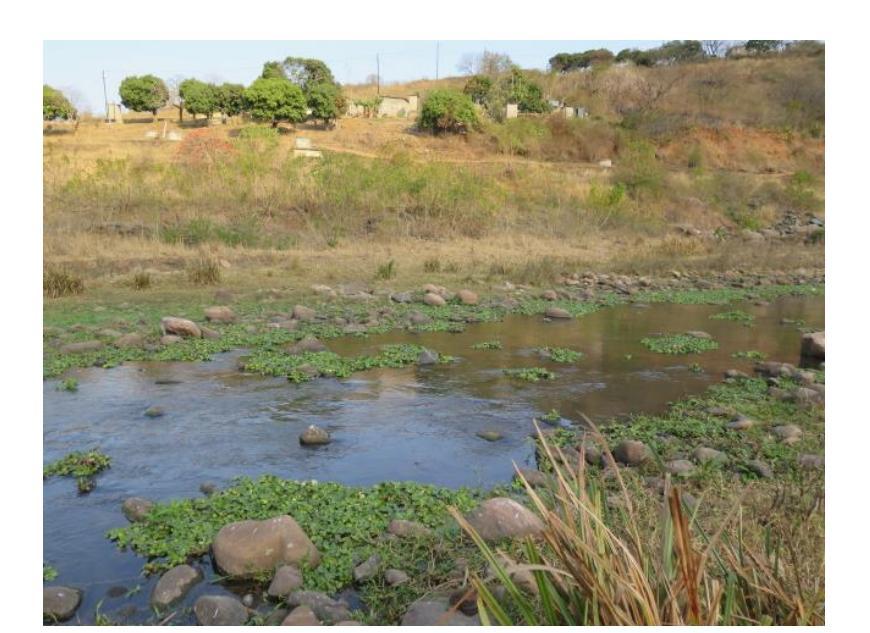
Middle: View upriver, from the eastern crossing looking towards the western alternative, with grassy vegetation dominated by alien shrubs and small trees just above the river banks.

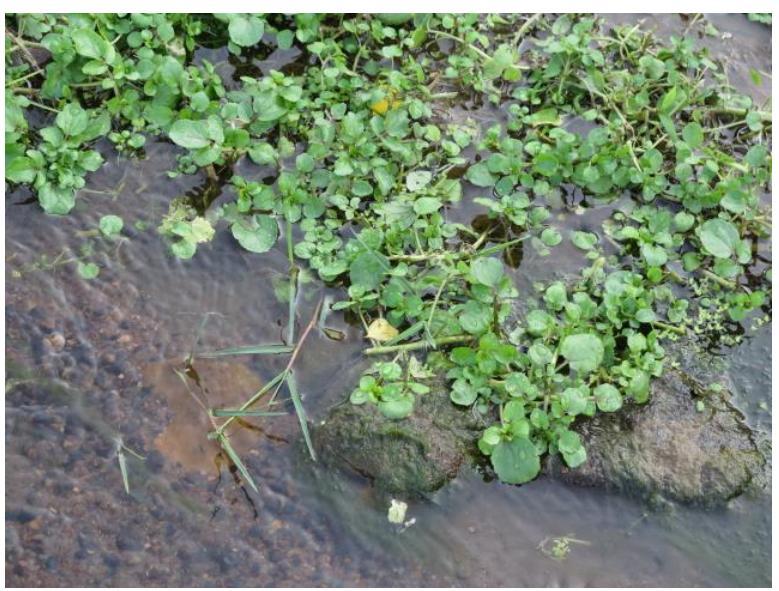
Top: The most common hydrophyte along the river banks is *Nasturtium*

officinale (Watercress). In spite of being a culinary herb, this is a serious invader of riverine habitats in eastern South Africa.

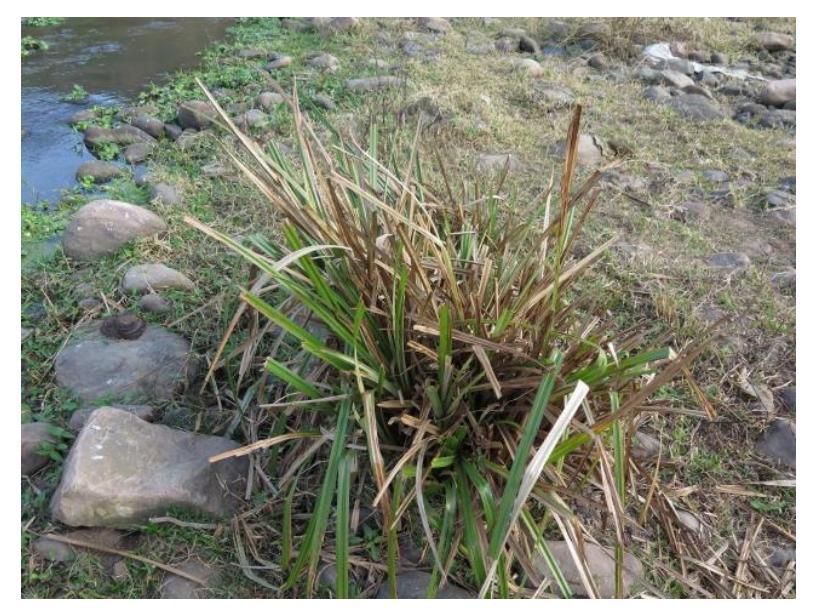
Bottom: Burned sedge *Cyperus dives* with newer green growth now with leaf ends cropped by grazing.
