PROPOSED DEVELOPMENT OF A 132 KV TRANSMISSION LINE (FROM THE EXISTING HARVARD 132 KV LINE TO NOORDSTAD) AS WELL AS 6 SUB-STATIONS, BLOEMFONTEIN, MANGAUNG METROPOLITAN MUNICIPALITY, FREE STATE PROVINCE

ECOLOGICAL IMPACT ASSESSMENT

May 2017

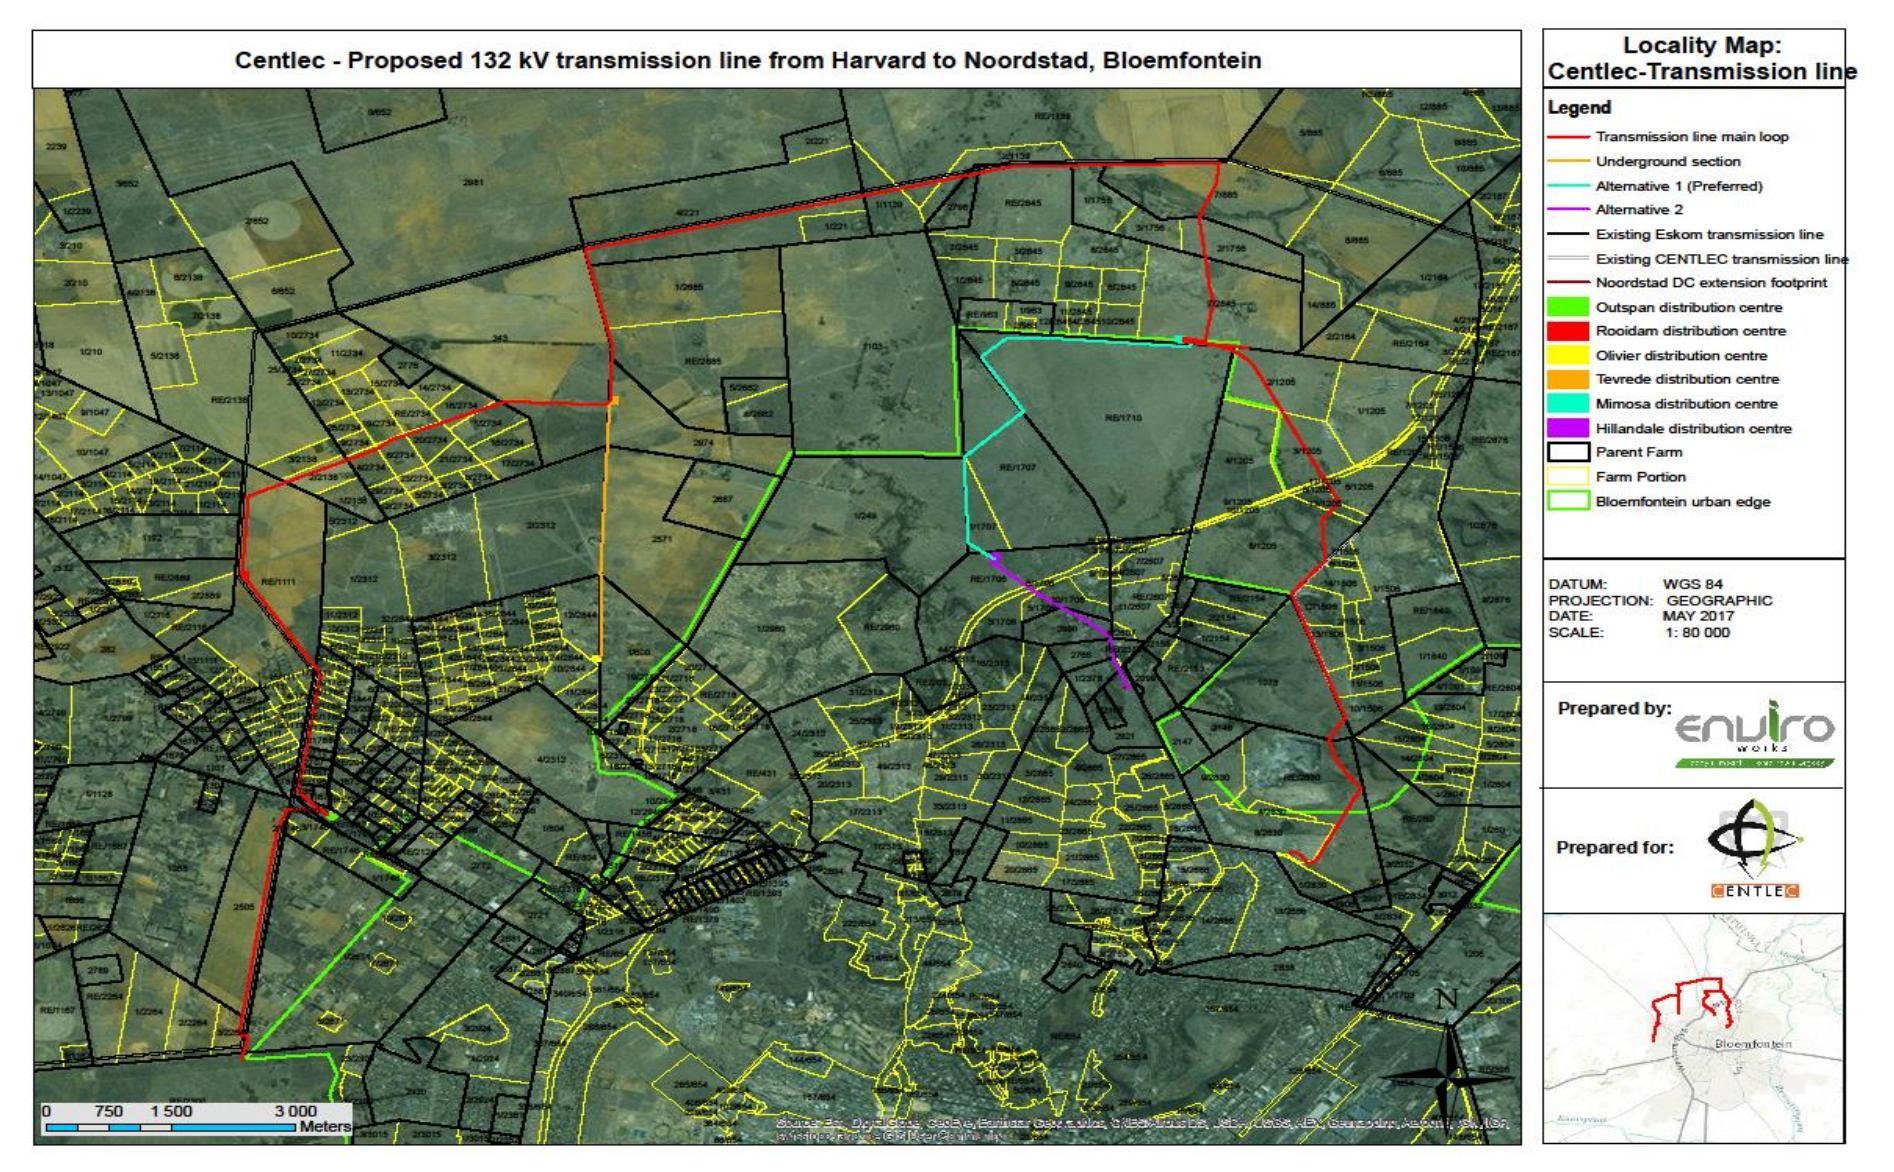
Figure 1: Locality/layout/route map of the proposed project route corridor

See Figure 1 below indicating the locality of the proposed project.

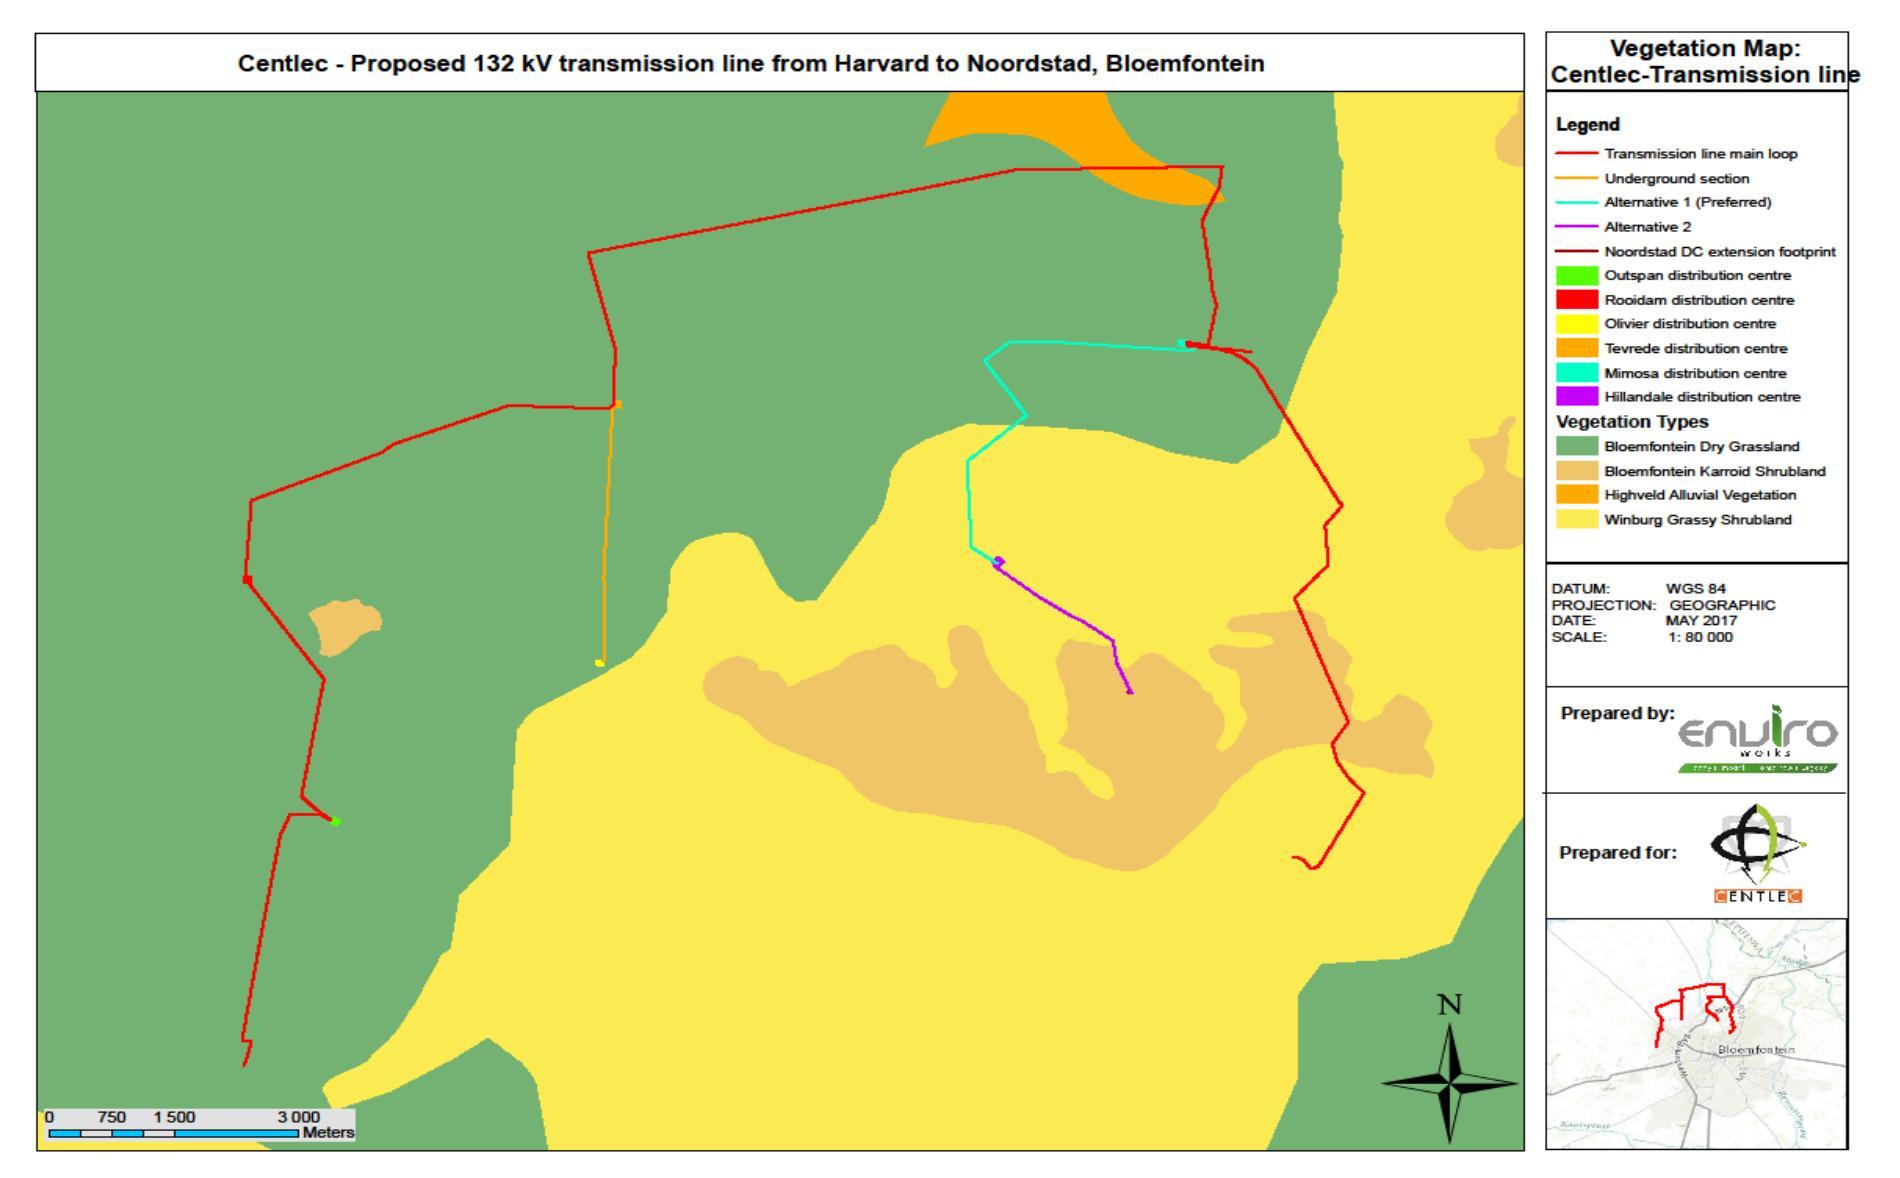
Figure 2: Vegetation map of the proposed project layout

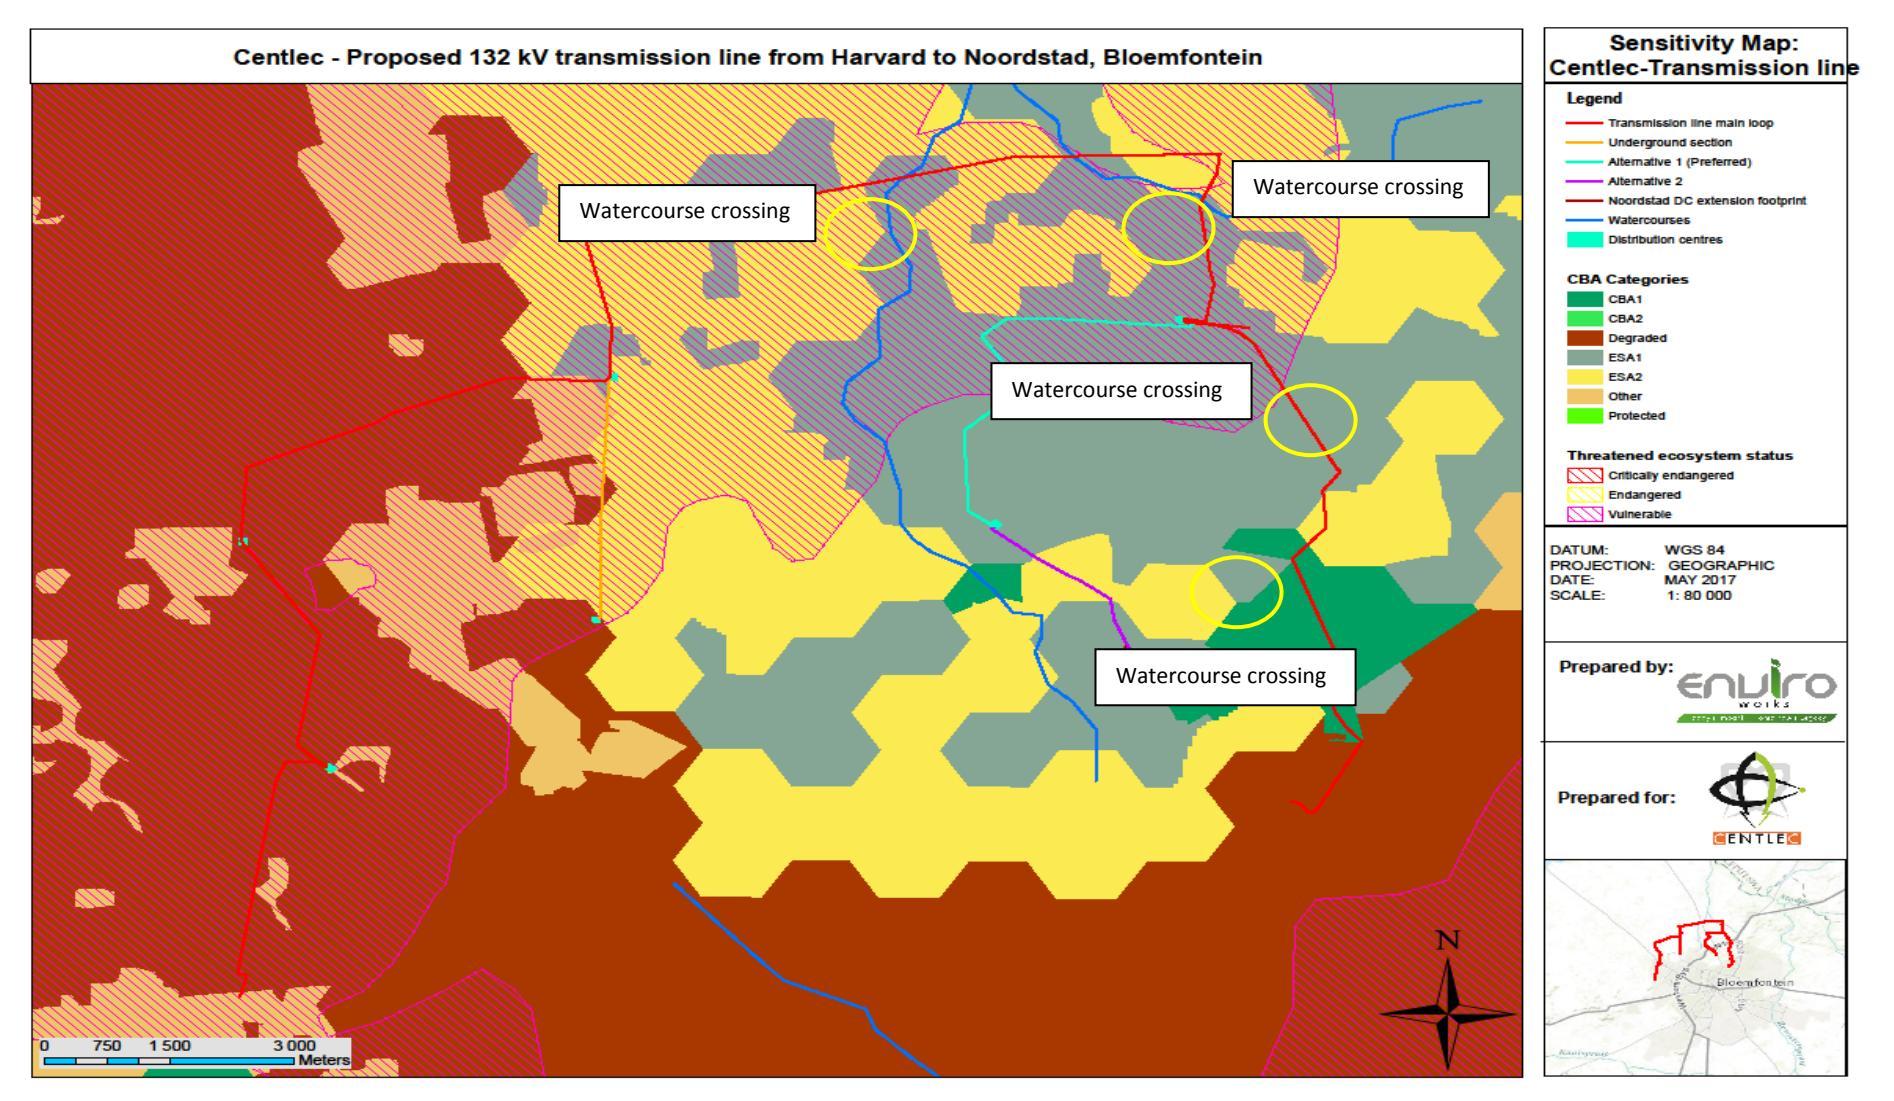
Figure 3: Sensitivity map of the proposed project layout

The proposed development will however have minimum physical footprint impact on the vegetation of the CBA as only the pylons positions will impact directly on the surface vegetation. The associated six sub-station footprints (total of 5.1 ha) will not be developed within any CBA's. See vegetation and sensitivity maps below.

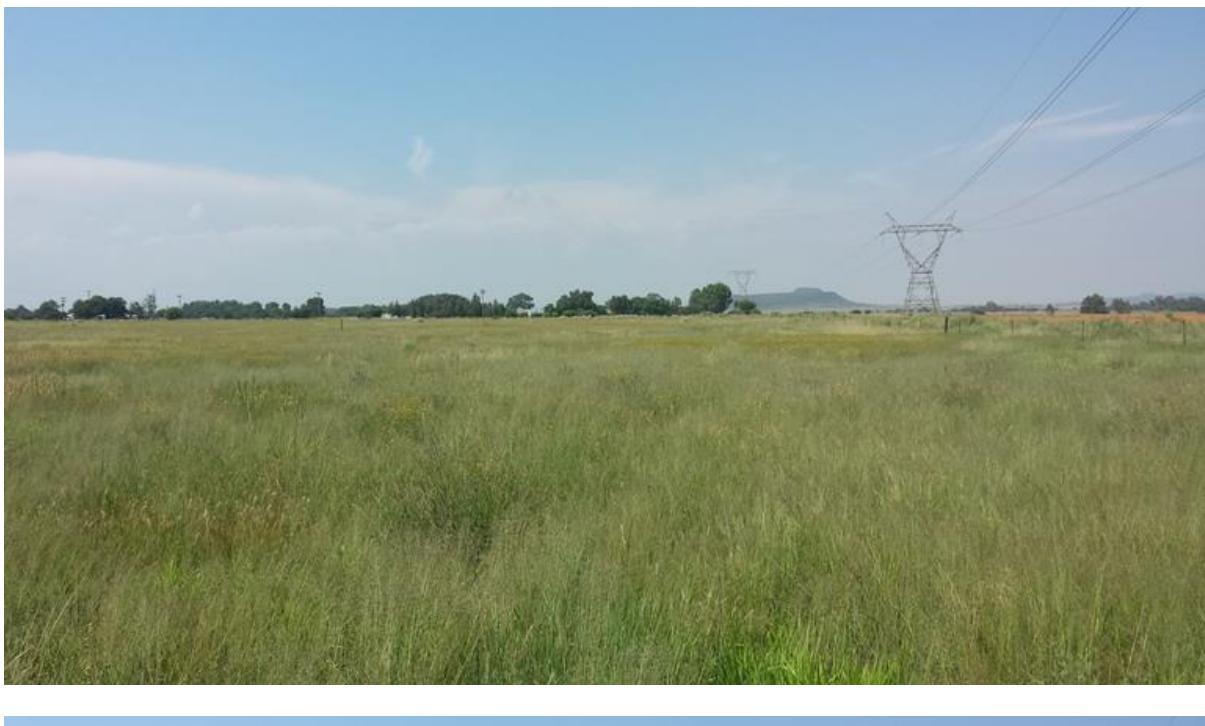
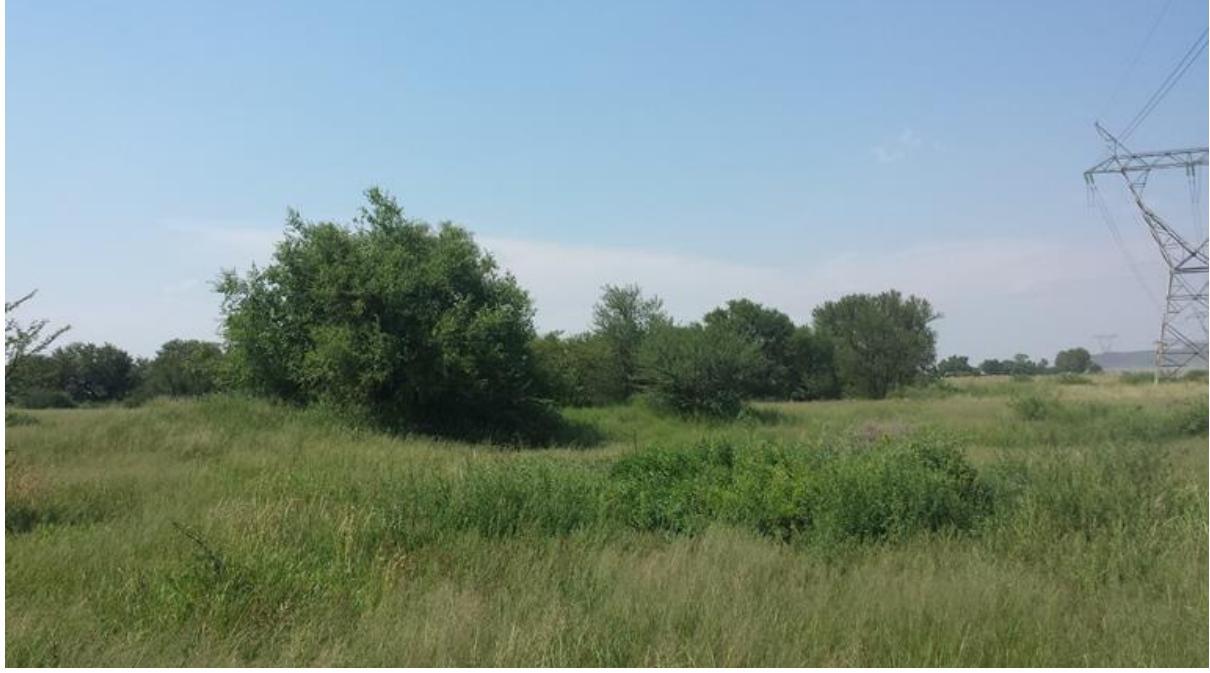
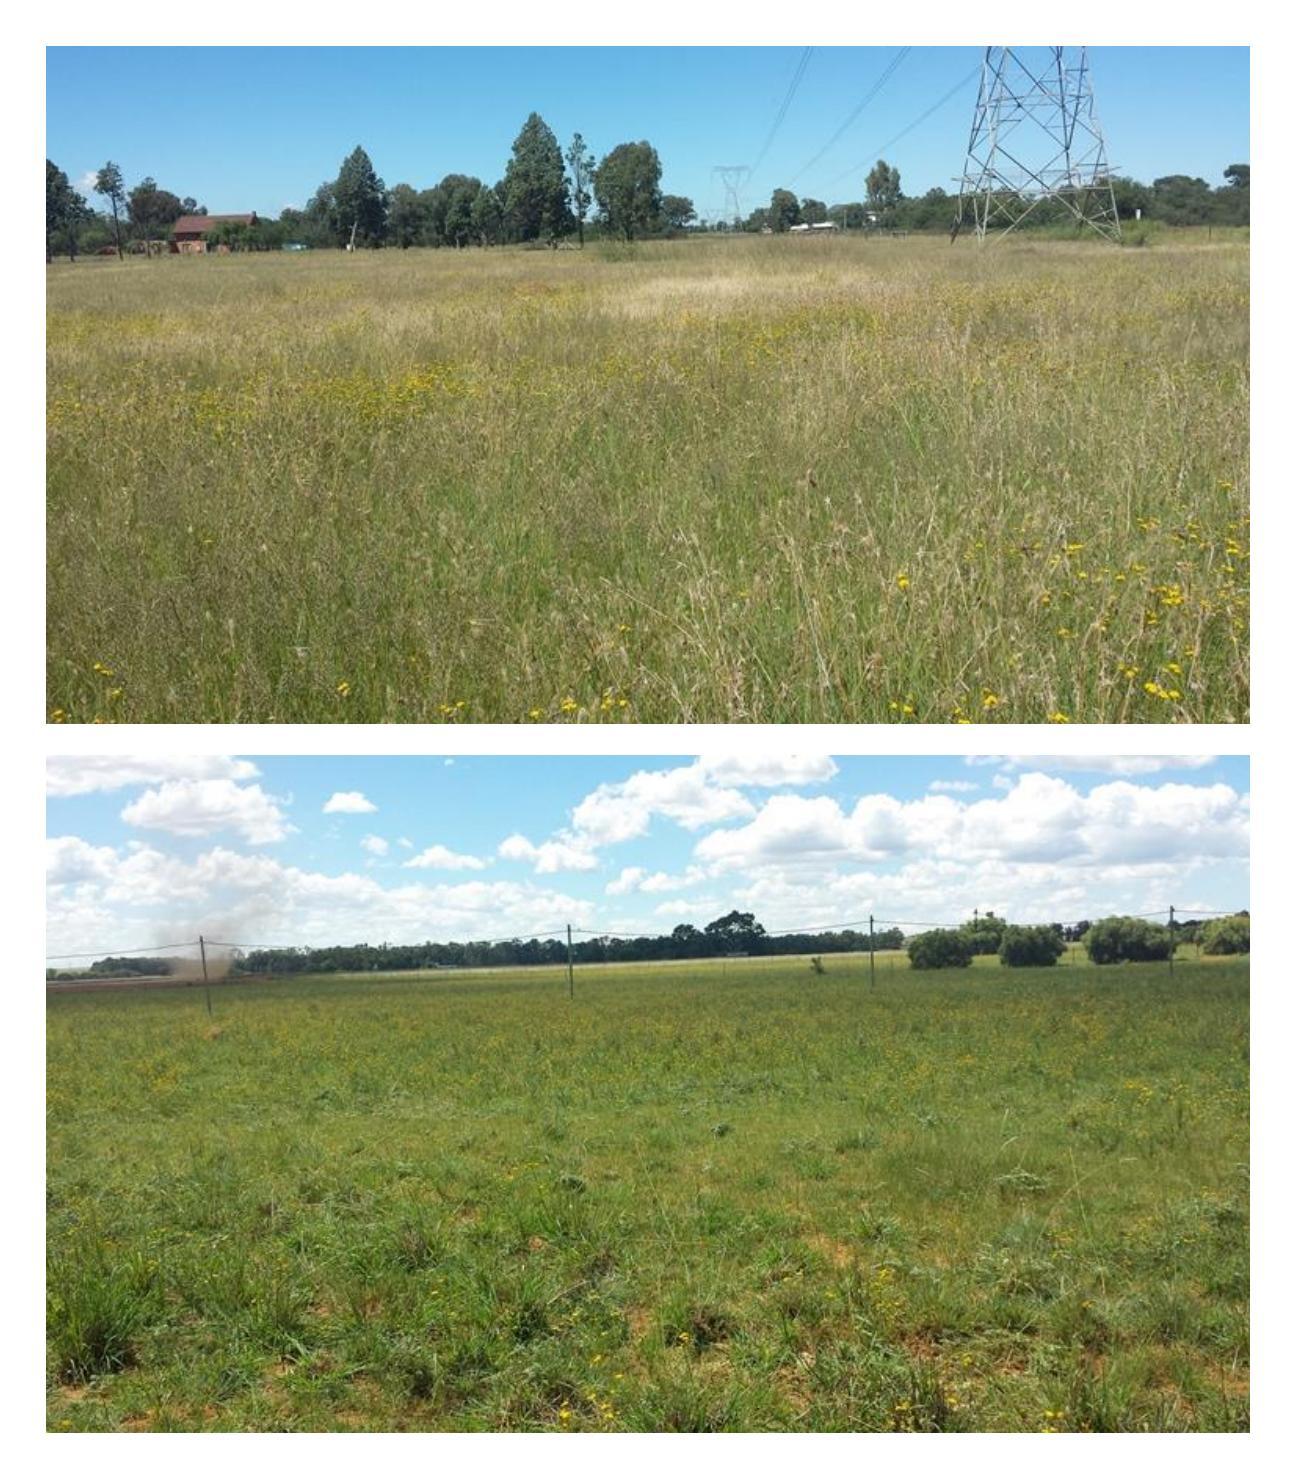
Figures 4 a-d: Four images indicating examples of semi-natural areas associated with the Bloemfontein Dry Grassland (Gh 5) vegetation type

Although being mostly fragmented and isolated (by developed urban infrastructure and cultivated lands discussed as under heading 8.1), a number of areas along the proposed transmission line route corridor still possess natural to semi-natural vegetation cover associated with the Bloemfontein Dry Grassland (Gh 5) vegetation type (see figures below). Such fragmented semi-natural areas can still provide available habitat for various plant and animal species associated with the vegetation type and contribute to ecological functionality of the larger ecosystem and natural corridors. The species richness ($60 \leq$) determined in these semi-natural areas corresponds closely with that of similar surrounding un-fragmented natural areas and it is therefore important to attempt to impact as little as practically possible on such identified areas. A list of species encountered in the semi-natural and natural areas associated with the Bloemfontein Dry Grassland (Gh 5) vegetation type is provided under heading 8.3.

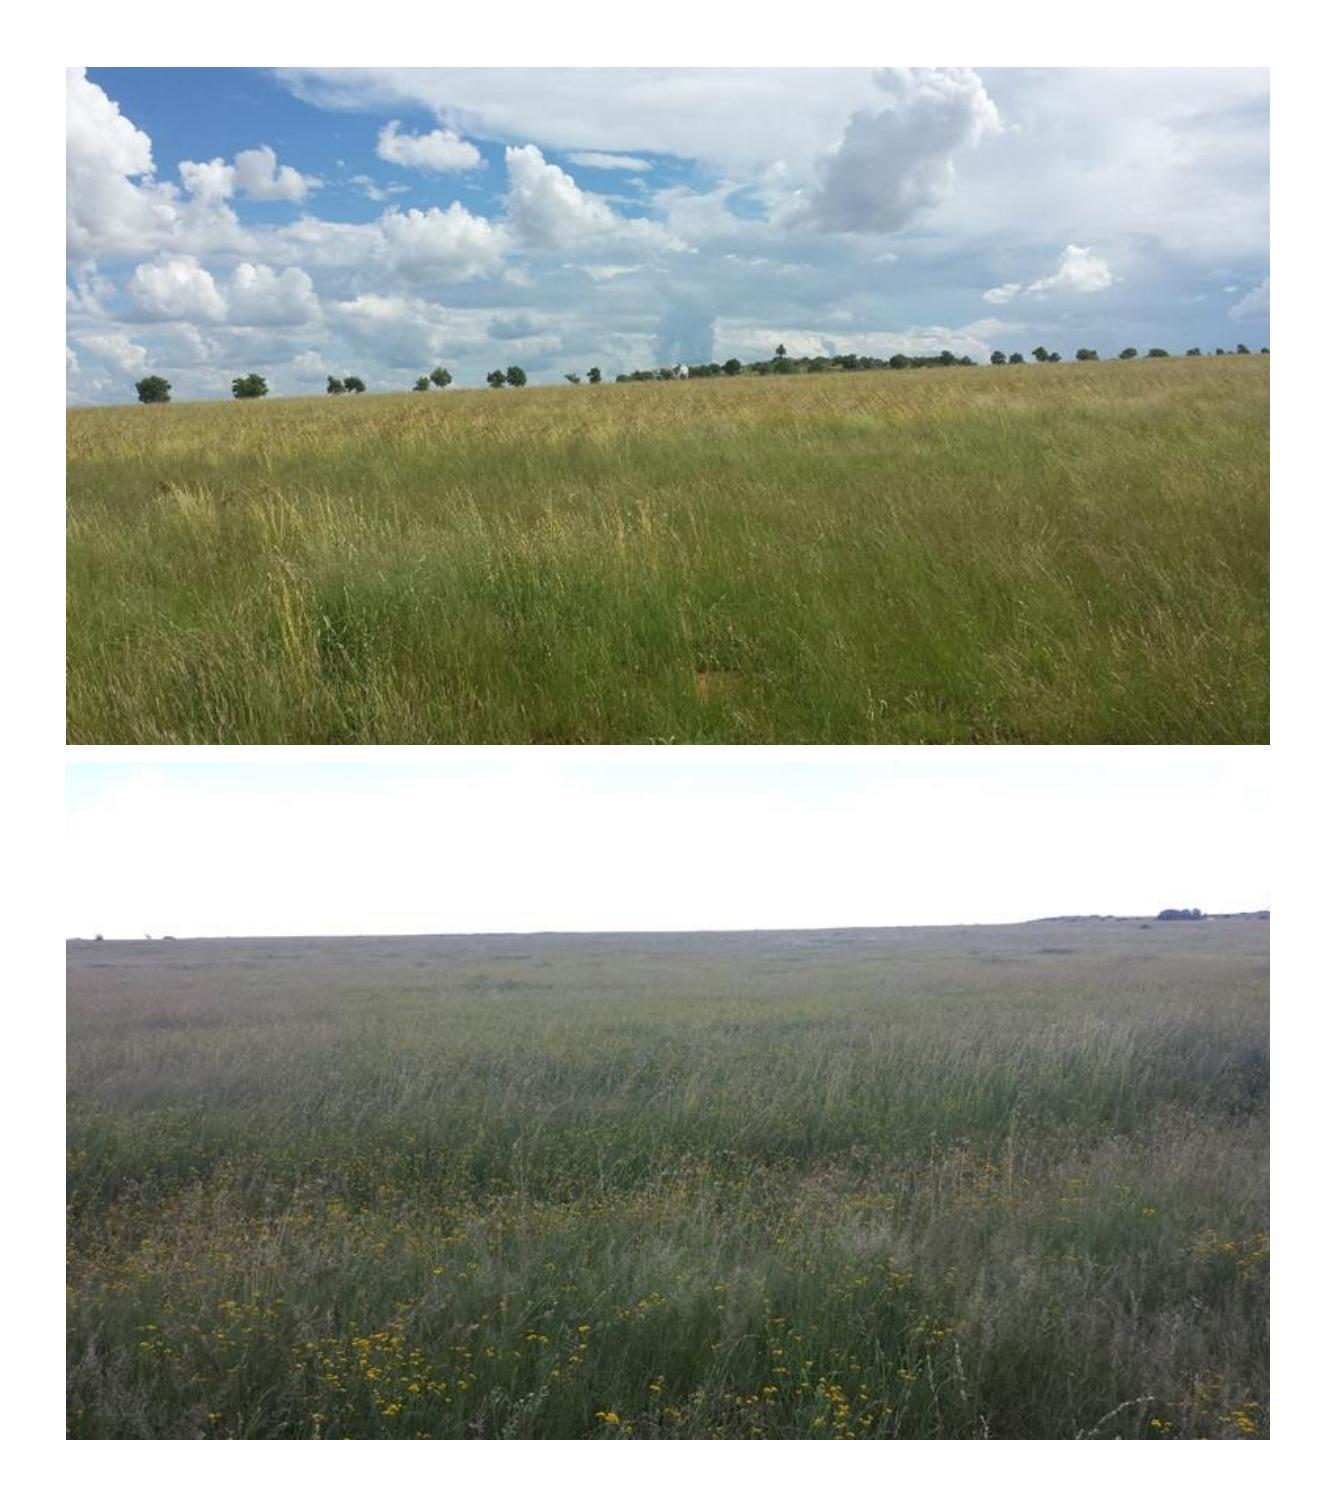
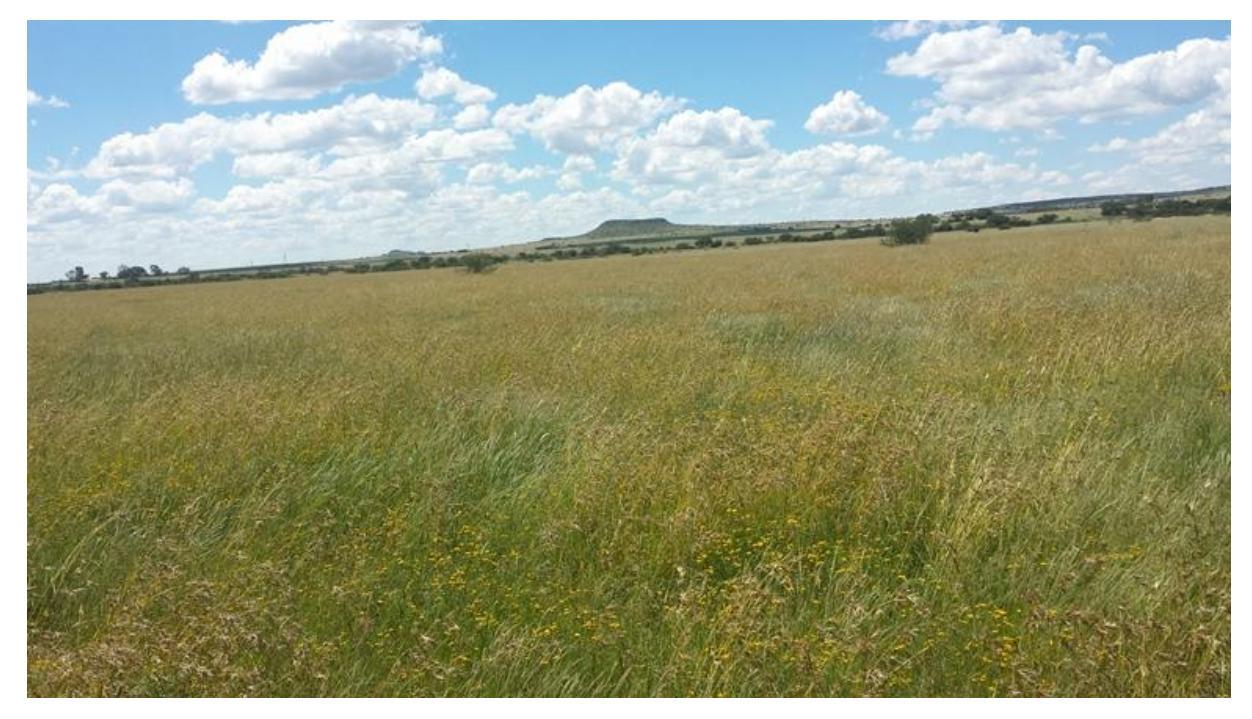
Figures 5 a-c: Three images indicating examples of natural areas associated with the Bloemfontein Dry Grassland (Gh 5) vegetation type

Seeing that urbanisation and cultivation expansion has resulted in extensive destruction and decrease in representation of this vegetation type (classified as a vulnerable ecosystem) and continues to do so, it is vitally important that impacts on these remaining natural areas be minimised as far as practicably possible and that the areas be efficiently managed and conserved.

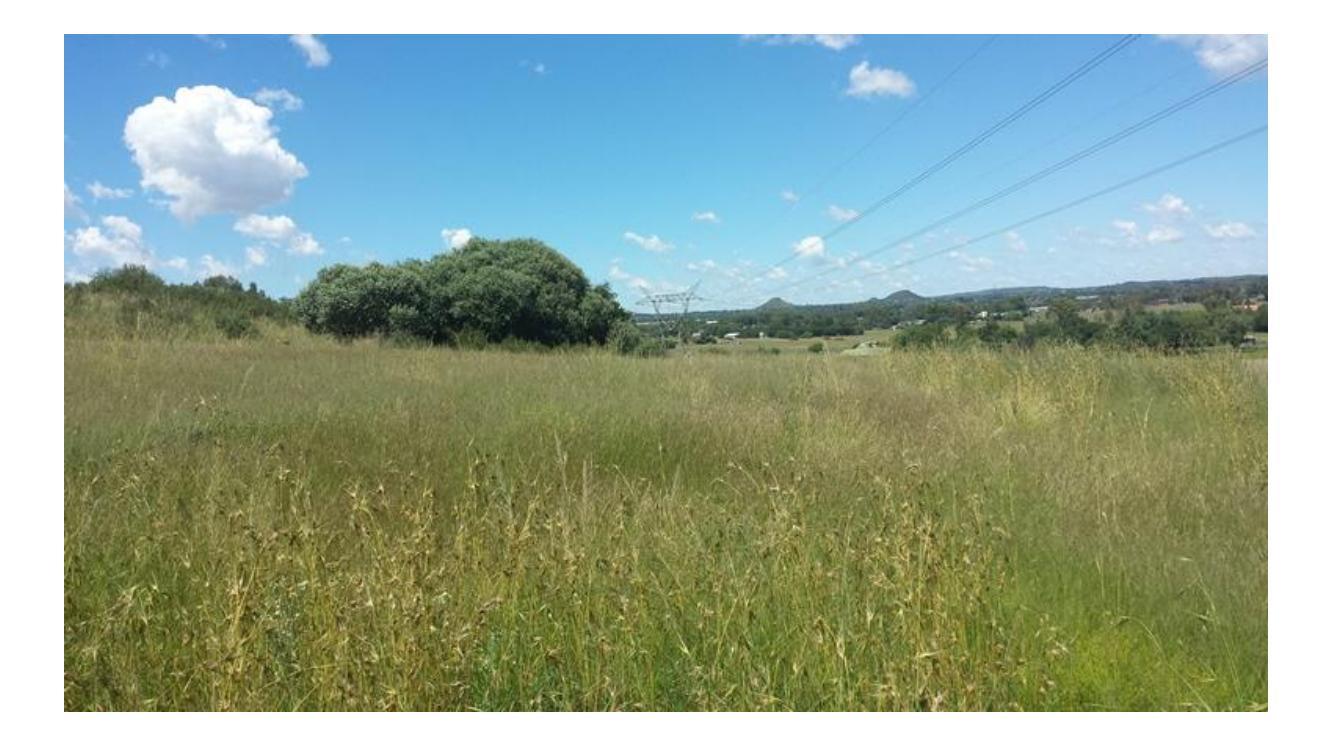
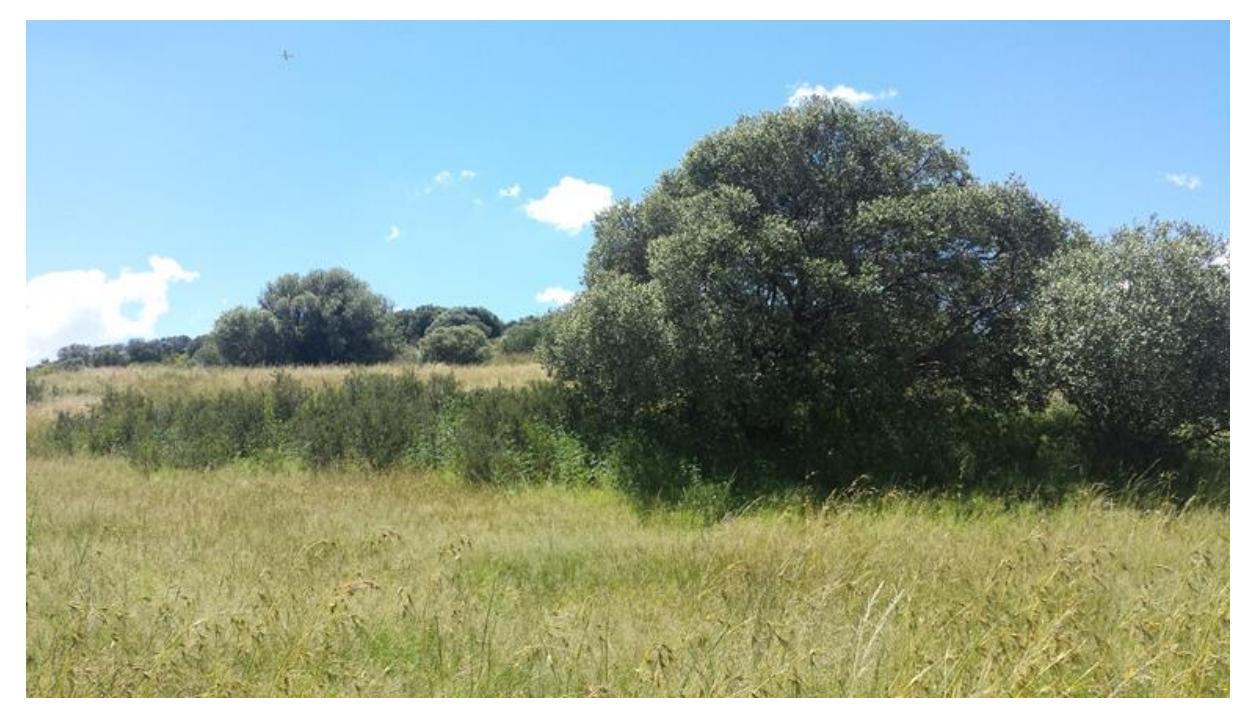
Figures 6 a & b: Two images indicating examples of natural areas associated with the Winburg Grassy Shrubland (Gh 7) vegetation type

Although the Winburg Grassy Shrubland (Gh 7) vegetation type is classified as least threatened by Mucina & Rutherford (2006), this hill provides a rather unique localised habitat for various plant and animal species which differs considerably from the surrounding grassland. It is therefore important that the structural integrity and diversity of the woody component of this hill be conserved and not be significantly impacted upon by the proposed development.

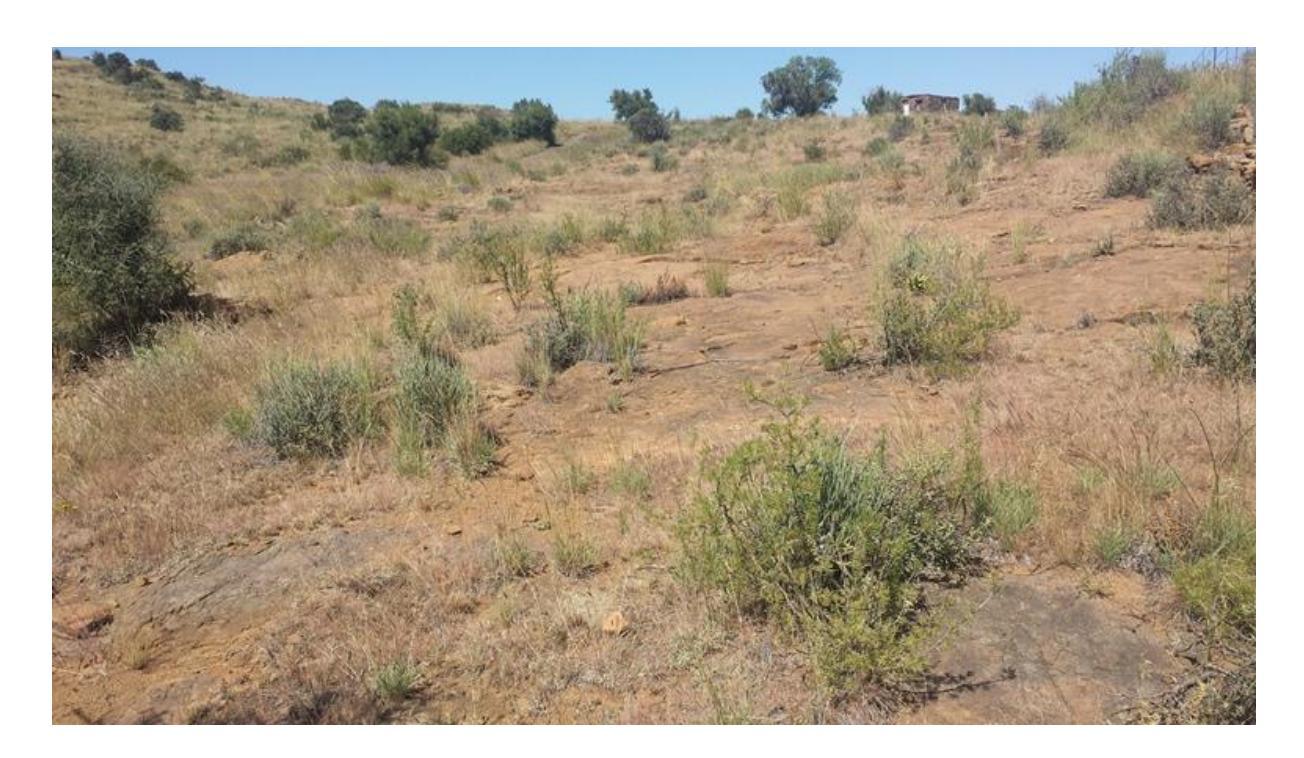
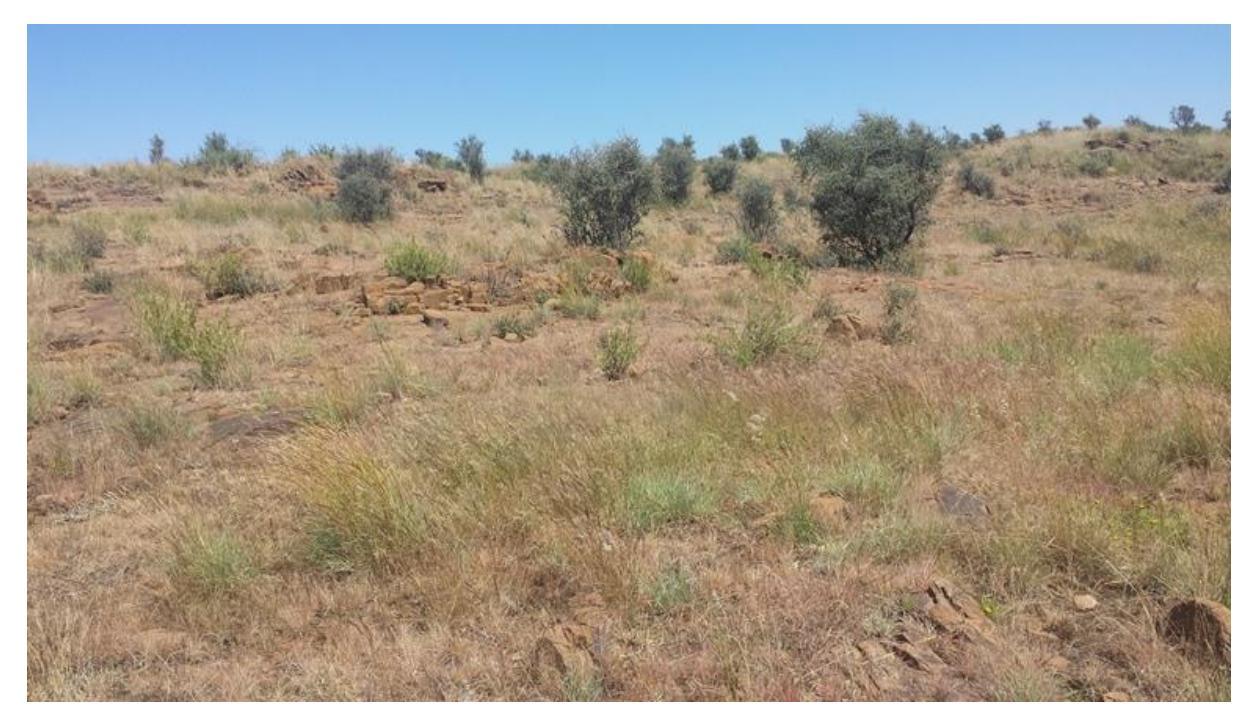
Figures 7 a & b: Two images indicating examples of the rocky outcrops inside the CBA associated with the Bloemfontein Karroid Shrubland (Gh 8) vegetation type

The hills and rocky outcrops areas are also home to numerous wild animals such as *Rock hyrax* and small deer species. The area is stocked with game animals such as zebra and larger antelope. The mobility of such animals will result in them moving away from the disturbance during construction process and returning after construction completion. It is however important that the noise impact and disturbance of wild animals and game be adequately managed and kept to a minimum during construction.

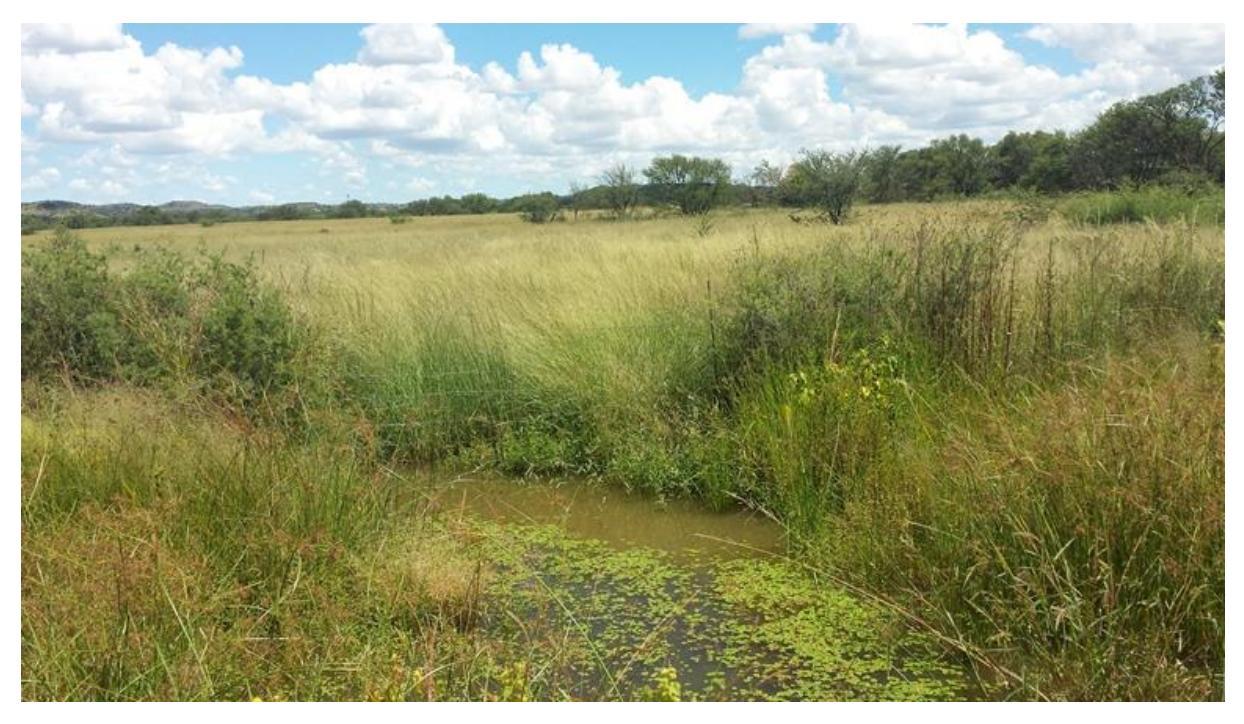
Figure 8: An image indicating an example of a seasonal watercourse

Although only being small and seasonal, these water drainage lines still cumulatively contribute to the adequate water drainage of the larger surrounding local catchment areas. Any impact on the vegetation and watercourse structures or impediment or diversion of flow must therefore be completely avoided. Adequate buffer areas must be implemented around these watercourses and no access or construction routes or any physical footprint impacts such as pylons are to be made within the recommended buffer areas without the prior inspection and approval by a suitably qualified, registered and experienced ecologist.

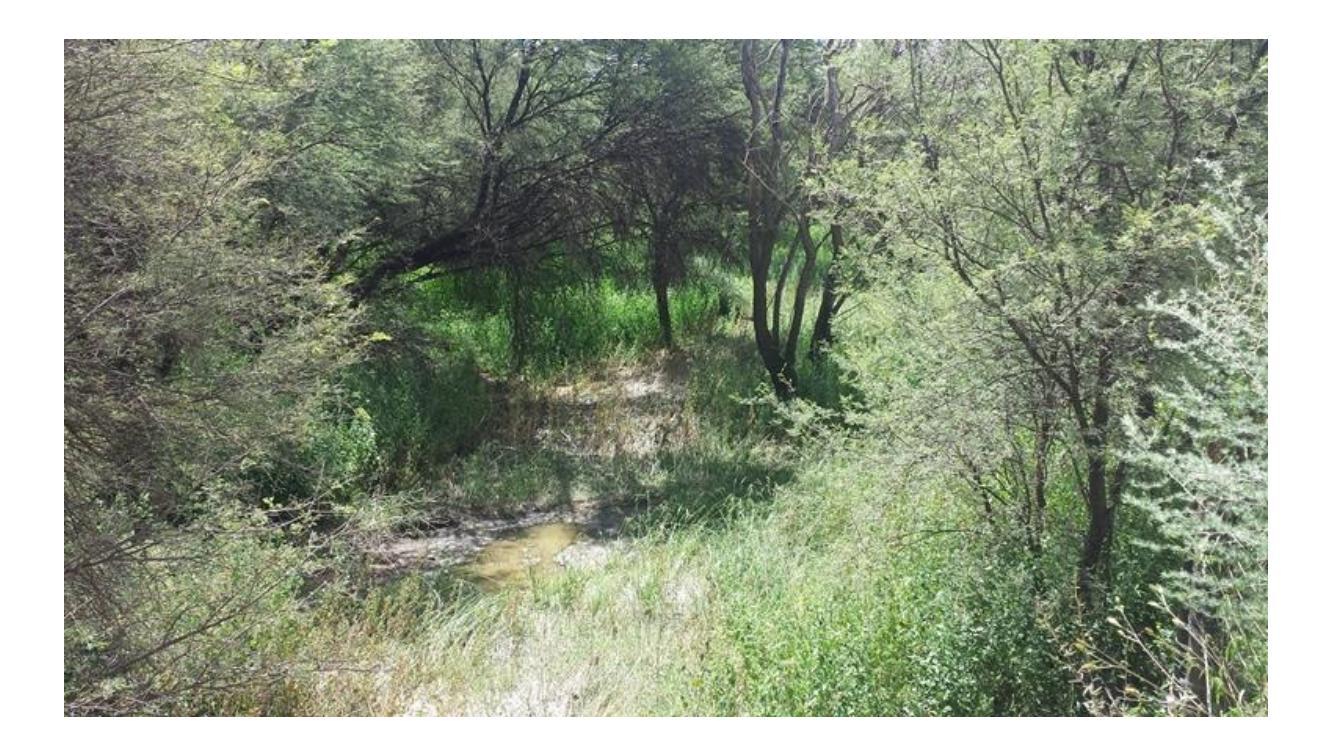
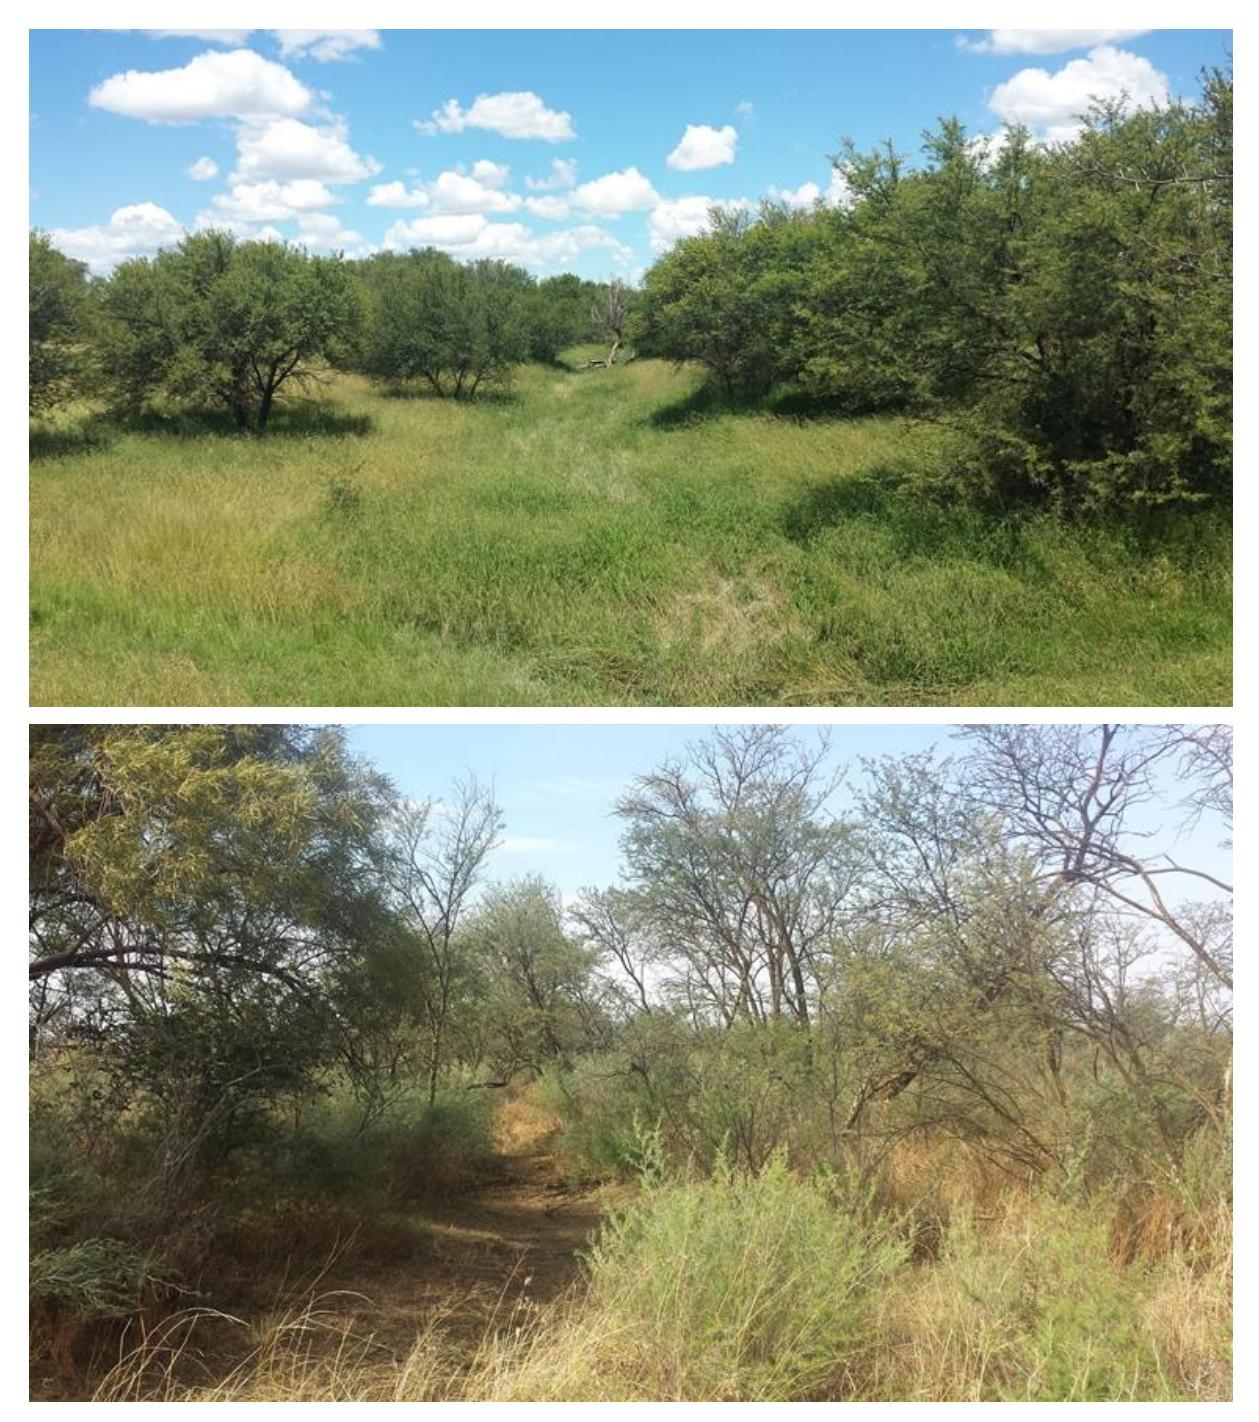
Figures 9 a - c: Three images indicating examples of a perennial watercourse

Only the two watercourses identified in the northern portion of the proposed line route are considered to be of a perennial nature. The perennial nature of these watercourses is confirmed by the presence of a well-established woody component consisting of mainly medium to large *Acacia karroo* but also *Ziziphus mucronata* shrubs and trees. These perennial watercourses are the primary contributors to adequate water drainage of the larger surrounding local catchment areas which form part of the branched Stinkhoutspruit and which subsequently drains into the Modder River. They are therefore vitally important to the ecological functionality of the surrounding ecosystem. They also provide important habitat for various forms of waterfowl and other aquatic avifauna. Red-knobbed coots (*Fulica cristata*), Egyptian geese (*Alopochen aegyptiacus*) and yellow weavers (*Ploceidae sp.*) were observed during the site visit.

Any impact on the vegetation and watercourse structures or impediment or diversion of flow must therefore be completely avoided. Adequate buffer areas must be implemented around these watercourses and no access or construction routes or any physical footprint impacts such as pylons are to be made within the recommended buffer areas without the prior inspection and approval by a suitably qualified, registered and experienced ecologist.
