PROPOSED DEVELOPMENT OF A 132 KV TRANSMISSION LINE (FROM THE EXISTING HARVARD 132 KV LINE TO NOORDSTAD) AS WELL AS 6 SUB-STATIONS, BLOEMFONTEIN, MANGAUNG METROPOLITAN MUNICIPALITY, FREE STATE PROVINCE

ECOLOGICAL IMPACT ASSESSMENT

May 2017

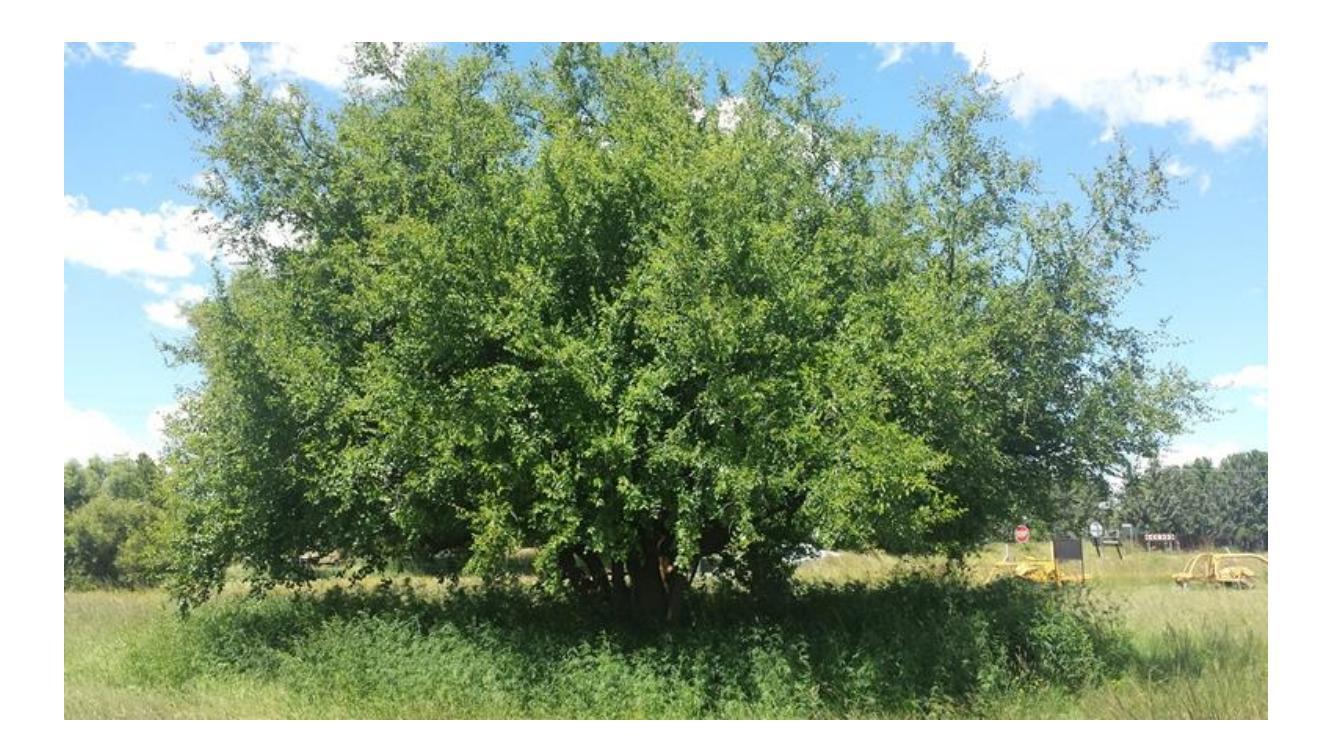
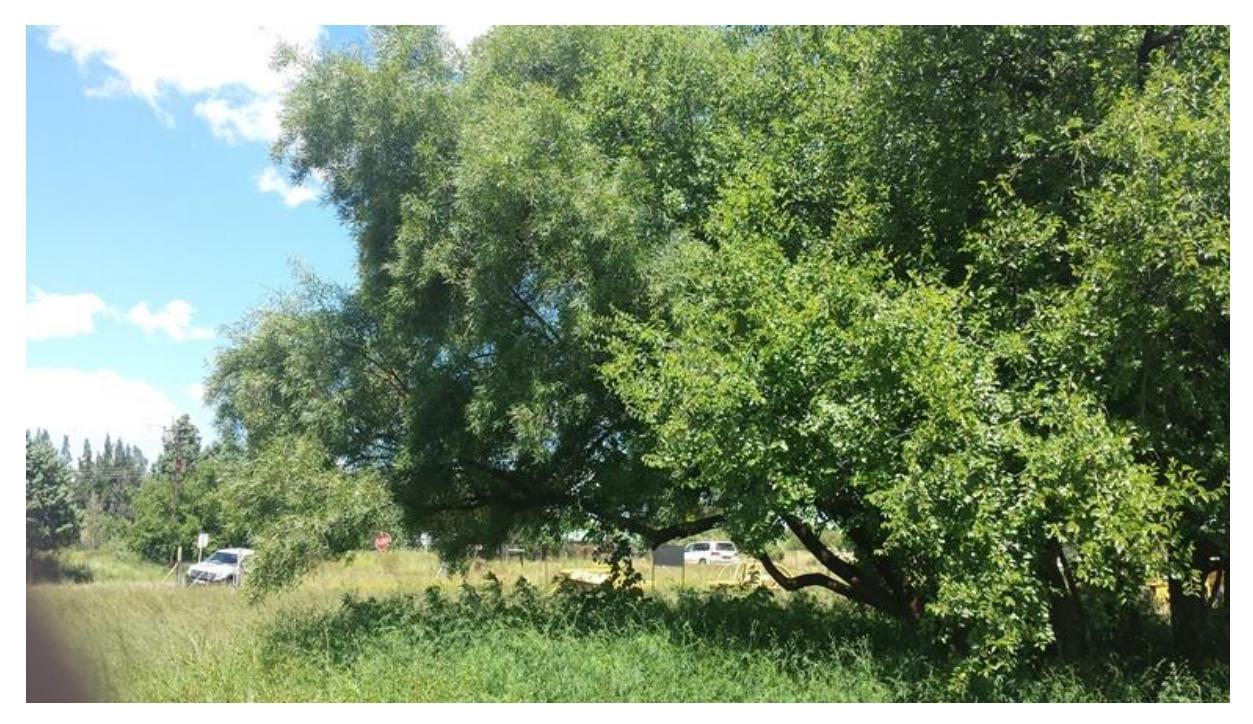
Figures 10 a & b: Two images indicating the existing *Ziziphus mucronata* & *Searsia lancea* tree individuals present on the Olivier distribution centre site

Outspan, Rooidam, Olivier and Tevrede distribution centres will all be situated within a transformed area and must therefore simply be managed in terms of heading 8.1. Care must be taken not to damage the existing *Ziziphus mucronata* & *Searsia lancea* tree individuals present on the Olivier site if possible (see figures below).

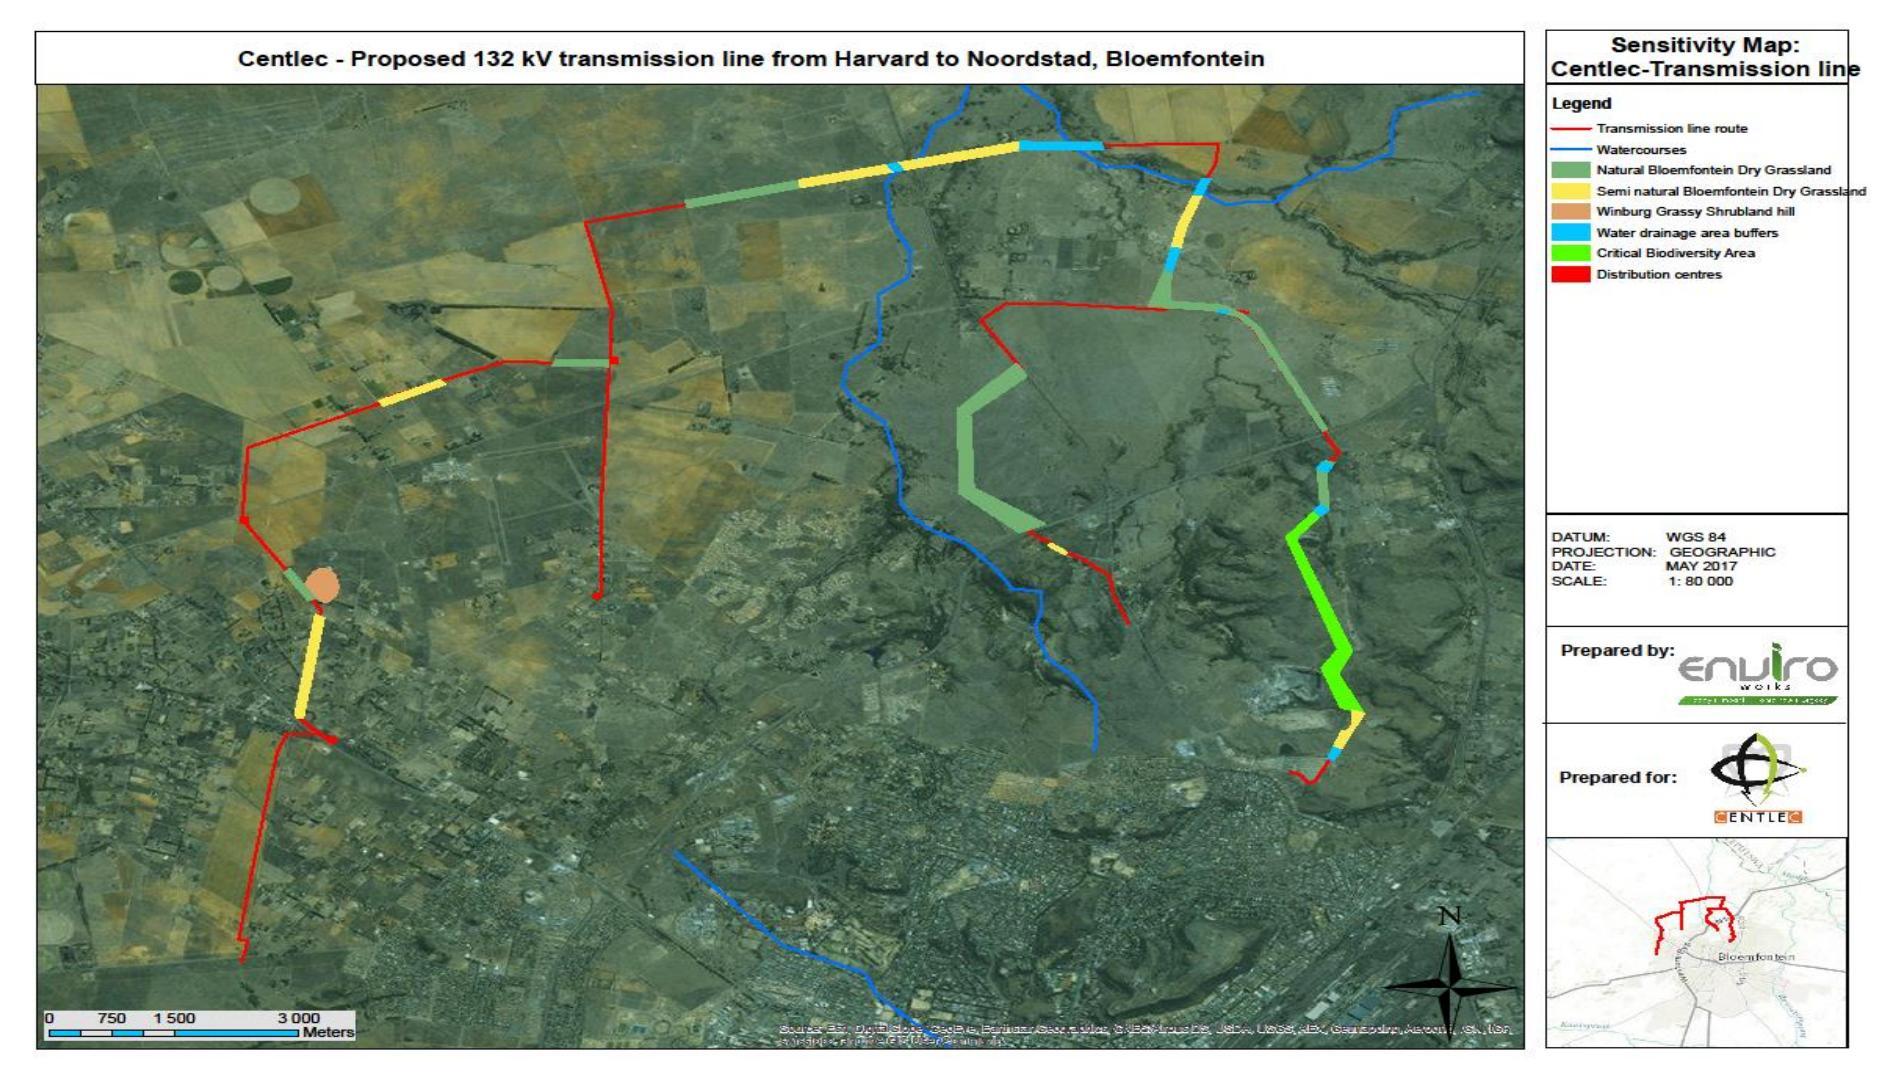
Figure 11: Sensitivity map of the proposed transmission line route corridor indicating the identified sensitive areas

The map below indicates the locations of the different sensitive areas as identified.
