Report on the biodiversity and ecological assessment of the proposed construction of the Reyneke Avenue dual carriageway in Bloemfontein, Free State Province.

January 2019

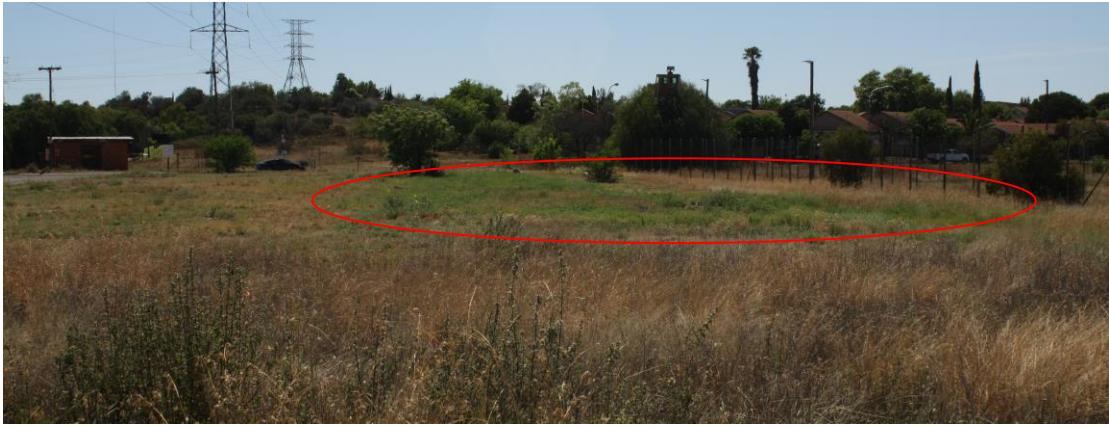
Figure 1: View of the north eastern end of the proposed road. A leaking sewer pipeline occurs here and causes seepage areas (red).

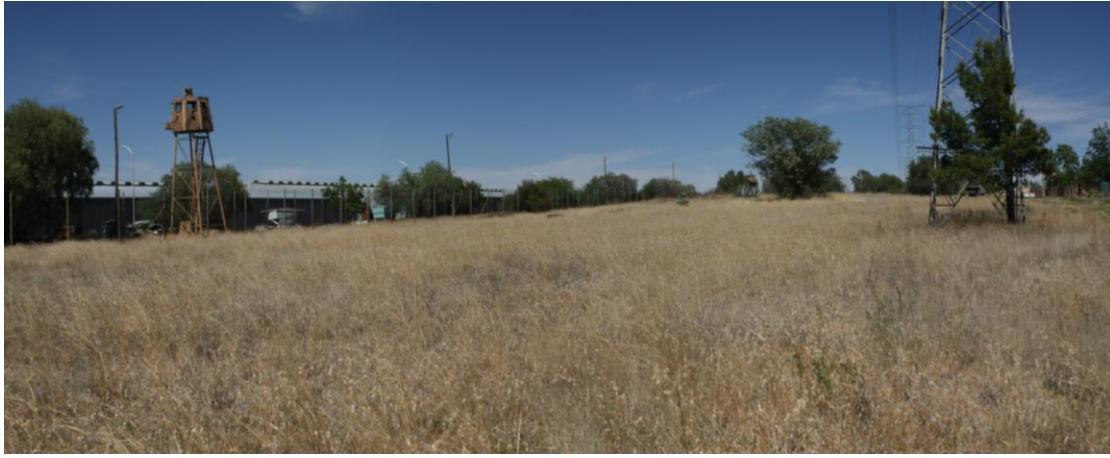
Figure 2: Panorama of the north eastern portion of the site situated in an urban area. A grass layer is still present although exotic species are prominent.

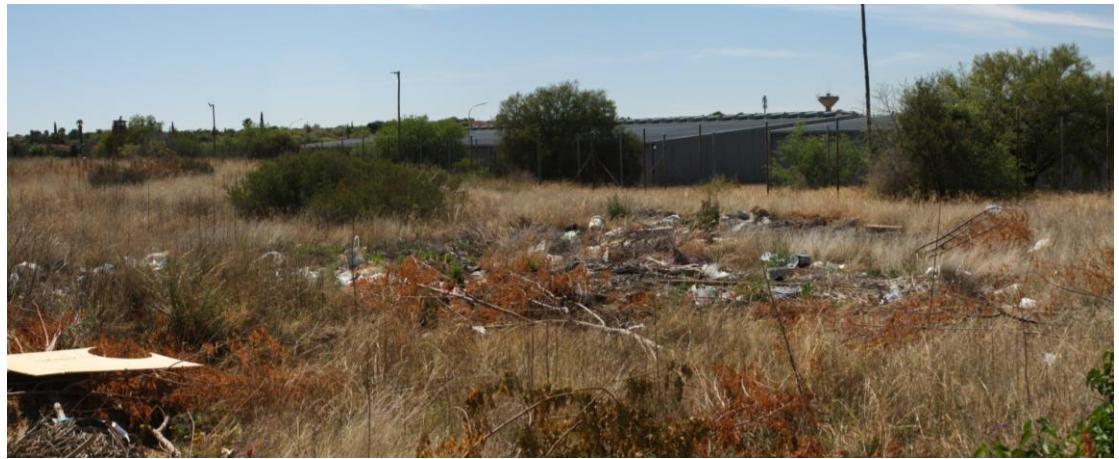
Figure 3: Rubbish dumping and high levels of disturbance is common in the north eastern portion of the site.

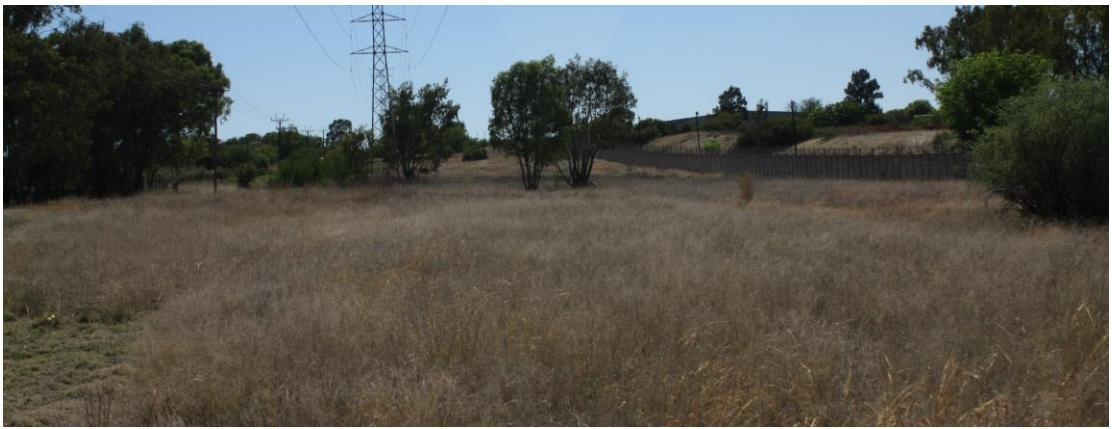
Figure 4: Another view of the north eastern portion of the site. Note again adjacent developments. A grass layer is present although exotic trees are also common.

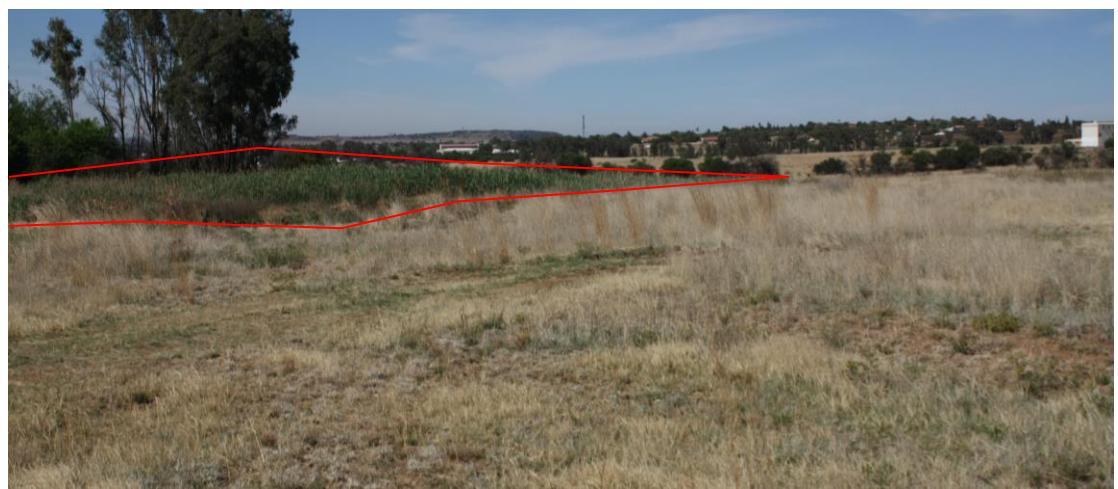
Figure 5: View of the origin of the Bloemspruit. Wetland conditions are clearly present here (red).

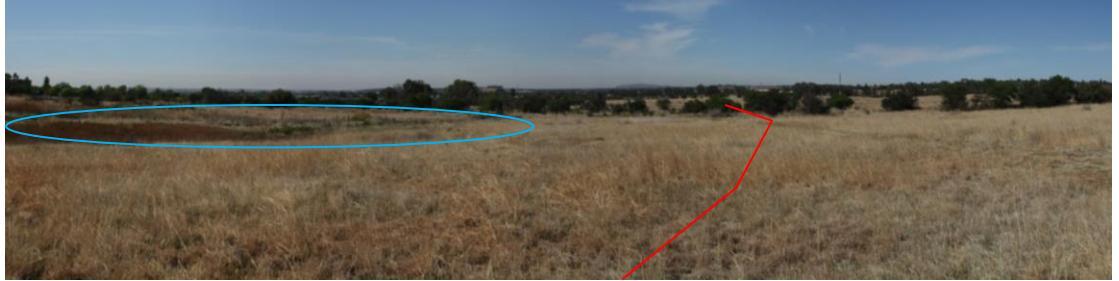
Figure 6: Panorama of the approximate road alignment (red) in the south western portion. Note the wetland areas associated with the Bloemspruit to the left (blue).

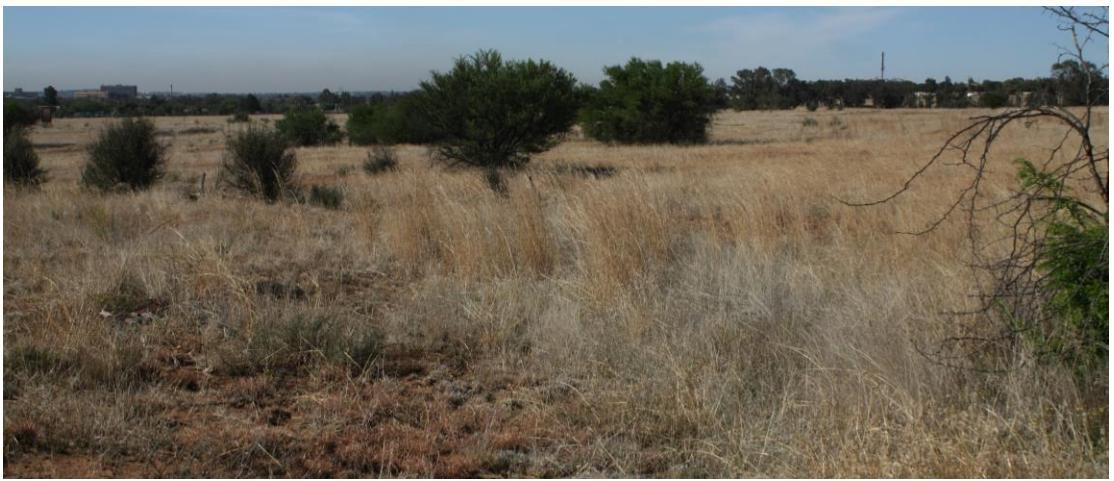
Figure 7: View of the south western portion of the road contains a grass layer with scattered trees although disturbance is significant.

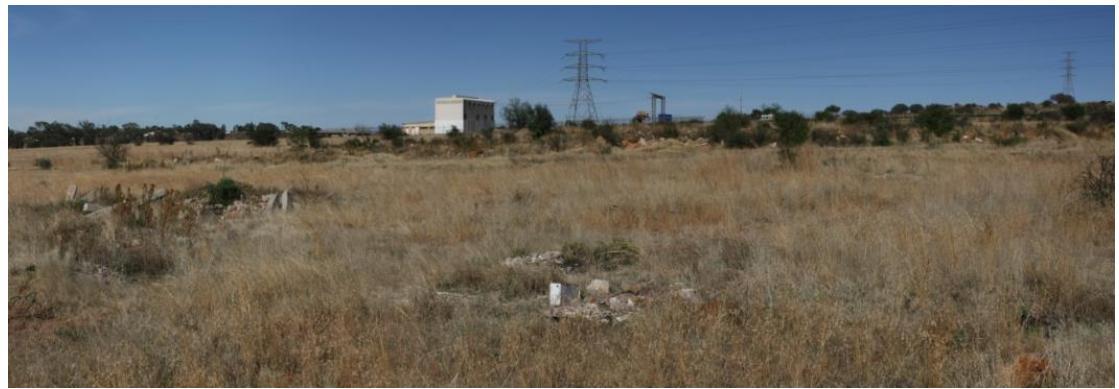
Figure 8: Panorama of the south western portion of the site. Rubble dumping is also common in some areas.

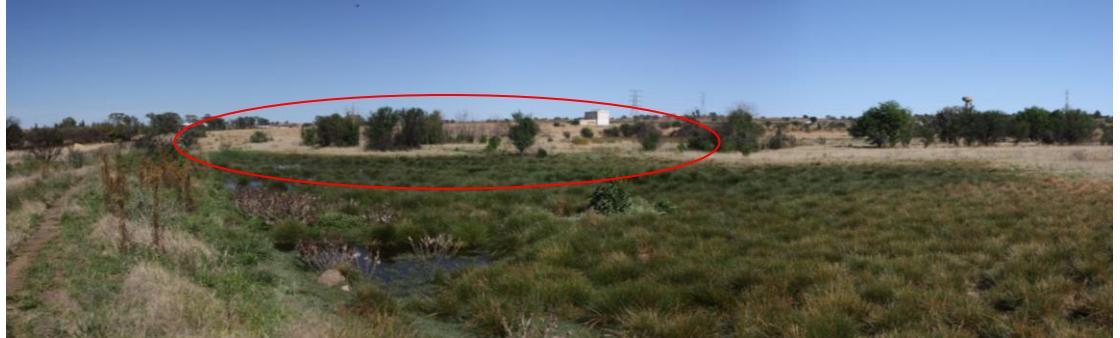
Figure 9: Panorama of the wetland areas associated with the Bloemspruit in the south western portion of the site. The proposed road layout may come into close proximity of the wetland area (red).

- Comprehensive monitoring should be implemented to determine any changes to the condition of the wetland area.
 - Where construction takes place within the wetland area it will be susceptible to erosion. Comprehensive rehabilitation and monitoring will therefore be necessary and preventative measures should include the use of gabions or other geotextiles.

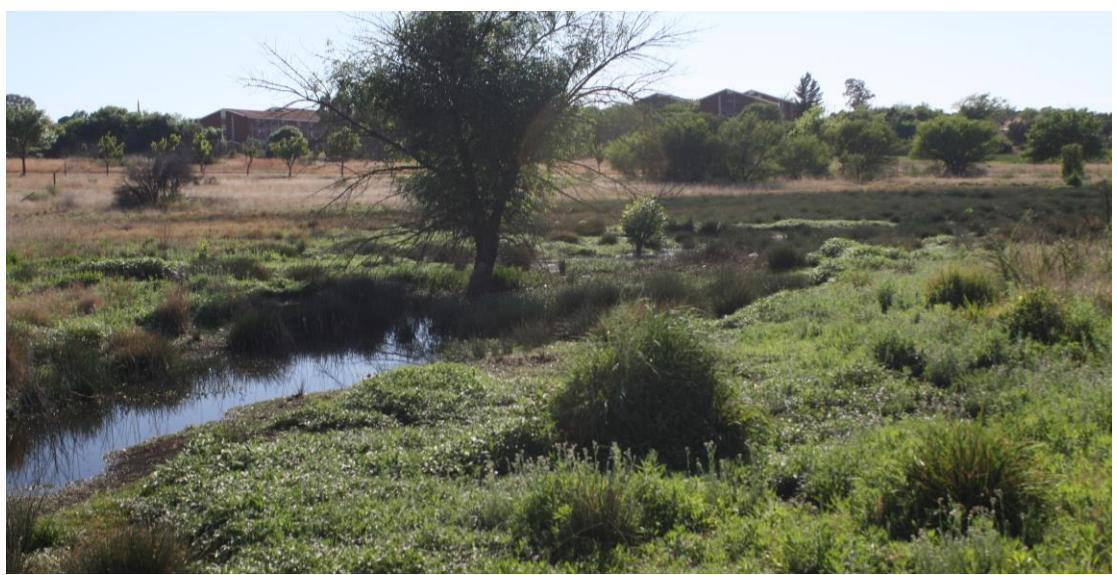
Figure 10: Another view of the wetland area which will be situated in close proximity to the proposed road layout.

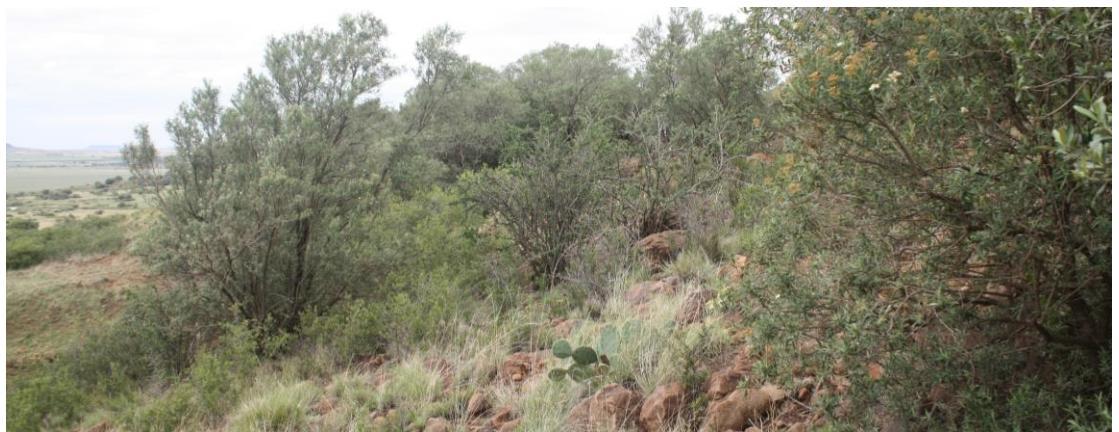
Figure 11: View of the slope of the low hill illustrating the relatively closed canopy. Note also the high percentage rocky cover.

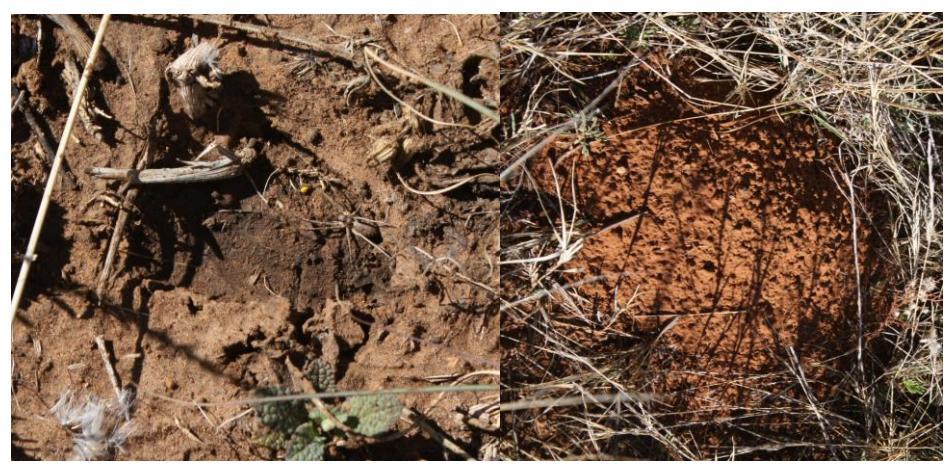
Figure 12: Observations of fauna on the site. On the left are spoor of a small antelope (Steenbok (*Raphicerus campestris*) or Common Duiker (*Sylvicapra grimmea*)). On the right is a soil mound of the Common Molerat (*Cryptomys hottentotus*).

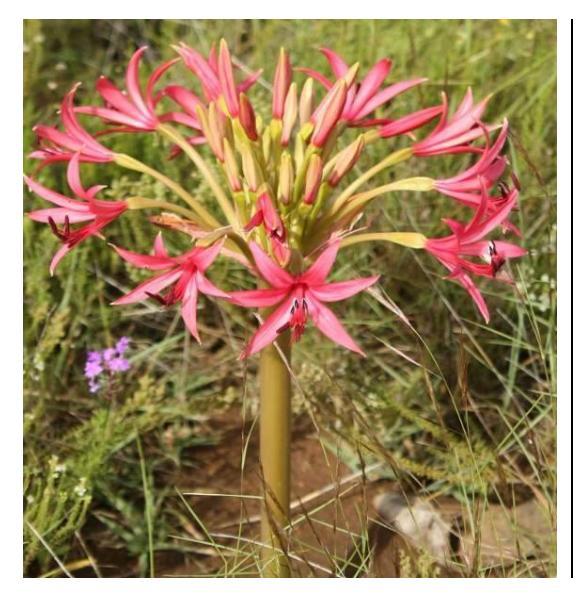
Brunsvigia radulosa Kandelaar Lelie/Candelabra Lily

Protected in the Free State Province

- Where specimens of the protected geophyte, *Brunsvigia radulosa* will be affected by the road construction it is recommended that the necessary permits be obtained to transplant them to adjacent areas where they will remain unaffected (Appendix C).
