ARCHAEOLOGICAL IMPACT ASSESSMENT OF PROPOSED BORROW PITS AT SPRINGFONTEIN 60 AND SKOPPELMANSKRAAL 54 AND THE EXTENSION OF AN EXISTING BORROW PIT AT DIKBOOM 53, LAINGSBURG DISTRICT, WESTERN CAPE

(Assessment conducted under Section 38 (8) of the National Heritage Resources Act as part of a Heritage Impact Assessment)

JUNE 2012

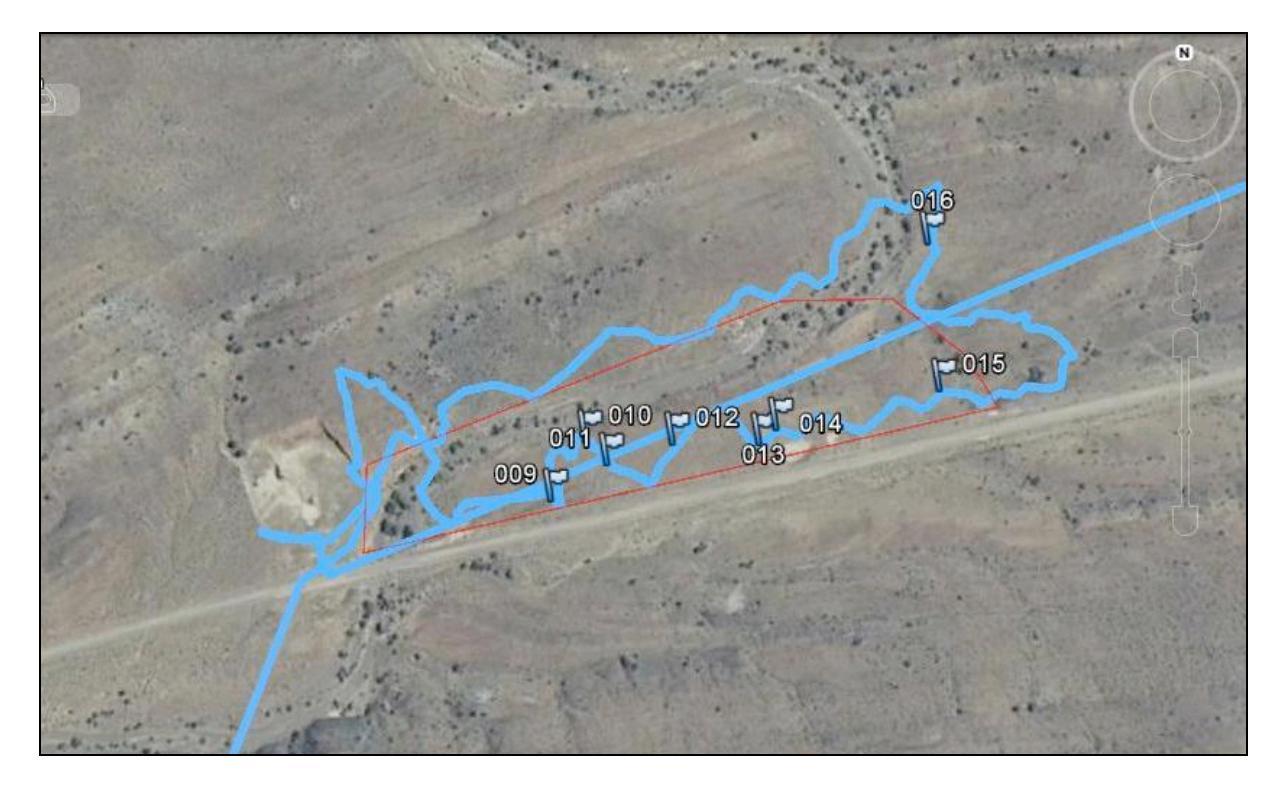
Figure 2: Google earth image showing the proposed borrow Pit 110, waypoints and tracks of the field survey. The small dam to the west of the affected area and the stream bed running through the northern half are evident. The side branch of the stream is close to the south-eastern boundary of the polygon. Please note that the straight blue lines do not indicate survey tracks.

Environment: The proposed borrow pit lies to the east of a small dam on a stream terrace along the MR00374 (Figures 2 & 4). A small stream bed runs in a north-easterly direction through most of the northern half of the affected area (Figure 3), with a side branch of the stream joining it in the south-eastern corner of the polygon. The water courses are obviously areas of disturbance and there is more evidence of sheet wash as the terrain slopes gently to the south and west. The only existing boundary of the proposed pit is the fence and road on the southern side of the area. The side branch of the stream approximately delimits the eastern boundary of the polygon. Alluvium and angular to sub-rounded sandstone gravels overlie mudrocks of the Abrahamskraal Formation of the Lower Beaufort Group. Scree from a small sandstone ridge to the north-west is the source of some of the coarser material. The vegetation consists of scattered karoo bushes and clumps of grass, with larger *Acacia karroo* trees along the stream bed (Figure 3). Archaeological visibility was thus good.

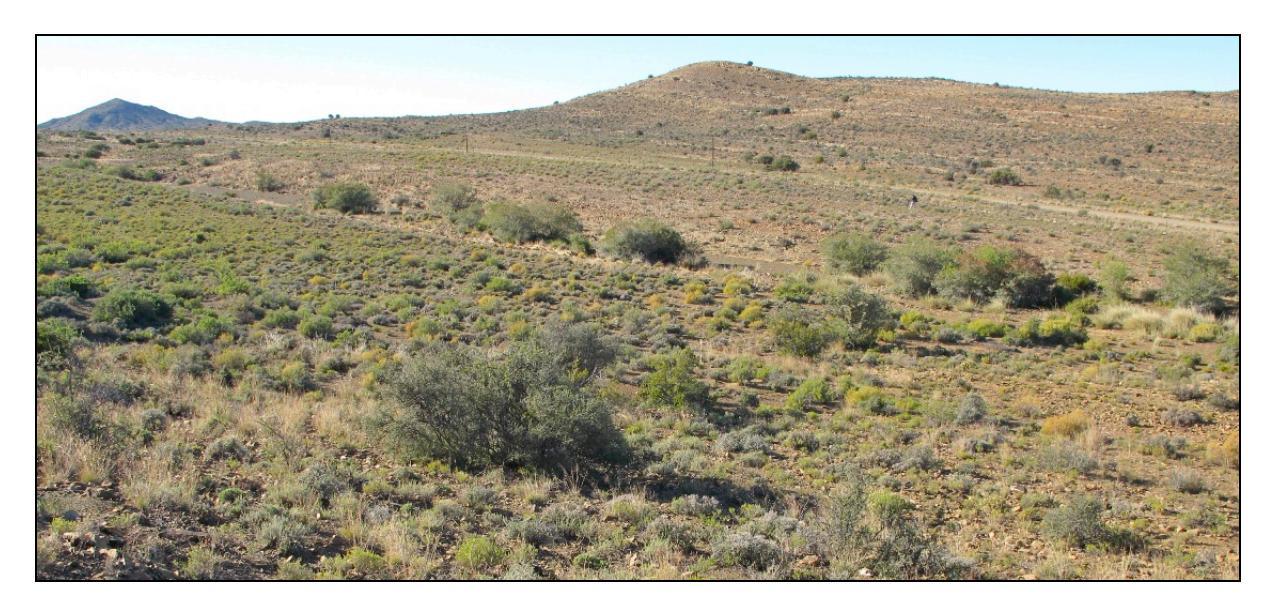
Figure 3: Pit 110 – view towards the south-east. The major part of the proposed borrow pit lies on the terrace between the stream bed and the gravel road in the background of the photo.

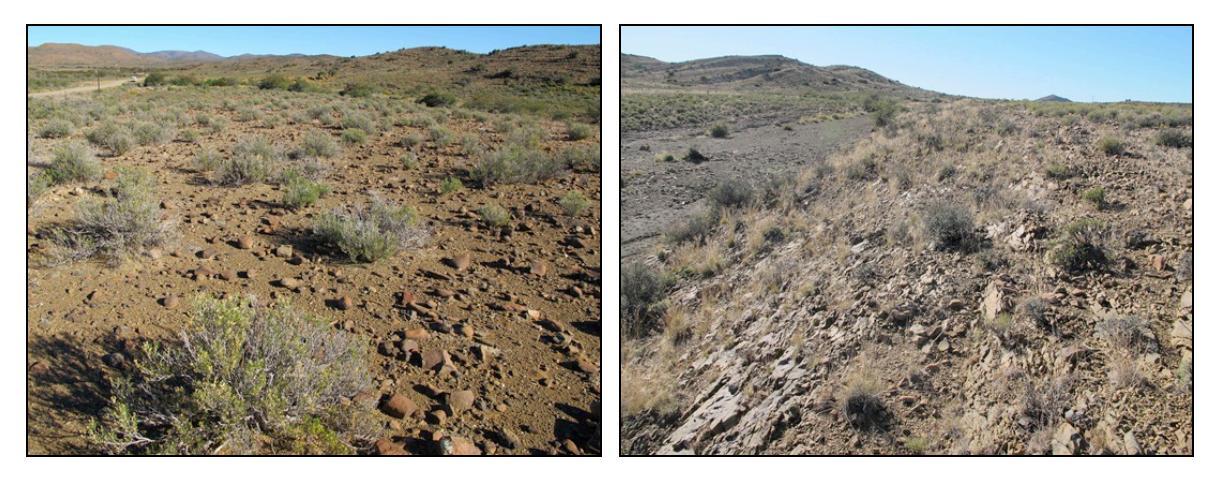
Figures 4 and 5: Pit 110 – view towards the south-west of the terrace where occasional artefacts were observed amongst the sandstone gravels; view towards the north-east of the edge of the terrace incised by the stream.

Results of the survey: A dispersed scatter of a few stone artefacts occurs amongst the sandstone gravels of the terrace mentioned above. Some of them were weathered and patinated. As the immediate area does not seem to have good sources of raw material for the manufacture of artefacts, most of the artefacts observed (Table 1 of the Appendix and Figures 6 to 11) seem to be made of Beaufort Group sandstone, some of it quite crude. Two artefacts made of Matjiesfontein chert – the proximal end of a snapped blade (Figure 6) and the tip of a point (Figure 10) were observed. The diagnostic artefacts such as blades and points appear to belong to the MSA. No dolerite boulders suitable for rock engravings occur in the area. No stone features such as walls or graves were observed.

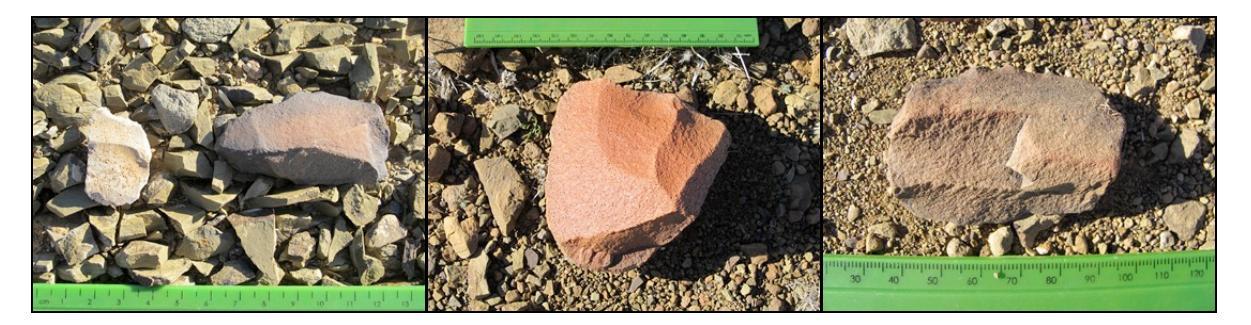
Figures 6, 7 and 8: Pit 110 – the proximal end of a Matjiesfontein chert blade and sandstone point; sandstone chunk; sandstone blade. The scale is in cm.

Most of the artefacts noted in this study came from proposed Pit 110 but, like the proposed extension at Pit 112, all the material was found in a secondary context in areas affected by sheet wash. No rock engravings or stone features such as walls or graves were observed. The archaeological material from these sites is considered to be of low heritage significance and no further archaeological studies or mitigation are recommended.

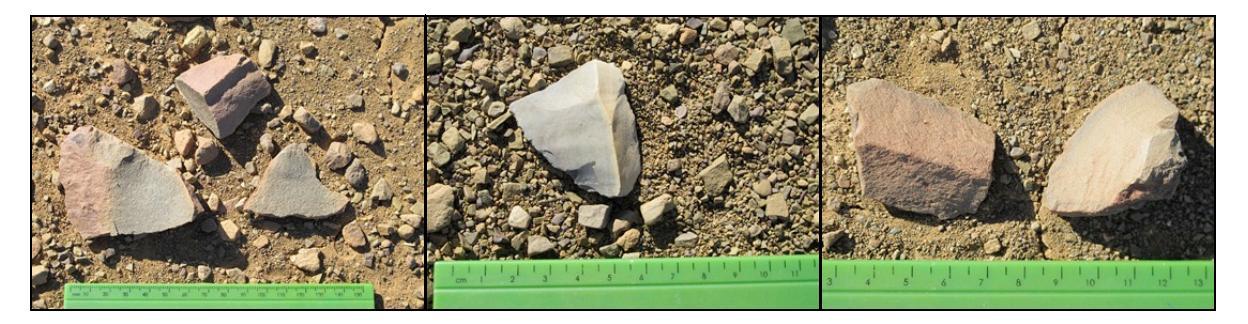
Figures 9, 10 and 11: Pit 110 – sandstone flakes and snapped blade; chert flake; sandstone blade fragment and flake. The scale is in cm.

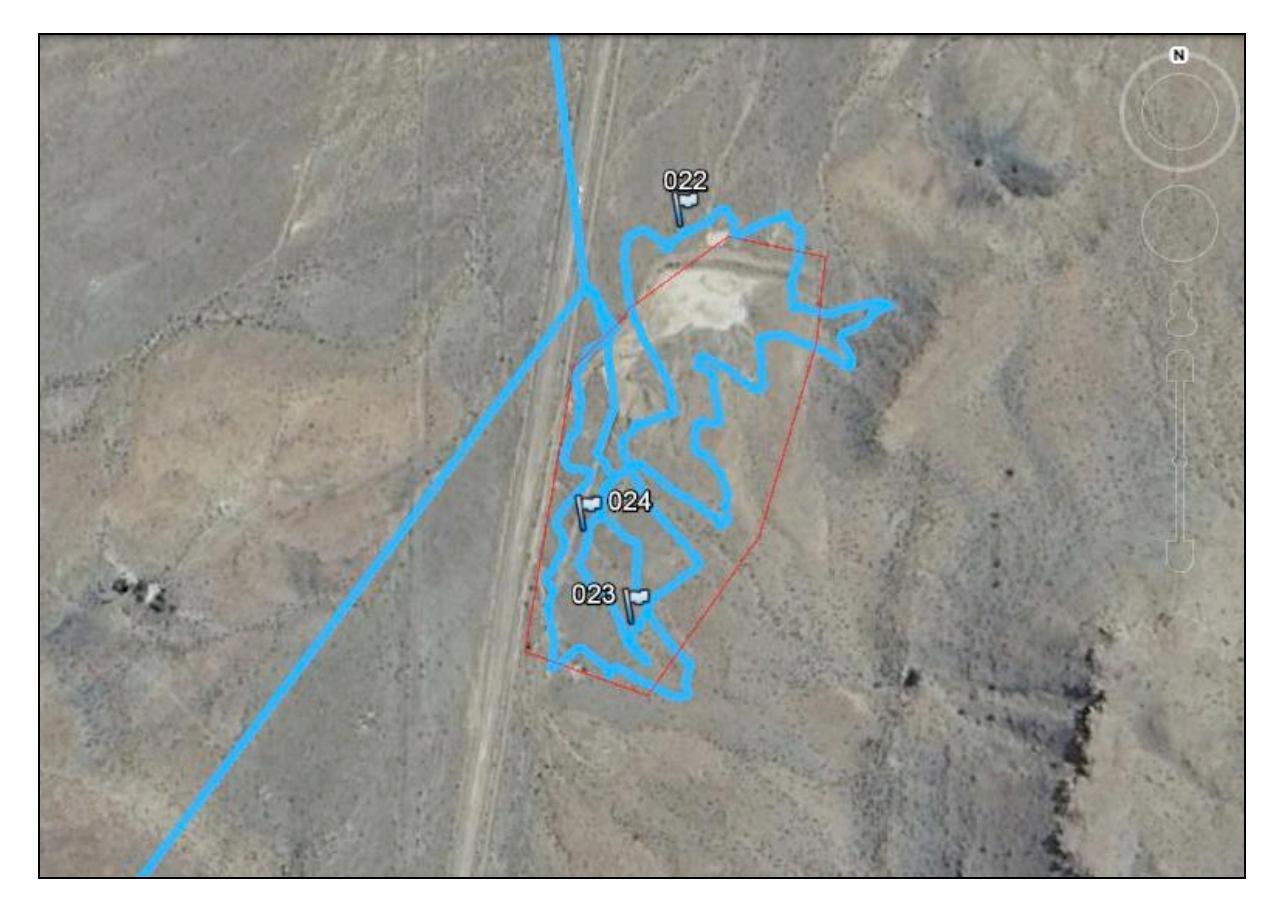
Figure 12: Google earth image showing the proposed extension to borrow pit 112, the tracks and waypoints of the field survey. The western side of the affected area has several channels and small dongas leading water to the existing dam. Please note that the straight blue lines do not indicate survey tracks.

Environment: Pit 112 is the proposed extension of an existing pit which has been converted into a dam (Figures 12 & 15). The affected area lies between the MR00374 to the west and a row of small hills to the east. The northern boundary lies just beyond the dam wall and a pipeline from a sheep trough was taken as the marker for the southern end of the proposed extension. Alluvium overlies Abrahamskraal Formation mudrock over most of the site (Figure 13). An apron of scree of angular to sub-rounded sandstone blocks and chunks overlies the alluvium at the foot of the small hills (Figure 14). Several channels and erosion gullies (dongas) occur in the western part and there is evidence of sheet wash over a large section of the affected area. The vegetation consists of scattered clumps of grass and small karoo bushes so the visibilility of archaeological material on the ground was good.

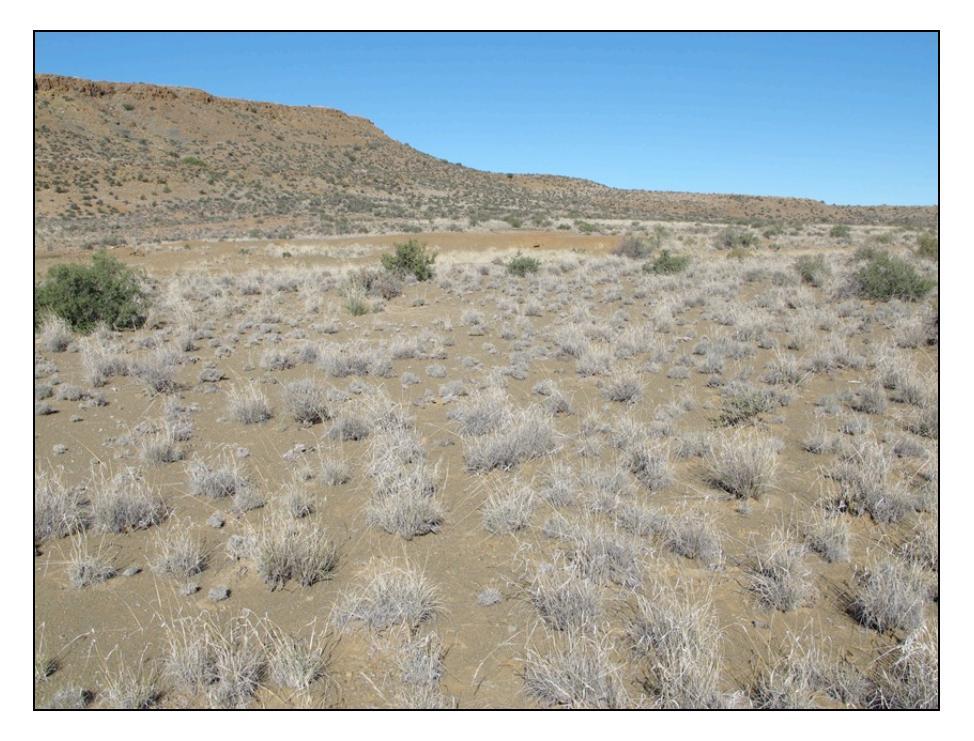
Figure 13: Pit 112 – view towards the south-east over the alluvium of the southern half of the affected area. The patch devoid of vegetation in the middle ground indicates the southern extremity of the existing borrow pit.

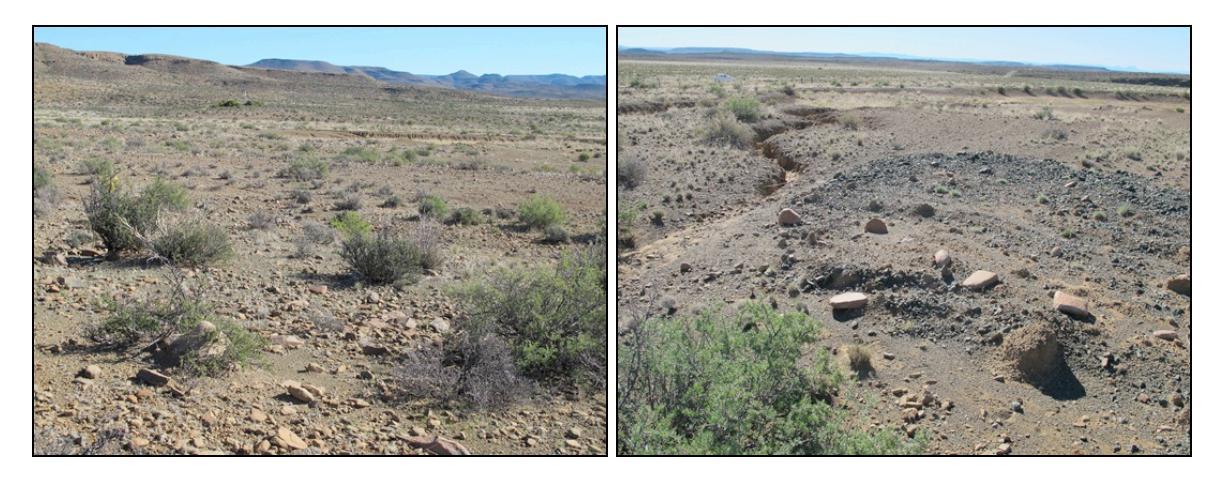
Figures 14 and 15: Pit 112 – view towards the south-west over most of the eastern and central parts of the affected area taken from the slope close to the north-eastern corner of the polygon; view towards the north showing dongas, a geotechnical test pit and the existing borrow pit converted into a dam.

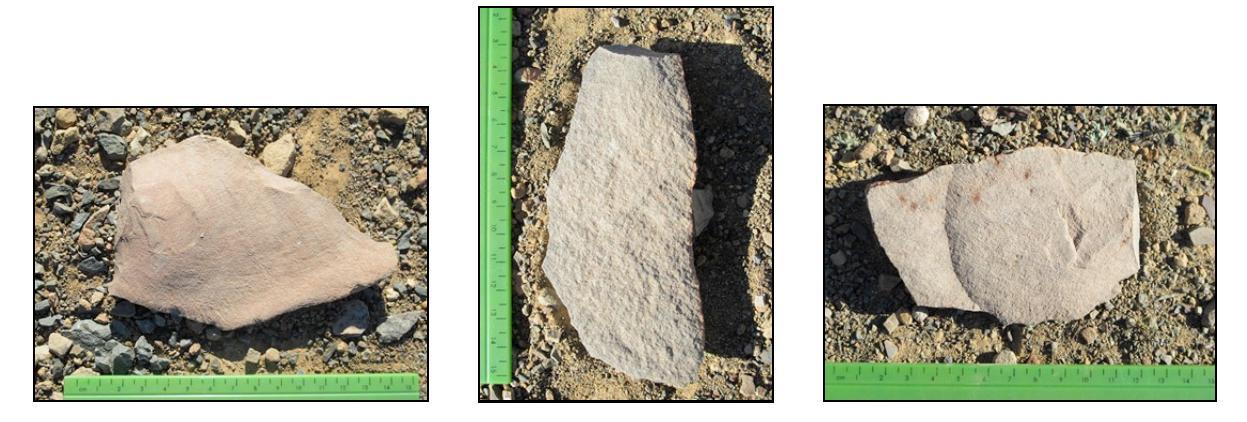
Results of the survey: Three isolated, large sandstone flakes of indeterminate age were the only artefacts observed (Table 2 in the Appendix and Figures 16 to 18). Given the evidence of sheet erosion, it is likely that they were brought in from elsewhere. No dolerite boulders suitable for rock engravings occur in the area. No stone features such as walls or graves were observed.

Figures 16, 17 and 18: Pit 112 – sandstone flakes. The ruler is about 15 cm in length.

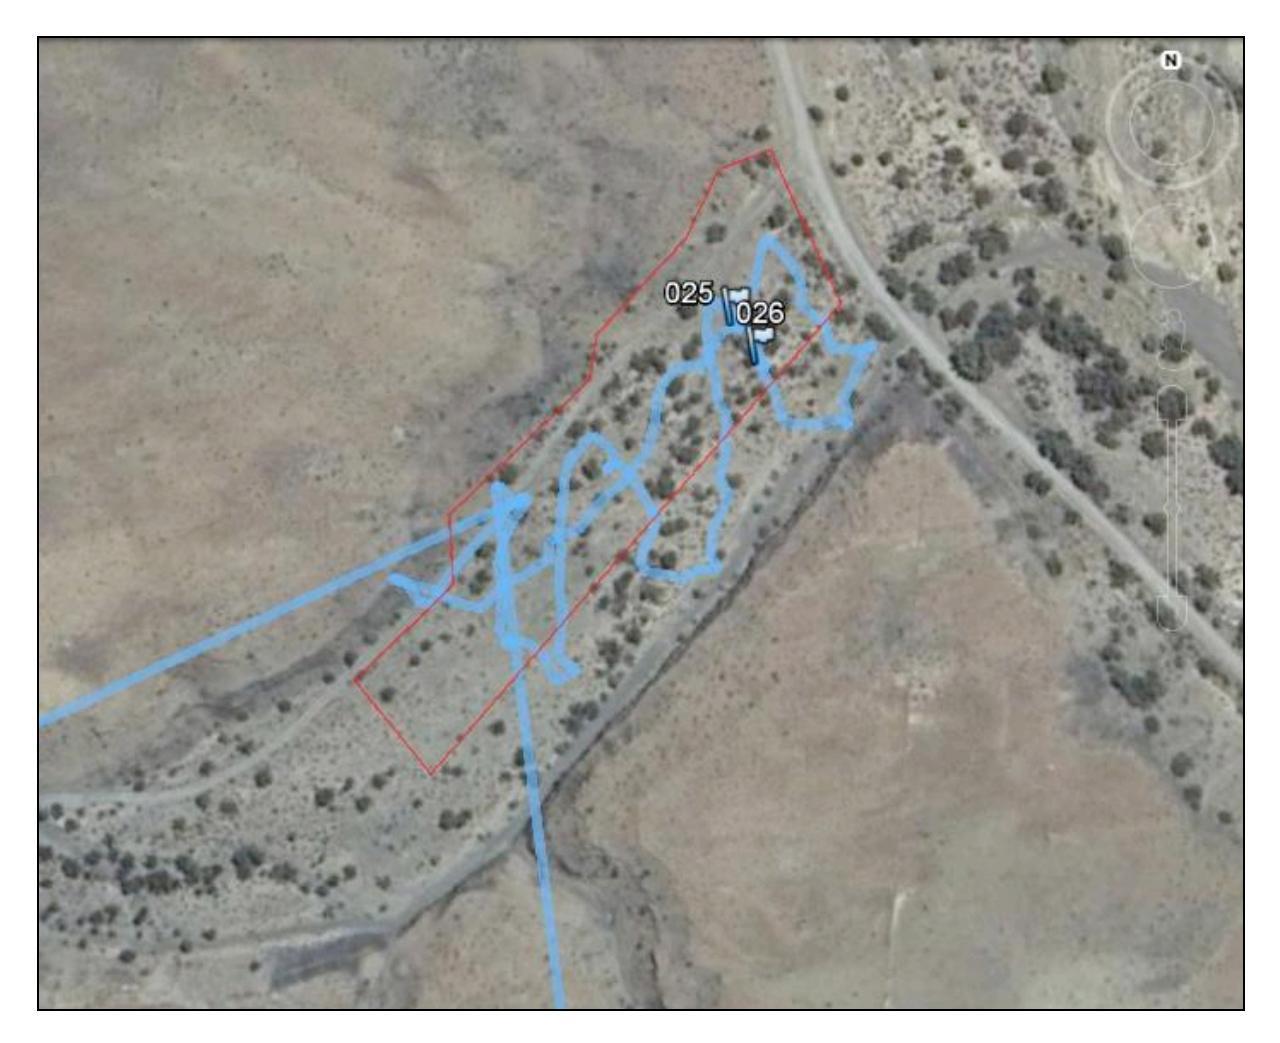
Figure 19: Google earth image showing proposed Pit 113, the tracks and waypoints of the field survey. Please note that the polygon provided is slightly displaced as the site report shows the affected area as lying between the track and stream bed. Also note that the straight blue lines do not indicate survey tracks. The vegetation appears to have become denser since the satellite image was taken.

Environment: The proposed borrow pit is roughly rectangular in shape and is aligned in a north-east to south-west direction (Figure 19). Boundaries are formed by the MR00374 to the north-east, the farm track to the north-west and a stream and cliff to the south-east. There is no obvious boundary for the south-western end of the polygon. The whole area lies on a river alluvial floodplain with coarse gravels containing blocks of sandstone and quartzite (Figures 20, 22 & 23). A good section through the mudrocks and sandstones of the Abrahamskraal Formation is evident in the cliff face (Figure 21). The density of the vegetation varies across the site and affects archaeological visibility. This ranged from good to poor. Concentrations of *Acacia karroo* occur in the central part (Figure 21) whereas lower, more scattered *Lycium sp.* and kraalbos (*Galenia africana*) are predominant in the rest. Dead branches also obscured the ground in some areas.

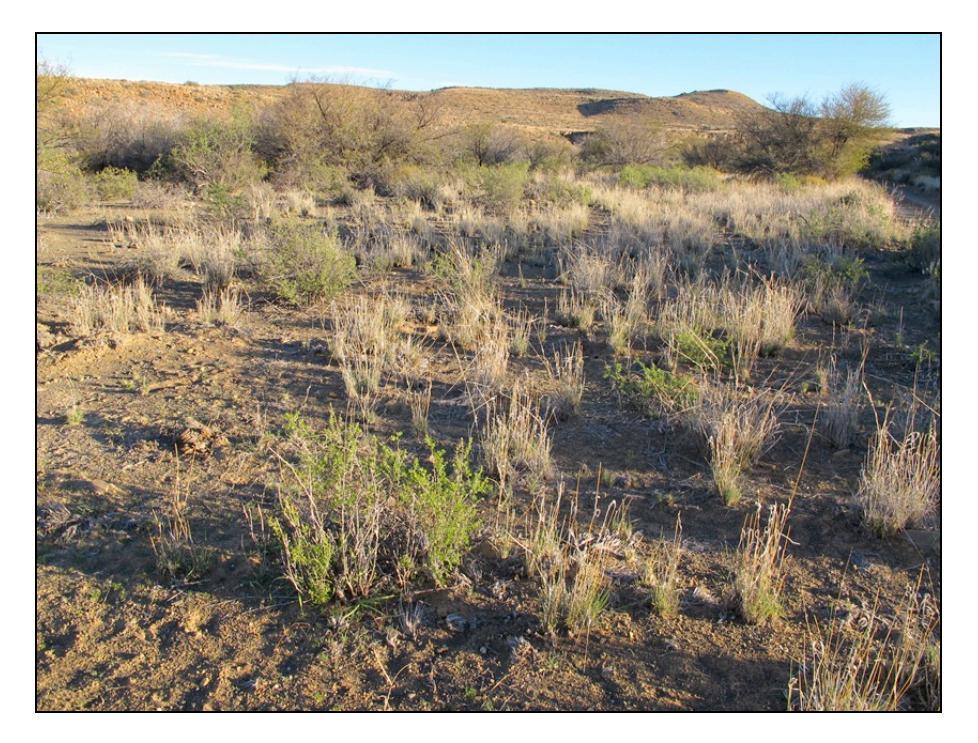
Figure 20: Pit 113 – view towards the south-west taken from the north-east corner of the affected area. The central area has denser vegetation consisting of *Acacia karroo*.

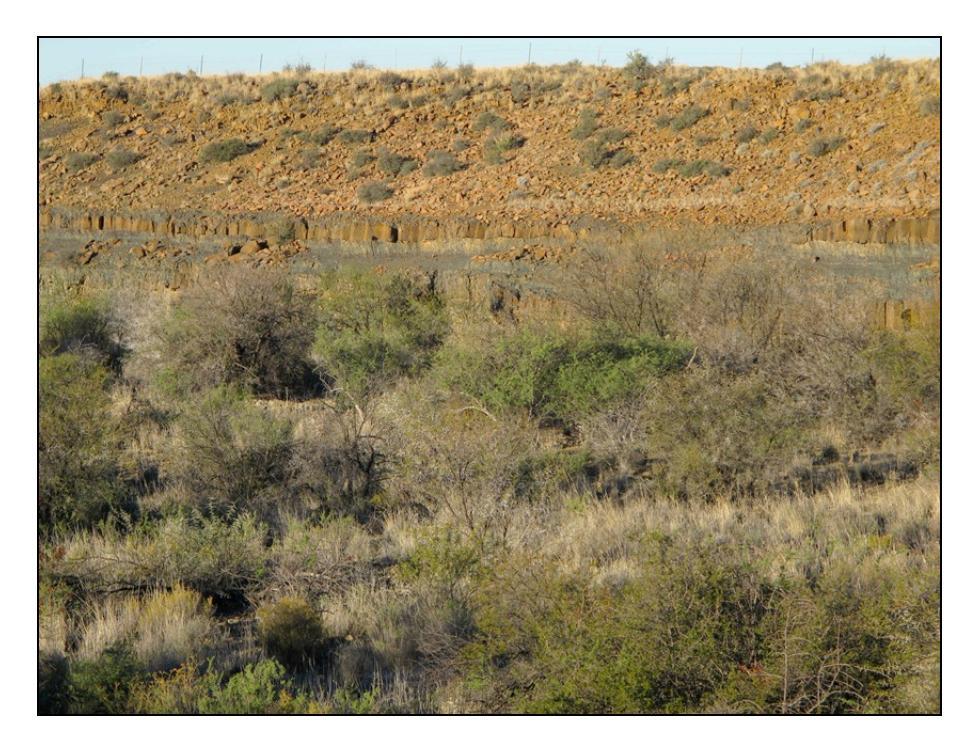
Figure 21: Pit 113 – view over the central part of the proposed pit area towards the stream and cliff to the south-east. Archaeological visibility was poor in this area.

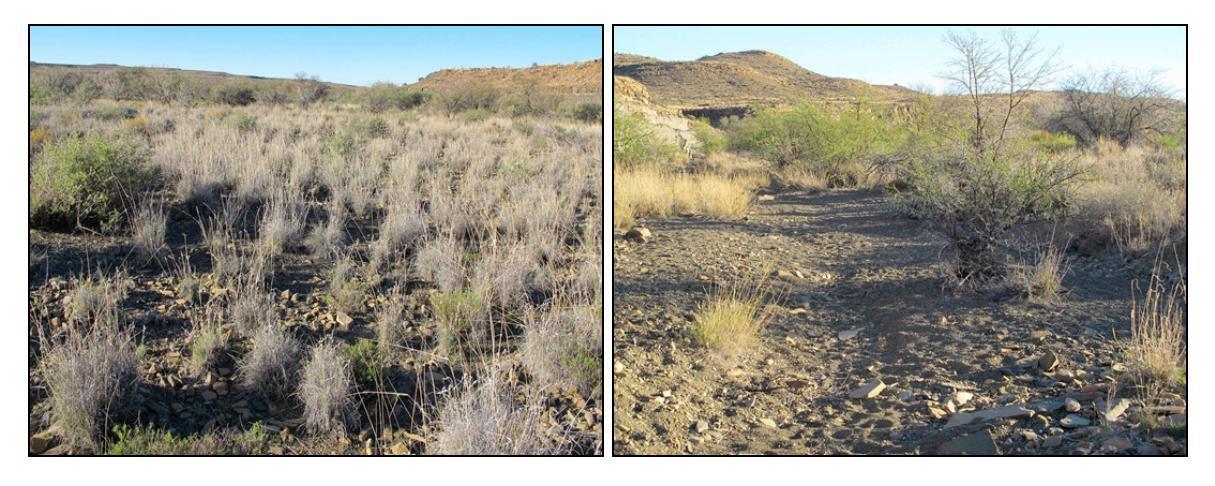
Figures 22 and 23: Pit 113 – view towards the north-east from the south-eastern part of the site; view towards the south-east from the stream bed at the foot of the cliff.
