PHASE 1 ARCHAEOLOGICAL HERITAGE IMPACT ASSESSMENT OF THE PROPOSED DEVELOPMENT OF A HOTEL AND RESORT ON ERF 6338, JEFFREYS BAY, KOUGA MUNICIPALITY, EASTERN CAPE PROVINCE

Compiled by: Dr Johan Binneman On behalf of: Eastern Cape Heritage Consultants P.O. Box 689 Jeffreys Bay 6330 Tel: 042 962096 Cell: 078006322

Date: October 2007

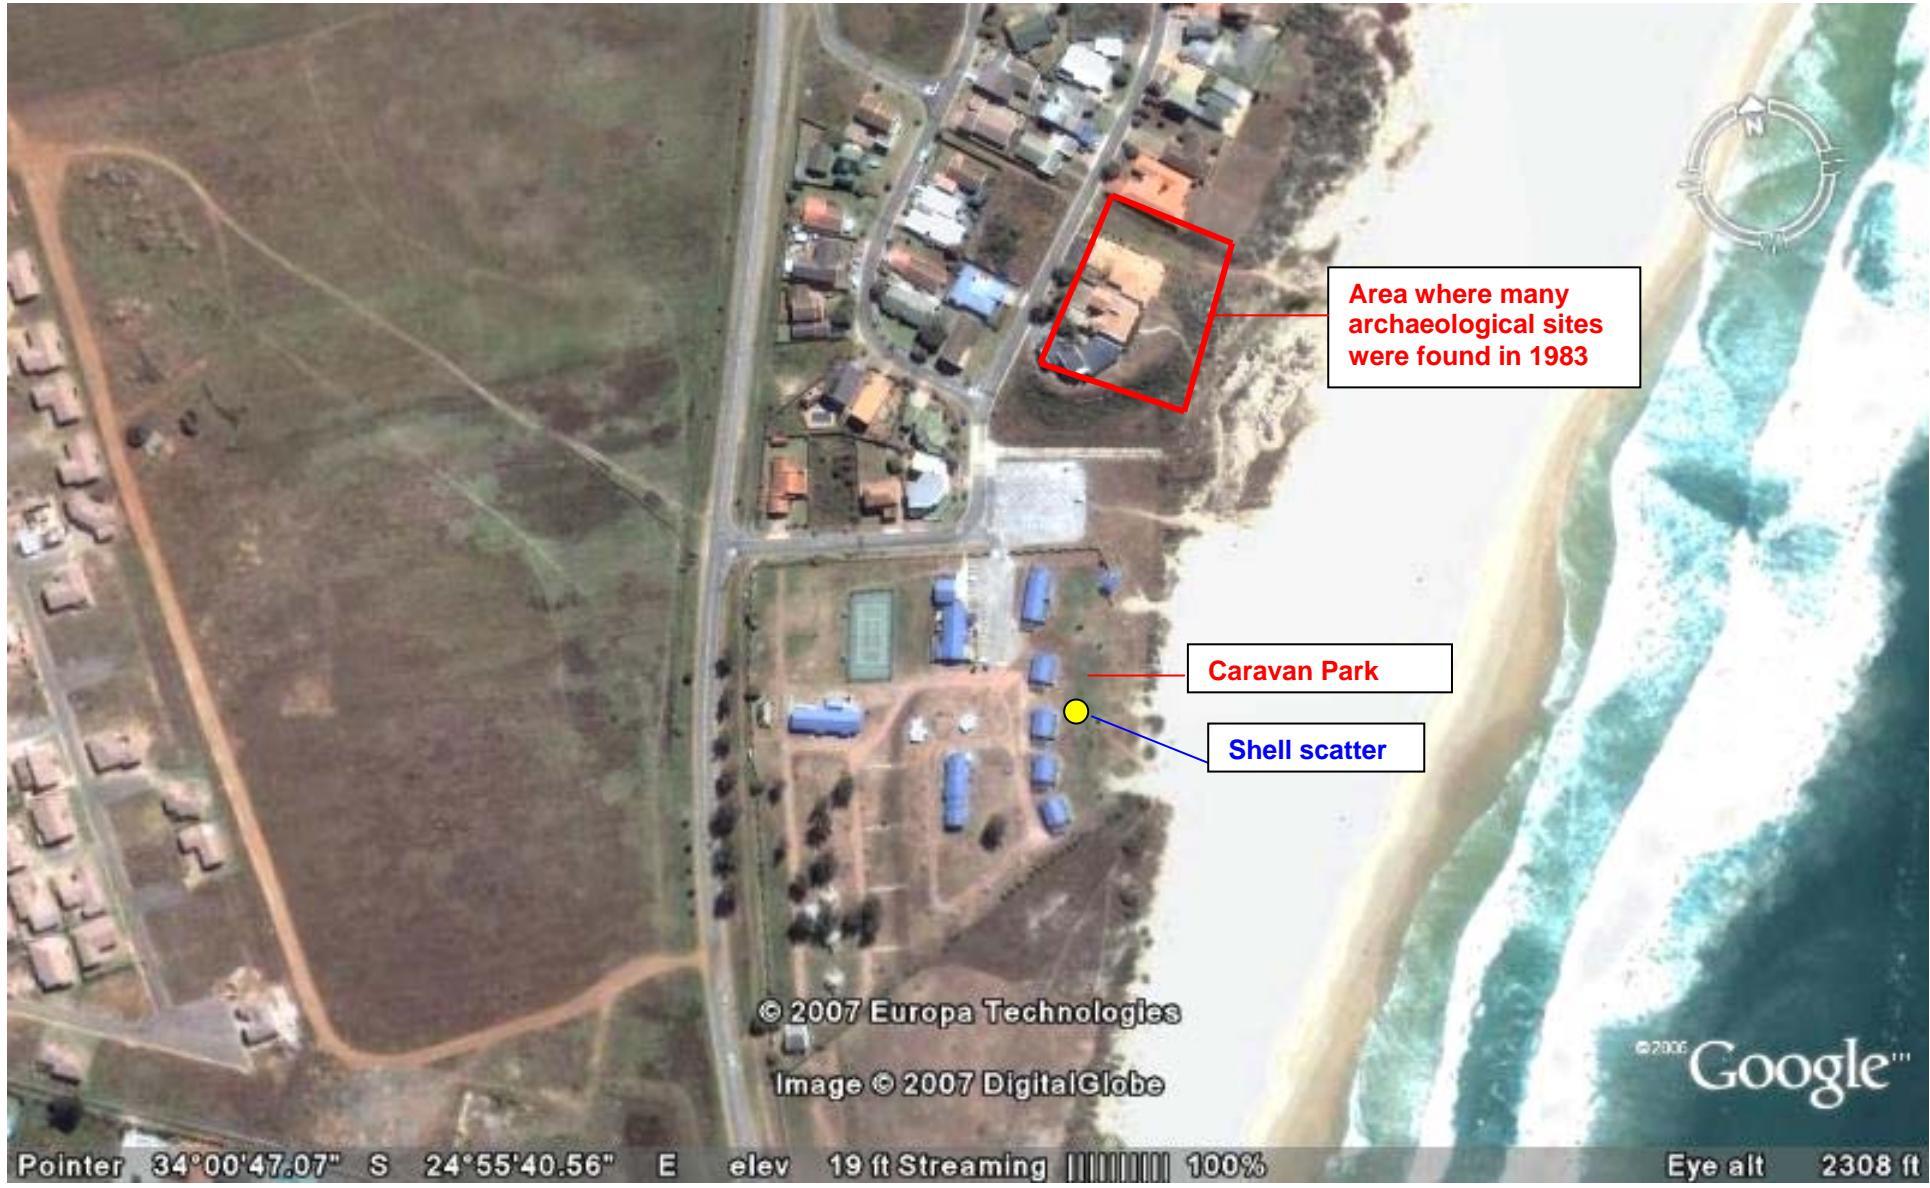
Fig. 2. Locations of the caravan park and the area where archaeological remains were found in 1983 as mentioned in the text.

- 1. The area between the beach and the first row of chalets (see Figs. 2, 3 & 4) where shell midden material is visible, must be investigated by a test pit or trench excavation before construction starts in that part of the proposed development. Further recommendations will follow from the investigation. This may include:
 - That further excavations/sampling must be conducted, or
 - That the Phase 1 development of that area may proceed.
- **Note:** Phase 1 (below) may proceed independently of the above investigation in other areas, subject to the conditions recommended below.

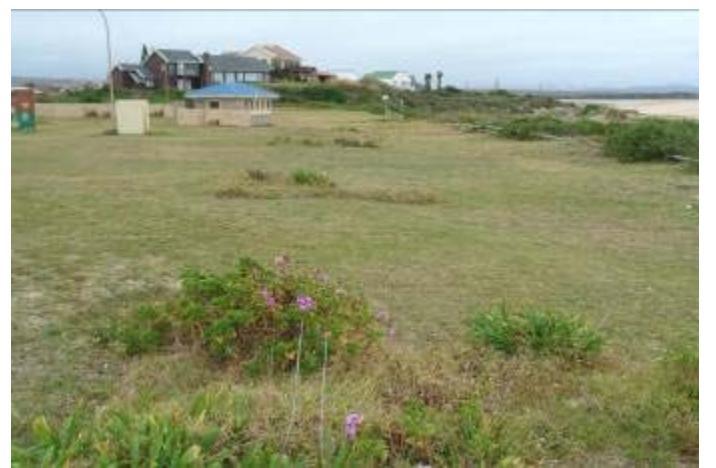
Fig. 3. View towards the estuary. The Houses mark the area where the sites were found in 1983.

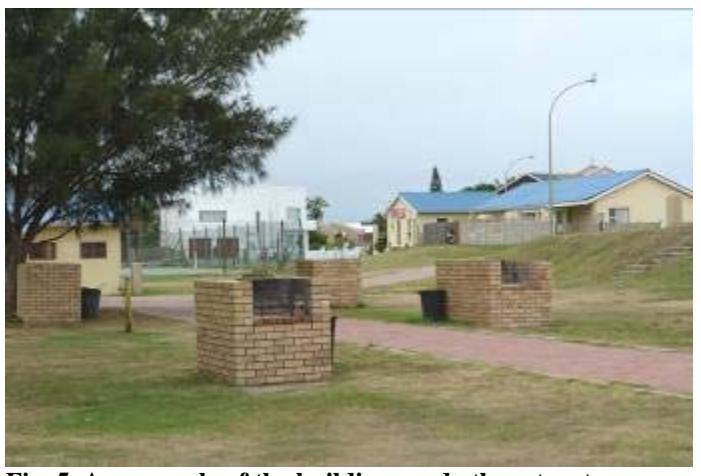
Fig. 5. An example of the buildings and other structures.

- 1.2. After the surface scraping exercise the buildings and other structures can be demolished.
 - However, foundations and concrete slabs/floors of demolished buildings and structures must be carefully removed because there may be possibly archaeological sites/material under these structures.

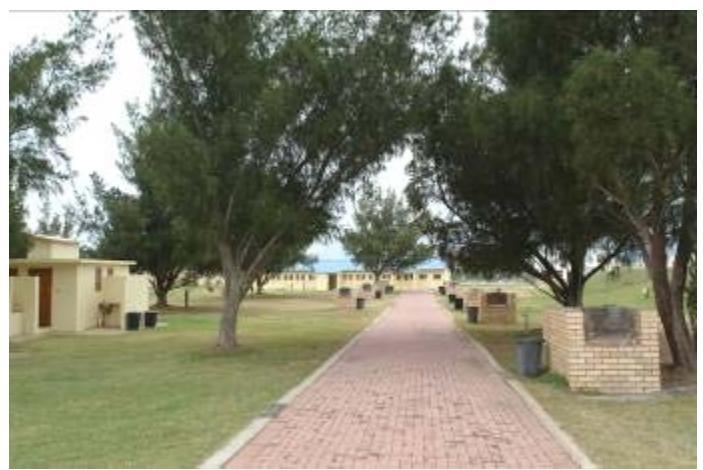
Fig. 6. Brick paved roads and grass covered top soil.

- 1.1. The top soil be carefully removed (scraped) by an experienced bulldozer operator, preferably before any buildings or structures are demolished or removed. This will be a quick and easy way to expose the area and would make it easier to locate possible sites.

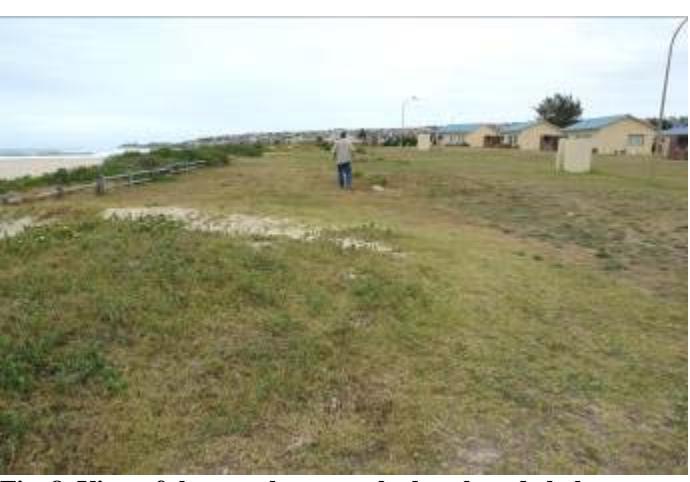
Fragmented marine shell were found over an area of some 10 metres between the beach and the first row of chalets (34.00.817S; 24.55,704E) (Figs 2, 8 - 10). The shell were pushed to the surface by dune moles and consisted mainly of *Donax* serra (white mussel). Usually these materials are associated with prehistoric shell middens and it may indicate that there are possibly larger accumulations of shells (possibly shell middens) buried under the lawn and surface soil. It is not known what the status of the material is, but given the fact that it is close to the row of chalets, it is probably disturbed. One Middle Stone Age stone tool (older than 30 000 years) was found on the surface in the same area. The presence of the isolated MSA stone tool is puzzling, because the age of the shell material appears to be of Late Holocene age (past 5000 years).

Fig. 8. View of the area between the beach and chalets.

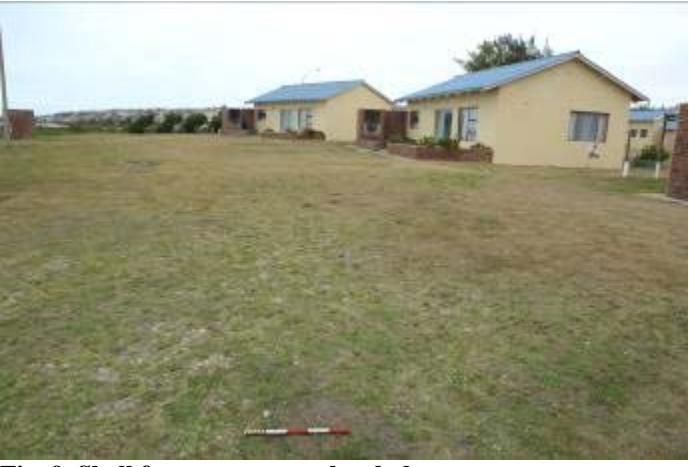
Fig. 9. Shell fragments near the chalets.

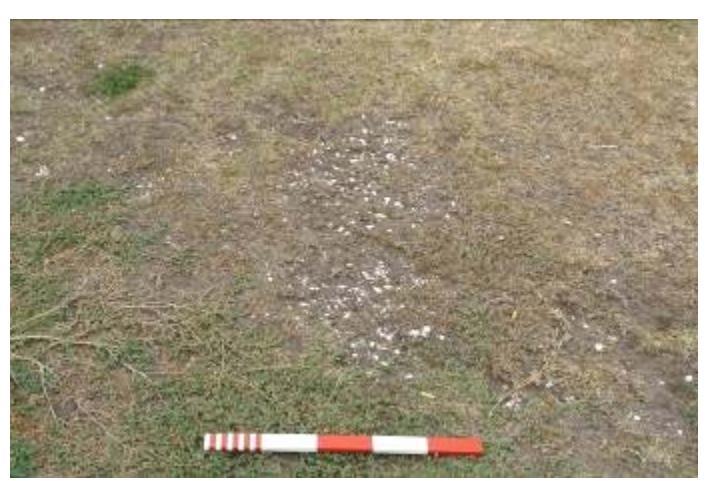
Fig. 10. Shell fragments pushed to the surface by dune moles, near the chalets.
