10. ARCHAEOLOGY

10.4.1. Footprint A: Coega Kammas Kloof 191 Portion 5

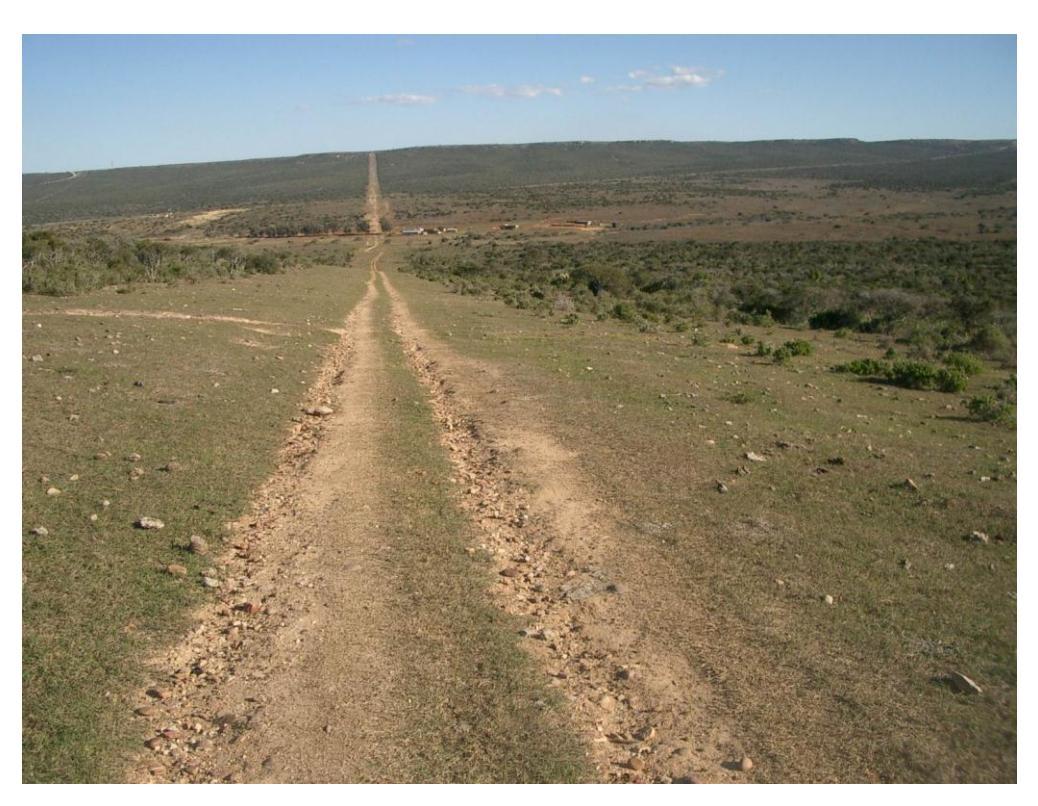
The footprint is infested with alien vegetation resulting in low archaeological visibility (Figures 10.1 & 10.2). Some open spaces do however occur.

Figure 10.1: Archaeological study Regional Hazardous Waste Site: Footprint A Access Road

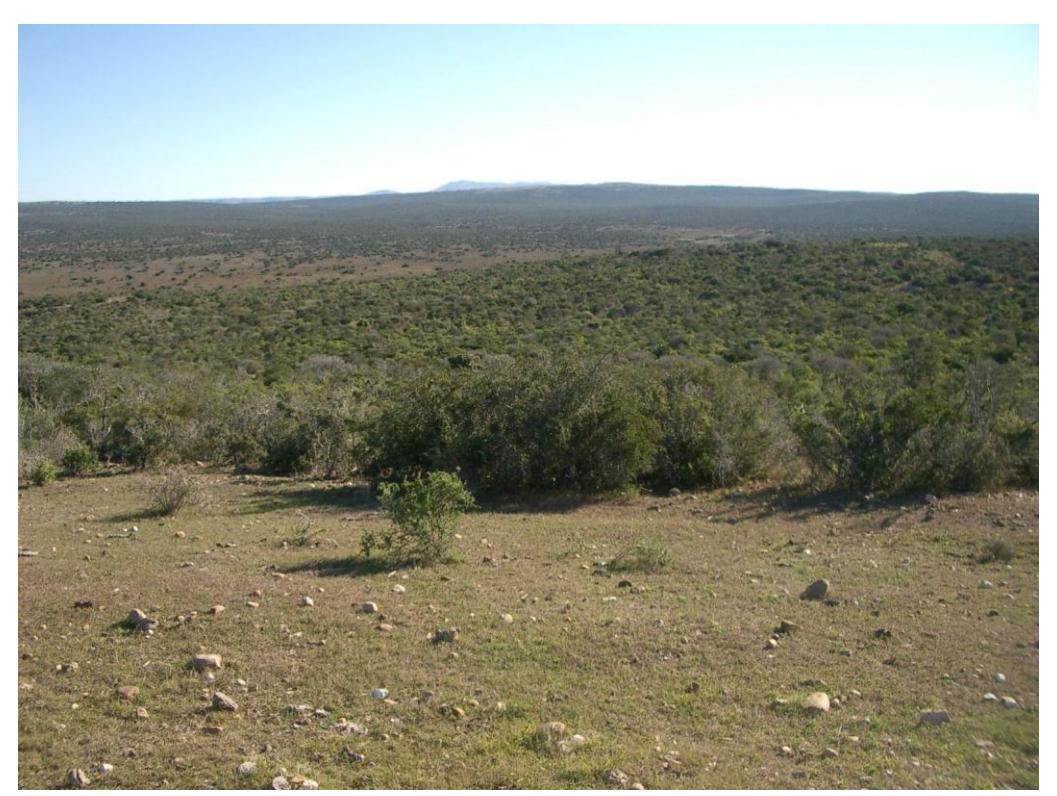
Figure 10.2: Archaeological study Regional Hazardous Waste Site: Footprint A

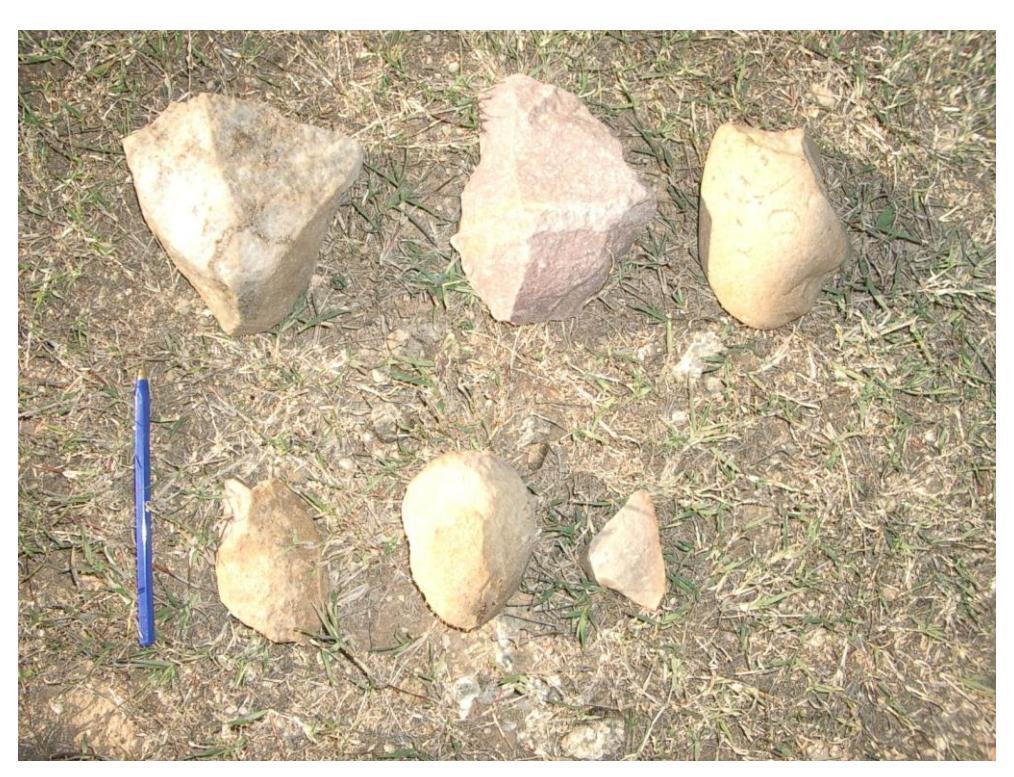
The tools include a range of cores, unmodified flakes, chunks, a hammerstone, a ground stone and split and flaked cobbles. All the tools were made on locally available quartzite cobbles (Figures 10.3 & 10.4).

The tools were located in a disturbed and degraded context and the finds are not considered to be significant.

Figure 10.3: Archaeological study Regional Hazardous Waste Site: Footprint A collection of stone tools

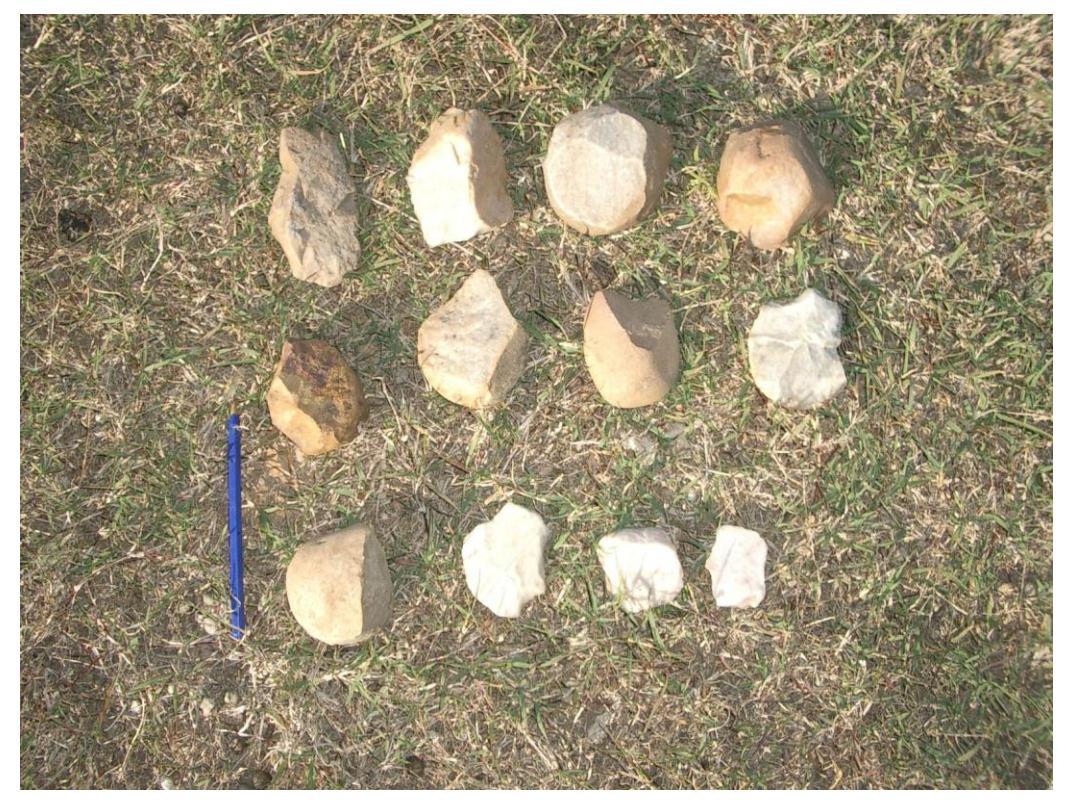
Figure 10.4: Archaeological study Regional Hazardous Waste Site: Footprint A collection of stone tools
