2022 UNDERWATER ARCHAEOLOGICAL IMPACT ASSESSMENT FOR THE PROPOSED GAS TO POWER POWERSHIP PROJECT AT THE PORT OF SALDANHA BAY

# 2022 UNDERWATER ARCHAEOLOGICAL IMPACT ASSESSMENT FOR THE PROPOSED GAS TO POWER POWERSHIP PROJECT AT THE PORT OF SALDANHA BAY, WESTERN CAPE

Report #:	2022/SALD/001
Status:	Final
Revision #:	2
Date:	11 October 2022
Prepared for:	Triplo4 Sustainable Solutions (Pty) Ltd
Representative:	Shanice Singh
Tel:	+27 (32) 946 3213
Address:	Suite 5, The Circle Business Centre, Douglas Crowe Drive, Ballito 4420
E-mail:	shanice@triplo4.com
Prepared by:	Vanessa Maitland
ASAPA Registration #	:326
Field:	Maritime Archaeology
Address:	203/71 Elandskraal, Sedgefield Rural, 6573
Tel:	082 490 4066
E-Mail:	vanessa@cocojams.co.za

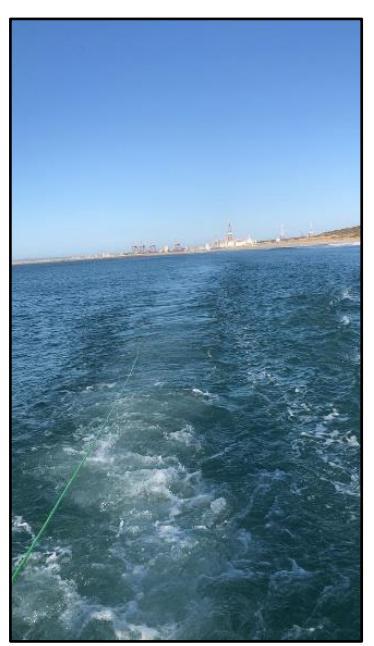
Figure 1: Deployed magnetometer (Maitland, A 2020)

A Geometrics G-882 cesium-vapor marine magnetometer was towed behind a 5.7 m fibreglass rigid inflatable boat (RIB), with a layback of 15 meters, at an average speed of 3 - 6 knots/hour, utilising 15m run-lines. The magnetometer data collected by MagLog® software was analysed twice. The first or field analysis is performed as the magnetometer is towed (Figure 1 - Figure 3). Possible sites are tabulated and analysed according to the environmental conditions in the field. The post-field analysis was interpreted with geophysical software (Surfer), with knowledge of the environmental conditions. The analyses were compared, and a final analysis completed.

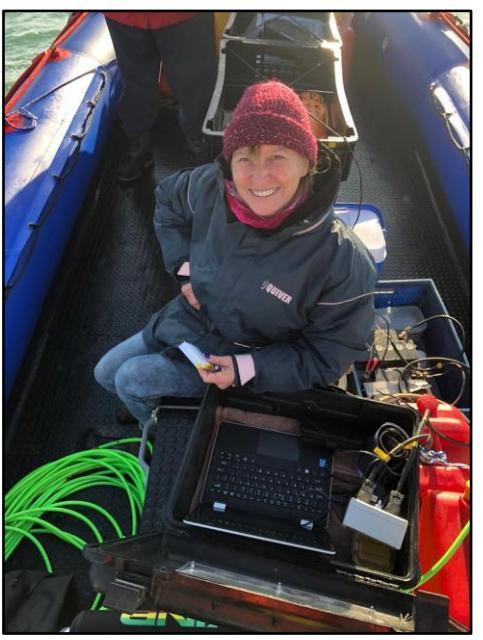
Figure 2: Magnetometer data capture (Maitland, A 2020)

The magnetometer data collected by MagLog software was analysed twice. The first or field analysis is performed as the magnetometer is towed (Figure 3). This analysis observes real time spikes within the magnetic field. Possible sites are tabulated and analysed according to the environmental conditions in the field. These conditions include:

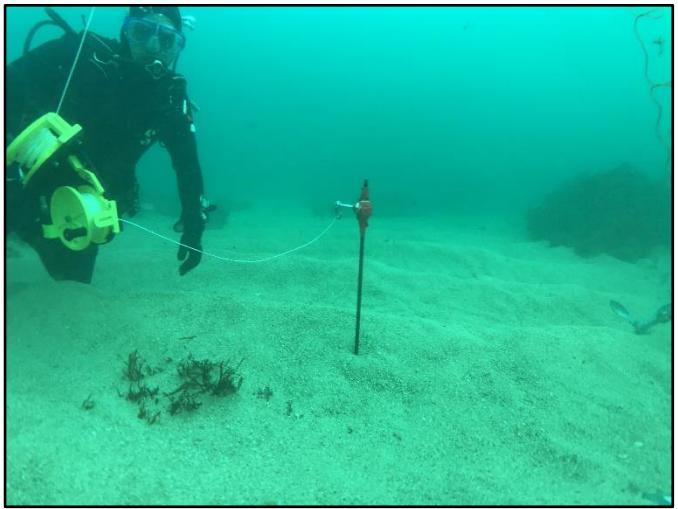
Figure 4: An example of how a circular search is undertaken, a marker buoy and attached search reel (Maitland 2018)

Some anomalies may be obvious shipwreck material while others may be covered in conglomerate and/or sand and silt. The limited visibility due to turbidity, that is suspended sediments negatively impacts diver searches.

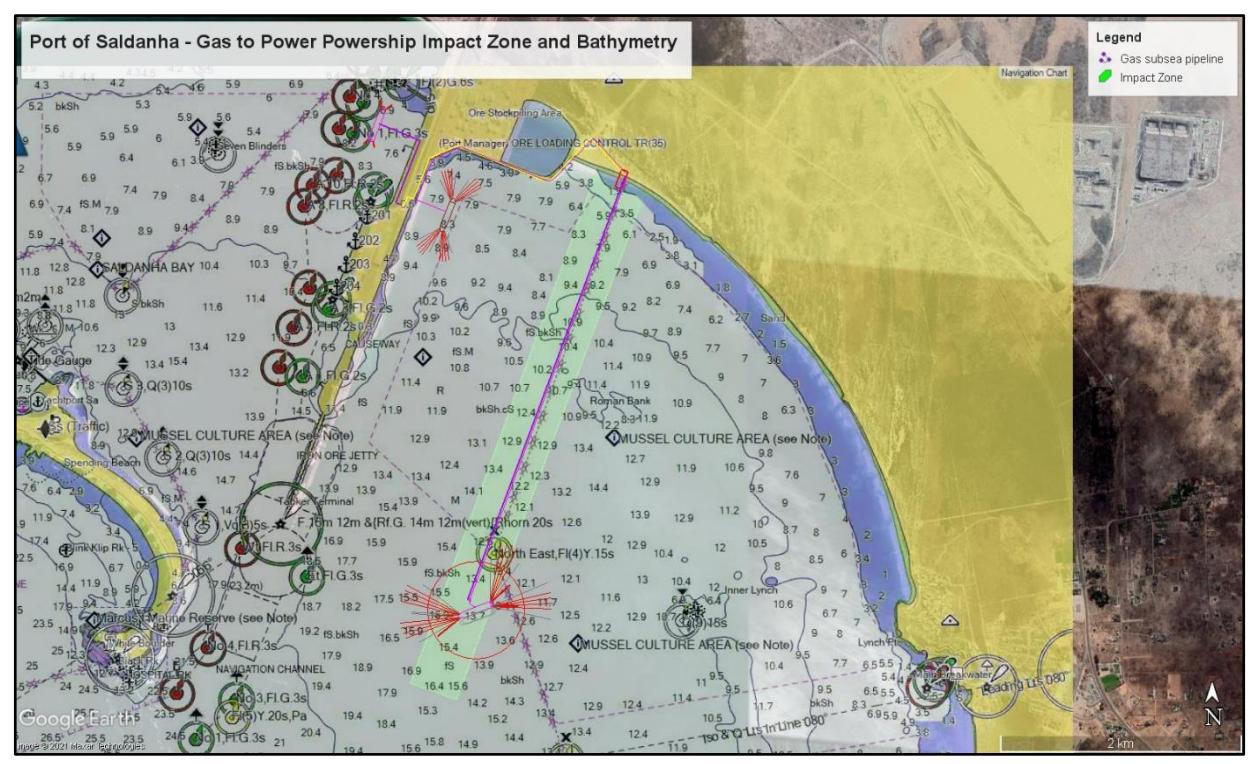
Figure 9: Bathymetry of the Impact Zone (Garmin BlueCharts: 2018)

The bathymetry of the Impact Zone has a maximum chart depth of 16.9 m Below Sea Level (BSL) sloping inshore to a depth of 1.5 m BSL. There are no indicated reefs or rocky areas, although the Roman Bank is to the east of the survey area (Figure 9).

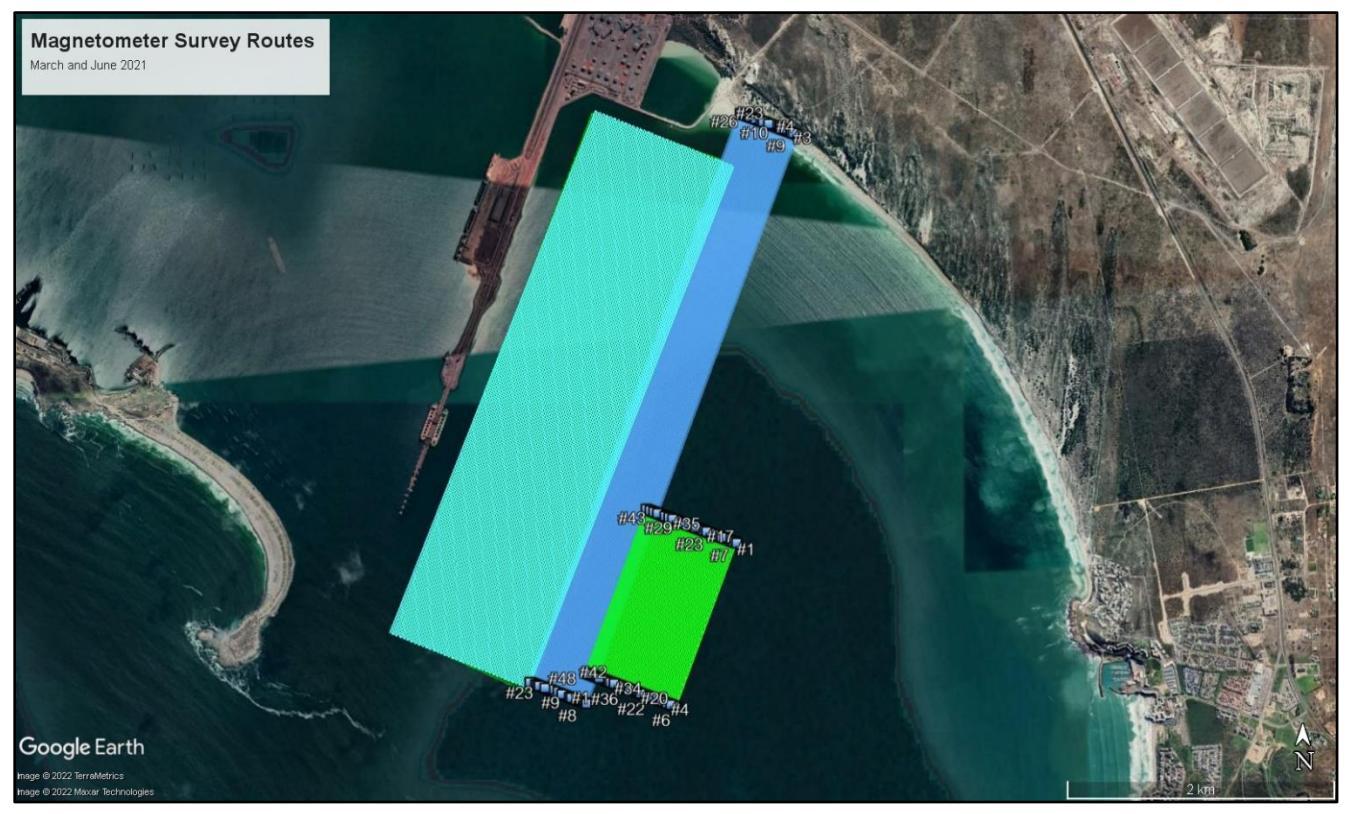
Figure 19: Saldanha Big Bay Pipeline All Survey Routes (Google Earth 2021)

As mentioned in Section 5.1, the bathymetry of the Impact Zone is -1.5 near the shore to -17 at the end of the Impact Zone. Big Bay has a tidal range of approximately 2 m, and we went as close to the shore as safety dictated (Figure 19). Page 28 of 53

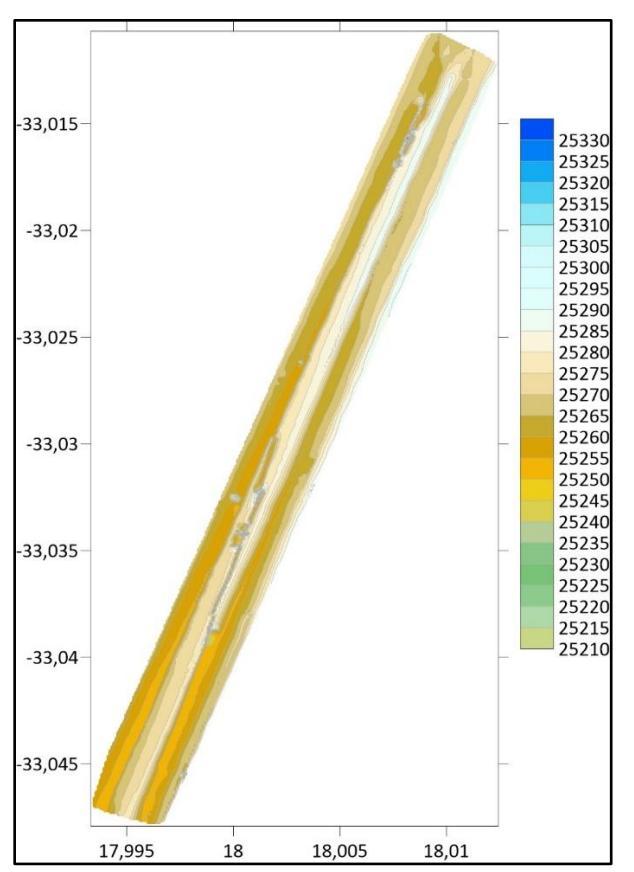
Figure 20: Zone 1: Surfer Survey Plot using contour intervals of 5 nT

The post-field analysis was interpreted with Surfer geophysical software (Figure 20).

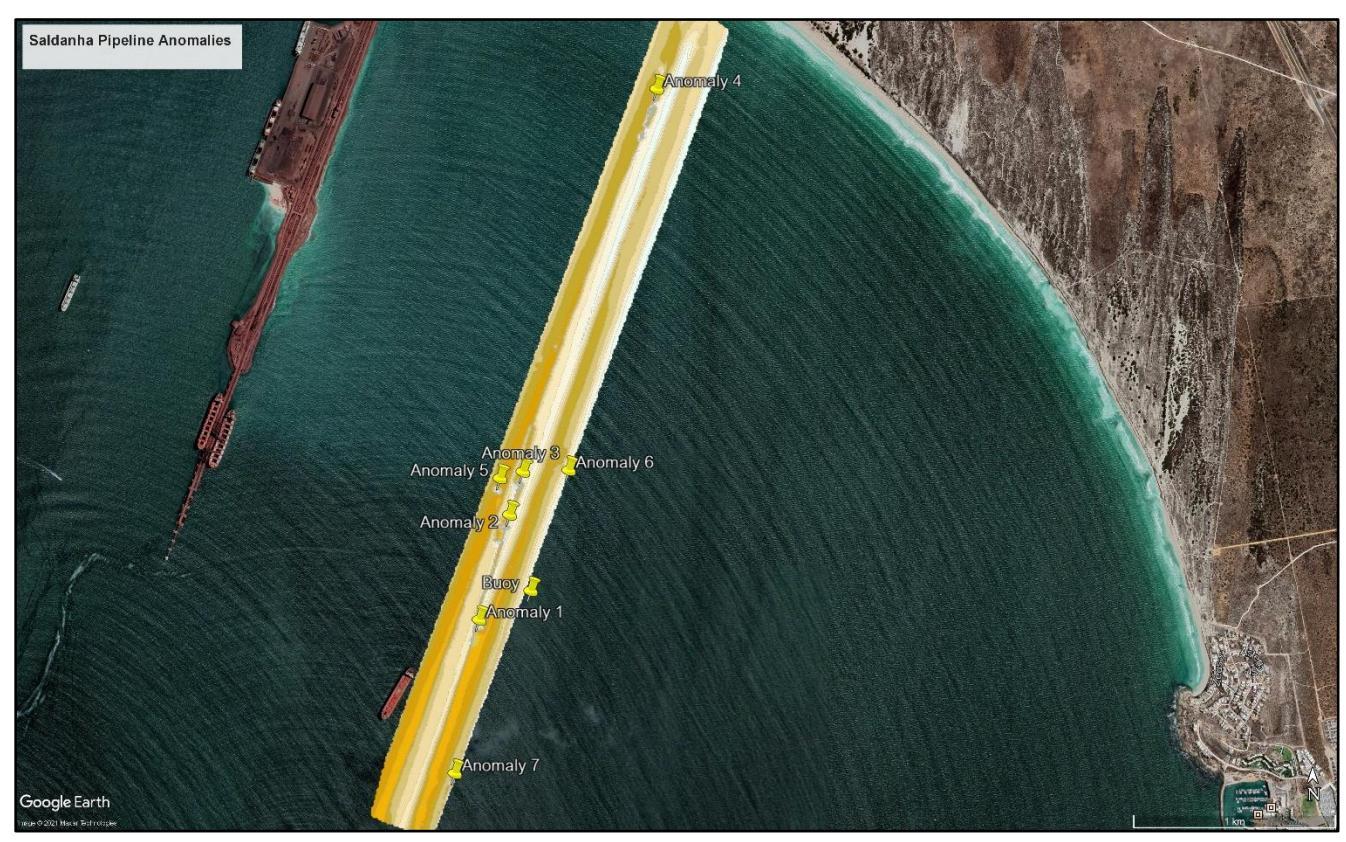
Figure 21: Magnetic map of Impact Zone with anomalies plotted

While there appear to be gaps between the blocks (Figure 29 and Figure 21), this is an artefact of the geophysical software processing. All the areas were surveyed as thoroughly as possible. The magnetic anomaly co-ordinates are supplied in Table 4. All shipwrecks, even wooden shipwrecks have a large magnetic signature. The field survey revealed a few anomalies (Figure 21)

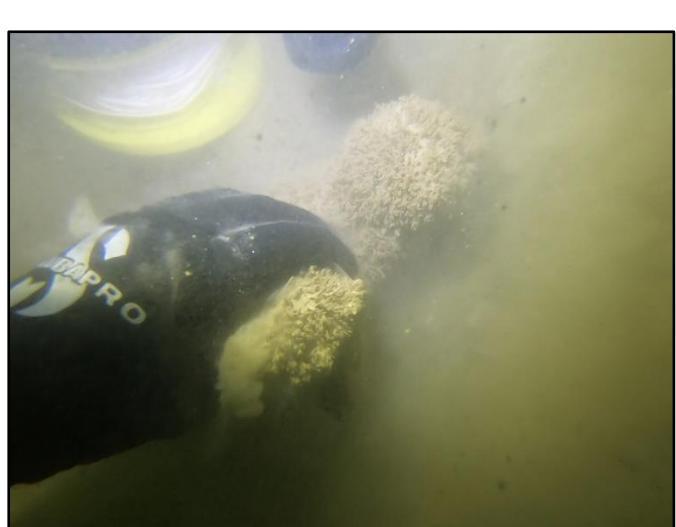
Figure 22: Silt seabed and low visibility

We decided to dive on Anomaly 6 first as it was further away from the vessels. The visibility was hampered by the turbidity with a visibility of 0.5 m (Figure 22). A circular search was conducted, and some ferrous objects were found (Figure 23).

Only two dives were undertaken. The high turbidity and zero visibility severely hampered the searches. No visible underwater cultural heritage resources were found. As the old pipeline was not visible, it is believed that the thick silt in Page 31 of 53

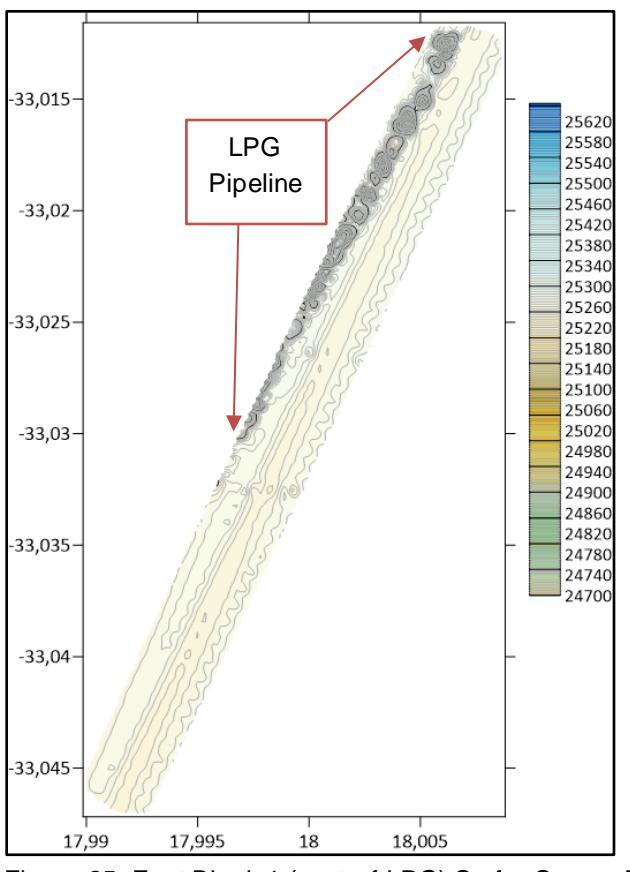
Figure 25: East Block 1 (east of LPG) Surfer Survey Plot using contour intervals of 5 nT

This block (Figure 25) picked up the LPG pipeline very nicely, I have not numbered this anomaly as it is very obviously the pipeline.

In view of this, I am revising my opinion as to the possible pipeline noted in the March 2021 report. I previously stated "Anomalies 1 - 4 are in a fairly straight line and there is a line of smaller anomalies connecting Anomalies 1 - 3. However, Anomalies 1 - 3 were much bigger than the connecting magnetic signature. Anomalies 5 - 7 were off the old pipeline." In between the two surveys, I received the .kmz file of the LPG mooring and four anomalies lie directly under the mooring blocks mapped, i.e., MA05, MA11, MA12 and MA13. Ergo, I assumed MA 1 - 3 with the connecting anomalies represented an old pipeline. However, given their proximity to MA05, these may be old chain from the mooring blocks. The other anomaly in this block is MA18 which correlates with the LPG buoys (Figure 32)

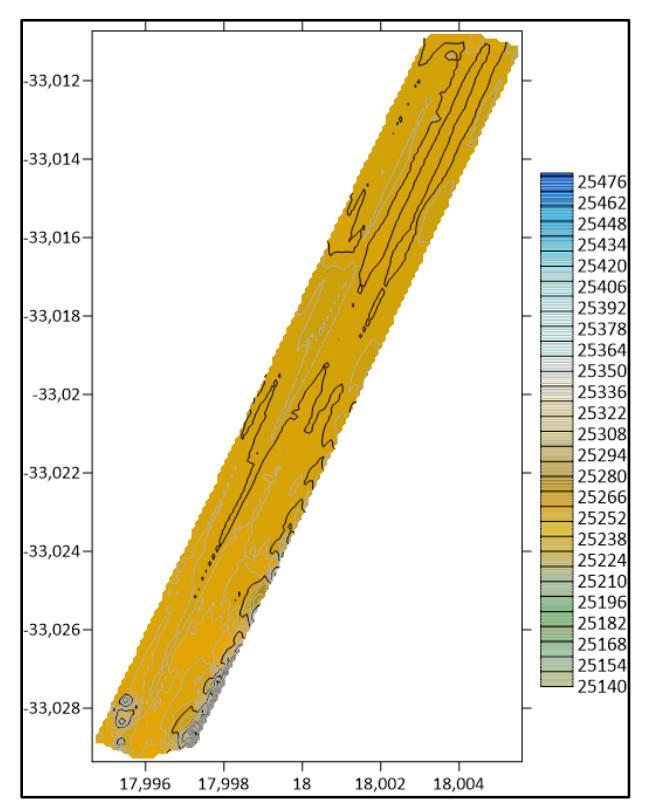
Figure 26: North Block (north of LPG) Surfer Survey Plot using contour intervals of 2 nT

This block (Figure 26) was surveyed as close as possible to the LPG mooring. This block has one major anomaly, MA13 which correlates with the LPG mooring block. There is a small anomaly on the extreme eastern edge, but I believe it is a result of the pumphouse on the wall of the beach well, this water is processed and used for iron ore dust dampening (Figure 33)

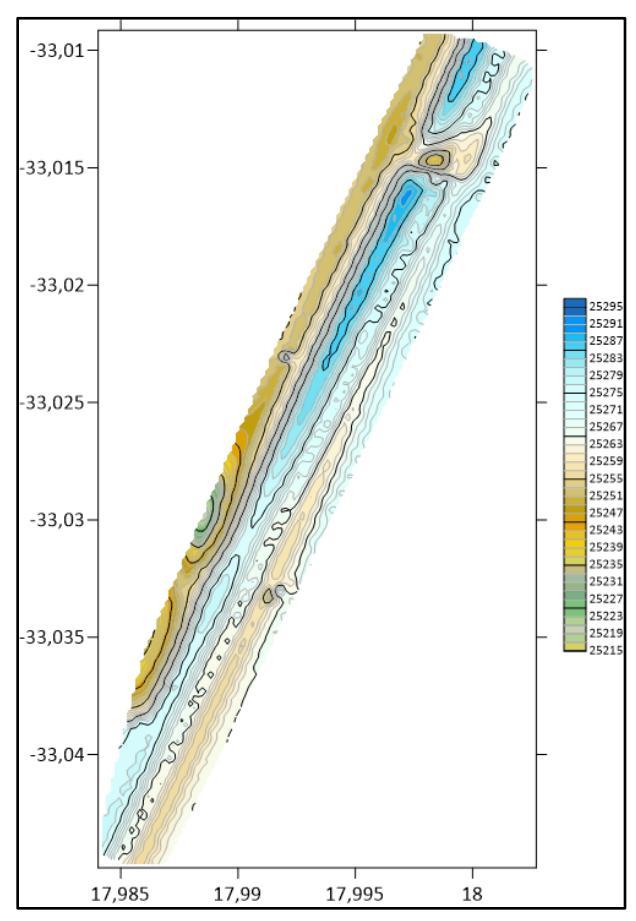
Figure 28: West Block (west of LPG) Surfer Survey Plot using contour intervals of 2 nT

This block (Figure 28) is truncated at the southern edge as it went into the shipping channel and that will always remain unobstructed by construction. MA12 correlates with the LPG mooring block and MA14 is the build -up of the magnetic signature of the vessel moored at the Iron Ore Jetty (Figure 34).

MA16, further north is 288 m from the jetty and may be jetty debris, although it may be MUCH. The anomaly to look out for during construction is further north. MA15, it is a fairly large anomaly, not near to the jetty and far away from where ships dock. It is also close to the shoreline where one usually finds wrecks. It is directly under the proposed pipeline and must be investigated prior to construction (see Section 12).

- An archaeologist must be appointed for the duration of the construction phase of the project, specifically for the beach/dune area.
- The appointed archaeologist must have the requisite experience and knowledge to recognise maritime cultural heritage that may be found in the beach/dune area.
- The appointed archaeologist must do a short induction to familiarise the contractors and workers, including divers, to the potential heritage material artefacts that may be exposed during work. This includes Stone Age, Early Farming communities, colonial and shipwreck artefacts and human burials.

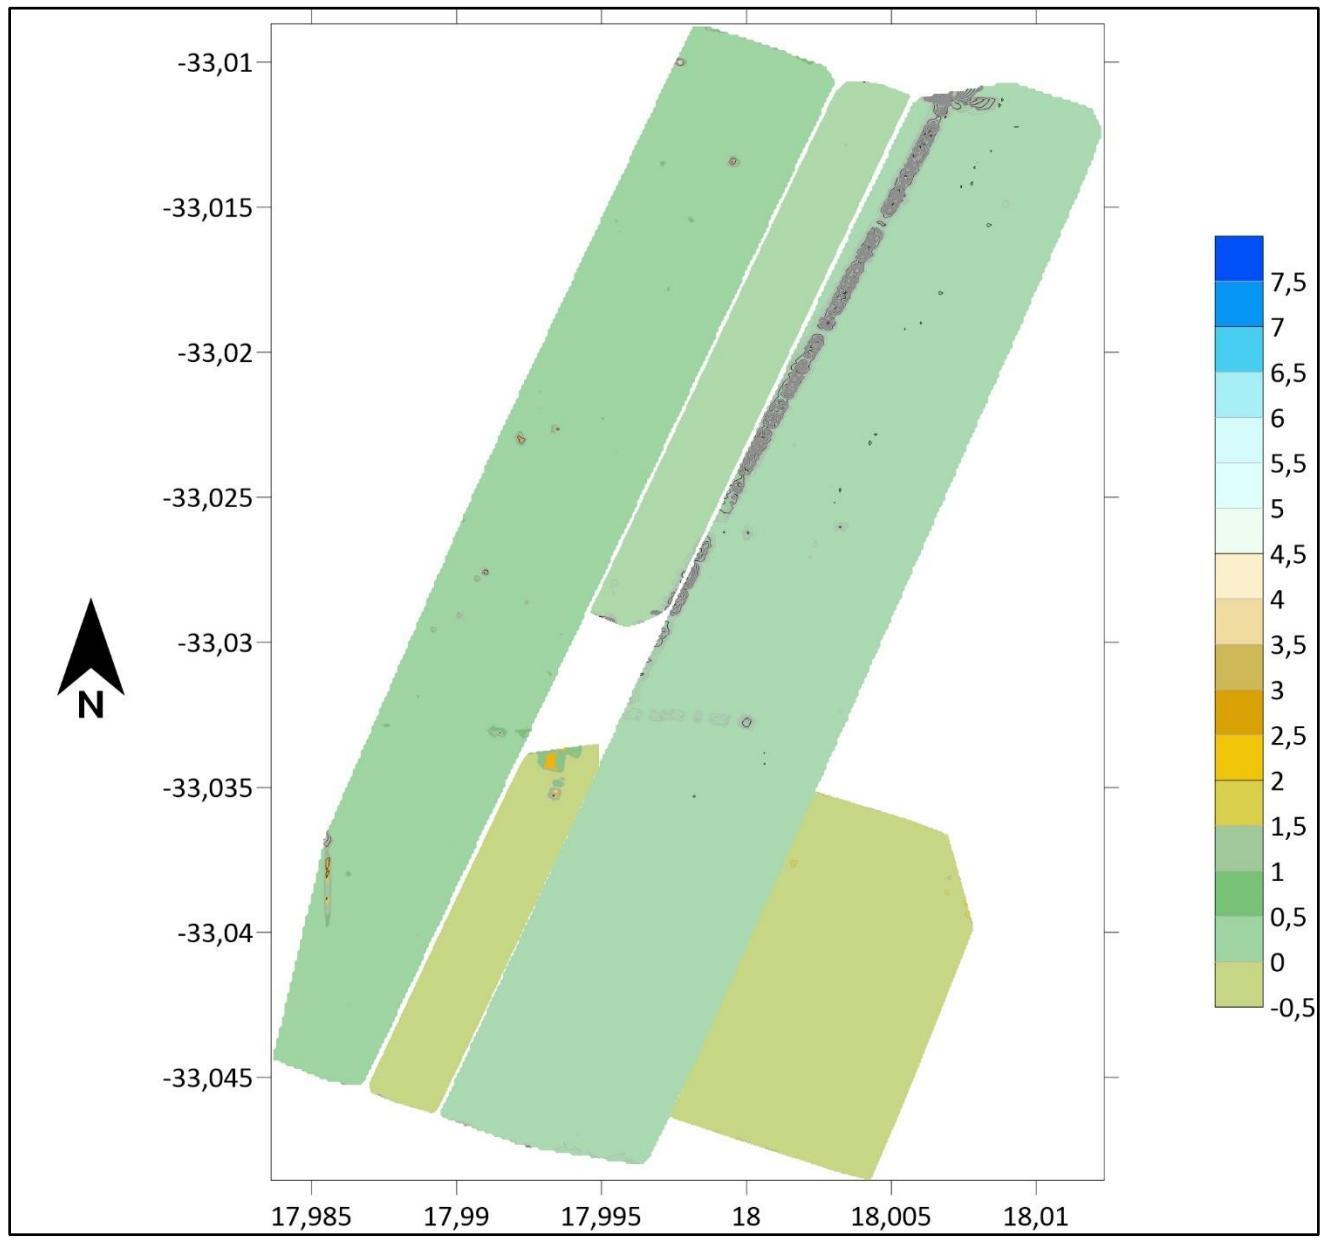
Figure 35: 3-point Gradient Magnetometer Map of the Impact zone

As can be seen in Figure 35, the magnetic contour lines are more distinct, while several anomalies are still visible, it is easier to interpret.

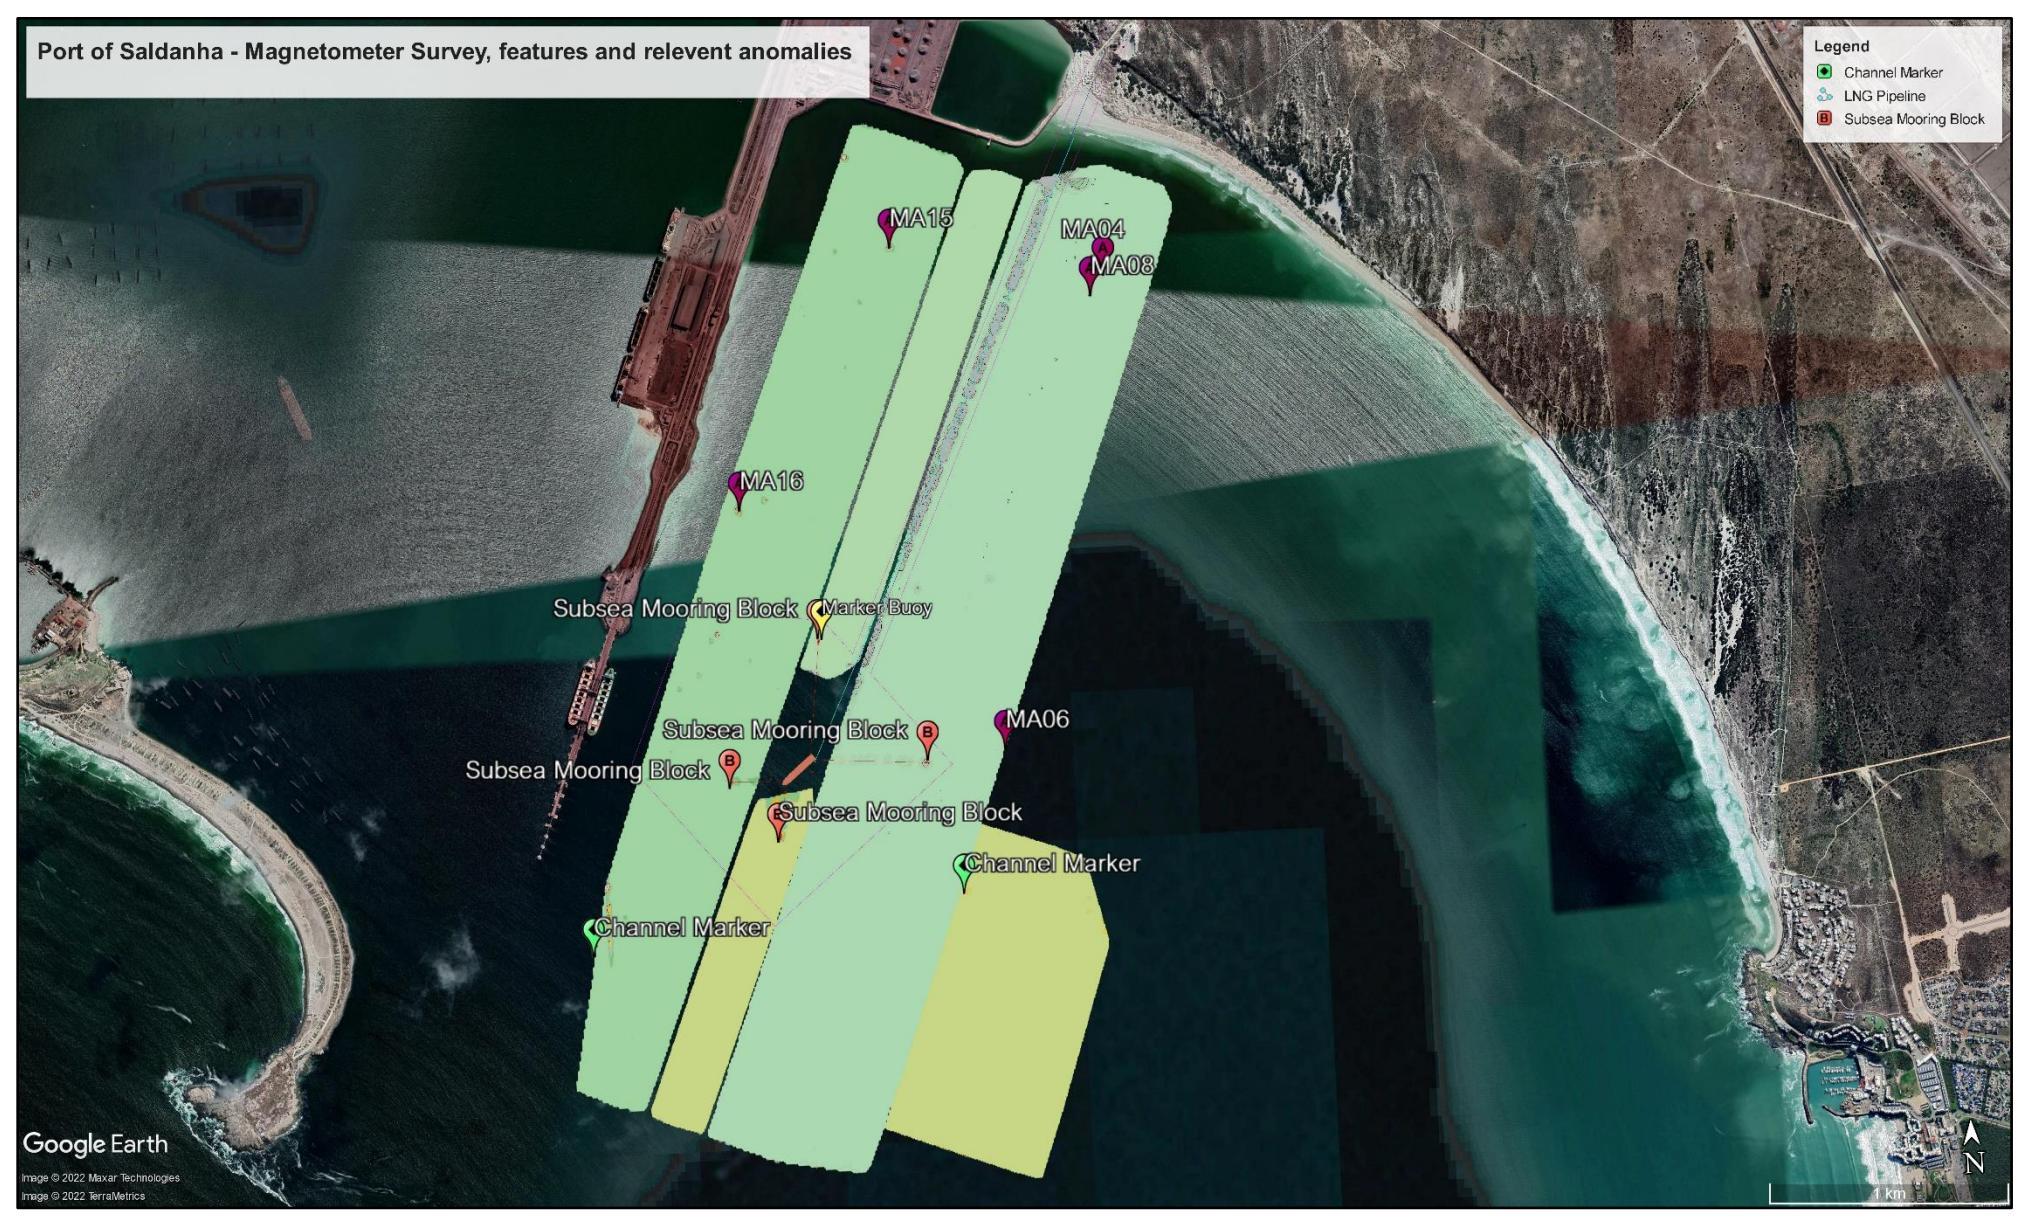
Figure 36: Revised magnetometer survey with features and relevant anomalies

Magnetic Anomaly #	c Co-ordinates y		Survey #	Cause	Final Notes after 3-point Gradient Applied
MA01	33° 2.328'S	17° 59.936'E	1	Unknown	Removed – N/A
MA02	33° 2.048'S	18° 0.033'E	1	Unknown	Removed – N/A
MA17	Blue Line			Possible length of chain between MA1 and MA2	Removed – N/A
MA03	33° 1.934'S	18° 0.075'E	1	Unknown	Removed – N/A
MA04	33° 0.894'S	18° 0.539'E	1	Unknown	To be investigated, if impacted
MA05	33° 1.951'S	18° 0.002'E	1	LPG Mooring Block	Removed – N/A
MA06	33° 1.944'S	18° 0.215'E	1	Possible build-up to object further East	To be investigated, if impacted
MA07	33° 2.736'S	17° 59.859'E	1	Unknown	Removed – N/A
MA08	33° 0.938'S	18° 0.502'E	1	Unknown	To be investigated, if impacted
MA09	33° 2.256'S	18° 0.101'E	2	Channel Marker (Figure 31)	Removed – N/A
MA10	33° 2.529'S	18° 0.159'E	2	Probably harbour debris	Removed – N/A
MA11	33° 2.112'S	17° 59.599'E	2	LPG Mooring Block	Removed – N/A
MA12	33° 1.986'S	17° 59.495'E	2	LPG Mooring Block	Removed – N/A
