SHEET 11 COPY 3

PROPOSAL: Front Boundary Wall

CLIENT: MR LAPIN

ADDRESS: 16 HIGHGATE PLACE

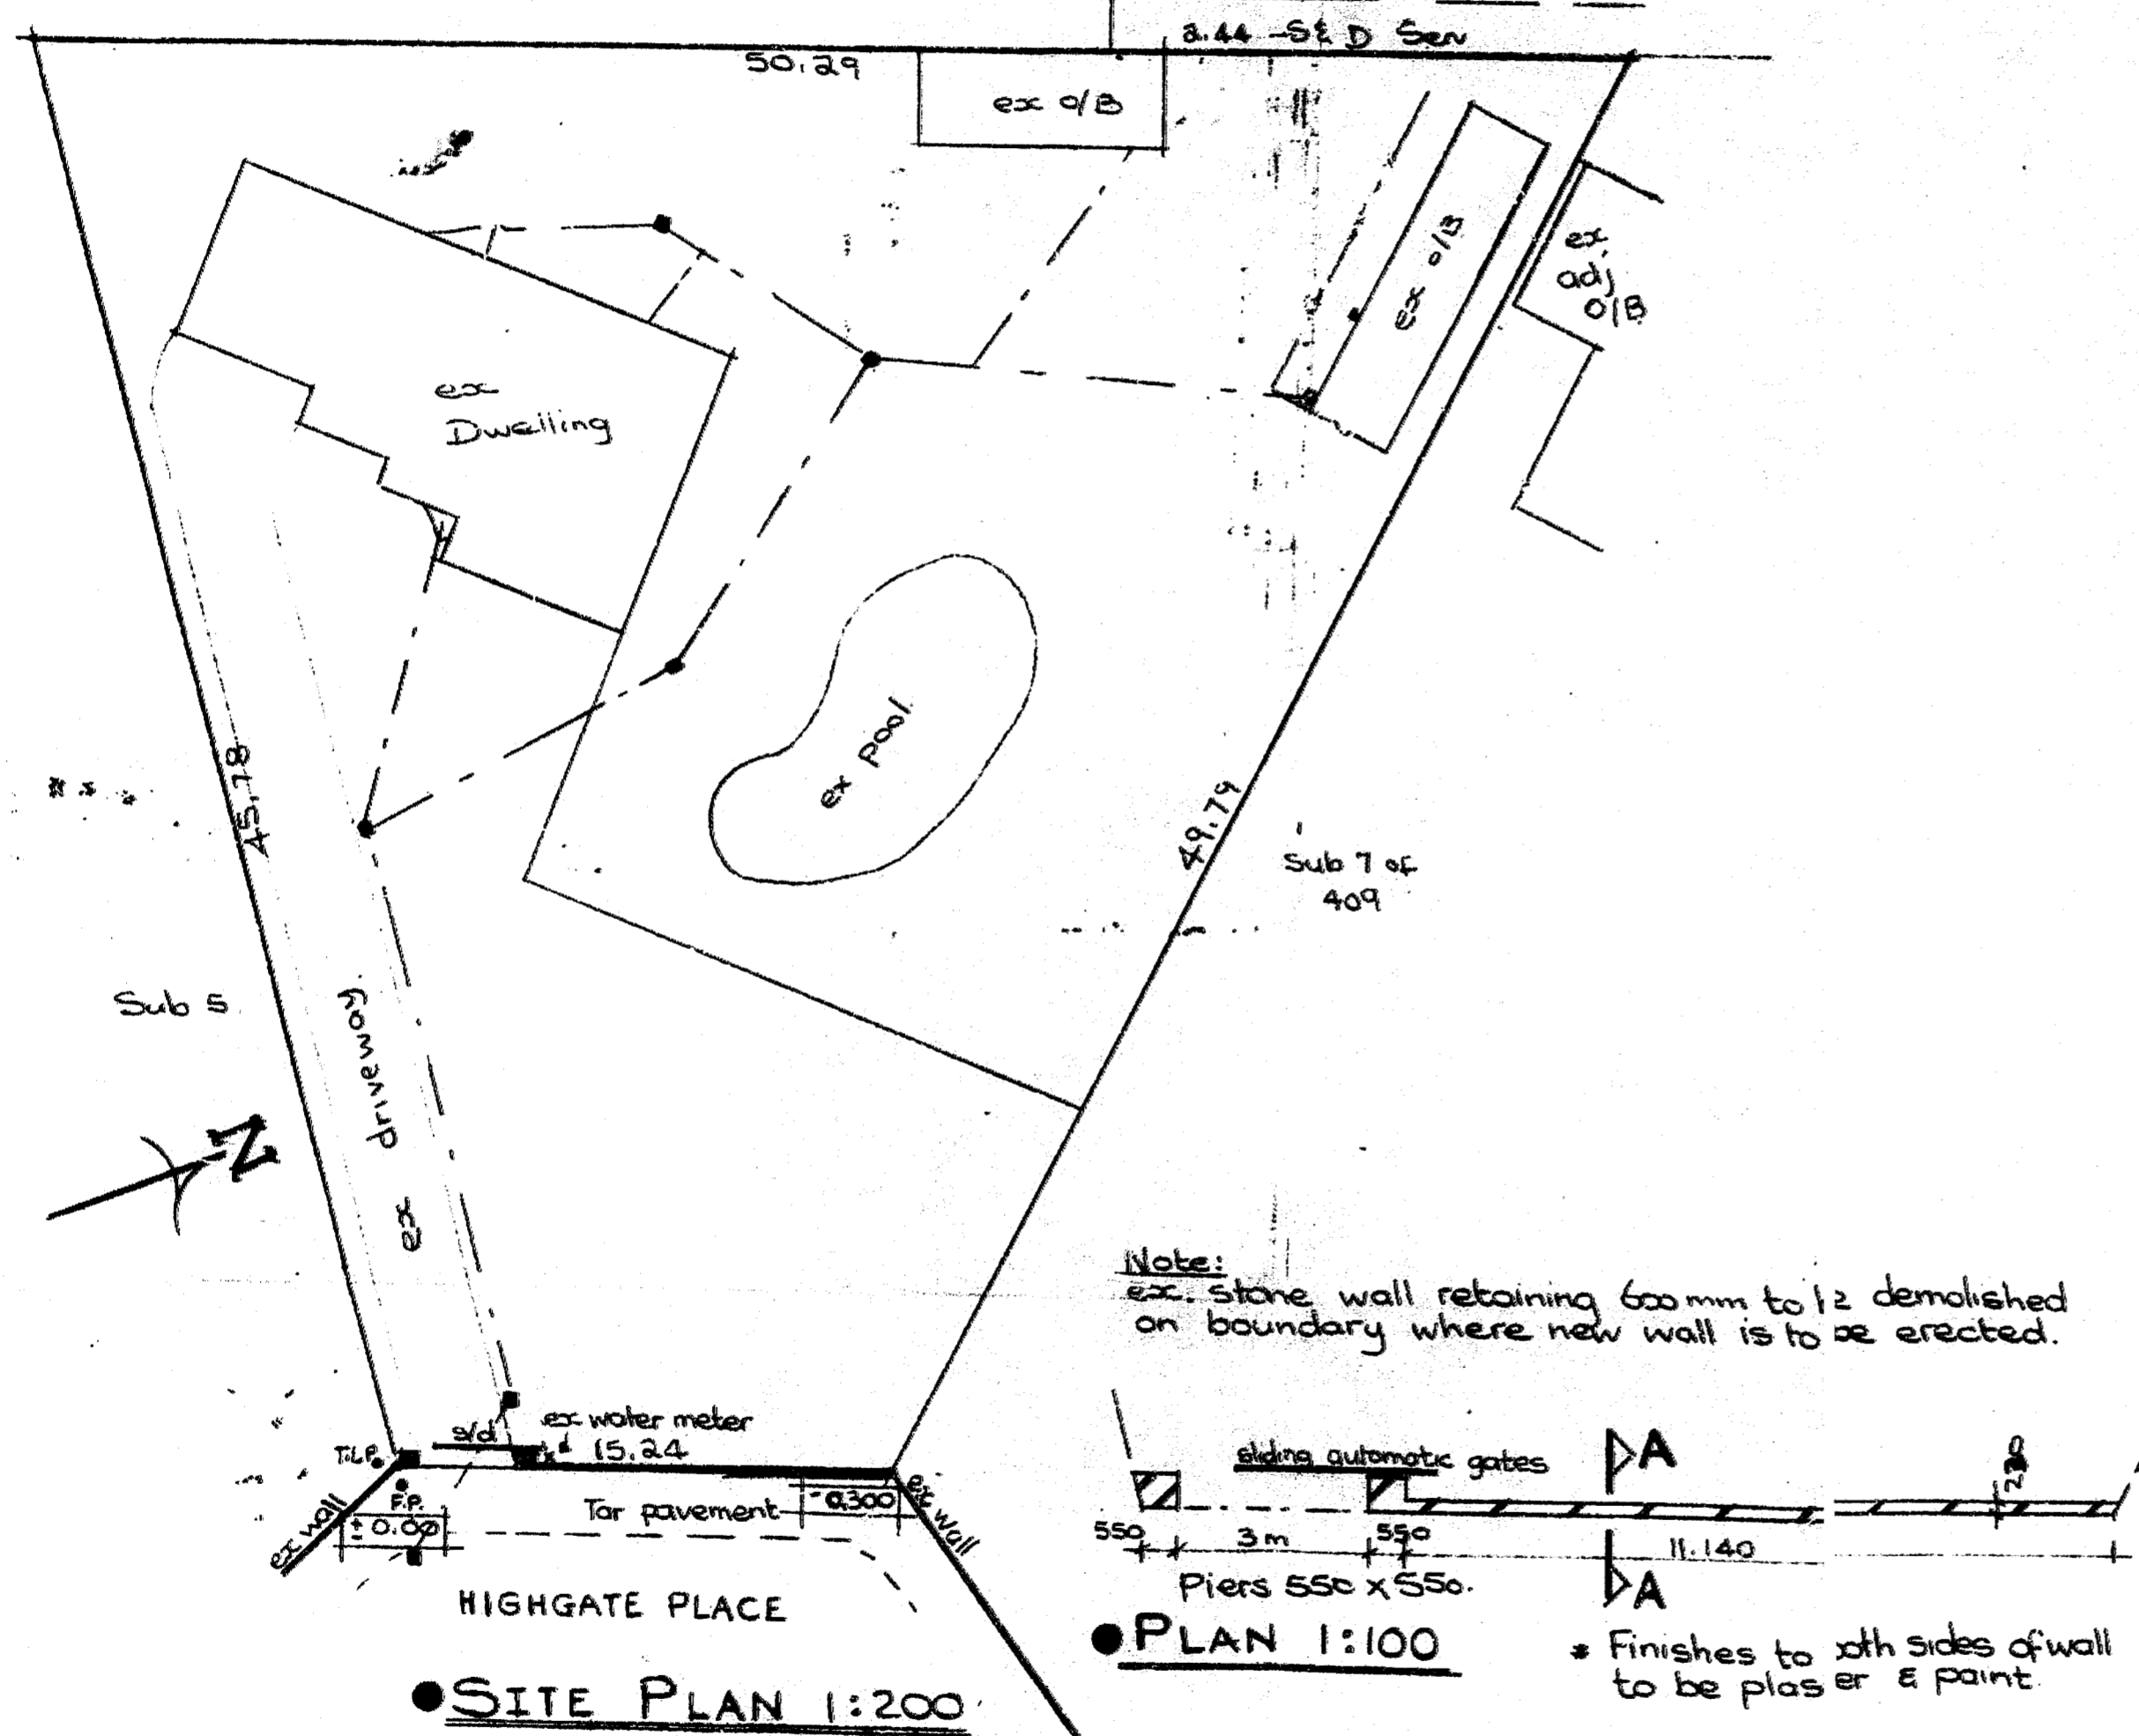
**PLAN 1:100**

**Note:**  
 ex. stone wall retaining 600mm to 12 demolished on boundary where new wall is to be erected.

sliding automatic gates

Piers 550 x 550.

\* Finishes to both sides of wall to be plaster & paint.
