FINAL BASIC ASSESSMENT REPORT:

**THE DEVELOPMENT OF A
RETAIL CENTRE ON
ERVEN 20, 21 AND 22 OF
PRESIDENT PARK X6,
EMALAHLENI (WITBANK)**

Report prepared for: Meronox (Pty) Ltd

Report dated: June 2021 (final)

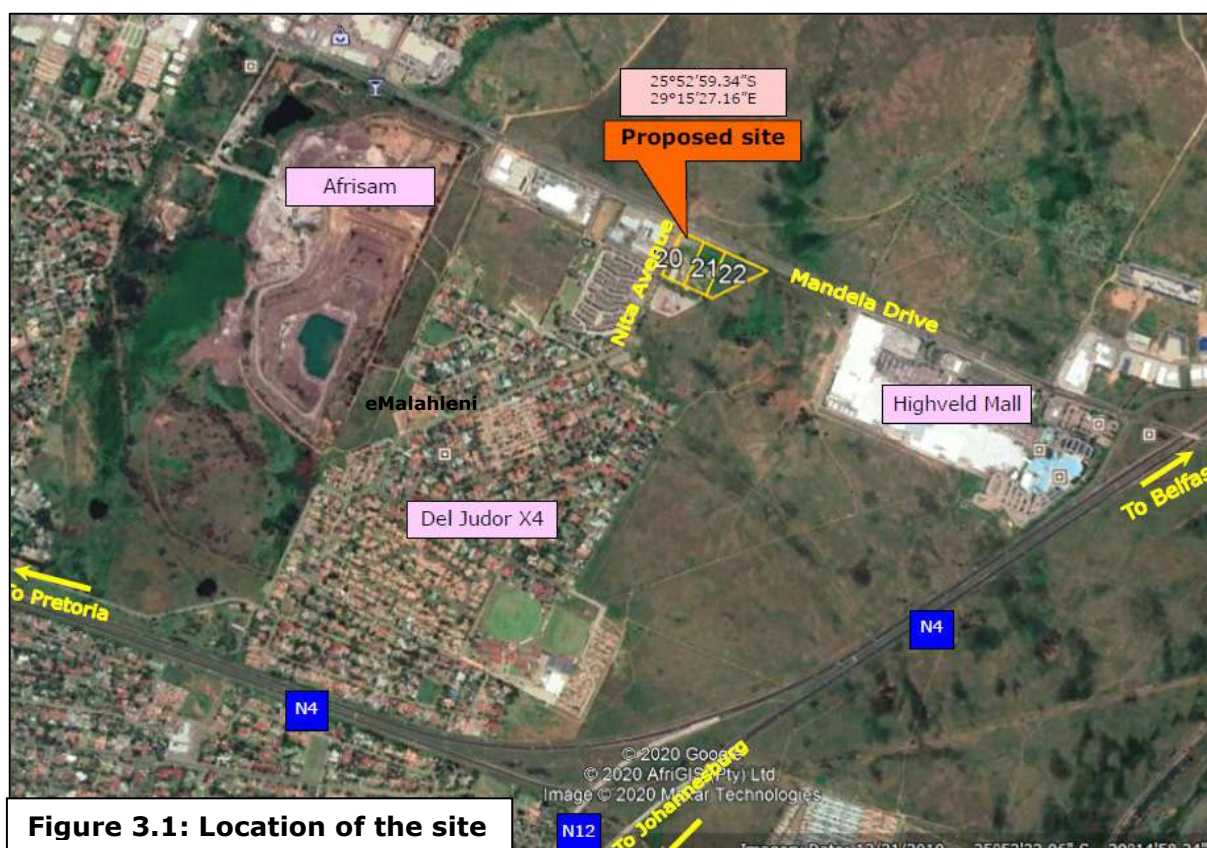
Figure 3.1: Location of the site

The applicant, **Meronox (Pty) Ltd.**, intends to develop a retail centre on Erven 20, 21 and 22 of President Park X6, eMalahleni. The proposed site is located on the corner of Nita Avenue and Mandela Drive, adjacent to the Portuguese Club and opposite the Nissan dealership, eMalahleni (Figure 3.1).

The applicant, **Meronox (Pty) Ltd.**, intends to develop a retail centre on Erven 20, 21 and 22 of President Park X6, eMalahleni. The proposed site is located on the corner of Nita Avenue and Mandela Drive, adjacent to the Portuguese Club and opposite the Nissan dealership, eMalahleni (Figure 3.1).

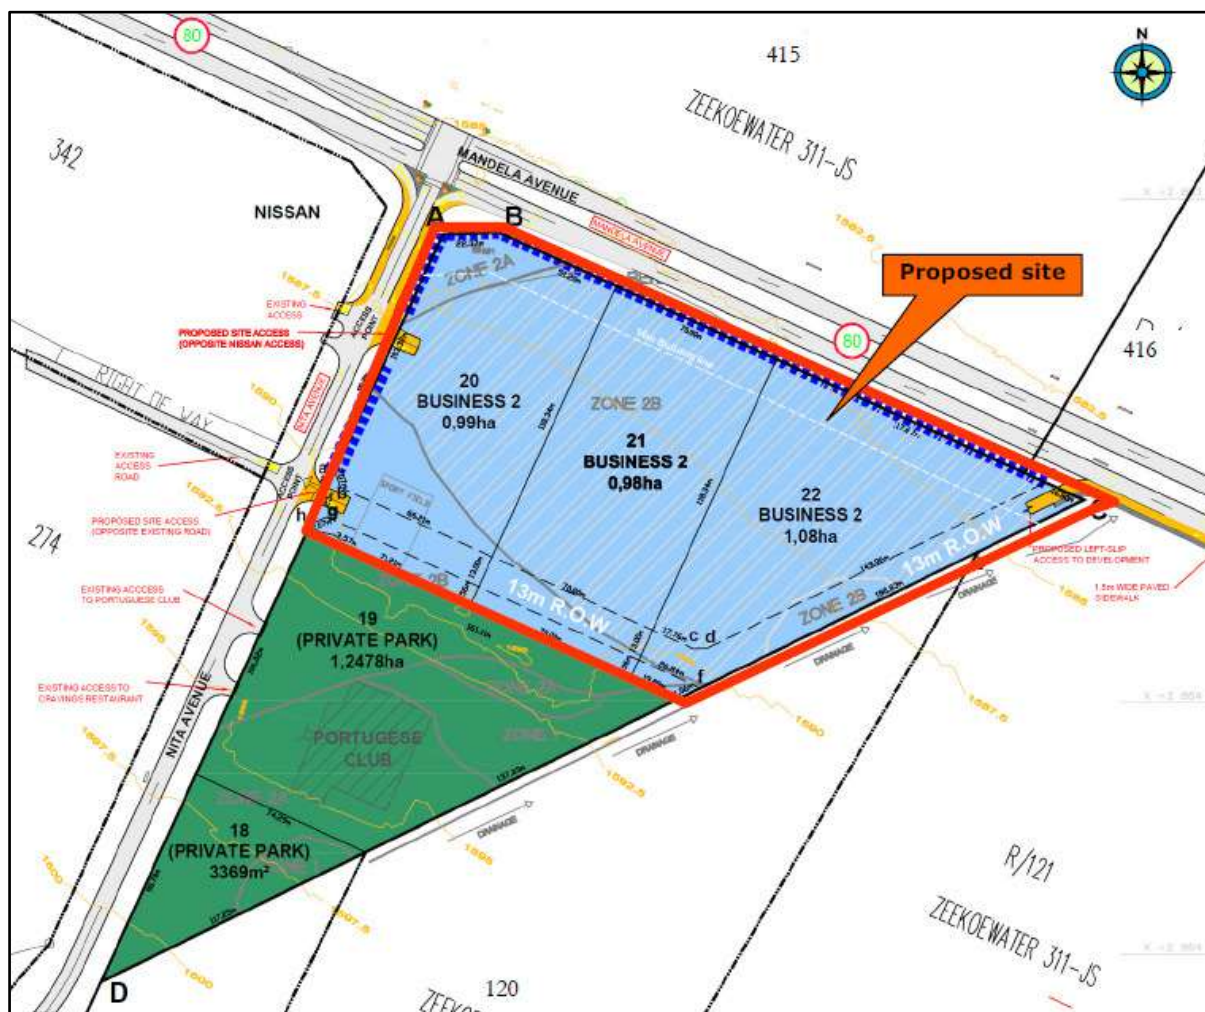
Figure 3.2: Layout of the 3 erven to be developed

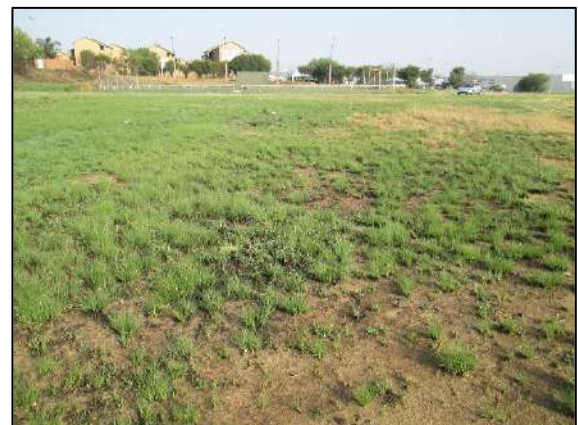
Photo 5.2: Levelled area on site used for parking

The entire area surrounding the sports facility was levelled and is used for parking (Photo 5.2). On an annual basis, the site is used by the circus and an amusement park company (with merry-go-rounds, ferris wheel, etc.).

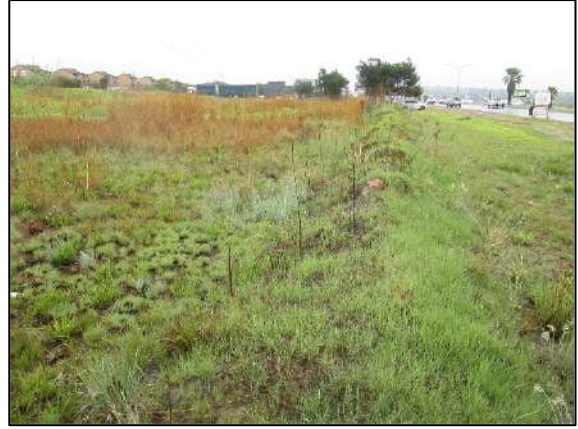
A berm was constructed along the northern boundary of the site (Photo 5.4) to divert storm water to a culvert extending underneath Mandela Drive (Photo 5.5). Sewer manholes were noted on the northern boundary of the site adjacent to the berm (Photo 5.6).

Photo 5.3: Area where building rubble is present **Photo 5.4: Berm along northern boundary**

A berm was constructed along the northern boundary of the site (Photo 5.4) to divert storm water to a culvert extending underneath Mandela Drive (Photo 5.5).

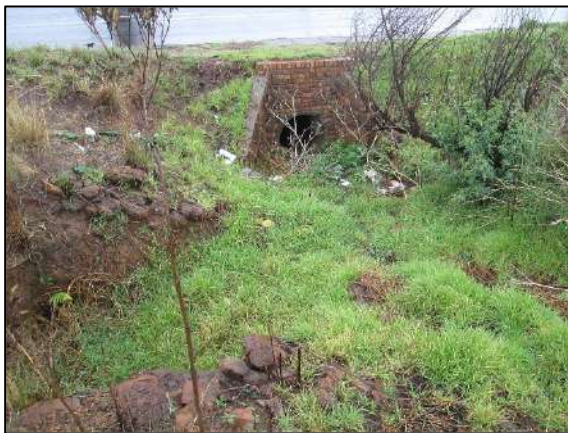
Photo 5.5: Storm water culvert under Mandela Drive **Photo 5.6: Open sewer manhole**

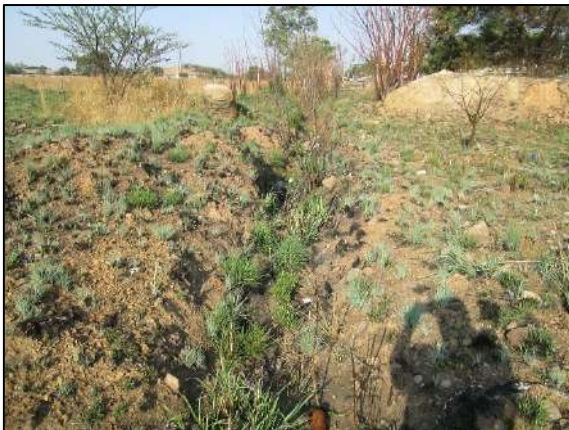
An old water pipeline, partially excavated (Photo 5.7), is present along the eastern boundary of the site. A Telkom line also used to be present along the eastern boundary (Photo 5.7).

Photo 5.7: Partially excavated pipeline and remains of Telkom infrastructure

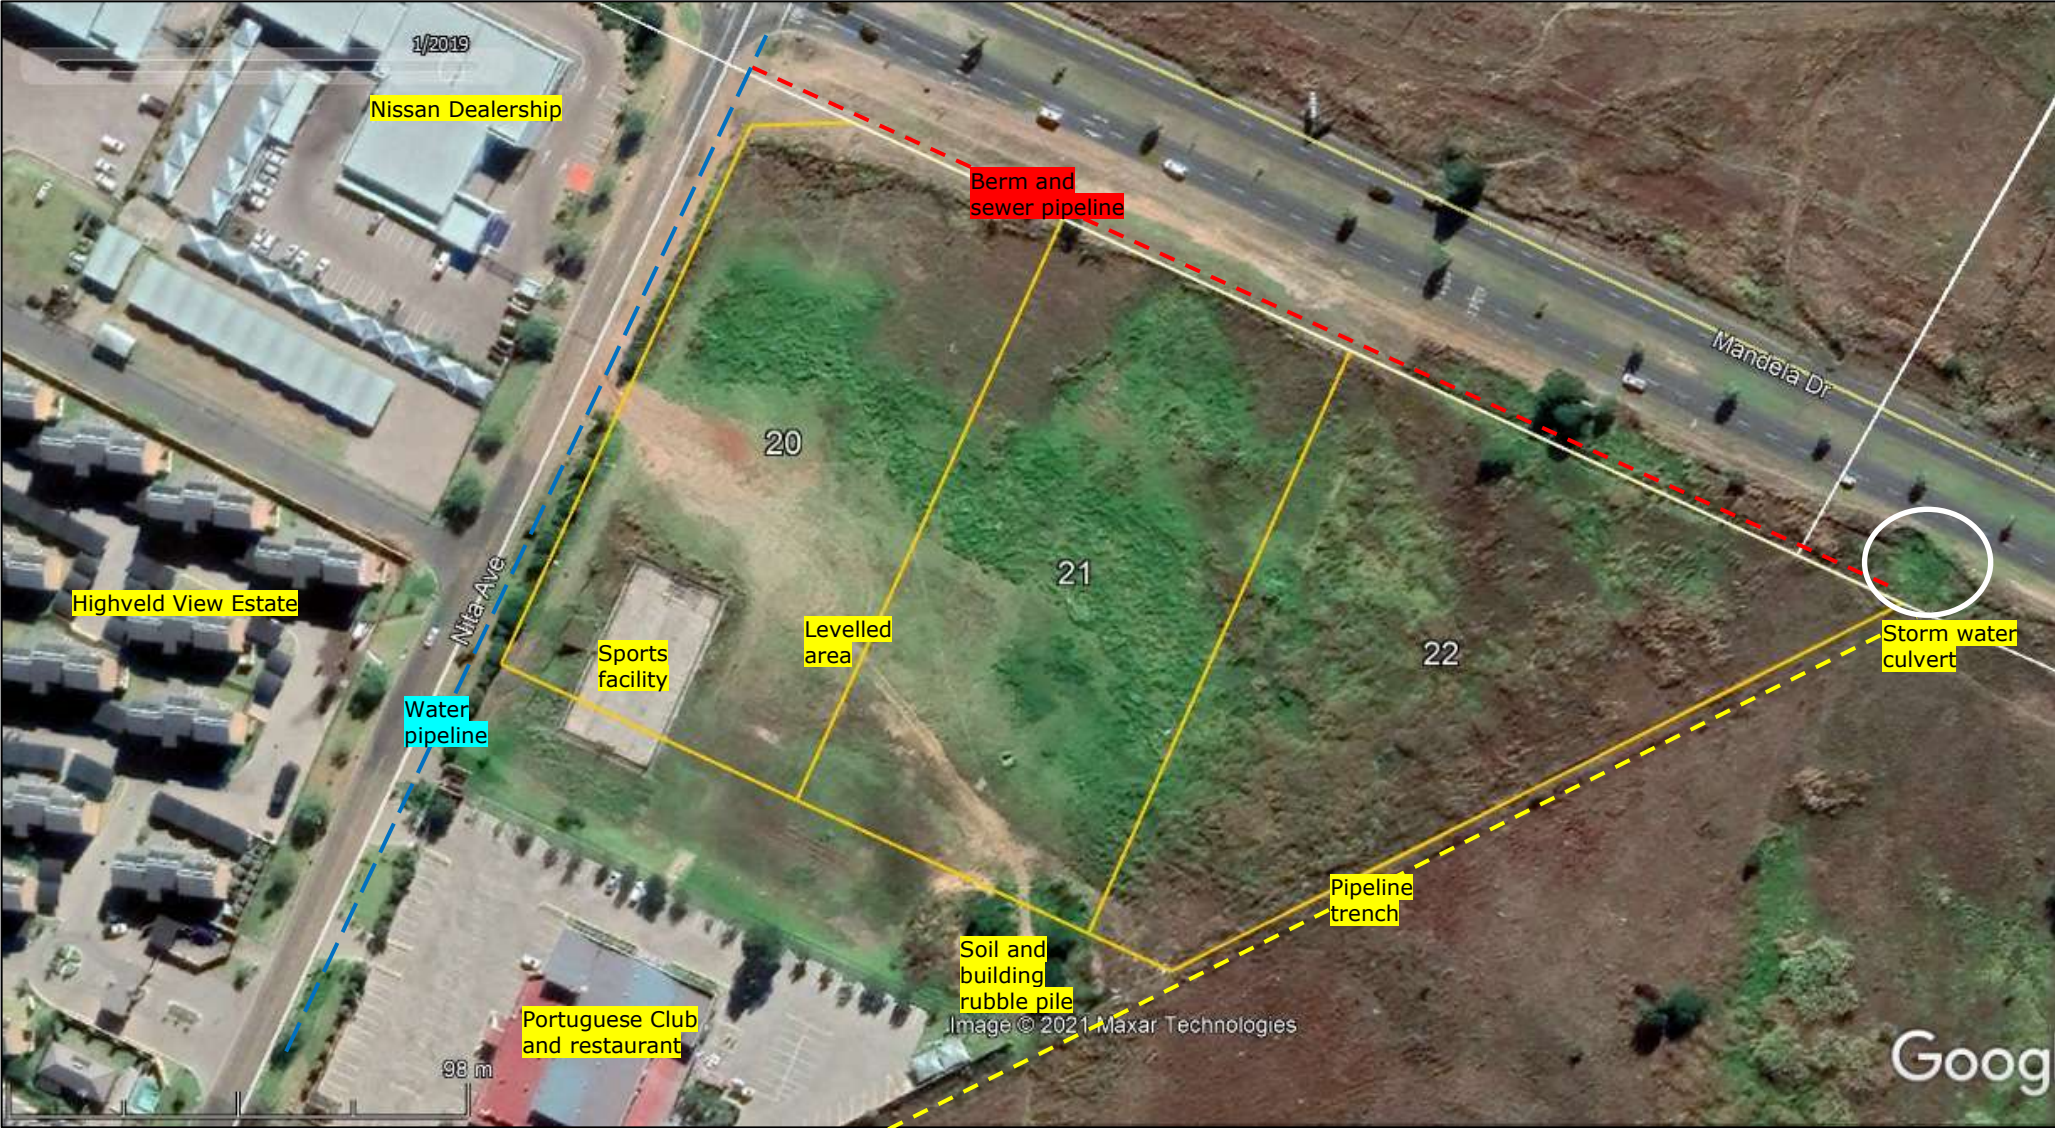
Figure 5.3: Aerial view of the site

Mandela Drive is located along the northern boundary of the site (Photo 5.8; Figure 5.3) and Nita Avenue along the western boundary (Photo 5.8; Figure 5.3).

A Nissan motor dealership, Highveld View Estate and Indlela Lodge are present west of Nita Avenue (Figure 5.3; Photo 5.9). Further west is the quarry belonging to Afrisam Aggregates and Ready-mix (Figure 5.4).

The Portuguese Club and Casa Portuguesa Restaurant are located on the southern boundary of the site (Figure 5.3).

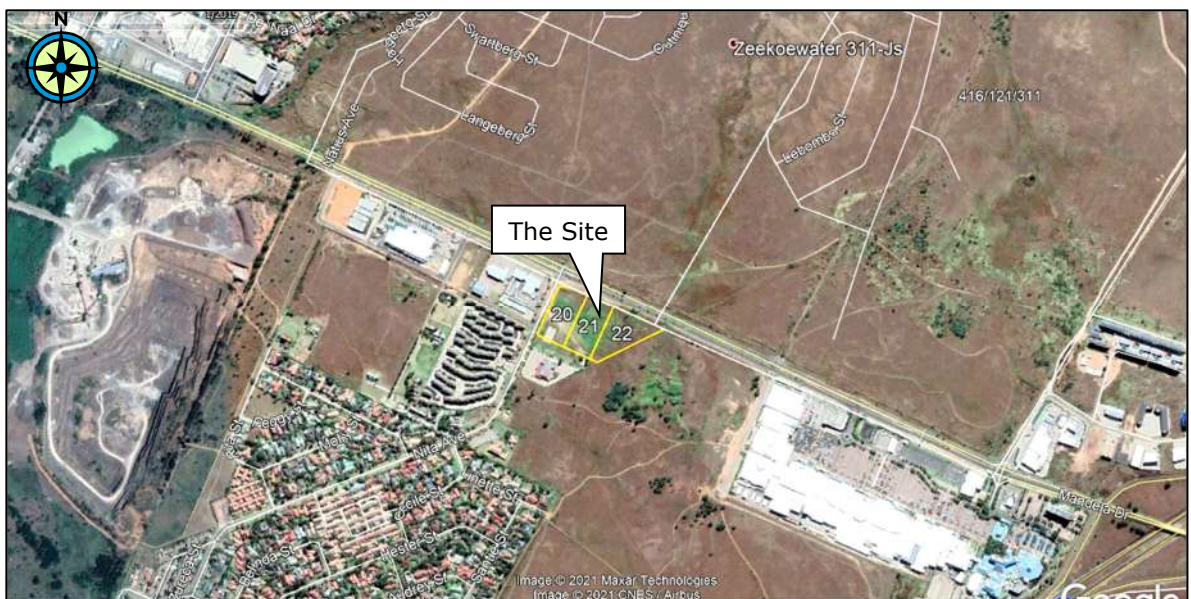
Figure 5.4: View of the site in relation to surrounding land uses

The properties north and east of the site are currently vacant (Figure 5.4) and are owned by the eMalahleni Local Municipality. The Highveld Mall, the Ridge Casino and Entertainment Complex and the N4 national road are located further towards the east (Figure 5.4).

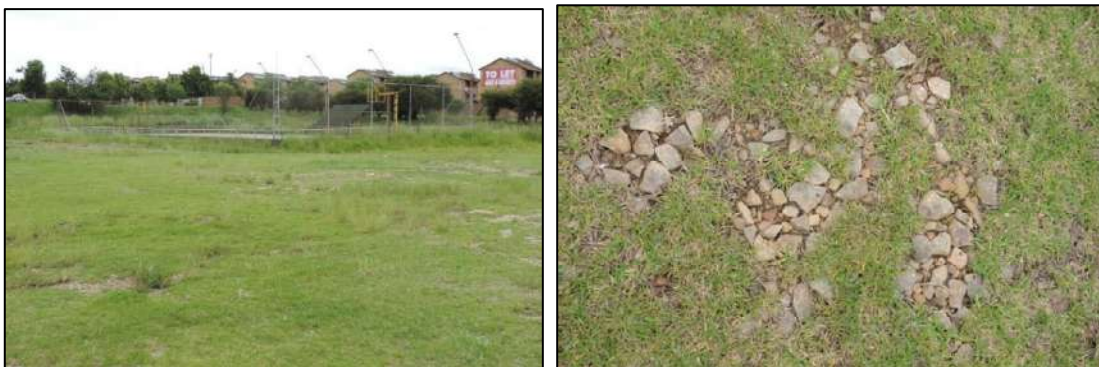
Venter (2020b) indicated that most of the site (i.e. the levelled area) falls within the Technosol group and more particularly the Johannesburg soil form, i.e. soil profiles covered by concrete structures, cement and waste materials including building gravel (Photo 5.10).

Photo 5.10: Johannesburg soil form present on the majority of the site (taken from Venter, 2020b)

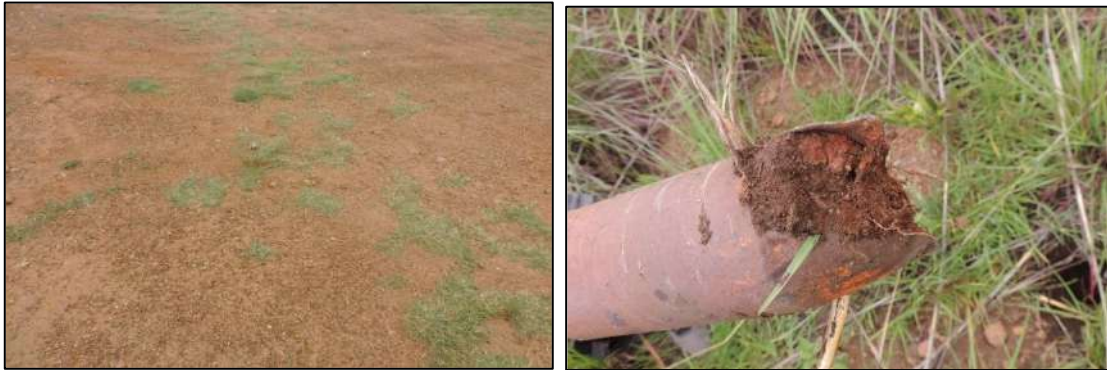
The north western corner of the site falls within the Anthrosol group and more particularly, the Grabouw soil form. According to Venter (2020b), this soil form may represent the original soil profile but with varying degrees of disturbance (including significant compaction) (Photo 5.11). In these areas, rainwater infiltration is very limited (as a result of the compacted surfaces) resulting in increased storm water volumes flowing from site towards Mandela Drive and properties located to the north thereof.

Photo 5.11: Grabouw soil form present in the north western corner of the site (taken from Venter, 2020b)

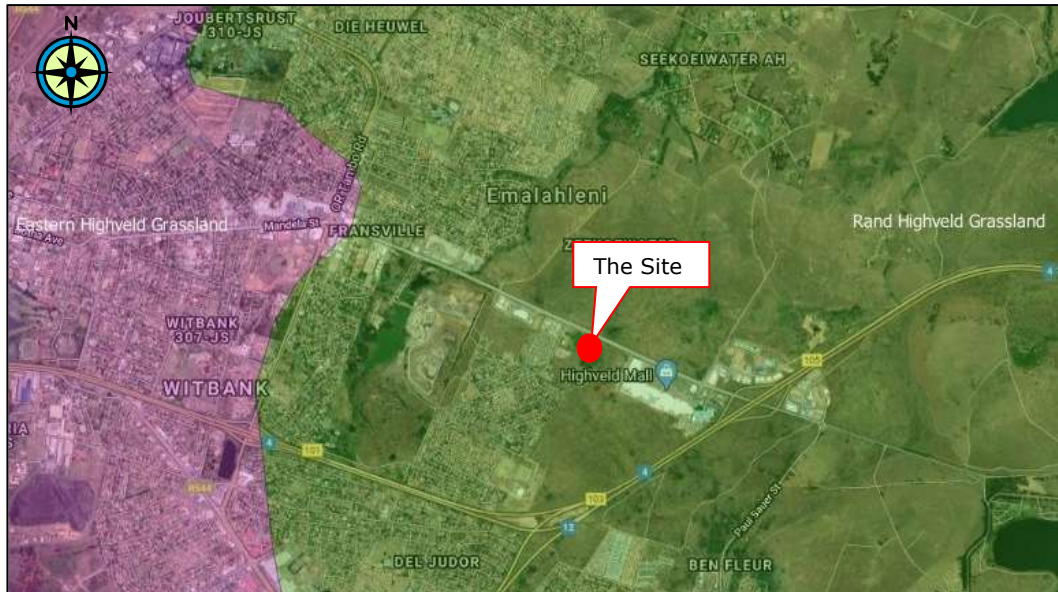
Figure 5.10: Vegetation type (taken from Mucina and Rutherford, 2006)

Almost half of the Rand Highveld Grassland has already been transformed by cultivation, urbanisation, plantations and dams. This vegetation type has been afforded the status of endangered with a conservation target of 24%. Only approximately 1% of this vegetation type is currently conserved.

The National List of Ecosystems that are Threatened and in need of protection (GN1002 of 2011), published under the National Environmental Management: Biodiversity Act (Act No. 10, 2004), lists this vegetation type as **Vulnerable**.

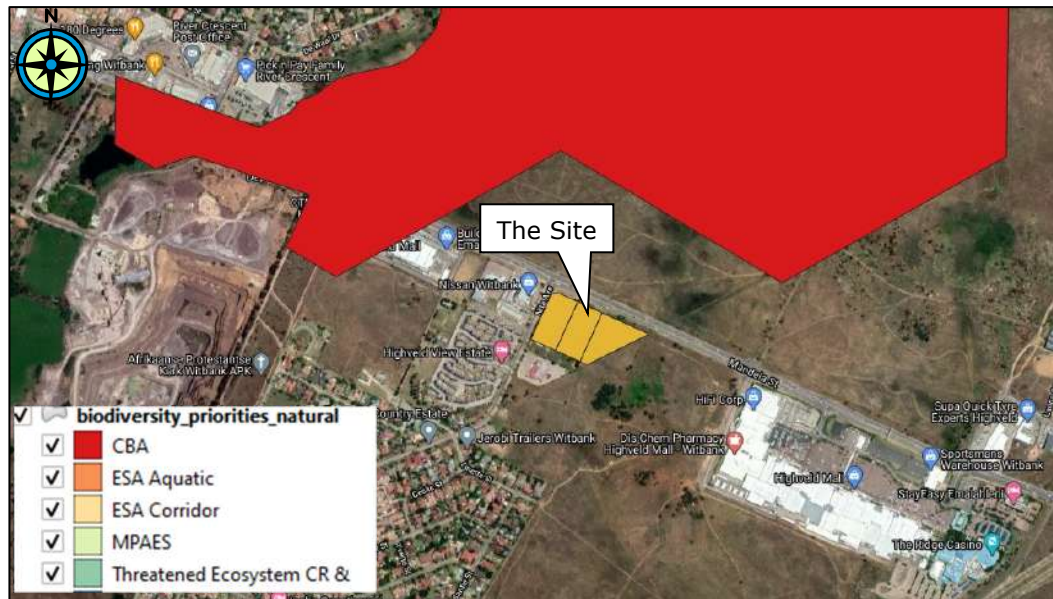
Figure 5.11a: Terrestrial biodiversity assessment of the Mpumalanga Biodiversity Conservation Plan, 2006

The site and surrounding area are indicated as '**No Natural Habitat Remaining**' (Figure 5.11a) in terms of the terrestrial biodiversity assessment of the Mpumalanga Biodiversity Conservation Plan (2006).

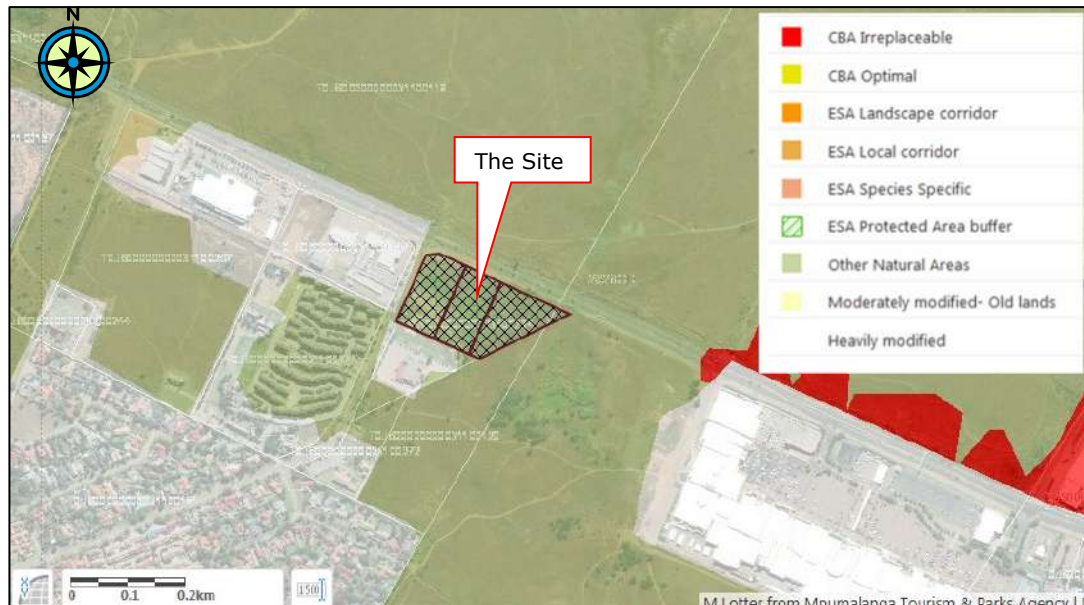
Figure 5.11b: Terrestrial biodiversity assessment of the Mpumalanga Biodiversity Sector Plan, 2013

The closest Critical Biodiversity Area (CBA) is located approximately 400m east of the site opposite the Highveld Mall (Figure 5.11b).

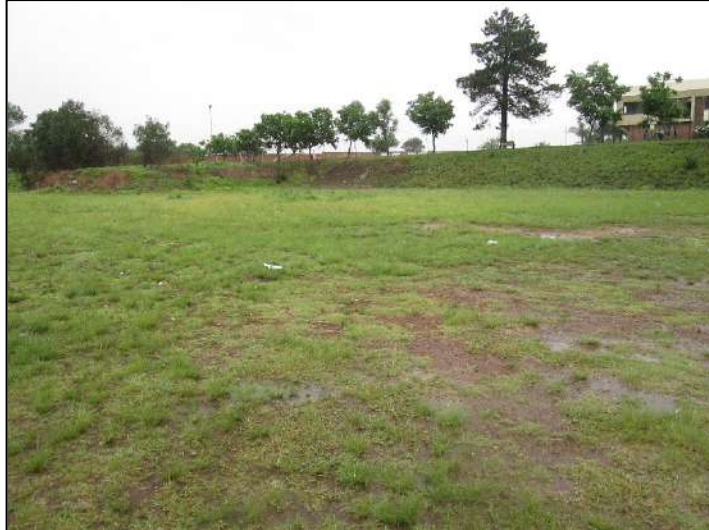
Photo 5.12: The Modified Grassland vegetation unit present on the levelled area (southern portion of the site)

Based on the above-mentioned, Venter (2020a) indicated that the vegetation on site is of **Low sensitivity**. A full vegetation assessment was therefore not required (Venter, 2020a).

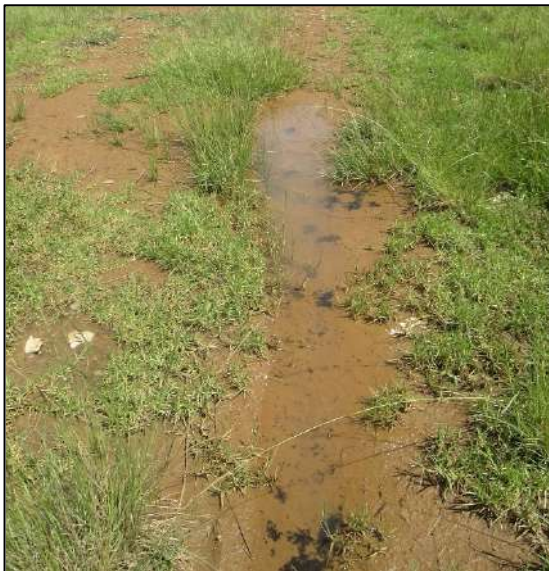
Photo 5.16c: Ponded vehicle tracks with tadpoles (@ 32 February 2021)

As indicated in the monitoring report (Appendix 3), AdiEnvironmental visited the site daily to monitor the progress of the tadpoles. It was soon evident that the artificial ponding area and the ponded vehicle track area (Photos 5.16b & c) do not contain water for long periods of time (as previously reported by Mr. Bloy).

- all the artificial ponding areas (Artificial Ponding area and the ponded vehicle tracks) were dry;
- all the tadpoles had died (Photo 5.16c).
- no further bullfrog breeding efforts (eggs and/or tadpoles) were observed on site.

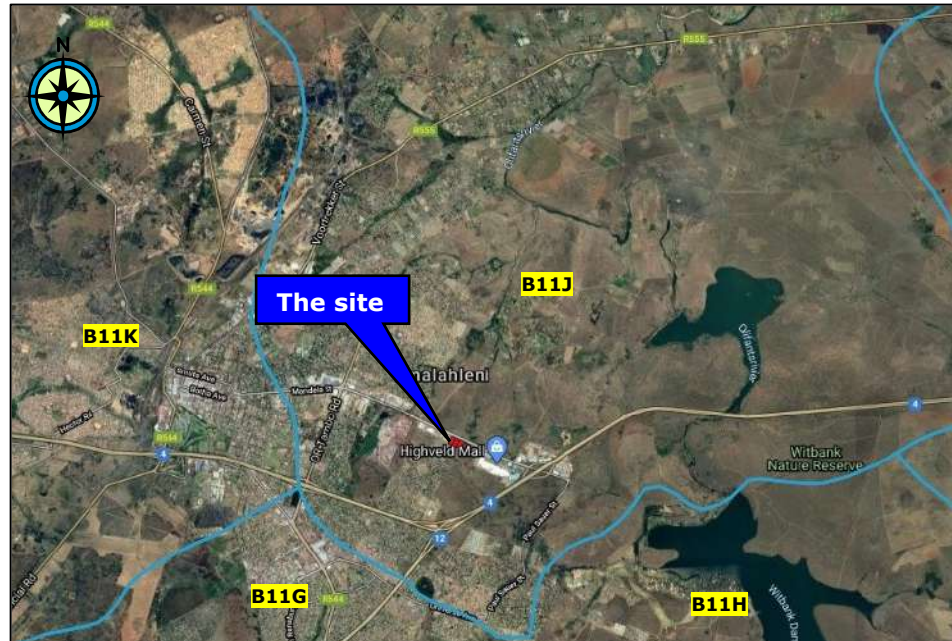
The proposed site is located within the Upper Olifants Water Management Area (WMA) and more specifically the B11J quaternary catchment (Figure 5.14).

Figure 5.14: The proposed site in relation to the B11J quaternary catchment.

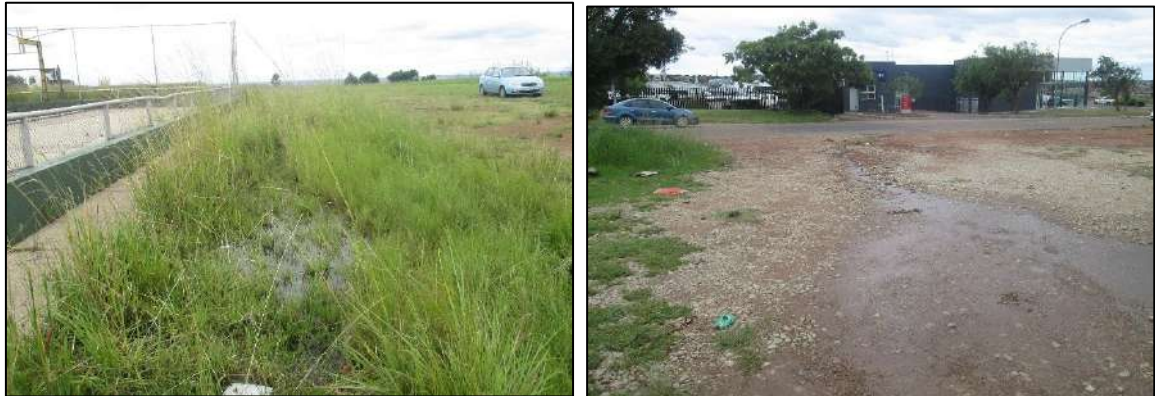
Photo 5.17: Storm water being diverted around the sports facility towards Nita Avenue

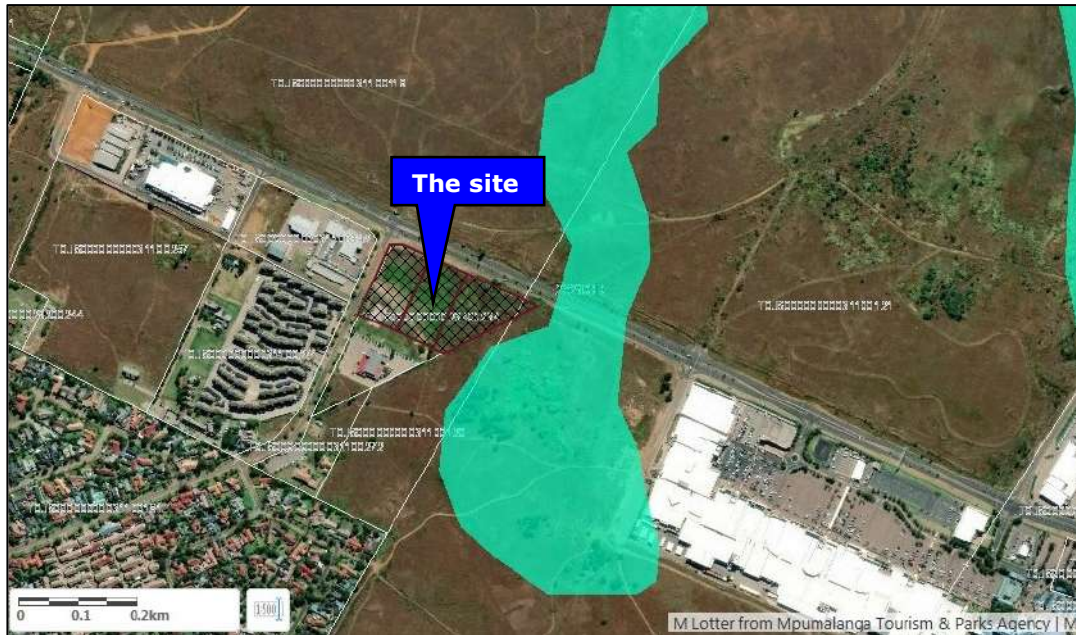
Figure 5.16: Mpumalanga Highveld Wetlands

According to the NFEPA database, the site is located within an area identified as an Ecological Support Area (ESA): Wetland Clusters. Wetlands are indicated to be present east of the site in both the Freshwater Biodiversity Assessment and Mpumalanga Highveld Wetlands databases (Figures 5.15 and 5.16).

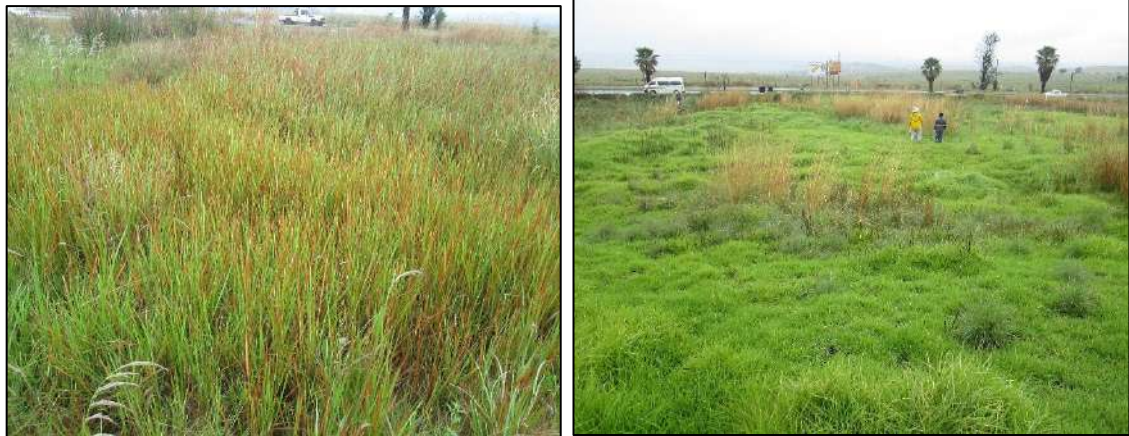
Photo 5.18: The Artificial Wetland area in the northern portion of the site (@5 November 2020)

As a result of the above-mentioned, Venter (2020b) identified an Artificial Wetland (Photo 5.18) and two Artificial ponding areas (Photo 5.19) on site as indicated in Figure 5.17. Venter (2020b) did not classify the Artificial Wetland and the Artificial Ponding areas as wetlands due to the absence of hydric (wetland) soil forms (see Section 5.6.2 for further details).

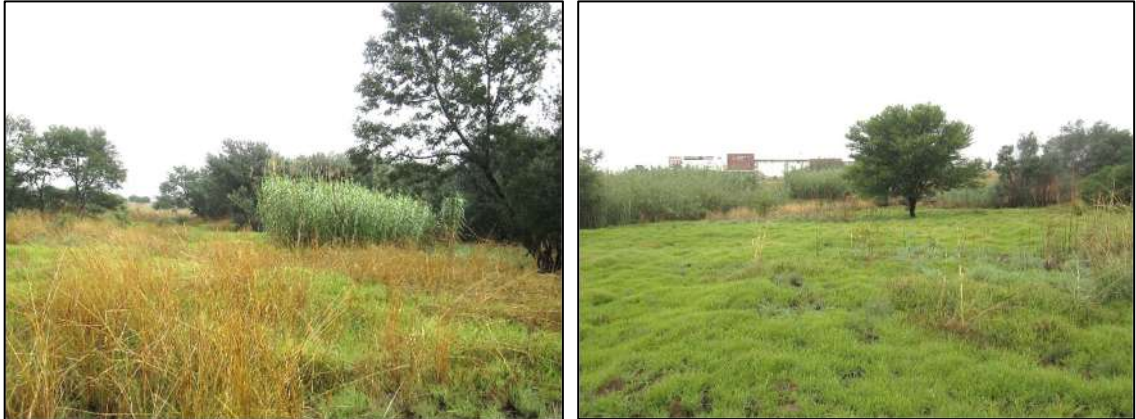
According to Venter (2020b), a Seep Wetland is present east of the site (Figure 5.17 and Photo 5.20). The Seep Wetland flows from the south to the north, passing through a culvert underneath Mandela Drive, after which it becomes a Channelled Valley Bottom wetland (Figure 5.17).

Photo 5.20: View of the Seep Wetland east of the site (@ 5 November 2020)

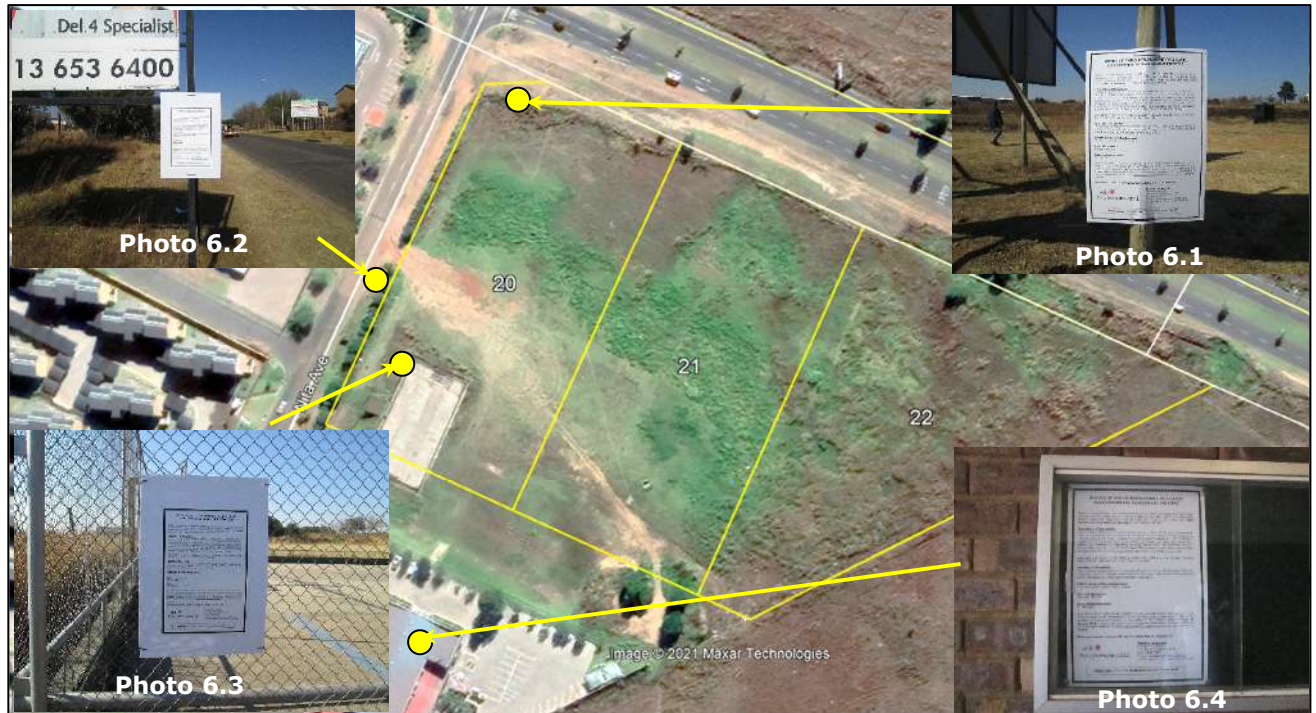
Figure 6.1: Aerial view of notice placements

It should be noted that the A1 notice was 594 mm x 841 mm and the A3 notices 416mm x 295mm (A3) in size.

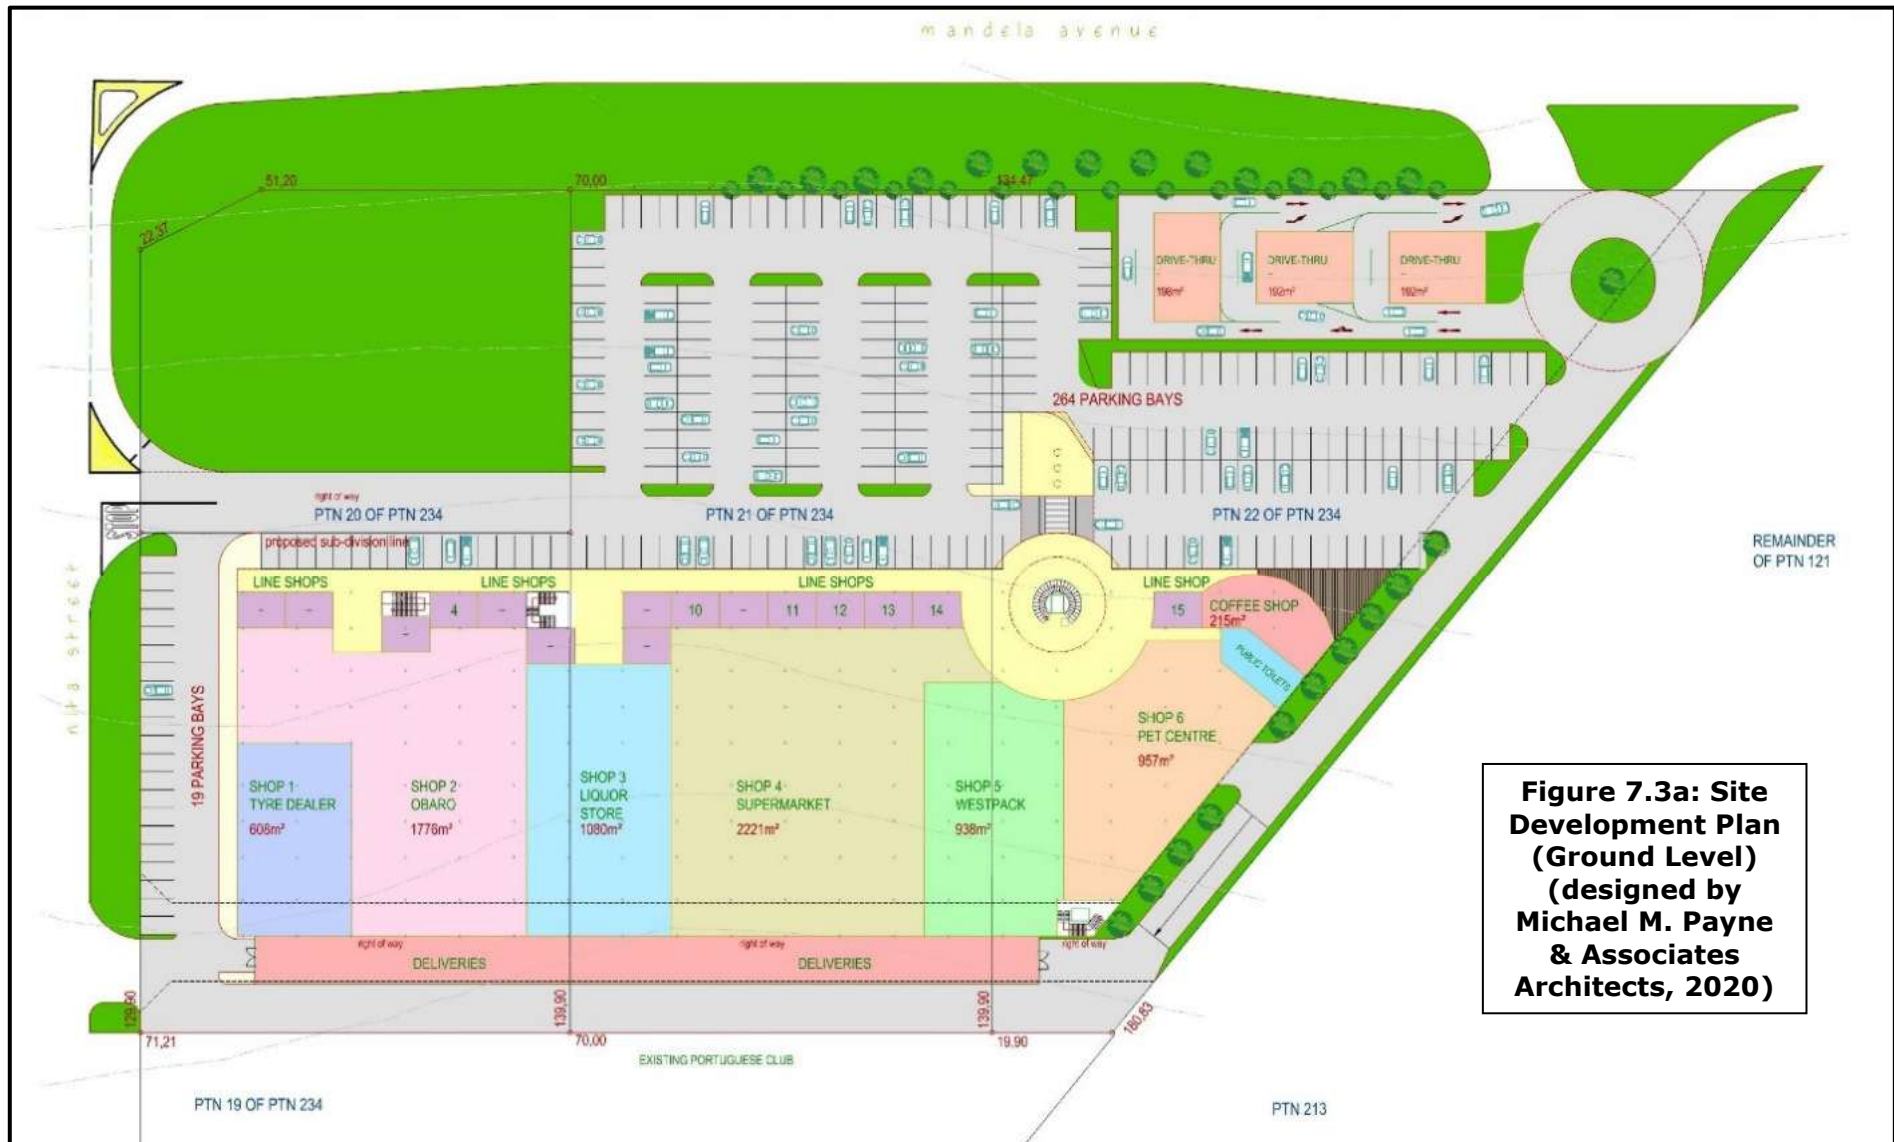
Figure 7.3a: Site Development Plan (Ground Level) (designed by Michael M. Payne & Associates Architects, 2020)

In addition to the above-mentioned, covered decks (1161.00 m²) and covered walkways (1673.00 m²) will also be provided. In total, 544 parking bays will be provided (including 238 open bays).

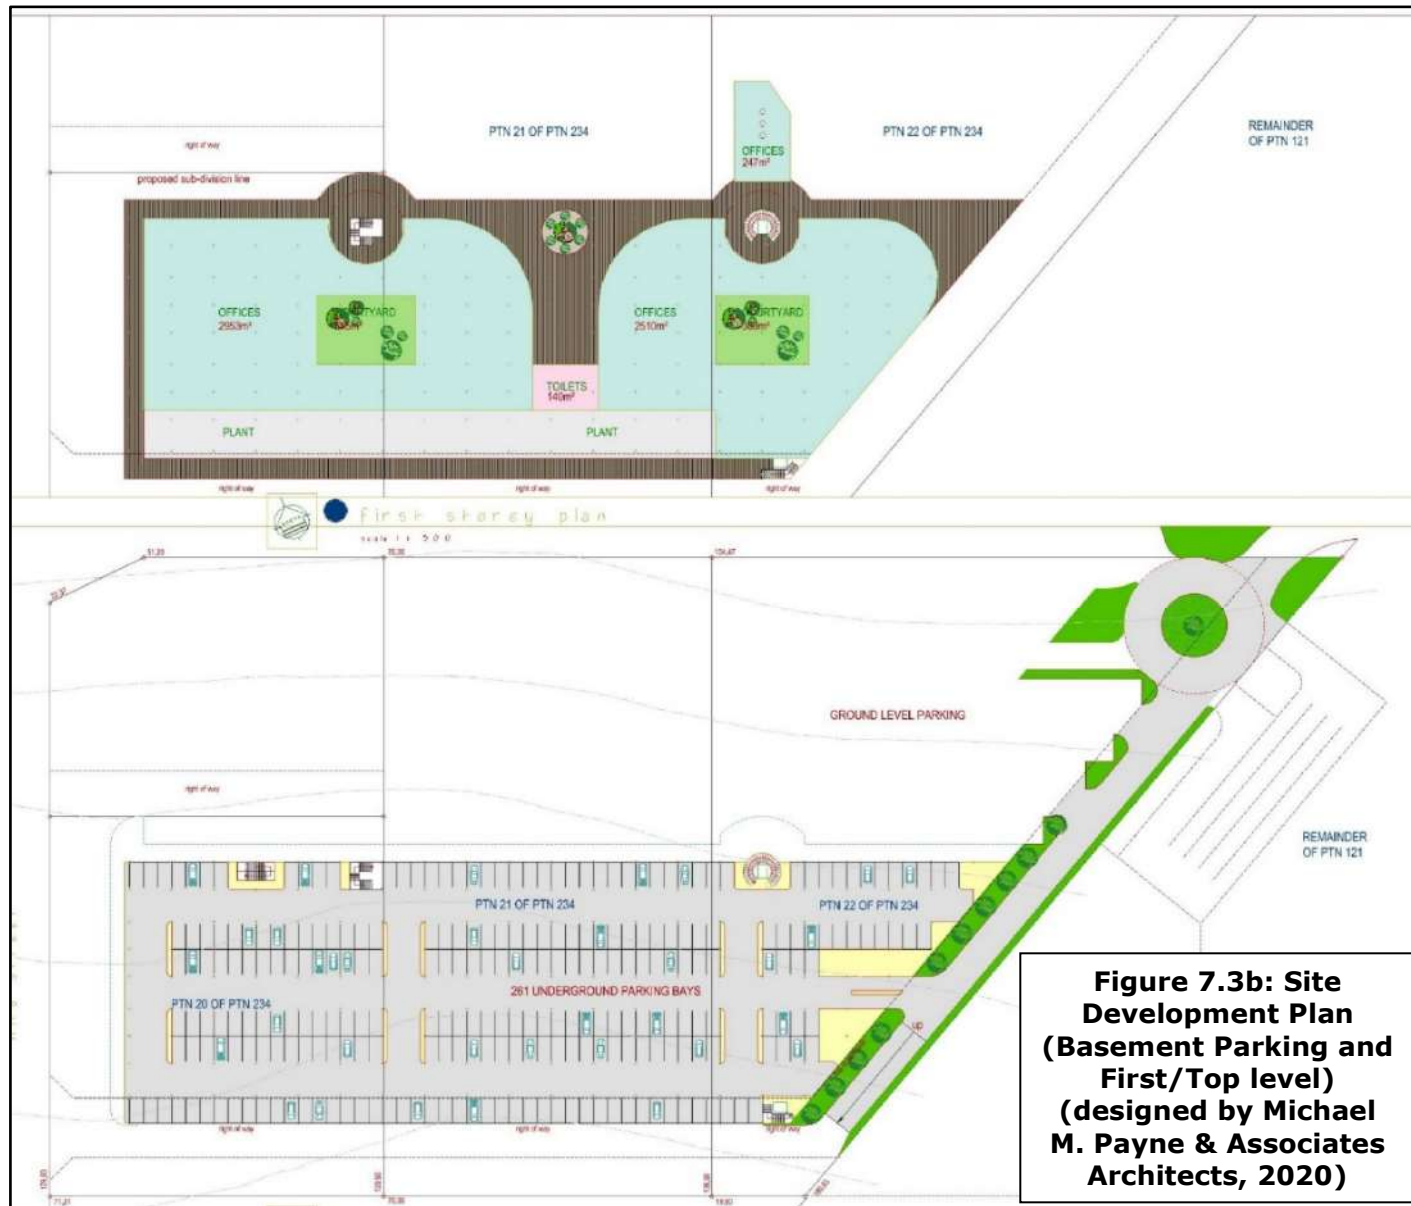
Figure 7.3b: Site Development Plan (Basement Parking and First/Top level) (designed by Michael M. Payne & Associates Architects, 2020)

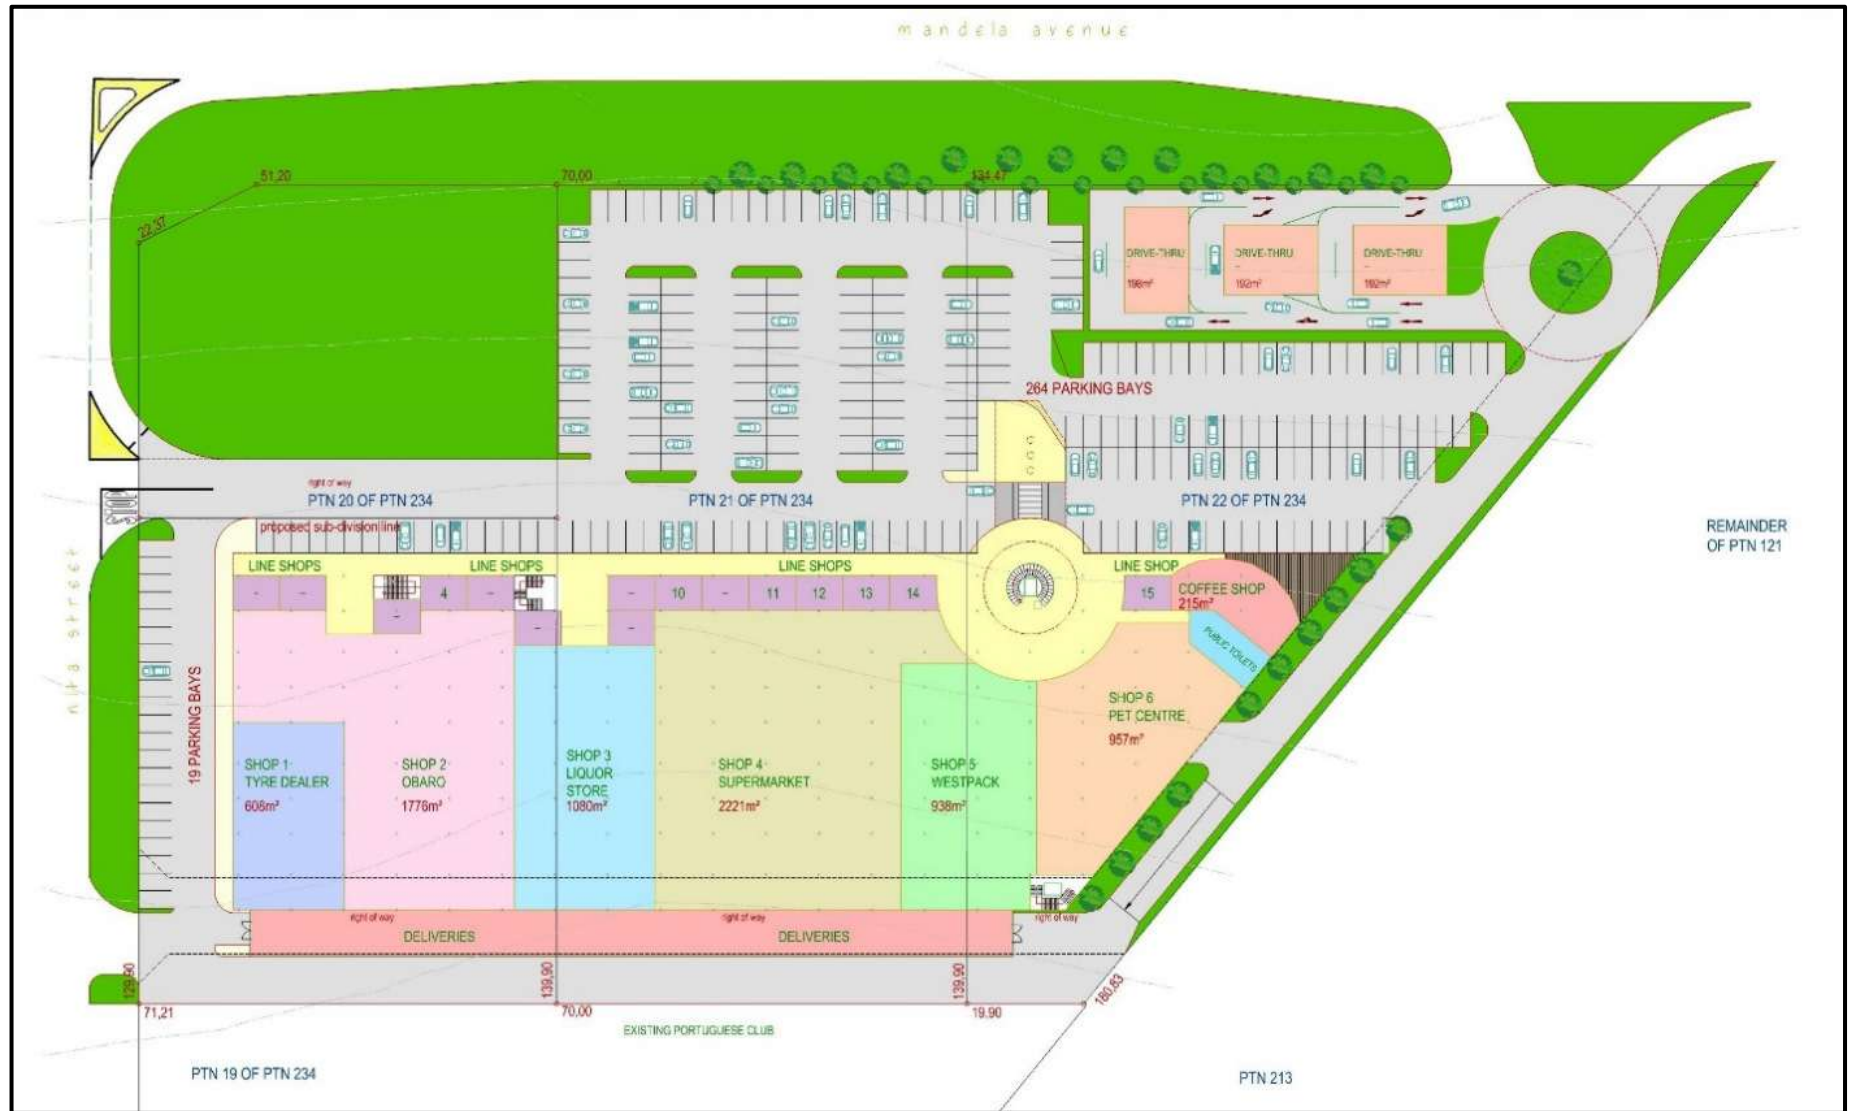
Figure 7.4: Alternative layout 1 (original layout) (designed by Michael M. Payne & Associates Architects, 2020)
