FINAL BASIC ASSESSMENT REPORT:

**THE DEVELOPMENT OF A
RETAIL CENTRE ON
ERVEN 20, 21 AND 22 OF
PRESIDENT PARK X6,
EMALAHLENI (WITBANK)**

Report prepared for: Meronox (Pty) Ltd

Report dated: June 2021 (final)

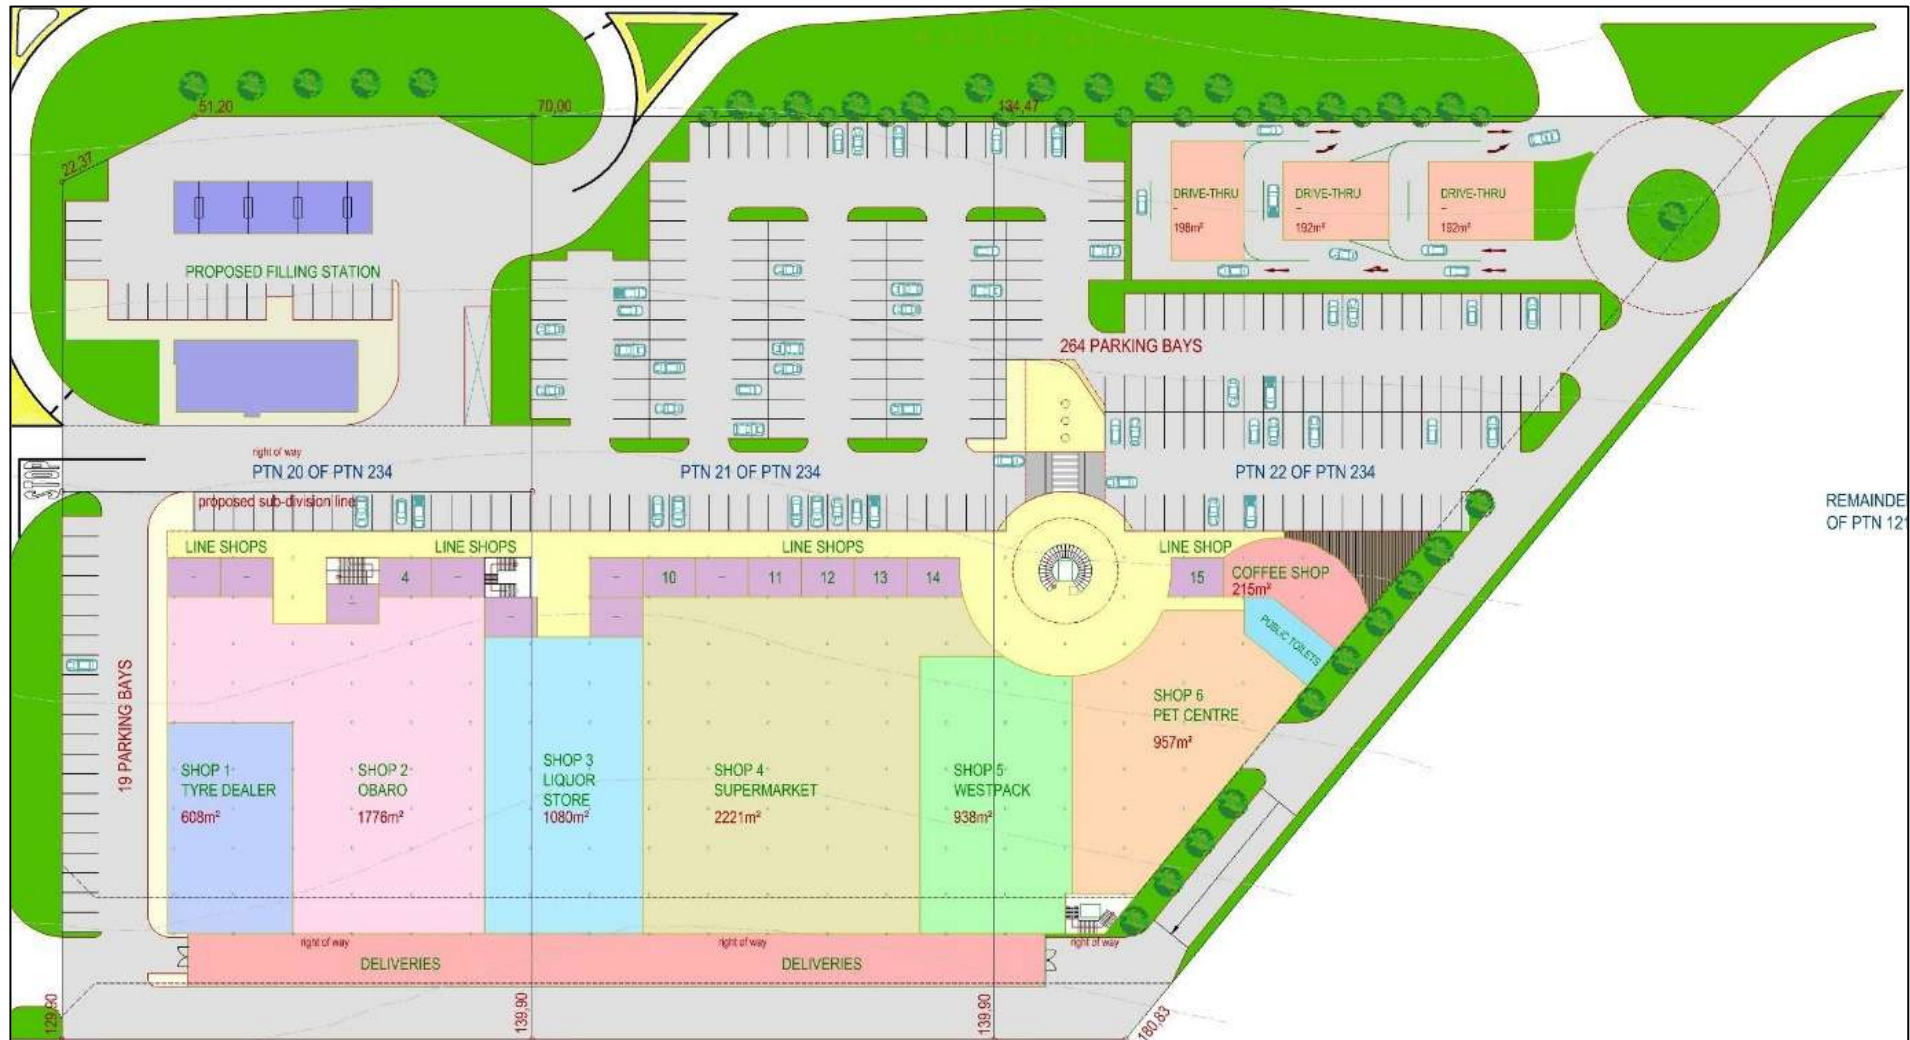
Figure 7.5: Alternative layout 2 (original layout with filling station) (designed by Michael M. Payne & Associates Architects, 2020)

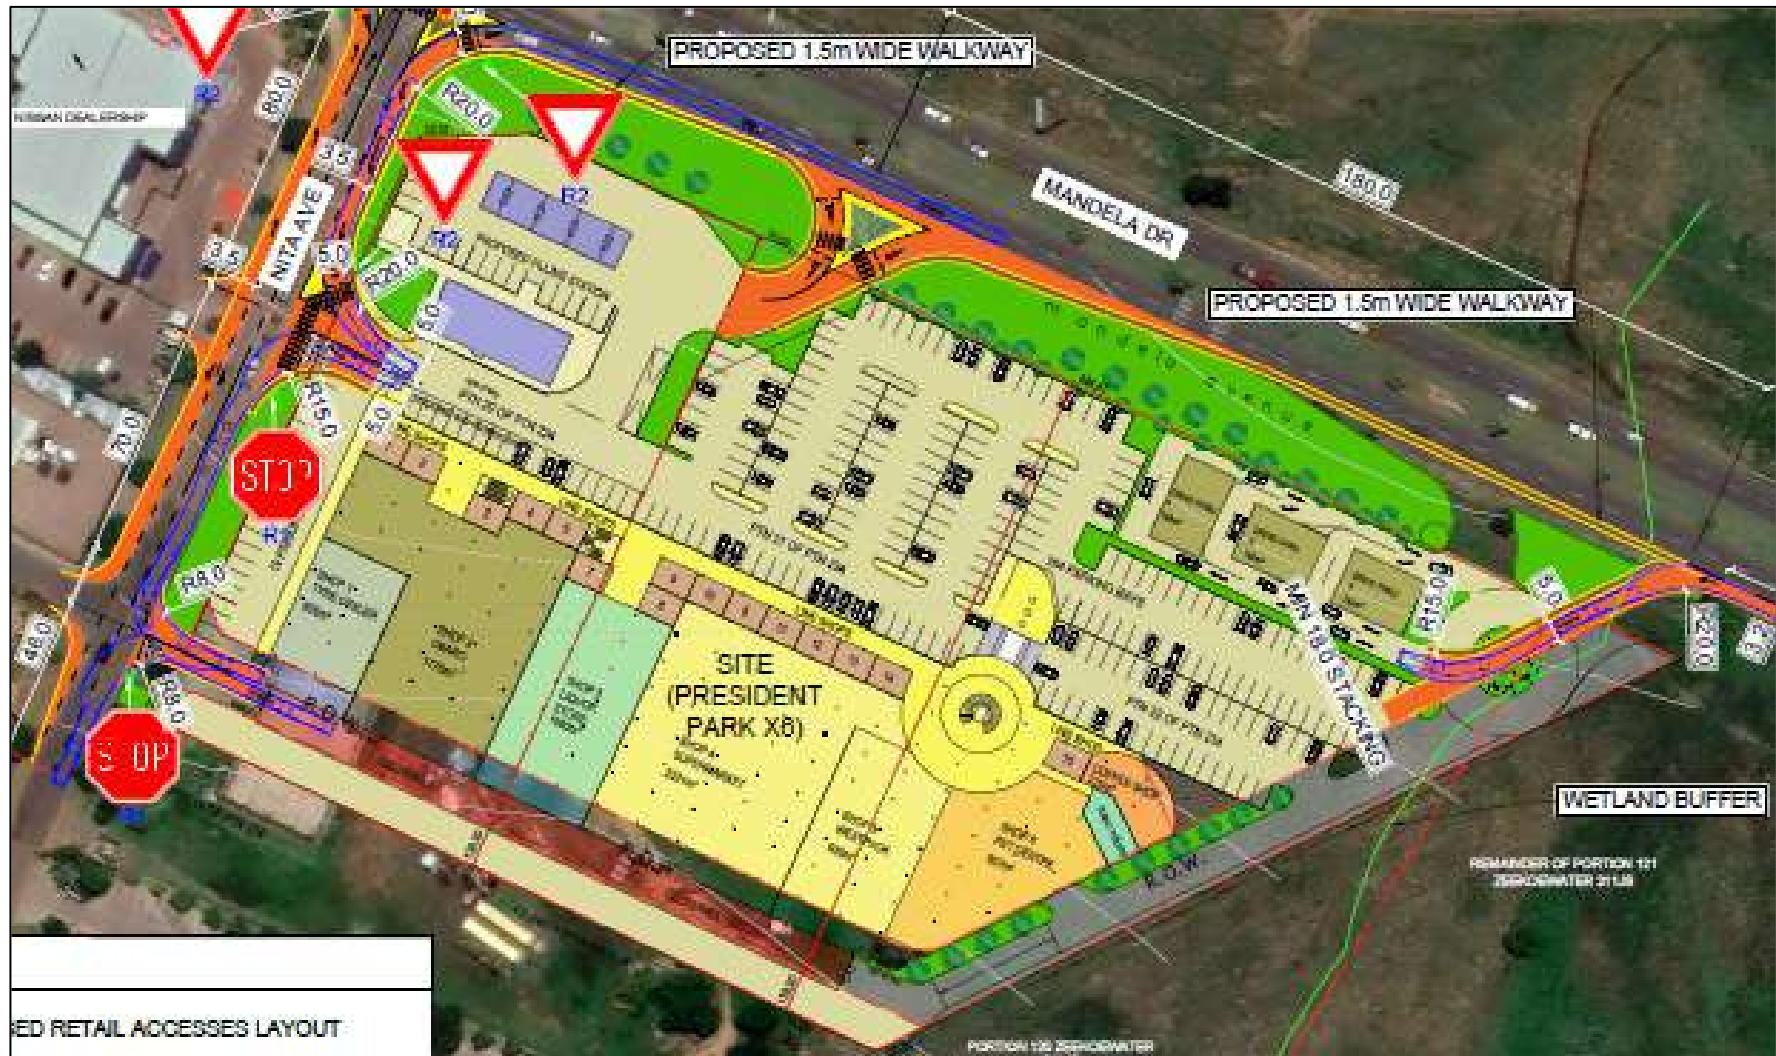
Figure 7.6: Alternative layout 3 (re-aligned access road from Mandela Drive) (designed by Michael M. Payne & Associates Architects, 2020)

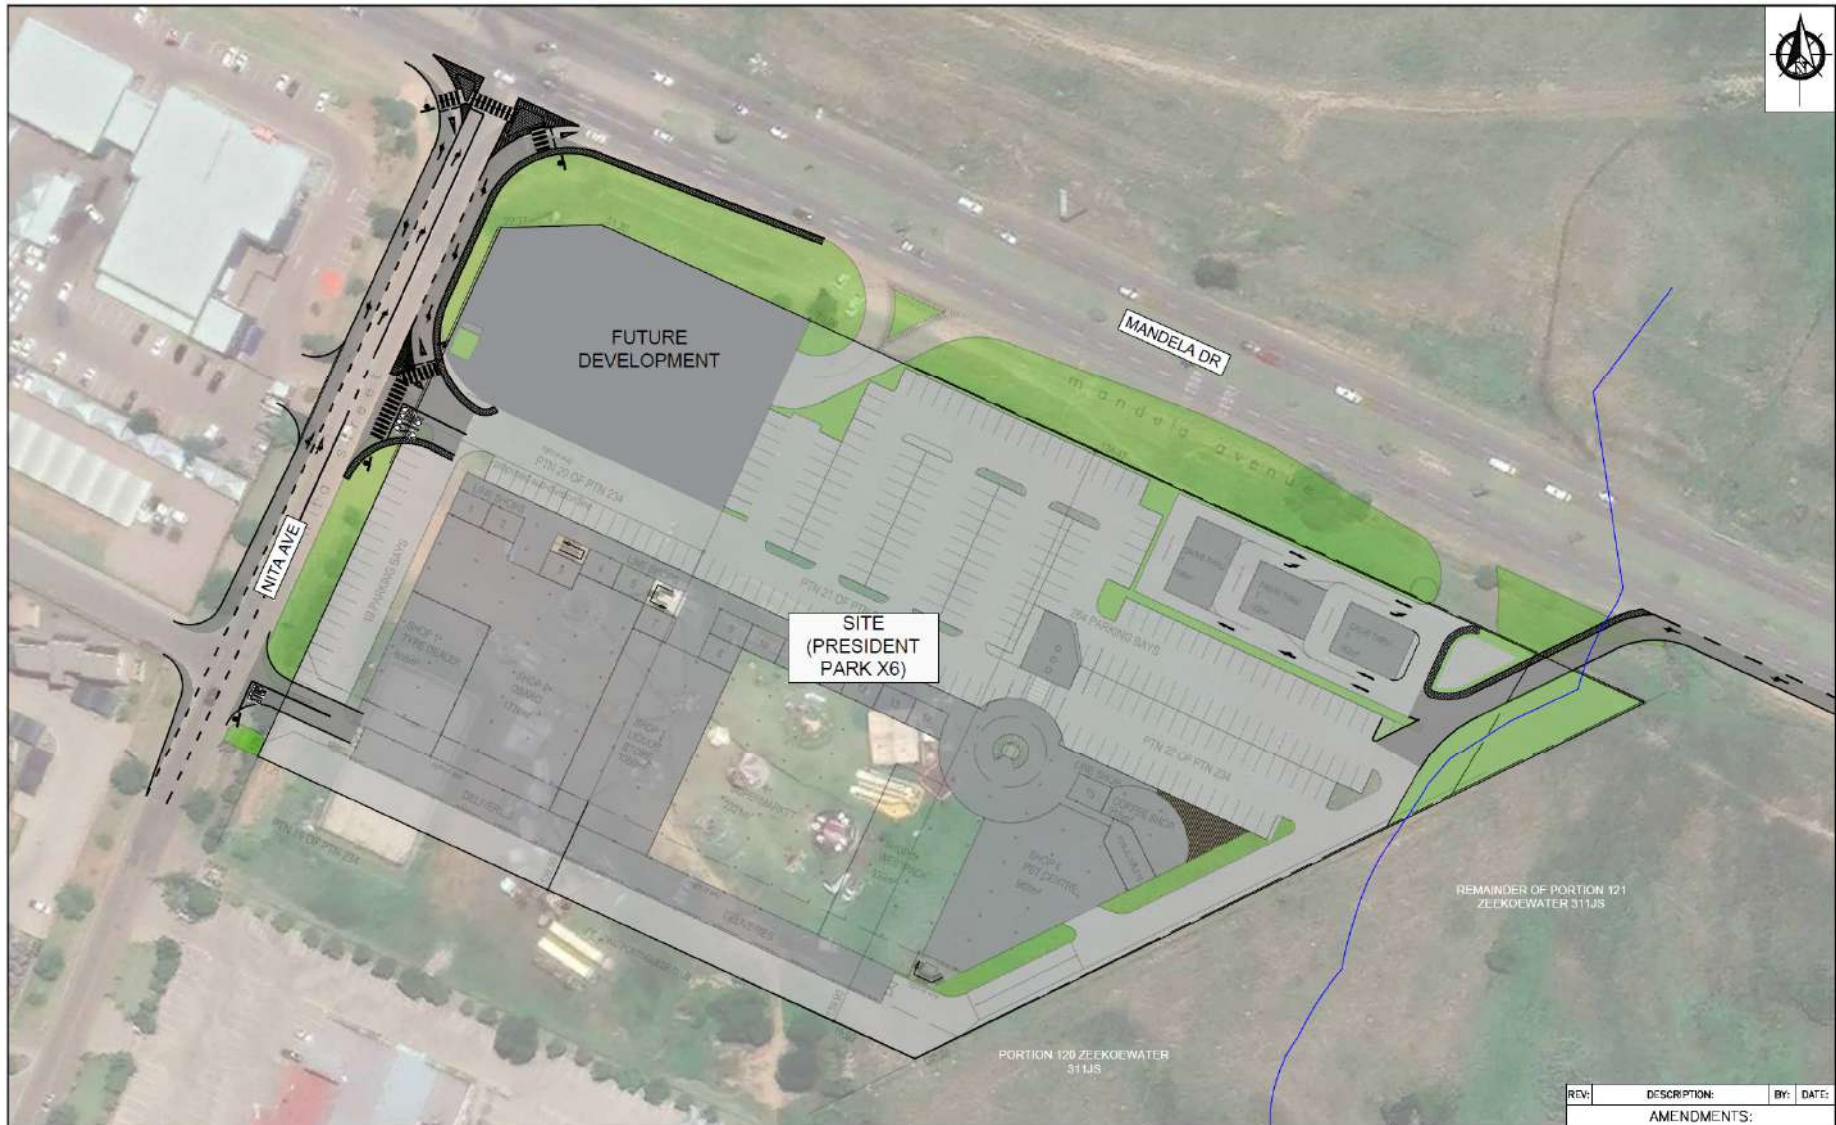
Figure 7.7: Alternative layout 4 (removed traffic circle and portion of R.O.W.; included storm water attenuation structures) (taken from EDL Consulting Engineers, 2021)

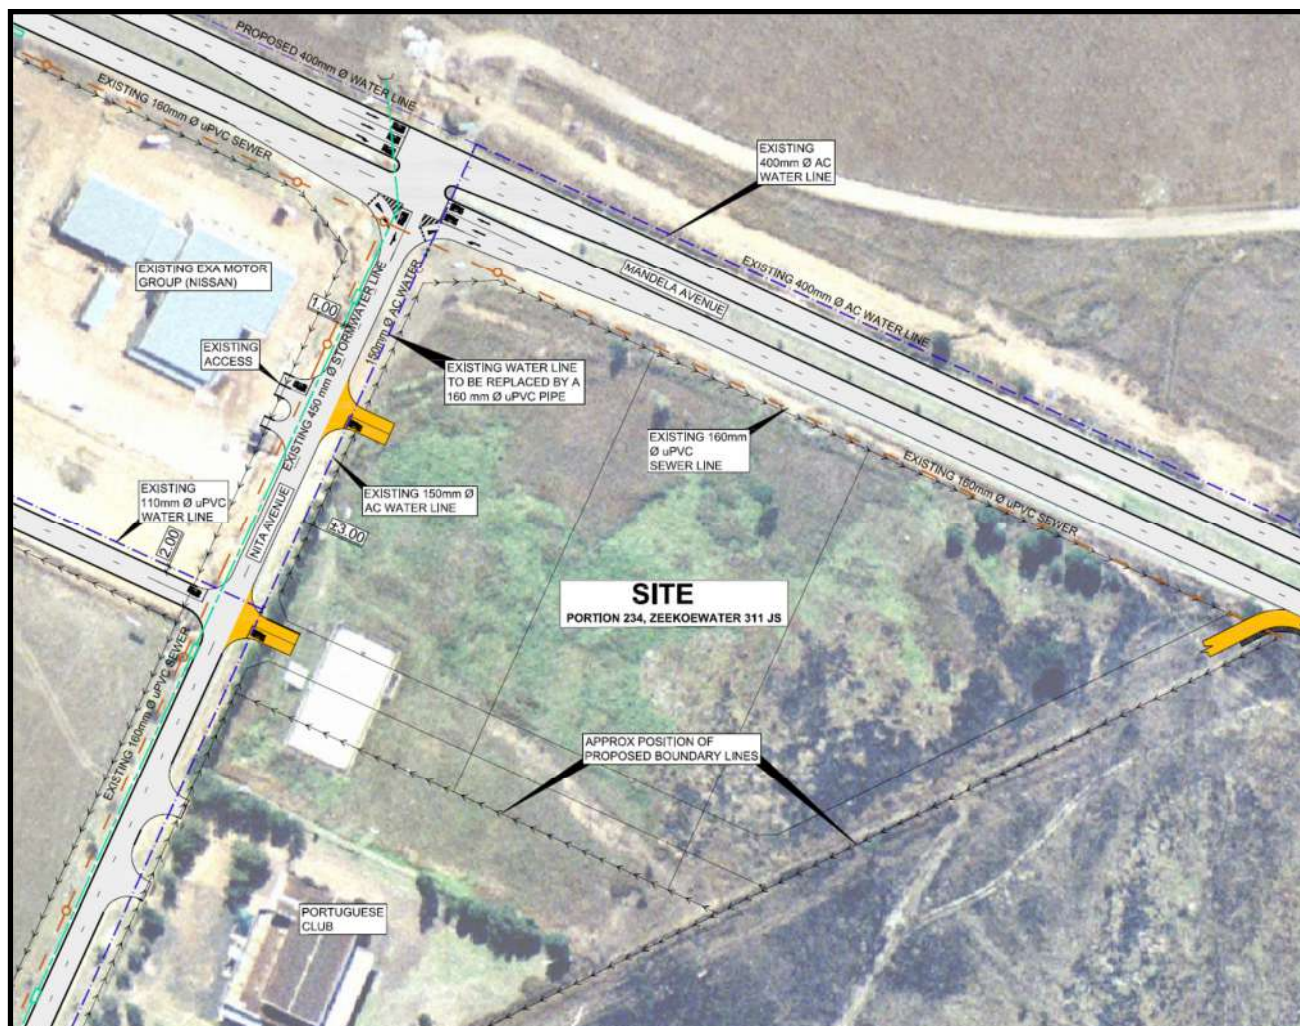
The proposed development site is located within the eMalahleni Local Municipality and can connect to the existing municipal services (water, sewage, electricity, etc.). Figure 7.8 indicates the location of the existing municipal water and sewer infrastructure adjacent to the site.

Figure 7.8: Location of the existing municipal water and sewer infrastructure adjacent to the site (taken from WSP SA Civil and Structural Engineers (Pty) Ltd., 2010)
