FINAL BASIC ASSESSMENT REPORT:

**THE DEVELOPMENT OF A
RESIDENTIAL AREA ON A
PORTION OF PORTION 93 OF THE
FARM RONDEBOSCH 403 JS,
MIDDELBURG**

Report dated: June 2019 (final)

Report number: BA 2018/01

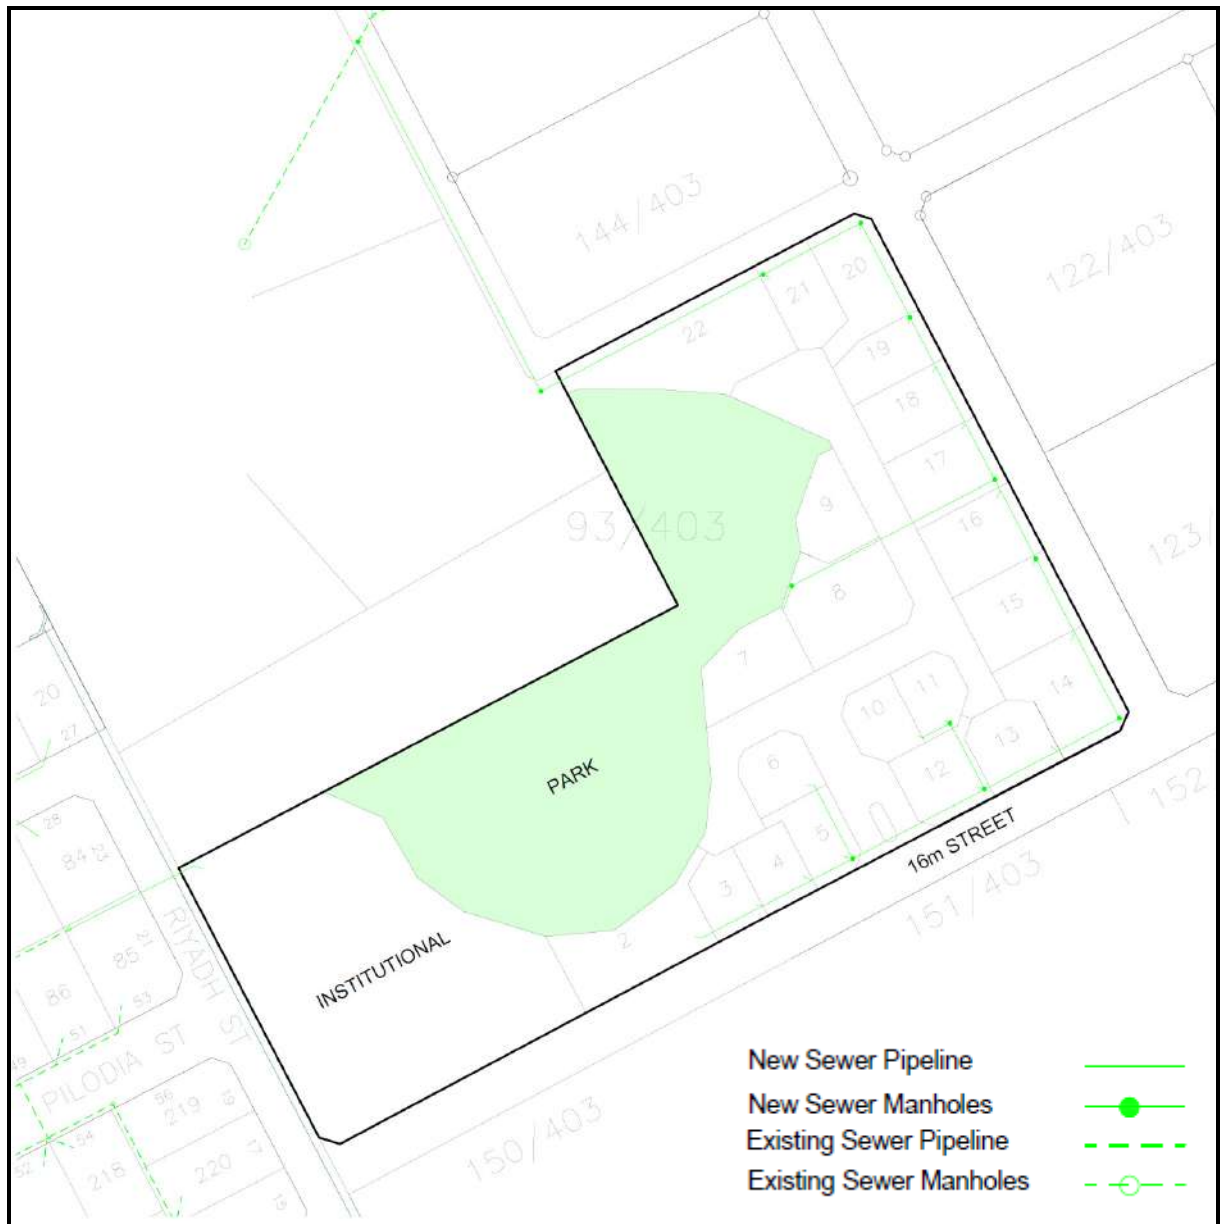
Service Standards	Design Parameters
Level of service	Level 4 - full waterborne sewer system
Design Parameter	
Average daily sewage produced	24.6 kl/day
Peak factor	PDWF = 2.5; PWWF = 4
Infiltration	25%
Average flow	0.37 l/s
Peak dry weather flow	0.93 l/s
Peak wet weather flow	1.49 l/s
Minimum flow speed	0.7 m/s
Minimum slope - 160 mm diameter pipe	1: 200
Service Standards	
Maximum manhole spacing	80 m
Materials (Sizes and Type)	
Minimum sewer collector	160 mm diameter
House connections	110 mm diameter
Reticulation	uPVC Class 34 sewer pipes
Sewage rising main	uPVC Class 9
Manholes	Pre-cast circular concrete chambers
Manhole covers	Concrete
Manhole size: <2 000 mm depth	1 000 mm diameter
Manhole size: >2 000 mm depth	1 500 mm diameter
Construction Parameters	
Minimum cover to pipes in servitudes	800 mm
Minimum cover to pipes at road crossings	1 200 mm

Figure 3.4: Sewer reticulation network (taken from Bower, 2018a)

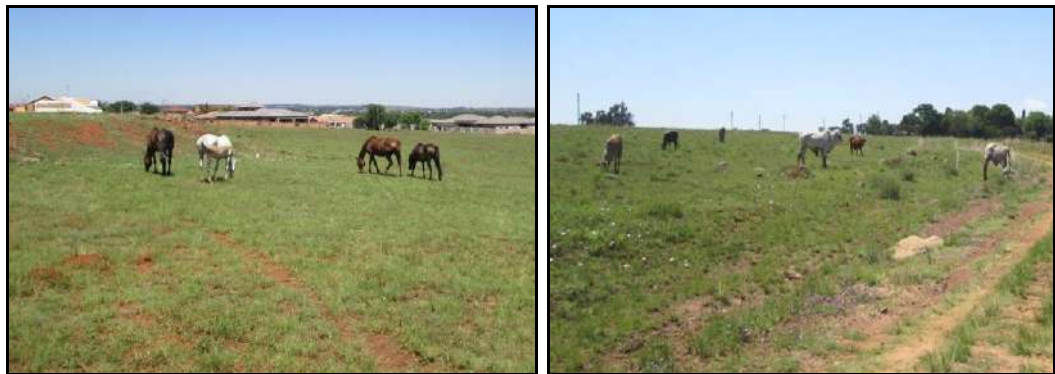
Photo 5.1: Horses and cattle grazing on site

Currently, the site is vacant and only used for grazing purposes (cattle and horses; Photo 5.1).

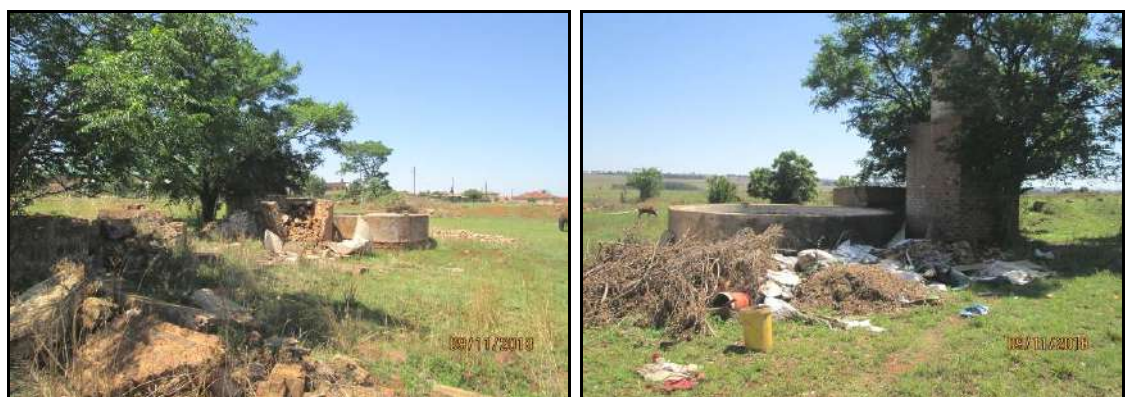
Photo 5.2: A view of the farmstead ruins in the southern portion of the site

Some building rubble, ruins (possibly farmstead) and possibly a dilapidated pig sty are present in the southern portion of the site (Figure 5.2; Photos 5.2 and 5.4). A demolished borehole filled with rocks, an old water tank and cement dam were also recorded (Figure 5.2; Photo 5.3). Building rubble, general waste/scrap metal and garden waste are dumped in the southern portion of the site, in and around the dilapidated buildings.

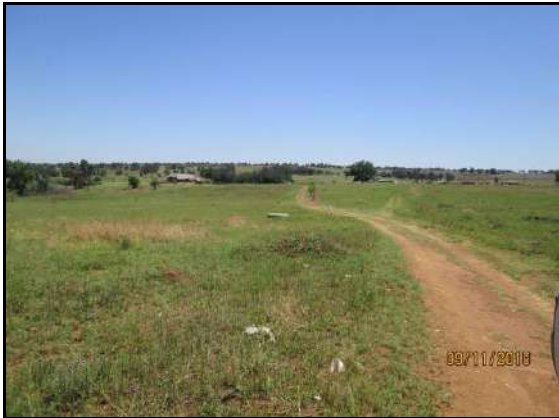
Photo 5.4: A view of the gravel road extending through the site

The site is accessed by means of a gravel road, which extends through the site and provides access to the homestead/smallholding in the northern portion of Portion 93 (Figure 5.2; Photo 5.4). The majority of the site is fenced, with an access gate on the southern boundary (Figure 5.2; Photo 5.5).

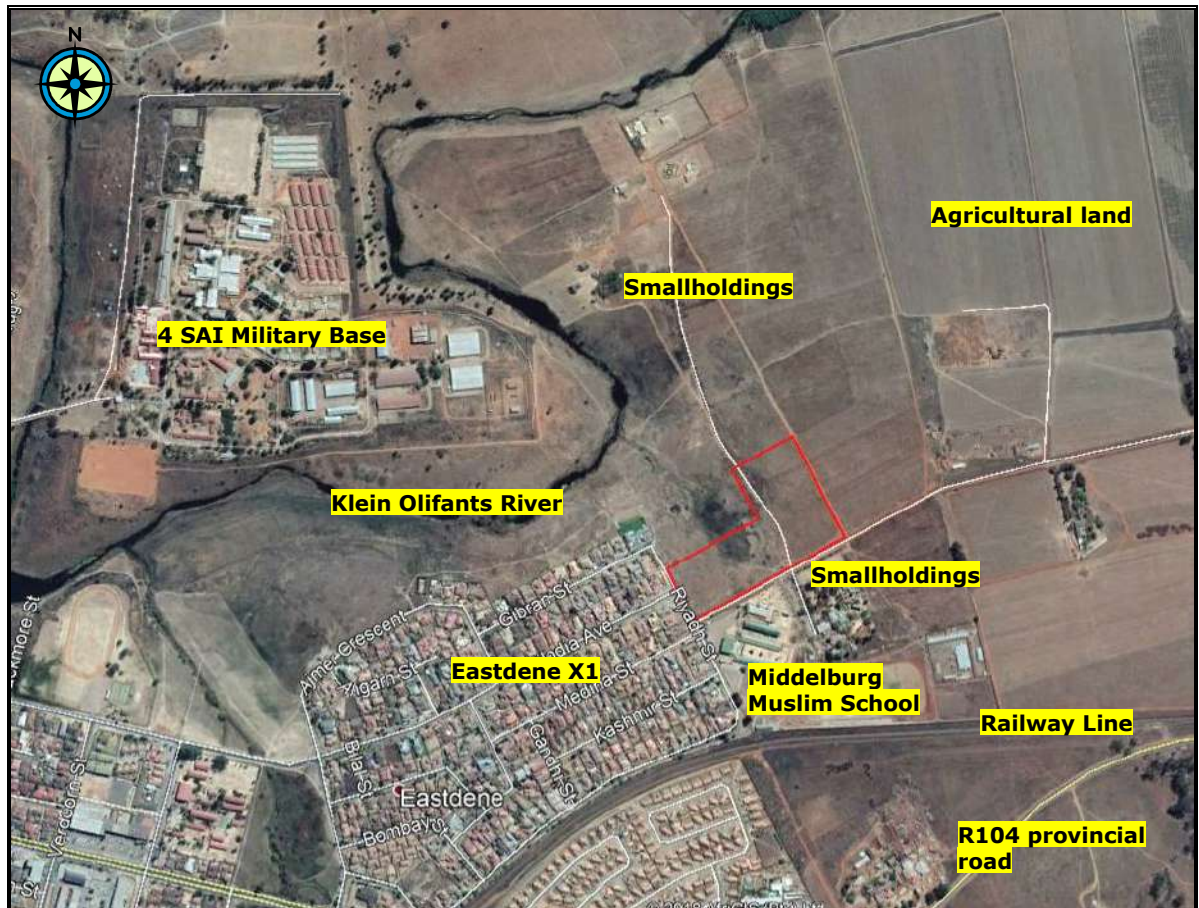
Figure 5.3: Surrounding land uses

The site is located within the urban edge of the Steve Tshwete Local Municipality and is surrounded by various land uses. Figures 5.2 and 5.3 can be consulted for an indication of the surrounding land uses.

The site is bordered on the east and north by property belonging to the applicant (Middelburg Muslim Jamaat). These properties are in the process of being subdivided into smallholdings (Figure 5.3). The properties further east (Figure 5.3) are zoned and used for agricultural purposes.

The 4 SAI Military Base is located northwest of the site (Figure 5.3). Also west of the site are Public Open Spaces (which includes the Klein Olifants River), which are registered to the Steve Tshwete Local Municipality.

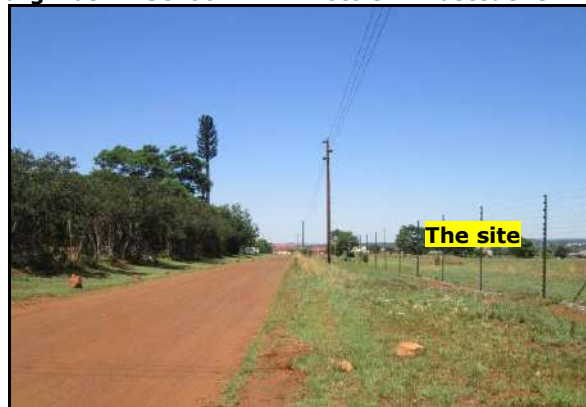
Photo 5.8: Right-of-Way gravel road and Eskom powerlines

Municipal and Eskom powerlines are present along the western, southern and eastern boundaries (Photo 5.8).

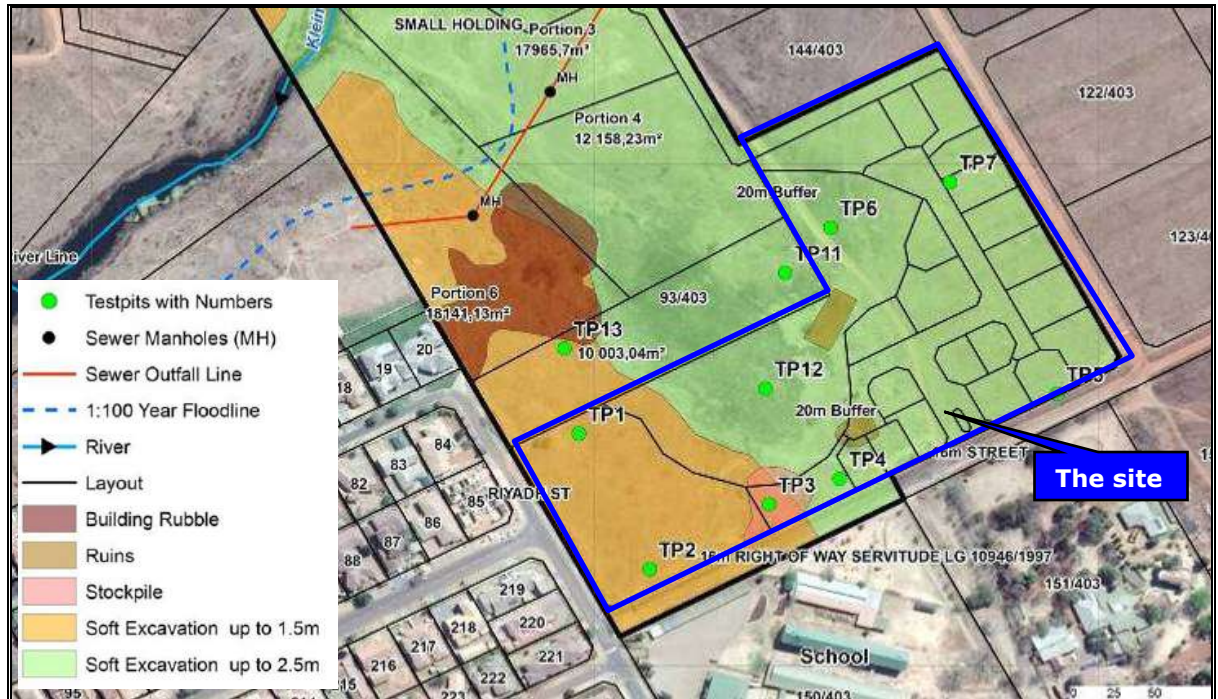
Figure 5.11: Excavation map (taken from Cilliers & Hansmeyer, 2018)

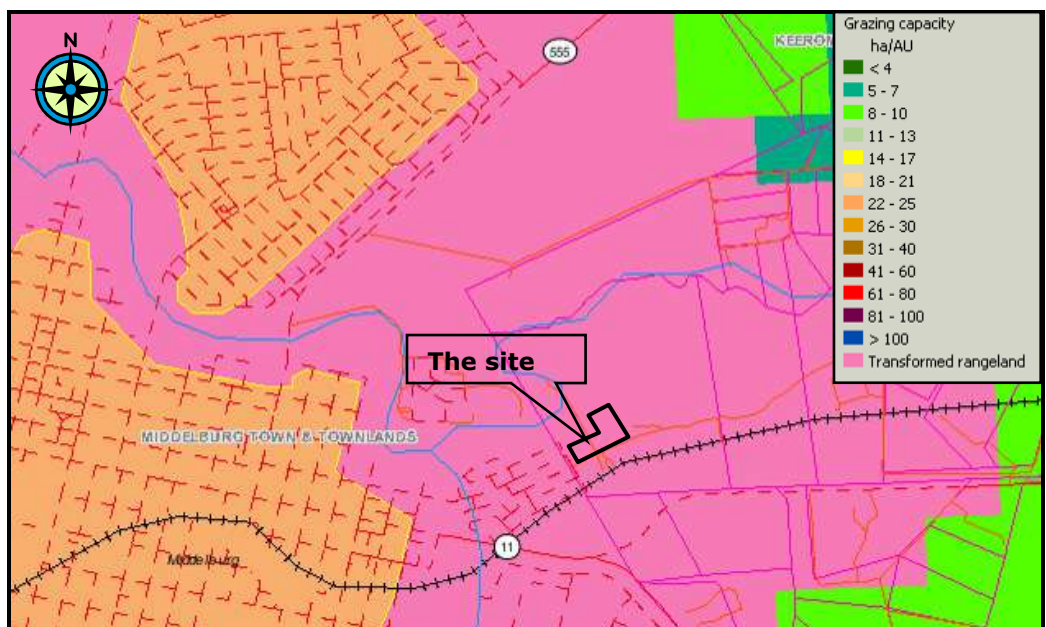
Figure 5.14: Grazing capacity of the proposed site (taken from Department of Agriculture, Forestry and Fisheries)

Looking at grazing capacity, Figure 5.14 (Department of Agriculture, Forestry and Fisheries) indicates the area as transformed rangeland.

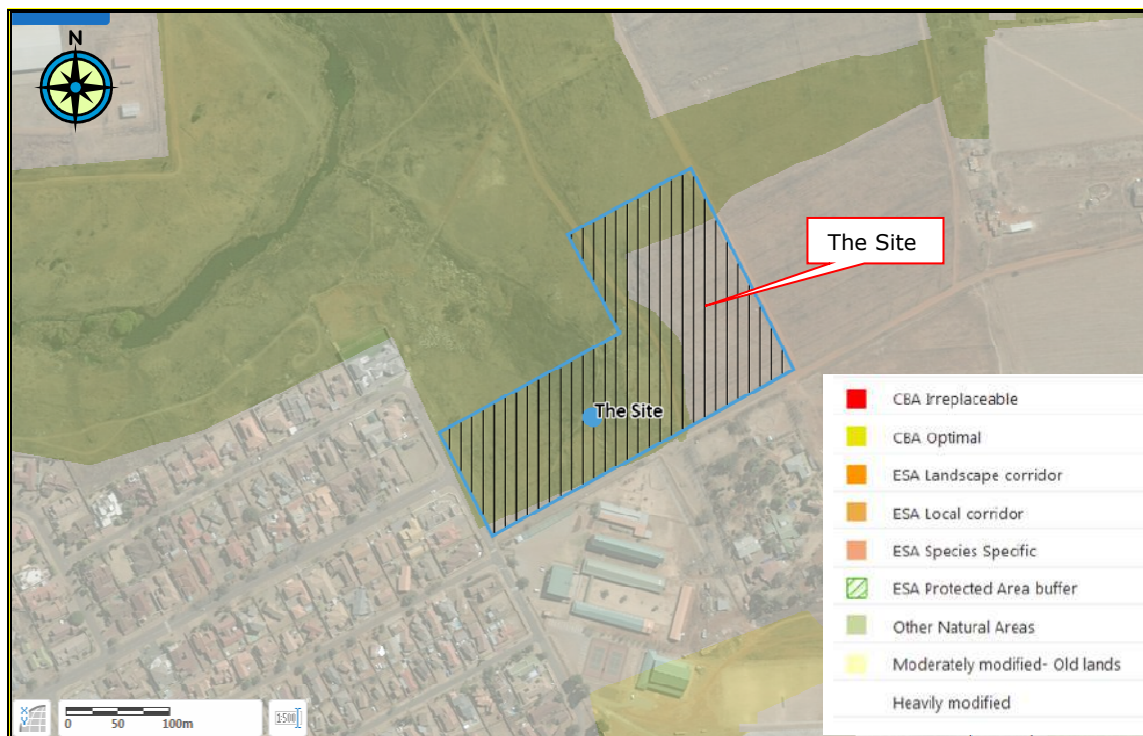
Figure 5.18: Terrestrial biodiversity assessment of the Mpumalanga Biodiversity Sector Plan, 2013

According to the MBSP (2013), the majority of the site is classified as '**Other Natural Areas**' (Figure 5.18). The previously cultivated area in the eastern portion of the site is classified as '**Heavily Modified**' (Figure 5.18).

No Critical Biodiversity Areas, Ecological Support Areas or Ecological Corridors are present on or near the site (Figure 5.18). The provincial assessment therefore attributes relatively low conservation value to the vegetation on site, despite the fact that any remaining natural vegetation is classified as being Endangered in the scientific literature and Vulnerable in the National Ecosystem List.

According to the MBSP (2013) the site is classified as '**Heavily Modified**' and '**Other Natural Areas**' in terms of the Terrestrial Biodiversity Assessment (Figure 5.18).

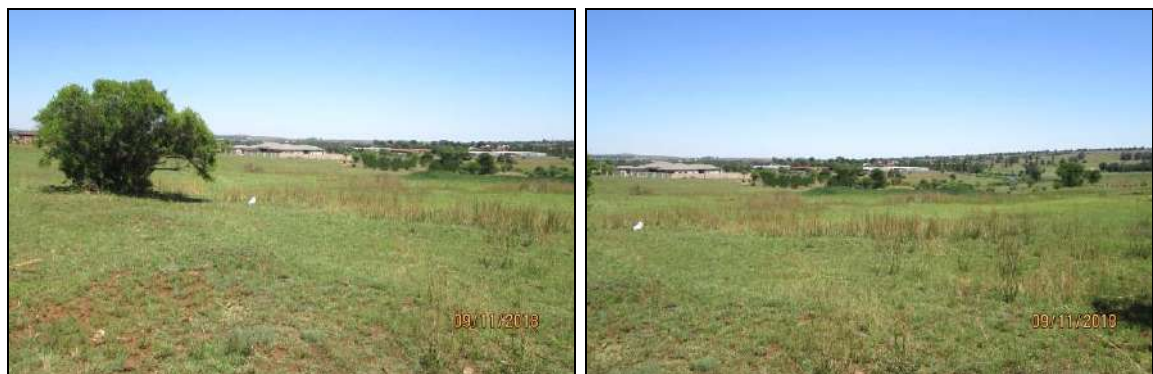
Photo 5.9: A view of the grassland in the western portion of the site.

According to Hoare (2012), the grassland on site is mixed and has a natural species composition typical of grassland in sandy soils, but a moderate species richness (Photo 5.9). Dominant species include *Heteropogon contortus*, *Hyparrhenia hirta*, *Themeda triandra*, *Cymbopogon pospischillii*, *Cymbopogon excavatus* and *Eragrostis chloromelas*.

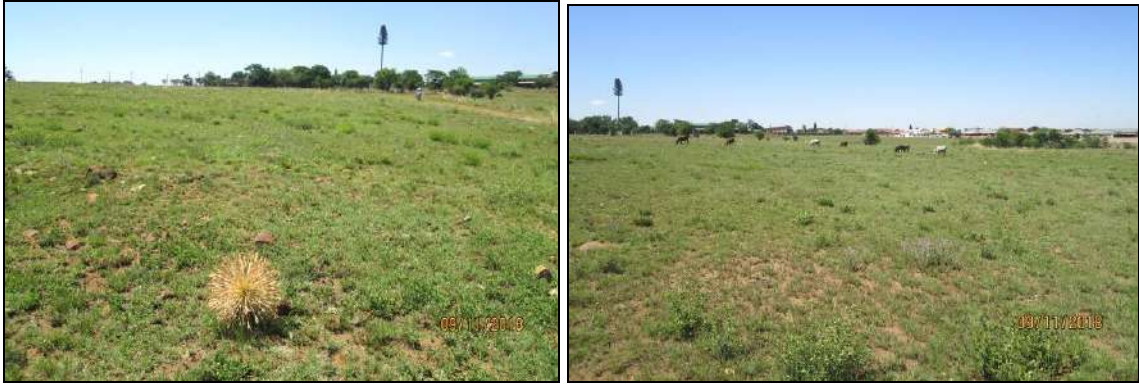
Photo 5.10: A view of the secondary grassland in the eastern portion of the site.

The secondary grassland occurs in areas that were previously cultivated (i.e. the eastern portion of the site). The perennial grass cover is good however, the species richness is generally low (Photo 5.10). Dominant species include, *Hyparrhenia hirta*, *Melinis nerviglumis*, *Sporobolus africanus*, *Eragrostis chloromelas* and *Cynodon dactylon*.

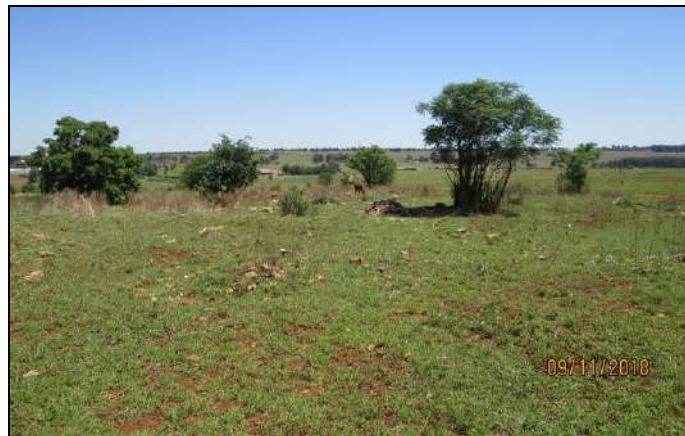
Photo 5.11: Disturbed grassland in the central/eastern portions of the site

The disturbed grassland is present adjacent to the gravel access road and in the area surrounding the old farmstead (Photo 5.11). According to Hoare (2012), the species composition is similar to that of the natural grassland. The vegetation was previously disturbed but has recovered to a natural state.

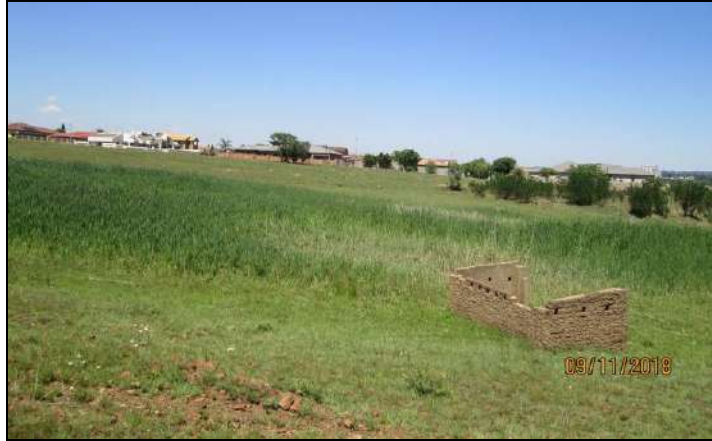
A spring is located in the central part of the site. The overflow from the spring and surface water runoff flows along a drainage area towards the Klein Olifants River. Wetland vegetation (i.e. plant species that are typical of permanently moist areas) is found within this drainage area (Photo 5.12). Dominant species include *Typha capensis*, *Agrostis lachnantha*, *Cotula species*, *Fimbristylis complanata*, *Juncus effusus* and *Cyperus species*. This species composition is typical of areas that are permanently moist, although surface water does not necessarily need to be present. According to Hoare (2012), 27 of the indigenous species found on site are indicators of wetland conditions. See Appendix 3 of Appendix 6 for further details.

Photo 5.12: The drainage area/wetland in the central portion of the site

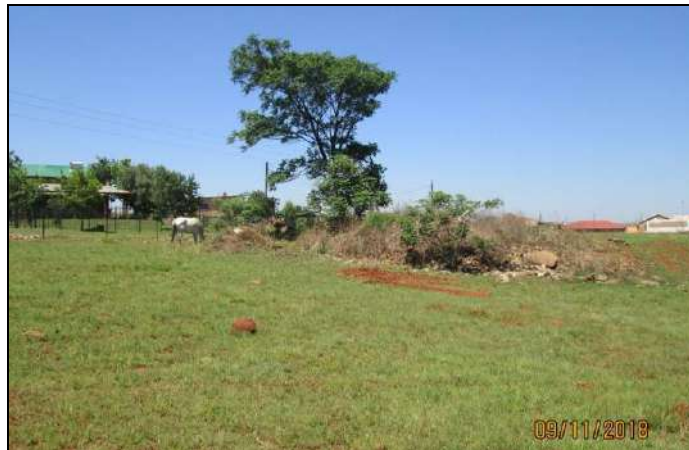
Photo 5.13: Degraded vegetation in the southern portion of the site

Plant species indicative of disturbance were found in areas where building rubble was dumped, adjacent to roads and footpaths, excavated areas, etc. (Photo 5.13). Species include *Datura ferox*, *Cyperus esculentus*, *Cynodon dactylon*, *Cleome monophylla* and *Portulaca oleraca*, and, in older sites, *Hyparrhenia hirta*, *Eragrostis chloromelas* and *Salvia* species.

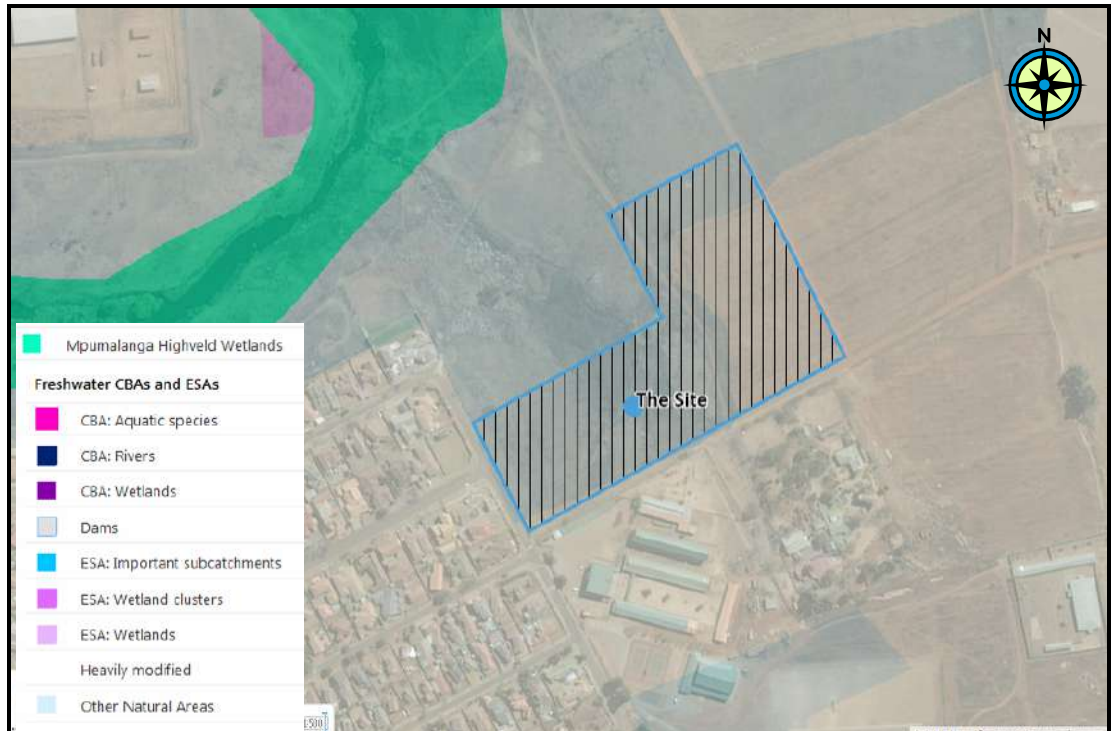
Figure 5.23: Freshwater biodiversity assessment of the Mpumalanga Biodiversity Sector Plan, 2013

The Mpumalanga Biodiversity Sector Plan (MBSP, 2013) does not indicate any important wetlands or wetland clusters on site (Figure 5.23). The closest ESA Wetland and Mpumalanga Highveld Wetland is located approximately 200m to the north west of the site (Figure 5.23).

The site is also classified as '**Heavily Modified**' and '**Other Natural Areas**' in terms of the Freshwater Biodiversity Assessment (Figure 5.23).

No Critical Biodiversity Areas (CBA's) for aquatic species or Ecological Support Areas (ESA's) for fish are present on or near the site (Figure 5.23).

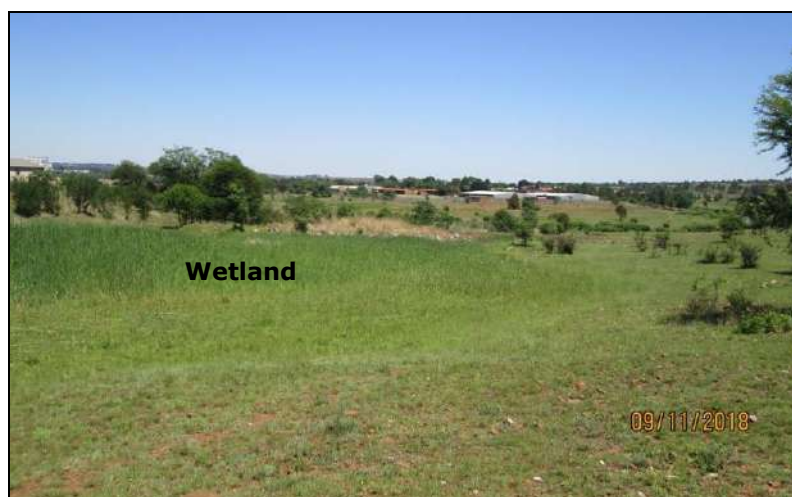
Photo 5.14: View of the hillslope seepage wetland in central portion of site

According to Davis (2012), a hillslope seepage wetland (Photo 5.14) was identified in the central portion of the site. This wetland extends in a north westerly direction, along a drainage line, to the Klein Olifants River (Figure 5.22). A riparian habitat (which is located off-site) was identified adjacent to the Klein Olifants River (Figure 5.24).

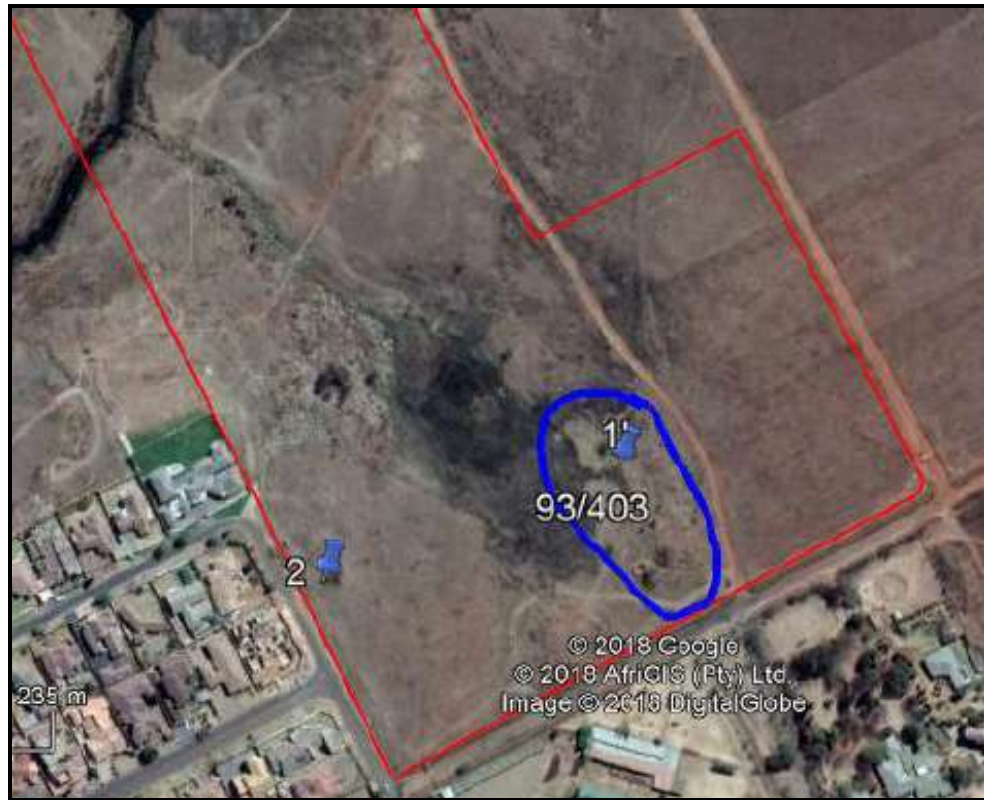
Figure 5.26: Location of heritage sites identified on site (taken from Van Vollenhoven, 2018)

The location of these two sites are indicated in Figure 5.26.

Site No. 1 - Ruins of historical farm yard (Figure 5.26)

Site No. 2 - Building ruins (Figure 5.26)

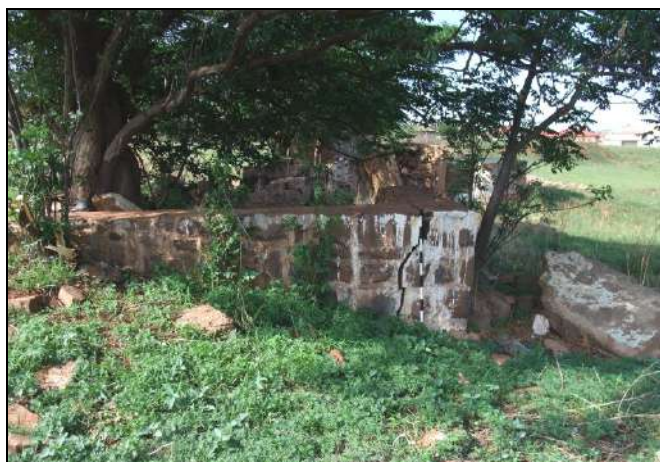
Photo 5.16: Remaining stone wall that may have been the foundation of a farm house

Site No. 1 comprises the ruins of a farm house and outbuildings, which are in an extremely bad state (Photos 5.16 and 5.17). According to Van Vollenhoven (2018), two of the outbuildings look like the remains of pigsties. The other outbuilding in such a poor conditions that it could not be identified. The buildings were constructed from stone, bricks and cement. The remains are spread over a relatively large area.

Van Vollenhoven (2018) gave the building remains of Site No. 1 a field rating of Local Grade IIIC (i.e. **low significance**). The buildings may be destroyed without a formal permit application, at the discretion of the relevant heritage authority.

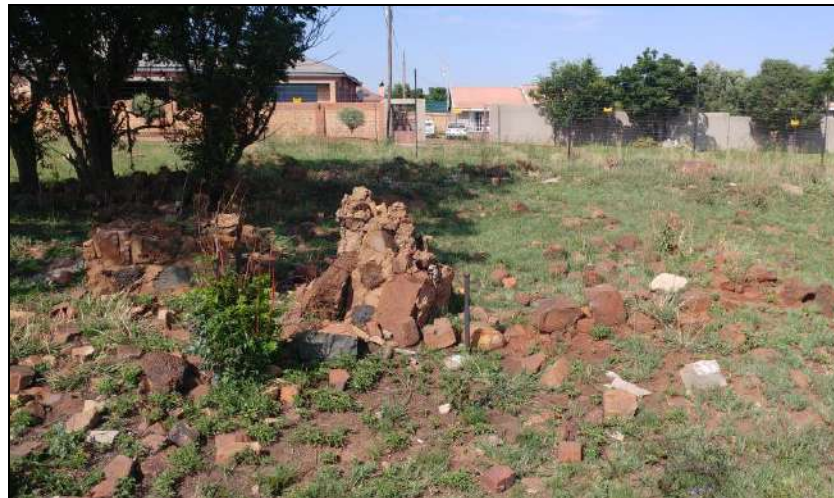
Photo 5.18: Remains of a possible farm worker's dwelling

The ruins at Site No. 2 comprise of a one room structure of about 3 X 4m. It was probably a farm workers dwelling and was constructed using clay and stone (Photo 5.18).

Van Vollenhoven (2018) gave the building remains of Site No. 2 a field rating of Local Grade IIIC (i.e. **low significance**). The buildings may be destroyed without a formal permit application, at the discretion of the relevant heritage authority.

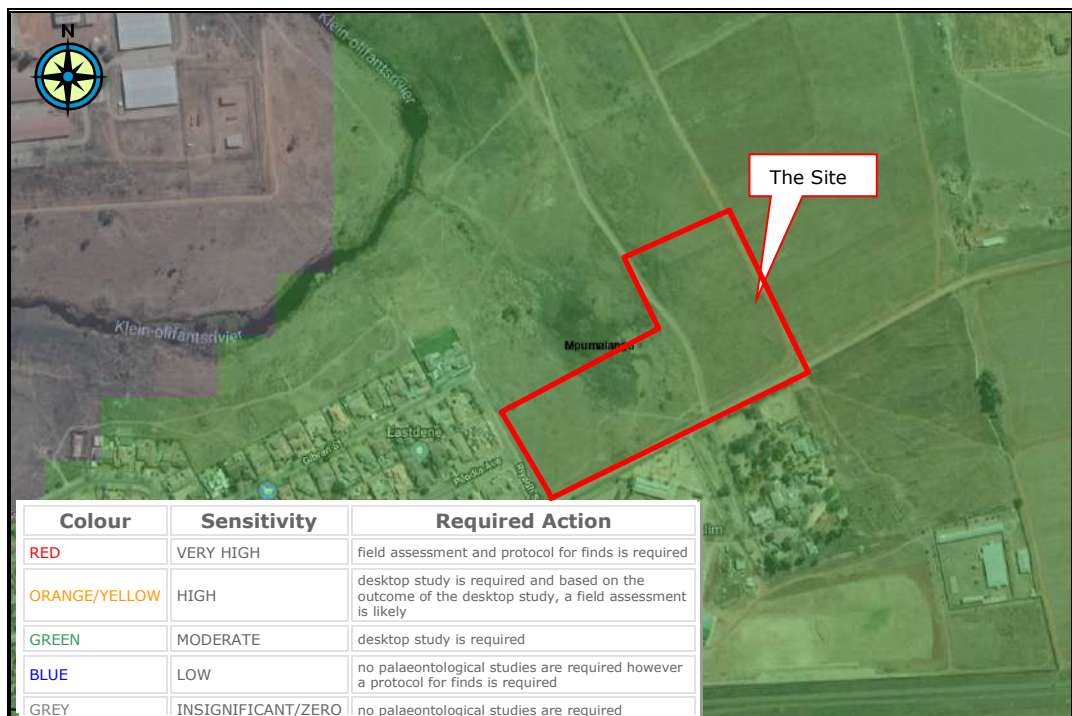
Figure 5.27: Requirement for palaeontological study (taken from SAHRA, 2018)

The aim of a Phase 1 Field Study is to ascertain if any palaeontological sensitive material is present within the proposed development site, to indicate the potential impact on the fossil heritage and state if any mitigation or conservation measures need to be implemented.

Fourie (2018) indicated that the Dwyka Group may contain visible fossils, therefore a field survey (and not a desktop assessment) was necessary.

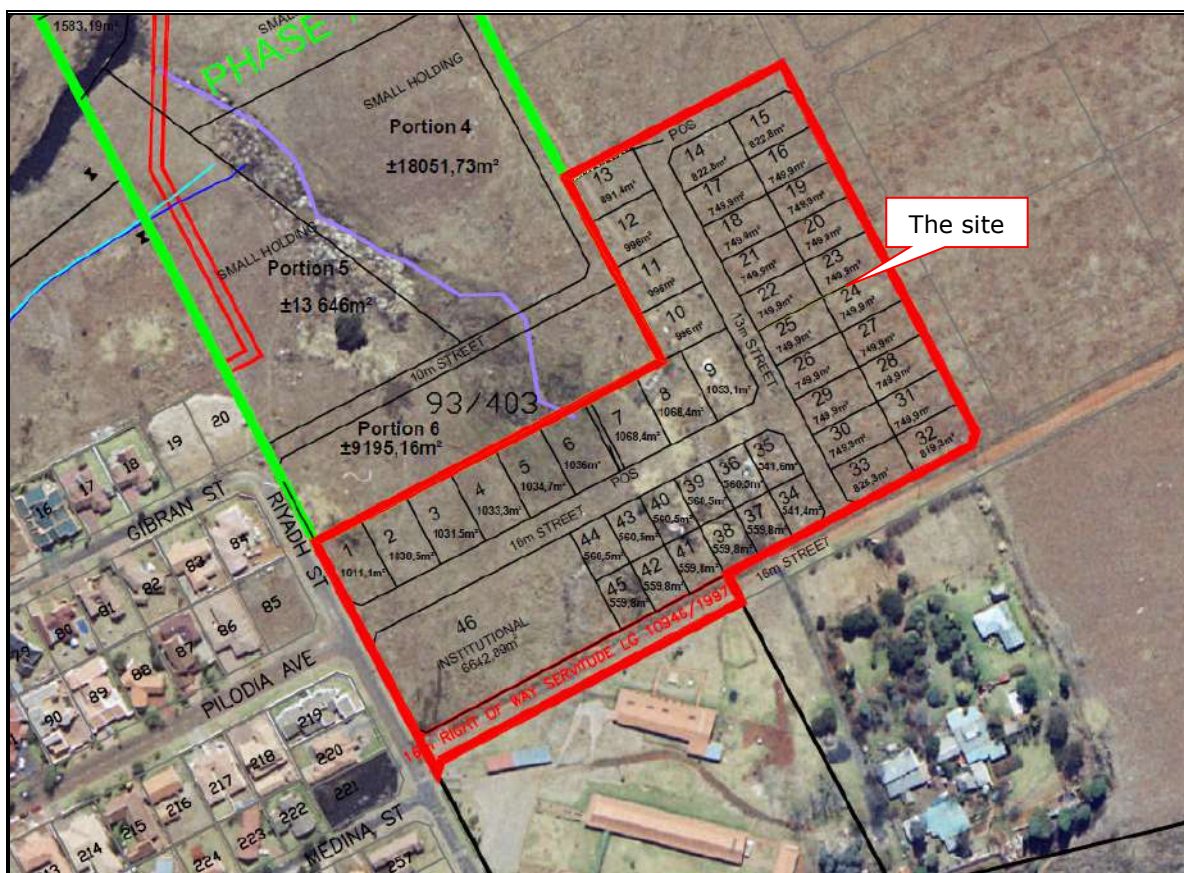
- 45 Residential stands;
- 1 Institutional stand;
- Main access to the site from Riyadh Street;
- Secondary access from the Right-of-Way servitude and the eastern boundary of the site.

Figure 7.1: Layout 1 - original layout (taken from Urban Dynamics, 2012)

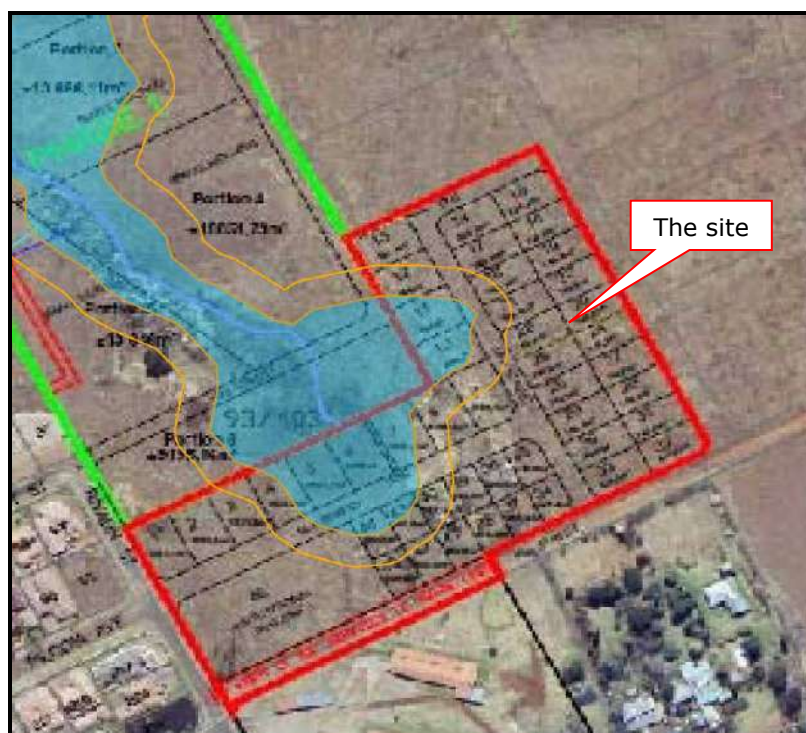
The wetland study (Appendix 7) identified a hillslope seepage wetland in the central portion of the site (Figure 7.2). Stands 3-12, 18-21, 40-45 and the Institutional stand (Stand 46) were affected by the wetland and 20m wetland buffer zone. No development is allowed within a wetland area and its associated wetland buffer since it is seen as a sensitive landscape and requires protection.

Figure 7.2: Layout plan 1 indicating wetland and 20m wetland buffer zone (taken from Davis, 2012)
