Site description: **OR TAMBO MEMORIAL SITE BIZANA MBIZANA EASTERN CAPE**

**O.R. TAMBO HOMESTEAD**

Drawing title:  
**TWO BEDROOM DWELLING FLOOR PLAN & ELEVATIONS RESTORATION CONSTRUCTION DETAIL**

Consultant Dwg. No. **1200079/100/STR/100** REVISION **01**

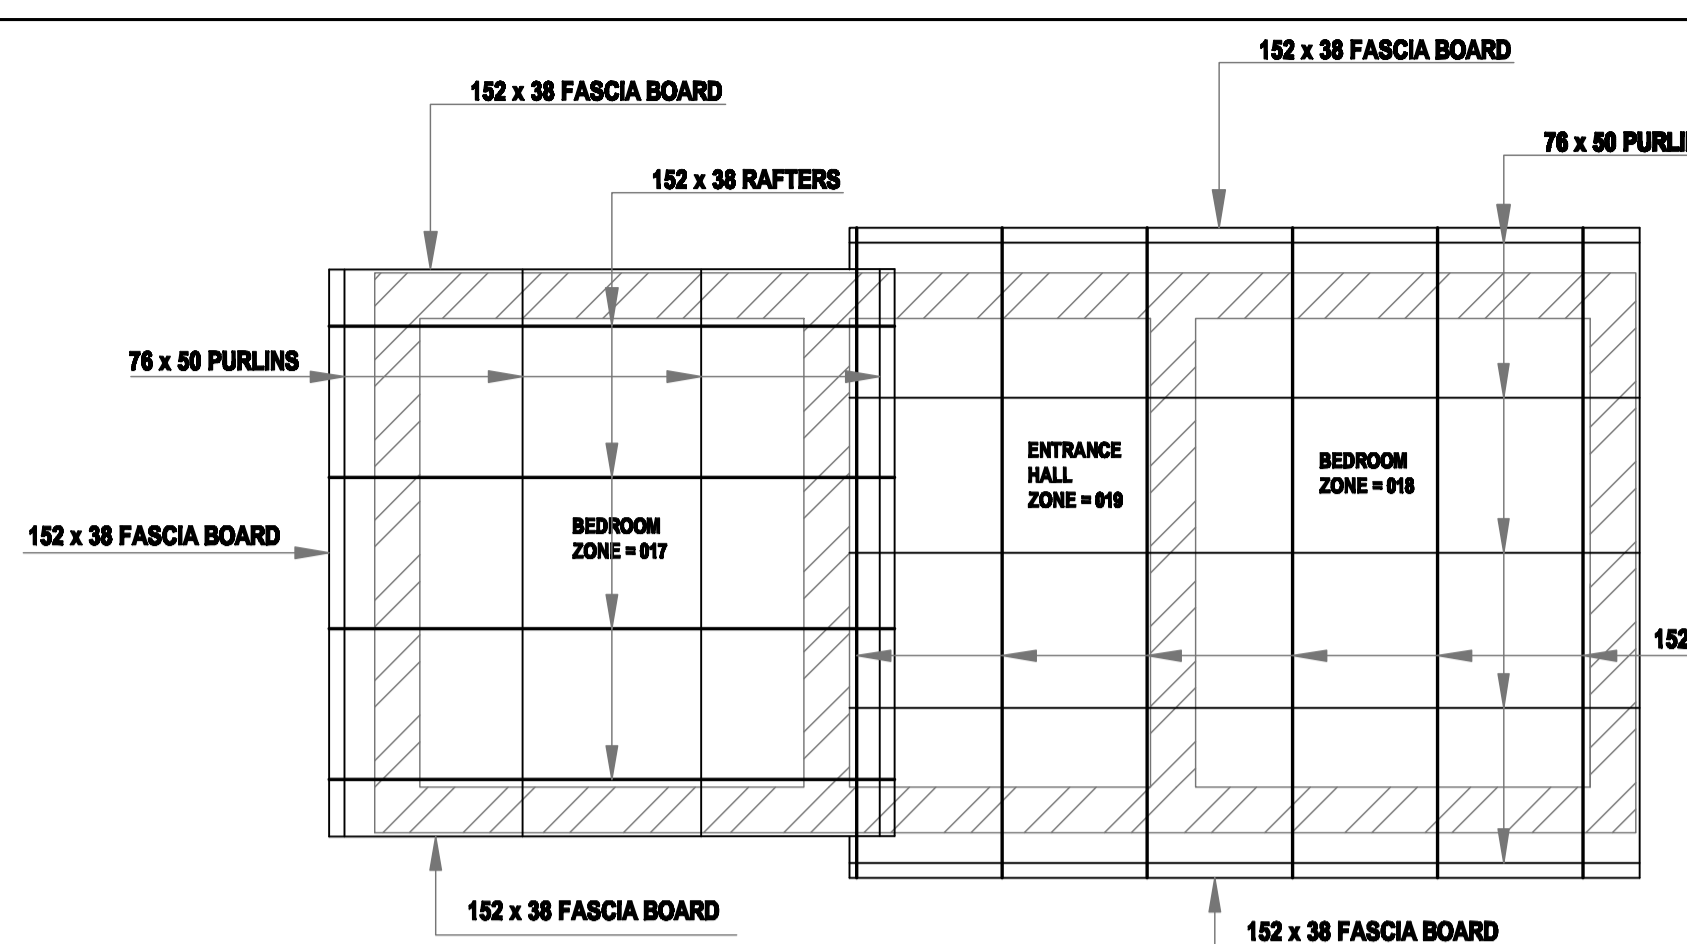
**ROOF PLAN**  
SCALE 1:50

**ROOF RESTORATION:**  
Carefully replace damaged and rotting roofing members with selected timber members to match existing. Architect and Engineer to be consulted on the selection of timber roofing members prior to erection. Corrugated iron roof to be carefully replaced with sheeting to match existing. Care to be taken as to not disturb the building integrity in any way. All jointing to be sealed to ensure water tightness. Gutter to be replaced with new gutter to match existing. Existing timber fascia to be replaced to match existing. Rough sawn timber fascia to be 152x38mm in size to match size of existing fascia. Purlins 76x50 S6 SA Pine. Rafters 114x38 and 152x38 S6 SA Pine to match existing sizes.

**Floor Treatment:**  
All existing floor coverings to be removed. Floor to be inspected for defects and all damage to be reported to architect. If structural defects are found, then after consultation with architect, the floor topping in the affected area is to be removed and replaced with a new layer of at least 30mm in depth to match existing.

**Repairs to Floors:**  
Where damaged, the floor covering will be chipped back and refilled with a 30mm sand/cement screed. The screed will be mixed as 1 part cement and 4 parts sand. The finish will match existing.

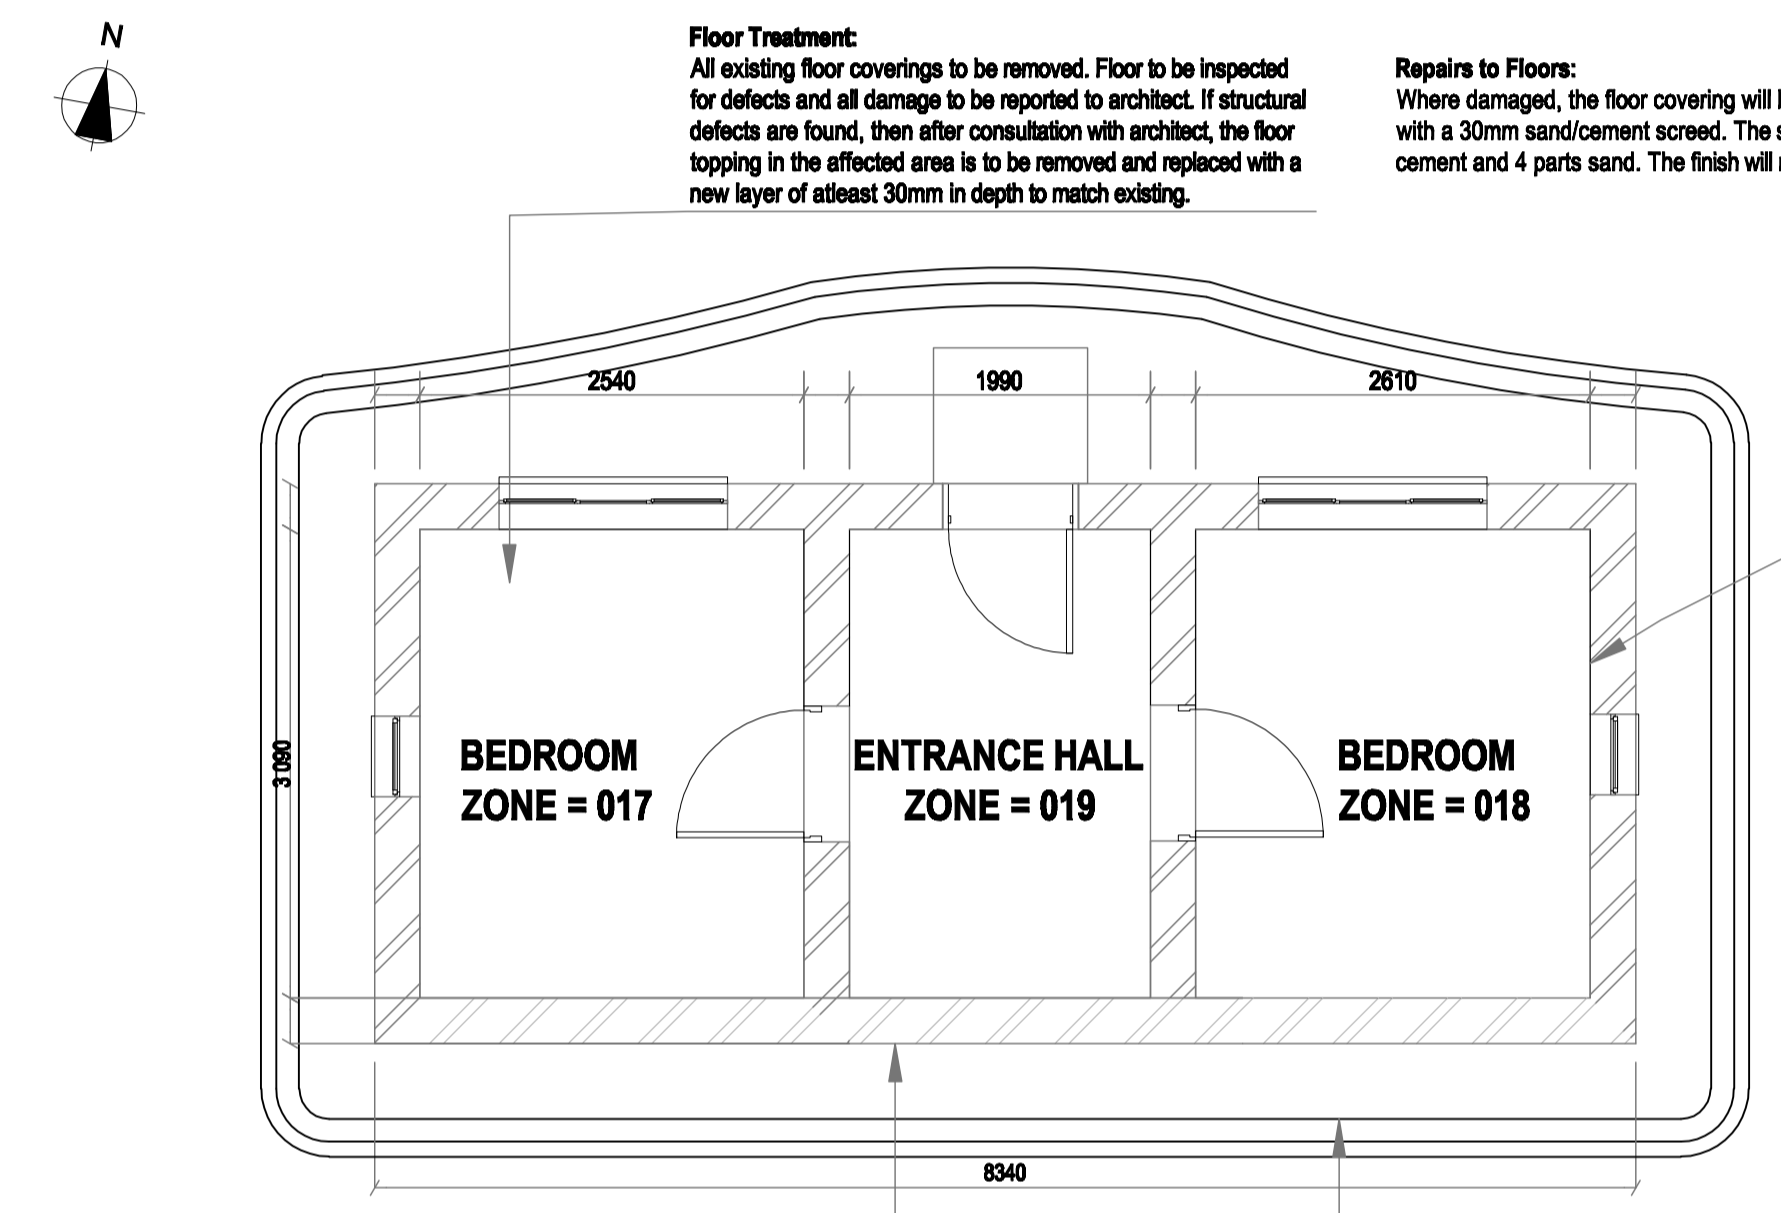
**FLOOR PLAN**  
SCALE 1:50

**Existing Foundation:**  
Expose the existing foundations all around to confirm the structural integrity. Areas which exhibit stress or cracked will have to be underpinned. Use 20MPa concrete under the existing foundations where necessary to add support.

**Interior:**  
Interior walls to be softly cleaned using sugar soap and steel wool. Furniture to be softly cleaned using sugar soap and steel wool.

**Repair to Walls:**  
1) Walls which exhibit plaster cracking only will have the plaster chipped back and re-plastered with a standard mortar mix of 1 part sand to 4 parts building sand.  
2) Walls which are cracked into the blocks will have the blocks removed and replaced. The mortar lines will have Y10mm reinforcement bars placed in them such that 500mm extends either side of the crack. Once fixed in the wall will be plastered as usual.

**Area around House:**  
Ground within 500mm band of the building circumference to be dug out to a depth 120mm and replaced with a compacted 1:15 cement clay soil mix. Drainage channel of 100mm in width and 80mm depth to be carved into compacted mix at a distance of approximately 250mm from building circumference. Ground around road level to be gently sloped at 2 degrees towards drainage channel. Newly compacted surface to be covered in loosely laid stones. Water sump and 160mm diameter drainage pipe to be constructed below ground and covered with compacted 1:15 cement clay soil mix.

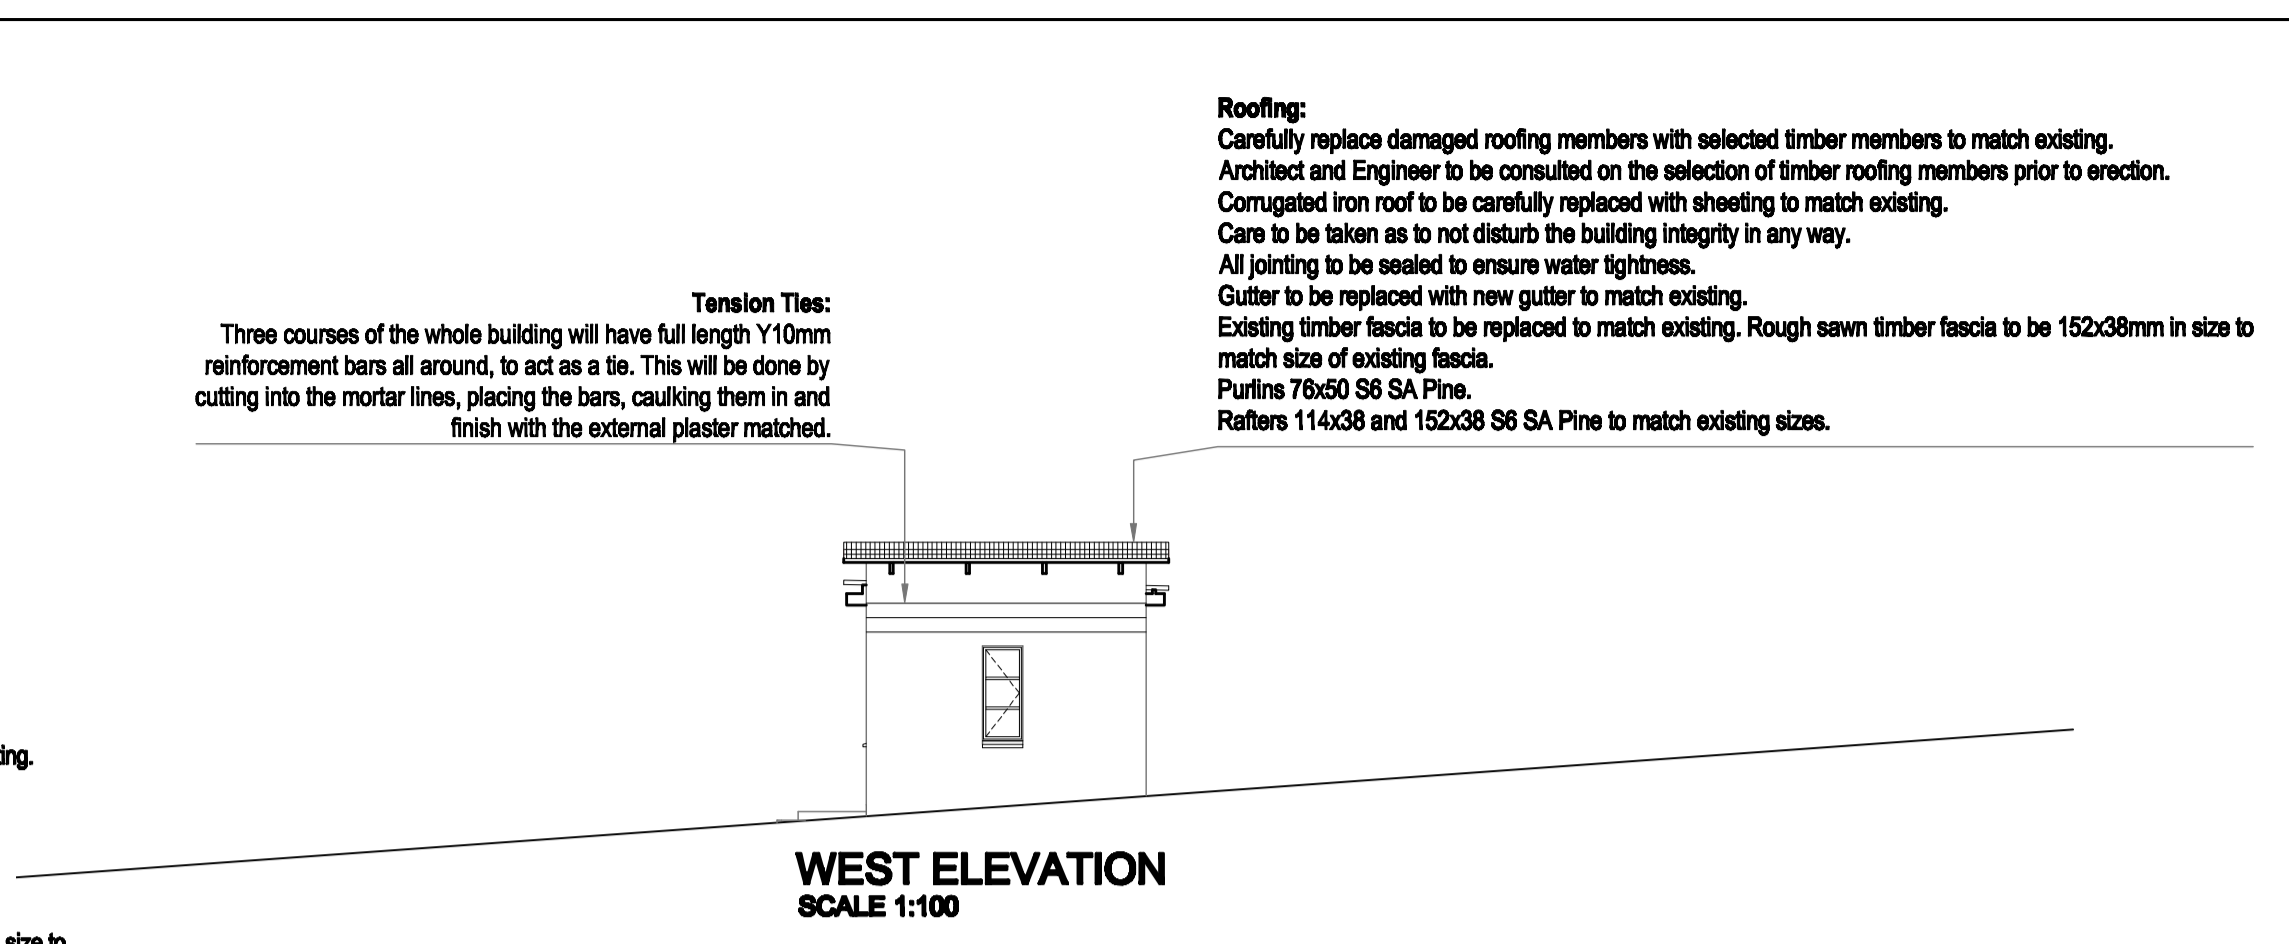
**WEST ELEVATION**  
SCALE 1:100

**Roofing:**  
Carefully replace damaged roofing members with selected timber members to match existing. Architect and Engineer to be consulted on the selection of timber roofing members prior to erection. Corrugated iron roof to be carefully replaced with sheeting to match existing. Care to be taken as to not disturb the building integrity in any way. All jointing to be sealed to ensure water tightness. Gutter to be replaced with new gutter to match existing. Existing timber fascia to be replaced to match existing. Rough sawn timber fascia to be 152x38mm in size to match size of existing fascia. Purlins 76x50 S6 SA Pine. Rafters 114x38 and 152x38 S6 SA Pine to match existing sizes.

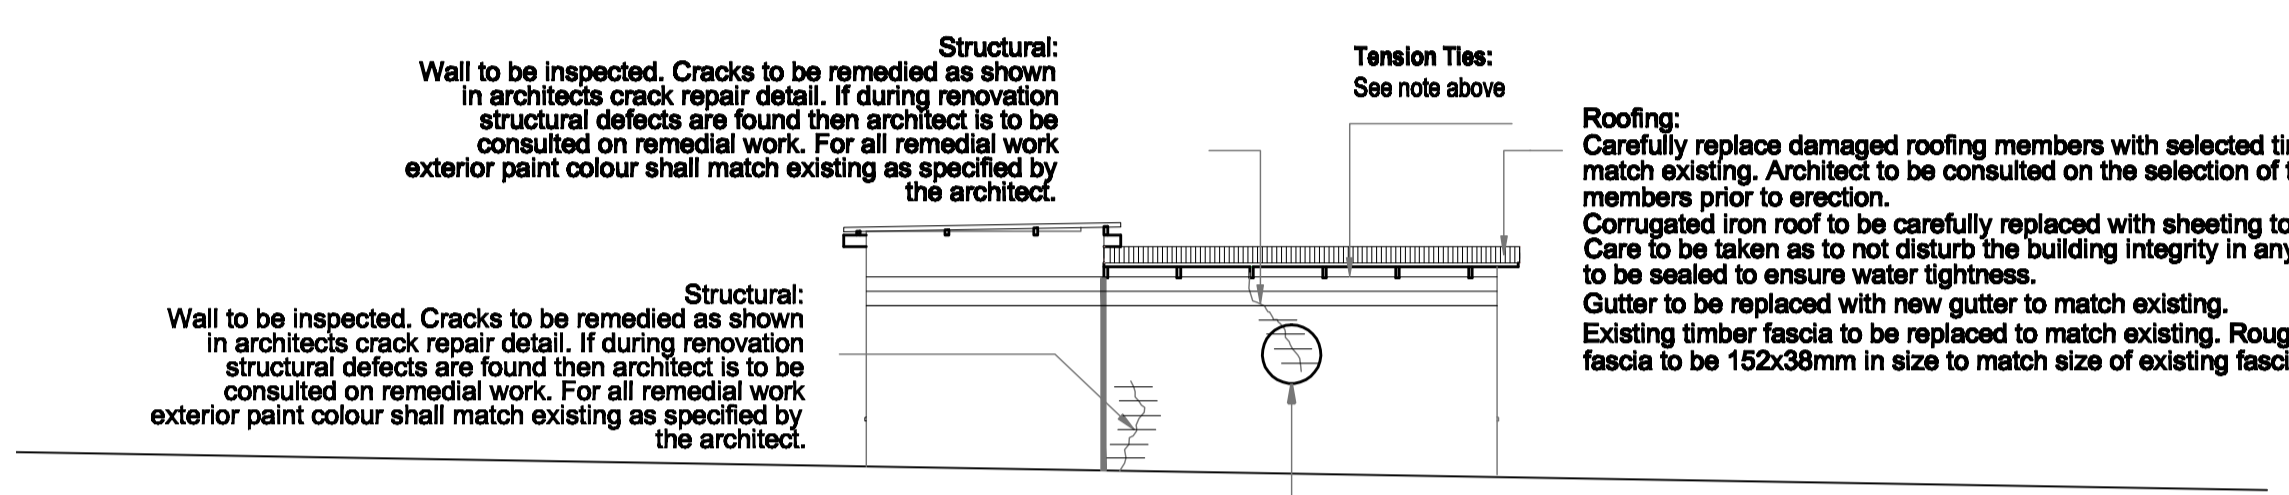
**SOUTH ELEVATION**  
SCALE 1:100

**Structural:**  
Wall to be inspected. Cracks to be remedied as shown in architects crack repair detail. If during renovation structural defects are found then architect is to be consulted on remedial work. For all remedial work exterior paint colour shall match existing as specified by the architect.

**Tension Ties:**  
See note above

**Roofing:**  
Carefully replace damaged roofing members with selected timber members to match existing. Architect to be consulted on the selection of timber roofing members prior to erection. Corrugated iron roof to be carefully replaced with sheeting to match existing. Care to be taken as to not disturb the building integrity in any way. All jointing to be sealed to ensure water tightness. Gutter to be replaced with new gutter to match existing. Existing timber fascia to be replaced to match existing. Rough sawn timber fascia to be 152x38mm in size to match size of existing fascia.

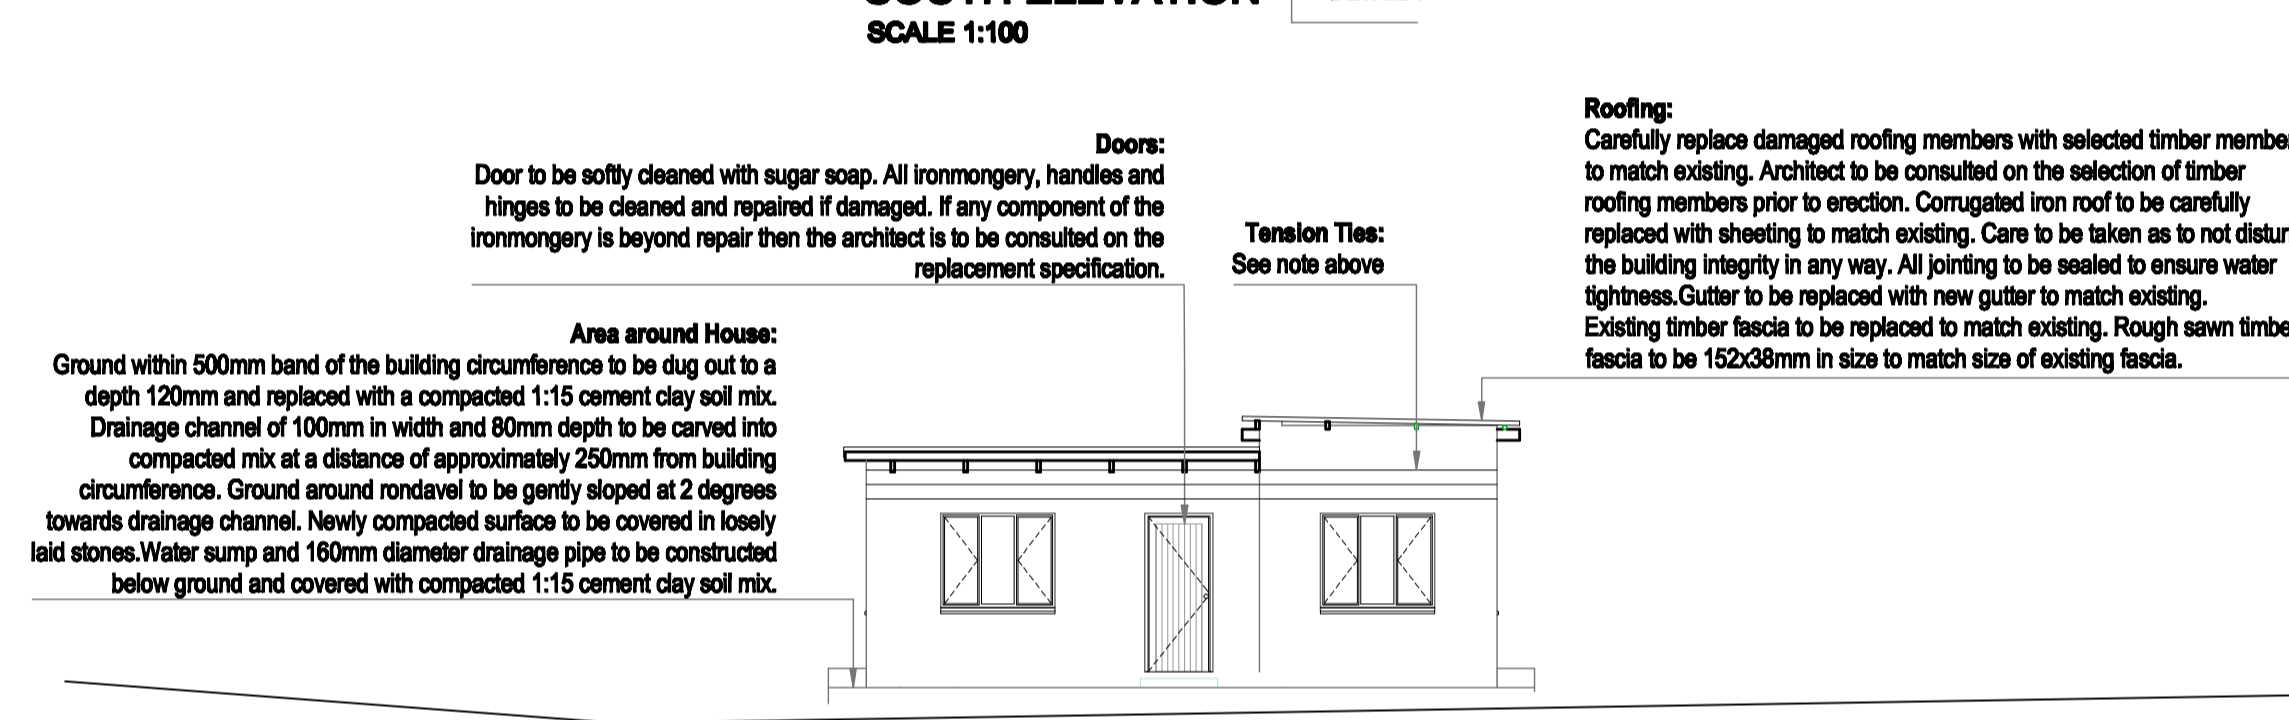
**NORTH ELEVATION**  
SCALE 1:100

**Doors:**  
Door to be softly cleaned with sugar soap. All ironmongery, handles and hinges to be cleaned and repaired if damaged. If any component of the ironmongery is beyond repair then the architect is to be consulted on the replacement specification.

**Tension Ties:**  
See note above

**Roofing:**  
Carefully replace damaged roofing members with selected timber members to match existing. Architect to be consulted on the selection of timber roofing members prior to erection. Corrugated iron roof to be carefully replaced with sheeting to match existing. Care to be taken as to not disturb the building integrity in any way. All jointing to be sealed to ensure water tightness. Gutter to be replaced with new gutter to match existing. Existing timber fascia to be replaced to match existing. Rough sawn timber fascia to be 152x38mm in size to match size of existing fascia.

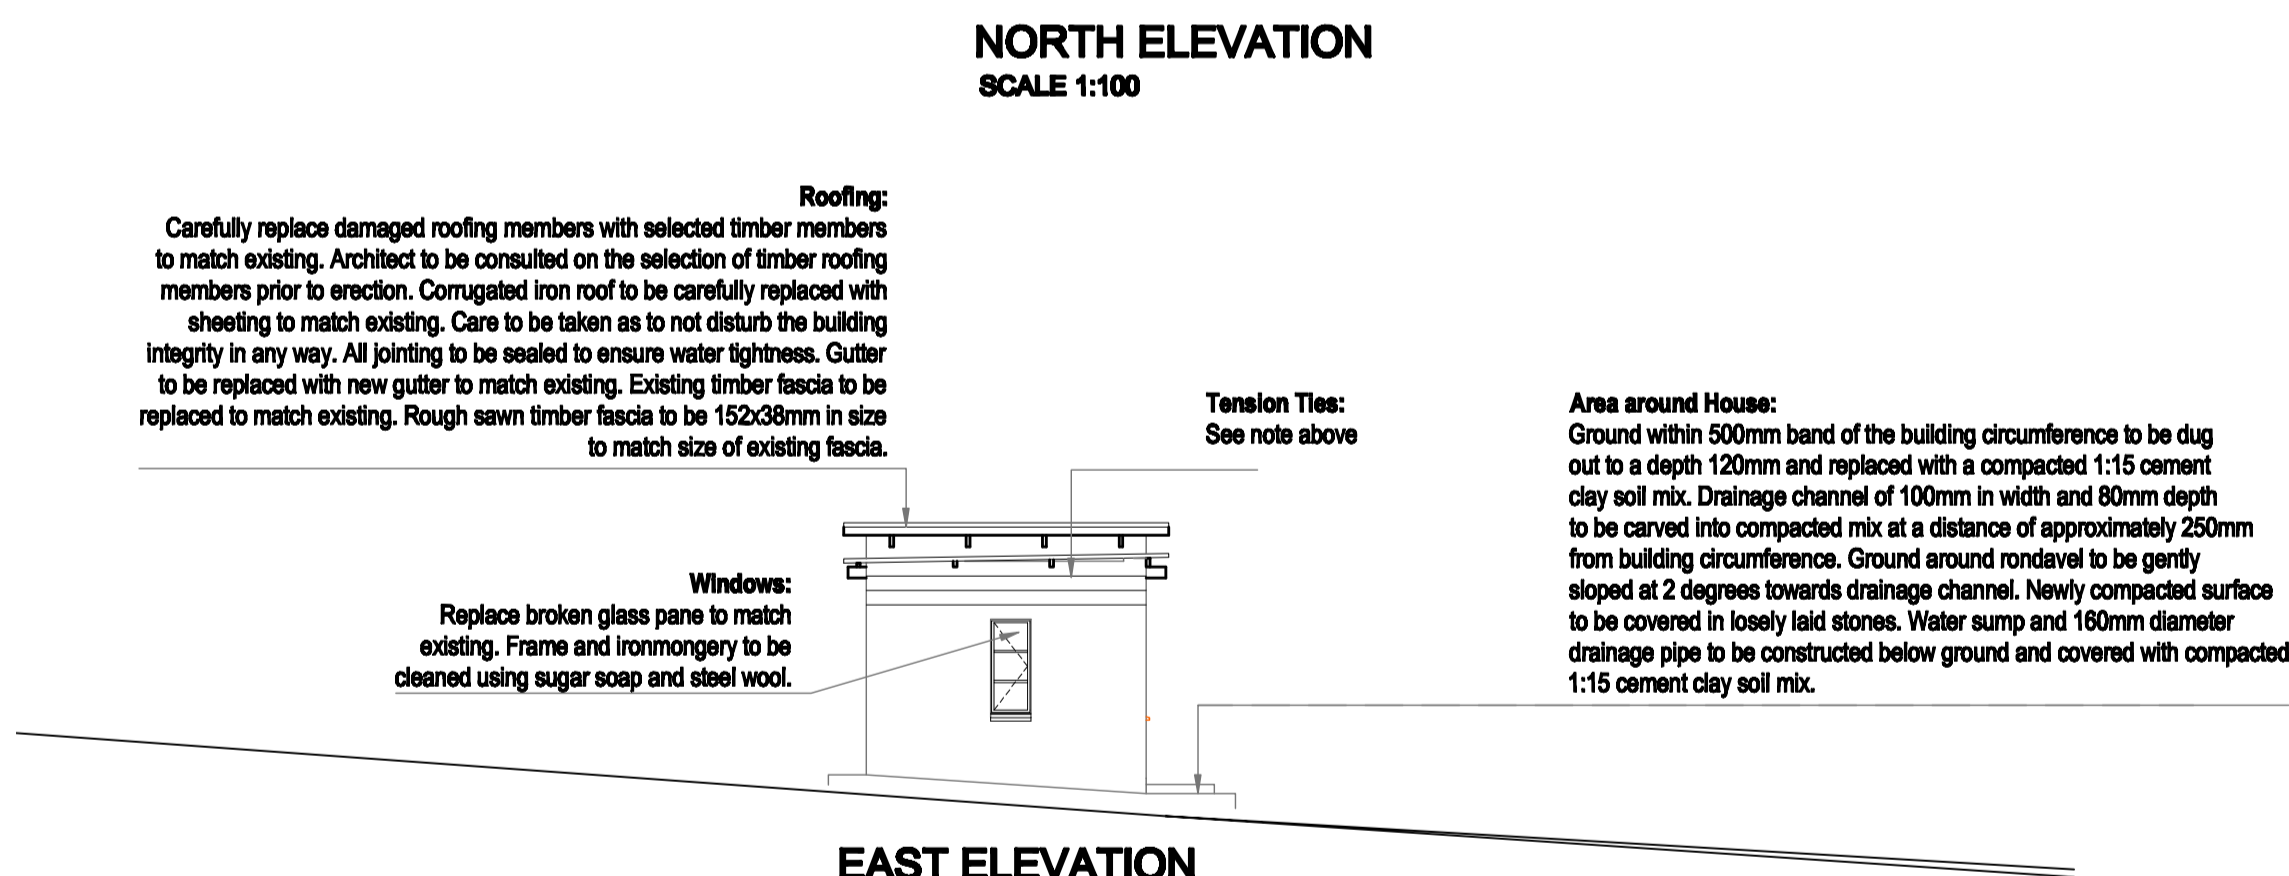
**EAST ELEVATION**

**Roofing:**  
Carefully replace damaged roofing members with selected timber members to match existing. Architect to be consulted on the selection of timber roofing members prior to erection. Corrugated iron roof to be carefully replaced with sheeting to match existing. Care to be taken as to not disturb the building integrity in any way. All jointing to be sealed to ensure water tightness. Gutter to be replaced with new gutter to match existing. Existing timber fascia to be replaced to match existing. Rough sawn timber fascia to be 152x38mm in size to match size of existing fascia.

**Tension Ties:**  
See note above

**Area around House:**  
Ground within 500mm band of the building circumference to be dug out to a depth 120mm and replaced with a compacted 1:15 cement clay soil mix. Drainage channel of 100mm in width and 80mm depth to be carved into compacted mix at a distance of approximately 250mm from building circumference. Ground around road level to be gently sloped at 2 degrees towards drainage channel. Newly compacted surface to be covered in loosely laid stones. Water sump and 160mm diameter drainage pipe to be constructed below ground and covered with compacted 1:15 cement clay soil mix.

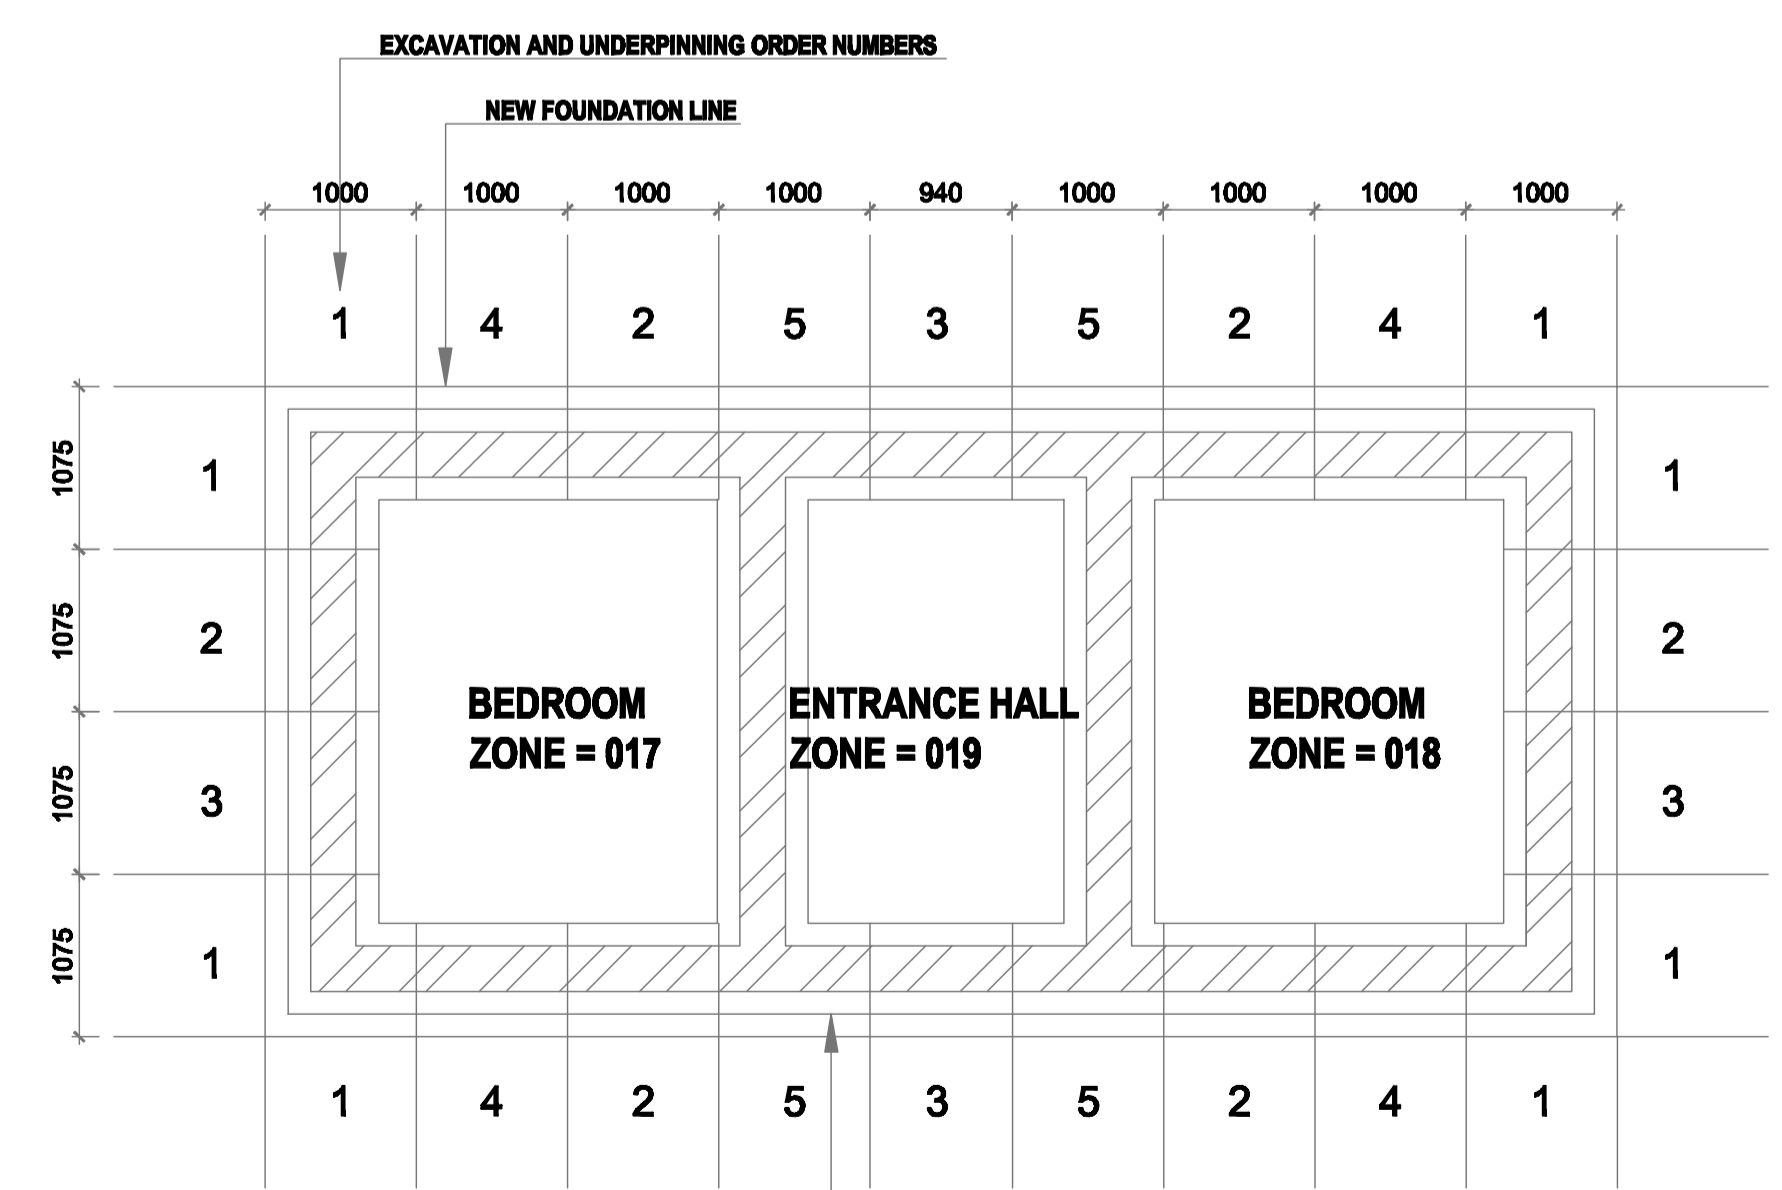
**FOUNDATION PLAN**  
SCALE 1:50

**Existing Foundation:**  
Expose the existing foundations all around to confirm the structural integrity. Areas which exhibit stress or cracked will have to be underpinned. Use 25MPa concrete under the existing foundations where necessary to add support.

**METHODOLOGY FOR UNDERPINNING**  
1. EXCAVATE WHERE DAMAGED 250mm BELOW, IN NUMBER ORDER AS SHOWN ON PLAN.  
2. PLACE SOLID CONCRETE BRICKS AS PROPS AND PROP WALLS TO MAINTAIN BALANCE.  
3. CAST 25MPa CONCRETE TO UNDERSIDE OF EXISTING BASE AND UP TO 100mm HIGHER THAN THE NEW BASE TO PREVENT SHRINKAGE.

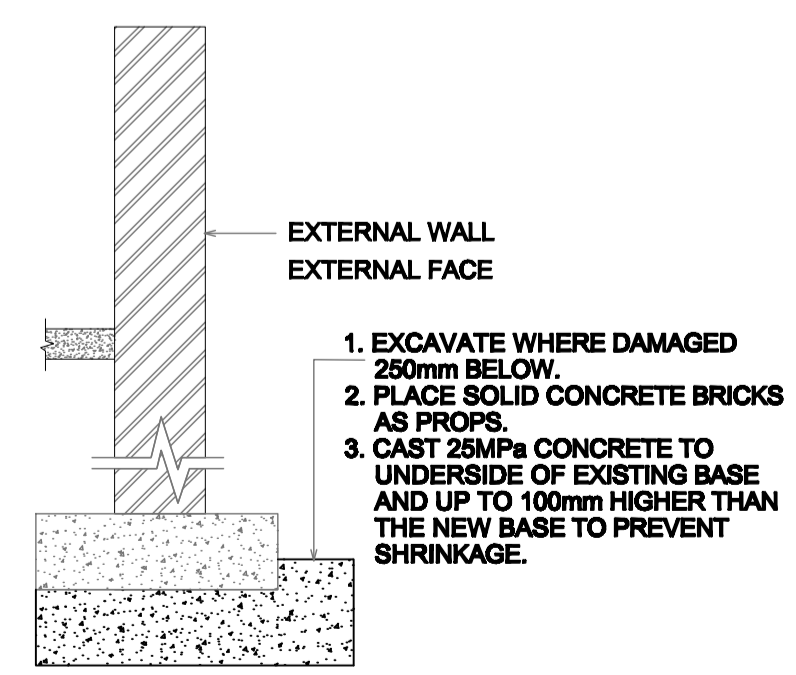
**UNDERPINNING DETAIL**  
SCALE 1:25

1. EXCAVATE WHERE DAMAGED 250mm BELOW.  
2. PLACE SOLID CONCRETE BRICKS AS PROPS.  
3. CAST 25MPa CONCRETE TO UNDERSIDE OF EXISTING BASE AND UP TO 100mm HIGHER THAN THE NEW BASE TO PREVENT SHRINKAGE.
