PROJECT  
SOUTHERN REGION  
PIETERMARITZBURG  
DEPARTMENT OF HEALTH  
TOWN HILL HOSPITAL  
REPLACEMENT AND  
RENOVATIONS TO ROOFS

DRAWING DESCRIPTION  
OCCUPATIONAL THERAPY  
BLOCK S4  
ALTERATIONS AND RENOVATIONS

DRAWING NO.	REV
044038 - E - 213

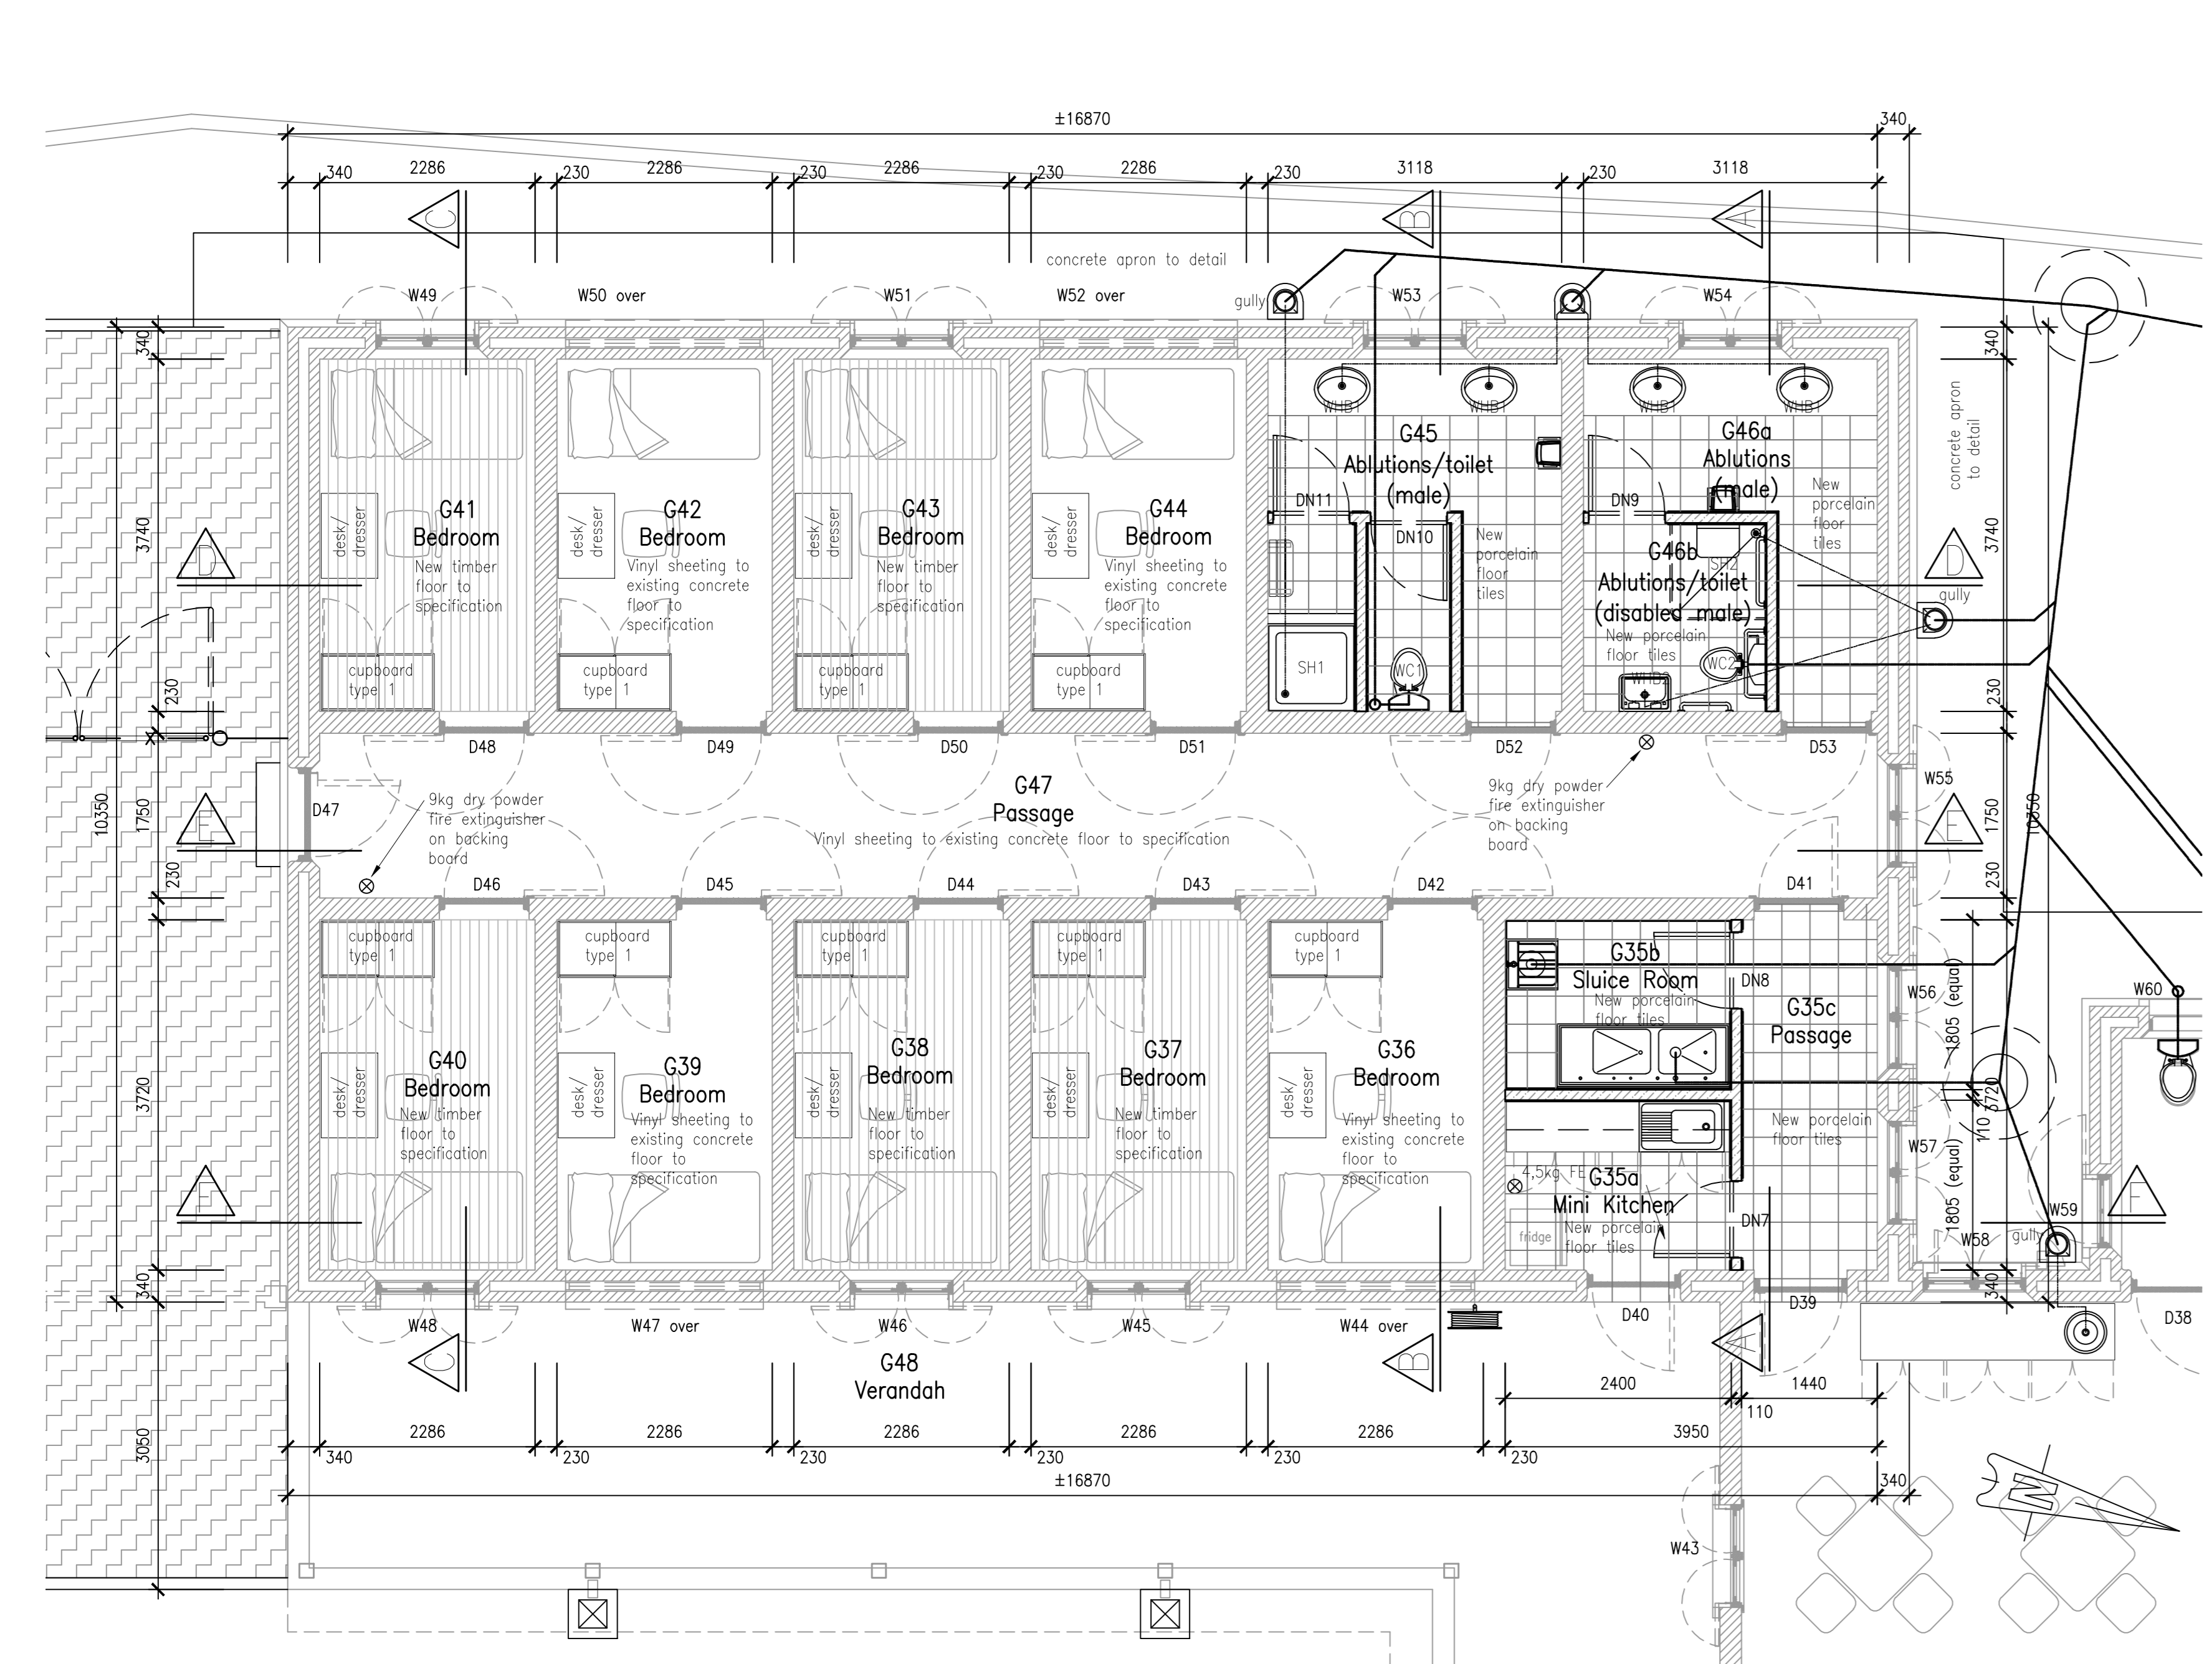
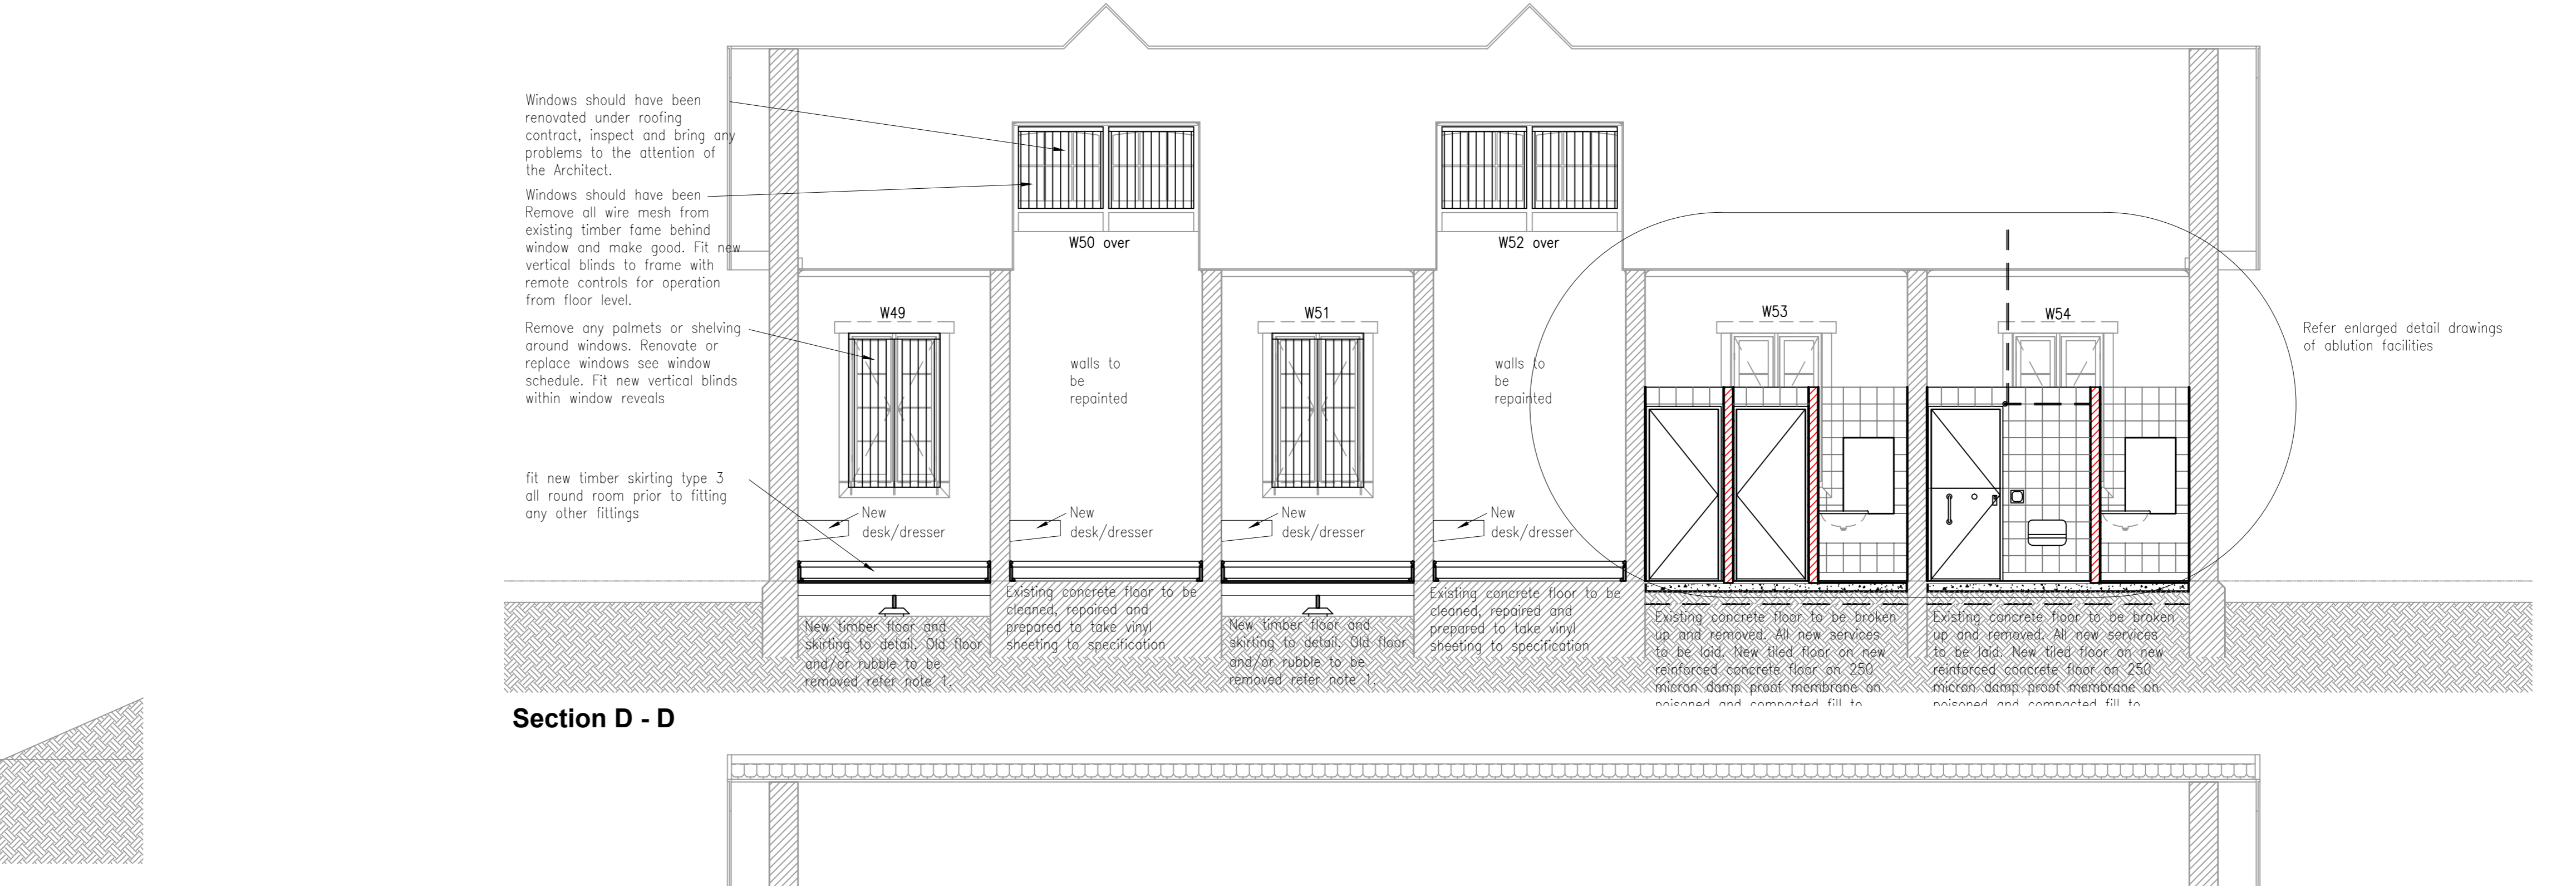
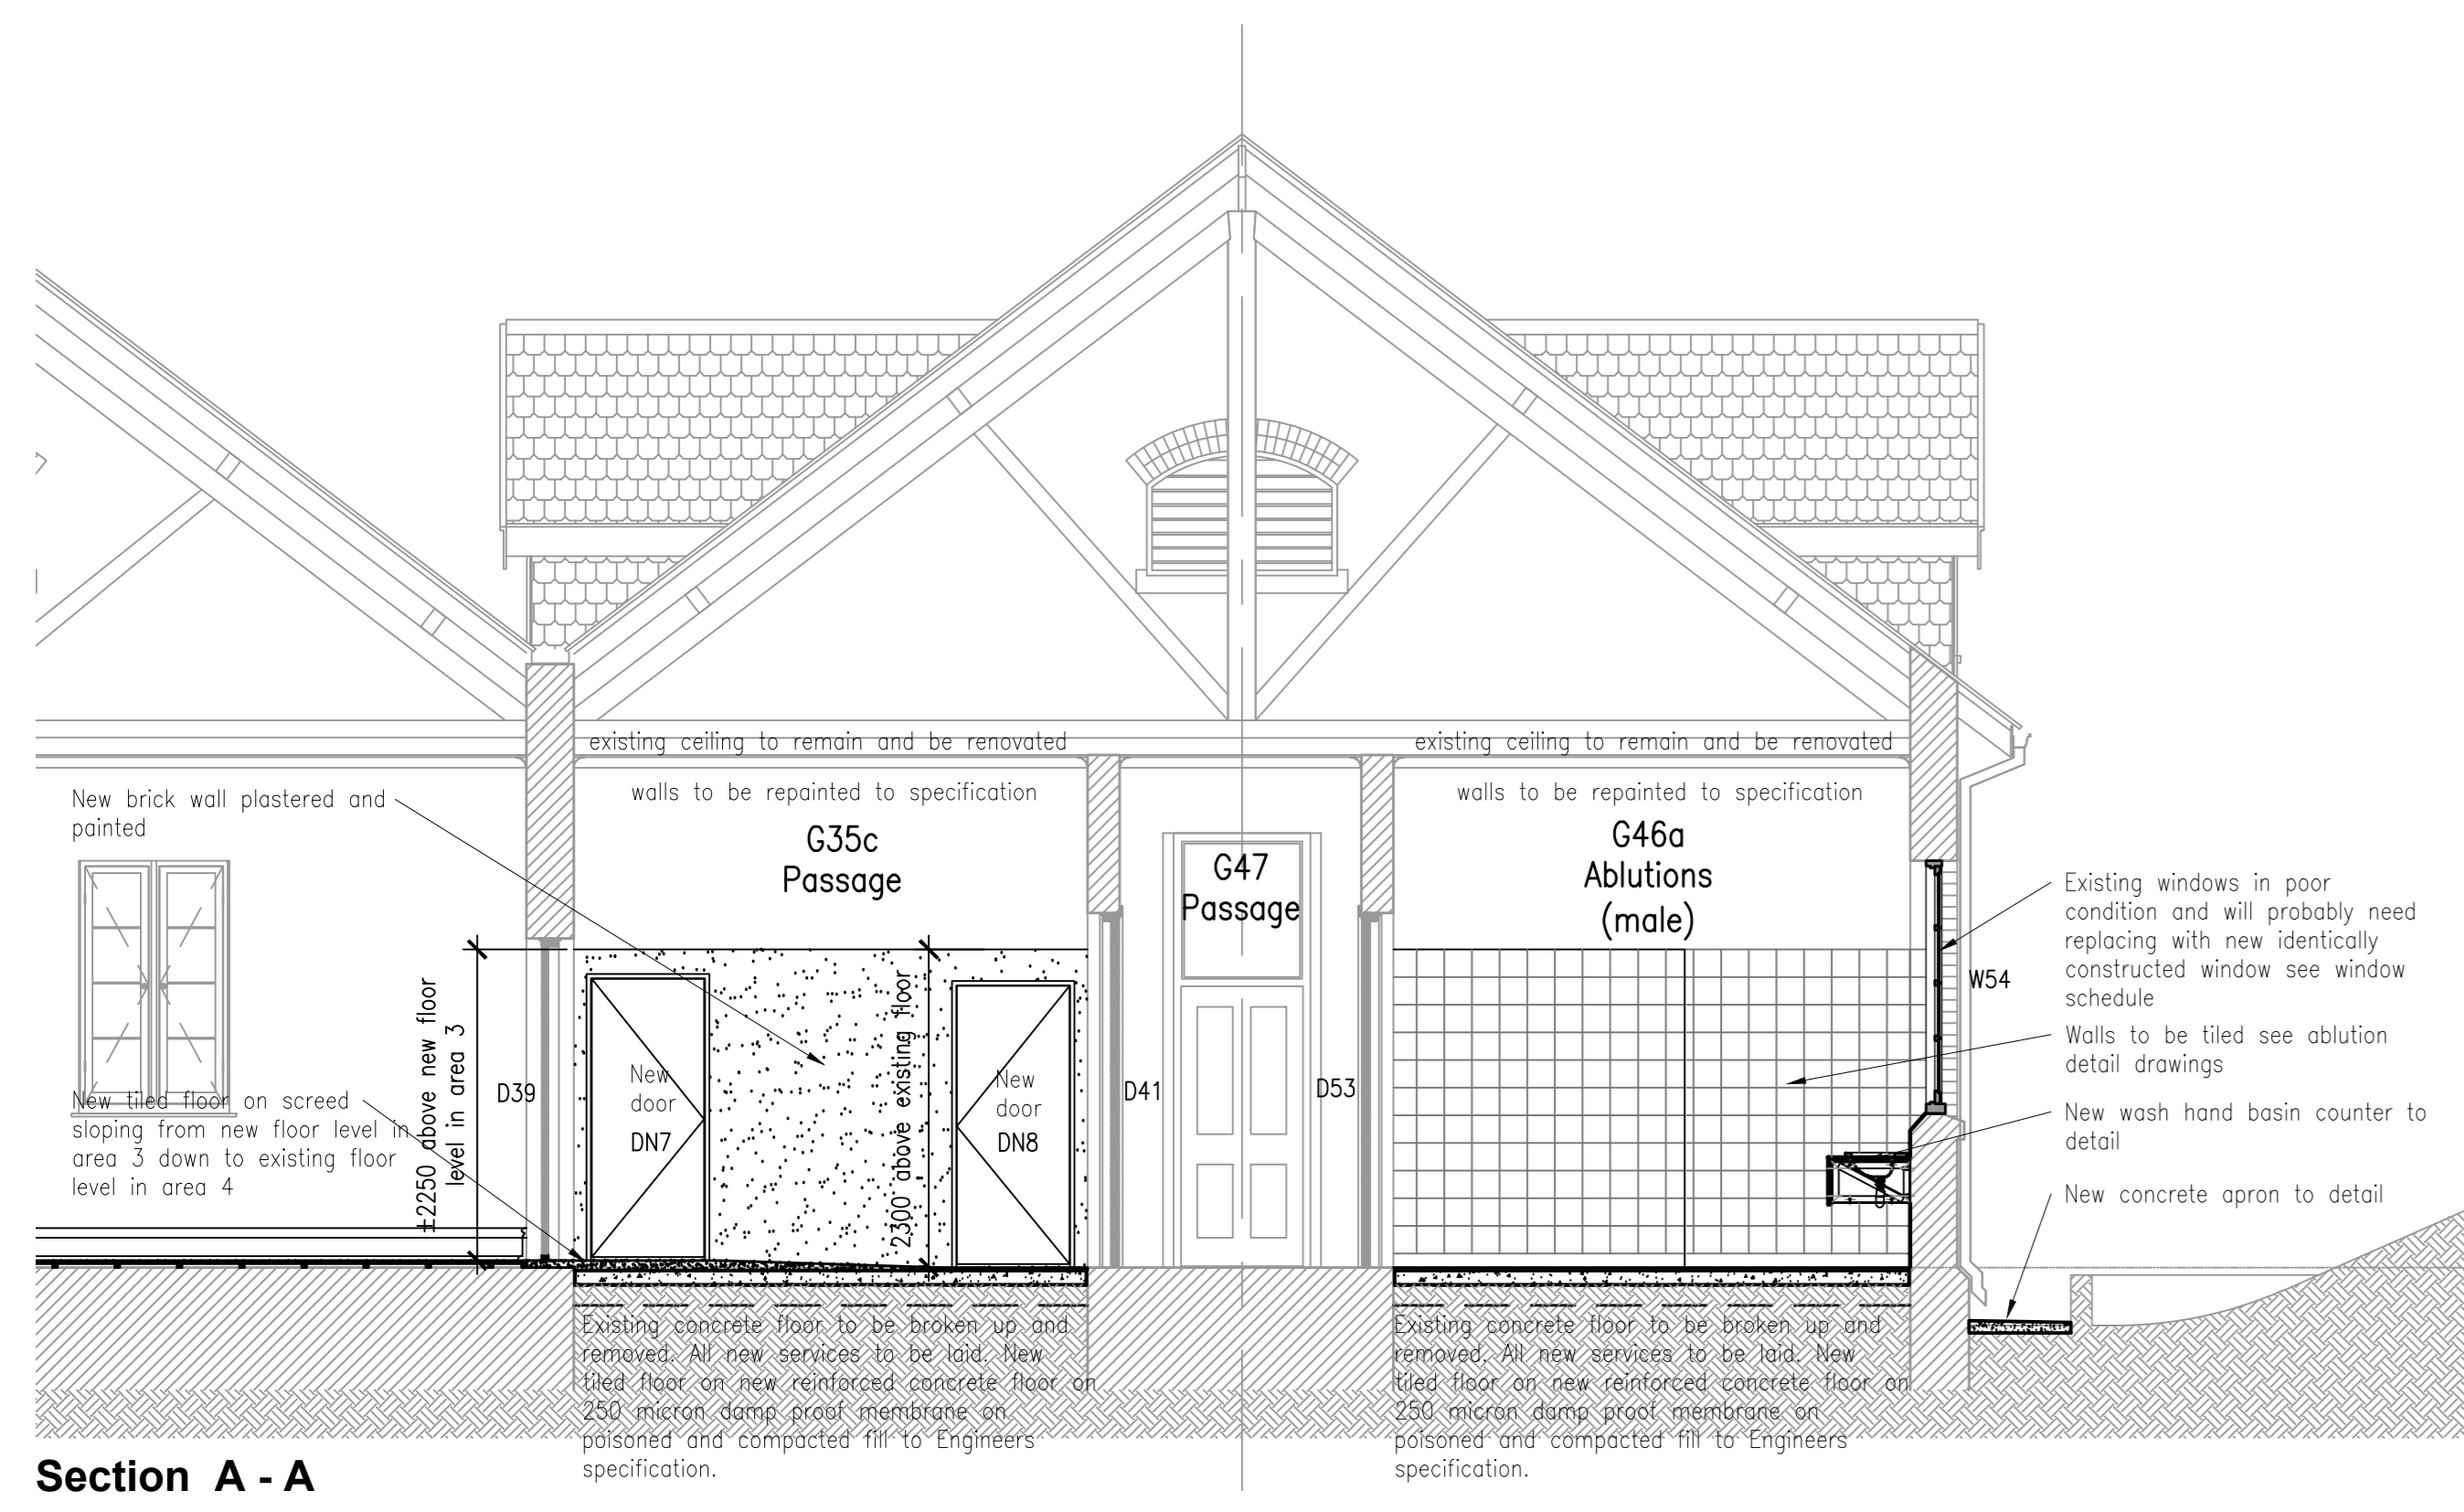
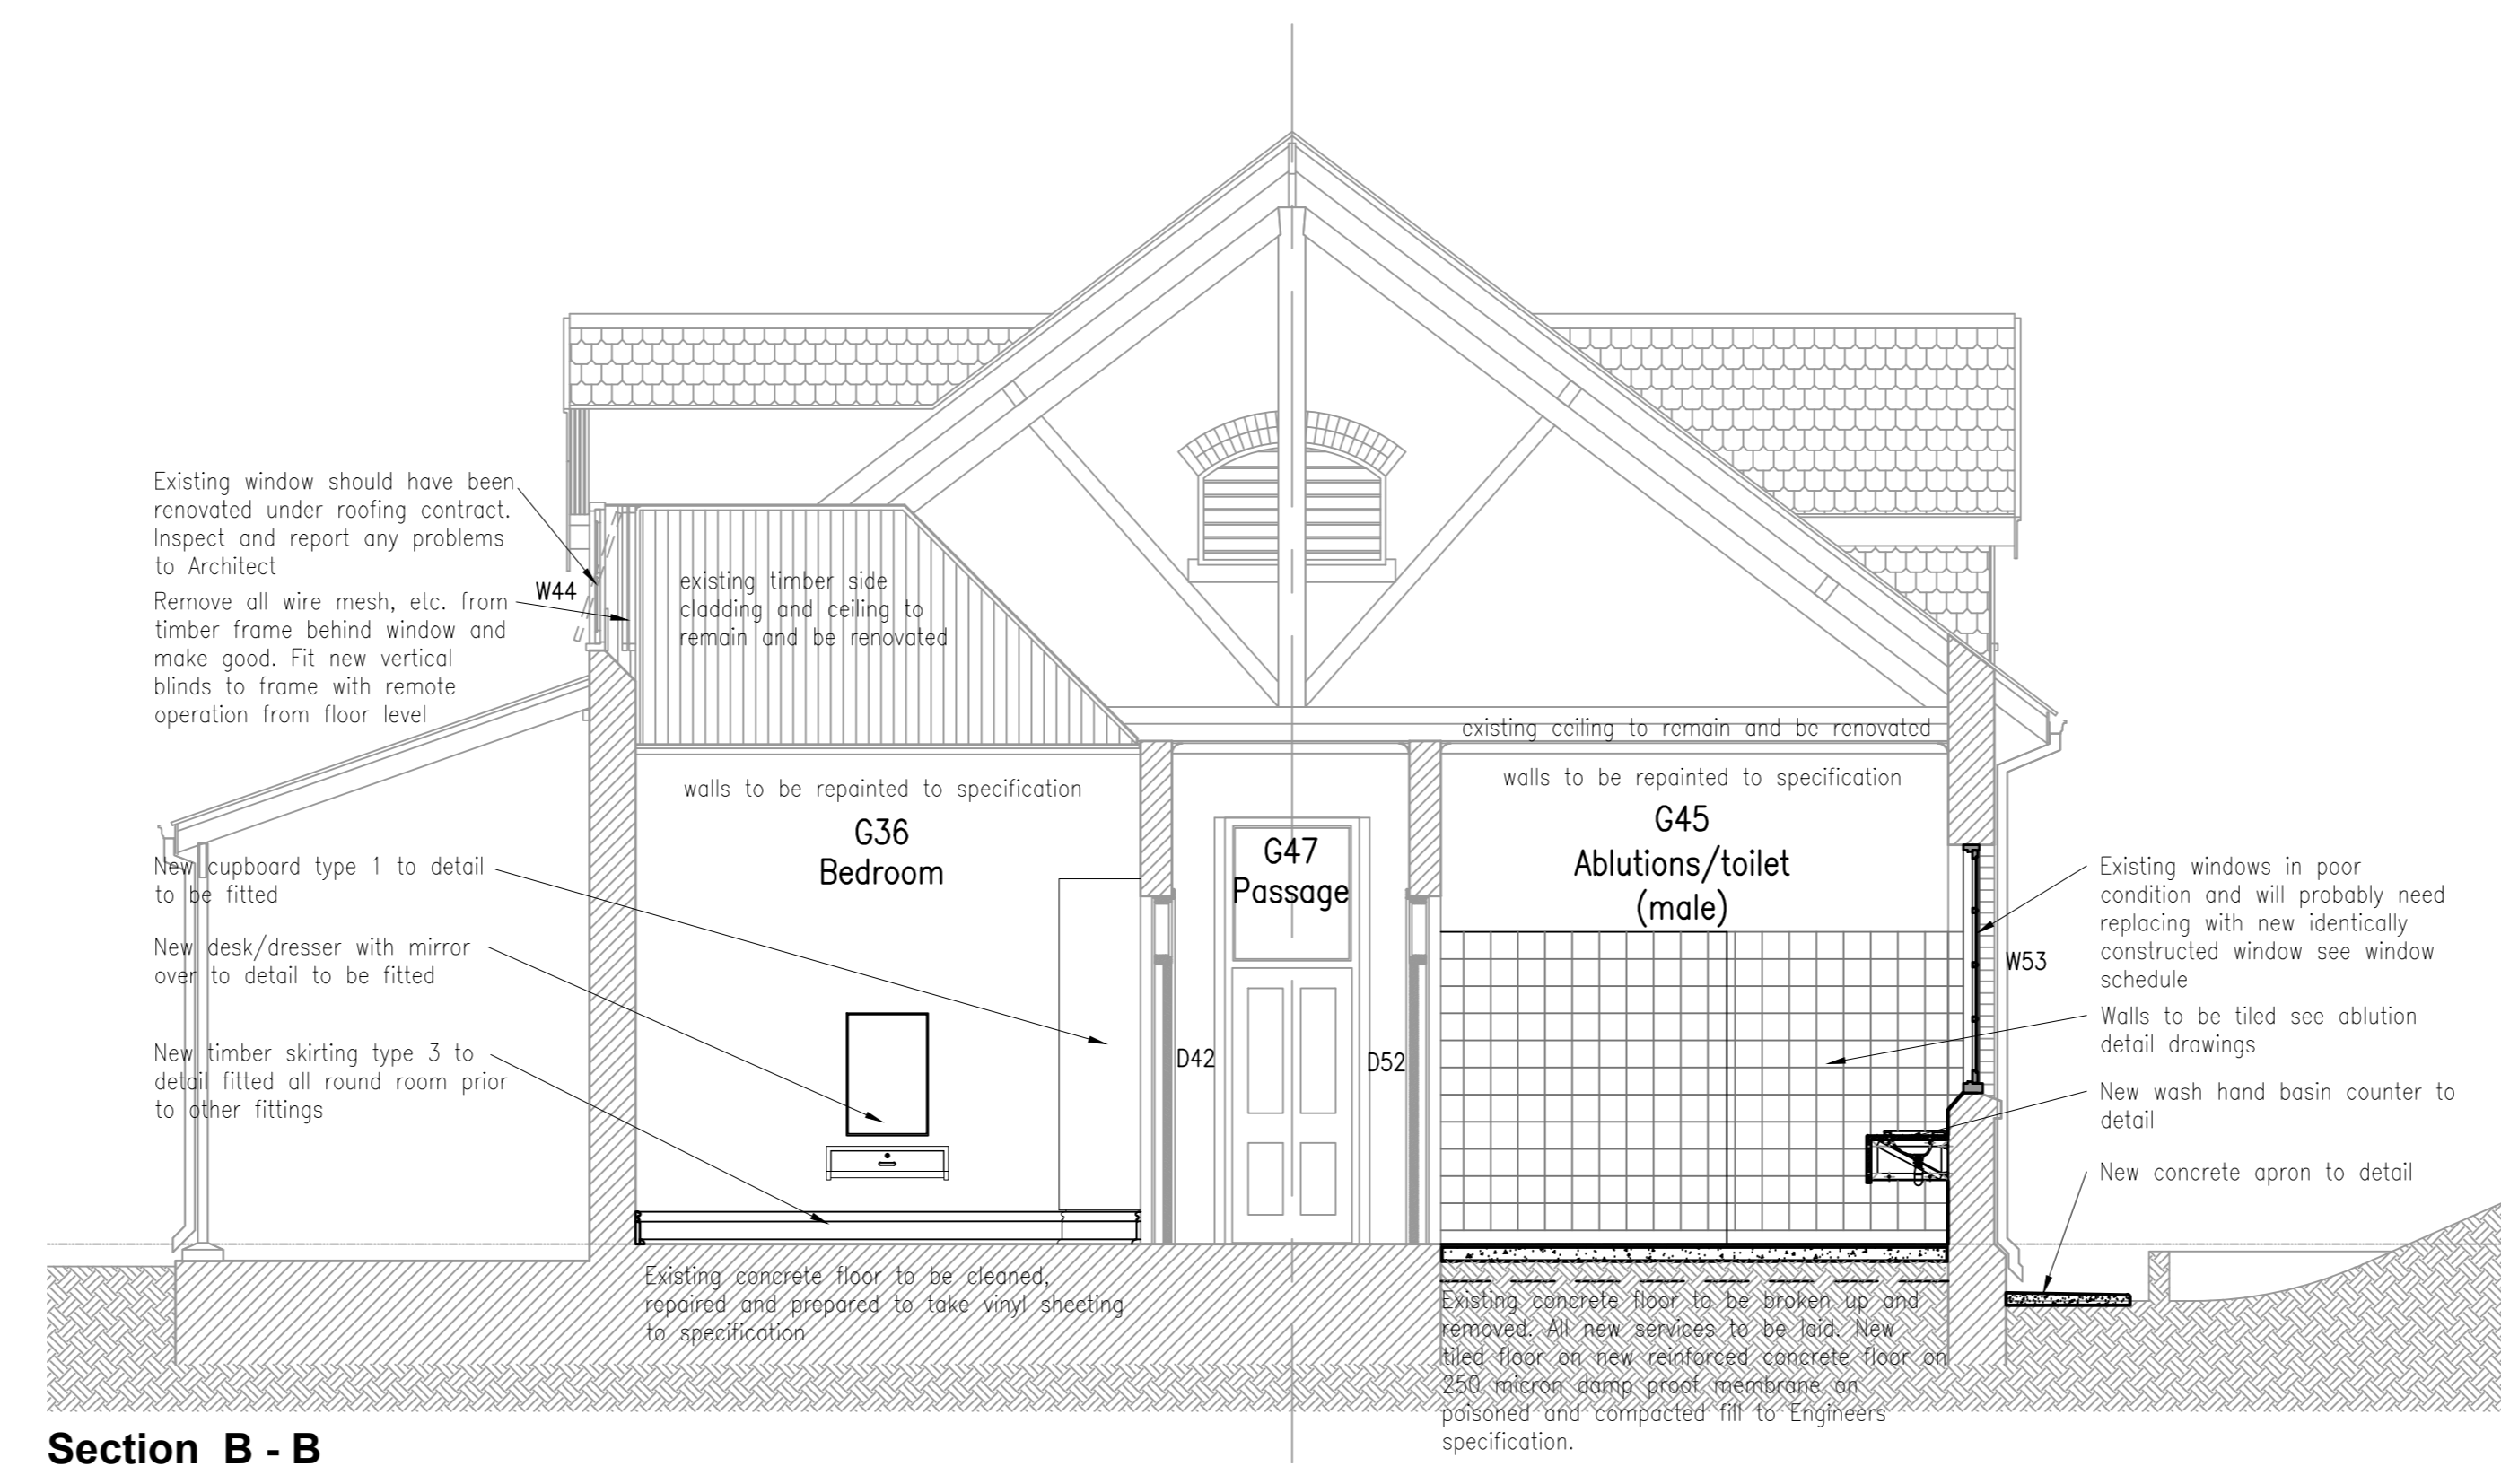
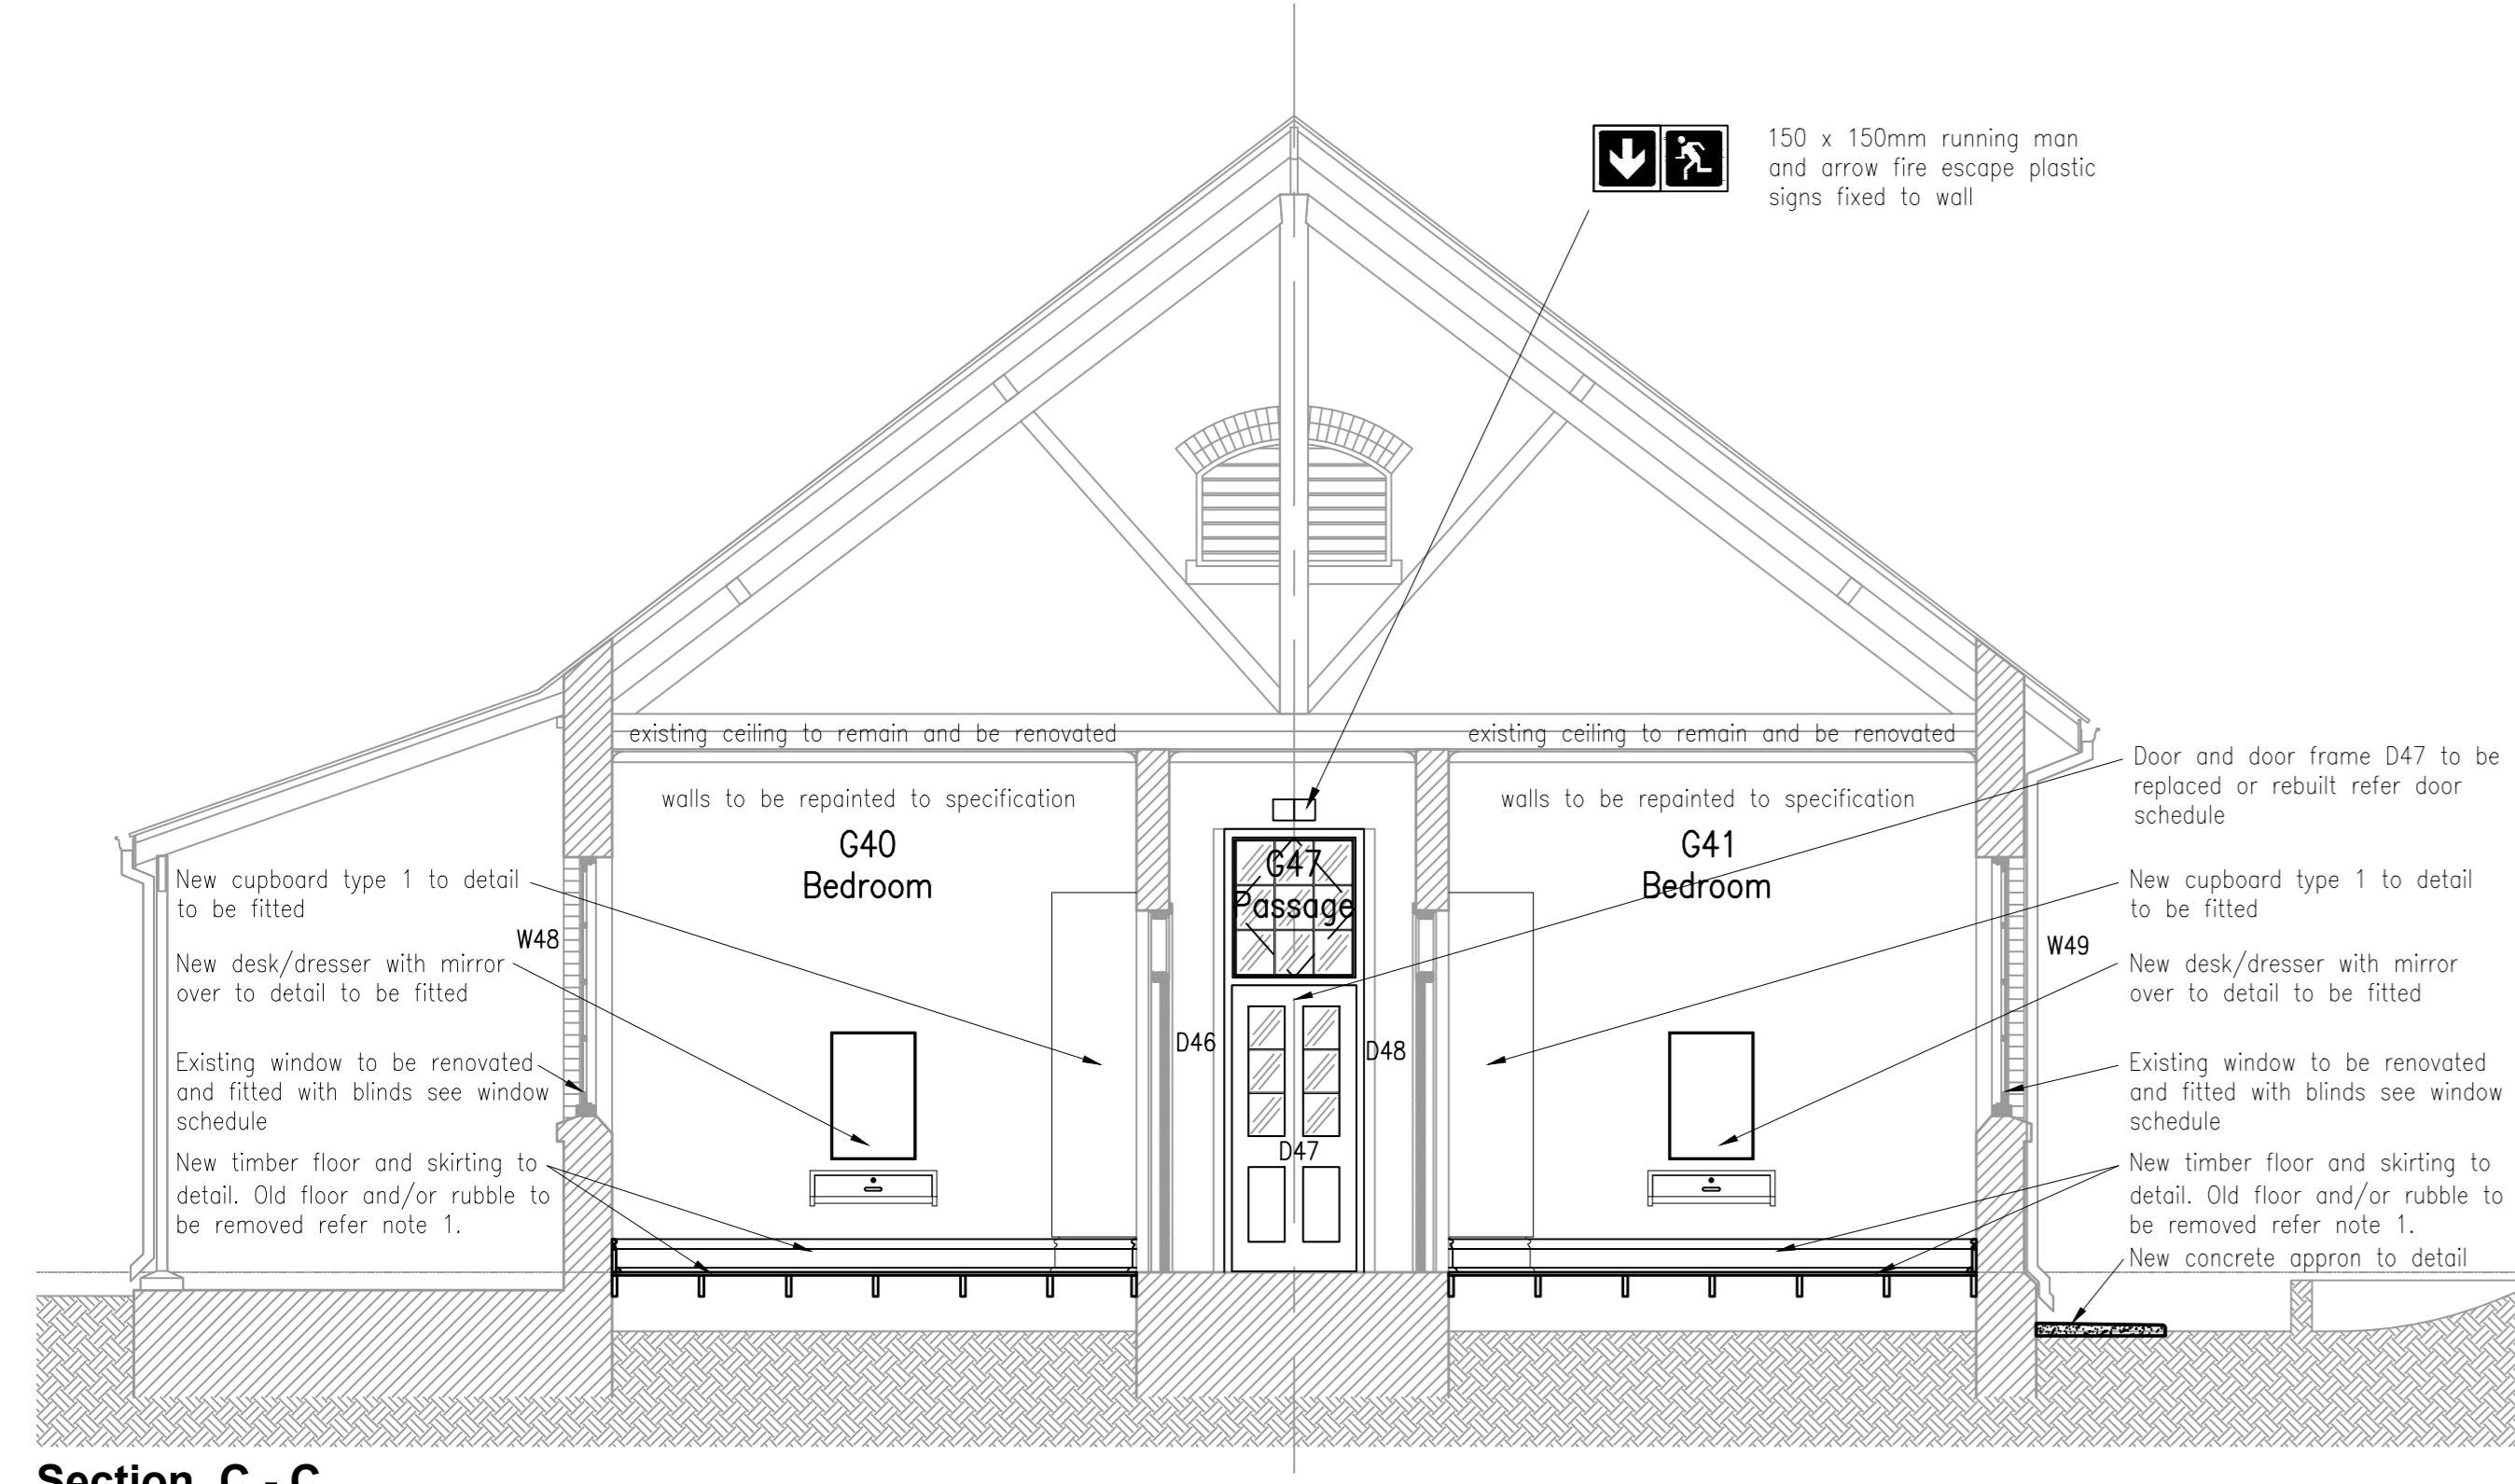
Notes:-  
1) Timber floors to rooms in S4 are in very poor condition and in many places have been removed and the under floor void has been filled with old building rubble. Remove any existing timber floor and/or skirtings. Remove the old building rubble down to clean natural ground level. Install new timber floor to specification and Engineers detail.
