PROJECT
SOUTHERN REGION
PIETERMARITZBURG
DEPARTMENT OF HEALTH
TOWN HILL HOSPITAL
REPLACEMENT AND
RENOVATIONS TO ROOFS

DRAWING DESCRIPTION
OCCUPATIONAL THERAPY
CUPBOARD AND
MISCELLANEOUS DETAILS

DRAWING NO.	REV
044038 - E - 221	.
SCALE	CHECKED
1:10 1:5	.
FILE NO.	CLIENT
WIMS 044038	.
DATE	DRAWN
Nov 2013	J.K.W.

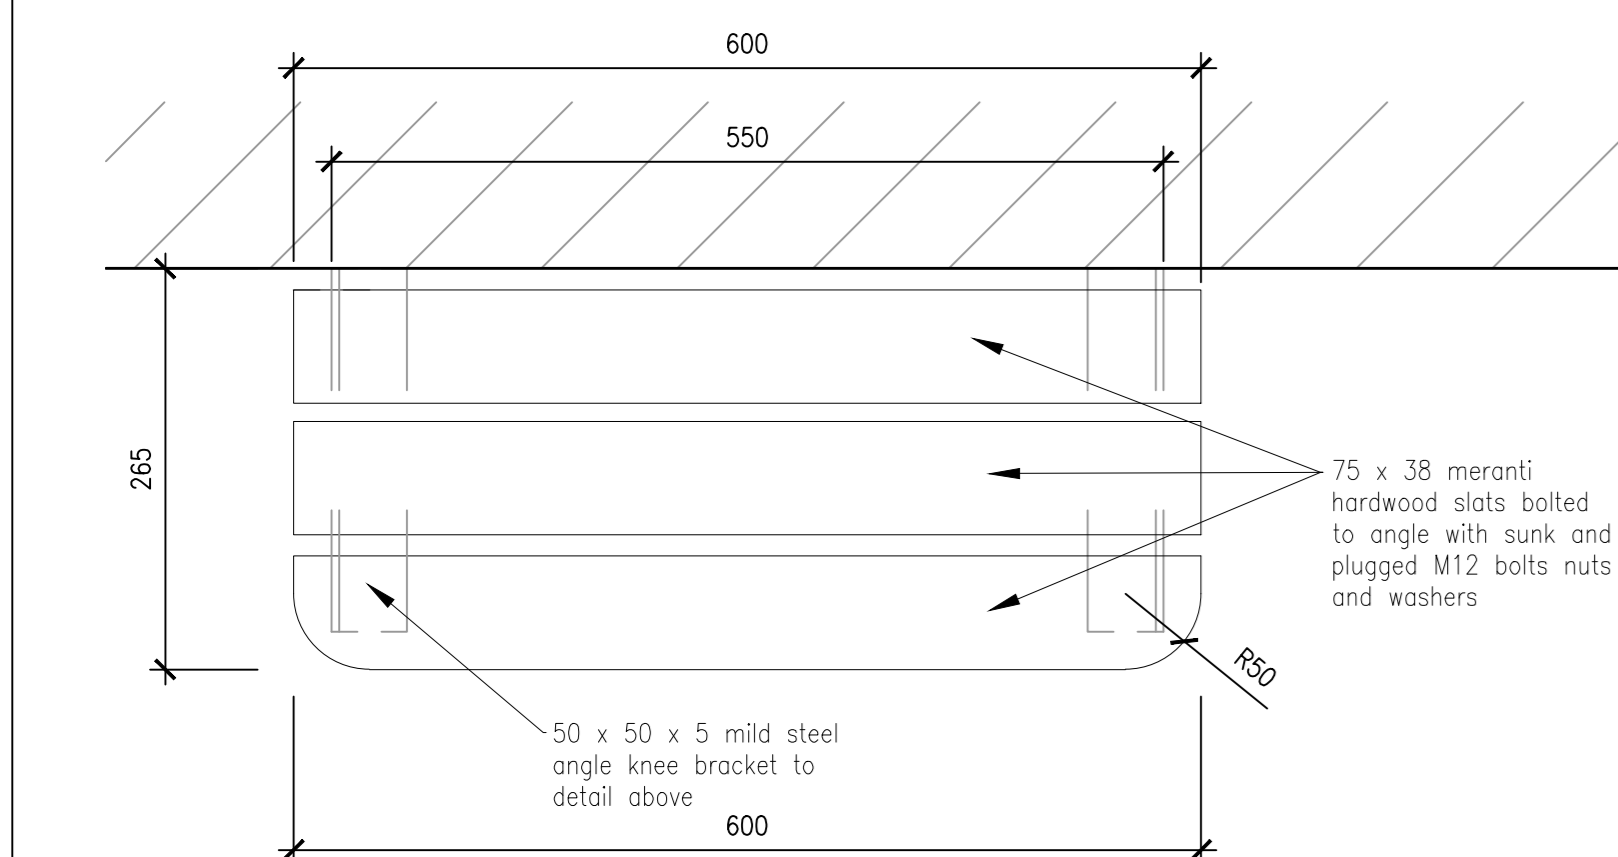
Plan Shower Bench Type 1 scale 1:5

Section Shower Bench

Notes
Steel brackets to be hot dipped galvanized left natural (unpainted)
Fixing of timber slats to be with galvanized nuts, bolts and washers. Head of bolts to be counter sunk into seat slat. Counter sunk hole to be plugged with dowel created from the same wood used to manufacture the slat - care to be taken to align the grain of the plug.
Steel bracket to be fixed to wall with suitable galvanized or cadmium plated wall anchors.
Slats to be sanded smooth with particular attention being paid to all rounded edges. Slats to be painted with a clear polyurethane varnish in accordance with the manufacturers recommendations to obtain a uniform and consistent finish.
