**AQUATIC SITE SENSITIVITY VERIFICATION REPORT FOR THE  
PROPOSED NYALA SOLAR ENERGY FACILITY 2, NEAR NORTHAM,  
THABAZIMBI LOCAL MUNICIPALITY, LIMPOPO PROVINCE.**

JUNE 2023

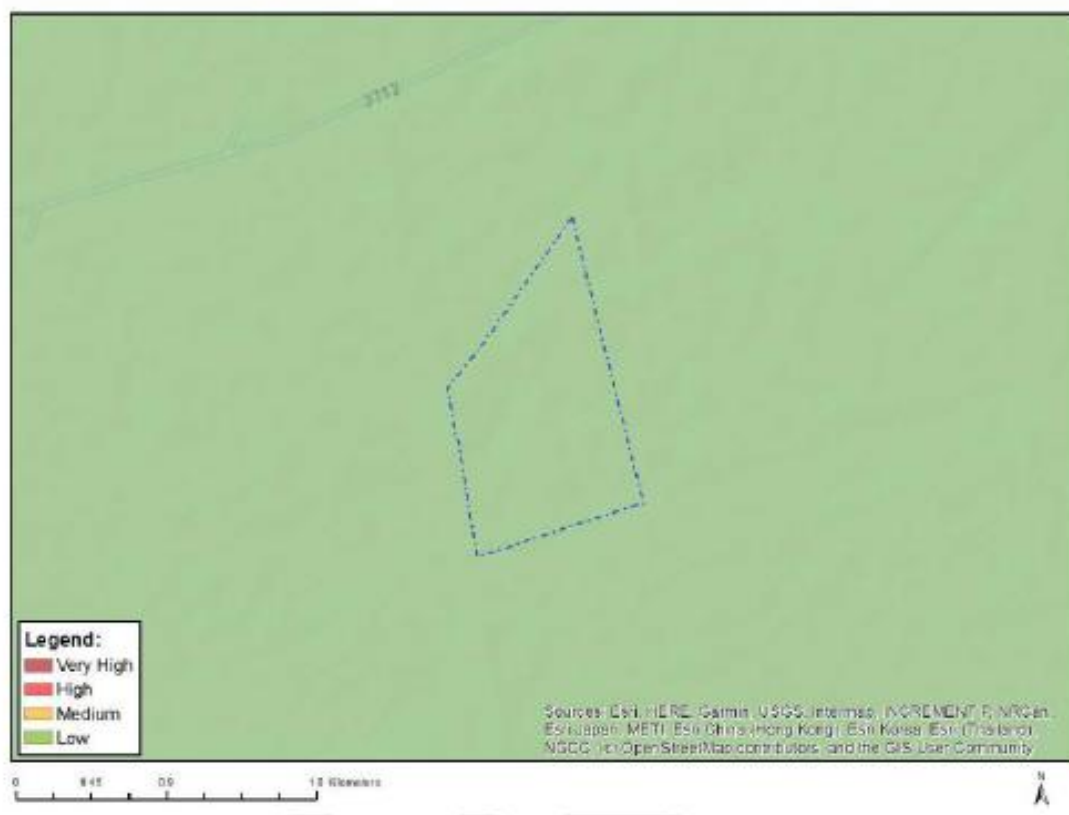
Figure 4. DFFE Screening Map for the area in terms of Aquatic Biodiversity Combined Sensitivity

In terms of the DFFE Screening Tool, the study site lies mostly within an area considered Low Aquatic Combined Biodiversity Sensitivity (Figure 4). There are no Aquatic Critical Biodiversity Areas (CBAs) or Freshwater Ecosystem Priority Area (FEPA) River Sub catchments within the study areas. The sites are also not located within Strategic Water Source Areas for groundwater or surface water. Only the natural wetland areas mapped in the National Wetland Map mentioned above are mapped within the wider area as being of very high sensitivity. As stated above, these natural wetlands are not likely to be impacted by the proposed activities at the site as they are 5 – 6 kilometres away from the site.

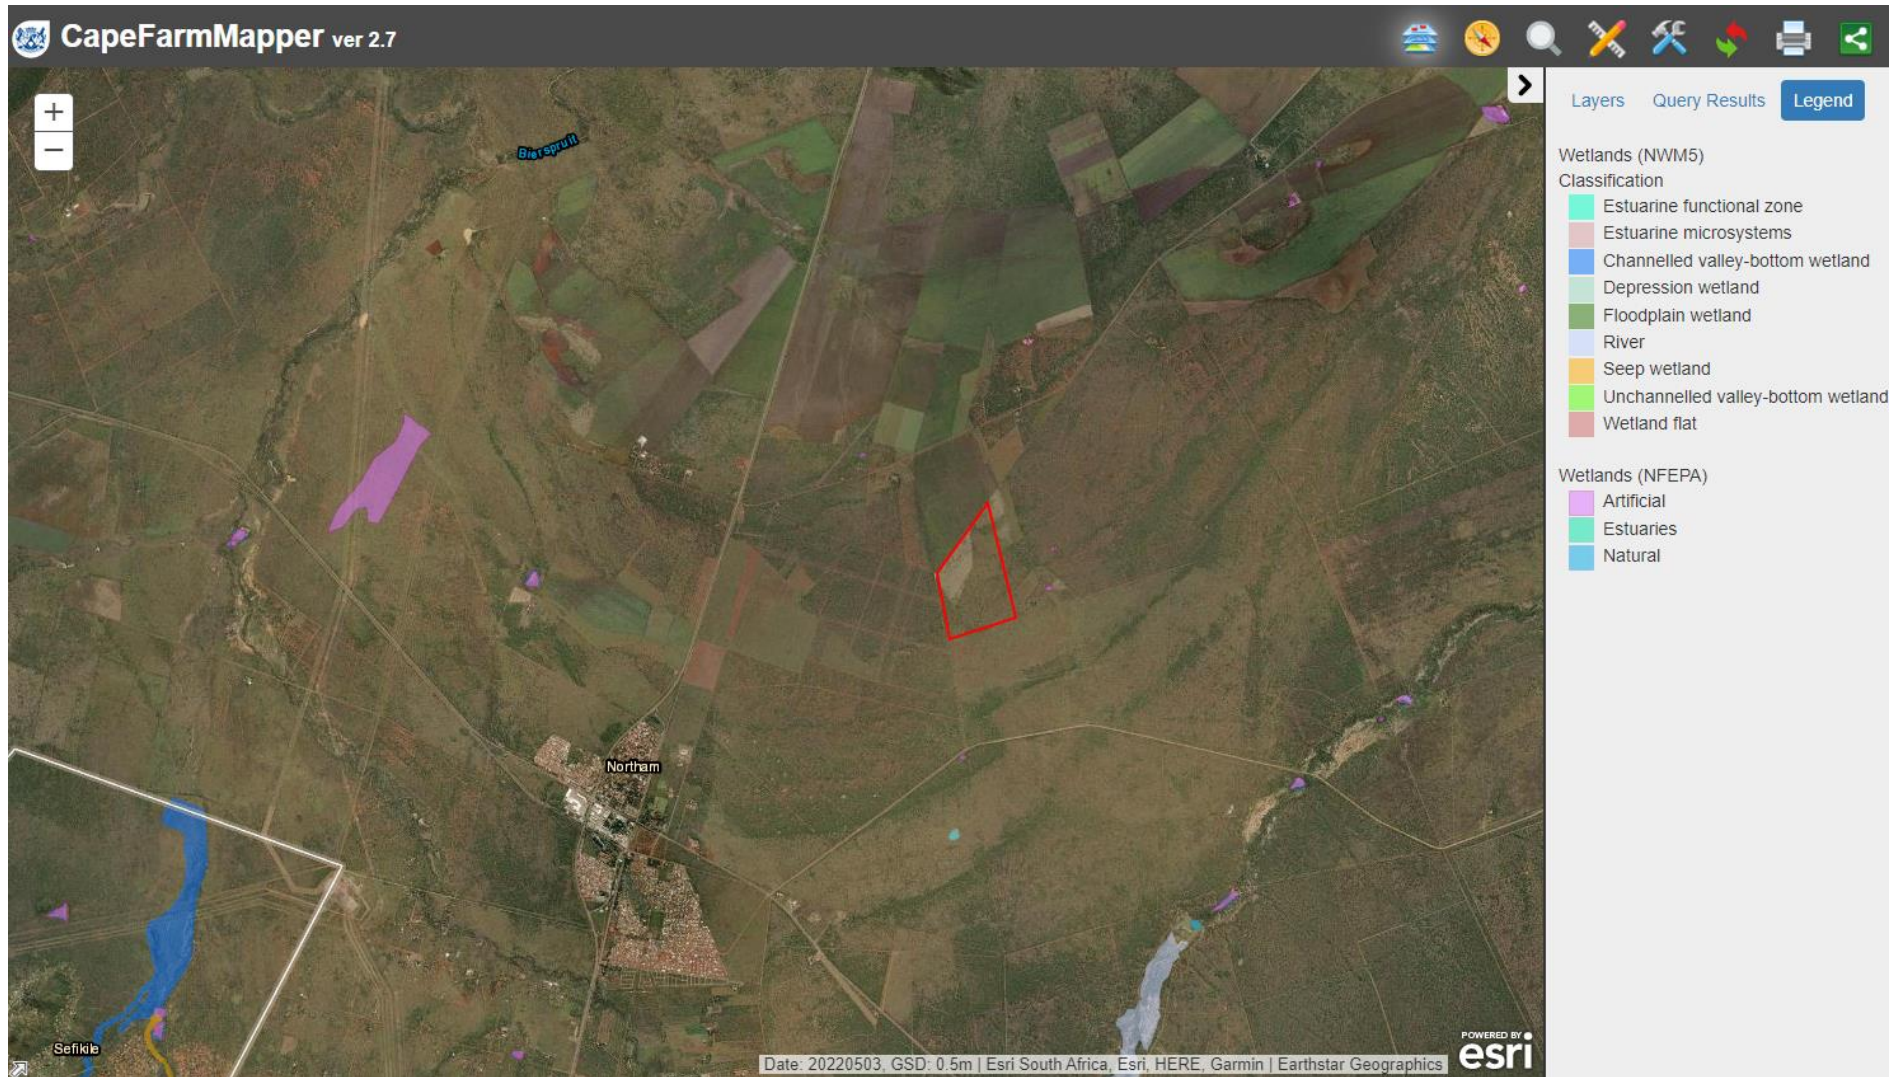
Figure 6. National Wetland map and National Freshwater Ecosystem Priority Areas map for the study site, where the red polygon indicates the study boundaries (CapeFarmMapper, 2023)

Figure 6 shows the National Wetland Map version 5 for the area together with the FEPA Wetlands. A channelled valley-bottom wetland is mapped that is associated with the Brakspruit further to the south of the site. A valley-floor wetland is also mapped to the southeast that is associated with the Renosterspruit, a tributary of the Crocodile River. These natural wetlands are not likely to be impacted by the proposed activities at the site as they are 5 – 6 kilometres away from the site.

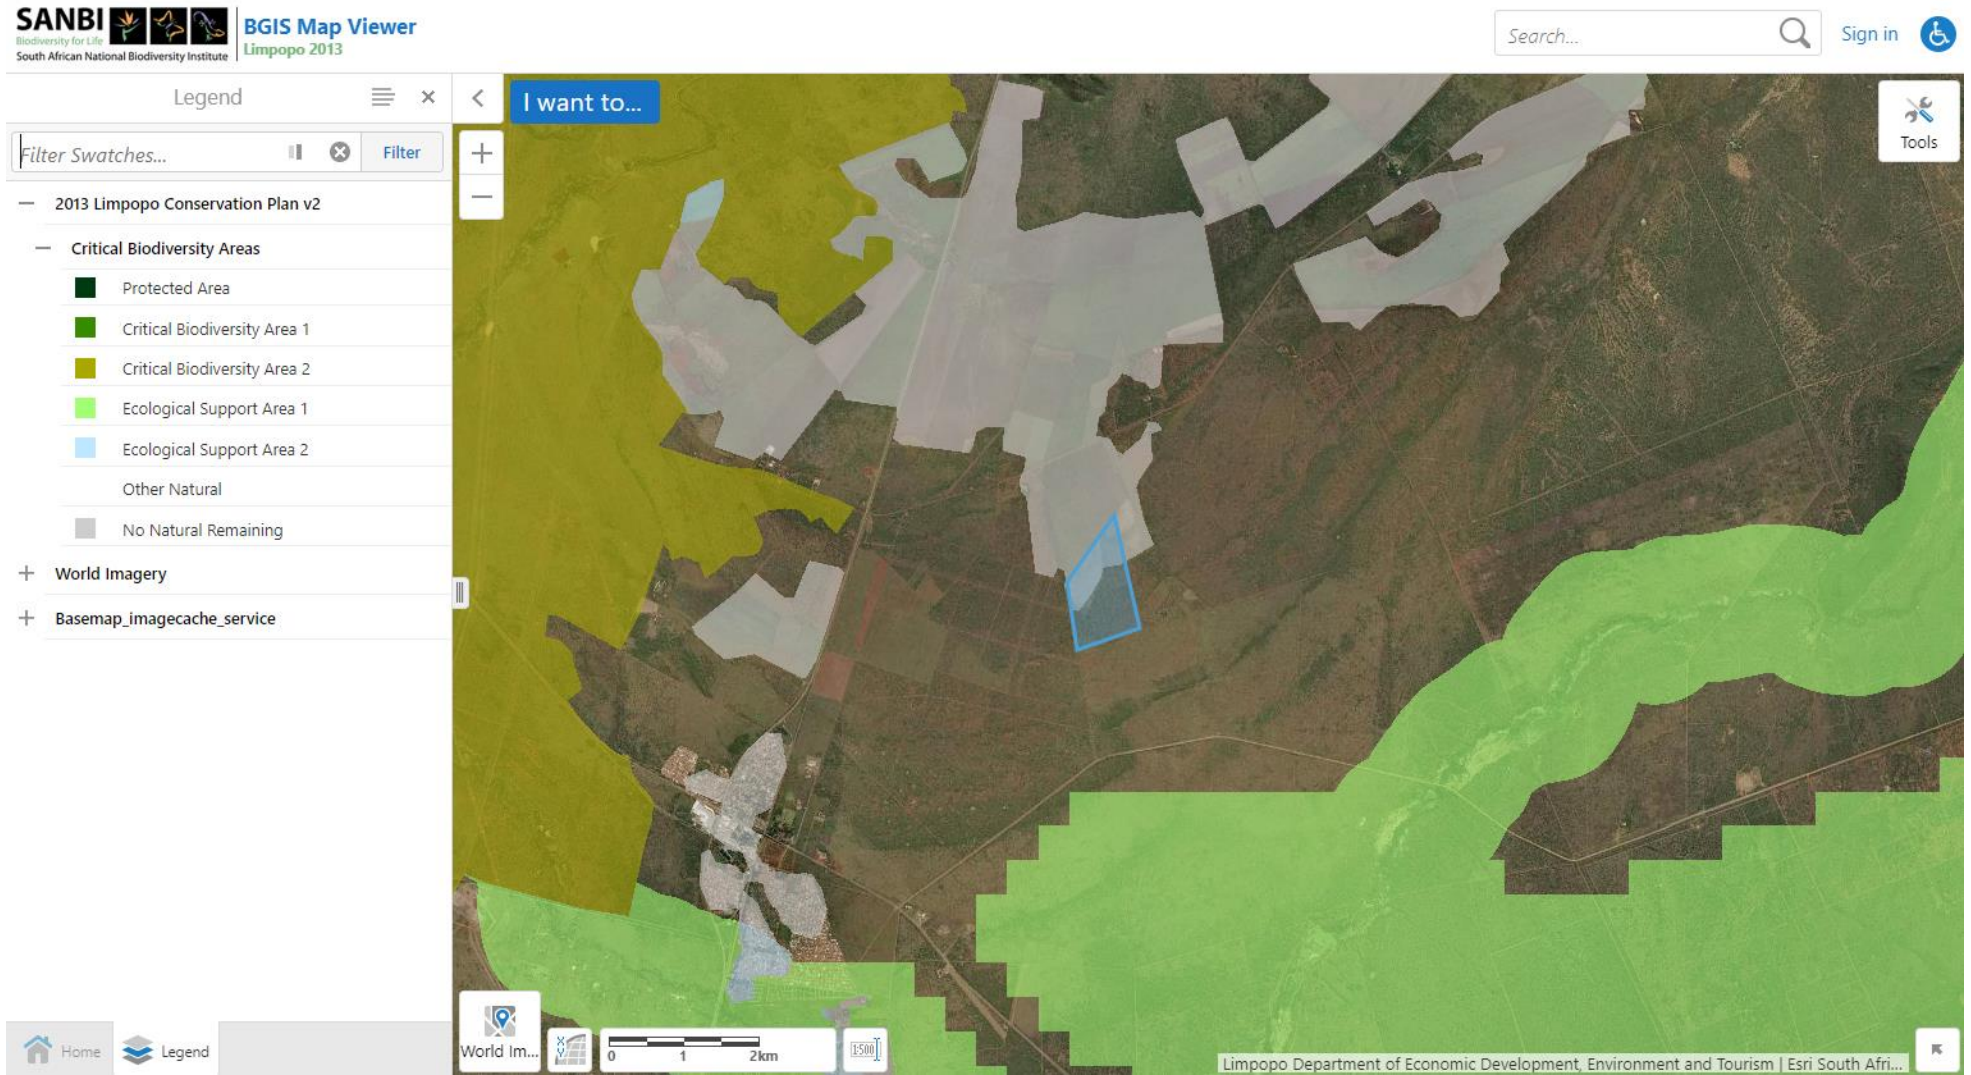
Figure 7. Limpopo Critical Biodiversity Areas map for the study site, where the blue polygon indicates the study boundaries (SANBI Biodiversity GIS, 2023)

In the 2018 Limpopo Critical Biodiversity Areas mapping (Figure 7), a CBA2 is mapped along the Bierspruit to the west of the site. CBA2 sites (can be either terrestrial or aquatic) are more widespread or not threatened, with choices on where in the landscape targets for these features can be achieved. The proposed activities are also unlikely to impact the CBA landscape targets. The northern portion of the site is mapped as still containing natural terrestrial areas and is addressed by the botanist for the project with no aquatic ecosystem concerns.

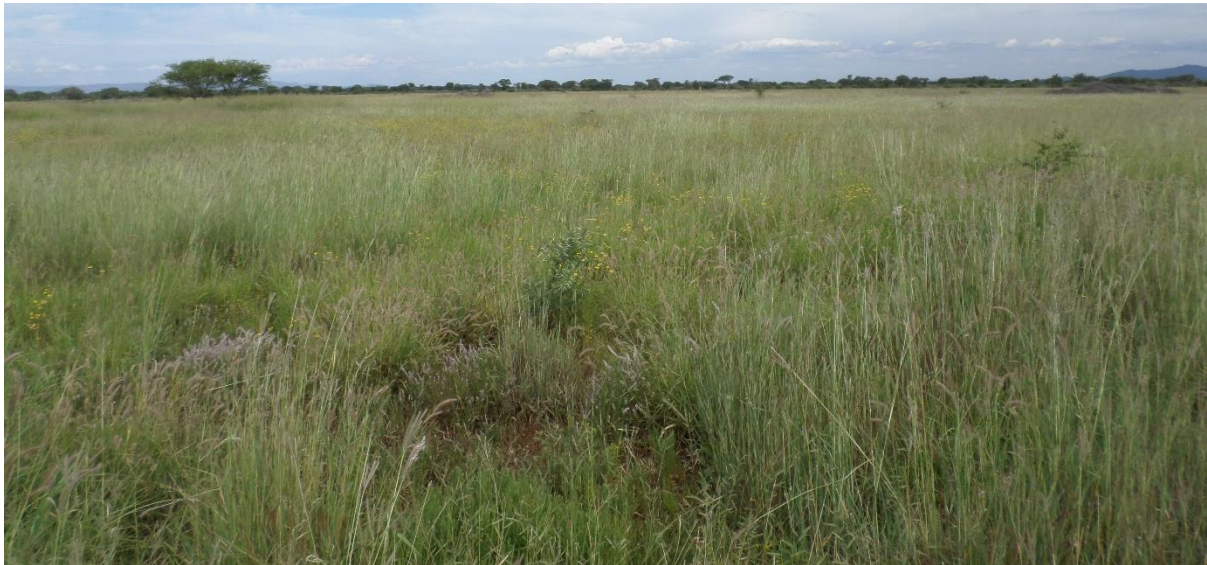
Figure 10. View of the site, taken from north of the site, looking southwards
