# DRAFT BASIC ASSESSMENT REPORT (DBAR)

PROPOSED ESKOM HOLDINGS (SOC) LIMITED BATTERY ENERGY STORAGE SYSTEM (BESS) PONGOLA SUBSTATION, LOCATED WITHIN THE uPHONGOLO LOCAL MUNICIPALITY, ZULULAND DISTRICT MUNICIPALITY, KWAZULU-NATAL

[November 2019]

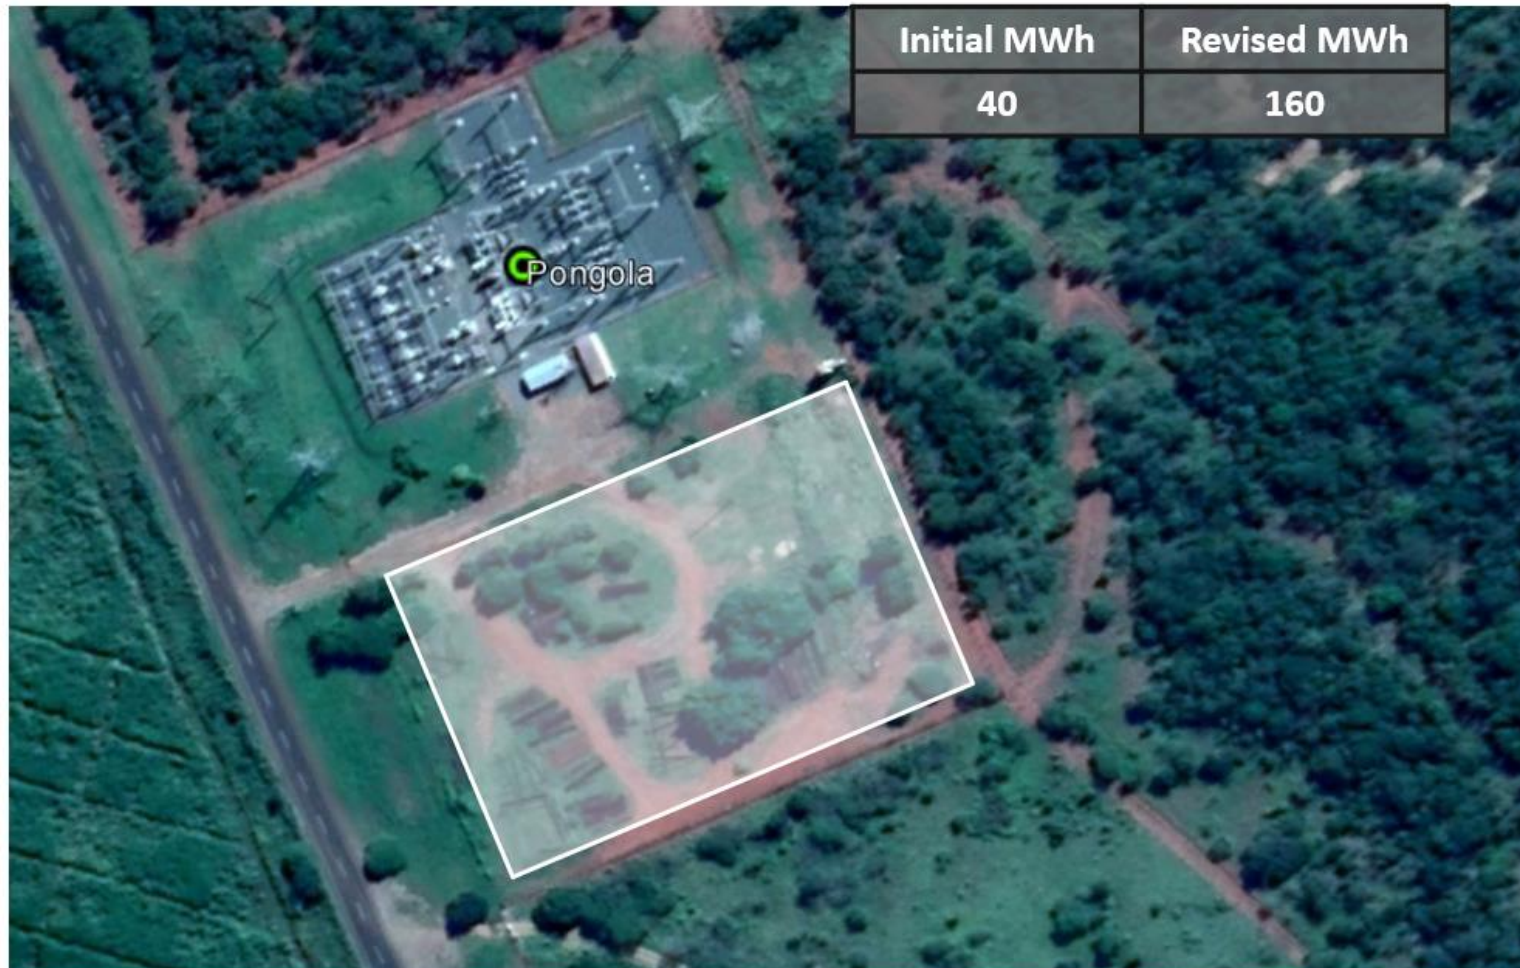
Figure 3: Pongola Substation and Proposed Area for BESS (white), (Eskom, 2019)

Figure 3 below depicts the Pongola Substation site with a sketch (white Block) indicating the area for the BESS. Figure 4 below is a conceptual design of the Pongola Substation and the area proposed by BESS as provided by Eskom Holdings SOC Limited.

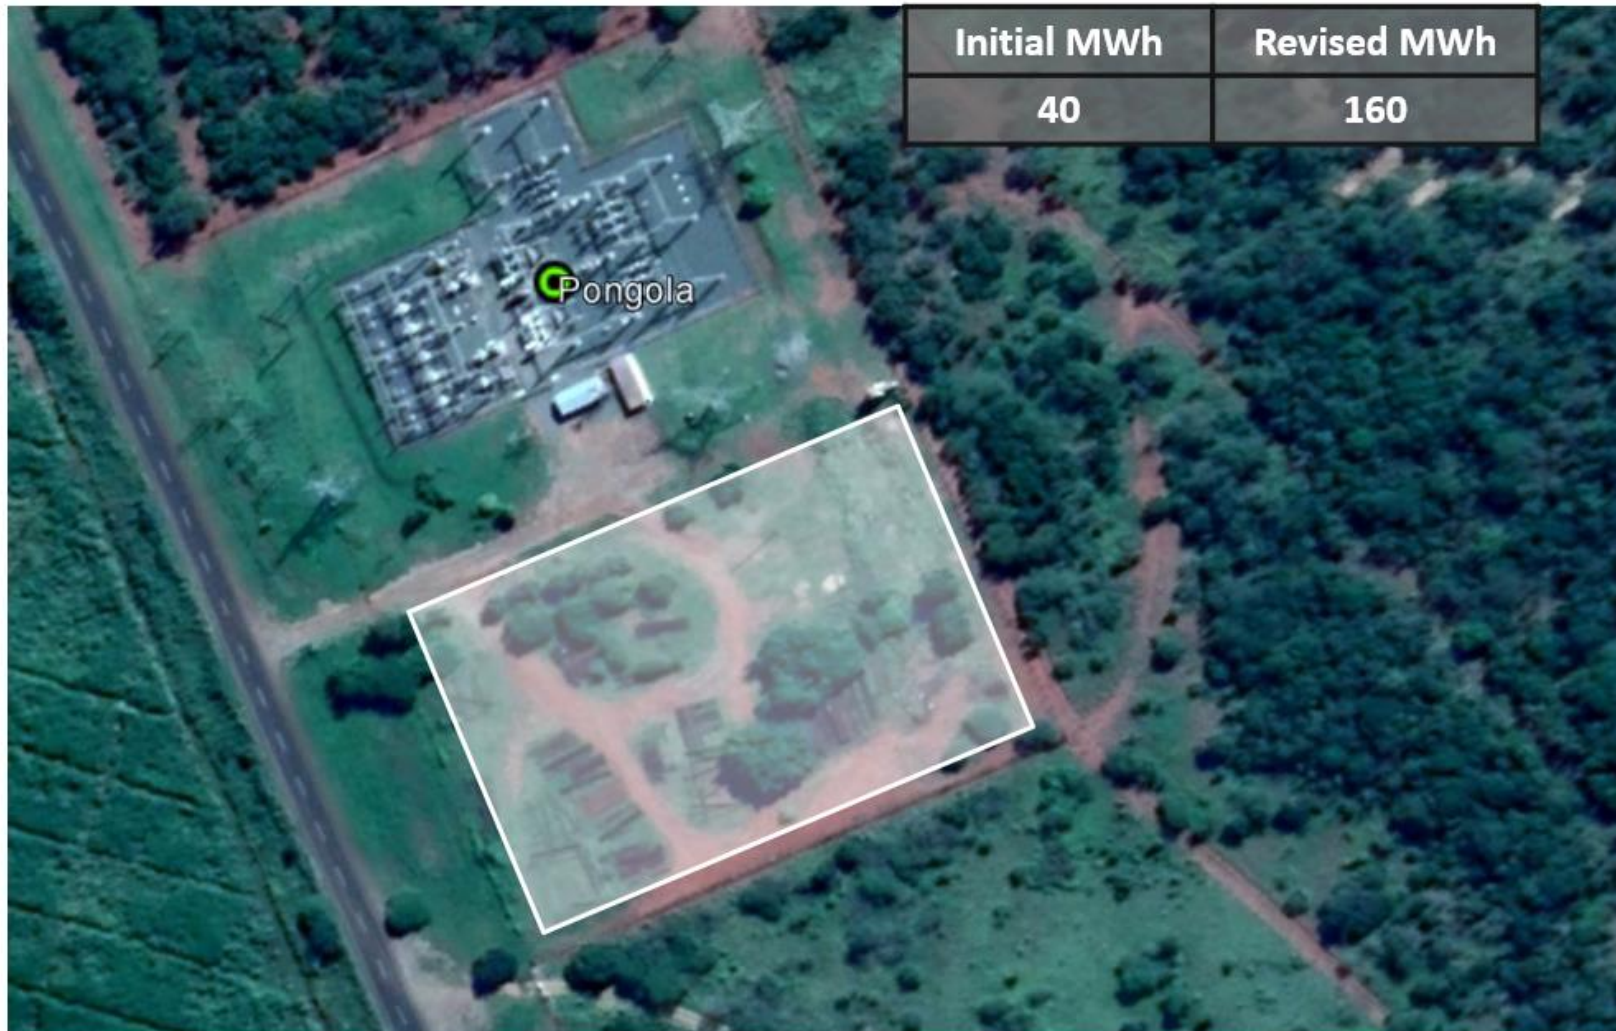
*Figure 7: Location of the Proposed BESS at the Pongola Substation*

No layout alternatives were considered as the proposed battery storage is restricted to the property. The site is also constrained in terms of layouts that allow maximum usage of the property.

Refer to Appendix C for conceptual designs.

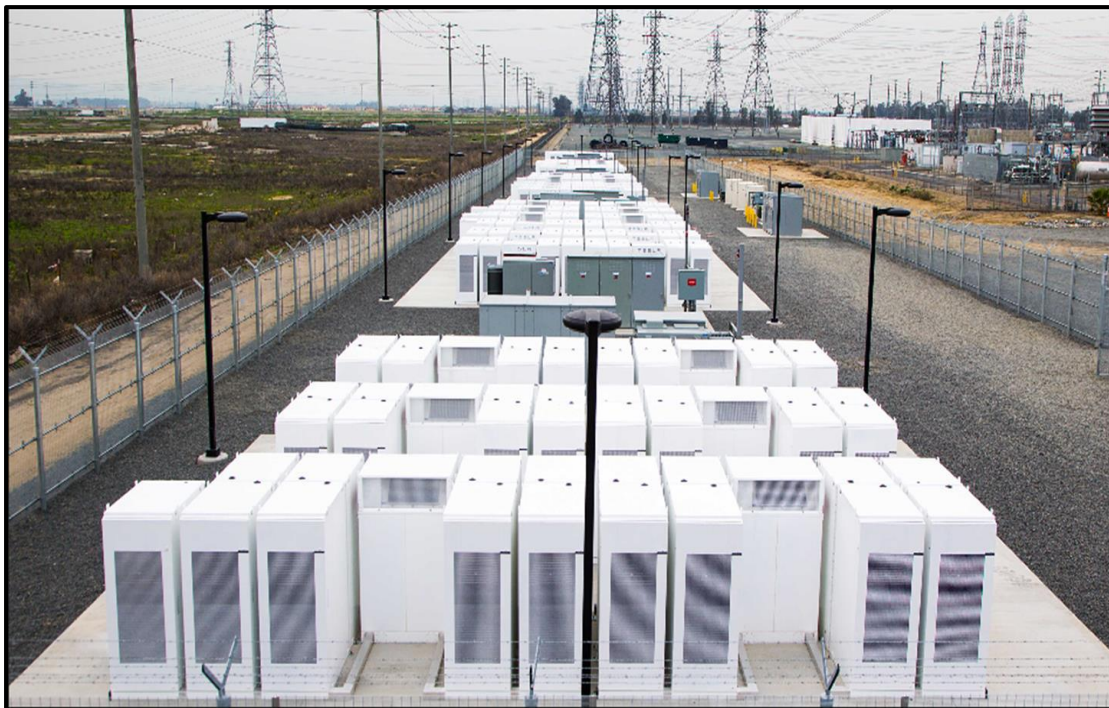
**Figure 8: Solid State Batteries**

8.4.1. Solid State Batteries: Solid State Batteries comprise of Lithium-ion, approximately 4.08 Cubic Meters per 1MWh (Exact amount of hazardous substance is unknown at this stage and will differ from supplier to supplier).

Figure 8 below is a typical setting / layout of Solid-State Batteries.

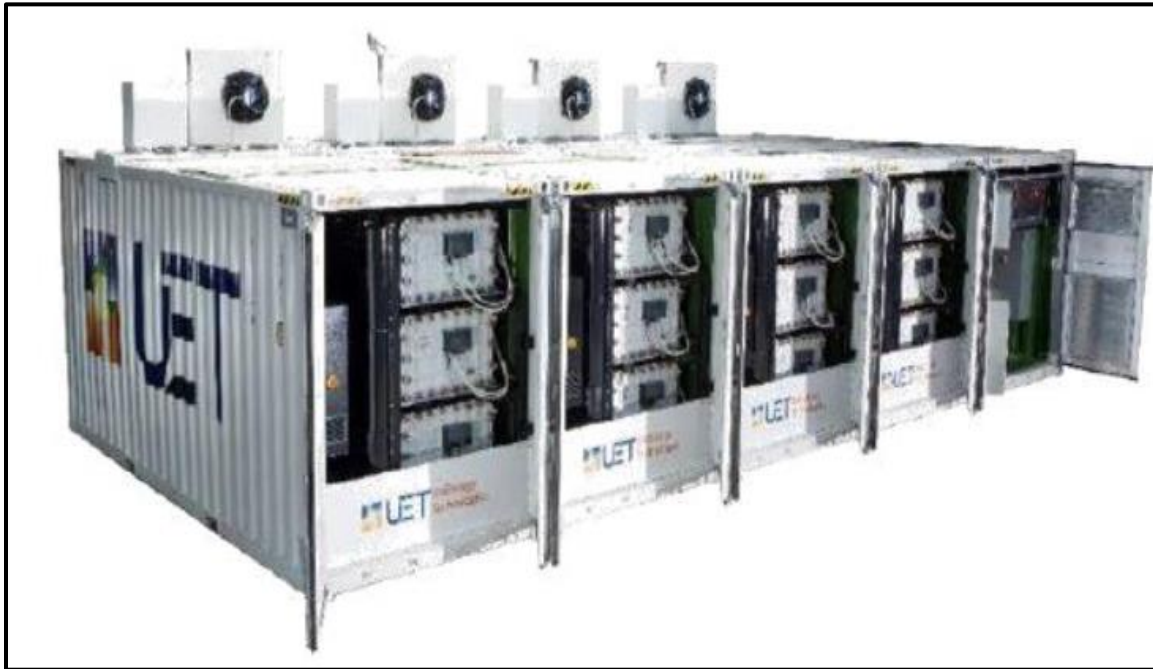
**Figure 9: Flow Batteries – Vanadium Redox Battery**

Maturity Level	Risks / Barriers	Advantages	Disadvantages
Commercial	New at utility scale	Vanadium Redox battery can offer almost unlimited energy capacity simply by using larger electrolyte storage tanks.	Vanadium Redox technology is a relatively poor energy-to-volume ratio.
		The battery can be left completely discharged for long periods with no ill effects.	Requires mechanical systems
		If the electrolytes are accidentally mixed, the battery suffers no permanent damage.	High cost of Vanadium
		A single state of charge between the two electrolytes avoids the capacity degradation due to a single cell in non-flow batteries.	
		The electrolyte is aqueous and inherently safe and non-flammable.

Figure 9 below is a typical Vanadium Redox Battery.

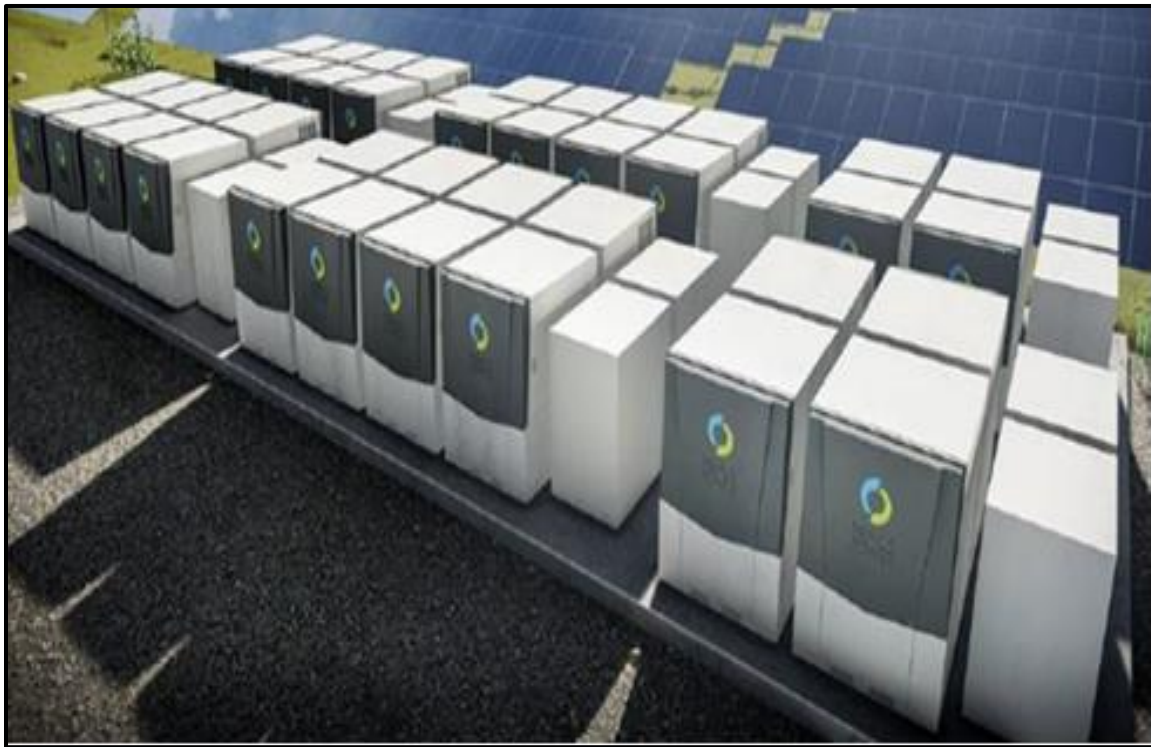
**Figure 10: Flow Batteries – Zinc Bromide**

The electrolyte is aqueous and inherently safe and non-flammable.	Requires occasional full discharge for dendrite removal
--	--	---	---

Figure 10 below is a typical Zinc Bromide Battery.

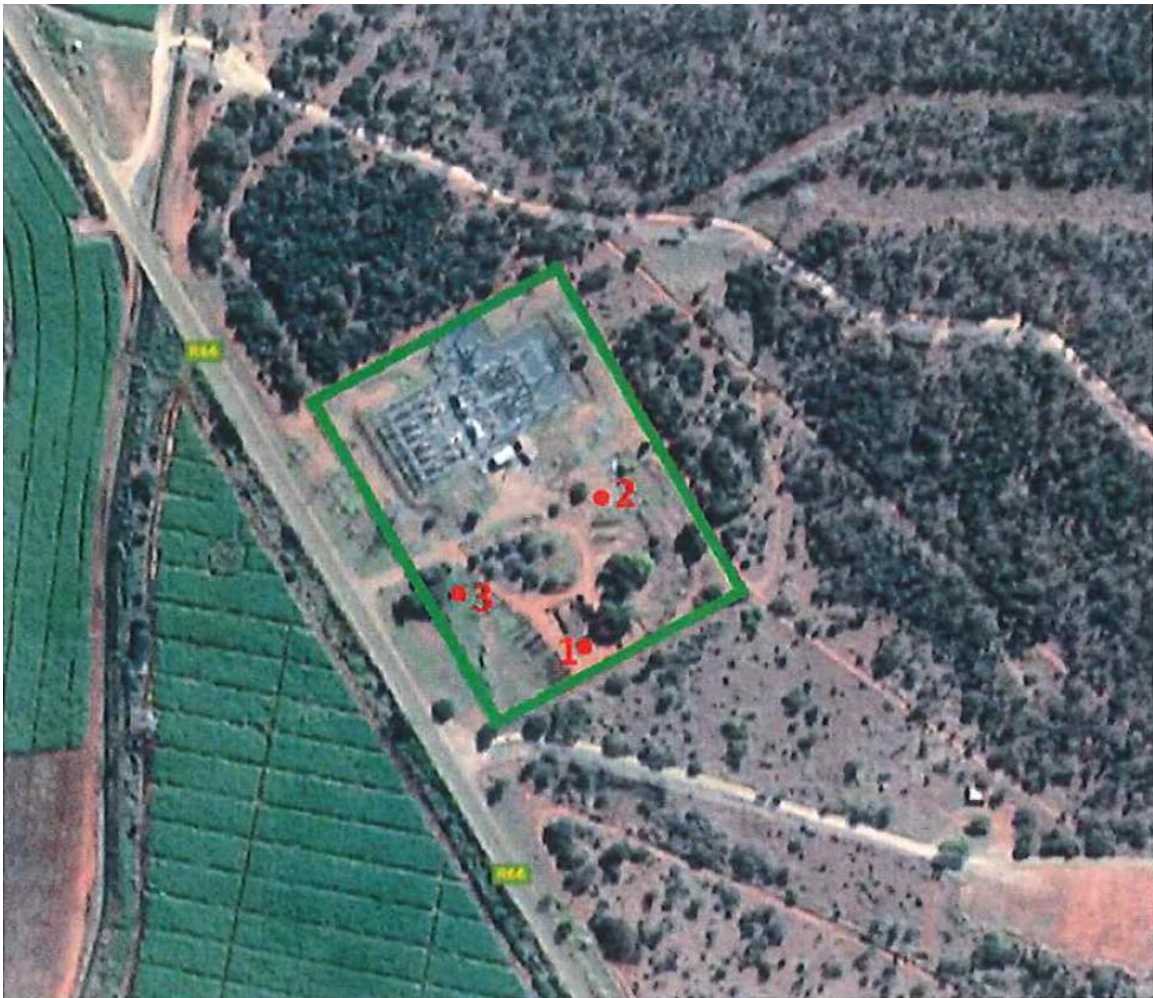
**Figure 11: Test Site Locations**

During the fieldwork, Dynamic Cone Penetrometer (DCP) Tests were undertaken to evaluate the strength of underlying in-situ material. The test position is indicated in Figure 11 below.

In terms of the soil classification, dry loose cohesion less soil or very soft to soft cohesive soil was observed.

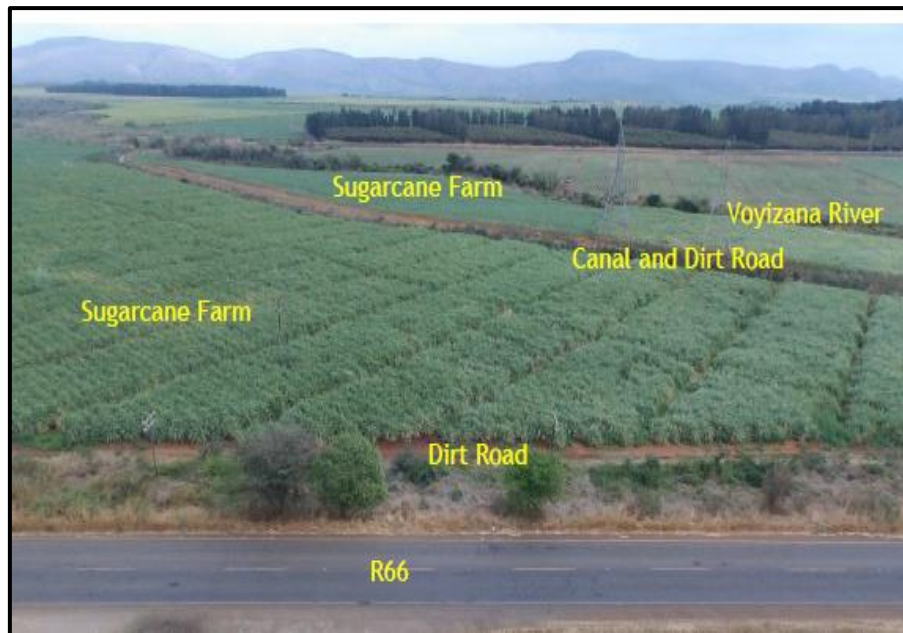
**Figure 14: Anthropogenic Impoundments Identified Between the Substation Site and the Voyizana River (Malachite Wetland Assessment, 2019)**

The Voyizana River is situated downstream of the proposed development. It must be noted that the Voyizana River and associated riparian zones are hydrologically isolated from the substation site. Impacts to the system are numerous and include anthropogenic development both in the form of infrastructure and agricultural activities. Any stormwater runoff will be intercepted by numerous anthropogenic impoundments including the R66 road, two dirt roads, a canal used for irrigation purposes, as well as a sugarcane farm as per Figures 14 and 15 below.

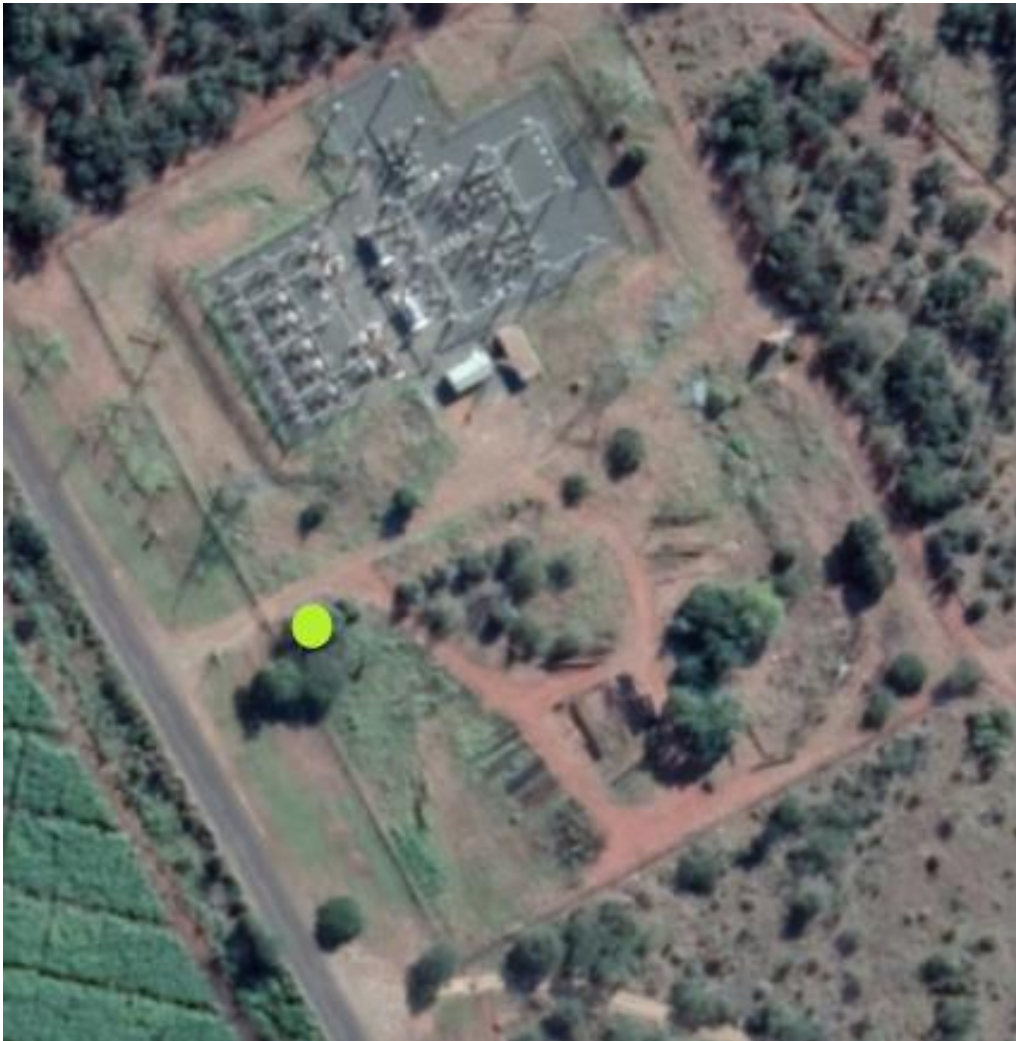
**Figure 17: Location of *Adansonia digitata***

- c. A single *Adansonia digitata* specimen was identified on the north-western edge of the BESS project area. Any impacts to this tree will require the acquisition of permits. Refer to Figure 17 below.

**Protected Trees:** During the site investigations a single, relatively young *Adansonia digitata* was recorded within the project area which is a Protected Tress under the National Forests Act (Act No. 84 of 1998). It is located on the north-western edge of the BESS site (27°26'55.20"S 31°38'18.56"E) close to the entrance to the substation. Should this tree be impacted (pruned or removed) by the proposed project, a permit must be granted by the relevant authorities. *Sclerocarya birrea subsp. caffra* was noted outside the southern boundary fence and no part of this tree must be impacted by the project.
