Cape Environmental Assessment Practitioners (Pty) Ltd

Document Reference: SIY402.27

LITHIUM-ION BATTERY ENERGY STORAGE SYSTEM HIGH LEVEL RISK ASSESSMENT FOR THE PROPOSED AMENDMENT OF THE EA FOR THE AUTHORISED HUMANSRUS SOLAR 3 ON FARM 147 HUMANSRUS, NEAR PRIESKA, NORTHERN CAPE PROVINCE.

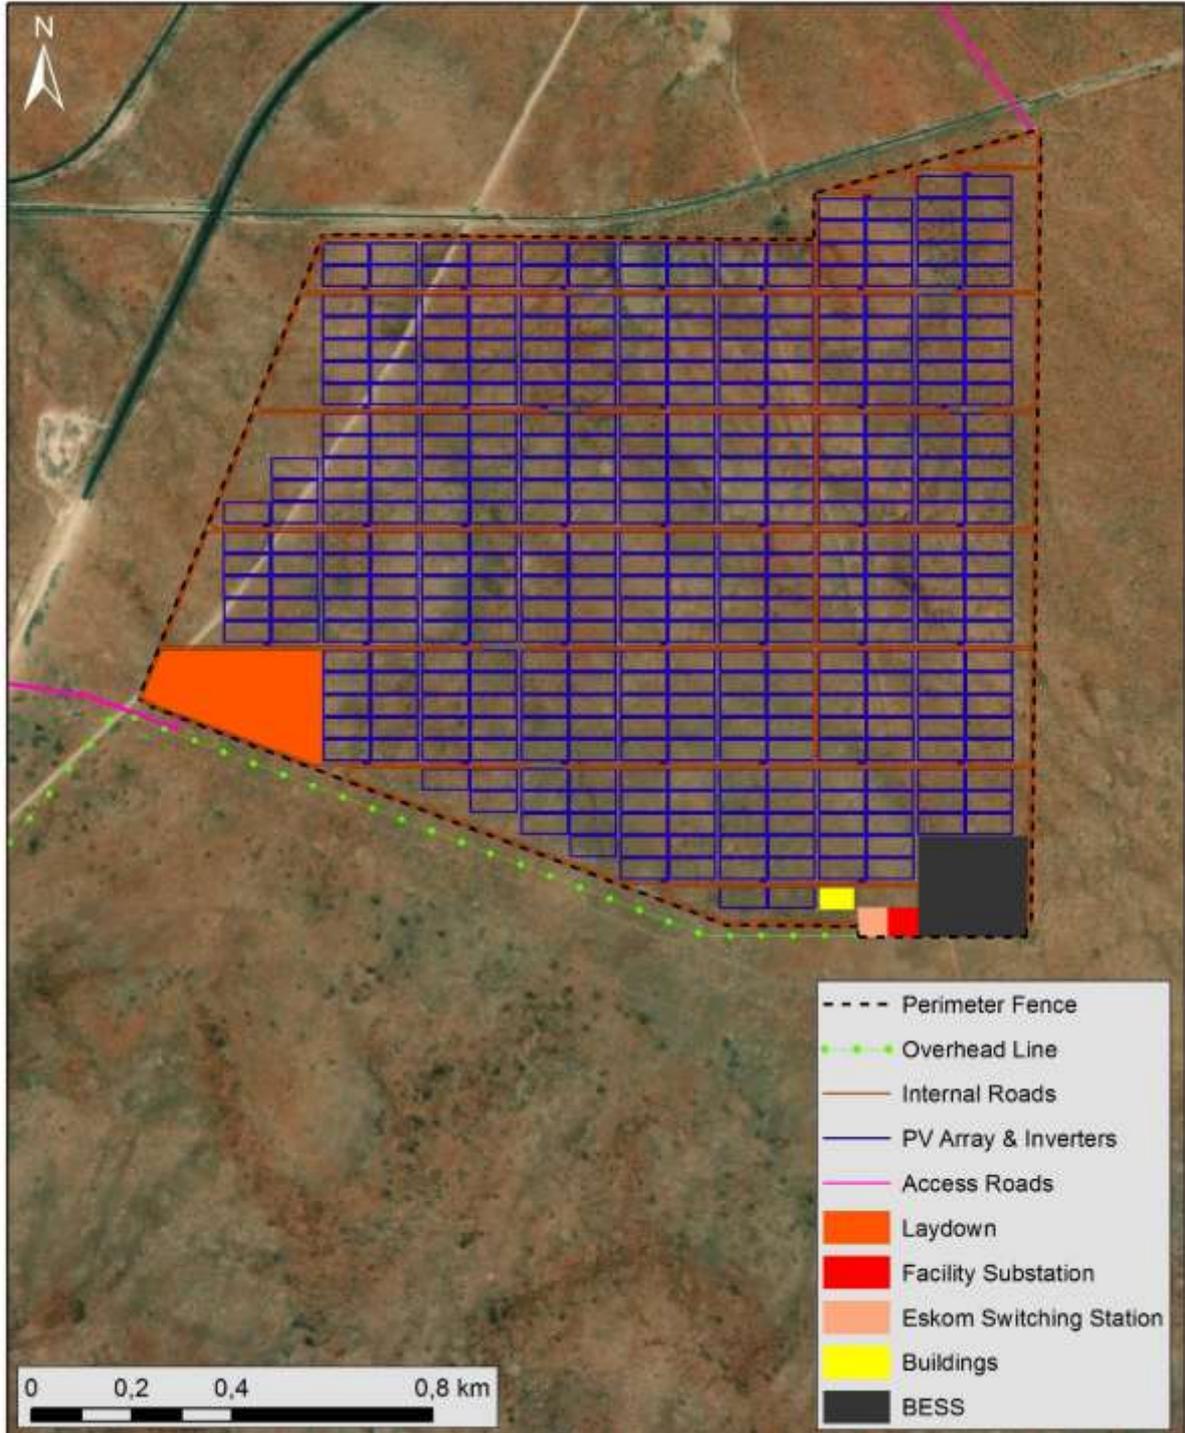
3. LAYOUT PLAN SHOWING BESS

The plan below shows the location of the BESS in relation to the authorised footprint of the facility.

As can be seen above, the proposed BESS is situated in the South East of the approved footprint, adjacent to the on-site substation. The full-sized layout plans are appended to the Amendment Assessment Report and application for amendment form.

The proposed Battery Energy Storage System (BESS) is proposed within the approved footprint, adjacent to the on-site substation. It is proposed that the BESS will have a maximum footprint of 6ha.
