FINAL REHABILITATION PLAN PROJECT: SOUTINI-BALENI B82G

**REHABILITATION PLAN FOR THE SOUTINI-BALENI WETLAND PROJECT,
LIMPOPO: PLANNING YEAR 2018/2019
AS PART OF
THE WORKING FOR WETLANDS PROGRAMME
FOR THE
DEPARTMENT OF ENVIRONMENTAL AFFAIRS
DIRECTORATE: WORKING FOR WETLANDS**

**MAIN REPORT
JUNE 2019**

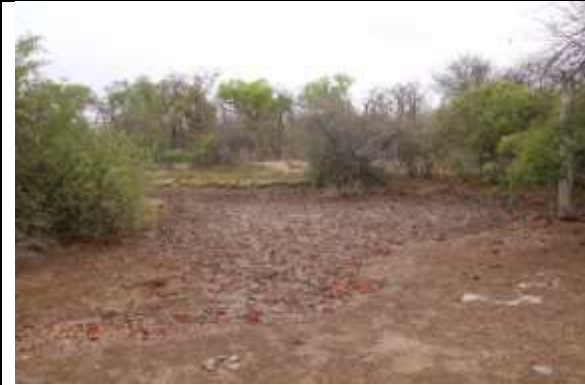
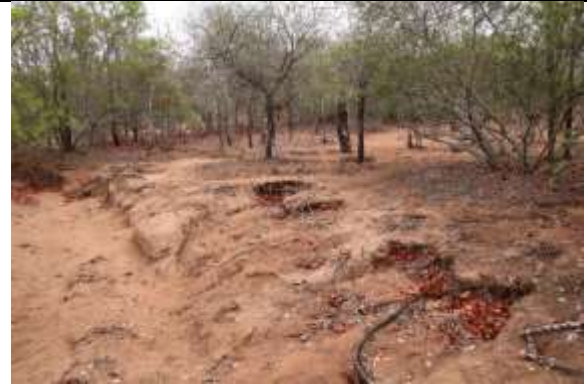
The section of wetland B82G-01 upstream of the road crossing is overgrazed and has limited ground cover (left). The wetland is also receiving sediment from the terrestrial area upstream of the wetland (right).

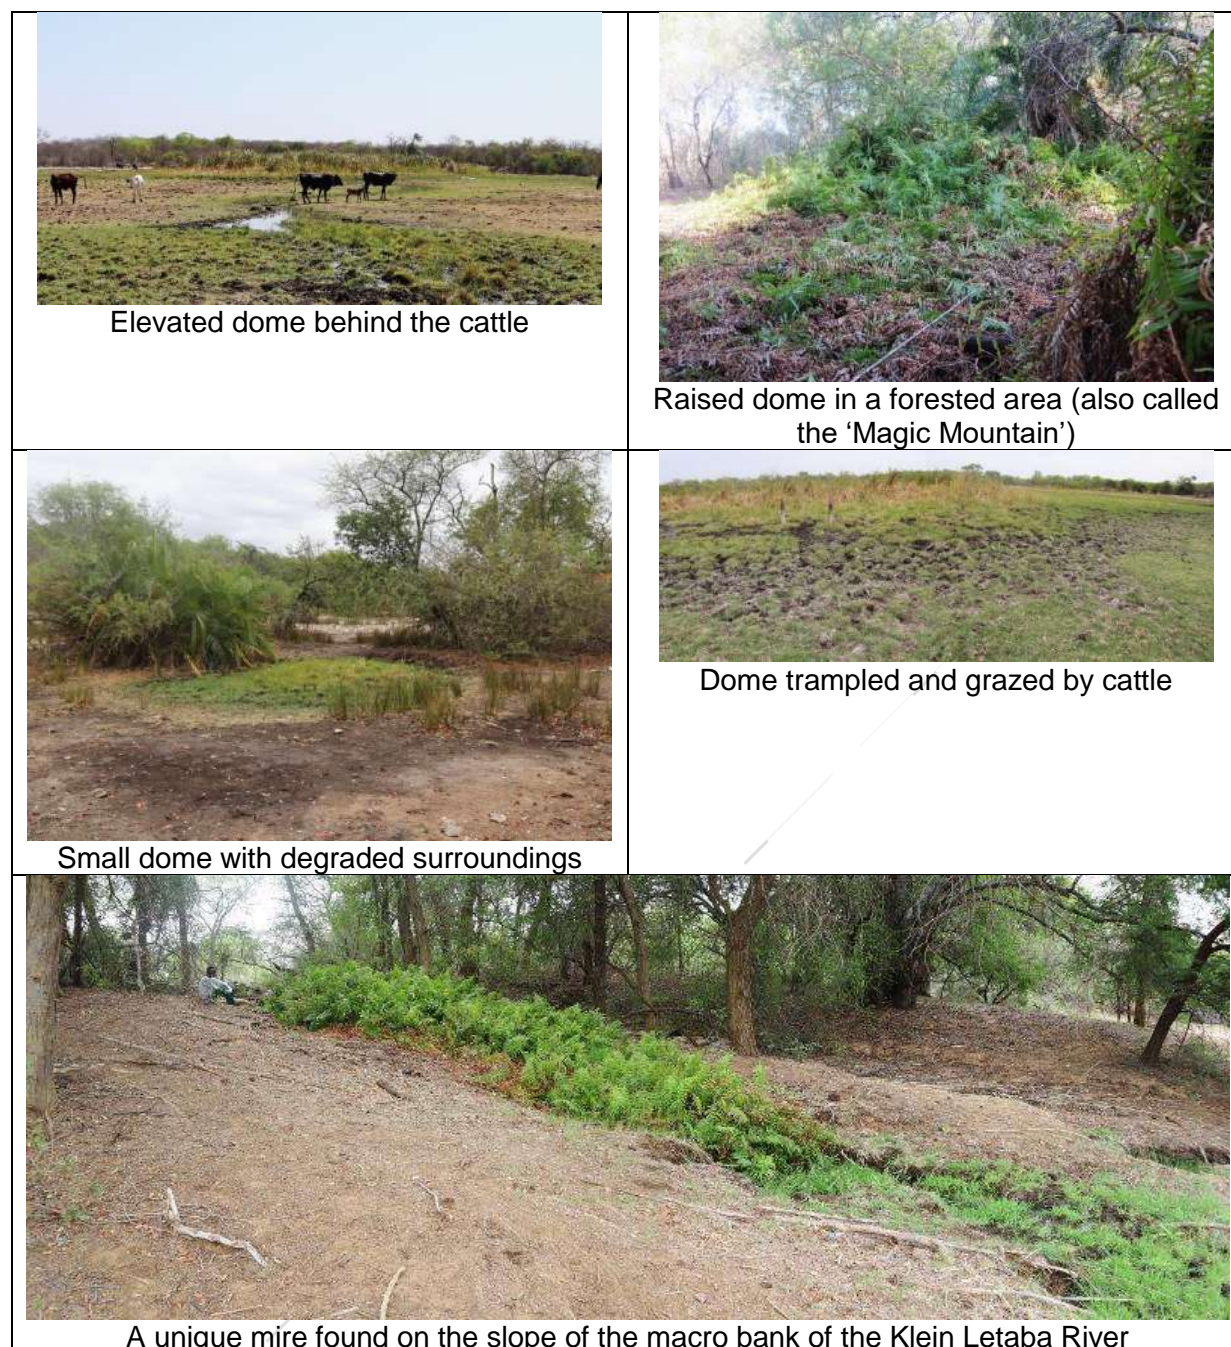
A unique mire found on the slope of the macro bank of the Klein Letaba River
Figure 4-2: Examples of mires in the area

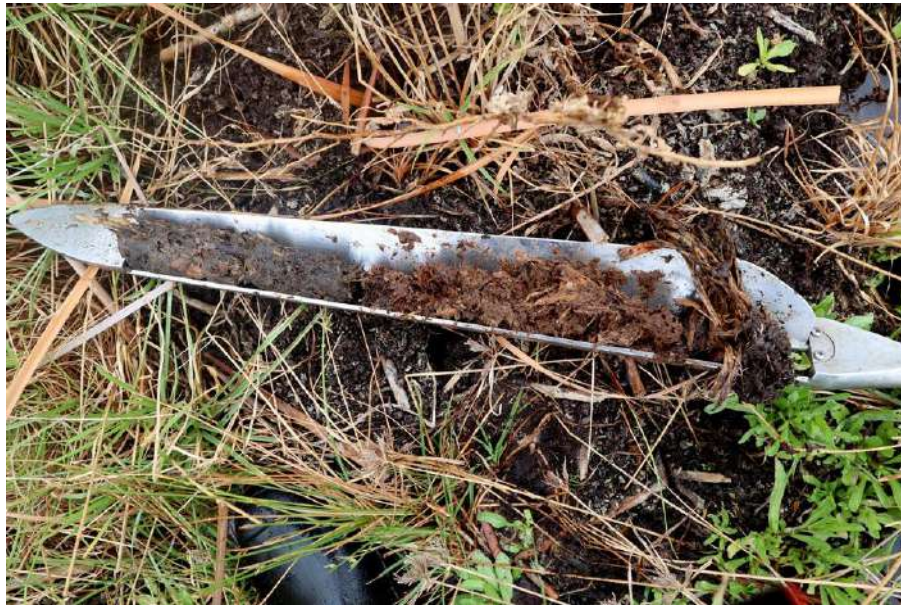
Figure 4-8: Sample of peat found in Hillslope Seep Wetland B82G-02

Due to the permanently wet conditions and the presence of possible artesian eyes the formation of peat is expected. In Figure 4-8 a peat sample is shown and has a depth of up to 1.4m.

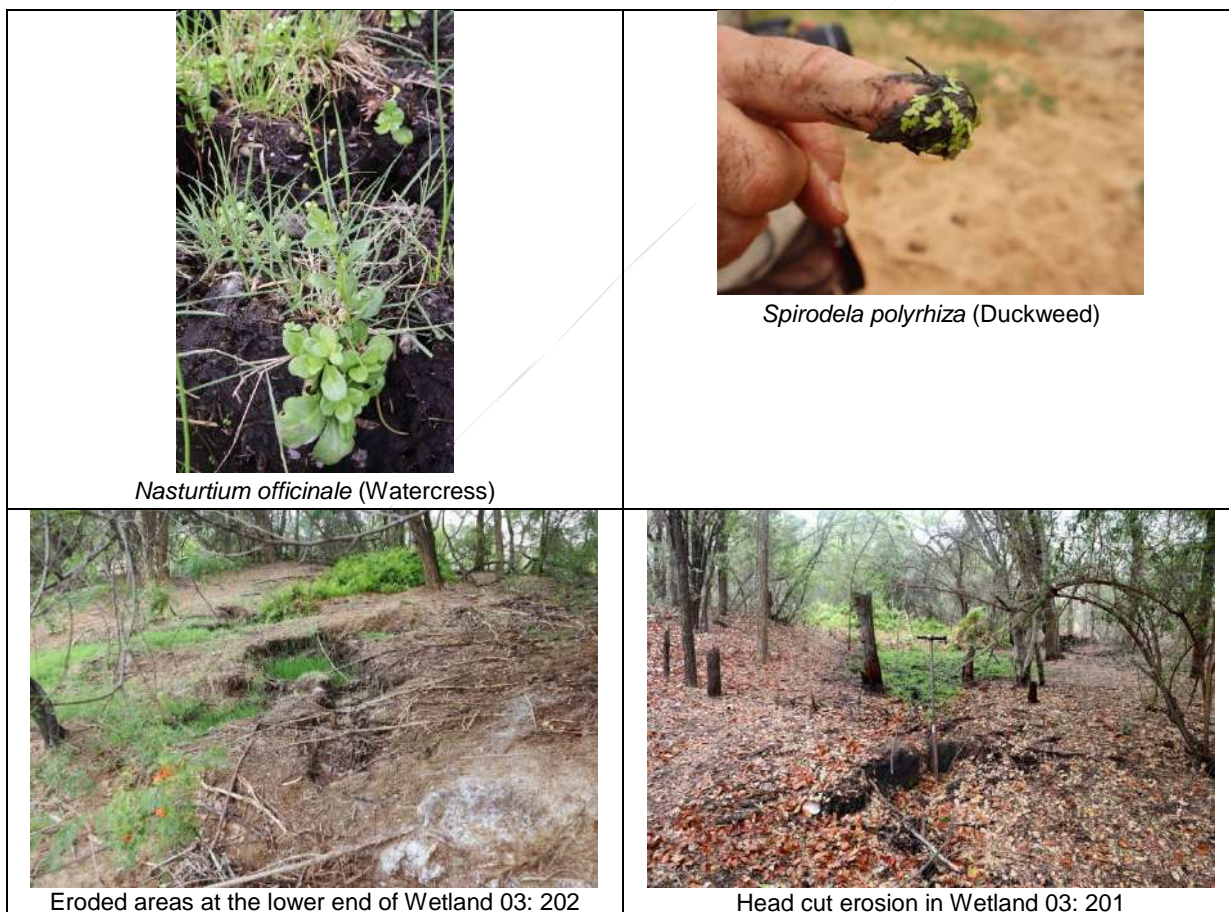
Figure 4-12: Exotic vegetation and evidence of erosion in the wetland

Wetland B82G-02 is in a natural state with good vegetation cover. The fern *Thelypteris confluence* is monospecific with several other hydrophytes such as the exotic *Nasturtium officinale*. The grass *Koeleria capensis* is also dominant. The seepage mire has a dome that is much higher than the surrounding natural ground level. The tree, *Acacia sieberiana*, is growing inside the dome in permanently wet conditions. Due to disturbances such as grazing and trampling, several exotic species have also found their way into the wetland habitat, these include: *Tagetes minutes*, *Verbena bonariensis* and *Nasturtium officinale*. At the lower end of this wetland head cut-erosion occurs. Visuals of these impacts can be seen in Figure 4-12.

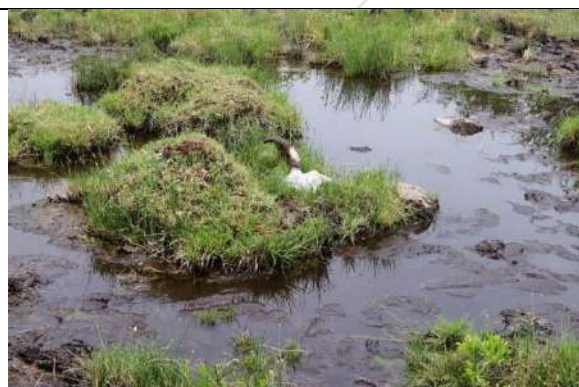
Trampling in eye causes hummock features

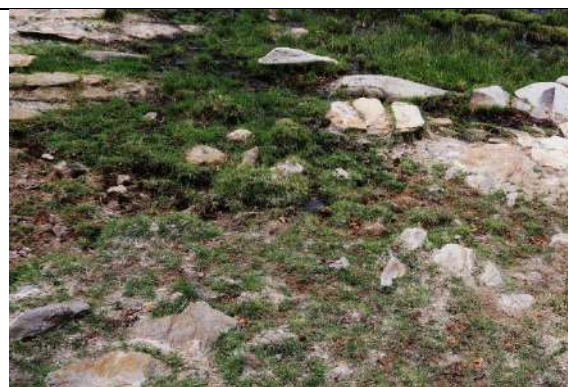
Trampling and overgrazing

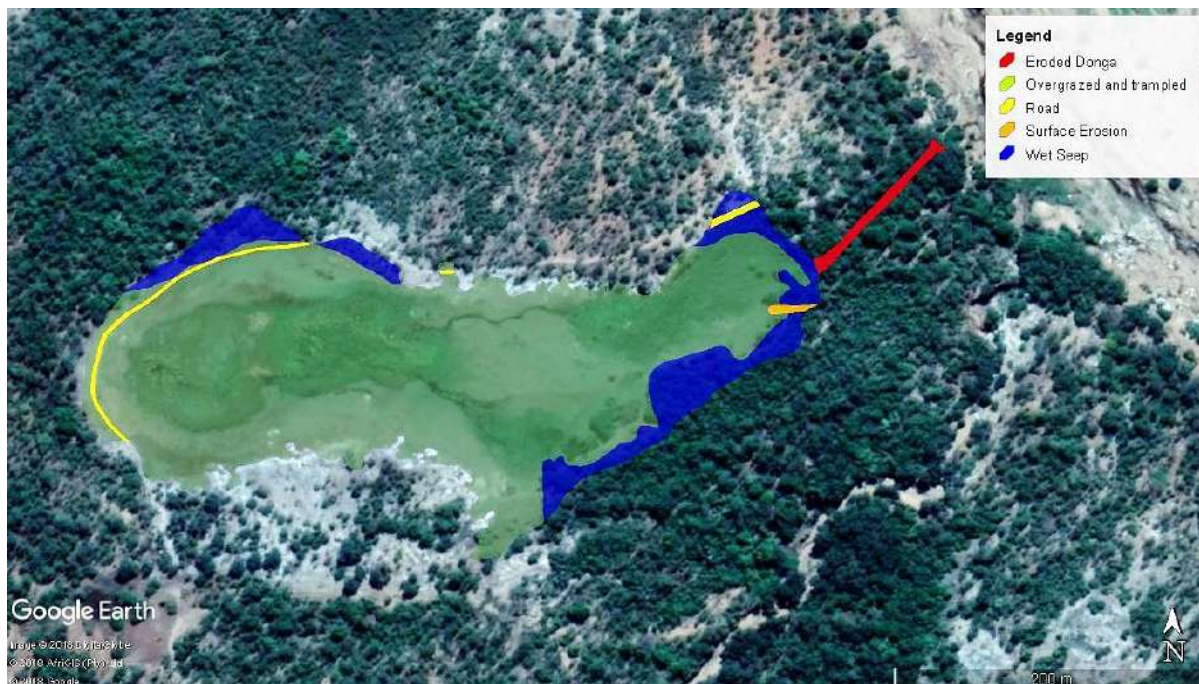
Figure 5-2: Aerial map presenting the impacts that may degrade the wetland’s integrity

The ecological integrity or PES of the wetland was assessed for the hydrology, geomorphology and vegetation components. A visual of impacts is presented in Figure 5-2. The integrity of the biophysical components of the wetland was assessed for the current, post-rehabilitation and without rehabilitation scenarios (Table 6-3). The assessment results of the hydrological, geomorphic and vegetation components are outlined in the following sections.

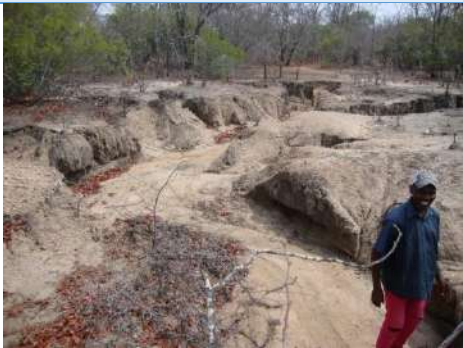
Intervention Number	Impact/Visual	Objective of intervention	Intervention Type	Location	Priority
B82G-01-212

<p>Head-cut donga erosion</p>	<ul style="list-style-type: none"> • Provide control over water flow. • Prevent directional flows in drains and dongas • Restore disturbed environment • Revegetate for stability • Prevent future degradation 	Rock/Gravel Pack	S23 25 15.0 E30 54 45.7	12
B82G-01-213

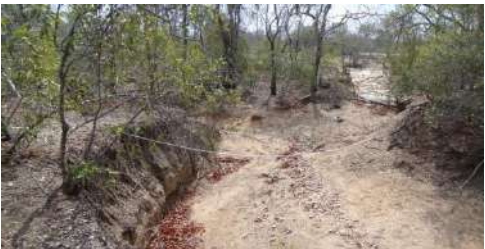
<p>Eroded channel</p>	<ul style="list-style-type: none"> • Stabilise high-energy environment • Control water flow • Prevent further incision and erosion of the channel • Lift water table and hydrate upstream and adjacent area • Re-hydrate wet soils • Take control of water through gabion • Release water in a controlled manner 	Stone Masonry Gabions	S23 25 08.8 E30 54 51.2	13

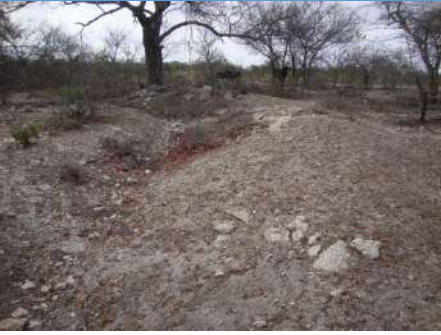
<p>Surface erosion</p>	<ul style="list-style-type: none"> • Restore natural flow patterns • Restore disturbed environment • Re-vegetate to stabilise • Prevent future degradation 	Earth Works	S23 25 12.7 E30 54 37.3	4

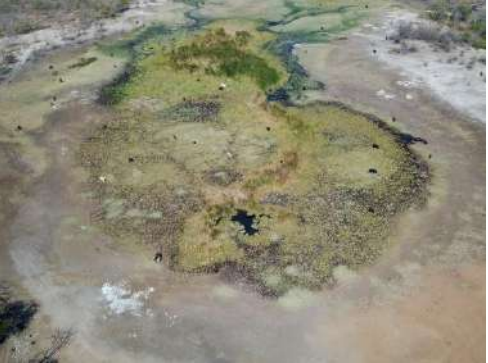
Intervention Number	Impact/Visual	Objective of intervention	Intervention Type	Location	Priority
B82G-02-205

<p data-bbox="465 652 855 678">Overgrazed and trampled 'eye area'</p>	<ul style="list-style-type: none"> • Construct cattle fence, to control access and grazing patterns • Prevent trampling and destruction of sensitive 'eye' area 	Cattle Fence	S23 25 10.99 E 30 54 42.07	5

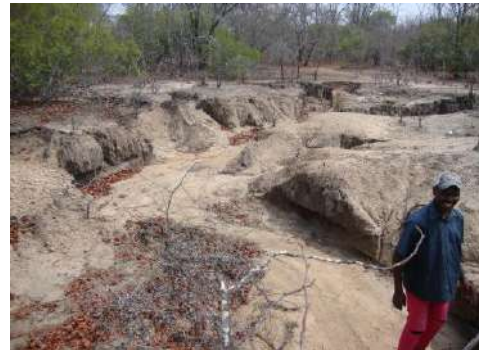
Intervention	Baleni
Designer	Cilliers Blaauw
Design Date	02 April 2019
Type	New
Description	Rock/ Gravel Pack
Rehabilitation Objectives	<ul style="list-style-type: none"> • Provide control over water flow. • Prevent directional flows in artificial drain. • Restore disturbed environment. • Revegetate for stability. • Prevent future degradation.
Latitude (D°M'S")	S23 25 15.0
Longitude (D°M'S")	E30 54 45.7

Item	Description	Units	Quantity
Rock/ Gravel Pack	Placing a layer of gravel (stone)/ placing rocks either directly on NGL or over Geotextile	m3	100.00
Earth Works	Cut, slope, fill (into GeoCells) & removal of soil for excavations and replacing topsoil	m3	55.00

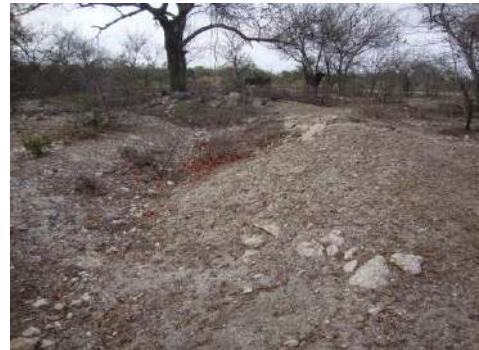
Intervention	Baleni
Designer	Cilliers Blaauw
Design Date	02 April 2019
Type	New
Description	Earth Works
Rehabilitation Objectives	<ul style="list-style-type: none"> • Take control over water flow. • Restore disturbed environment. • Re-vegetate to stabilise. • Prevent future degradation.
Latitude (D°M'S")	S23 25 12.7
Longitude (D°M'S")	E30 54 37.3
