C1-3 Plasterwork E1-4 Timber doors / frames E3 Glazing to doors E4-9 Paintwork to existing doors F1-3 Timber windows G1 Existing burglar proofing to be reinstated. H1-2 Ironmongery Existing internal timber elements to be reinstated to spec. Existing external timber elements to be reinstated to spec. Existing external timber elements to be reinstated to spec. Existing external timber elements to be reinstated to spec. Existing external timber elements to be reinstated to spec. Existing external timber elements L1 Cement screed flooring L2 Encaustic tile flooring Subsiding veranda reinstated and retiled to spec to match. M1 Internal suspended timber flooring M2 Existing cork floor tiles M3 Existing encaustic tiles, cleaned M4 Existing clay tiles, cleaned pressed. M5 Existing plasting pressed metal ceilings M6 Existing painted plastered ceiling M8 Repair existing T&G and timber ceiling M9 Repair existing flast timber ceiling M1 Repair existing paster cornices M1 New roof sheeting. S-Rib M2 Damaged roof structure assessed Reinstated M3 Replace existing insulation M4 Replace imber with bitumen roof shingles M6 Replace existing insulation M6 Reinstate damaged barge / fascia boards M6 Cle

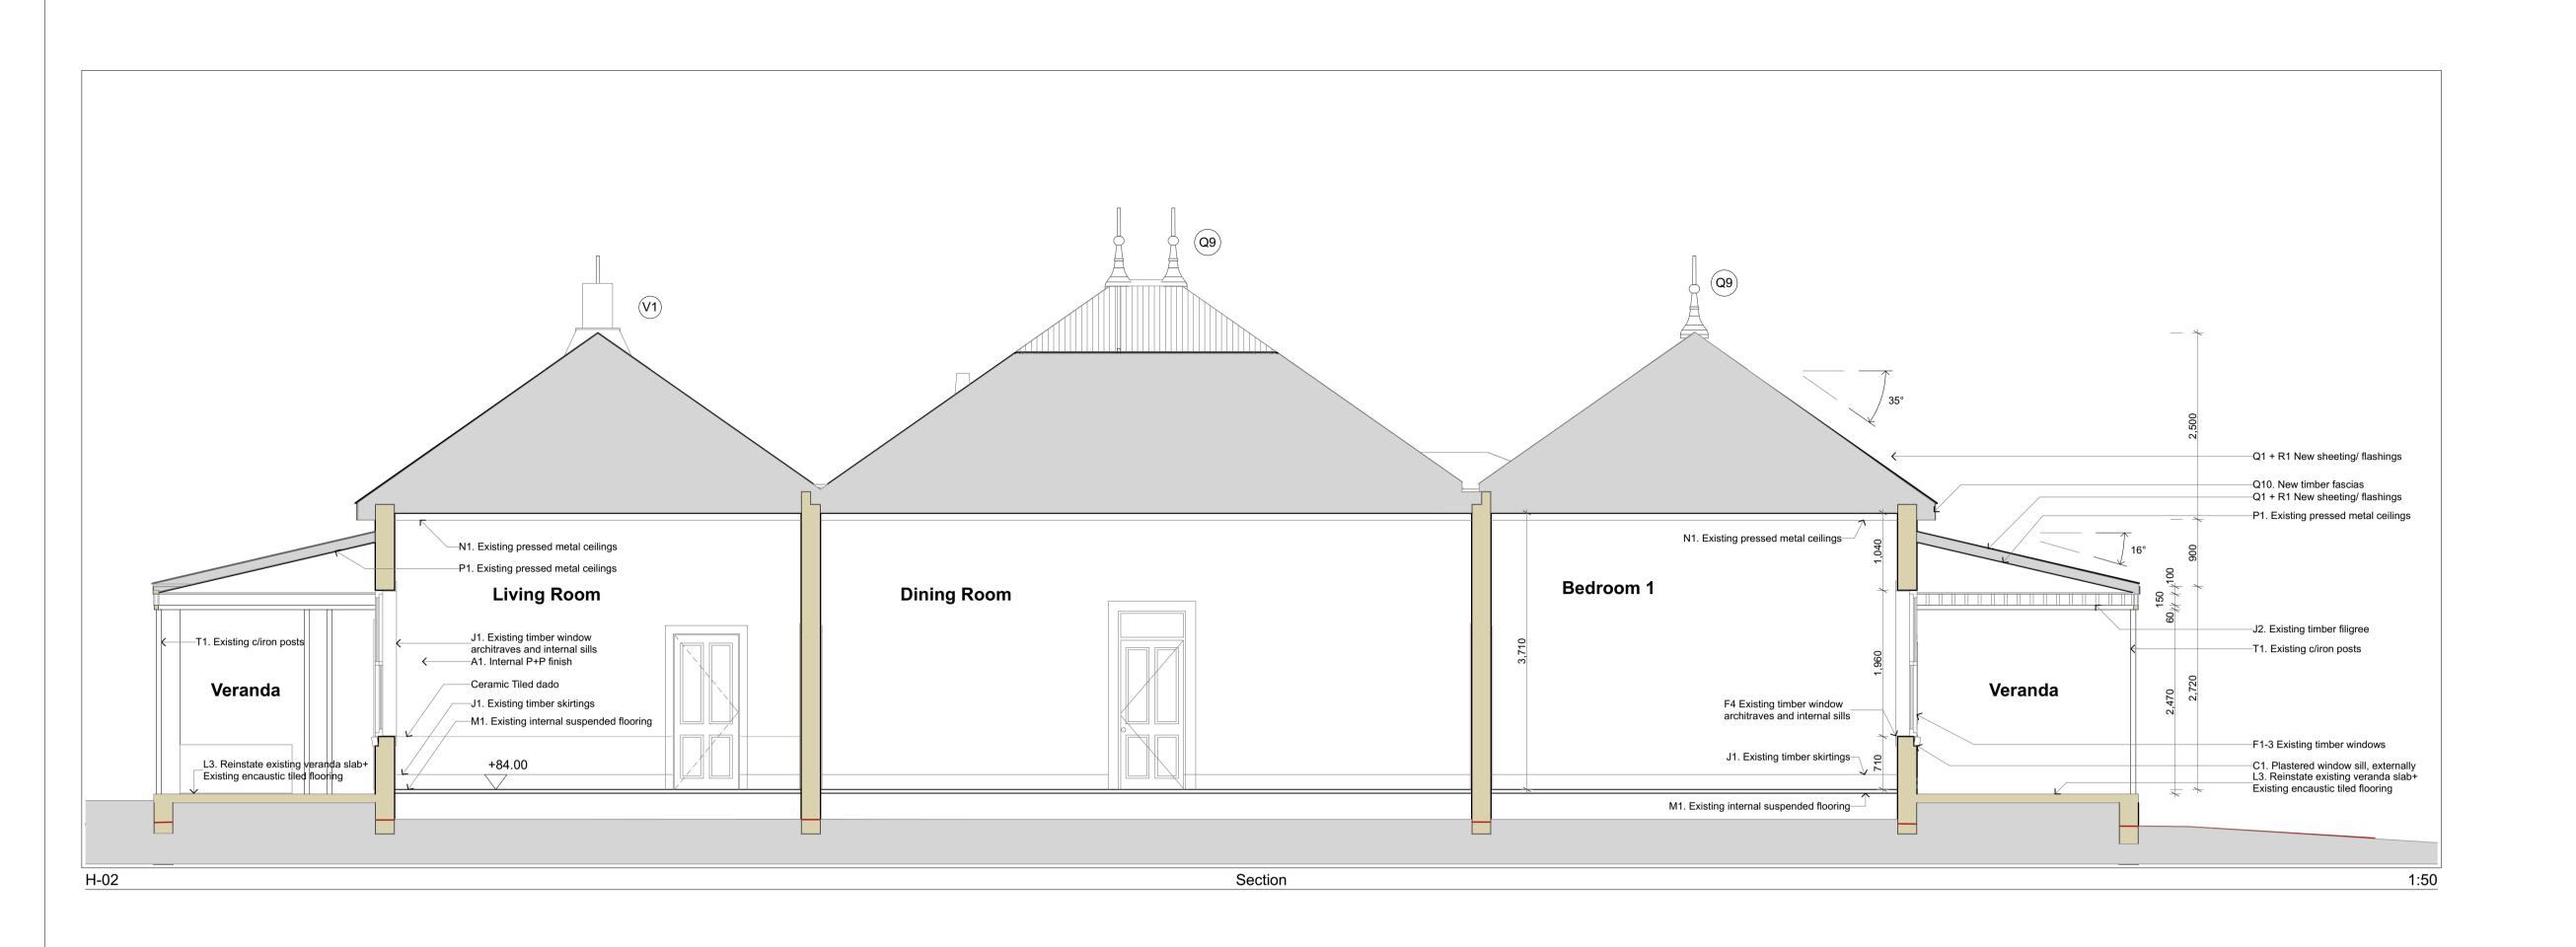
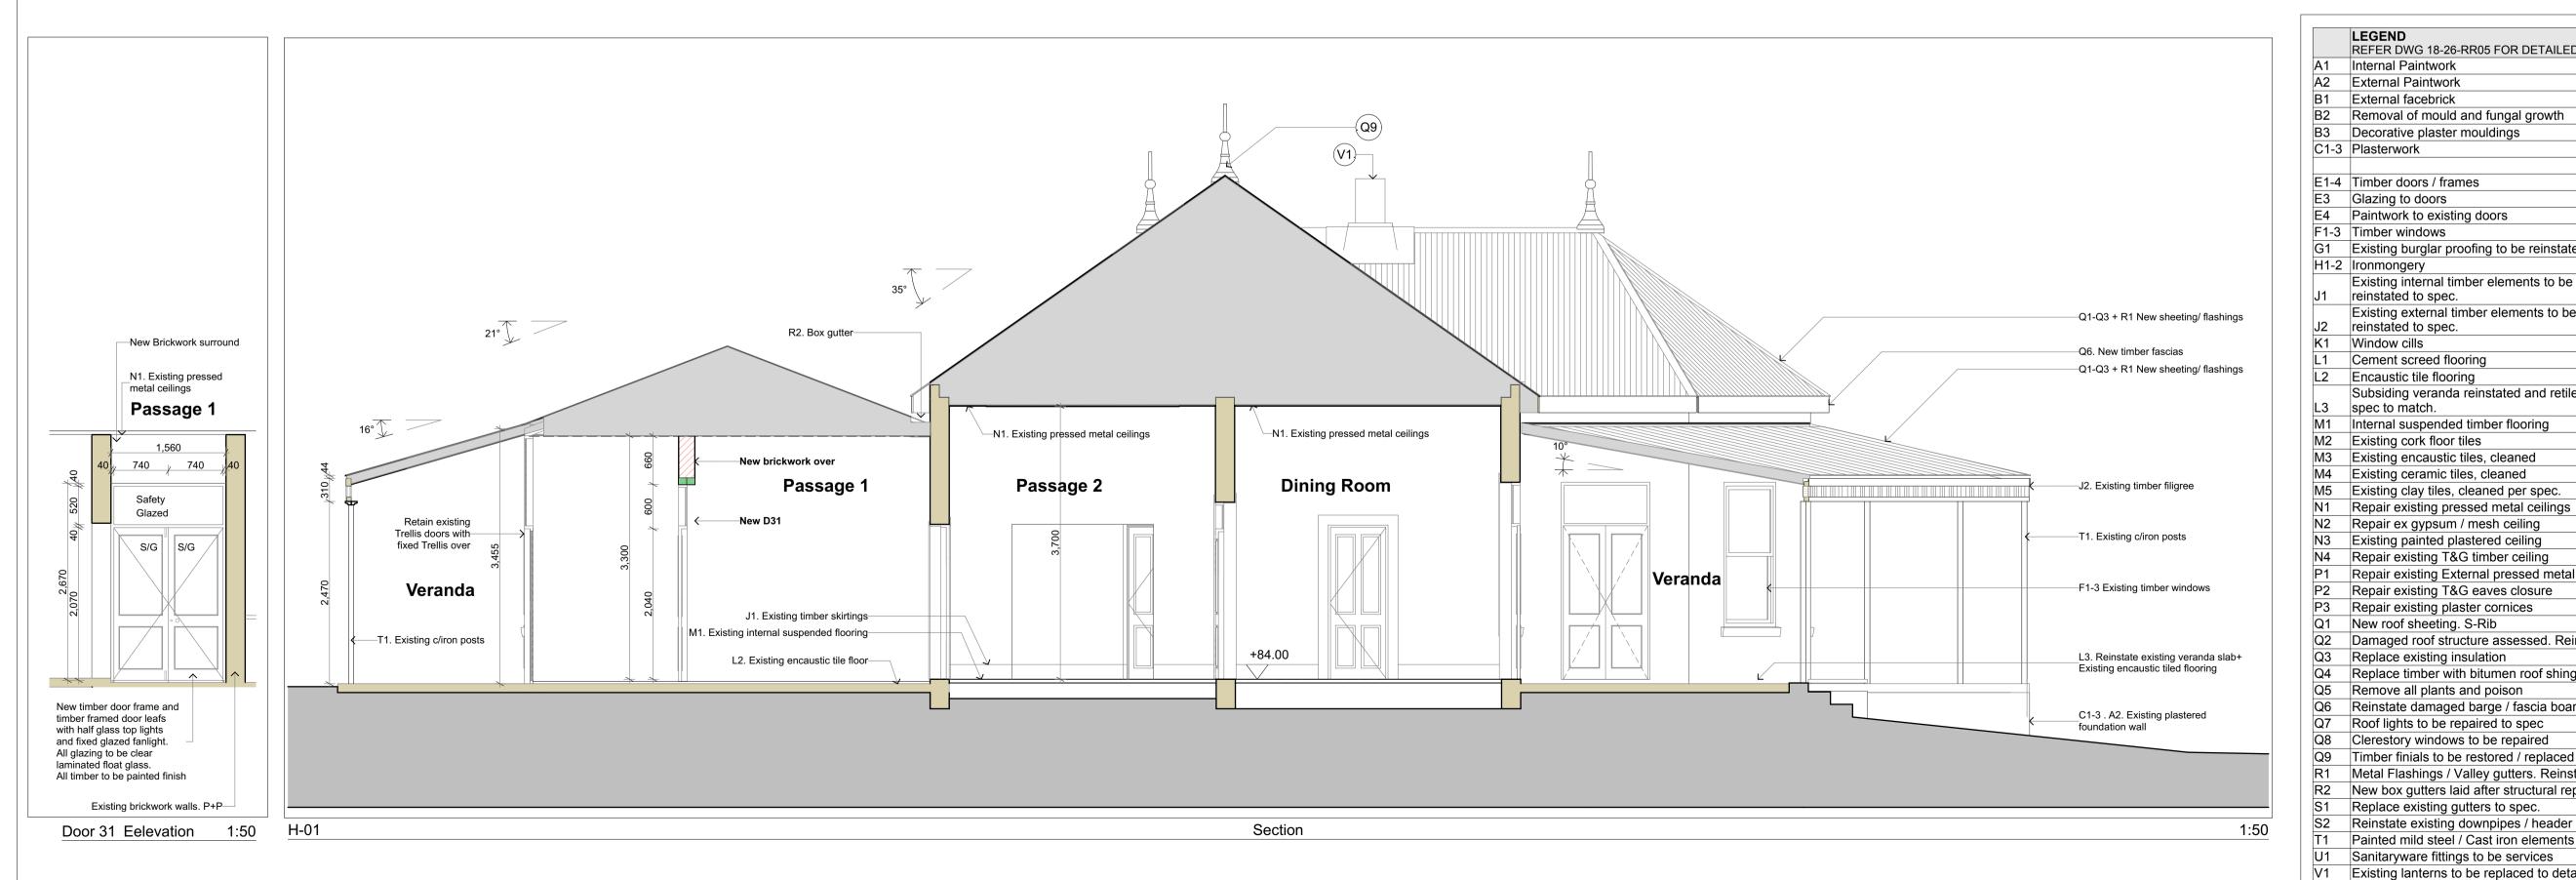
Drawing no.: 18-26-RR05			-				
	^_	LAISTING STOTH WATER SYSTEM TO DE SETVICEU.		Drawing no	o. : 18-26-F	RR05

V1 Existing lanterns to be replaced to detail. Original lights and fittings to be retained per heritage architects direction. Existing electrical fittings to be assessed / reinstated and certified. X1 Existing drainage to be serviced. X2 Existing stormwater system to be serviced.				Sect	ions H1	/ HB.	
Original lights and fittings to be retained per heritage architects direction. Existing electrical fittings to be assessed / reinstated and certified. X1 Existing drainage to be serviced. X2 Existing stormwater system to be serviced.		, o		Exis	ting resi	idence	è
W1 heritage architects direction. Existing electrical fittings to be assessed / W2 reinstated and certified. X1 Existing drainage to be serviced. X2 Existing stormwater system to be serviced.	V I	· .					
Existing electrical fittings to be assessed / W2 reinstated and certified. X1 Existing drainage to be serviced. X2 Existing stormwater system to be serviced.	۱۸/1			•
