Draft Basic Assessment Report and Environmental Management Programme for a Cable Repair Yard and Pre-Assembly Yard to be located at Anglo American Platinum, Rustenburg Platinum Mines, Mogalakwena Complex, Limpopo Province

**Anglo American Platinum Limited –
Mogalakwena Complex**

November 2022

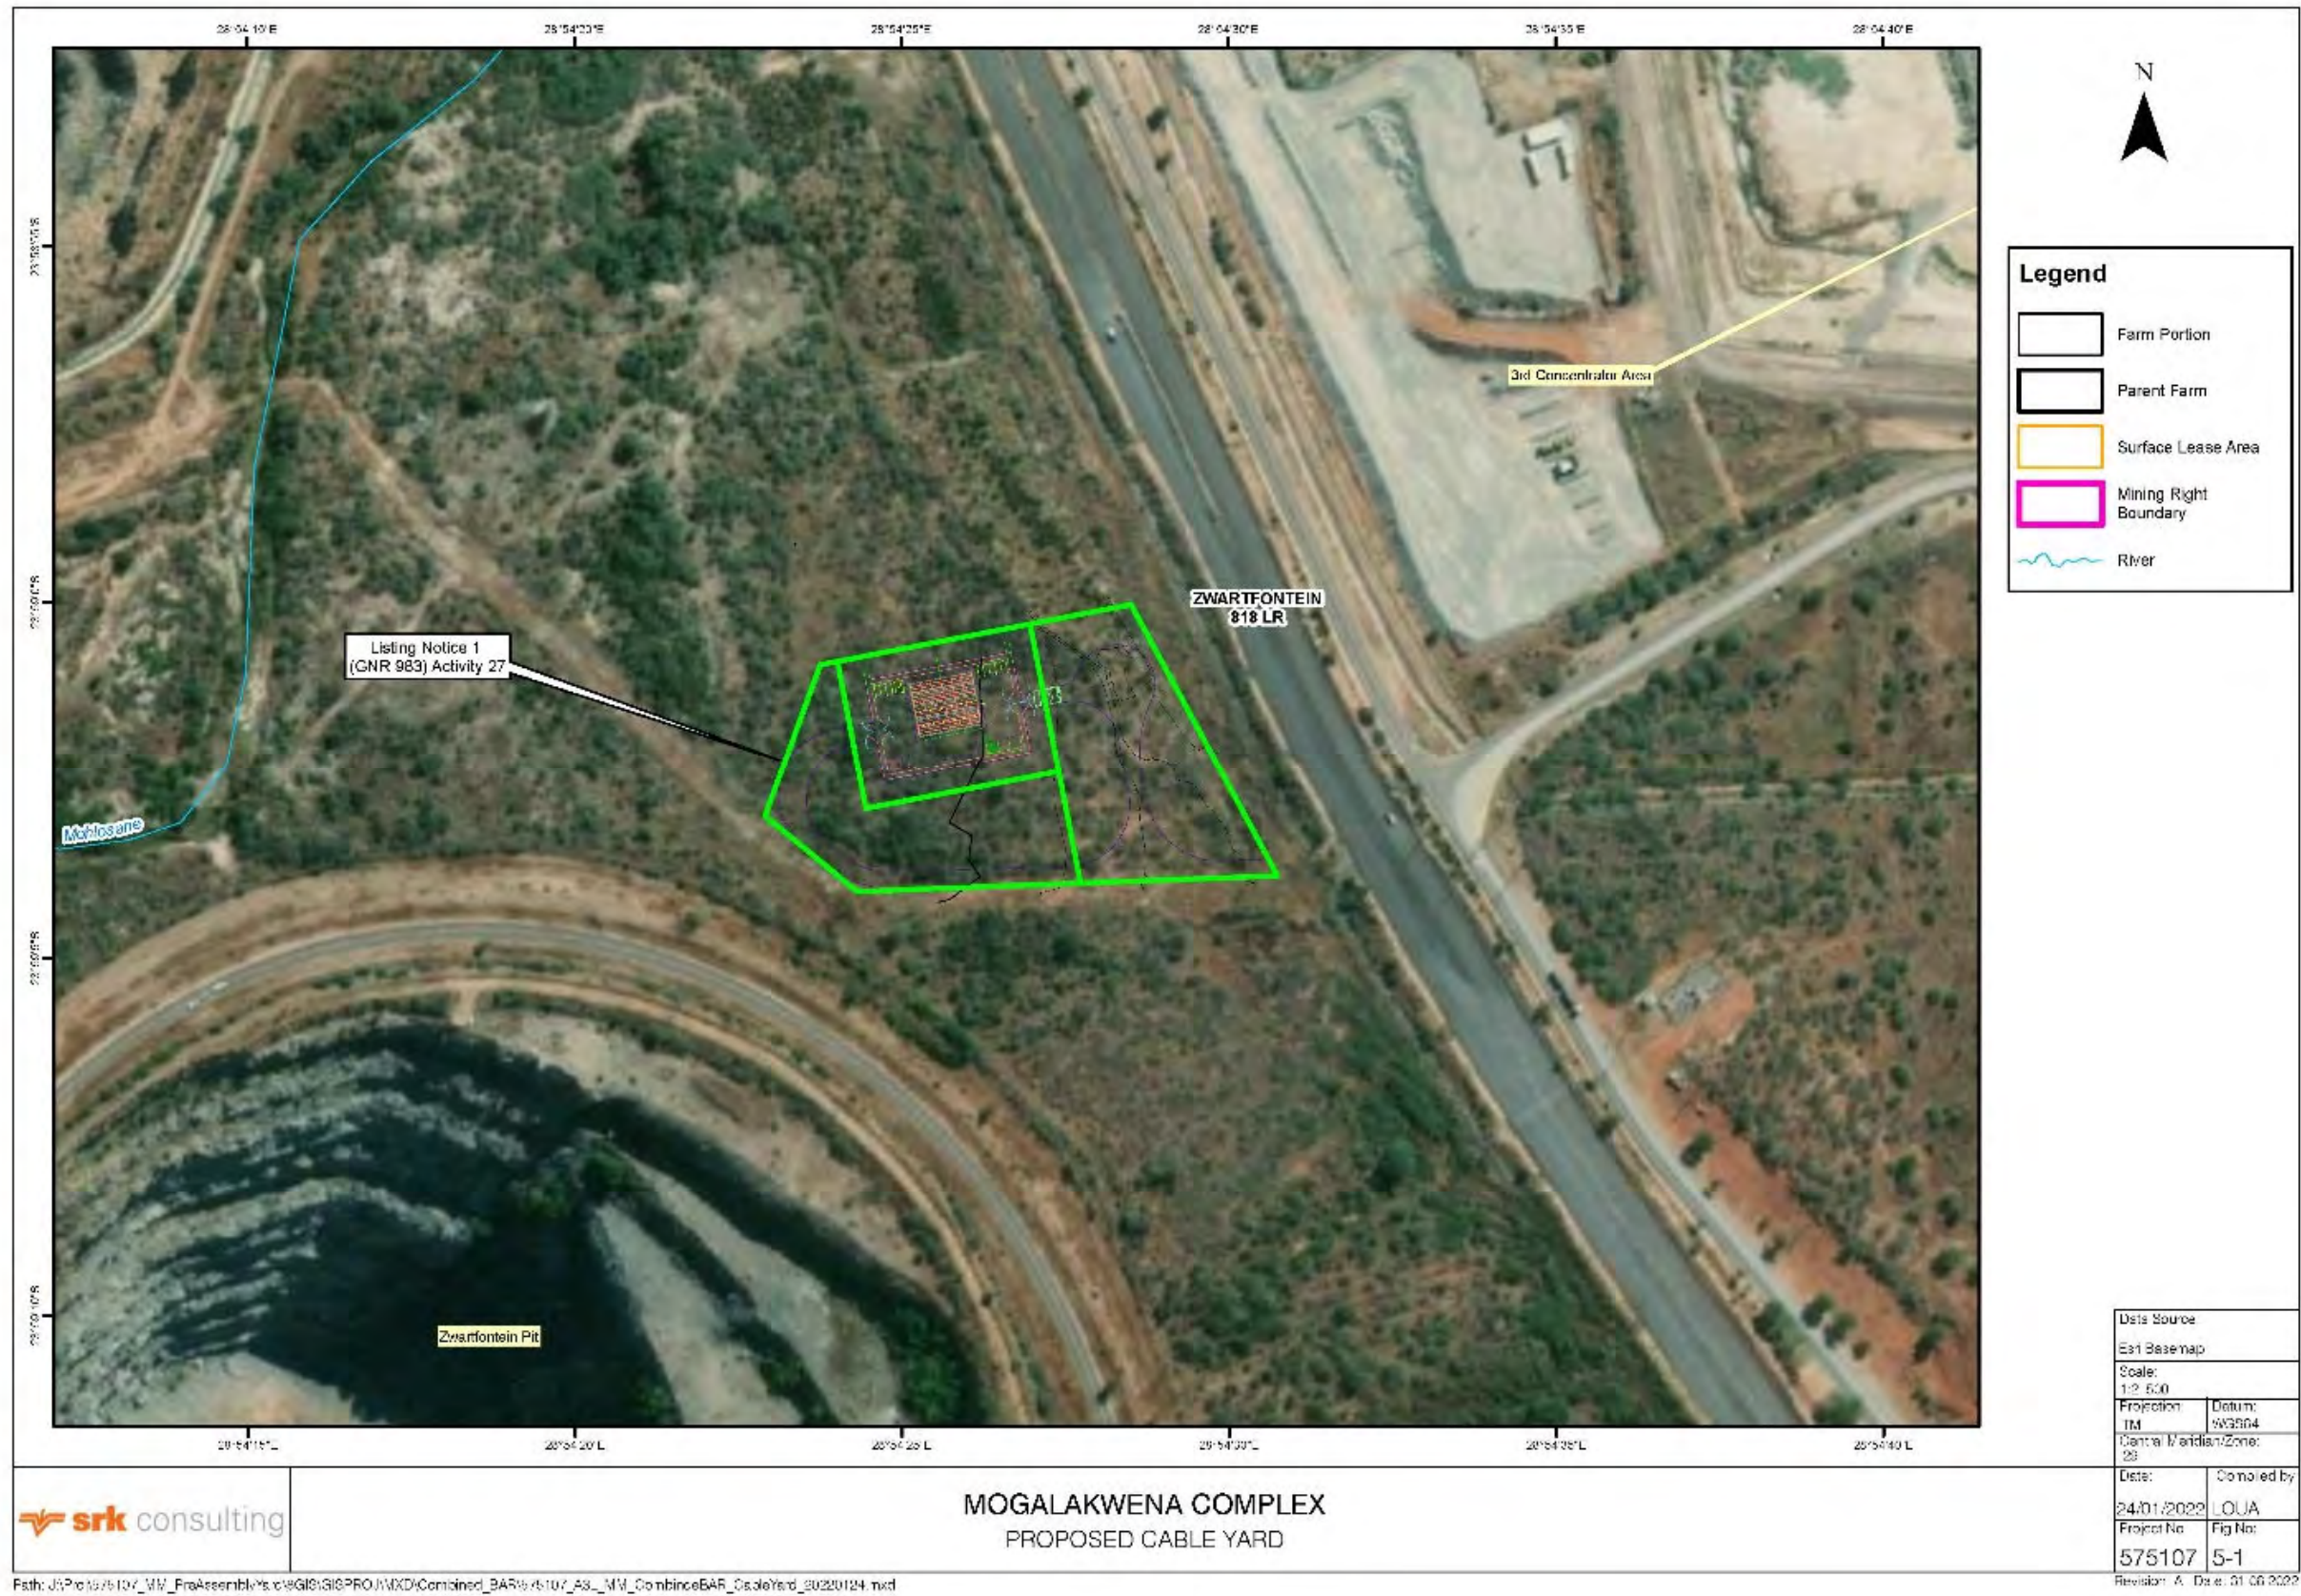
situated within the existing Mogalakwena Complex mining right and lease areas to the north east of Zwartfontein pit on the Farm Zwartfontein 818 LR (Figure 5-1). The proposed cable repair yard will be used for the repair and maintenance of cables required for primary equipment across the mine area. The area will need to be cleared of more than 1ha (but less than 20ha) of indigenous vegetation to make way for the cable yard as well as associated infrastructure.

Figure 5-1: Proposed cable yard area

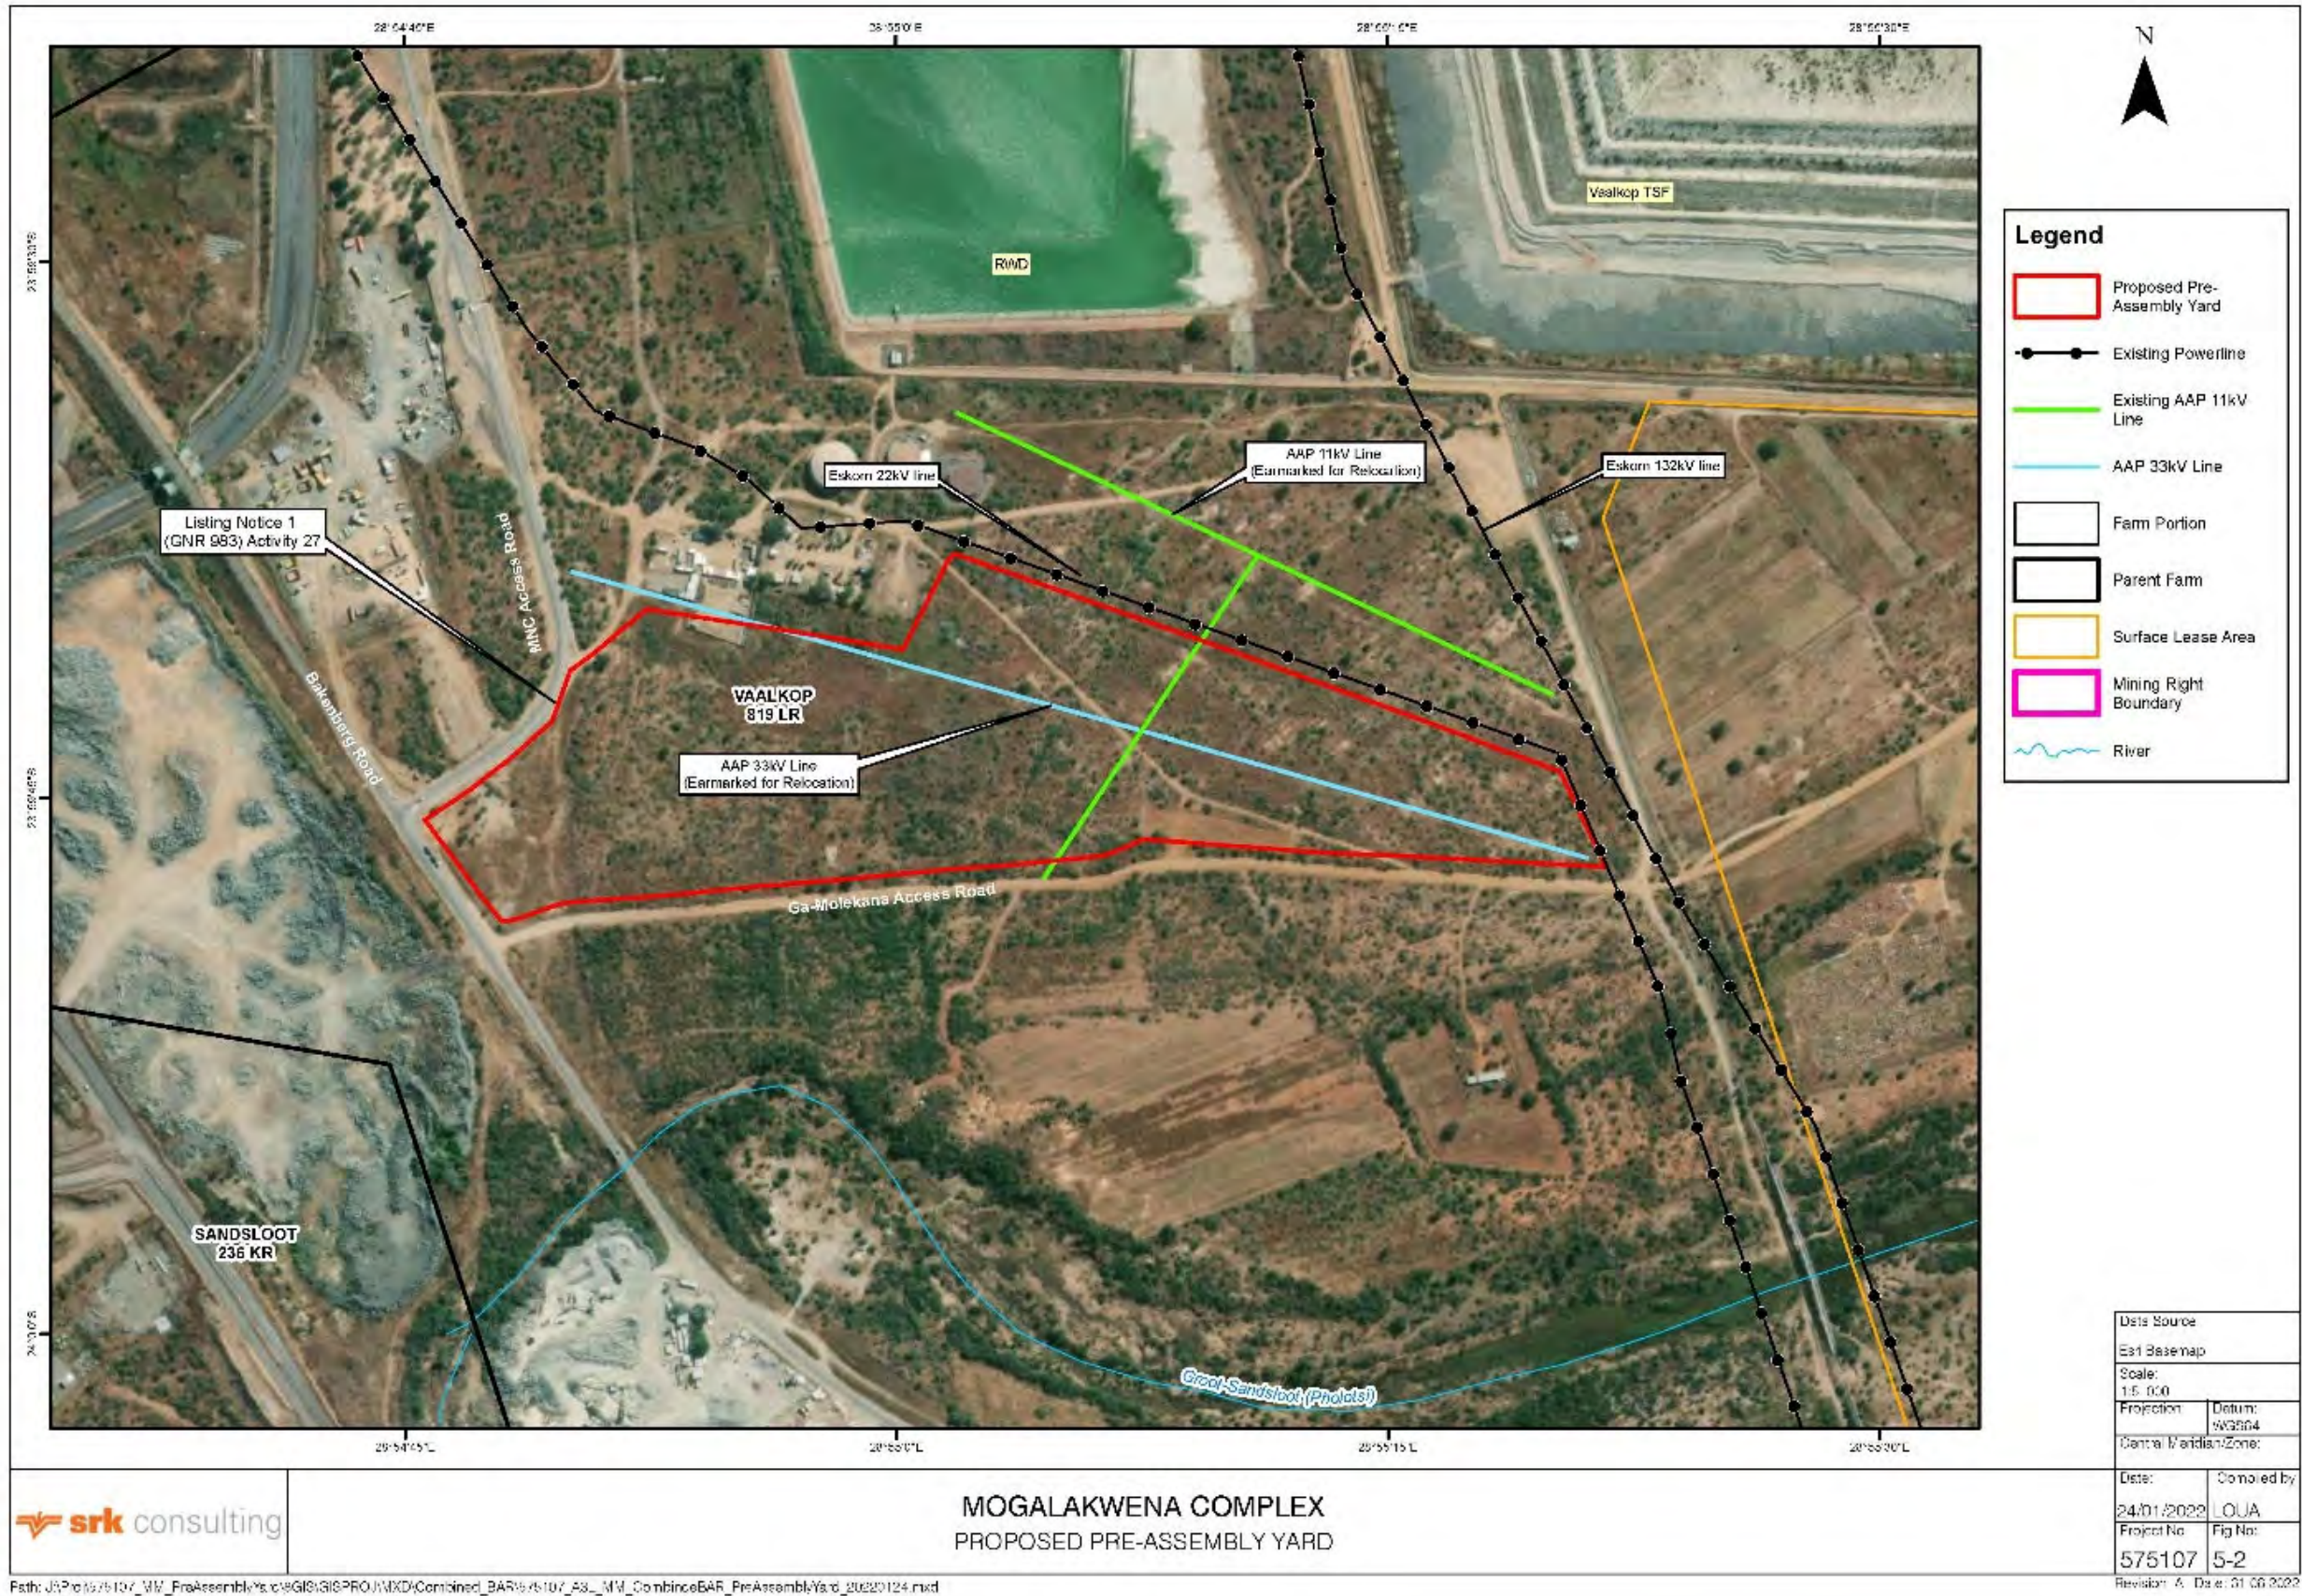
Figure 5-2: Proposed pre-assembly yard area

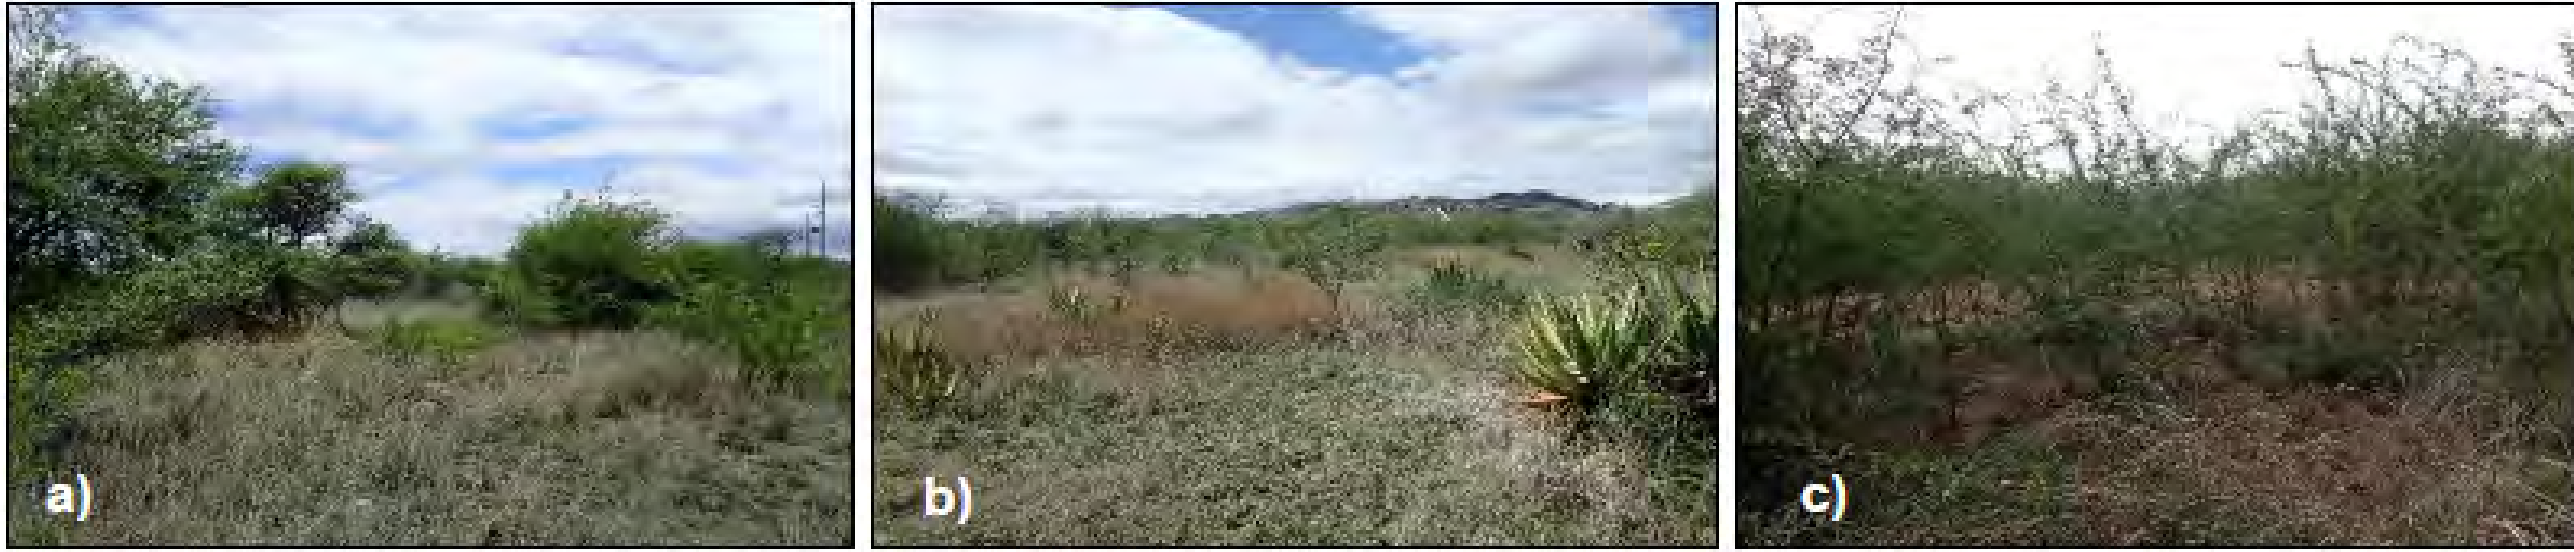
<p>Habitat overview</p>	<p><u>Disturbed Thornveld Habitat</u></p> <ul style="list-style-type: none"> • Comprises the smallest extent of the study area (approximately 2 ha) and was characterised by a semi-open to closed woody layer with small, scattered areas that had a slightly rockier affinity. • Has not been impacted directly by anthropogenic activities or mining expansion and thus conforms to the definition of indigenous vegetation (as floral communities have not been significantly transformed within the last decade). • The habitat is surrounded by infrastructure servitudes and historic mine expansion within the north-eastern, western, and southern boundaries of the study area. This has resulted in several edge effects impacting on habitat conditions, e.g., alien and invasive plant (AIP) proliferation. • At present, the habitat is associated with indigenous encroachment, particularly by <i>Dichrostachys cinerea</i> and several <i>Aloe</i> species, further serving as an indication of poor veld conditions and an alteration in natural ecological drivers such as herbivory and fire regimes. • The current and historic association with disturbances has therefore resulted in degraded floral communities that are markedly less diverse than that of the surrounding natural habitat. • Although the habitat unit provides habitat for indigenous vegetation, the alteration in fire and herbivory regimes and the residual impacts from nearby historic activities (e.g., mining activities etc), have resulted in a habitat that is no longer being considered representative of the reference vegetation type, i.e., the Makhado Sweet Bushveld. <div data-bbox="341 1228 2745 1743">

</div> <p>Figure 10-4: Photographs illustrating the landscape associated with the Disturbed Thornveld Habitat Unit: a-b) typical landscape (with encroaching species (including <i>Dichrostachys cinerea</i> and <i>Aloe</i> species) in the background) associated with the habitat unit, and c) woody encroachment by <i>Dichrostachys cinerea</i> is evident in parts of the habitat.</p>

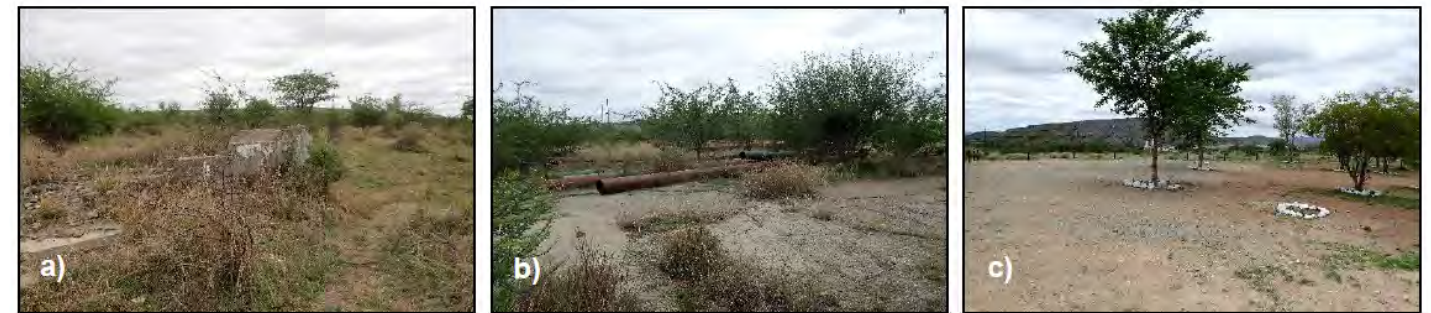
Given the level of transformation and overall degradation of the floral communities associated with the Heavily Degraded Habitat unit, it is no longer considered representative of the reference vegetation type, i.e., the Makhado Sweet Bushveld.

Figure 10-9: Photographs illustrating the landscape associated with Heavily Degraded Habitat: a-b) typical areas in which old structures and/or infrastructure has not been cleared or rehabilitated, c) areas cleared for parking lots

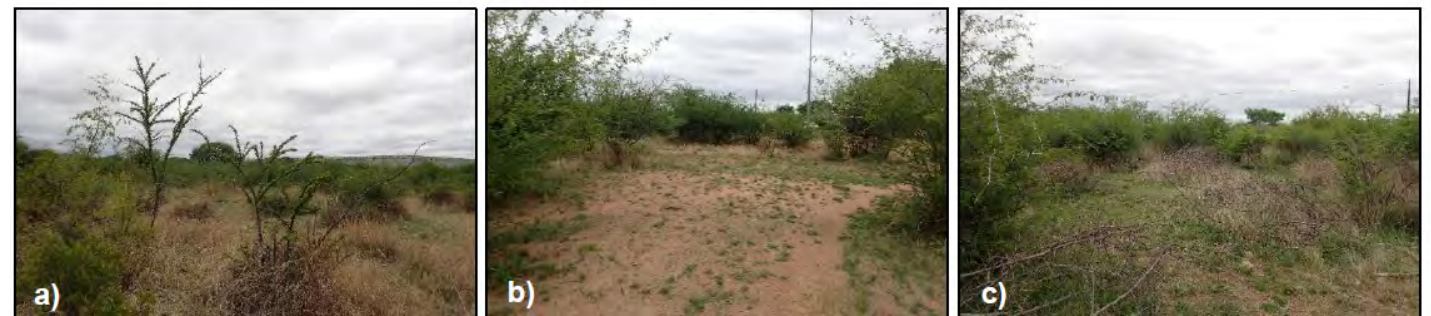
- Although the habitat unit has recovered somewhat, the alteration in fire and herbivory regimes and the residual impacts from historic activities (e.g., subsistence farming etc), have resulted in a habitat that is no longer being considered representative of the reference vegetation type, i.e., the Makhado Sweet Bushveld.

Figure 10-10: Photographs illustrating the landscape associated with the Secondary Thornveld Habitat Unit: a) typical landscape (with encroaching woody species in the background) associated

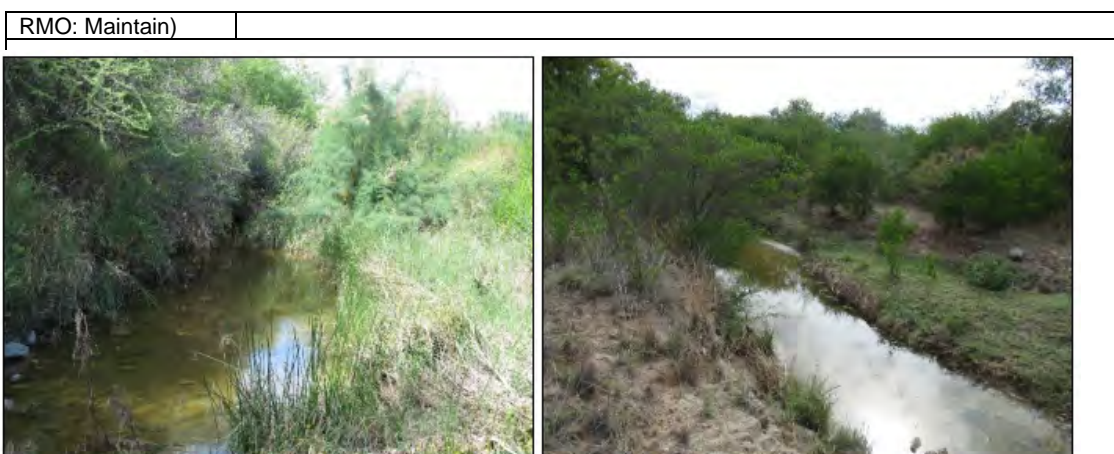
Ecoservice provision (moderately low / very low)	Ecological service provisioning by the assessed reach of the river is limited by the seasonal availability of water. It is, nevertheless considered important for the provision of key services such as flood attenuation, streamflow regulation, nutrient and toxicant assimilation, sediment trapping and biodiversity maintenance.
REC, RMO & BAS Category (REC: C/D BAS: C)	The ecological integrity of the Mohlosane River should not be permitted to degrade further, and all efforts should be made to ensure that minimal cumulative impacts occur.

Figure 10-16: Representative photographs of the reach of the Mohlosane River associated with the proposed project illustrating relatively robust vegetation cover

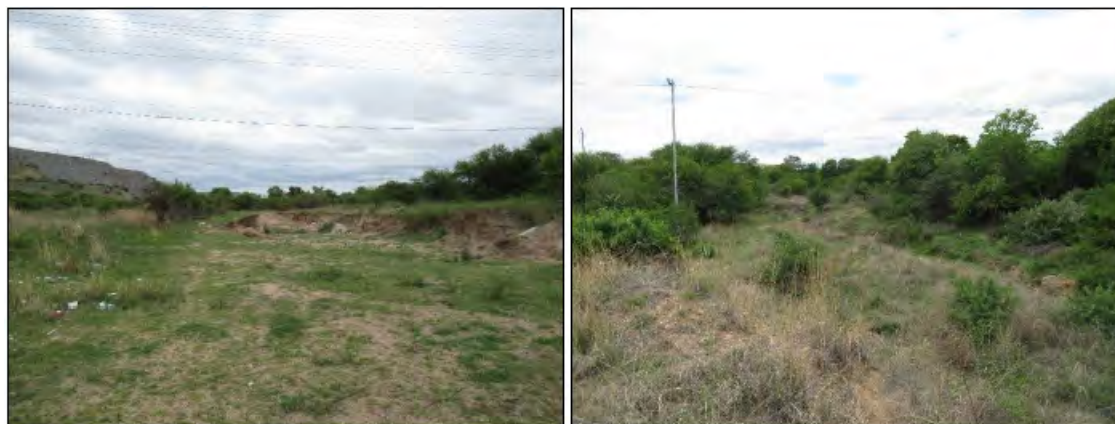
<p>REC, RMO & BAS Category (REC: C/D BAS: C RMO: Maintain)</p>	<p>Direct impacts associated with the proposed project are not anticipated, therefore maintaining the PES and EIS of the reach of the Groot-Sandsloot associated with the study area is feasible. Any future projects within the regulated zones around the river must however be assessed on an individual basis to ensure that such activities do not impact on the river.</p>
--	--

Figure 10-20: Representative photographs of the reach of the Groot Sandsloot River associated with the proposed project, illustrating the weakly-defined riparian zone in the portion east of the study area (left) whilst to the west of the study area the riparian zone is more distinctly formed.

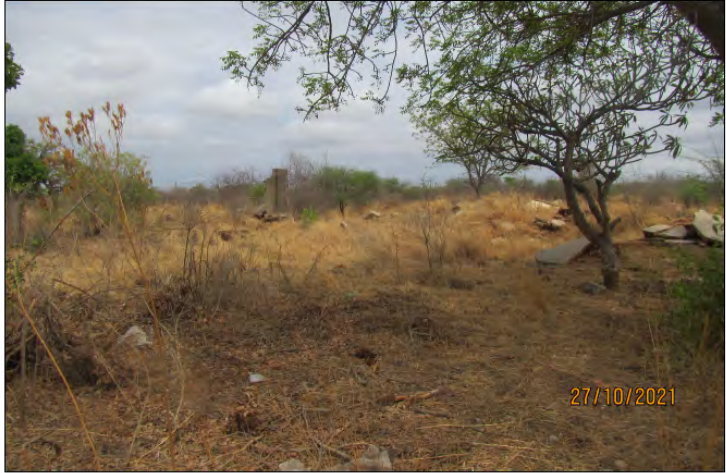
<p>Figure 10-29: General view of the site. Some of the structural remains can be seen.</p>												
<p>Significance of findings</p>	<p>Due to the contemporary nature of the site, the structural remains of the site are deemed to be of:</p> <ul style="list-style-type: none"> • Generally Protected C (GP. C) or Low Significance. • However, the risk for the presence of unmarked graves does exist. Until such time that the presence of graves in the area has been confirmed or disproved, the site must be viewed as containing graves. All graves have high levels of emotional, religious and in some cases historical significance. The possible presence of graves requires a higher significance level for the site. Site MPAY-01 (coordinates provided in Table 10-23) is therefore deemed to be of Generally Protected A (GP. A) or High/Medium Significance, which means that mitigation is required (refer to Section 11). 	<p>Table 10-23: Coordinates of heritage site MPAY-01</p>
