## **Appendix D3 Heritage**

**ARCHAEOLOGICAL IMPACT ASSESSMENT  
THE PROPOSED ROMA ENERGY SOLAR FARM  
ON ERF 753 DANIELSKUIL  
NORTHERN CAPE PROVINCE**

**PROPOSED DANIËLSKUIL ROMA ENERGY SOLAR  
PLANT, KGATELOPELE LOCAL MUNICIPALITY,  
NORTHERN CAPE**

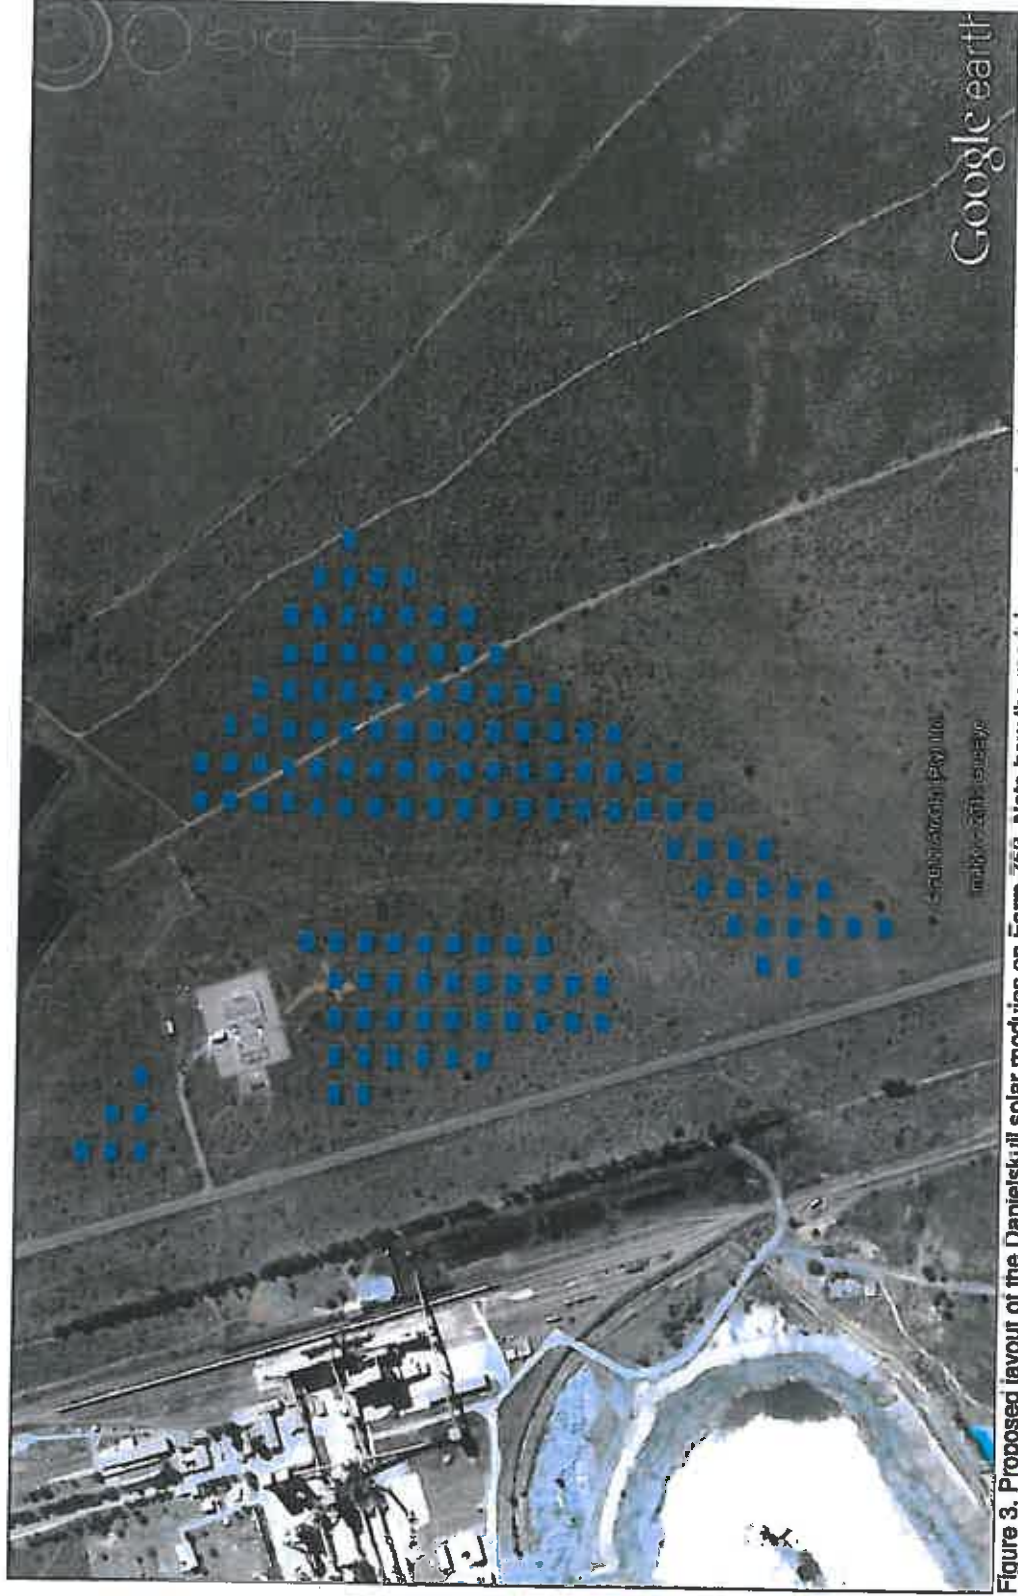
Figure 3. Proposed layout of the Danielskuil solar modules on Farm 753. Note how the modules are spread out over the landscape

Roma Energy Danielskuil proposes to construct and operate a commercial solar energy that entails the construction of about 140 CPV solar panels covering a footprint area of about 20 ha (Figures 3-9). The CPV panels will be mounted on pedestals drilled and set into the ground. Extensive bedrock excavations are not envisaged, but some vegetation may need to be cleared from the site. Associated infrastructure includes single track internal access roads, trenches for underground cables, transformer pads, a switching station, a maintenance shed, and a temporary construction camp. The electricity generated from the project will be fed directly into the national grid to the Eskom Danielskuil substation which is situated alongside the proposed facility. Note that due to the extensive infrastructure covering the proposed site, the solar modules have been spread out over the surrounding landscape.

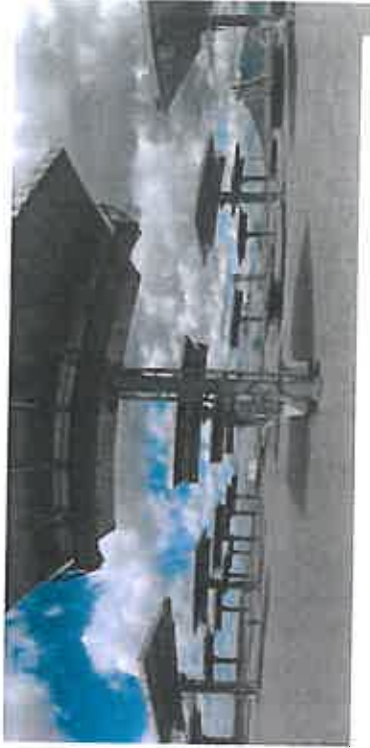
Figure 8: Night slow position

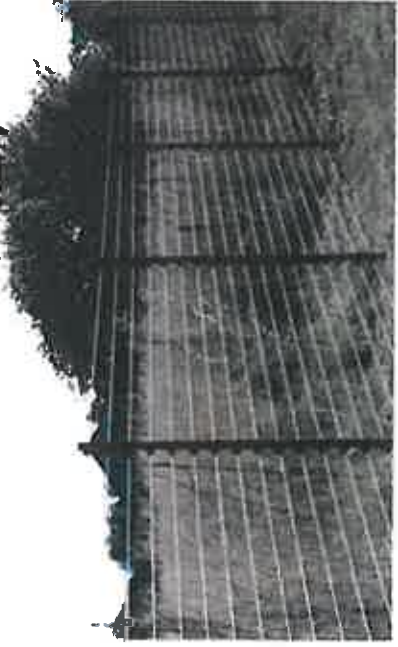
Figure 9: Typical electrical fence

Double fencing with inner fence consisting of galvanized palisade fence and outer an electrified fence of 2.4m in height.

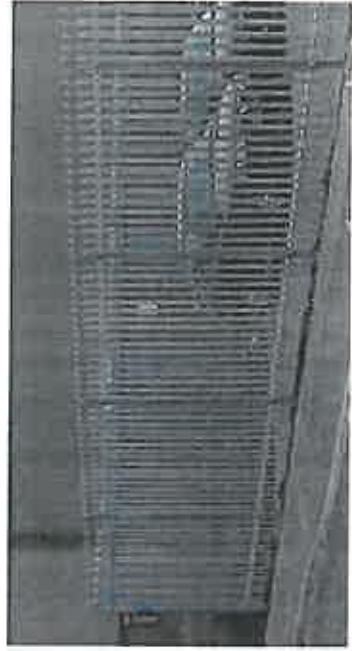
Figure 10: Typical galvanized palisade fence

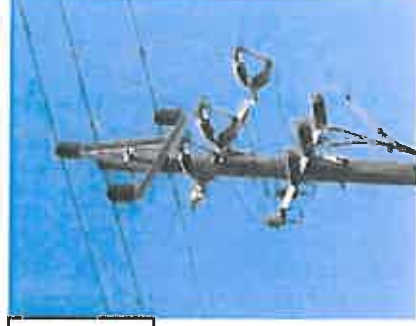
Single 22KV Power lines will feed from the transformers to the FSKOM

Figure 11: Typical 22KV single Powerline
