Savannah Environmental (Pty) Ltd

SITE LAYOUT PLAN DEVELOPMENT

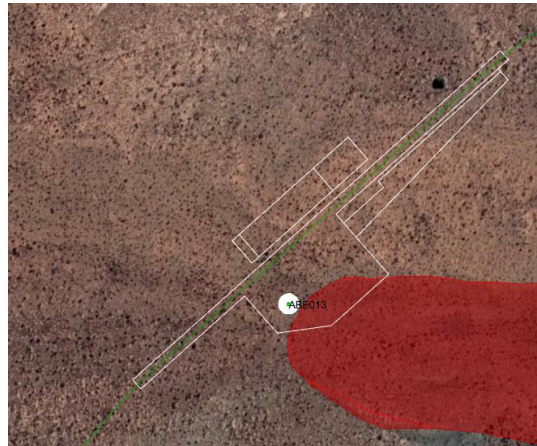
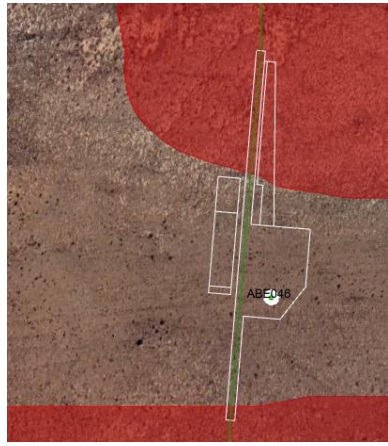
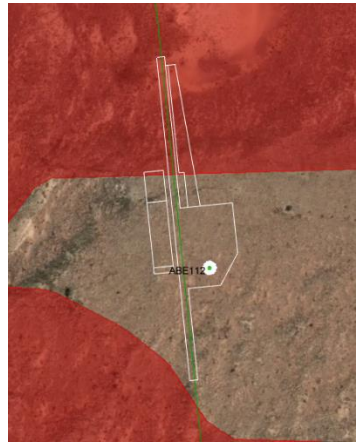
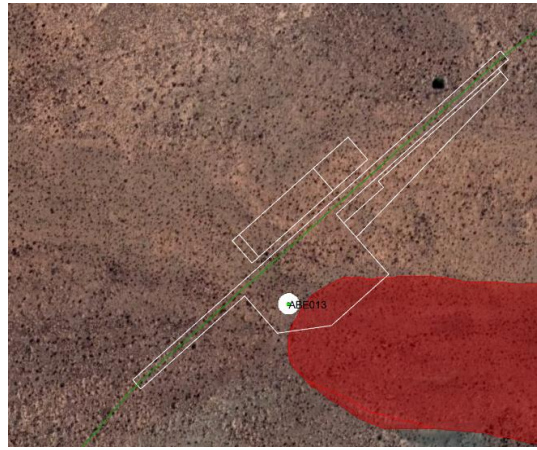
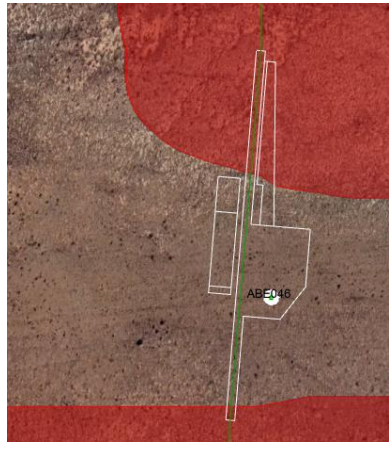
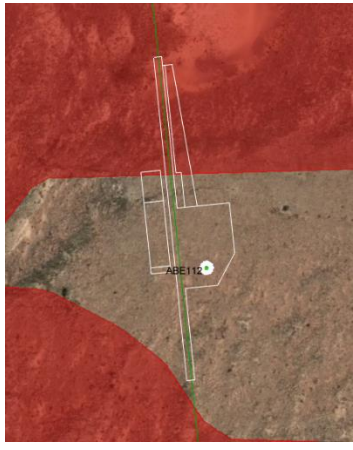
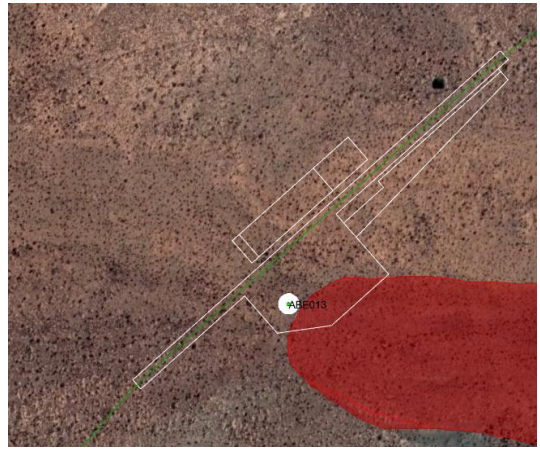
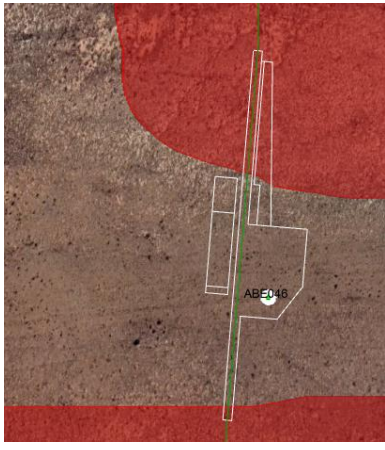
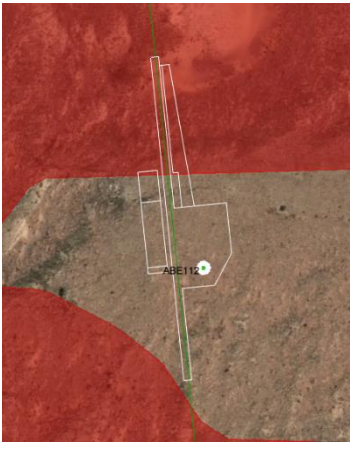
Turbine #	13	46	112

Version #	Date	Informant Constraints	Comments								
Preliminary Layout											
1	October 2020	Lease areas	Boundaries of the lease areas as defined and agreed to with affected landowners								
		Desktop wind resource	Desktop wind resource data informed the optimum turbine placement								
		Avifaunal screening	An avifaunal specialist was appointed to conduct an initial site survey and report on any key priority species nesting within the project or neighbouring properties which may require buffering out large portions of the proposed project site. N								
2	February 2021	Met mast location	Suitable locations for the measurement masts were modelled based on the preliminary layout (Version#1)								
3	March 2021	Increase in turbine size to 120	Considering the extent of upstream strengthening required need sufficient scale								
4	September 2021	Amendment to met mast locations	Following a site-visit undertaken by the resource technical team in May 2021, alternative measurement mast positions were identified. This had knock-on effects on the preliminary turbine layout which needed to be remodelled.								
		Avoidance of aquatic buffers	Refined aquatic buffers were available at this point and were considered in this iteration.								
Draft BAR Layout											
5	July 2022	Specialist constraints available at the time	All verified specialist constraints were available at this stage, except for avifauna, bats and ecology which at the time was pending further monitoring and/or verification.								
		1 yr verified wind data	At the time, the project resource team had completed a year of the wind measurement campaign. The data obtained up to this point informed optimised turbine placement.								
6	August 2022	Final bat constraints	Based on 12-month monitoring campaign and sensitive feature verification								
7	October 2022	Final avifaunal constraints	Based on 12-month monitoring campaign and collision-risk modelling								
8	November 2022	Micro-siting of turbines 13, 46 and 112 outside of no-go areas	<table border="1"> <thead> <tr> <th>Turbine #</th> <th>13</th> <th>46</th> <th>112</th> </tr> </thead> <tbody> <tr> <td></td> <td>

Design Recommendation	Shift all infrastructure 18 m NW	Shift all infrastructure 130 m W OR Reflect and shift upwards	Shift 90 m S OR Reflect and shift upwards
9	November 2022	Micro-siting of turbine 92 and re-alignment of a portion of access road	Turbine #	Turbine 13	Access Road

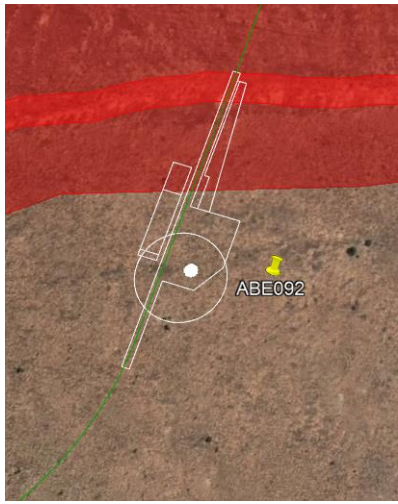
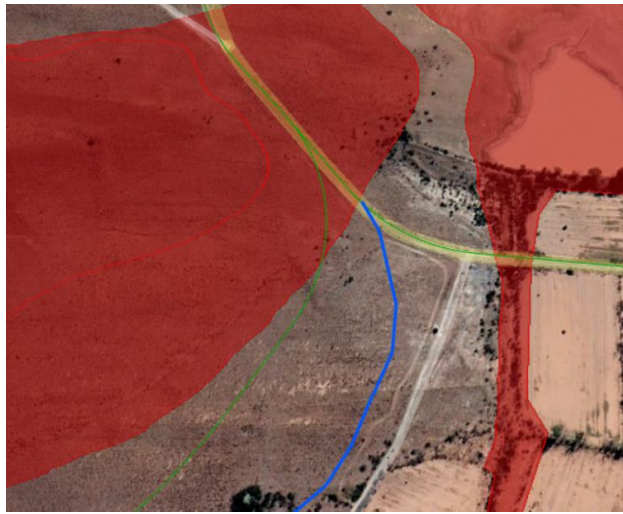
Design Recommendation	Reflect the hardstands so as to remove the blade assembly area from the drainage line	<p>A portion of the new access road (green) was microsighted outside of an ecological high sensitive area (blue).</p> <p>Any widening of an existing roads within ecological high sensitive areas (as above) is deemed acceptable by the ecologist:</p> <p><i>“Yes, it is preferable to use the existing roads even where these traverse the sensitive areas. There may be one or two sites where this may be an issue, but I doubt it.</i></p> <p><i>So yes, it is ok to have the roads widened to 6m in these areas.”</i></p>
