**ENVIRONMENTAL IMPACT  
ASSESSMENT PROCESS: PROPOSED  
PHOTOVOLTAIC (SOLAR) ENERGY  
FACILITIES ON HOEKPLAAS FARM  
NEAR COPPERTON, NORTHERN  
CAPE**

Conceptual Stormwater Management  
Plan - Hoekplaas Farm

**Reference:** 109378  
**Prepared for:** Mulilo  
Renewable Energy (Pty)  
Ltd  
**Revision:** 1  
**20 August 2013**

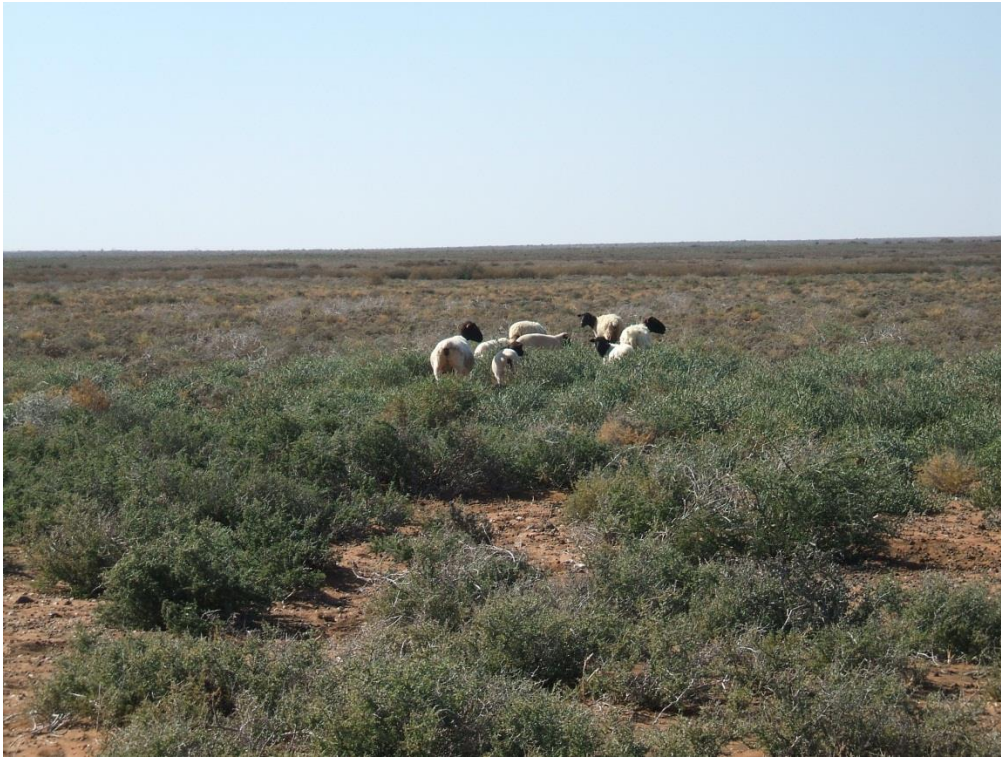
Figure 6: Grazing land at Hoekplaas Farm

The average catchment slope for Catchment 1, 2 and 3 is 1%. The current land use is grazing land (Figure 6) while the soils within the project area have been deemed unsuitable for arable agriculture (SiVest, 2013).

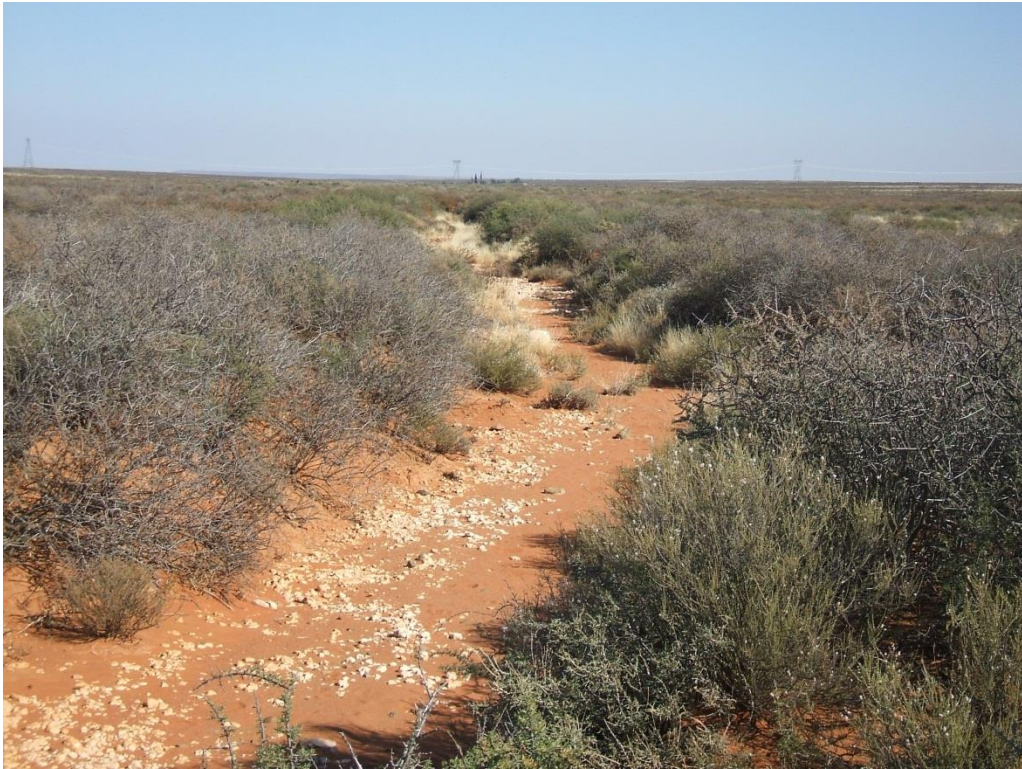
Figure 7: Ephemeral watercourse on Hoekplaas Farm

There is a well-defined ephemeral watercourse to the south-east of the farm (Figure 7). This watercourse is in Catchment 1 (Figure 1) and is the catchment for the Hoekplaas Farm Dam which has a catchment area of 54.18km<sup>2</sup>. Two endorheic pans on Hoekplaas have been previously identified (Mackenzie, 2013). Two other ephemeral pans, immediately west of PV 8 and PV10 are also considered important for ground water recharge. Figure 8 shows the pan immediately west of PV8.

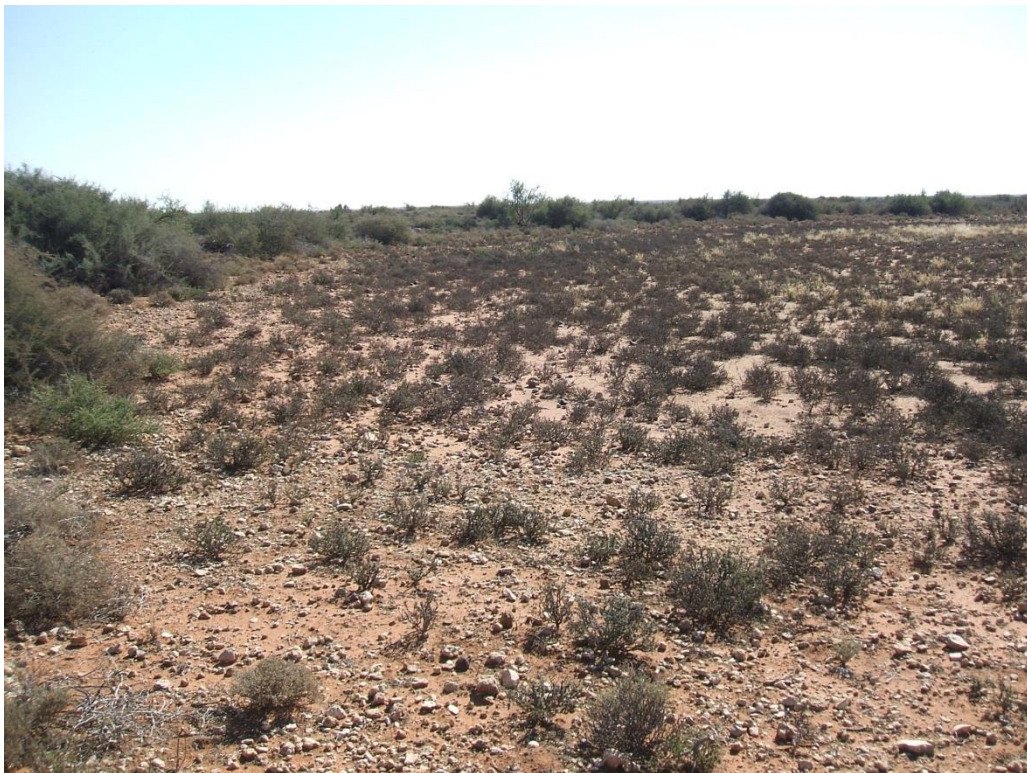
Figure 8: Pan at Hoekplaas Dam

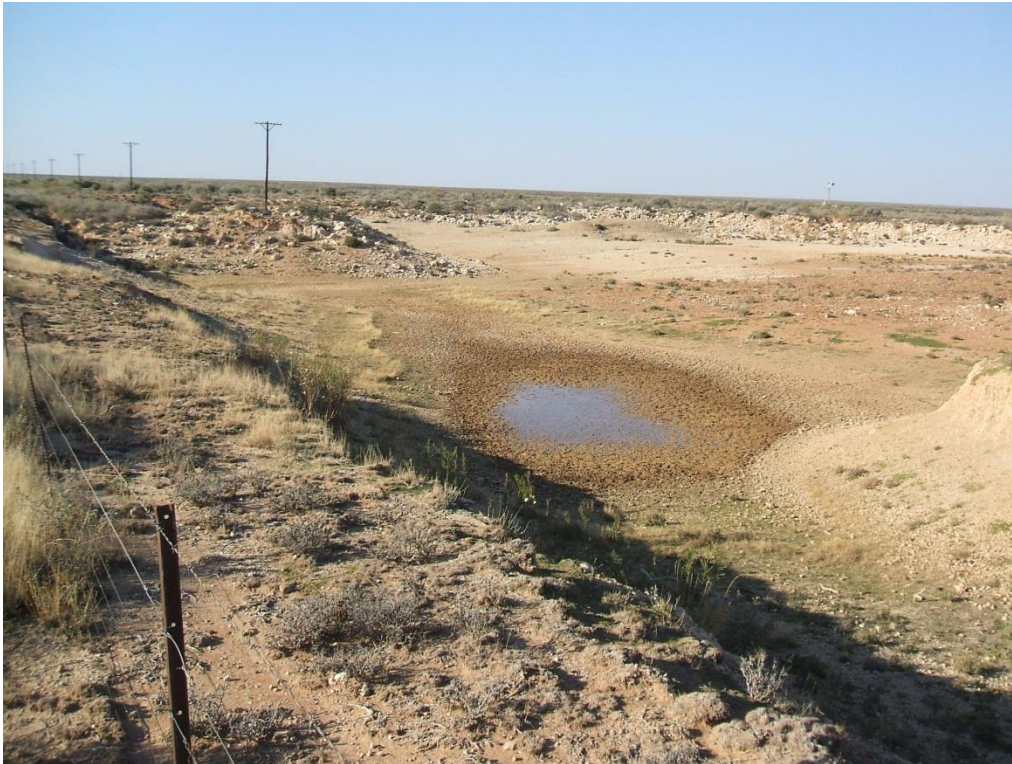
Figure 9: Large Borrow Pit on R357 approximately 2.6km from the Kronos sub-station

There is a large borrow pit adjacent to the R357, shown in Figure 9, approximately 2.6km from the Kronos sub-station which appears to have impact on the ephemeral watercourse that crosses the R357 close by. The water course drains from the Hoekplaas Farm through the Klipgats Pan Farm and exits the farm boundary to supply the several pans.

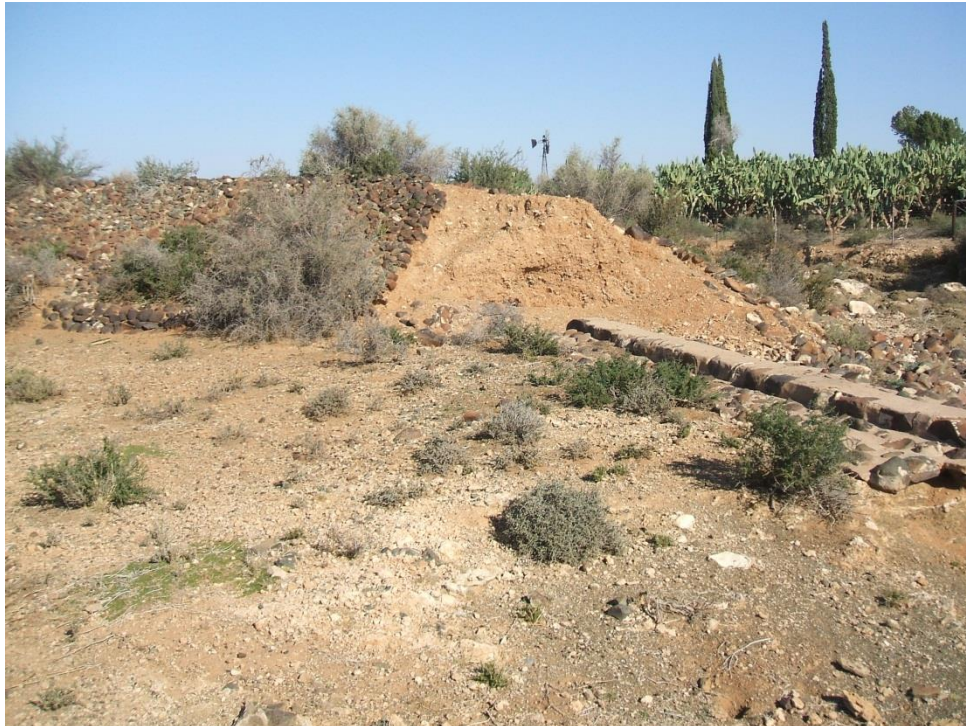
**Figure 12: Hoekplaas farm dam wall**

There is an increased 1:20 year flood peak for Catchment 1 (64% for Alternative 1 and 86% Alternative 2). At the downstream end of Catchment 1 Hoekplaas farm the watercourse feeds into a dam. The dam wall is approximately 2.5 m high and has been damaged by a previous flood event (see Figure 12), where the dam wall meets the spillway. The farm worker dwelling and the Hoekplaas farmhouse have been previously inundated with flood waters in the farm worker dwelling estimated at 0.5m deep. As a consequence the increase in flood peak should be reduced to pre-development levels before the runoff leaves the PV facilities which could be achieved by using attenuation ponds. The pre-developed Hoekplaas farmhouse and other dwelling are at risk from flooding therefore it is recommended that during the formulation of a detailed stormwater management plan that Mulilo Renewable Energy (Pty) Ltd discuss with the landowner the flood risk implications pre- and post-development. Possible measures to manage flood risk which would require further investigation are:

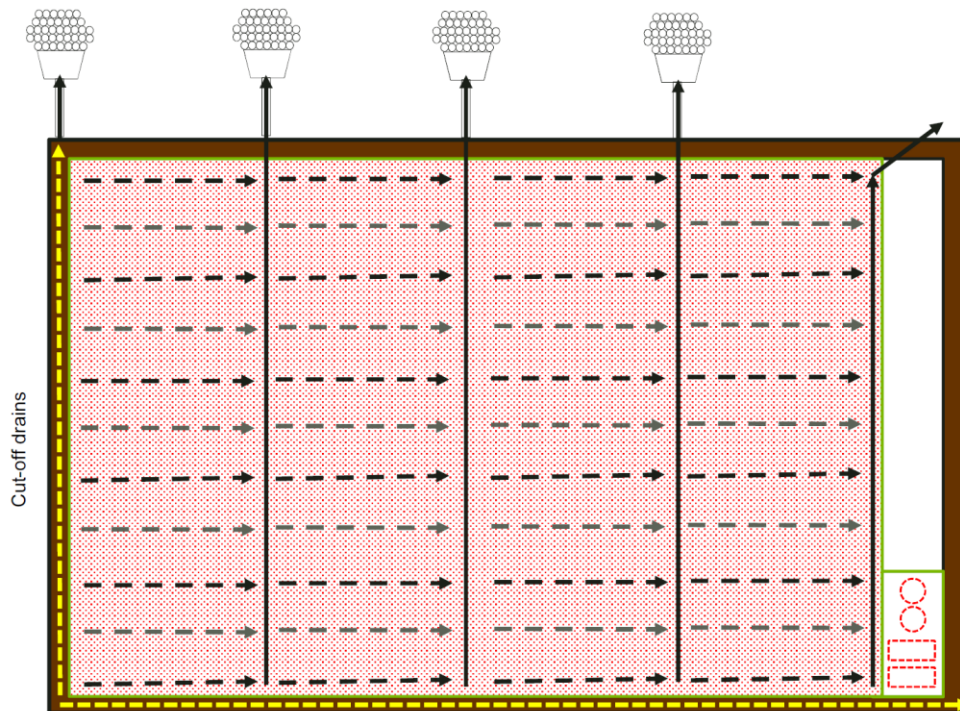
**Figure 13: A typical drainage scheme**

The topography would determine the actual placement of drainage spines (indicated as solid lines in Figure 13) and as such a detailed survey is required to correctly place the drainage spines. Cross drainage in the form of v-drains should be provided (indicated as dashed lines in Figure 13) to intercept overland flow and to direct this to the spines. The cross drainage would also assist with erosion control. These v-drains can take the form of road side drains and should be lower than the surrounding area to intercept flows. The channels can be compacted earth channels but would require maintenance on a regular basis and after each rainfall event due to possible scouring. A typical channel size is 300 mm deep, v-shaped. This could, for example, have a left side slope of 1:1 and right side slope of 1:3 when water enters the channel from the right side and flows down the channel. The general slope of the surrounding ground would be right to left.

Erosion around concrete plinths and supporting structures is a concern and is dependent on the erodibility of the material. It is recommended that the surfaces around plinths be compacted with graded gravel and a 38mm gravel capping. Erosion protection in the form of rip-rap with average diameters of 200 mm would be required at the drain outfalls from the solar facilities for a distance of no less than 12 m (Figure 13).
