Boegoeberg Hydro-power Project

Botanical Assessment for Boegoeberg Hydro-power Project at Boegoeberg Dam on the Orange River, near Groblershoop, Northern Cape Province

PROPOSED HYDROPOWER STATION AND ASSOCIATED INFRASTRUCTURE AT BOEGOEBERG DAM ON THE ORANGE RIVER, NEAR GROBLERSHOOP, NORTHERN CAPE

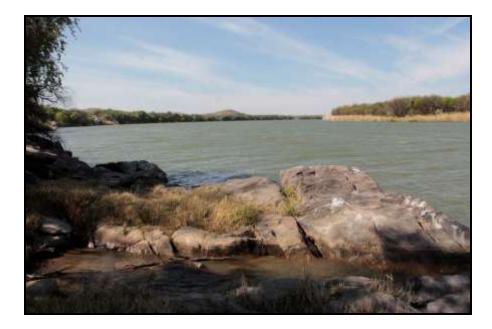
In the study area Lower Gariep Alluvial Vegetation is found at the proposed off-take or abstraction point for the Boegoeberg Hydro-power installation and lining the river banks along the Orange River on the east and west sides above and below the Boegoeberg weir (Figure 7). In the area of the proposed off-take or abstraction point the Lower Gariep Alluvial Vegetation is almost a monotypic stand of *Searsia pendulina*, with occasional occurrence of *Ziziphus mucronata*.

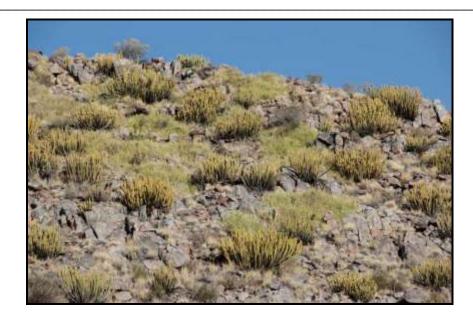
Figure 8. Lower Gariep Broken Veld with the characteristic Euphorbia avasmontana.

The vegetation of the Lower Gariep Broken Veld is sparse, dominated by shrubs and dwarf shrubs with perennial grasses. Annual species are more prominent in spring. Tall *Aloe dichotoma* var. *dichotoma* is found as scattered isolated individuals or groups with the ubiquitous blackthorn or swarthaak (*Vachellia mellifera* subsp. *detinens*) being a prominent feature. *Euphorbia avasmontana* is also characteristic of this vegetation type (Figure 8). A list of important plant taxa is provided by Mucina *et al.* (2006).

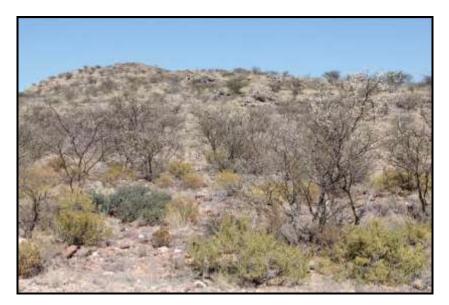
Figure 9. Bushmanland Arid Grassland with low trees of Vachellia mellifera subsp. detinens.

Bushmanland Arid Grassland (Figure 9) is much more widespread than either of the other vegetation types which occur in the study area. It occurs over a wide expanse in the Northern Cape Province from the Bushmanland Basin in the south to the vicinity of the Orange River in the north and from Prieska in the east to Aggeneys in the west (Mucina *et al.* 2006). In the study area it interleaves with Lower Gariep Broken Veld and has numerous plant species in common with the latter type.

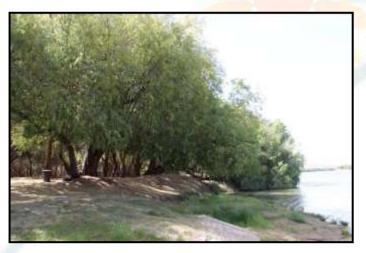
Figure 12. Searsia pendulina lining the east bank of Boegoeberg Dam where the off-take structure would be located.

Only small areas of Lower Gariep Alluvial Vegetation and Lower Gariep Broken Veld would be affected by the Boegoeberg Hydro-power plant. The Lower Gariep Alluvial Vegetation is represented by only *Searsia pendulina* in the area of the 'off-take' to the hydro-power plant (waypoint BBD4) (Figure 12). *S. pendulina* is a common species with low botanical sensitivity. No other species with high conservation value such as *Euclea pseudebenus* (Cape ebony) or *Vachellia erioloba* (camel thorn tree) were found in the area. Along the access road to the site numerous trees of *S. pendulina* and *Ziziphus mucronata* (blinkblaar wag-'n-bietjie) trees would have to be cut and trimmed to provide access for vehicles and equipment (waypoint BBD3) (Figure 13). Once the construction is complete, these trees would coppice or re-sprout from the cut surfaces and they would not suffer any permanent damage. The access road to the sould not adversely affect any vegetation. It must be emphasized that impacts on (loss of) Lower Gariep Alluvial Vegetation would be minimal and **Low negative**.

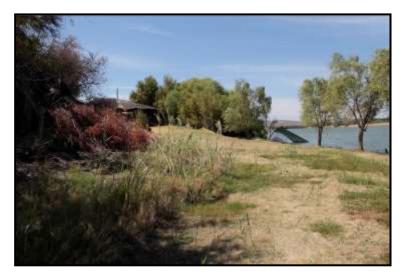
Figure 14. The east bank of Boegoeberg Dam close to the weir. This area which is covered with grass and not botanically sensitive would be excavated for the off-take canal (View southwards).

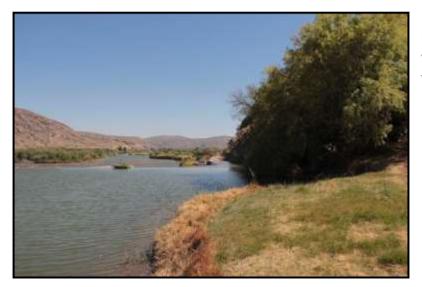
Figure 15. View northwards over the Boegoeberg weir (mid-ground) with vegetated bank on the east side that would be excavated for the off-take canal.

To allow for construction of the off-take canal or pipeline the side of the hill or koppie adjacent to the east side of the Boegoeberg weir would be excavated for building a canal (one alternative) or tunnelled (second and preferred alternative). If the canal option is pursued the vegetation on the west part of the koppie would be lost. Most of the vegetation is not sensitive, however, a number of *Boscia albitrunca* (Shepherd's tree; Witgatboom) trees (a protected species) (Alias, Milton, Herrmann & Seymour, 2003) would be lost depending on the construction method. It is estimated that in the order of eight (8) *B. albitrunca* trees would need to be removed, for which a permit would be required from the Department of Agriculture, Forestry & Fisheries (DAFF). A tree of *Ficus cordata* (Namaqua rock fig) growing on the west face of the koppie would also be lost, however, this species is not rare or protected. If the tunnel option is implemented the loss of vegetation would be greatly reduced.

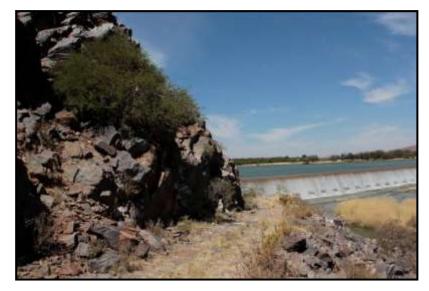
Figure 18. The Boegoeberg weir with DWA access track and koppie on the east side. The small green tree amongst the rocks is *Boscia albitrunca*.

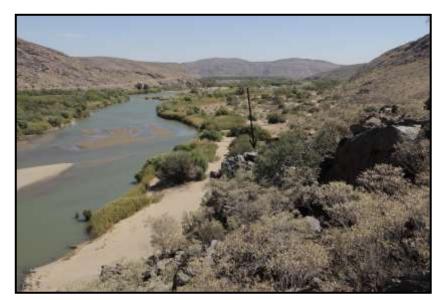
Figure 19. View northwards from the summit of the koppie on the north side of Boegoeberg Dam. The reaches of the Orange River below the dam are seen with the proposed power-house, transformer yard, switch-room to be located approximately in the position indicated by the black arrow.

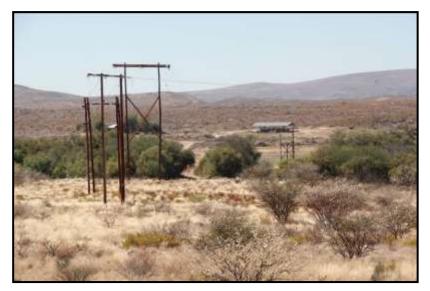
Figure 20. View from the gravel road on the west side of Boegoeberg Dam, looking eastwards over the Orange River along the existing Eskom powerline route to Rugbreek Boerdery at Zeekoebaart 306 on the east side of the river.

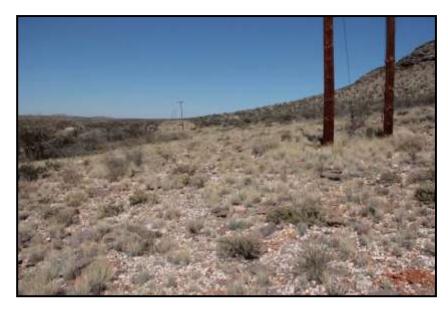
Figure 21. The Eskom transmission lines on the west side of the gravel road from Boegoeberg Dam (west) southwards. Note how the servitude has been cleared of tall shrubs and small trees, notable *Vachellia mellifera* subsp. *detinens* (blackthorn; swarthaak).

A transmission line servitude (Eskom) exists on the west side of the gravel road for 3.17 km southwards before its crosses the road at S 29° 05' 48.77" E 22° 12' 13.25". The servitude is kept clear of tall shrubs and low trees such as *Vachellia mellifera* subsp. *detinens* (Figure 21).

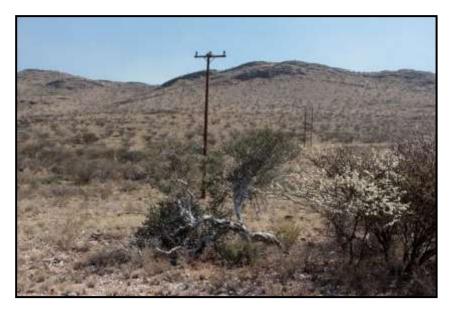
Figure 22. The Eskom power-line with old *Boscia albitrunca* tree in the foreground. These trees must be avoided since they are protected.

However, where *Boscia albitrunca* trees are found they have been left untouched (Figure 22). The Bushmanland Arid Grassland has low botanical sensitivity apart from the presence of protected *B. albitrunca* trees. It would be prudent to construct the proposed new transmission line in the same servitude on the west side of the road to the point where it crosses, to minimize further clearing of low trees. A new servitude would be required (west of the road) from S 29° 05' 48.77" E 22° 12' 13.25" to the entrance to Greeffsput. It would require that all *B. albitrunca* trees should not be removed or damaged. However, since the density of these trees is not great, it should be possible with little or no difficulty to avoid them.

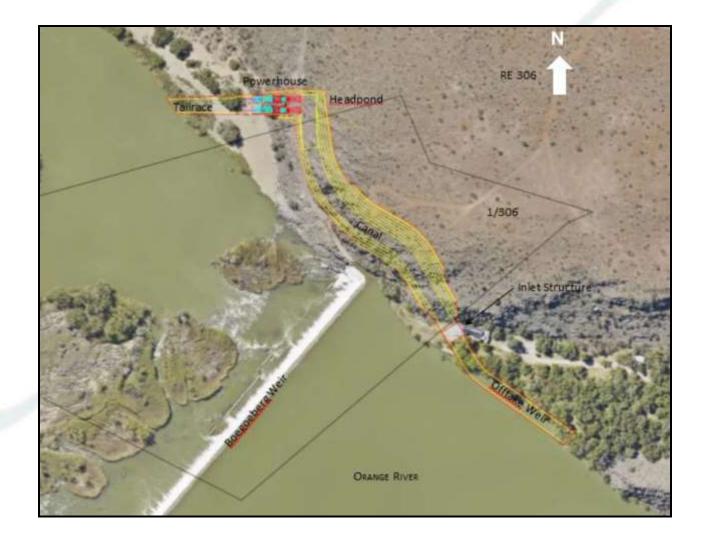
Figure 26. Aerial view of the proposed hydro-power infrastructure at Boegoeberg Dam on the farm Zeekoebaart 306 (Source: Boegoeberg Hydro-Power Final Scoping Report, Aurecon)

Owing to the design requirements of the Boegoeberg Hydro-power plant, only one site alternative is possible i.e. the location on the east side of the Boegoeberg weir as shown in Figure 26.

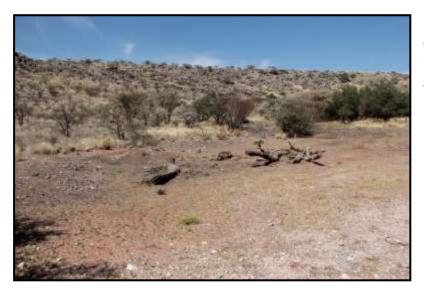
Figure 27. The proposed site for the construction camp which is already impacted by disturbance from agricultural activities.

A construction camp with site office, crusher etc. and temporary accommodation for personnel would be located at a site indicated by waypoint BBD5 [S 29° 2'25.44" E 22°12'26.77") [Figure 11a]. The latter site is already disturbed (Figure 27) and is an ideal site for the proposed temporary construction camp.
