BASIC ASSESSMENT FOR THE GUNSTFONTEIN BATTERY ENERGY STORAGE SYSTEM  
(BESS), NORTHERN CAPE PROVINCE:

**FAUNA, AVIFAUNA & FLORA BASIC ASSESSMENT SPECIALIST REPORT**

**September 2020**

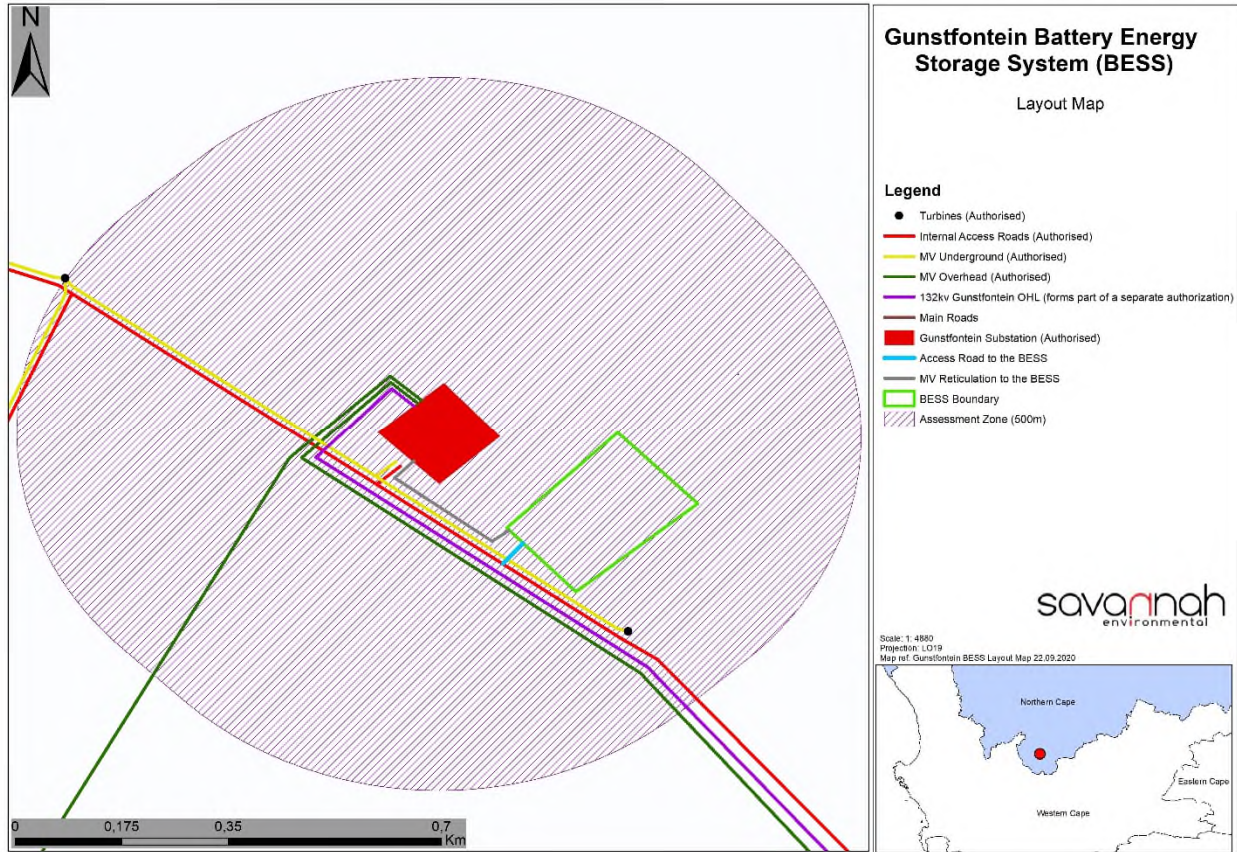
**Figure 1.** Map showing the location of the BESS 500m assessment area with the preliminary location of the BESS footprint adjacent to the substation within the Gunstfontein WEF area.

The BESS would be located near to (within 500m of) the approved Gunstfontein Wind Farm substation, and would be approximately 5ha in total extent. MV cabling (33kV or less) will connect the BESS to the adjacent substation. The MV cabling may be overhead or below-ground.

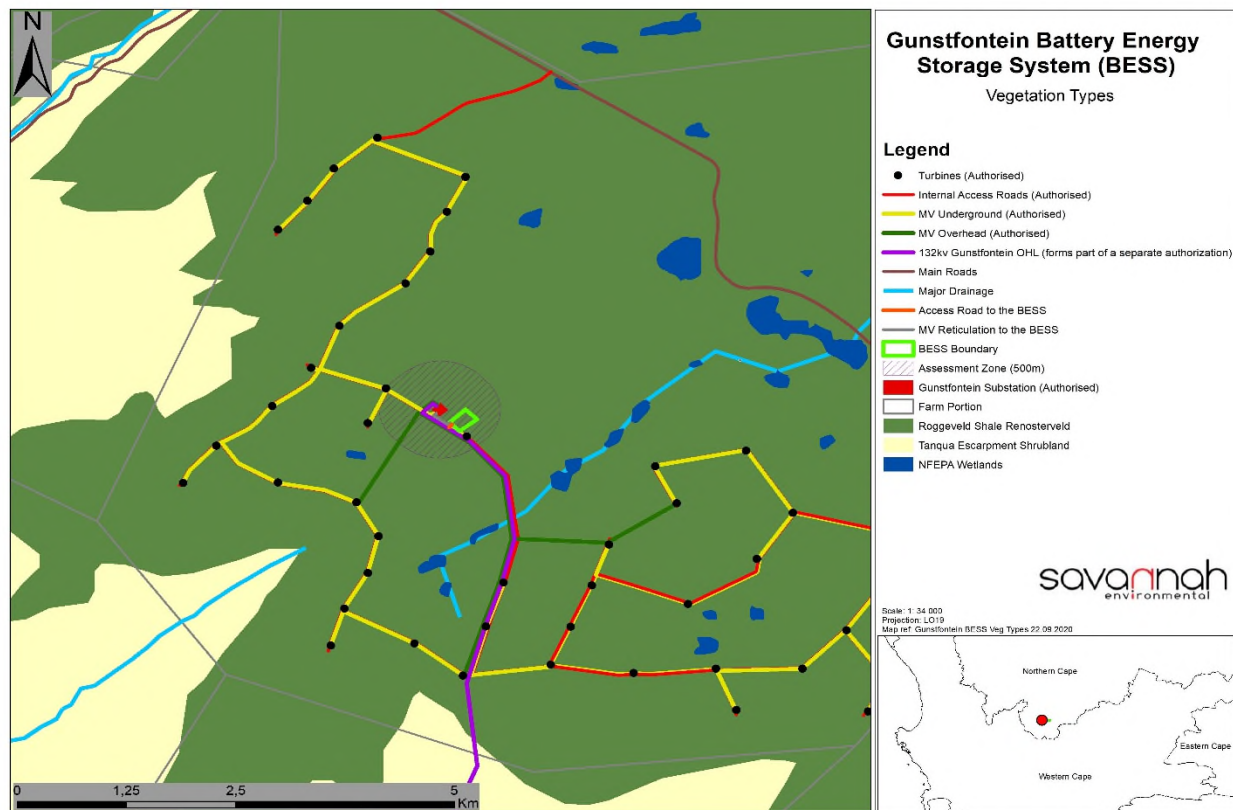
**Figure 2.** Broad-scale overview of the vegetation in and around the Gunstfontein substation and BESS study area. The vegetation map is an extract of the national vegetation map (Mucina & Rutherford 2006 & 2018 update) and also includes drainage lines delineated by the NFEPA assessment (Nel et al. 2011).

According to the national vegetation map (Mucina & Rutherford 2006/2018), there are two within the affected area Roggeveld Shale Renosterveld and Tanqua Escarpment Shrubland (Figure 2). The BESS 500m assessment region is however restricted entirely to the Roggeveld Shale Renosterveld vegetation type. Roggeveld Shale Renosterveld occurs in the Northern and Western Cape and occupies the majority of the Roggeveld from the Western edge of the Great Escarpment mostly above the Tanqua Basin, reaching as far east as the higher-lying areas of the Teekloof Pass south of Fraserburg along the northwest summit plateaus of the Nuweveldberge. It occupies undulating, slightly sloping plateau landscapes, with low hills and broad shallow valleys supporting mainly moderately tall shrublands dominated by renosterbos with a rich geophytic flora in the wetter and rocky habitats. It occurs mostly on mudrocks and sandstones of the Adelaide Subgroup. The land types present are mostly Fc and Da. Mucina & Rutherford (2006) list 12 endemic species for this vegetation type, which is a large number given that the total extent of the vegetation type is only 2917 km<sup>2</sup>.

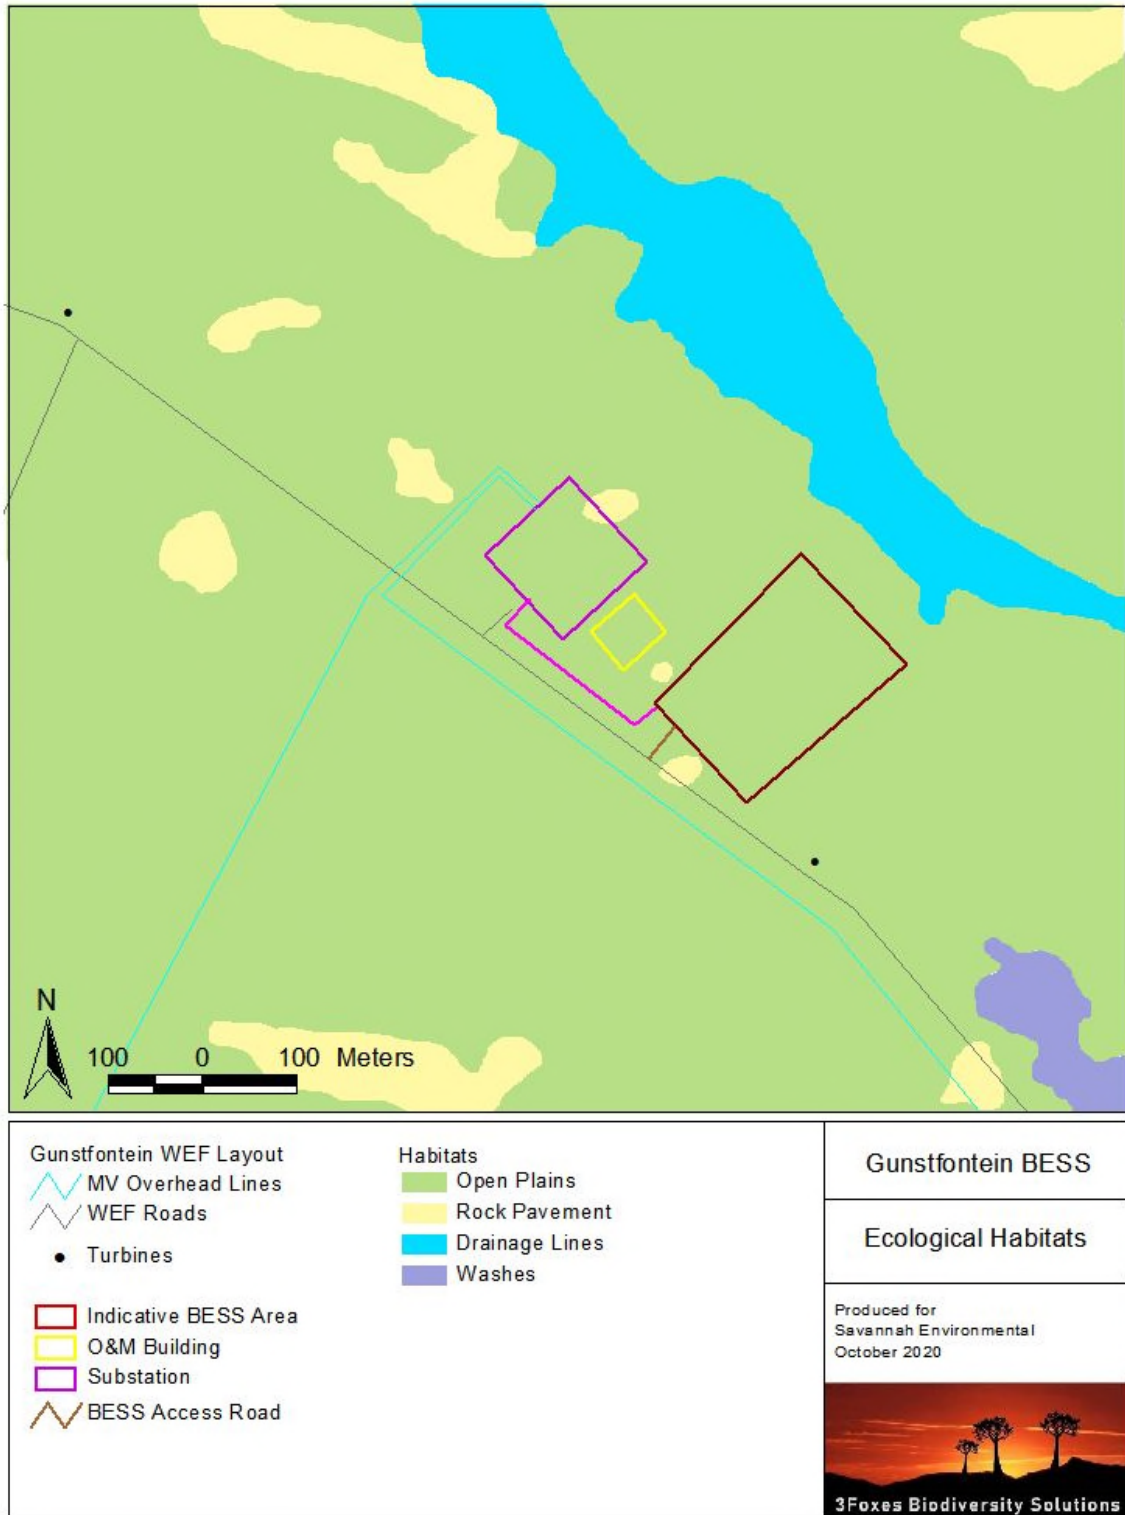
**Figure 3.** Ecological habitats observed within the Gunstfontein BESS 500m assessment region (entire frame) and which are described in detail below.

The area around the approved substation site for the Gunstfontein WEF consists of typical Roggeveld Shale Renosterveld. There are however several different habitats present within the 500m assessment region around the substation site which are illustrated and described below (Figure 3).

The majority of the BESS area consists of Roggeveld Shale Renosterveld typical of the Sutherland Plateau area. The soils are fine-textured but sandy soils and are generally quite shallow with several areas of exposed bedrock within the BESS area. There are also a few areas of deeper soils which can be recognized by their somewhat taller vegetation. Typical and dominant species observed within the BESS study area include *Euryops lateriflorus*, *Dimorphotheca cuneata*, *Selago saxatilis*, *Rosenia oppositifolia*, *Pteronia tricephala*, *Pentzia punctata*, *Euryops annae*, *Dicerotheramnus rhinocerotis*, *Ehrharta calycina*, *Ehrharta eburnea* (NT), *Senecio erosus*, *Romulea tortuosa* subsp. *tortuosa*, *Asparagus capensis*, *Euryops multifidus*, *Poa bulbosa*, *Oxalis obtusa*, *Berkheya spinosa*, *Chrysocoma ciliata*, *Romulea atrandra* var. *atrandra*, *Colchicum coloratum* subsp. *burchellii*, *Othonna auriculifolia*, *Diospyros austro-africana*, *Oxalis melanosticta* var. *melanosticta* and *Oxalis pocockiae*.

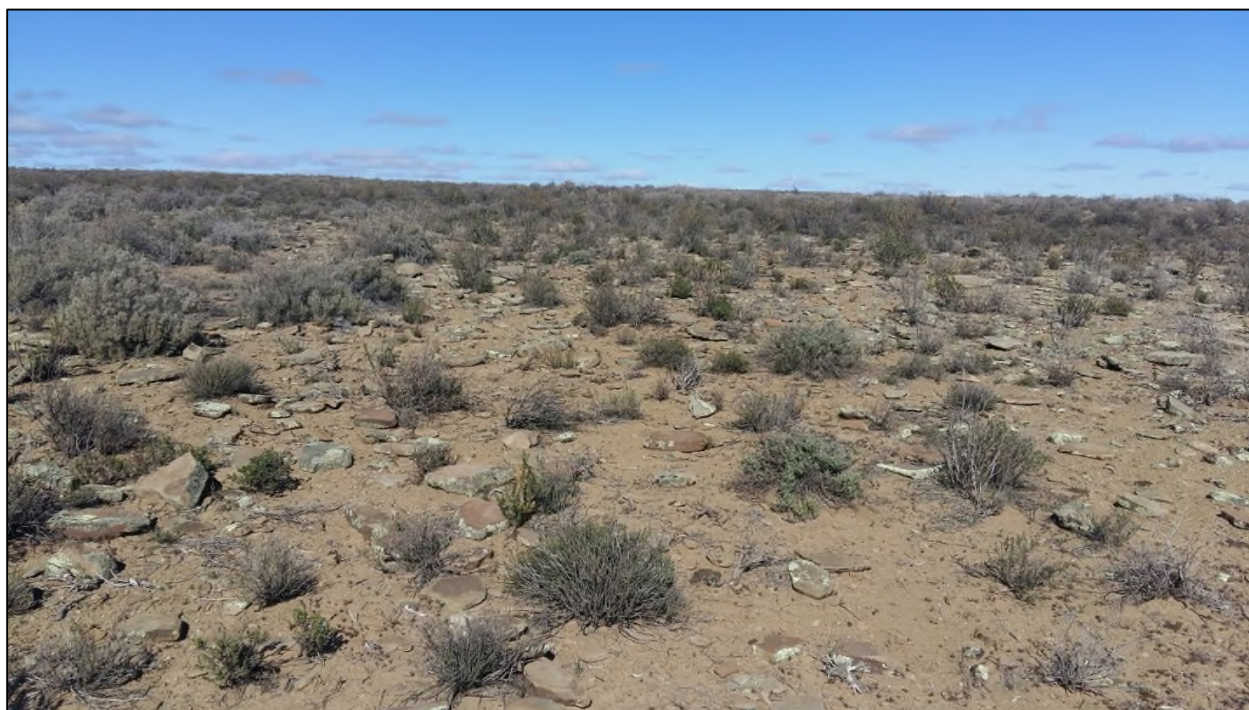
**Figure 4.** The typical Roggeveld Shale Renosterveld on shallow soils within the BESS 500m study region. This habitat is considered relatively low sensitivity and is considered acceptable for the location of the BESS.

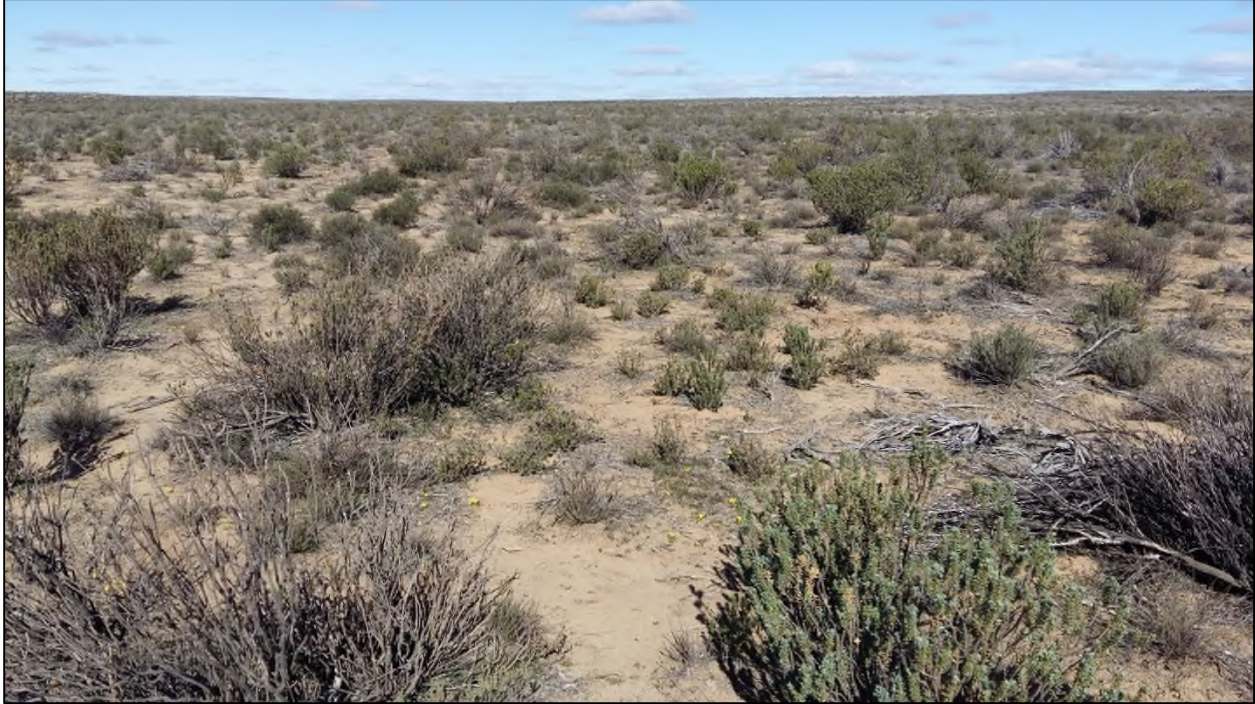
**Figure 5.** Roggeveld Shale Renosterveld on deeper soils within the BESS study area, with taller shrubs dominated by *Euryops lateriflorus*.

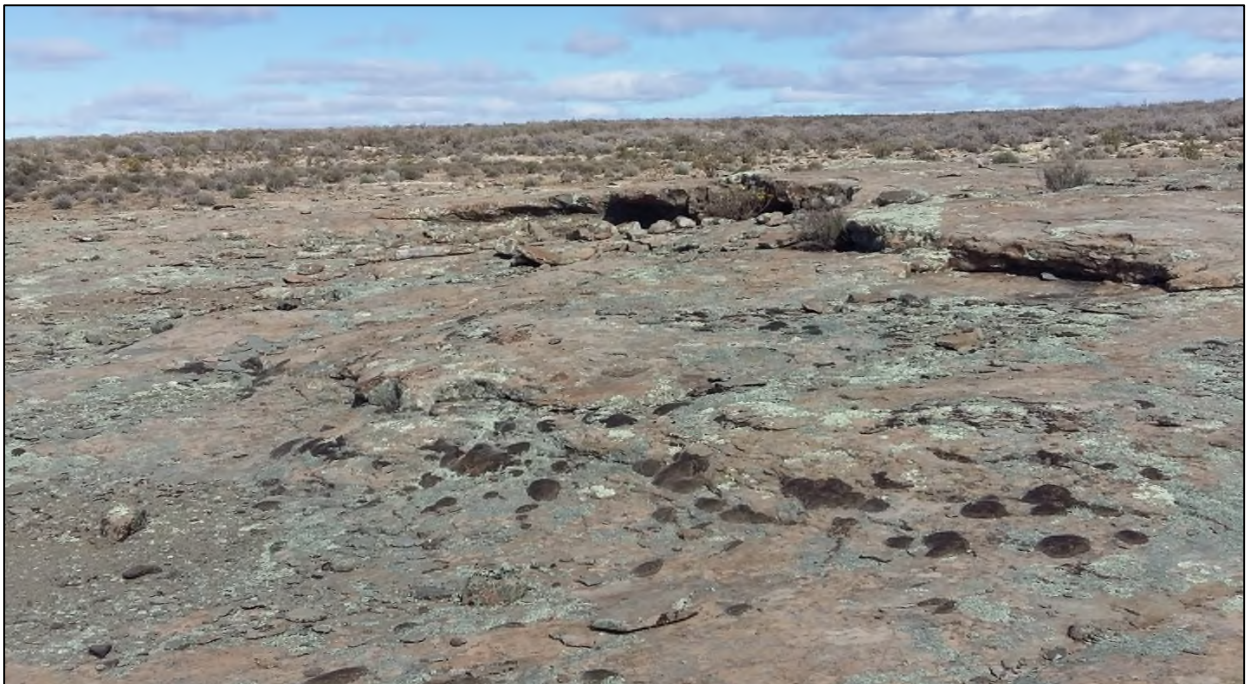
**Figure 6.** There are several areas of exposed bedrock within the BESS study area. Although there is very little vegetation associated with these areas and they are not considered important from a botanical point of view, they were observed to be a relatively important local habitat for reptiles and other fauna which prefer rocky habitats.

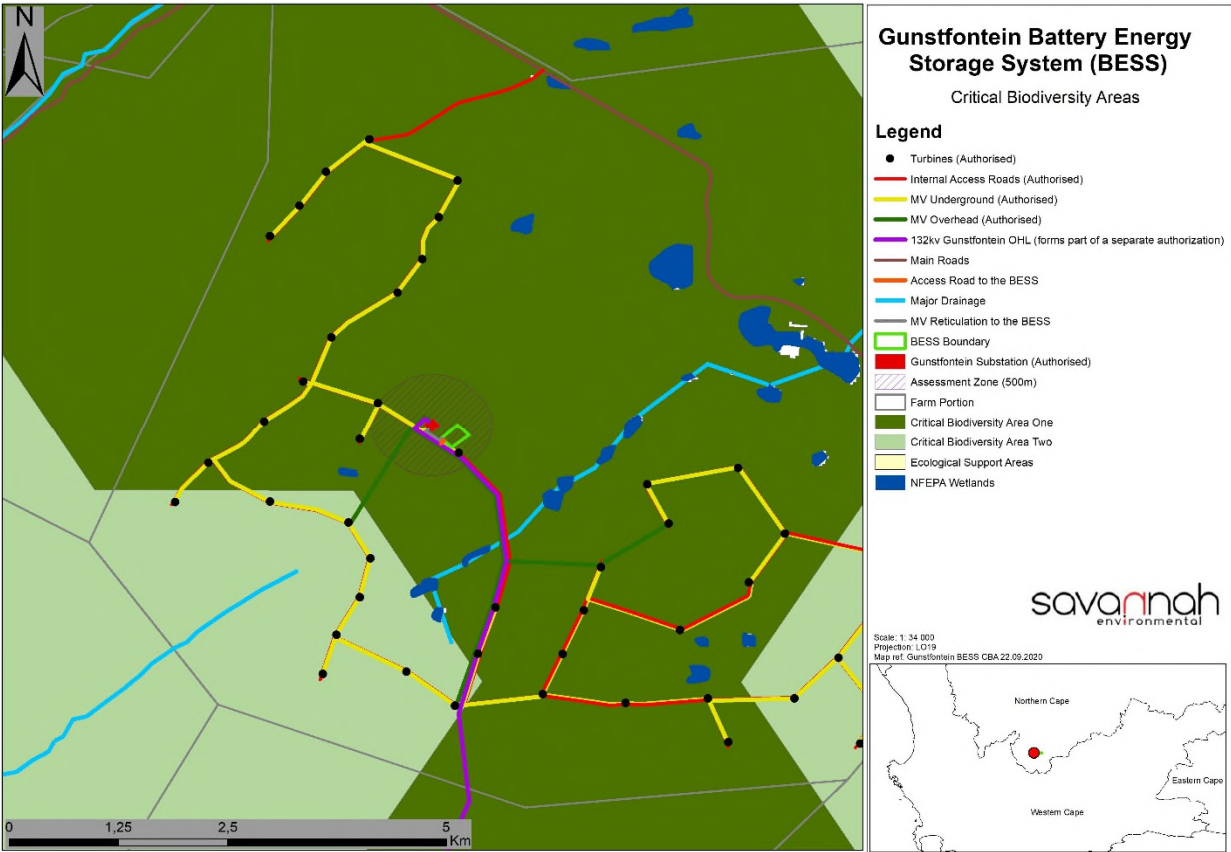
Figure 8. Extract of the Northern Cape Critical Biodiversity Areas map for the broader study area around the Gunstfontein BESS, showing that the BESS occurs within an area classified as CBA 1.

An extract of the Northern Cape Critical Biodiversity Areas map for the broader study area is depicted below in Figure 8. The entire BESS study area falls within an area classified as CBA 1. Development within CBAs is undesirable and can potentially lead to loss of biodiversity and negatively affect ecological processes. The impact of the current proposed BESS would be mediated by the proximity of the BESS to the facility substation and the low overall footprint of the BESS.

The loss of an additional ~5ha of habitat near to the approved substation would be very unlikely to compromise the ecological functioning of the affected CBA in any way. A summary of the underlying features associated with the CBA within the site is provided below in Table 1. It is important to note that apart from the process and representivity roles of the CBAs, the features of concern underlying the CBAs are not located within the 500m assessment zone, as these features are well outside of the 500m assessment region. In terms of the representivity of vegetation types, only Roggeveld Shale Renosterveld is within the site and the loss of less than 5ha of this vegetation type would not be significant, especially given that the field assessment indicated that the abundance of SCC within this area was low. In terms of the process features, the development would contribute to cumulative habitat loss and fragmentation in the area to some degree, but the specific contribution of the BESS at less than 5ha would not be sufficient to significantly compromise the functioning of these broad-scale ecological processes. Given the small footprint of the BESS and the avoidance of hydrological features at the site, the impact on the BESS on water runoff quality and quantity

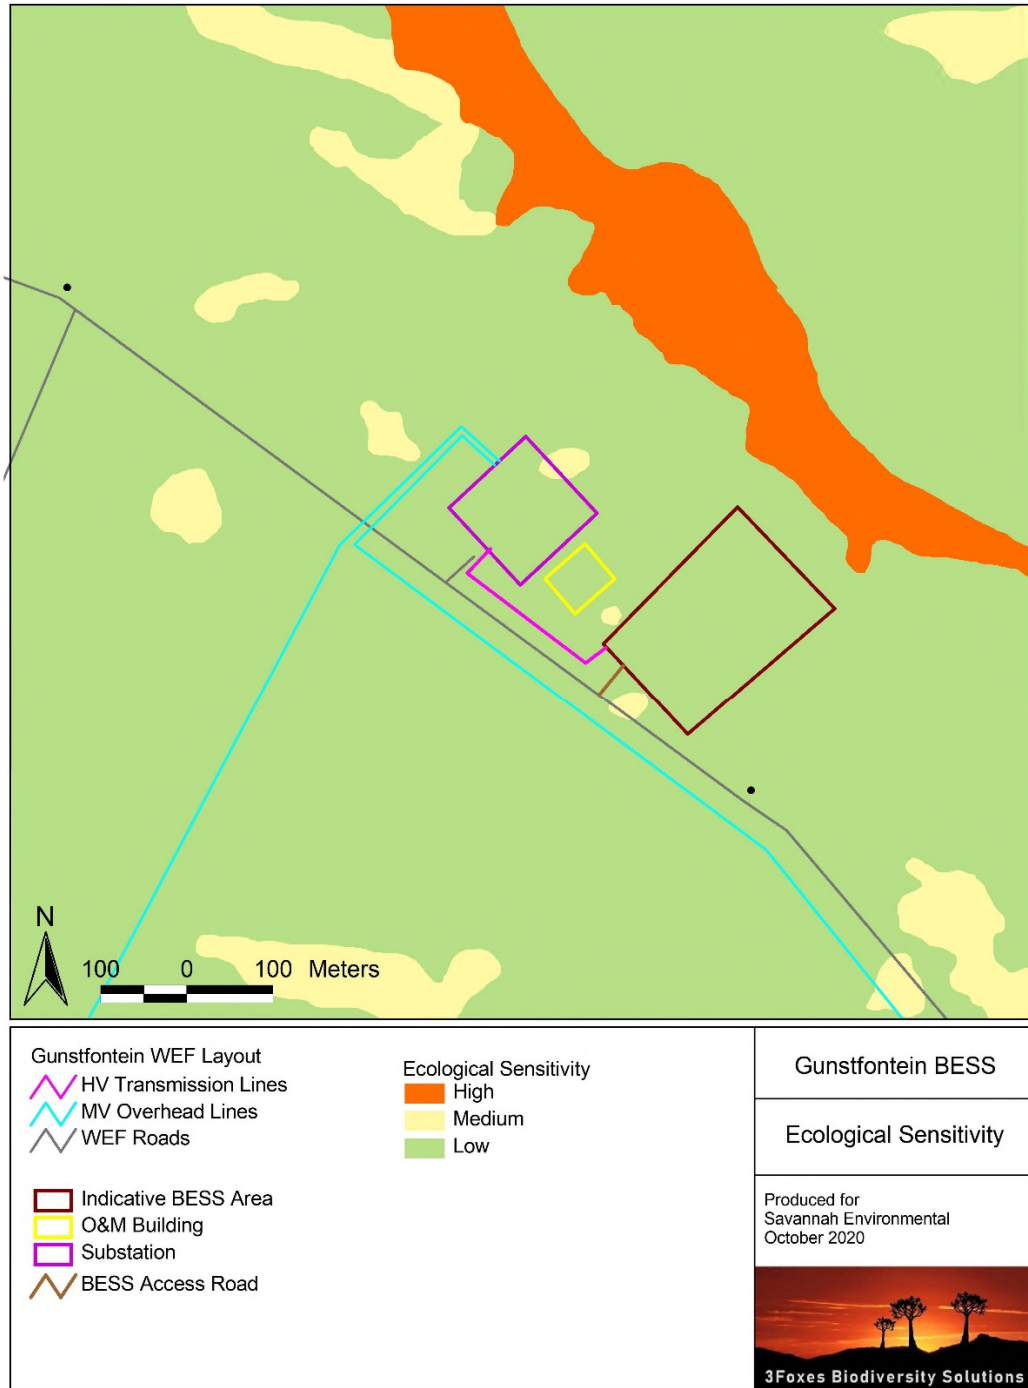
**Figure 9.** Sensitivity map for the Gunstfontein BESS 500m assessment region.

The sensitivity map for the BESS 500m assessment region is illustrated below in Figure 9. The majority of the 500m assessment region is typical, open plains Roggeveld Shale Renosterveld, considered to be low ecological sensitivity. There is however one minor drainage line within the BESS 500m assessment region that is considered to be high ecological sensitivity and unsuitable for development. There are also some areas of rock pavement distributed across the site which are considered medium sensitivity on account of the value of these areas as faunal habitat. Under the layout of the BESS provided for this assessment, the BESS would be restricted to the low sensitivity parts of the site, with the result that the impacts associated with the BESS would be low. Provided that the BESS footprint can be restricted to the low and/or medium sensitivity areas within the 500m assessment zone, the exact placement of the BESS within this area would not result in significant differences in impact. As such, the current placement is considered acceptable but alternative placements within the medium and low sensitivity areas would also be acceptable.
