Terrestrial Ecology Basic Assessment Study

99 MW Oya Wind Energy Facility (WEF) and associated
infrastructure between Sutherland and Matjiesfontein,
Western and Northern Cape Provinces

Terrestrial Ecology Walk Down Verification for the proposed 99 MW Oya Wind Energy Facility between Sutherland and Matjiesfontein in the Western and Northern Cape Provinces.

18 January 2021

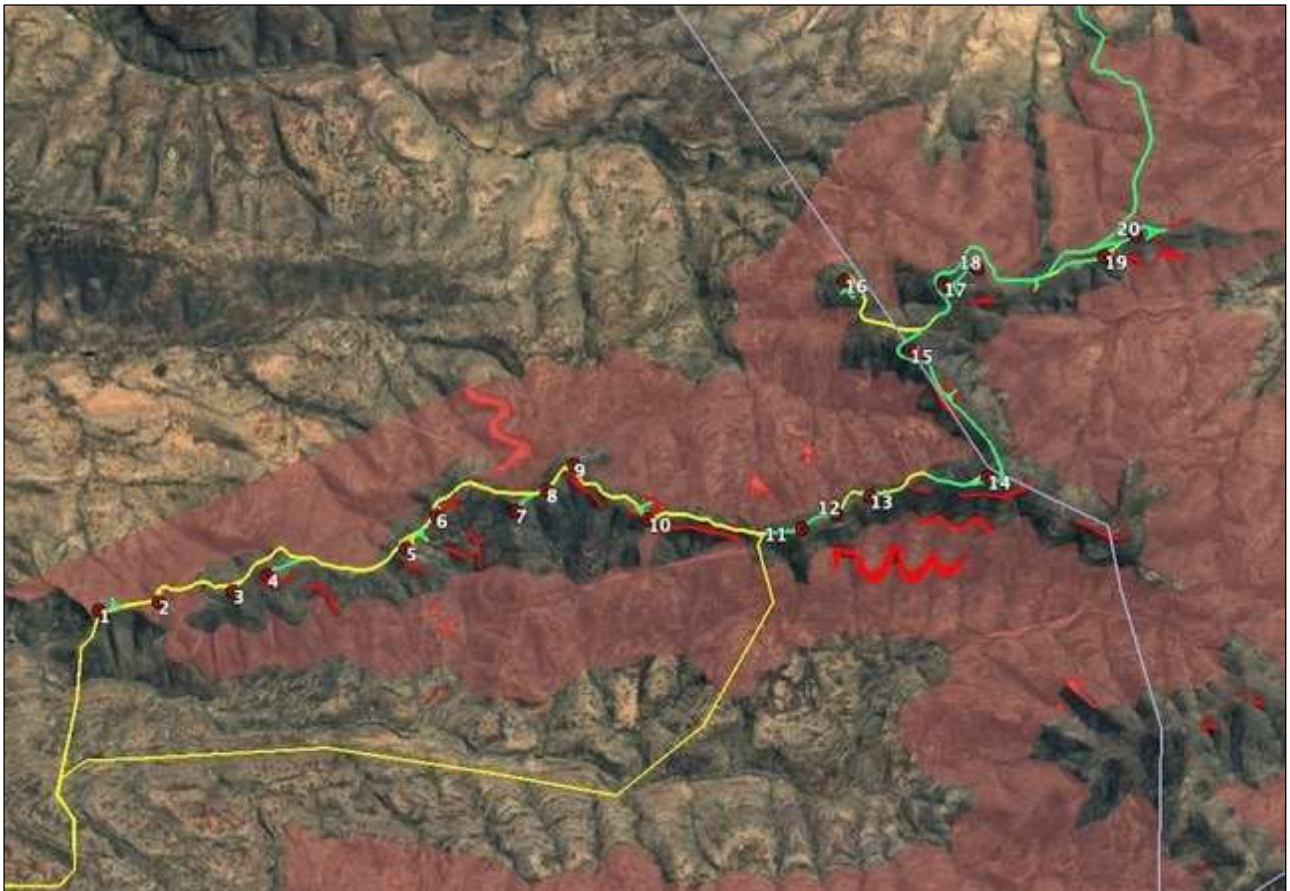
Figure 2: Location of infrastructure relative to areas of Very high and High sensitivity (Ekotrust 2018).

The proposed Oya WEF is located largely on the higher-lying Oliviersberg and Koedoesberg Mountains between Matjiesfontein and Sutherland. The proposed wind turbines are to be placed on mountain ridges that are mostly east-west orientated. The regional vegetation on the summit of these ridges is Central Mountain Shale Renosterveld, whereas the midslopes and lower-lying areas are within Koedoesberge-Moordenaars Karoo.

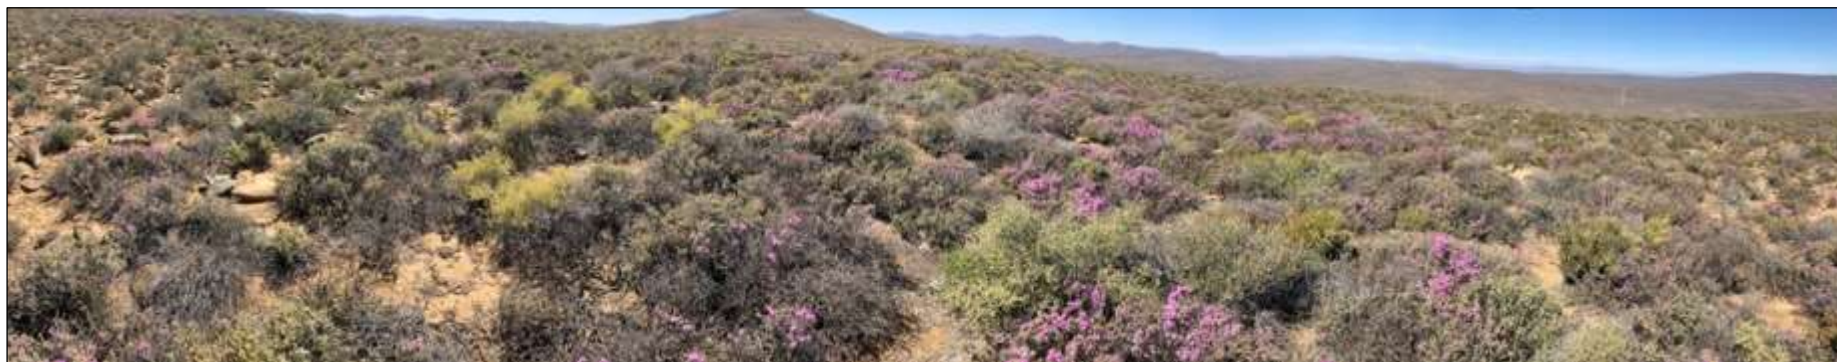
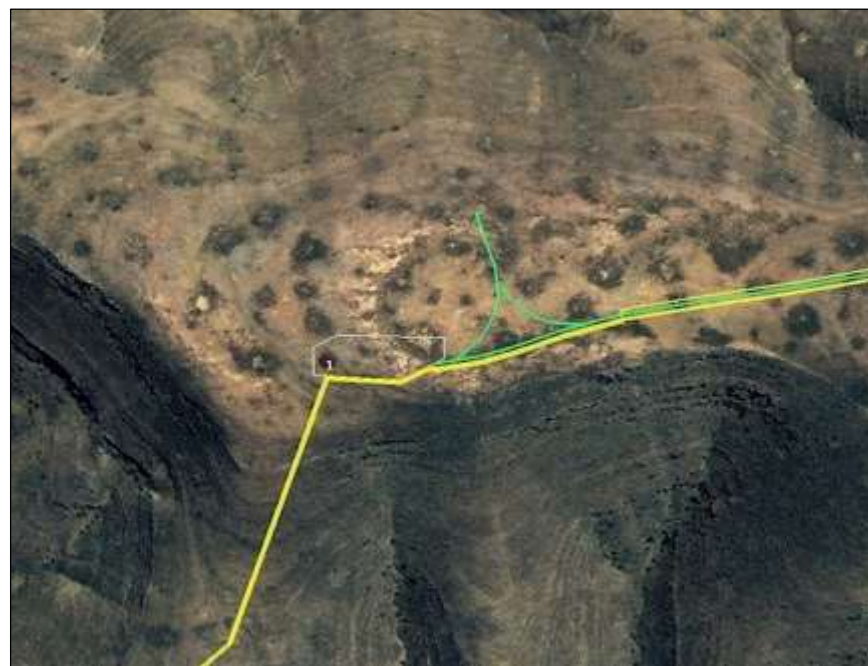
Figure 3: Panoramic view and Google Earth image of landscape at Turbine 1.

Plant species* *Aizoon cymosum*, *Aizoon africanum*, *Caroxylon aphyllum*, *Chrysocoma ciliata*, *Cotyledon papillaris*, *Crassula deltoidea*, *Crassula nudicaulis*, *Crassula subaphylla*, *Dimorphotheca* species, *Eriocephalus ericoides* (D), *Euphorbia mauritanica*, *Euphorbia rhombifolia*, *Euryops lateriflorus* (D), *Felicia filifolia*, *Indigofera meyeriana*, *Lycium cinereum*, *Manochlamys albicans*, ***Mesembryanthemum guerichianum***, ***Mesembryanthemum nitidum***, ***Mesembryanthemum noctiflorum***, ***Ruschia intricata* (D)**, ***Moraea flaccida***, ***Octopoma species***, *Pentzia incana*, *Pteronia empetrifolia* (D), *Pteronia incana* (D), *Roepera* species, *Tylecodon wallichii*

One species found within the laydown area has been tentatively identified as *Octopoma*, a genus for which all three currently recognised species are listed as Vulnerable. A more detailed assessment of this species is given on the next page. No additional habitat sensitivities identified within turbine or laydown area footprint.

There is a possible occurrence of a Vulnerable plant species within 40 m of Turbine 1. This plant (tentatively identified as *Octopoma quadrisepalum*), is on the Red List, as well as protected under the Cape Nature and Environmental Conservation Ordinance 19 of 1974. If the identity of this species is confirmed then it may be required that Turbine 1 is shifted a minimum of 90 m eastwards and that the crane pad is located to the east of the new position so as to avoid any direct impacts on this species. Alternatively, an application can be submitted for a permit to relocate the plant or destroy it, but there is no guarantee that the permit application would be approved.

On the basis of the walk down, no sensitivities have been identified within the footprint of proposed infrastructure, except for a possible occurrence of a Red List species near to Turbine 1, the identity of which needs to be confirmed before any final recommendations are made. If the identity is confirmed as a Red List species then a shift of the Turbine 1 location 100 m to the east is recommended. No other changes are required to the proposed layout.

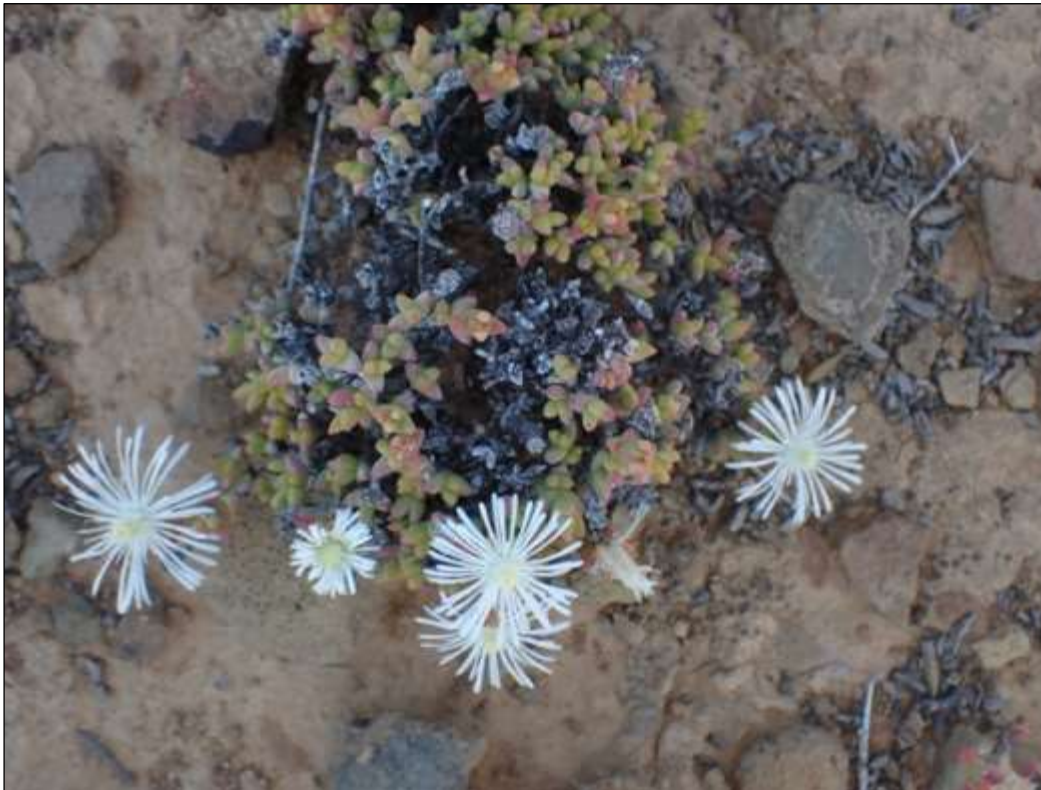
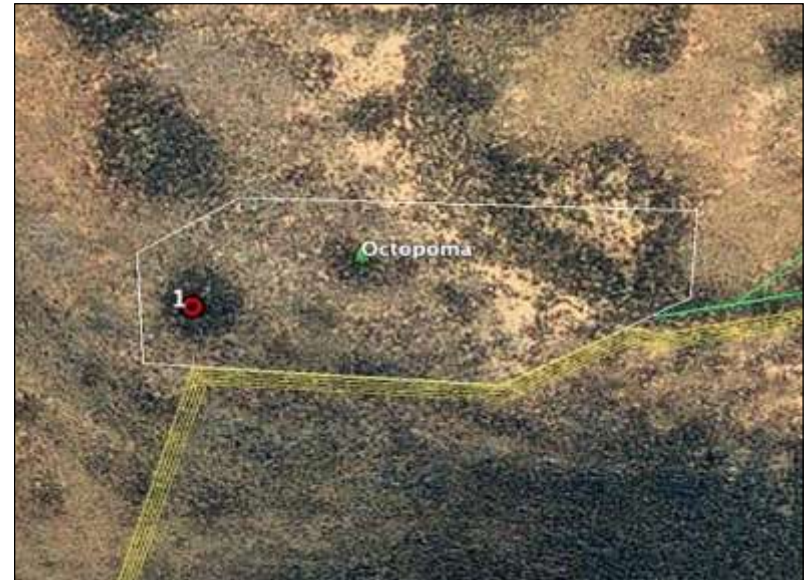
Figure 4: *Octopoma quadrisepalum* (preliminary identity), listed as Vulnerable, seen close to Turbine 1.

A plant photographed within the laydown area has been tentatively identified as *Octopoma* species. The SANBI Plants of South Africa online database (<http://newposa.sanbi.org/>) gives a current list of three recognised species of *Octopoma*, which matches a recent taxonomic review of the genus (Powell et al. 2016) in which these three species are described. All three are listed as Vulnerable (<http://redlist.sanbi.org/genus.php?genus=104>). The taxonomic consensus is therefore that if the plant observed on site is within this genus then it is listed as Vulnerable, and most probably *Octopoma quadrisepalum*.

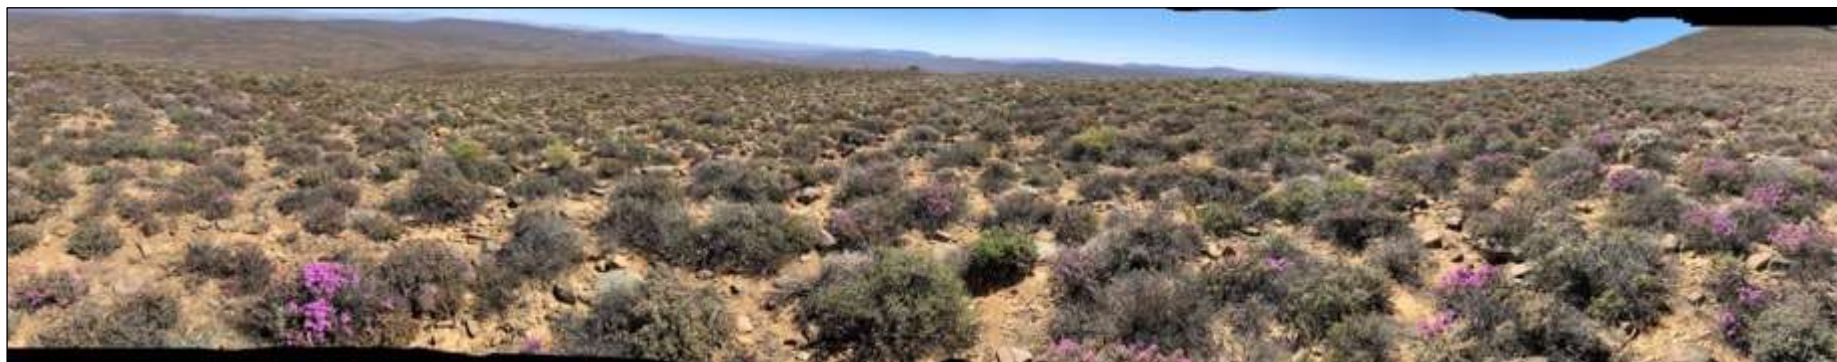
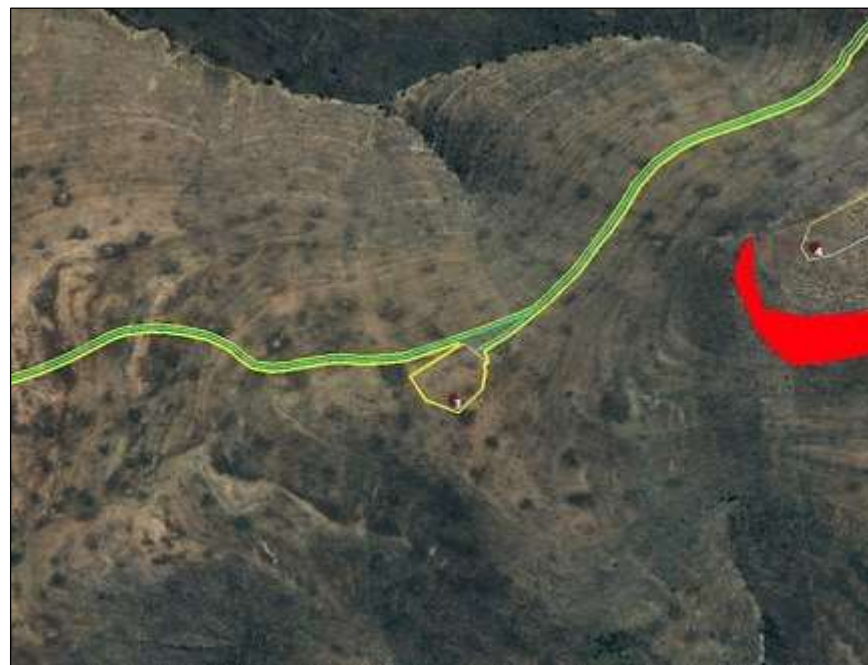
Figure 5: Panoramic view and Google Earth image of landscape at Turbine 3.

No habitat or plant species sensitivities identified within turbine or laydown area footprint.

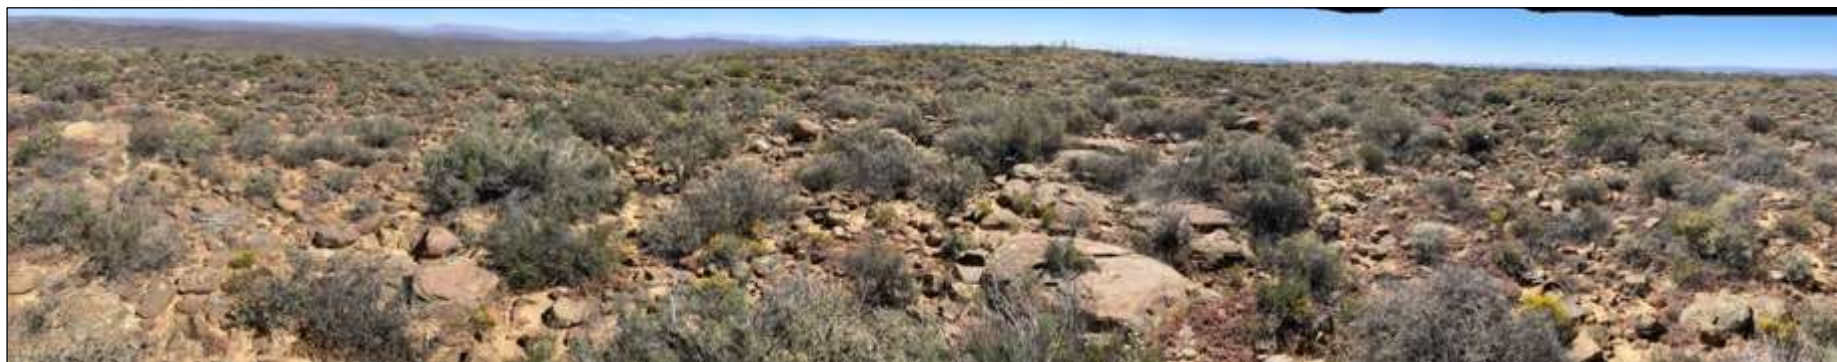
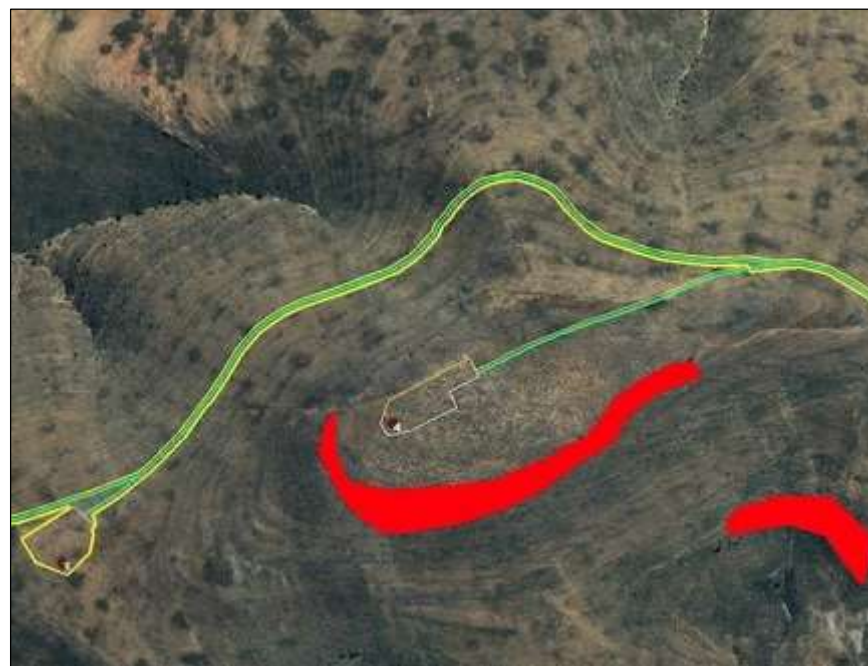
Figure 6: Panoramic view and Google Earth image of landscape at Turbine 4.

No habitat or plant species sensitivities identified within turbine or laydown area footprint.

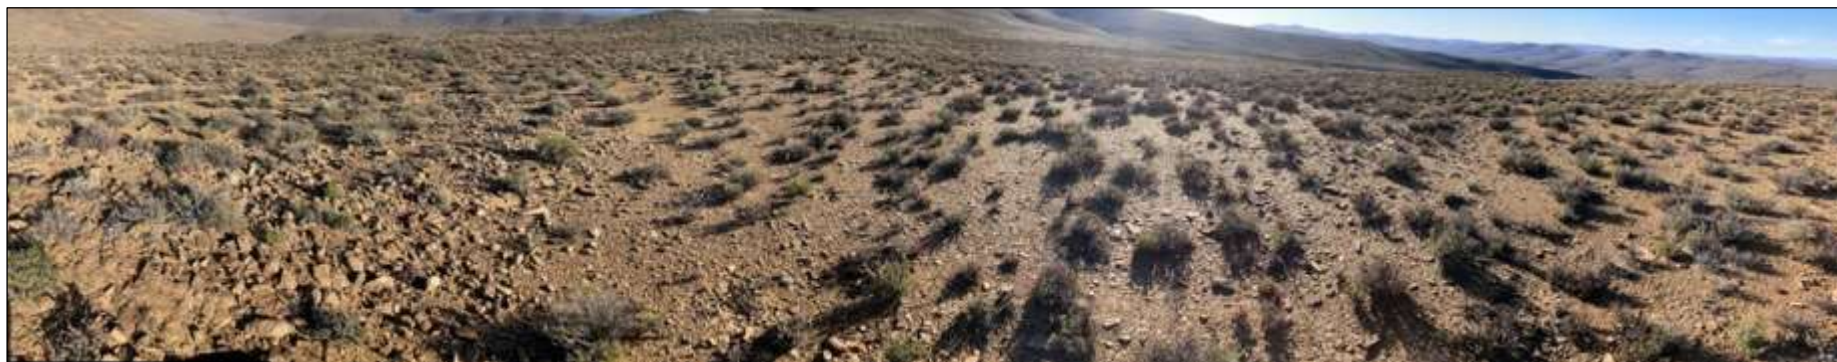
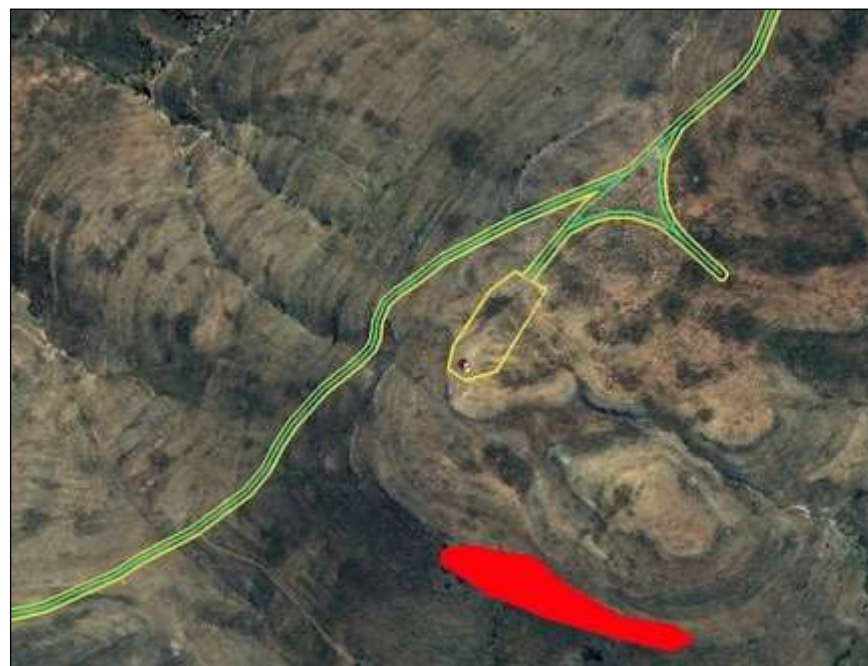
Figure 7: Panoramic view and Google Earth image of landscape at Turbine 5.

No habitat or plant species sensitivities identified within turbine or laydown area footprint.

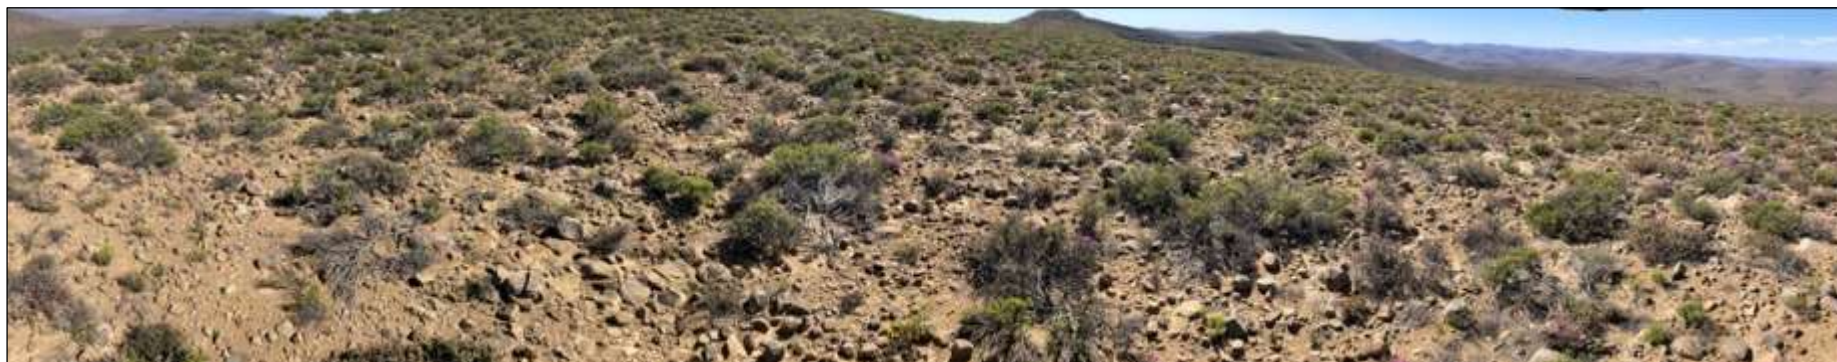
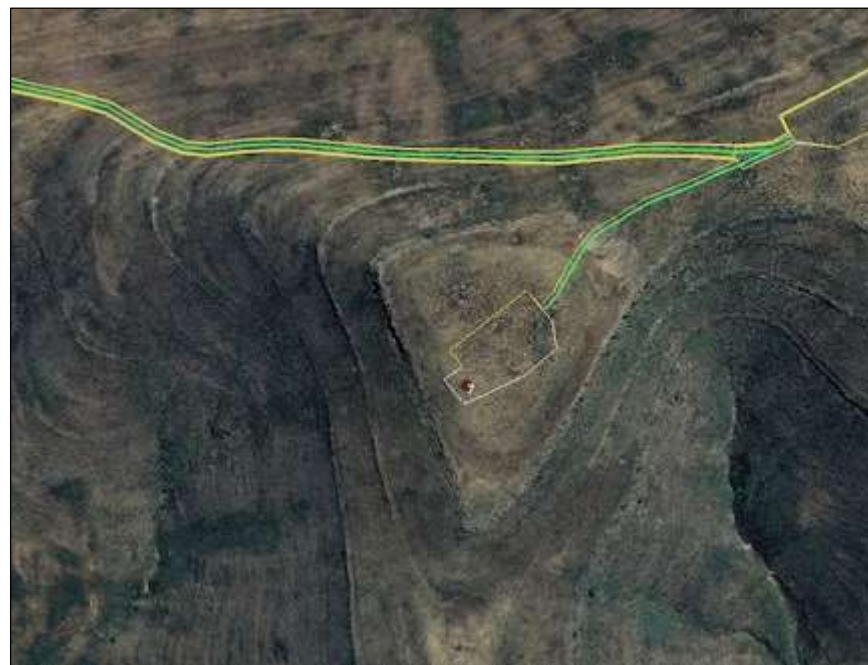
Figure 8: Panoramic view and Google Earth image of landscape at Turbine 7.

No habitat or plant species sensitivities identified within turbine or laydown area footprint.

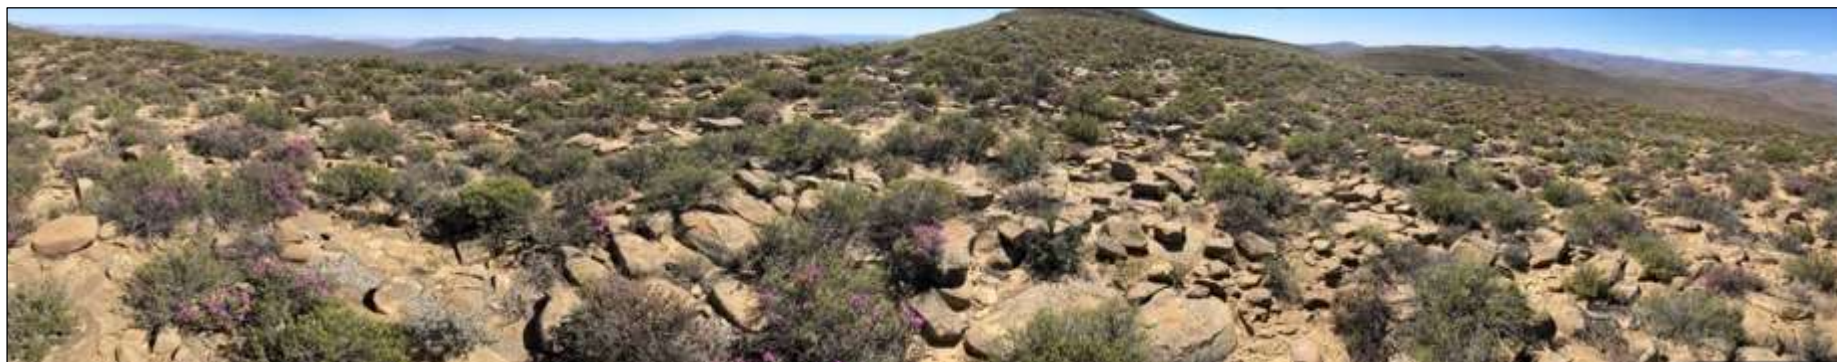
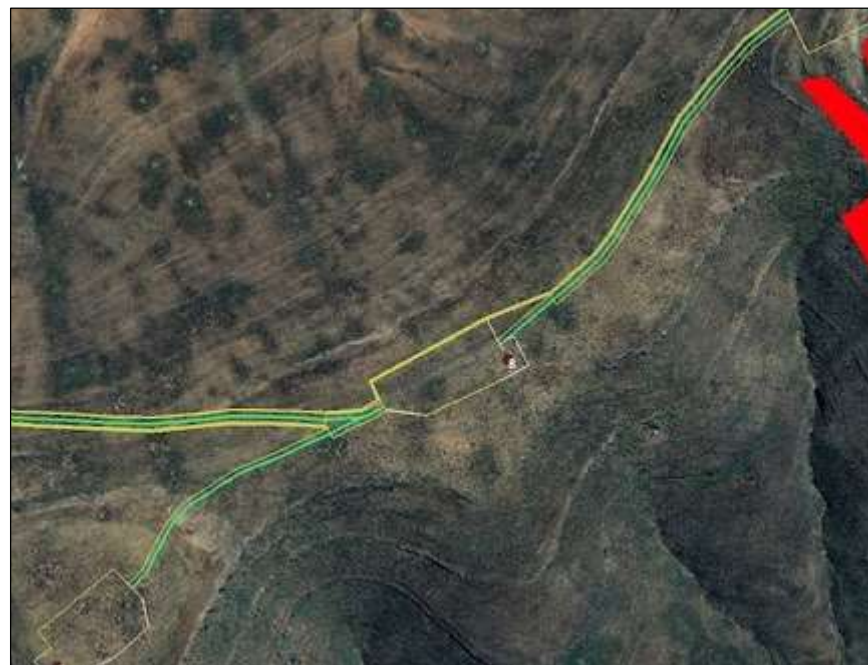
Figure 9: Panoramic view and Google Earth image of landscape at Turbine 8.

No habitat or plant species sensitivities identified within turbine or laydown area footprint.

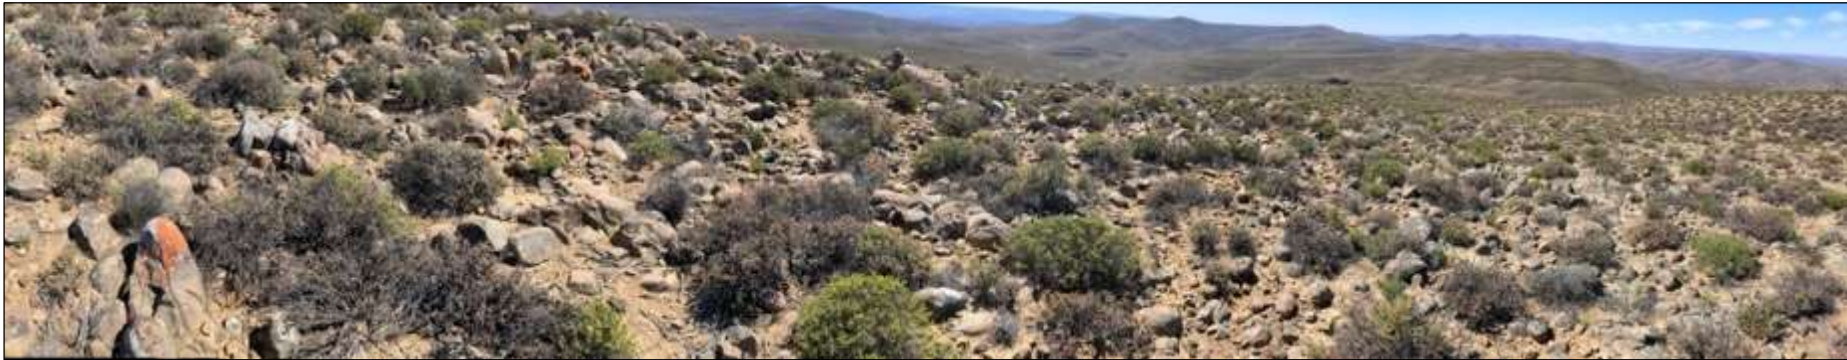
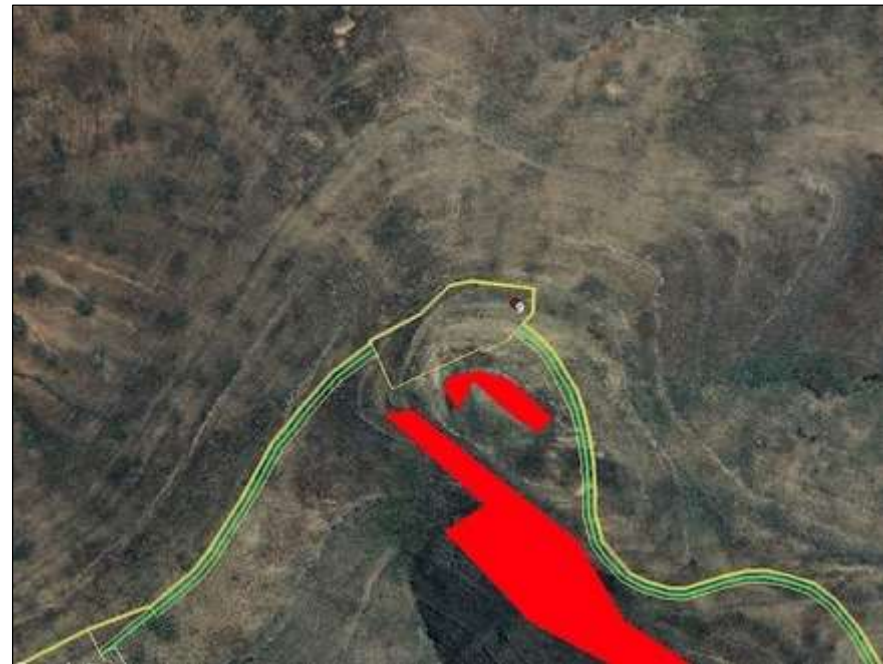
Figure 10: Panoramic view and Google Earth image of landscape at Turbine 9.

No habitat or plant species sensitivities identified within turbine or laydown area footprint.

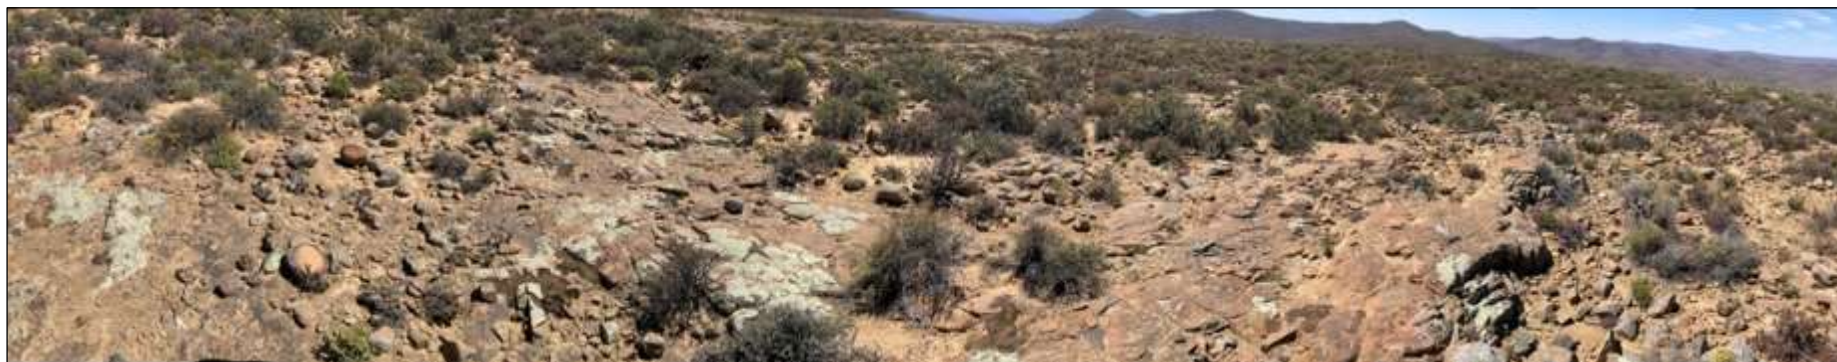
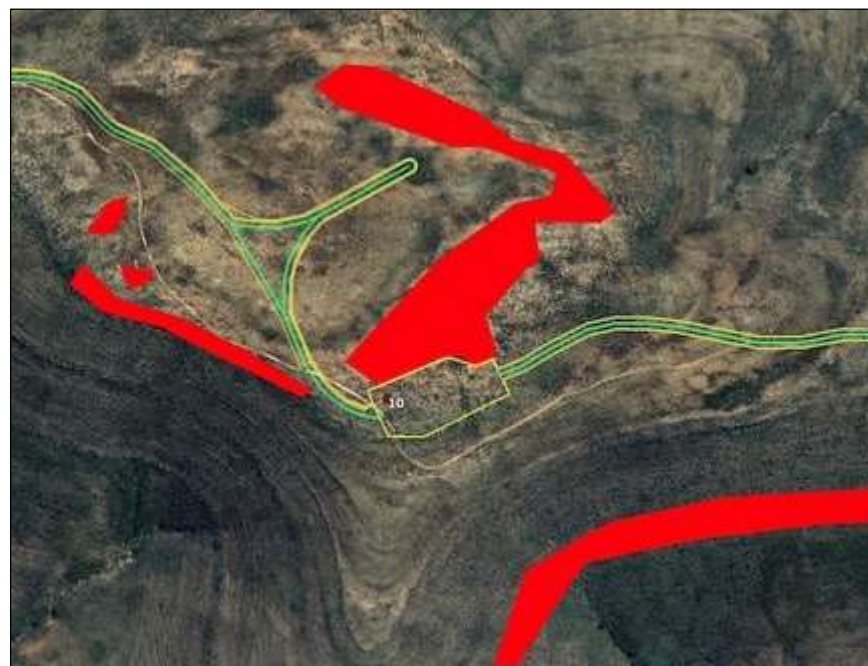
Figure 11: Panoramic view and Google Earth image of landscape at Turbine 10.

No habitat or plant species sensitivities identified within turbine or laydown area footprint.

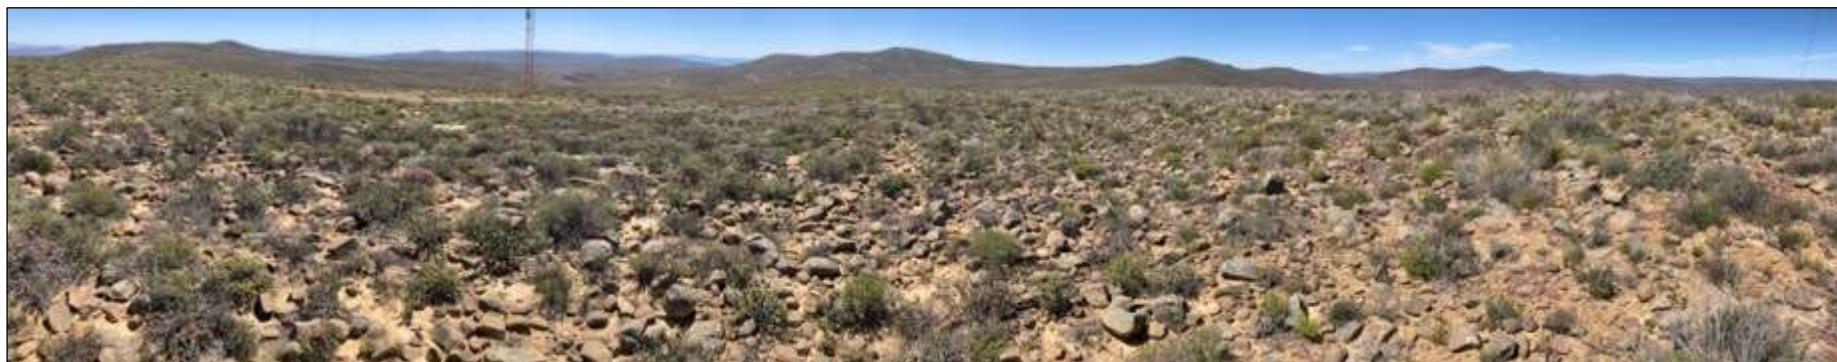
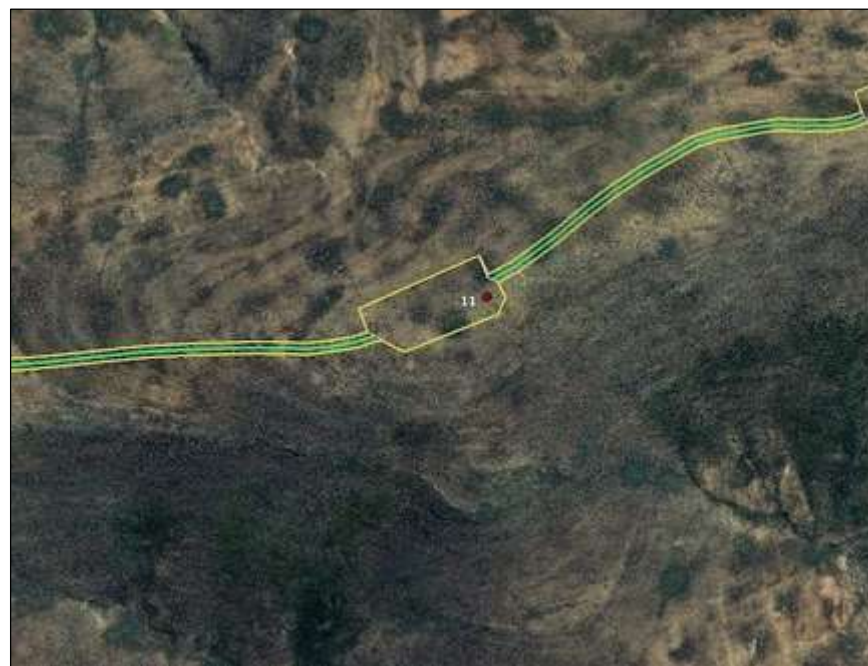
Figure 12: Panoramic view and Google Earth image of landscape at Turbine 11.

Existing test tower at site. No habitat or plant species sensitivities identified within turbine or laydown area footprint.

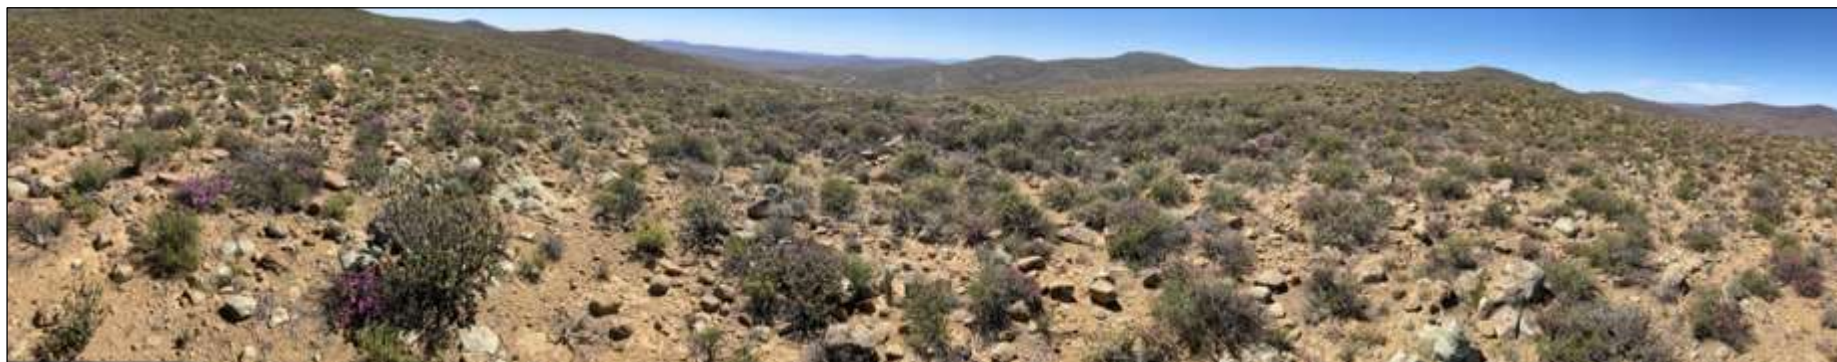
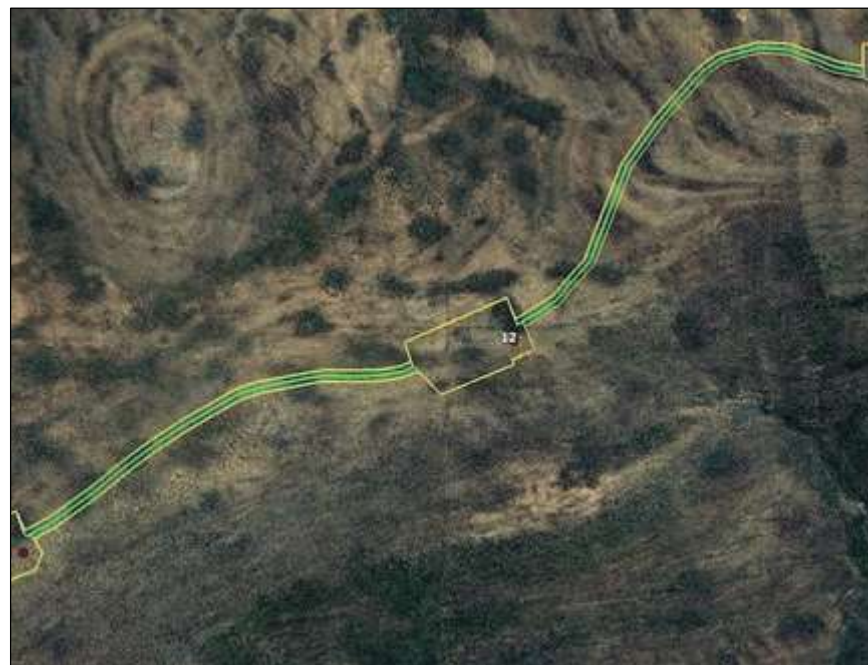
Figure 13: Panoramic view and Google Earth image of landscape at Turbine 12.

No habitat or plant species sensitivities identified within turbine or laydown area footprint.

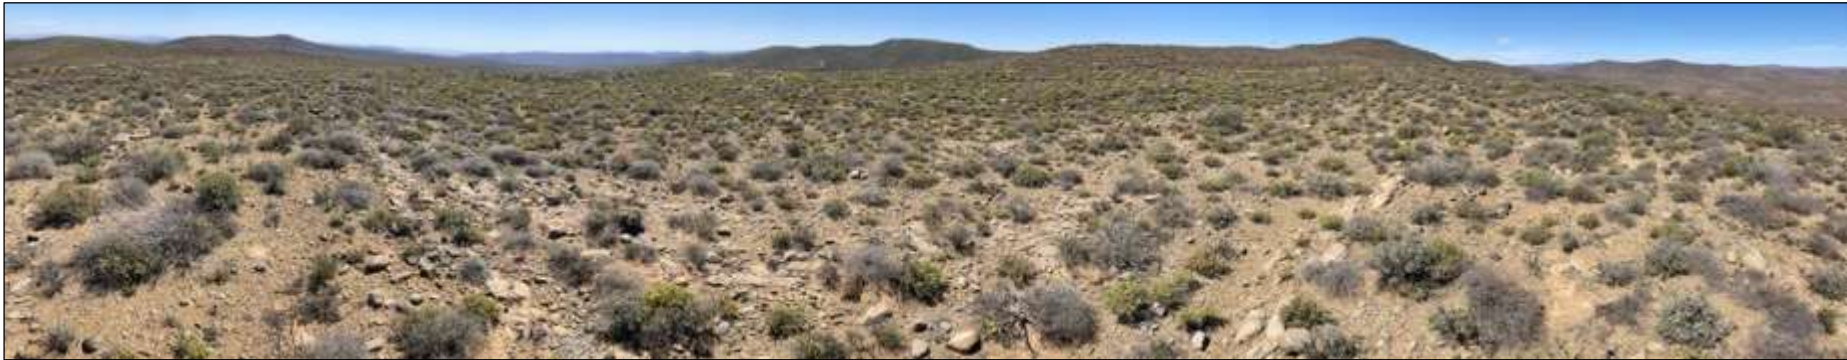
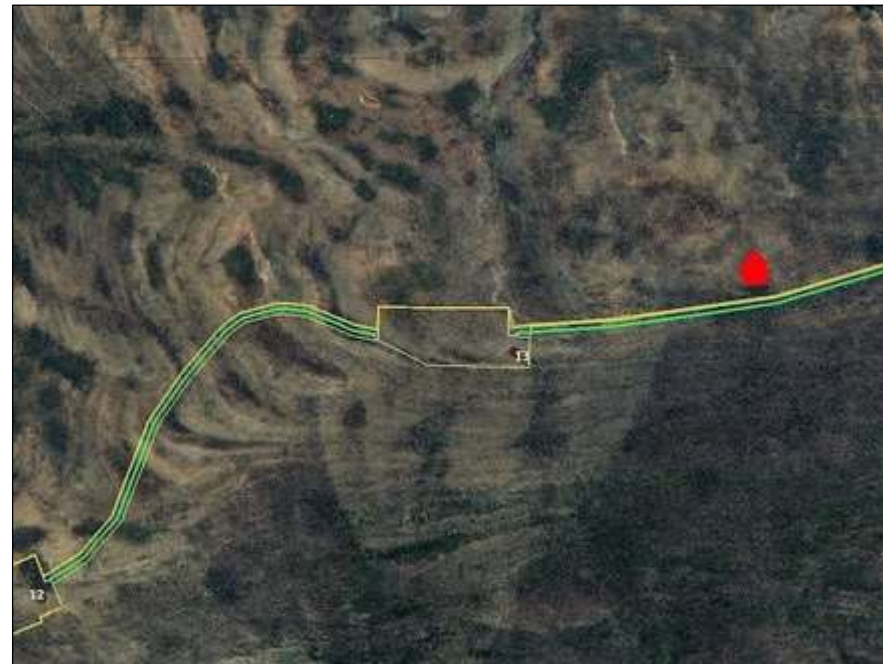
Figure 14: Panoramic view and Google Earth image of landscape at Turbine 13.

No habitat or plant species sensitivities identified within turbine or laydown area footprint.

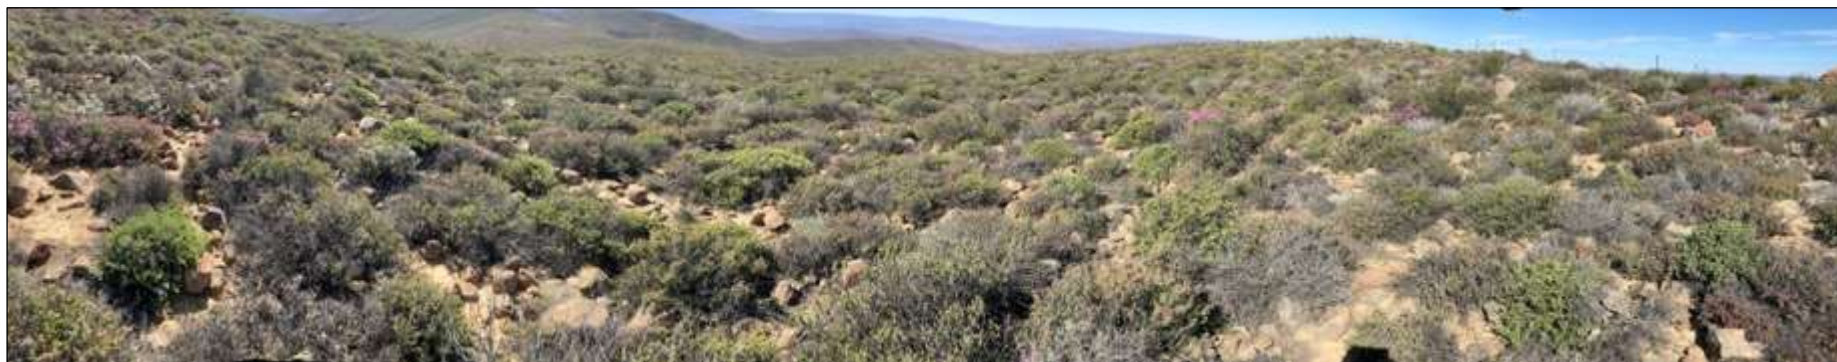
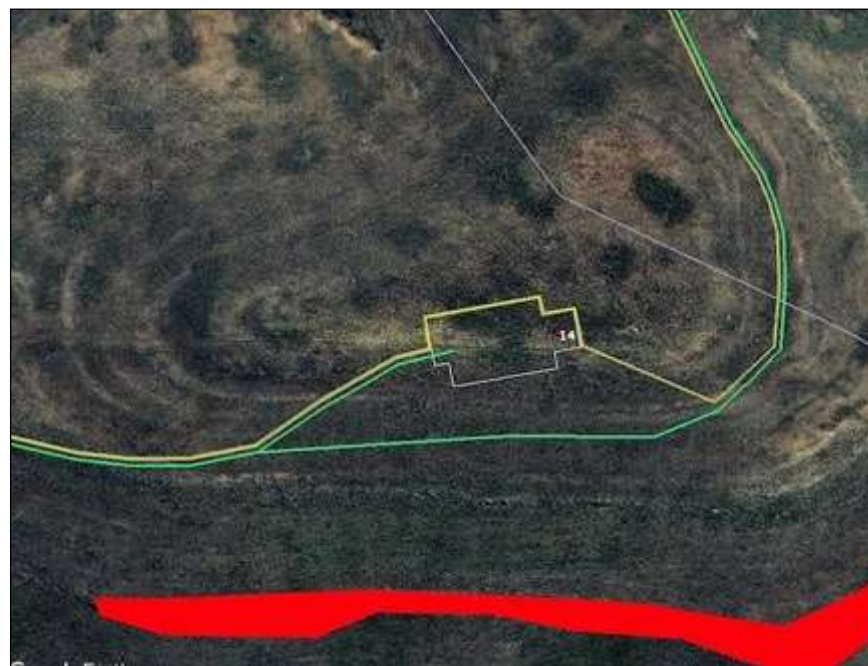
Figure 15: Panoramic view and Google Earth image of landscape at Turbine 14.

No habitat or plant species sensitivities identified within turbine or laydown area footprint.

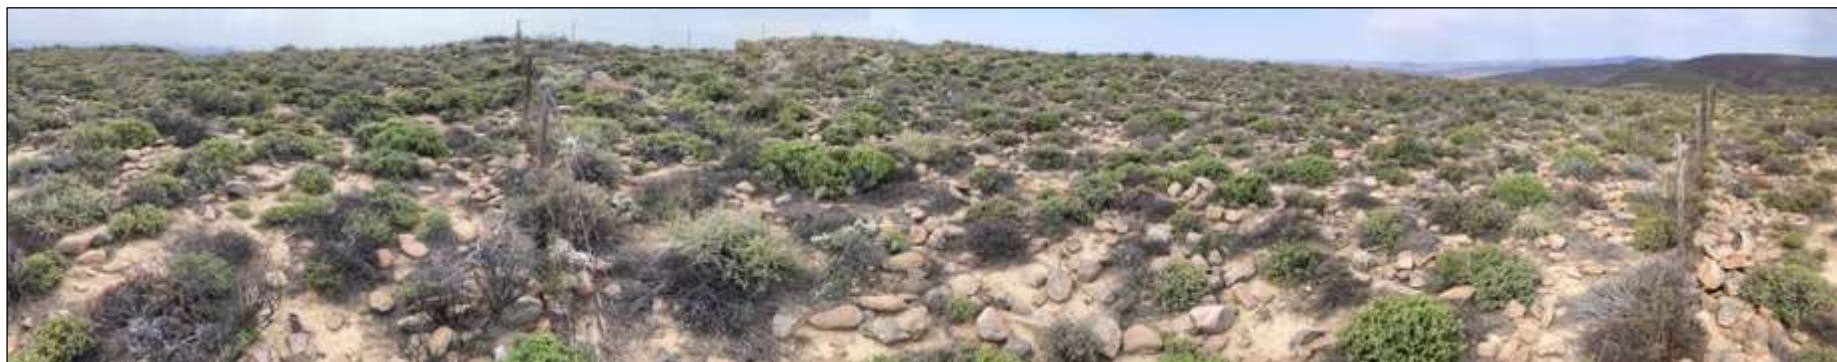
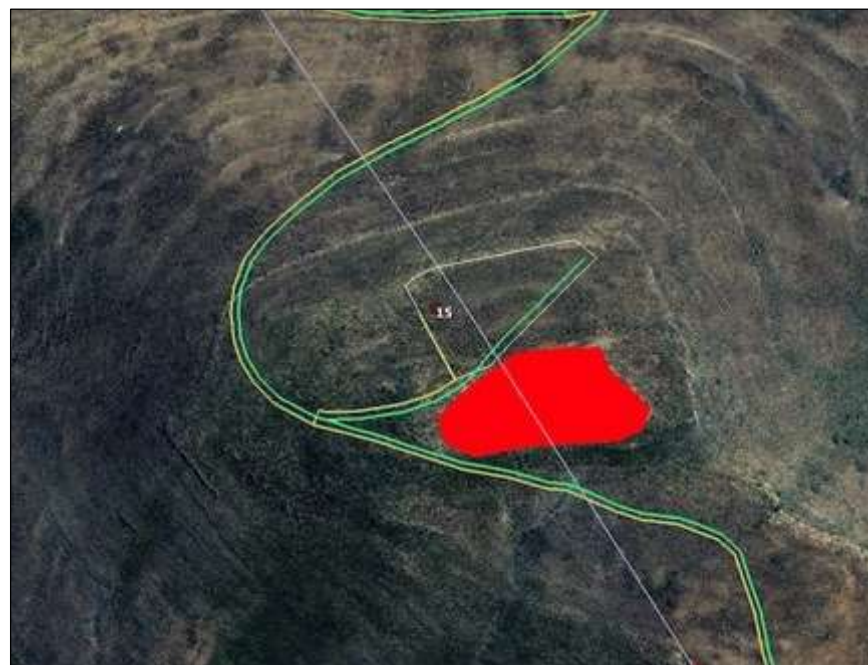
Figure 16: Panoramic view and Google Earth image of landscape at Turbine 15.

No habitat or plant species sensitivities identified within turbine or laydown area footprint.

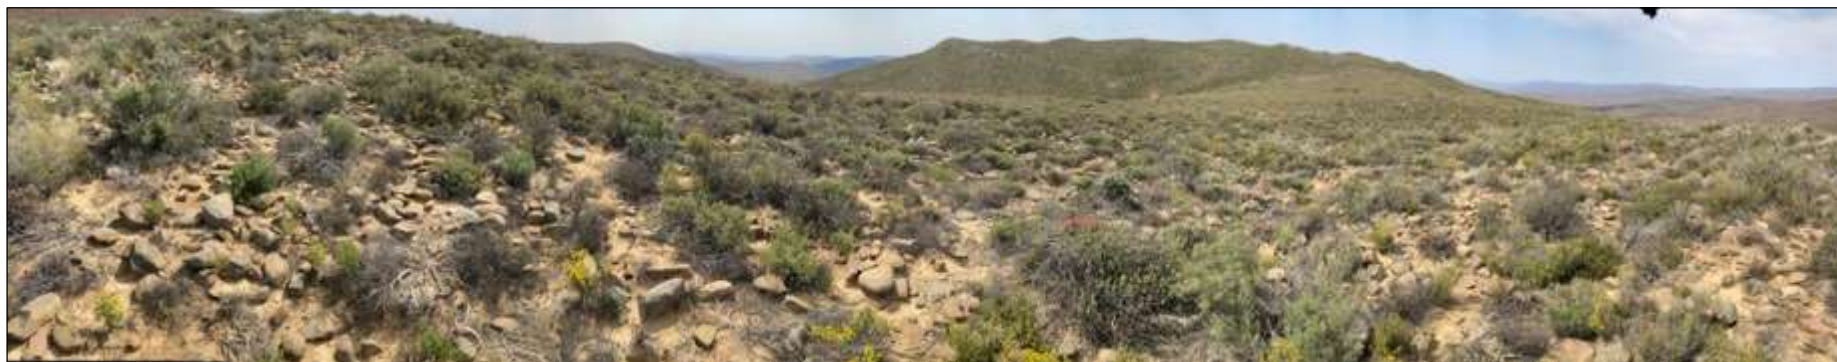
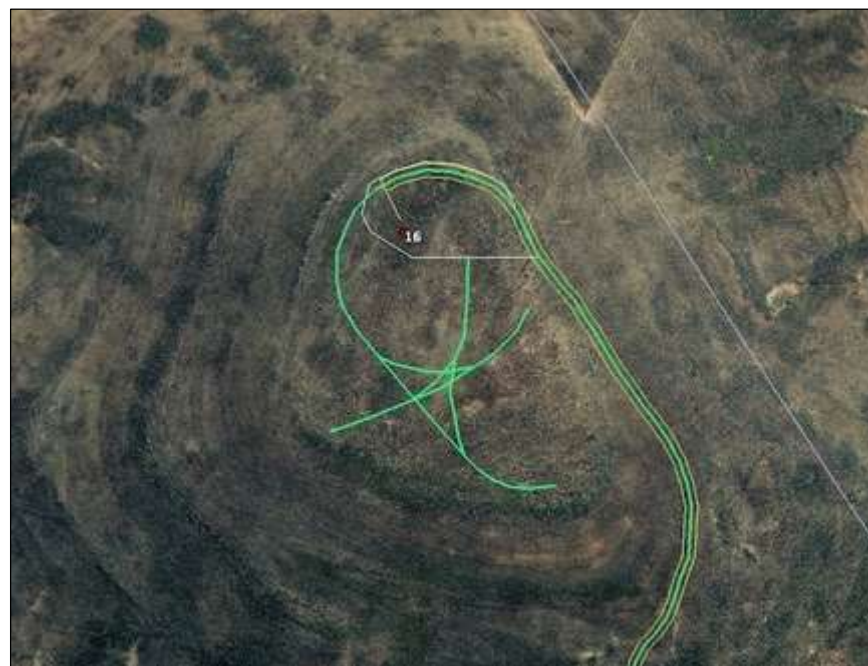
Figure 17: Panoramic view and Google Earth image of landscape at Turbine 16.

No habitat or plant species sensitivities identified within turbine or laydown area footprint.

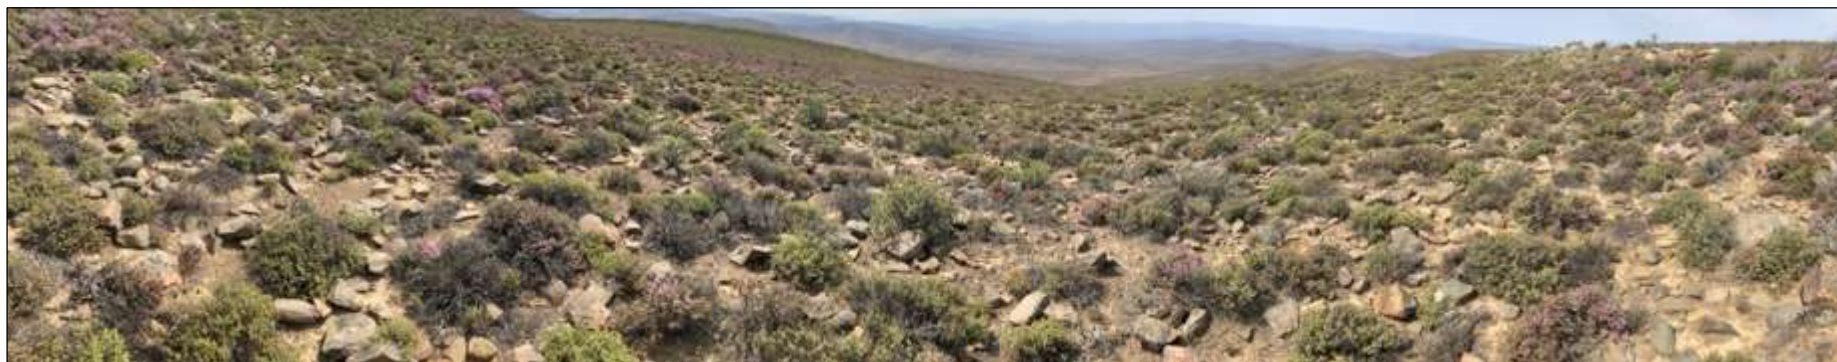
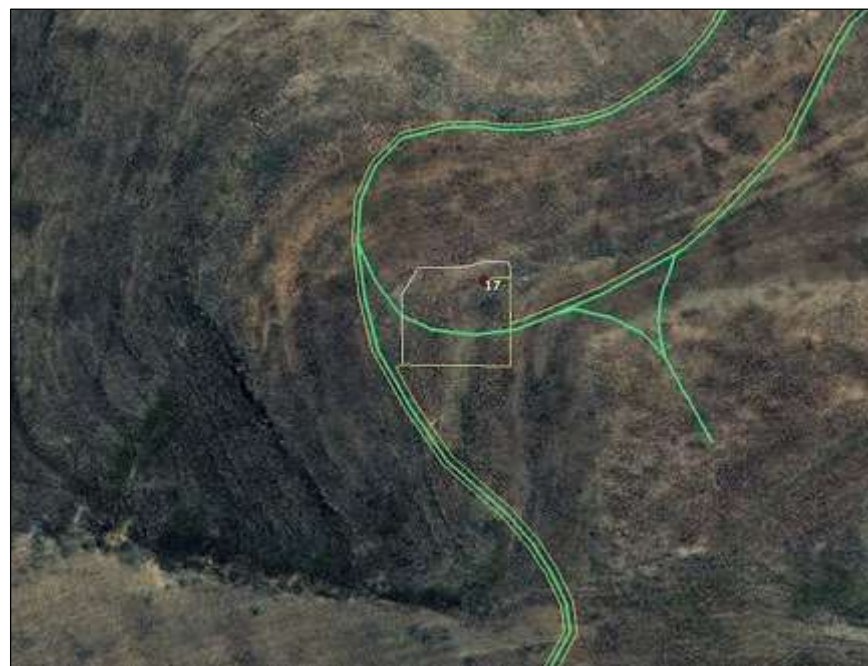
Figure 18: Panoramic view and Google Earth image of landscape at Turbine 17.

No habitat or plant species sensitivities identified within turbine or laydown area footprint.
