Terrestrial Ecology Basic Assessment Study

99 MW Oya Wind Energy Facility (WEF) and associated
infrastructure between Sutherland and Matjiesfontein,
Western and Northern Cape Provinces

Terrestrial Ecology Walk Down Verification for the proposed 99 MW Oya Wind Energy Facility between Sutherland and Matjiesfontein in the Western and Northern Cape Provinces.

18 January 2021

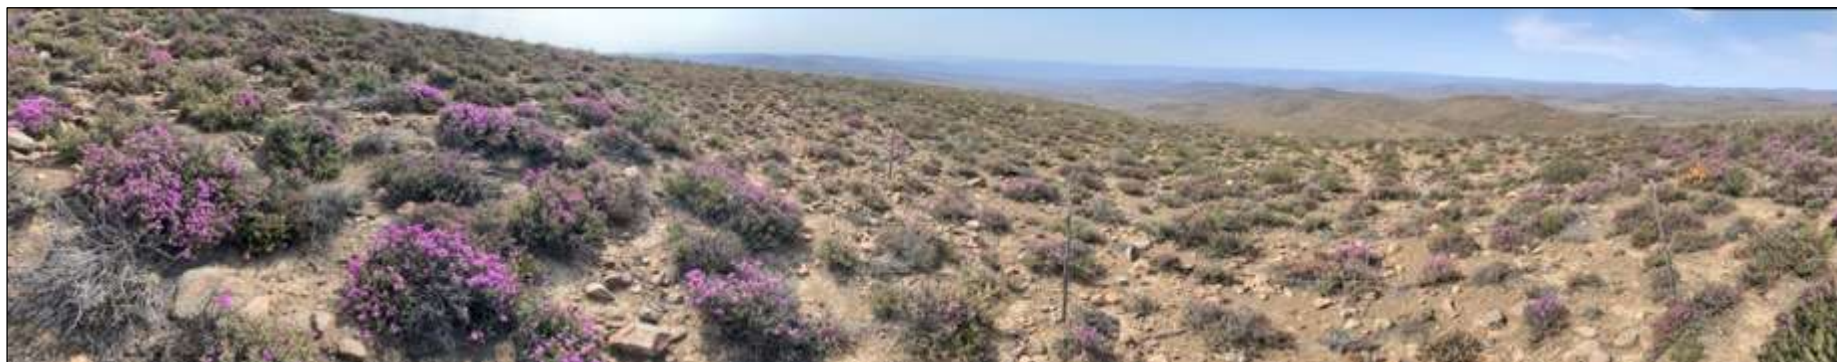
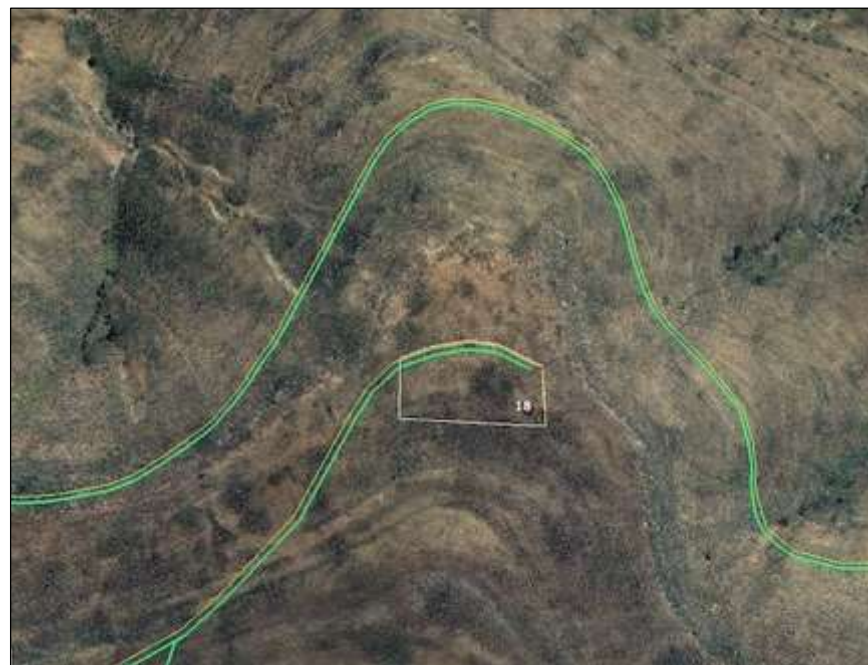
Figure 19: Panoramic view and Google Earth image of landscape at Turbine 18.

No habitat or plant species sensitivities identified within turbine or laydown area footprint.

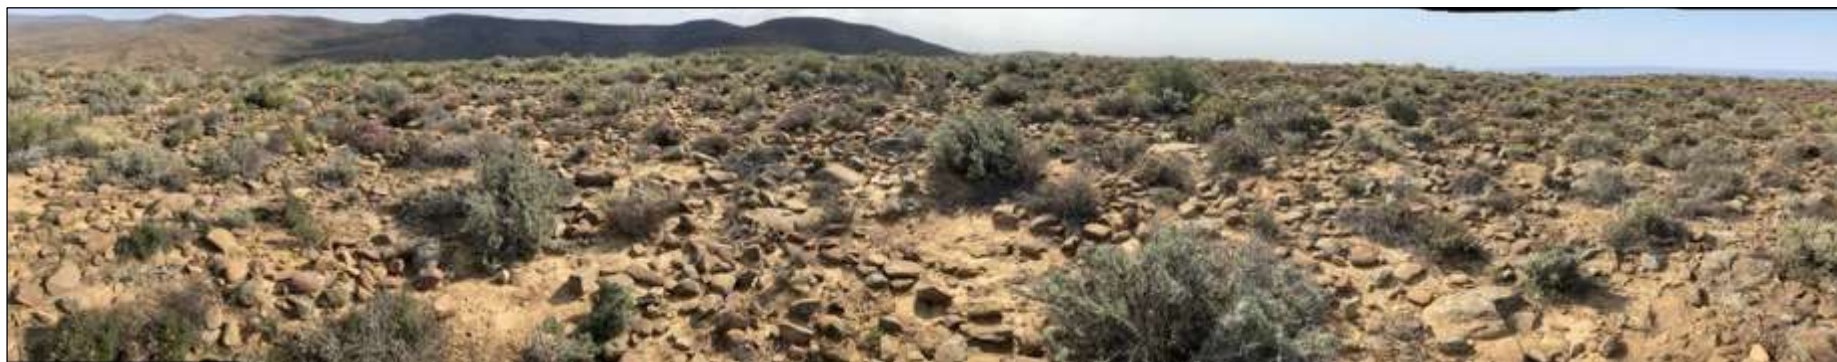
Figure 20: Panoramic view and Google Earth image of landscape at Turbine 19.

No habitat or plant species sensitivities identified within turbine or laydown area footprint.

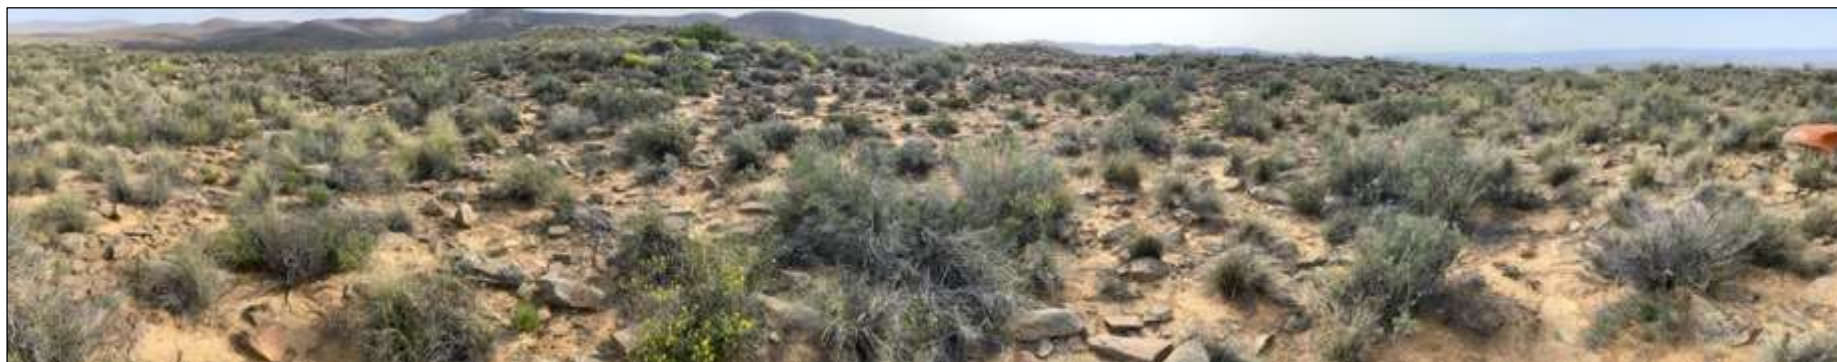
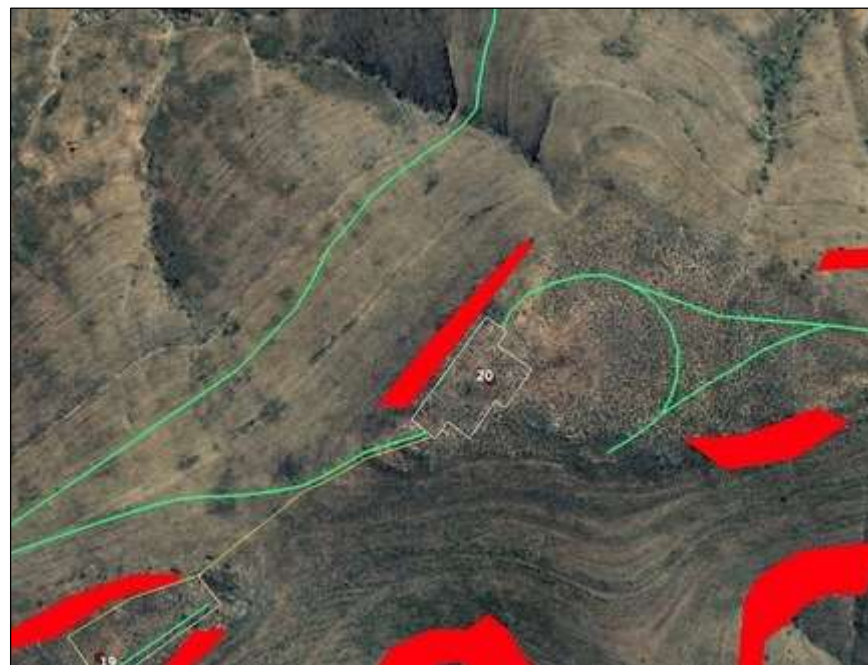
Figure 21: Panoramic view and Google Earth image of landscape at Turbine 20.

Slightly degraded from overgrazing. No habitat or plant species sensitivities identified within turbine or laydown area footprint.

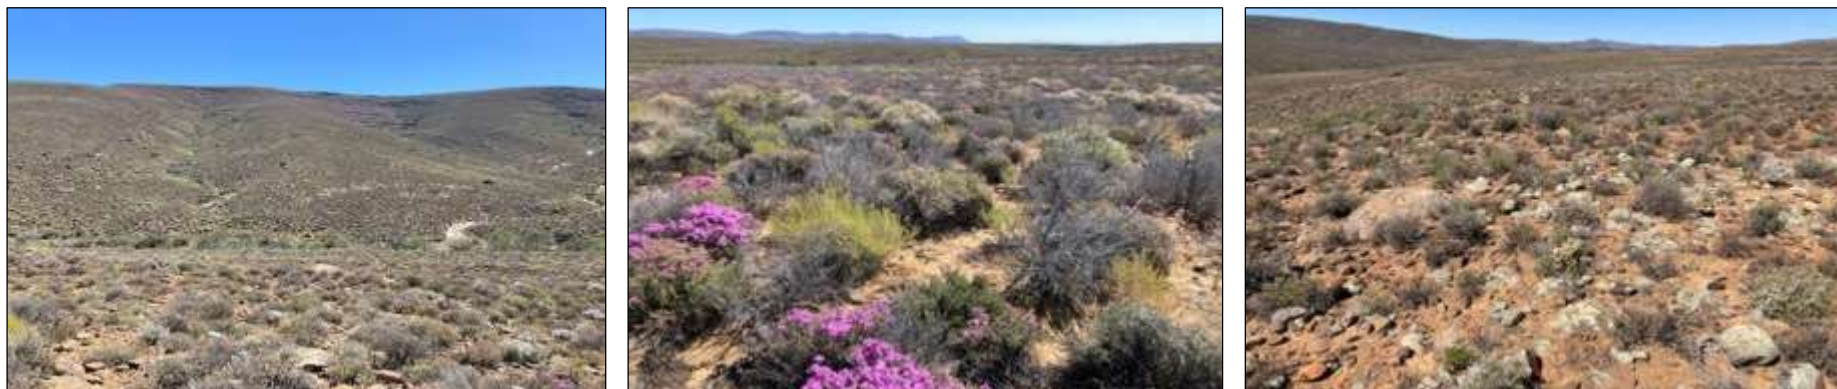
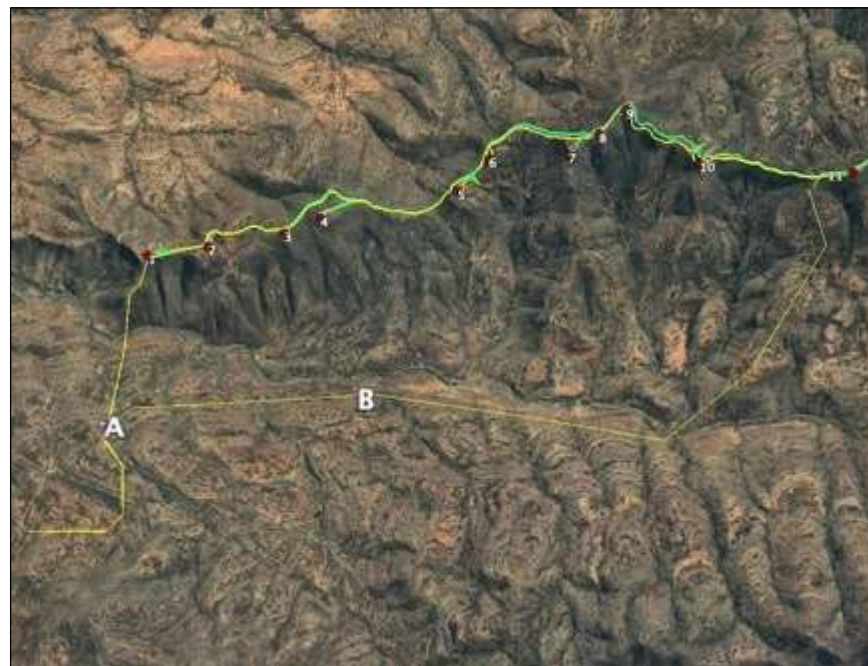
Figure 22: View of collector alignment from A (northwards), from A (southwards), and from B (eastwards).

With the exception of the areas south of the ridge, and going up the ridge in two places, the collector system follows the turbine access roads, the sensitivity of which is covered in the assessment of the turbines themselves. The remaining part of the collector system includes a straight part along the flats in the south, and two rising sections. The rise from the lower-lying areas to the ridge traverses moderately steep slope in both places, otherwise there are no particular issues associated with the collector system. There is a 4x4 trail rising up the mountain in proximity to the eastern alignment, which is positive in terms of existing impacts. The southern flat part runs close to the existing gravel road.

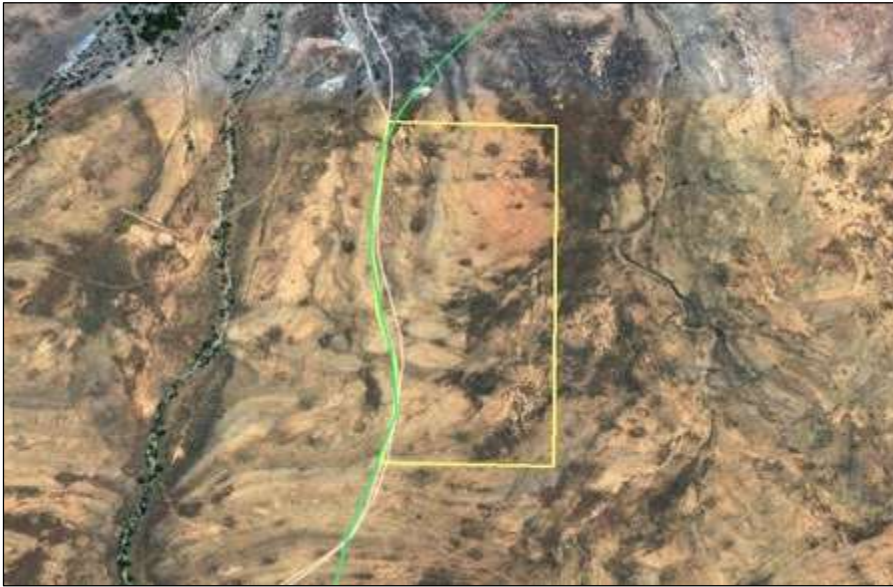
Figure 23: View of the construction site.

The location of the construction site is perched on the lowlands bordering on an existing road. No issues were identified for the site.

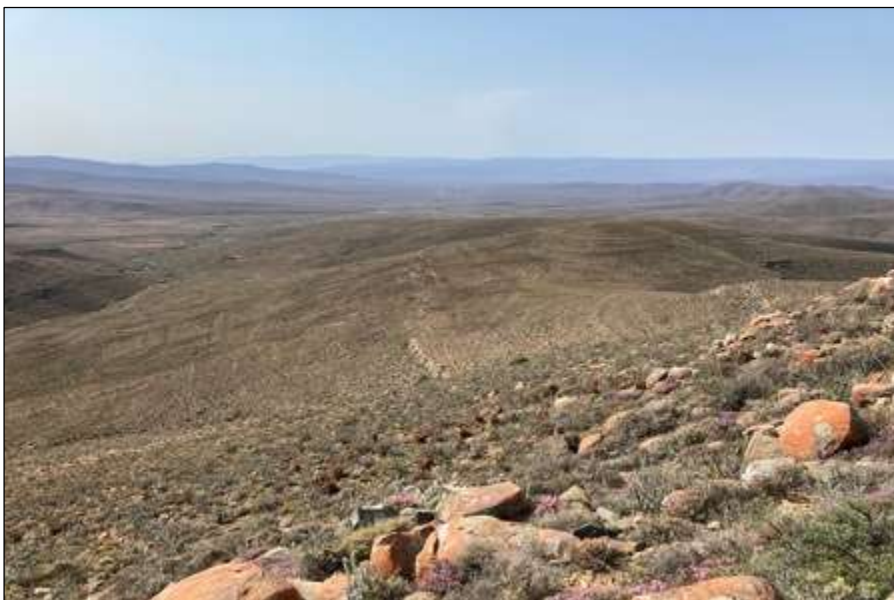
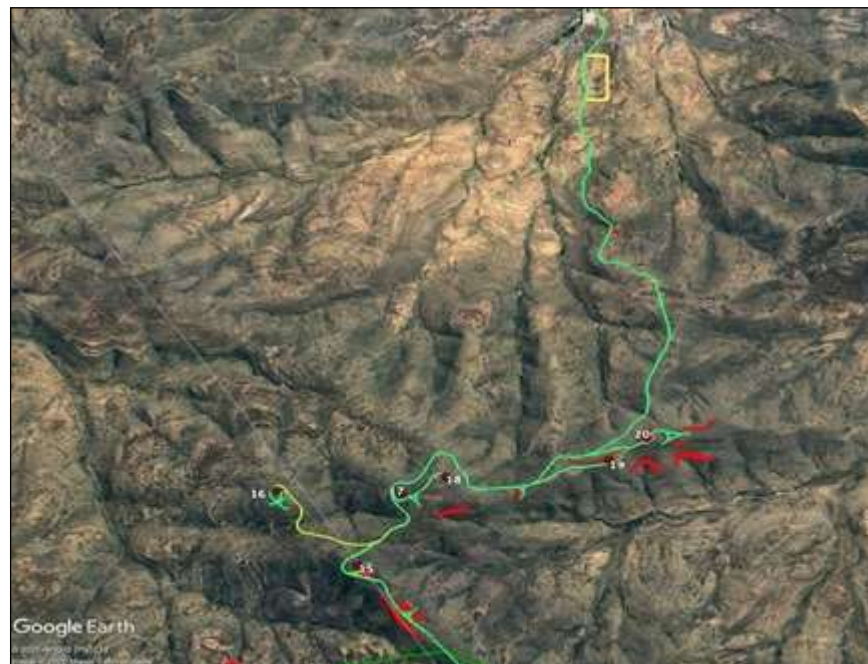
Figure 24: View from near Turbine 19 towards the north, following the alignment of the main access road.

There is a main access road from the north onto the main ridge of the WEF. This follows a path from the construction site southwards up the ridge towards Turbines 19 and 20. A view from the top of the climb looking northwards is shown in Figure 25. No sensitivity issues were identified along this route alignment.
