Title: SOIL EROSION GUIDELINE Unique Identifier: **41-337**
 Area of Applicability: **T**
 Document Type: **GL**
 Revision: **1**
 Total pages: **12**
 Next Review Date: **NOVEMBER 2014**

1. Introduction

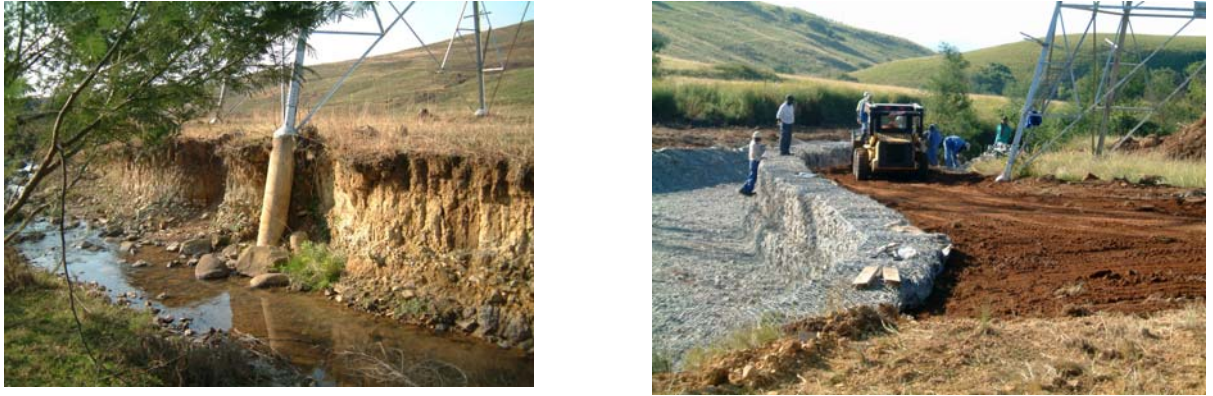
Figure 1: The photo on the left shows the foundation of a tower exposed by erosion. The photo on the right shows the extensive and costly remediation by using gabions and reno mattresses. Also note the use of good topsoil that will permit the re-establishment of vegetation around the tower (photos JorgeCorreia).

- In the first case, erosion in the vicinity of the tower could threaten its structural integrity. Failure to remedy the situation may lead to the collapse of the tower and line.

- **Heavy systems:** These solutions include concrete or brick structures and gabions and reno mattresses, etc. (refer to figure 1). Concrete or cement structures can be constructed on solid rock foundation or they could be floating structures. Several publications on the planning and design of these structures are available from the Agricultural Research Council as well as from commercial companies. The choice between gabions and concrete structures depends inter alia on the availability of rocks. Care should be taken not to disturb the environment where rocks are collected as this could result in the creation of new erosion problems. These structures are normally expensive and should be planned carefully by a specialist.

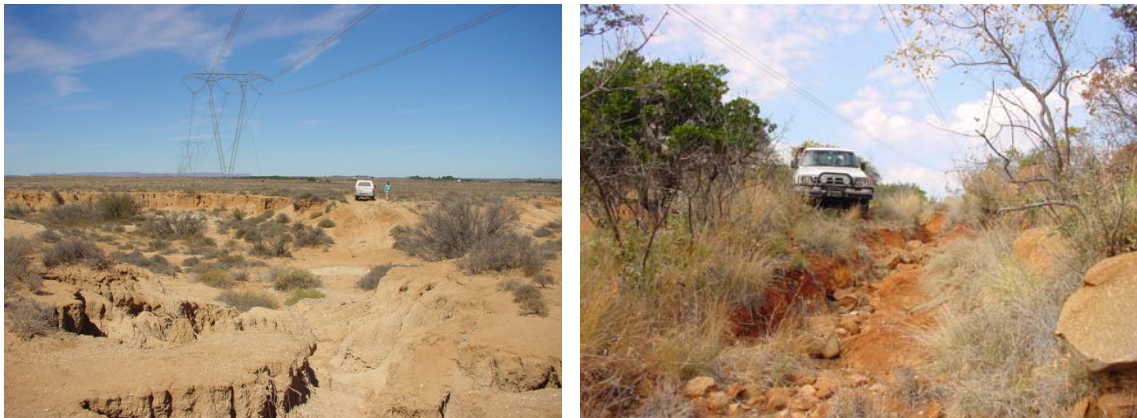
Figure 2. Examples of erosion in the servitude, which hampers access during maintenance and emergencies.

- Secondly, erosion in the area between towers may not threaten the towers directly or initially, but will prevent access for maintenance or emergency repair purposes.

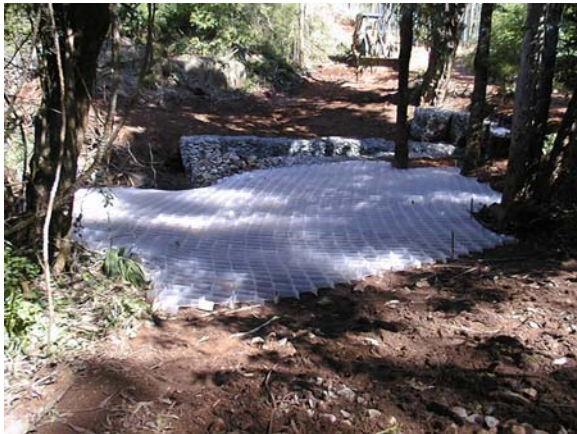
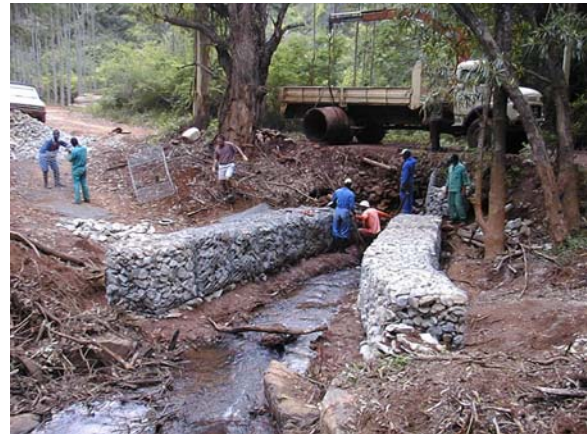
Figure 3. Extensive measures taken to prevent erosion, during the construction of access roads for a new power line. Continuous cellular mat (left) and gabions (right) are some of the measures used during the building of access roads during the construction phase of a power line. (Photos: JoseClara).

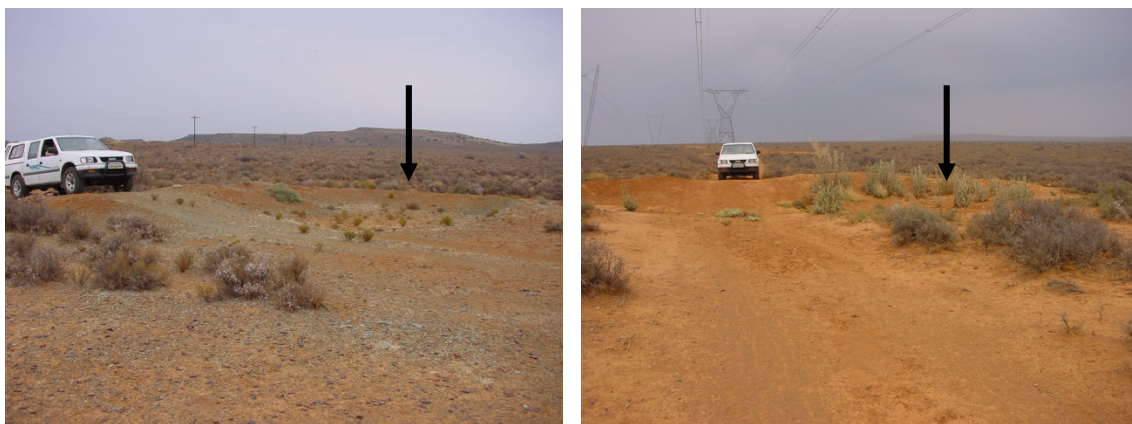
Figure 4. Examples of well constructed berms under the Hydra-Droërivier 1&3 lines. This design uses an overflow dam to spread water collected by the berm (see arrows). After ten years virtually no maintenance is required on these structures.

Regular spacing of berms will prevent the formation of erosion of the access roads. These should be spaced as follows:

Berm spacing (in Metres):

$$\frac{300\text{m}}{\text{Slope of the road (\%)}}$$

Areas that have highly erodable soils as well as areas in the vicinity of watercourses require special measures as shown above in figure 4 above.

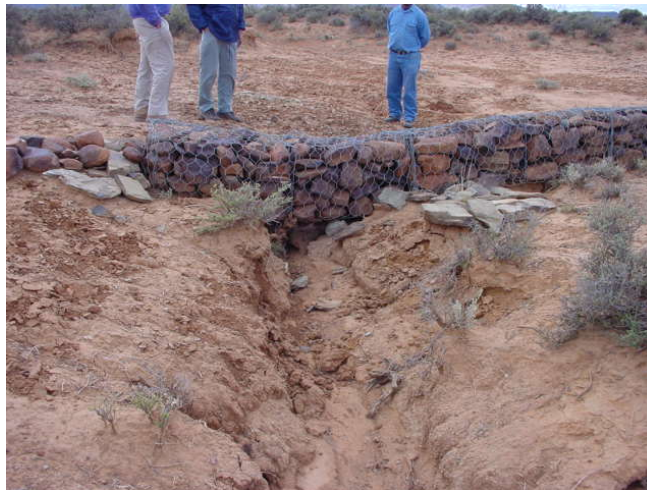
Figure 5. An example of an inappropriately designed gabion. No geotextile or apron was used in this case and erosion eventually occurred under the structure. No provision was made to prevent erosion at the overflow.

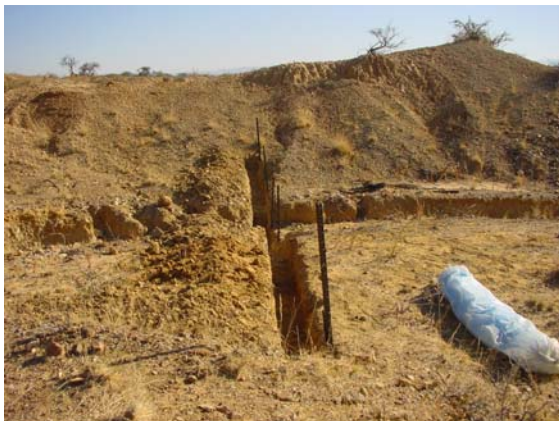
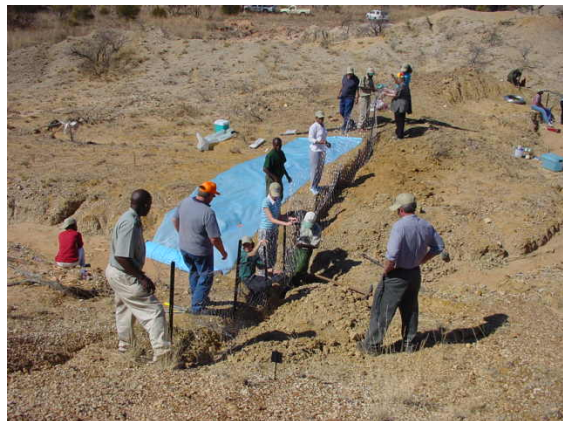
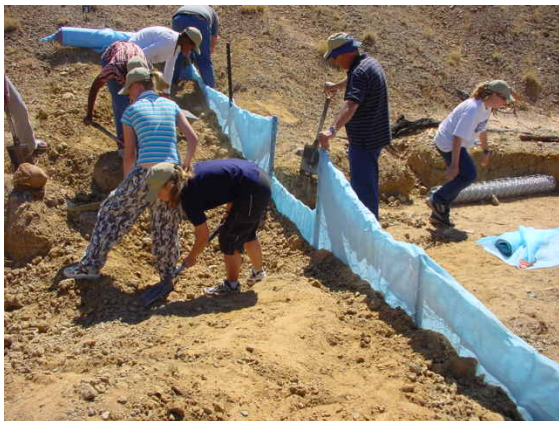
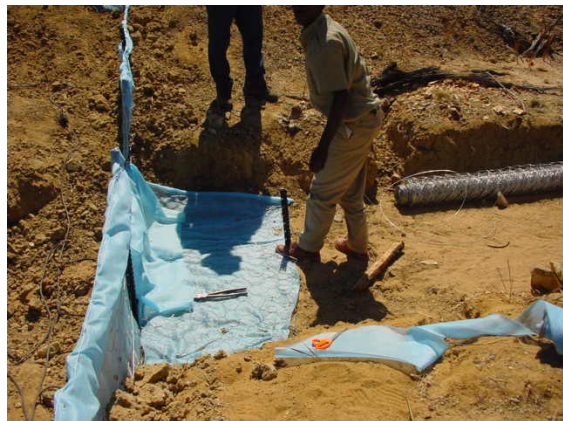
Figure 6: The photographs show the steps in the construction of a silt-screen. Girls from two schools in Pretoria on the Mabula Game farm carried out this exercise. In photo 1 the trench is dug across the erosion channel and Y standards are placed to form the main part of the structure. In photo 2 the Y standards are connected with stay wires and covered with wire mesh. The structure is then covered with a biodegradable geo-textile in photo 3. In photo 4 the structure is completed by adding an apron, made of geo-textile and wire mesh.

The silt-screen is used to trap small particles and seeds, whilst permitting the water to pass through. In this way the fertile trapped soil will permit the re-growth of vegetation and aid the stabilization of the

soil. These structures are placed at intervals such that the re-growth of the one structure will reach the overflow of the previous one.

These structures are cheap to construct and the material that is used is a very strong knitted polyethylene, which is biodegradable and will not pollute the environment. The structures are spaced at intervals, which are determined by the slope, vegetation and soils present. (van Heerden 2000, p3-4). A typical design appears in Annexure A

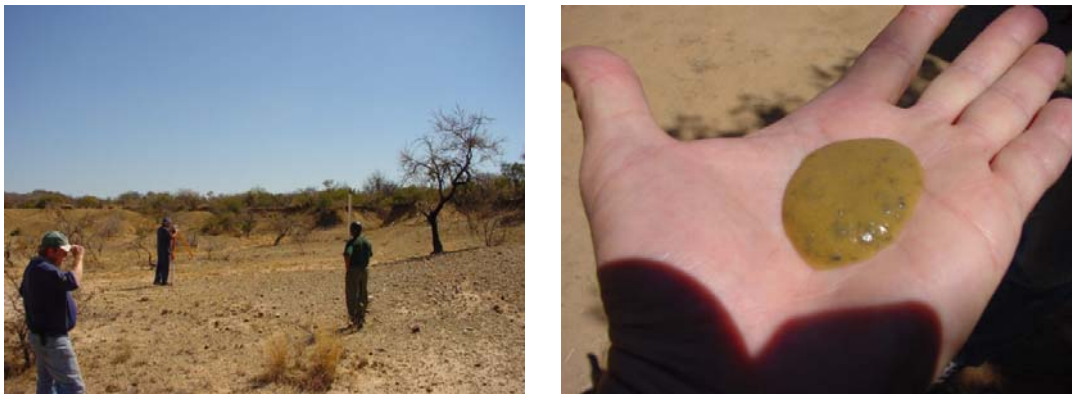
Figure 7. The photo on the left shows an area without topsoil or plant material. The position of the contour is being determined. The photo on the right shows the silicate mineral after water has been added.

To overcome this problem, use is made of a silicate water-retaining mineral. This mineral absorbs water during rain and then retains it. The water does not evaporate but remains accessible to the plants.

Recently, the following procedure was suggested for soil reclamation. A mixture of soil, manure, seeds and a silicate water retardant mineral is mixed and placed in long bags made of a geotextile. These bags are then pinned to the ground, following the contour.

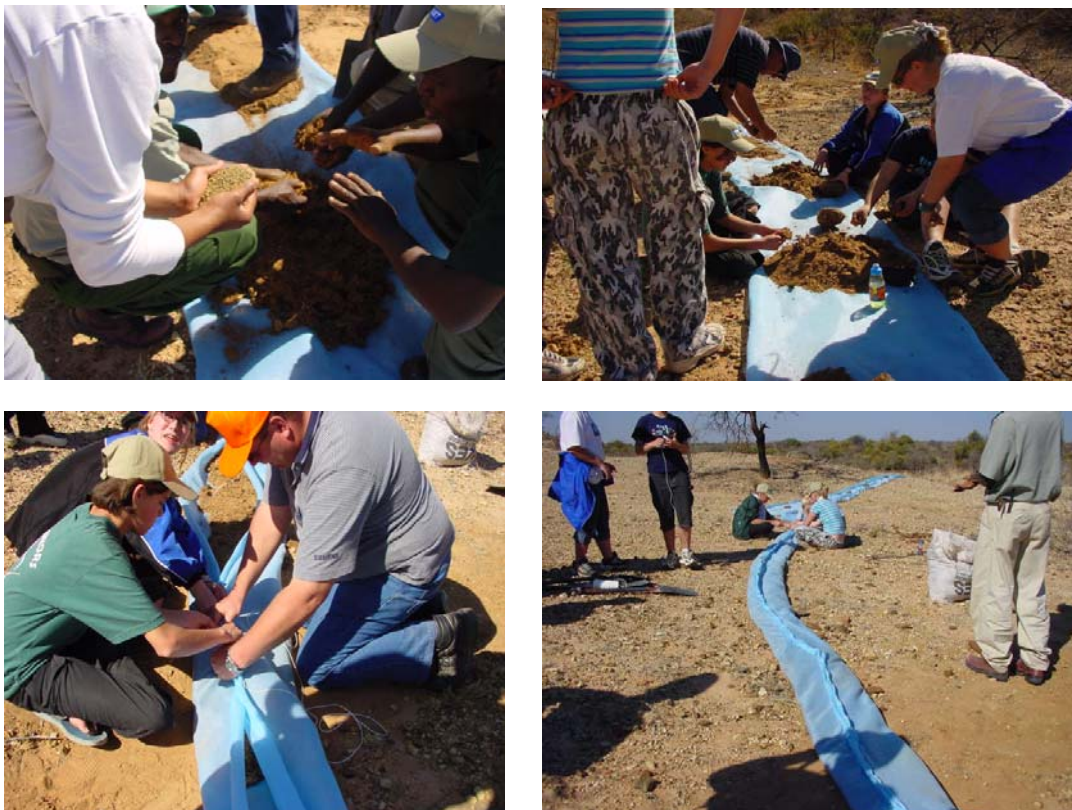
Figure 8. The photo's show the mixing of the soil, the manure seed and silicate mineral before placing it in the geotextile bags
