ANCILLARY NOTES FOR ORT 2-BEDROOMED DWELLING

Project title :
OR TAMBO HOMESTEAD

Building : **OR TAMBO DWELLING**

WEST ELEVATION, SOUTH ELEVATION, NORTH ELEVATION, EAST ELEVATION, FLOOR PLAN

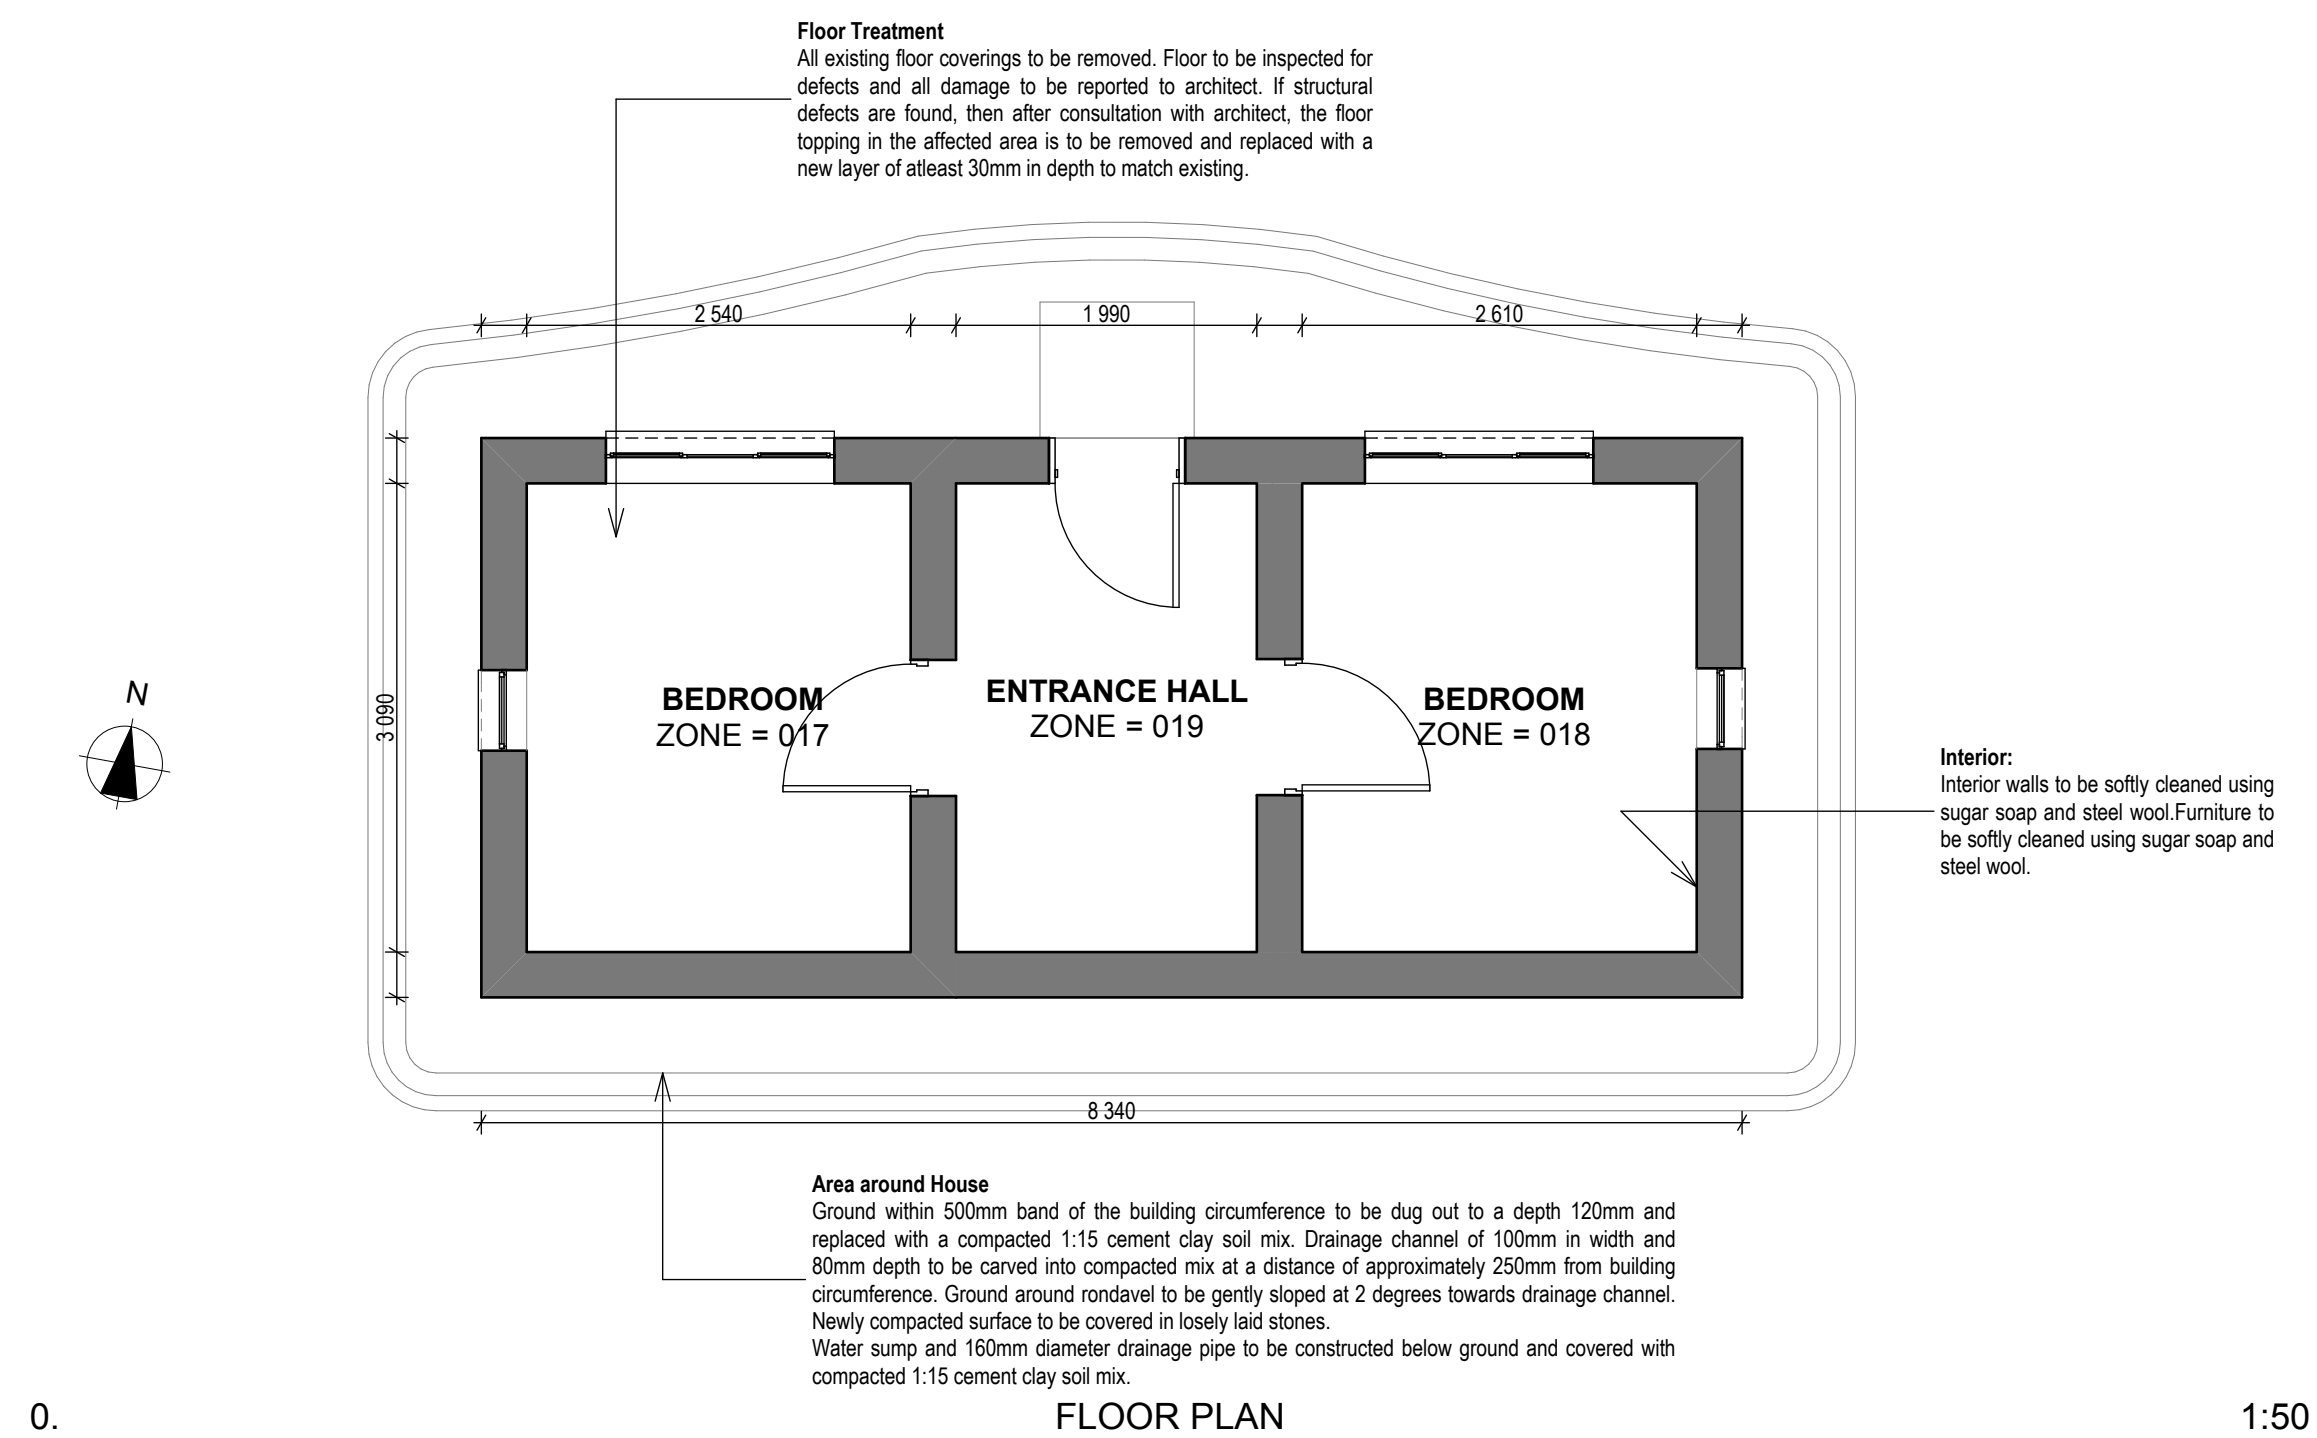
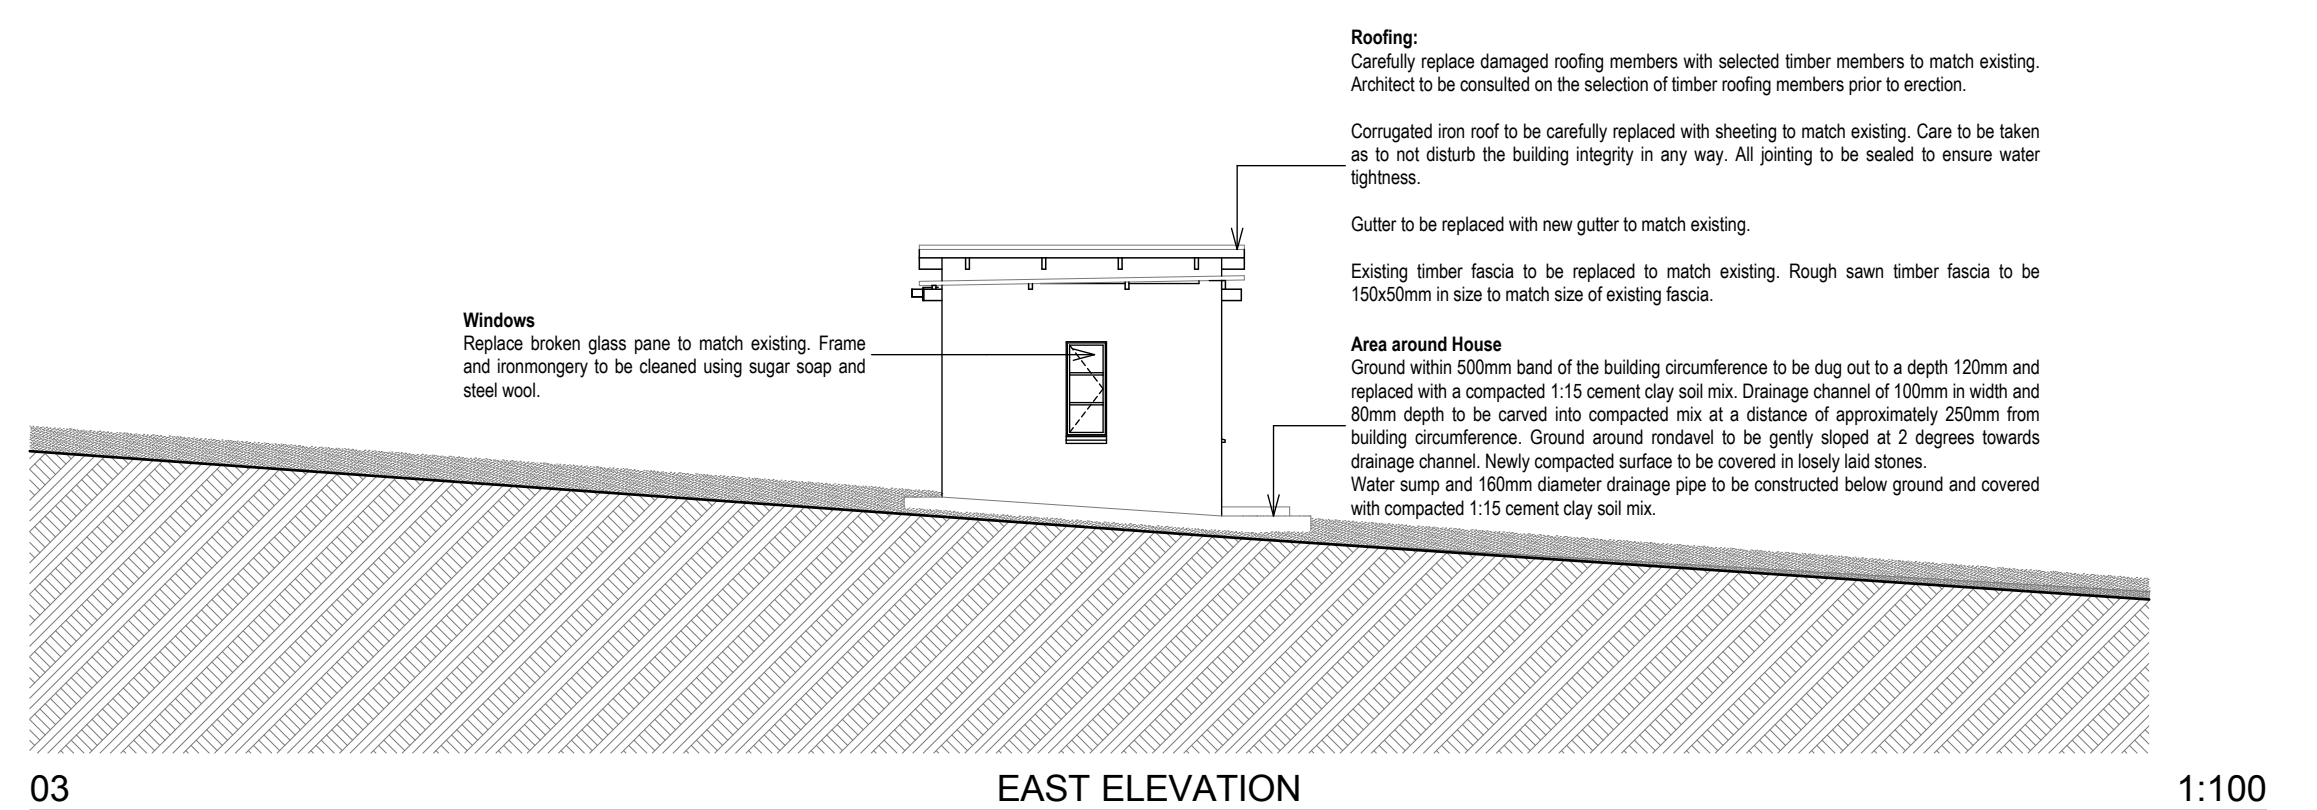
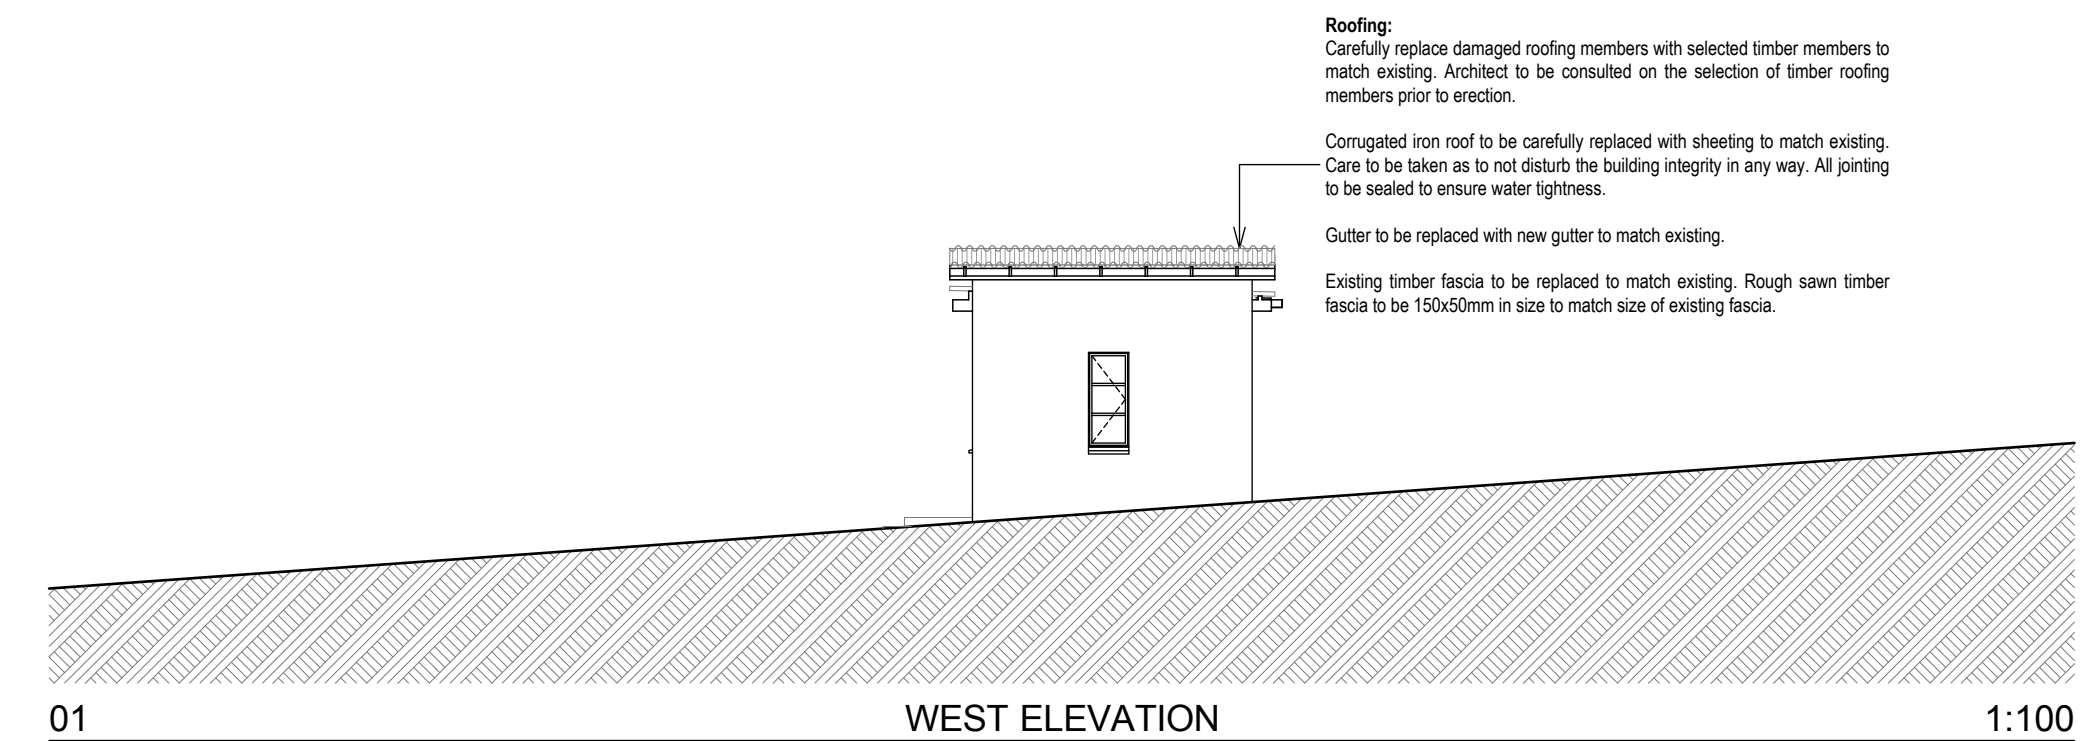
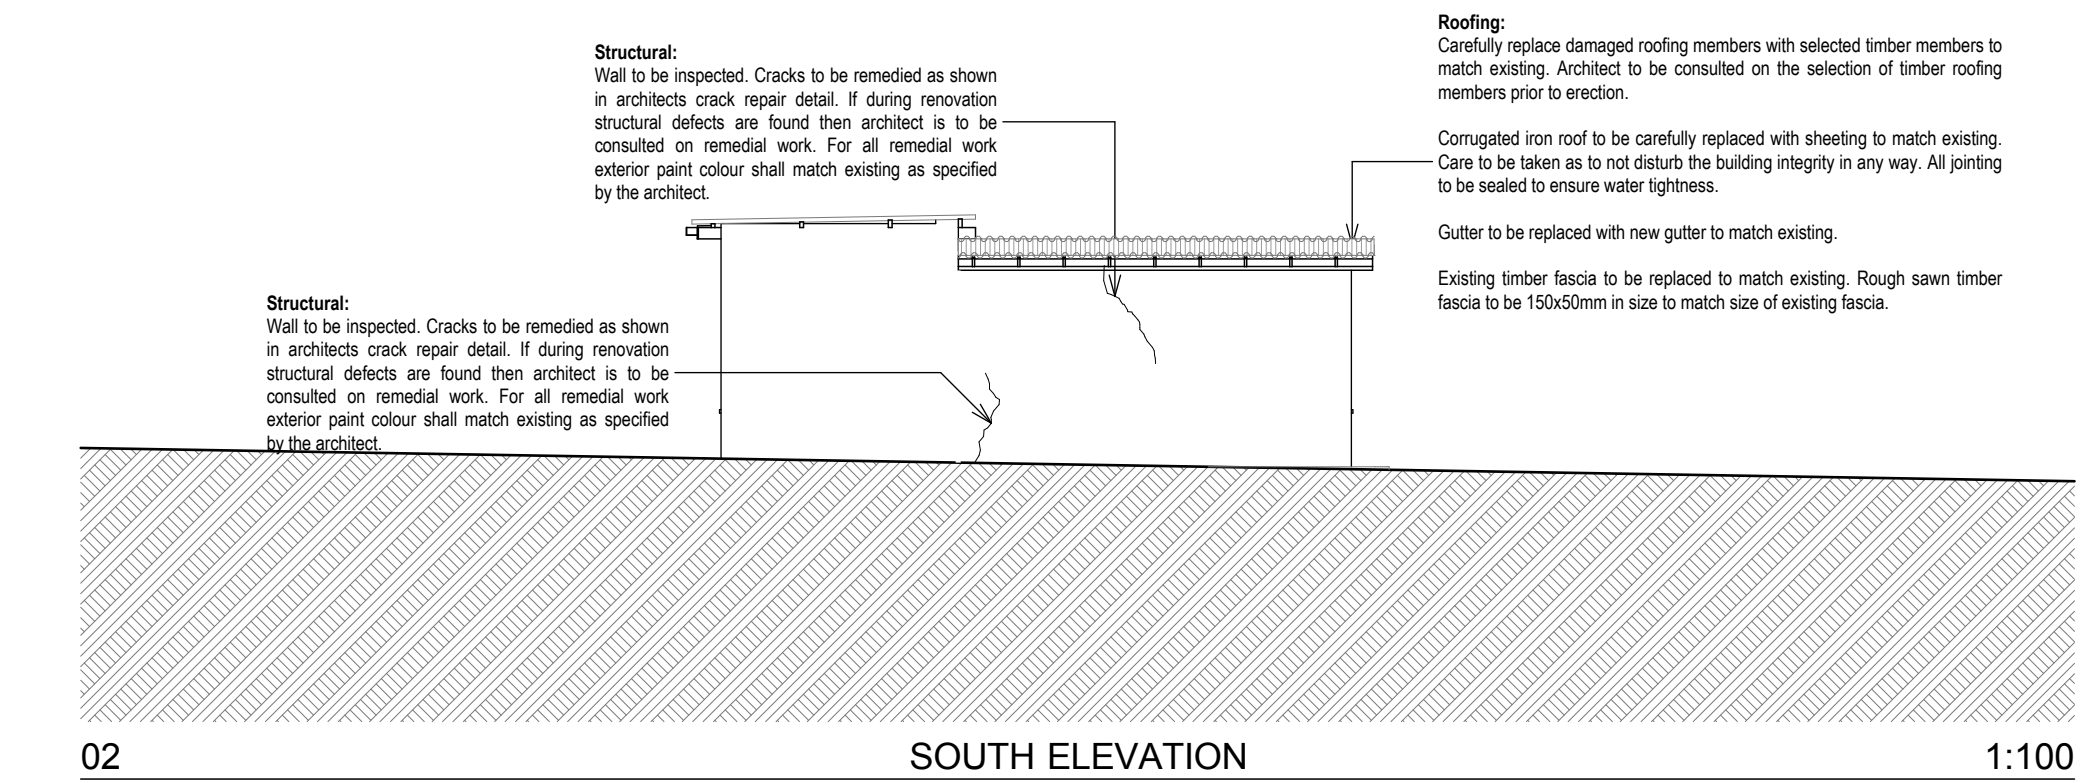
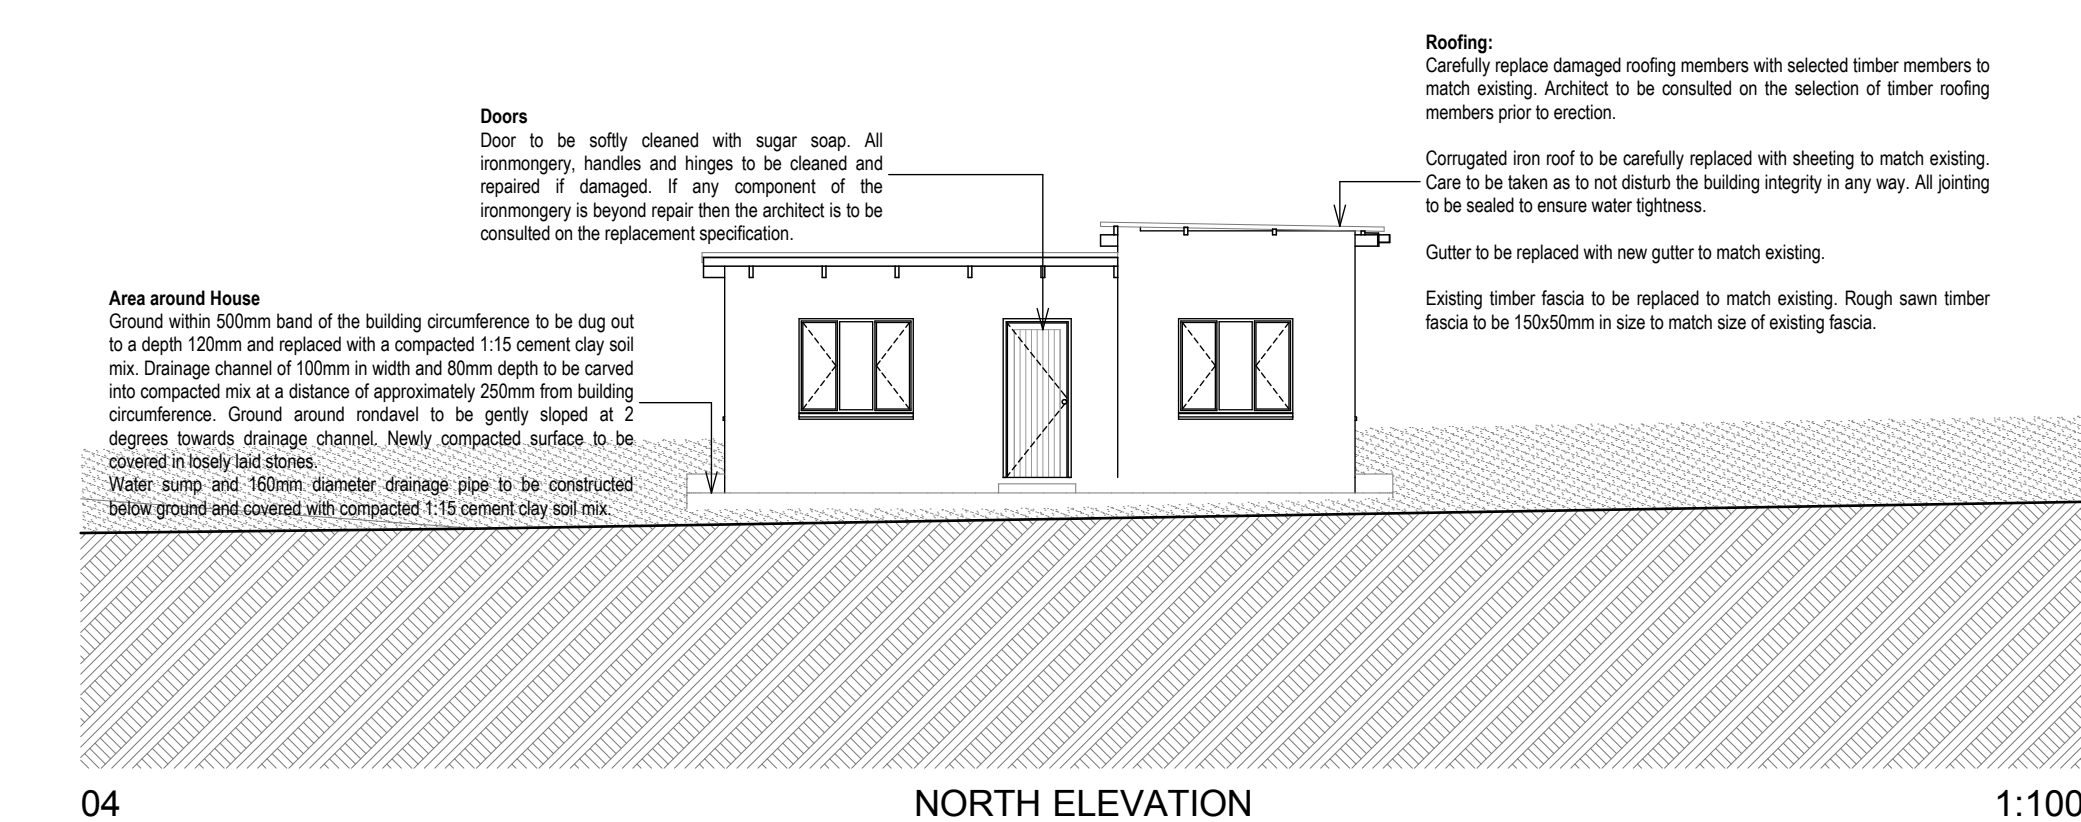
Walls are cement plastered on the interior and it has a cement screed floor. This structure requires assessment to determine whether it is structurally sound; at least one wall has an exterior bulge. Door is Trading Store stock T&G SAP on butt-hinges. Windows are Trading Store stock 6-pane mild steel frame. Painted light yellow with Trading Store stock water and lime-based paint.

The OR Tambo Dwelling was constructed of sundried earthen bricks and daga mortar on a cement block double course foundation. The walls are plastered with cement internally and externally. There was a gutter along the western roof edge, but this was removed once the plank holding it in place had rotted away. There is no ceiling and the corrugated iron roof, roof timbers, metal windows and window frames; metal door frame and cement floor are all original.

The wooden front door has been replaced twice and the structure has been repainted twice. The original interior wall colour was white and that of the exterior cream. The roof was painted on top with red oxide 2-3 years after construction; the interior of the roof is painted white in the entrance hall, but those of the rooms are unpainted. In anticipation of a State visit by the Deputy President in 1999 tile windowsills were installed and large cracks in the western wall were repaired with cement and chicken wire.
