<p><b>Synergistics</b> Environmental Services</p> <hr/> <p><b>Johannesburg:</b> Tel: 011 807 8225, Fax: 011 807 8226 PO Box 1822, Rivonia, 2128 64 Wessels Road, Rivonia</p> <p><b>Eastern Cape:</b> Tel: 041 583 1156, Fax: 086 562 0165 Suite 71, P Bag X13130, Humewood, Port Elizabeth, 6013</p> <p><b>KwaZulu Natal:</b> Tel/Fax: 033 343 4642 15 Quarry Road, Hilton, 3201</p>
Our Ref:	S0342/S0438/S0493	
Attention:	<p><b>Donald Lithole</b> <b>SAHRA Limpopo</b> <b>P.O. Box 1371</b> <b>Polokwane</b> <b>0700</b></p> <p><b>cc. Mary Leslie</b> <b>SAHRA Head Office</b> <b>P.O. Box 4637</b> <b>Cape Town</b> <b>8000</b></p>	
<p><b>Expansion of the Char Plant and Construction of Coke and Co-generation Plants at Exxaro's Grootegeluk Mine in Lephalale, Limpopo Province</b></p>

#### **Project Description – Char Plant Expansion**

### **Project Description – Coke and Co-generation Plants**

**HERITAGE SURVEY REPORT OF THE KUMBA PROPERTIES AT  
GROOTEGELUK MINE, LEPHALALE AREA, LIMPOPO PROVINCE**

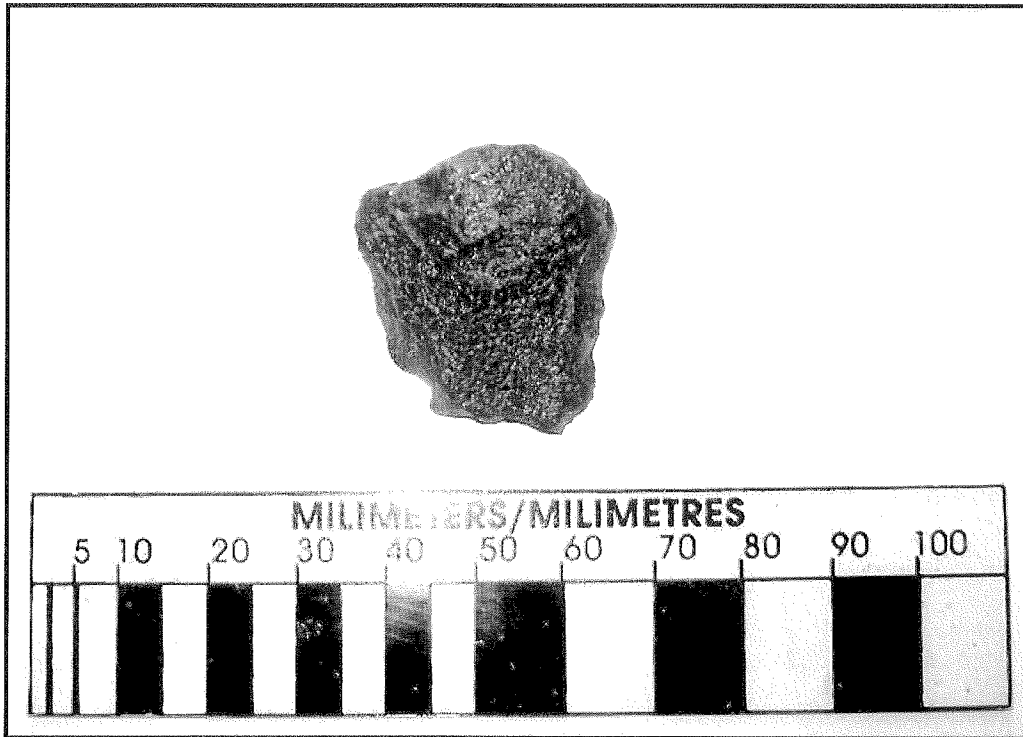
**Figure 9.** Quartzite stone tool dating to the Middle Stone Age, found near the edge of the pan.

Stone tools dating to the Middle Stone Age were recorded at a few select spots, predominantly at outcrops and pans (Fig. 9). As these artefacts were found on the surface, they are not in their original context any more and can yield very little information. As a result, they are viewed to have no significance.
