PART 2 ENVIRONMENTAL AUTHORISATION AMENDMENT APPLICATION: 75 MW HUMANSRUS PHOTOVOLTAIC (PV) 1 SOLAR POWER FACILITY

DFFE Ref: 2022-09-0038

MAY 2023

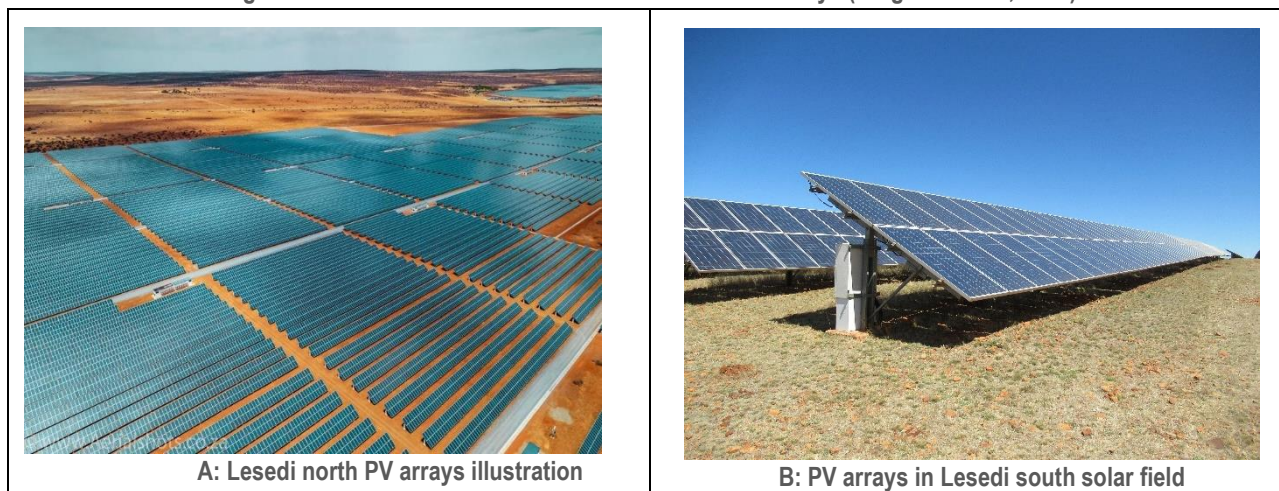
The panels are mounted on metal frames with a maximum height of approximately 3m above the ground, supported by a combination of friction and end bearing pile foundations, and face north in order to capture the maximum sunlight. The facility is a fixed-tilt PV plant where the solar panels are stationary. Figure 3 (A & B) indicates the PV panels / arrays.

A: Lesedi north PV arrays illustration

B: PV arrays in Lesedi south solar field

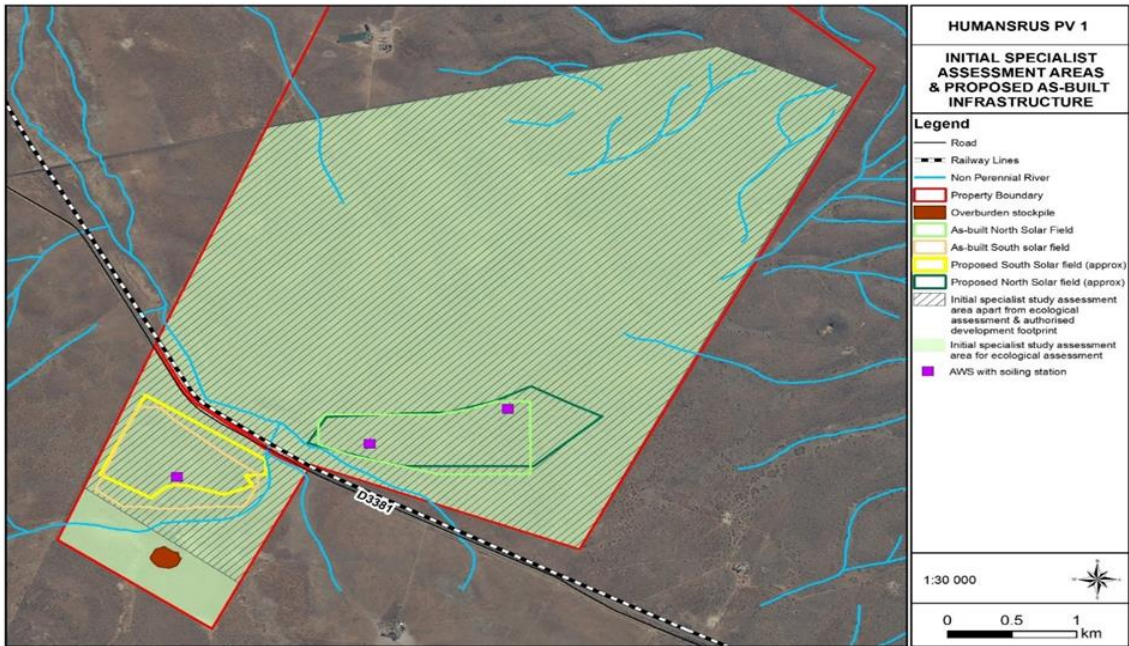
solar fields with PV arrays occupy a total of less than 150ha of the site in total. The north solar field covers an area of approx. 75ha with PV arrays of up to 1,5km in length, while the south solar field covers an area of approx. 67ha with PV arrays of up to 1km in length.

Figure 4: As-built and proposed infrastructure (north and south solar fields with PV arrays, AWS and soiling stations)

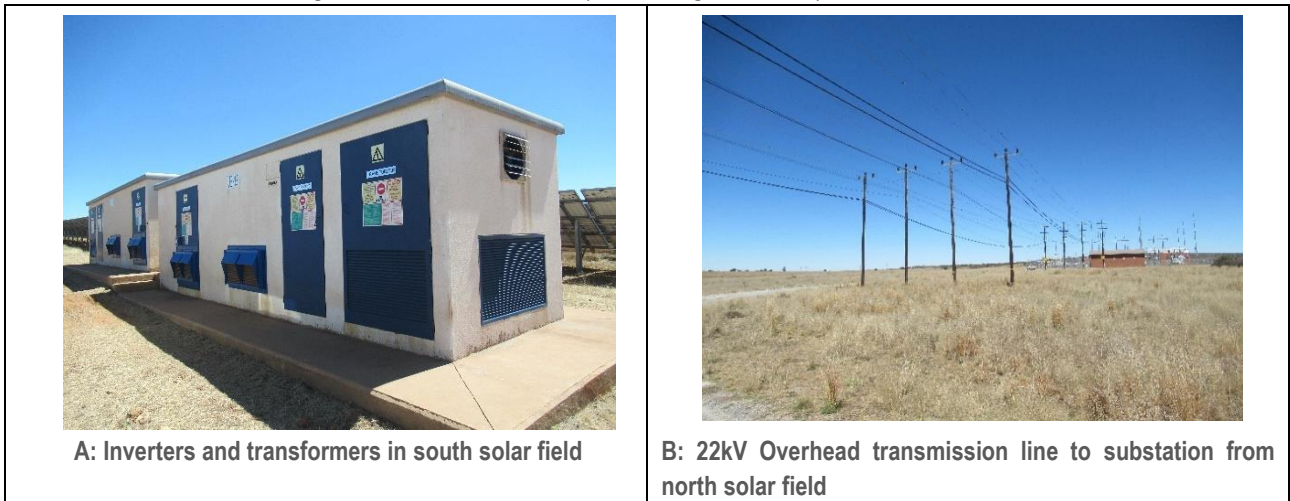
Each row of PV panels is connected via an internal underground electrical reticulation system, running up to an inverter building, to convert the direct current (DC) output to alternating current (AC). The inverters are connected to a number of step-up transformers, which convert the low voltage AC to a medium voltage (22 kV) internal collection system. The medium voltage collection system is comprised primarily of underground cables, while the solar field to the north is connected to the substation via a 22kV overhead transmission line with a total length of less than 500 meters (Refer to Figure 5 A & B).

A: Inverters and transformers in south solar field

B: 22kV Overhead transmission line to substation from north solar field

Figures 5 and 6 respectively show the 22kV powerline connects the northern solar field and substation – across railway line and D3381 road, and has been installed above-ground. There are several disadvantages associated with the installation of underground lines including: time to repair, cost of installation, more complex construction (especially with a road crossing and through culverts under the railway line) and poorer heat dissipation. Therefore, for these reasons, and for Lesedi Power Project to comply with Eskom’s specifications, overhead powerlines were constructed over the railway line and D3381 Road Crossing in 2014.

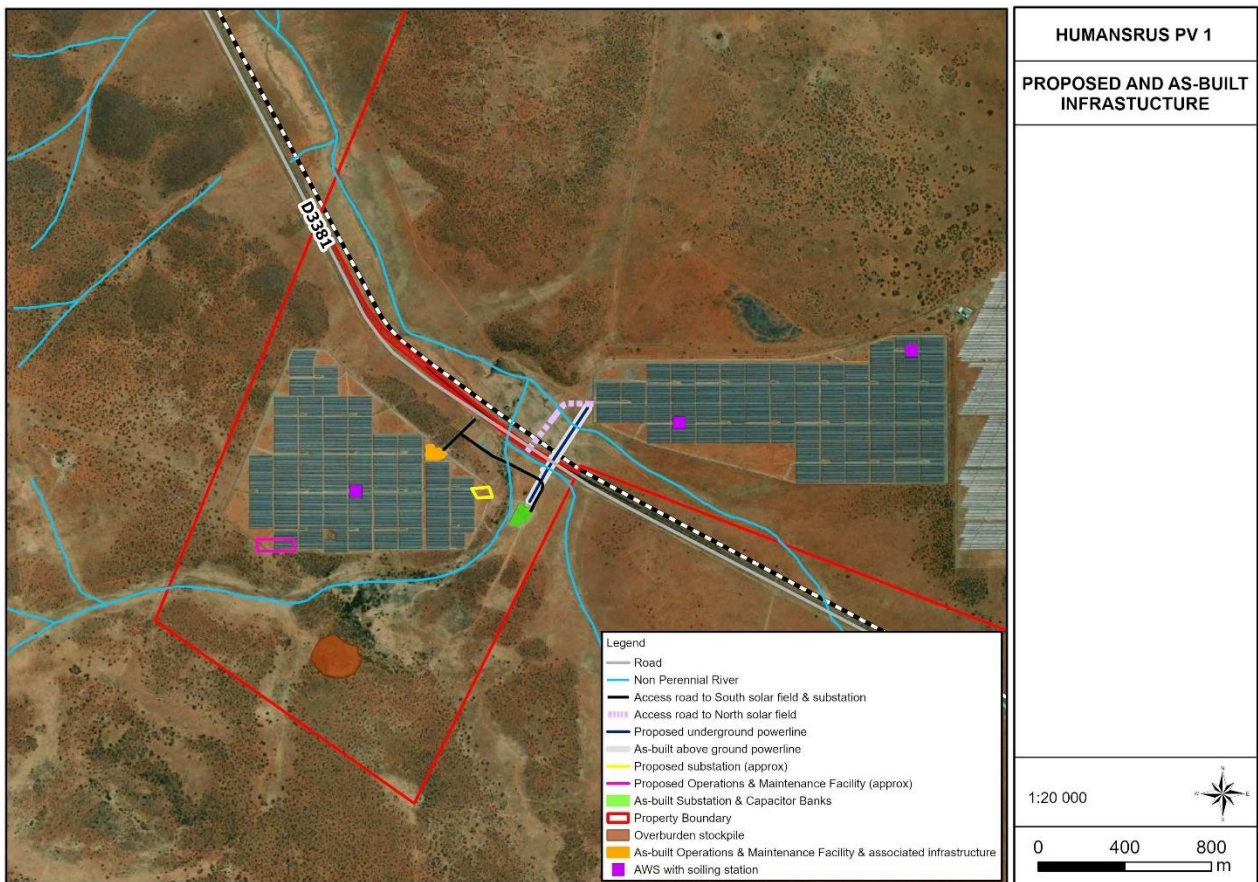
Figure 6: Proposed and as-built infrastructure (powerlines, substation and O&M facility)

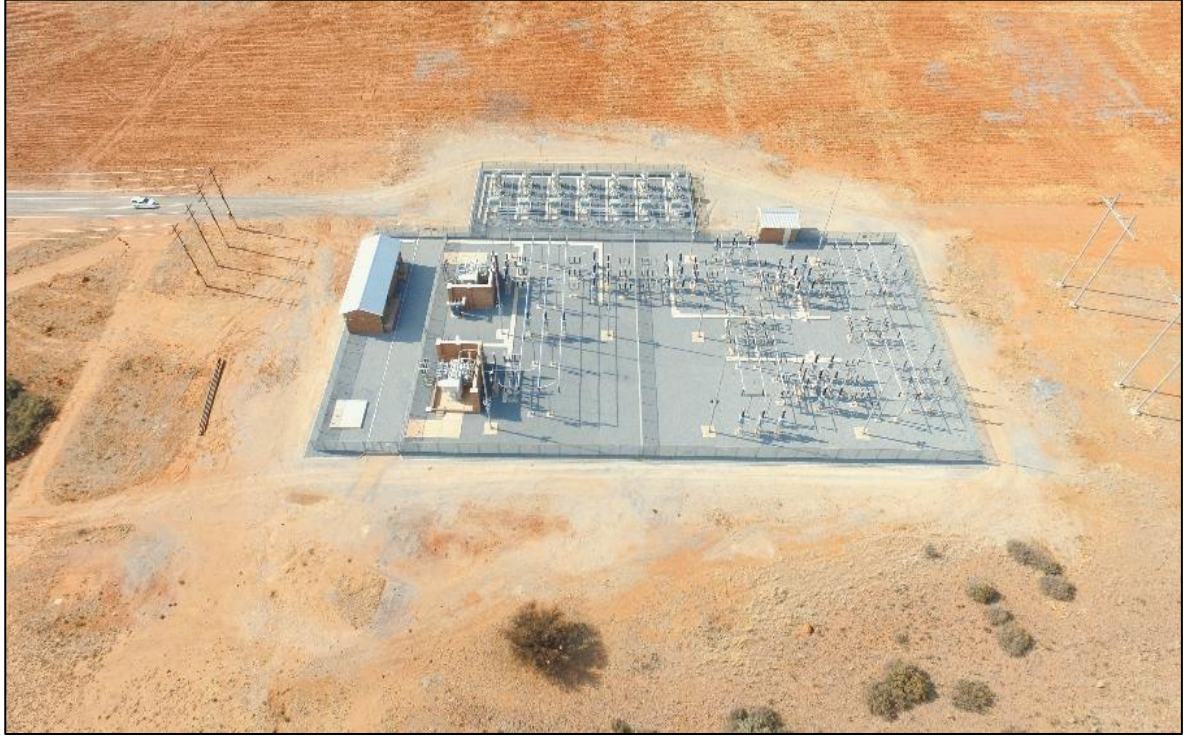
A substation, transformer bays and associated switching facilities were built to facilitate connection of the solar facility to the national transmission and distribution grid network (Refer to Figure 7). The high voltage side of the substation is maintained and owned by Eskom. The substation is located close to Eskom's existing 132kV overhead transmission line, situated to the south-west of the site (Refer to Figure 9 A & B). The substation and capacitor banks over an area of up to 5 970m² and includes external 132kV transformers, electrical switchgear and capacitor banks which is fenced for security and safety. The substation and associated infrastructure are shown in Figures 7 & 8 (A & B). The capacitor banks were installed to satisfy the National Energy Regulator of South Africa (NERSA) regulations and the national Grid Code put in place in 2014.

Figure 7: Substation, capacitor banks and grid connection

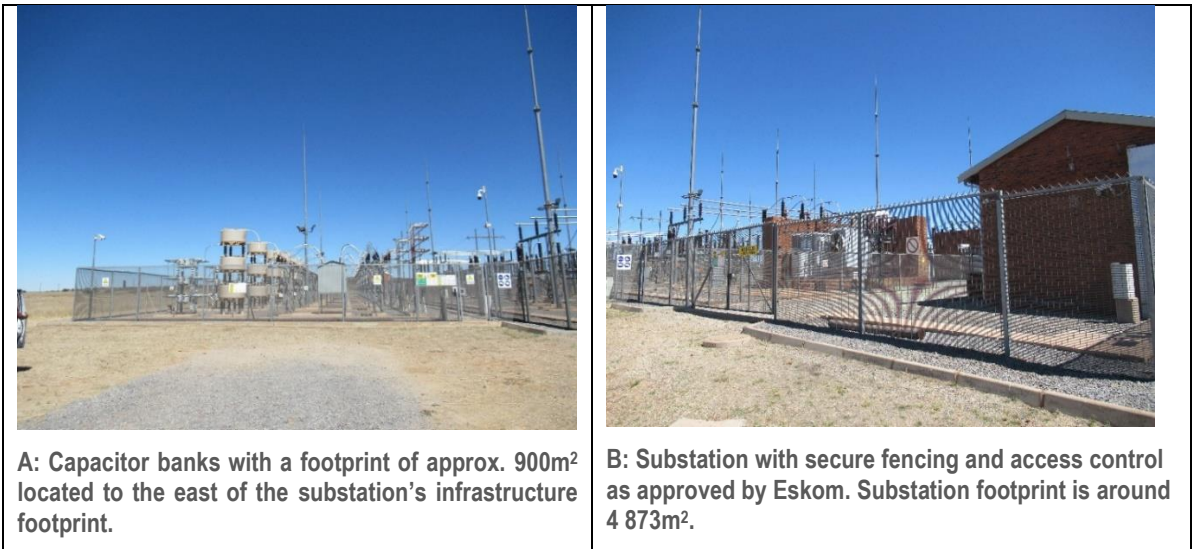
Figure 8: Installed capacitor banks and substation with security

A: Capacitor banks with a footprint of approx. 900m² located to the east of the substation's infrastructure footprint.

B: Substation with secure fencing and access control as approved by Eskom. Substation footprint is around 4 873m².

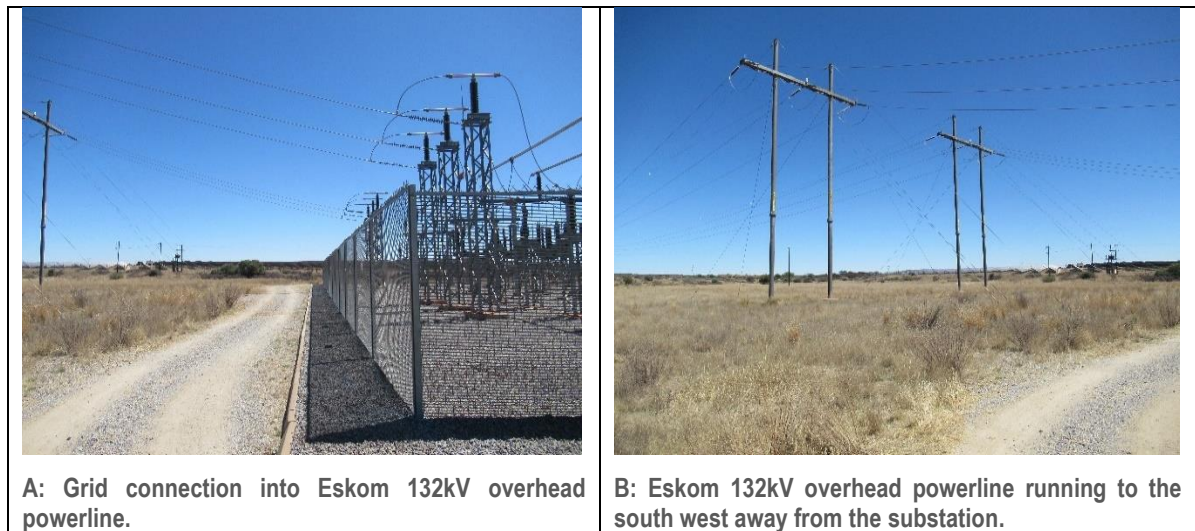
Figure 9: Eskom 132 kV overhead powerline connection

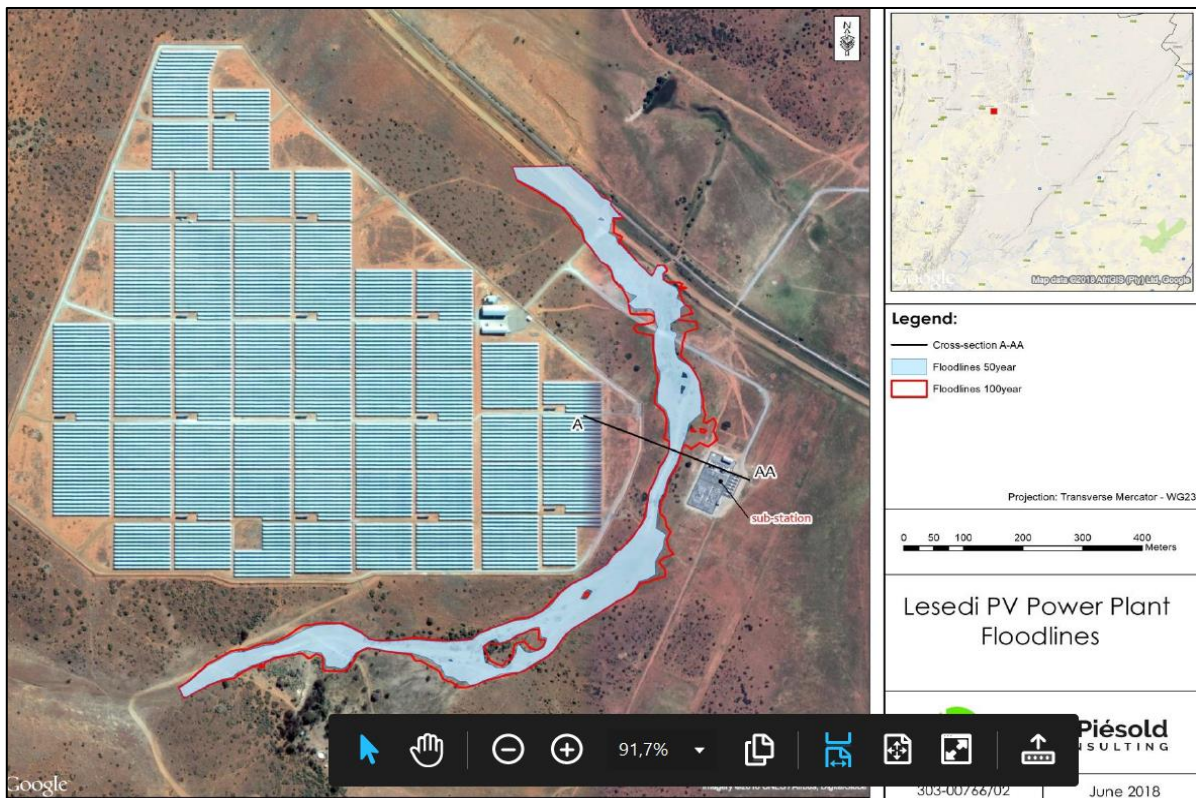
Figure 10: Substation in relation to 1:50 and 1:100 year floodlines (Knight Piesold, 2018)

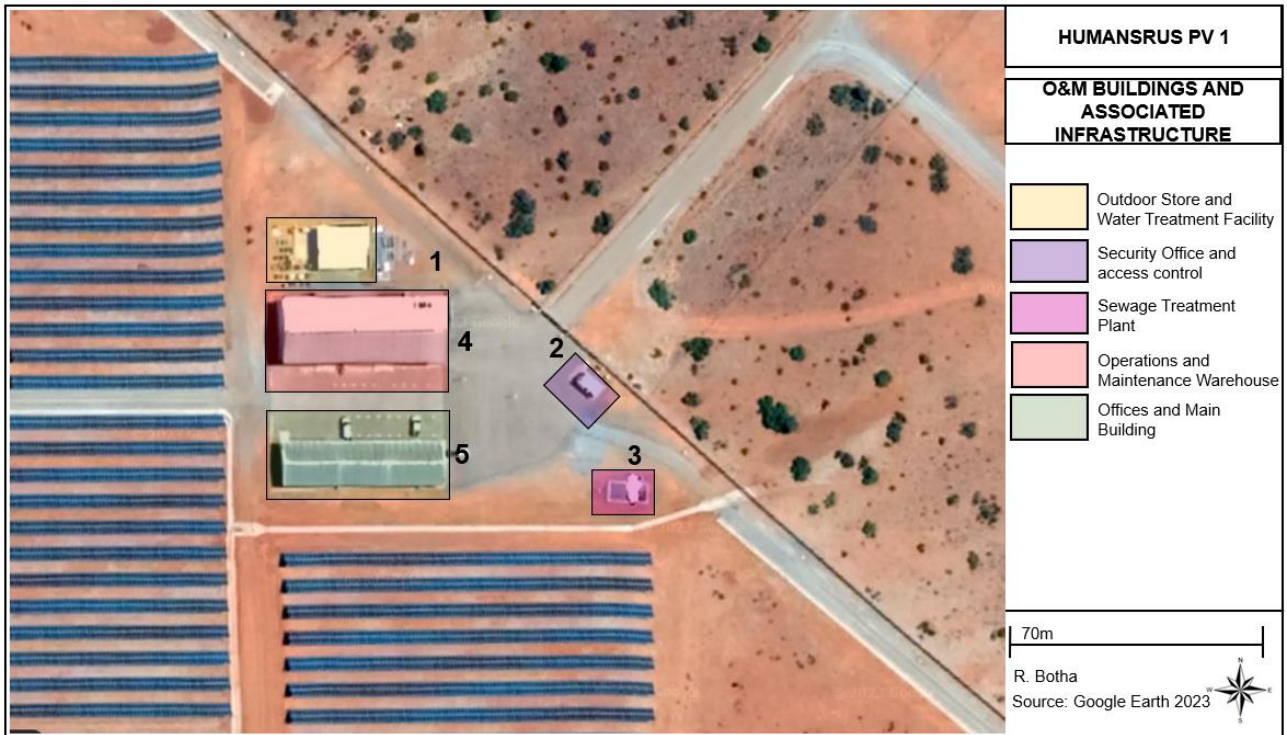
Figure 11: O&M buildings and associated infrastructure

The following infrastructure was constructed as part of the Lesedi Solar Power Facility: O&M building, waste-, water-, sewage- and stormwater infrastructure etc.) (Figure 11). Sections 4.5.1 – 4.5.4 below details the respective infrastructure as well as amendments applied for.

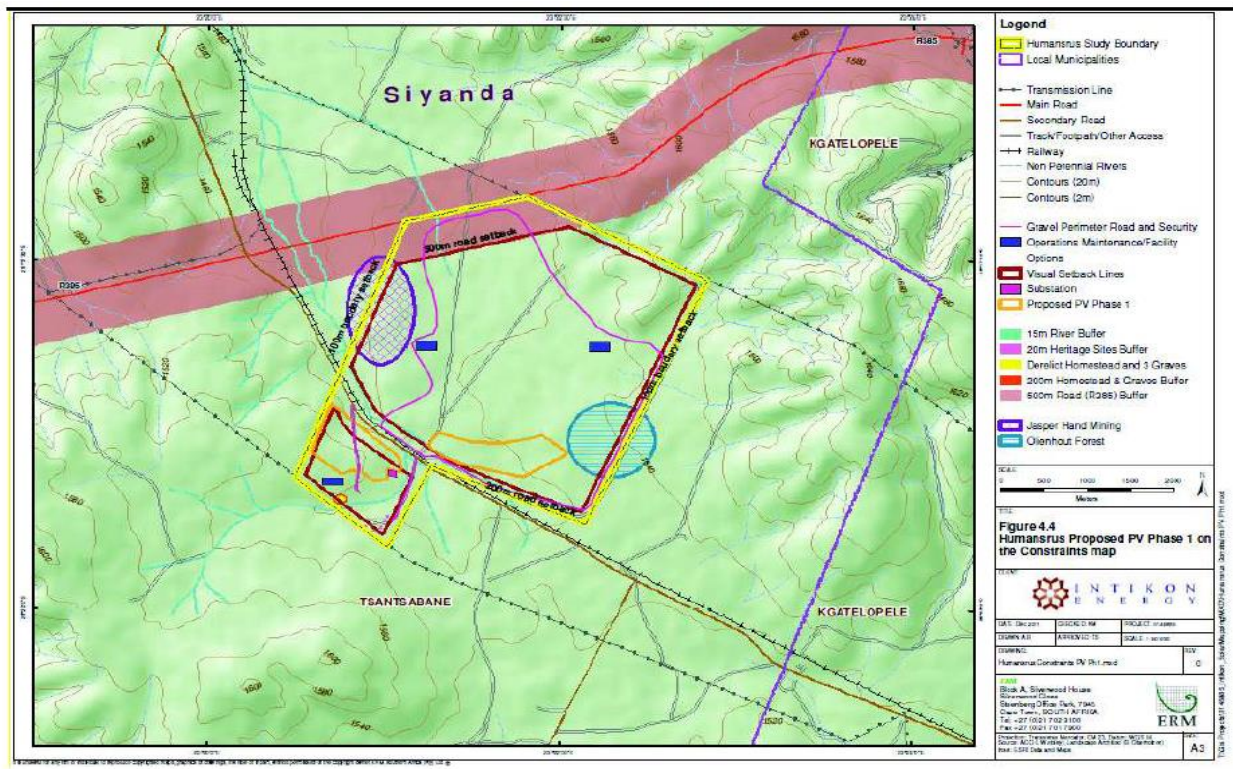
Figure 12: Indicative Site Layout Plan (ERM, 2011)

Reference is made Figure 12 below extracted from the 2011 EIR report of the original NEMA EIA Application (EA 12/12/20/1903), where it is indicated that several alternatives were identified and considered for the location and construction of the O&M building.

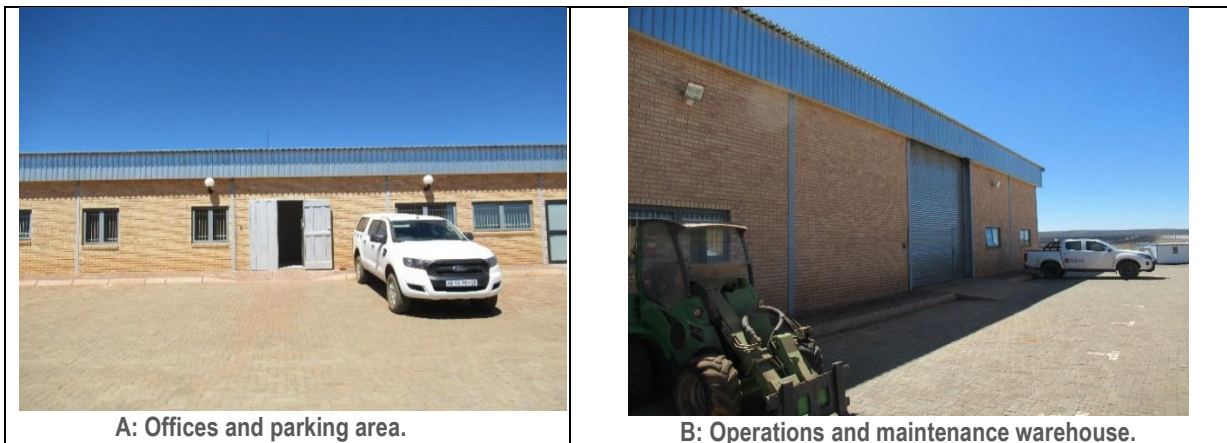
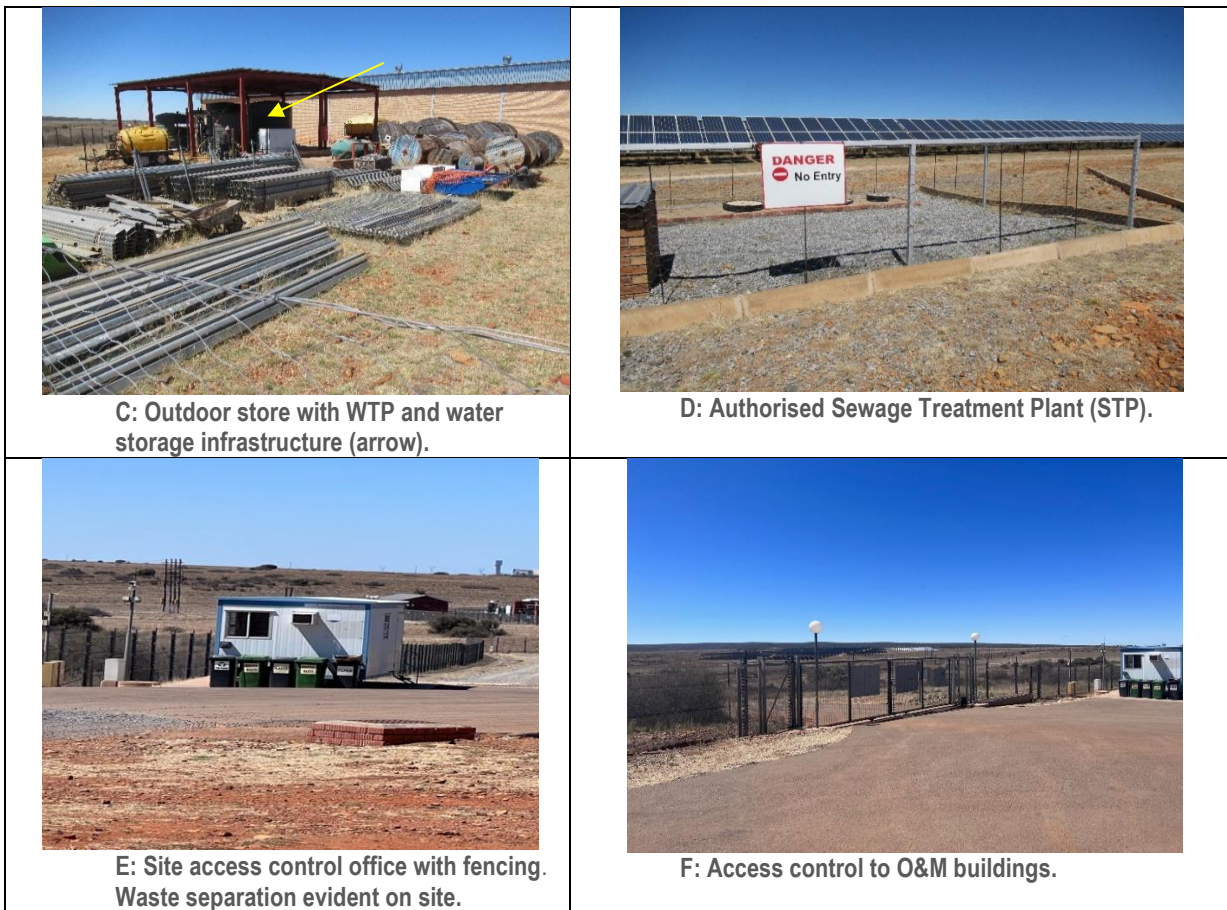
Figures 13 A – F below highlights the as-built O&M building and associated infrastructure that was constructed within a fenced footprint of the south solar field at 28°31'52"S and 23°35'40" E within authorised 150ha footprint of the solar field, as indicated in Figure 12 above.

Figure 13: O&M facilities including offices, warehouse, parking, access control and sewage treatment plant etc.)

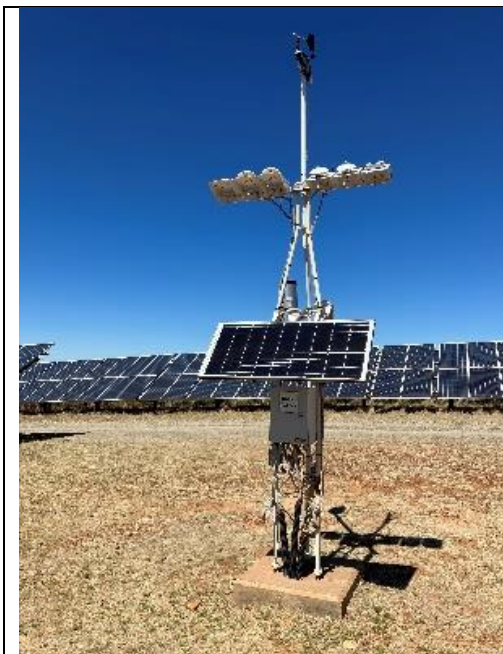
- Three Autonomous Weather Stations (AWS), approximately 4m in height, are located within the solar fields; for continuous monitoring of local conditions during the operational phase (Figure 14). GPS coordinates of the AWS’ are as follows:
 - AWS1 located at: 28°19'0.58"S and 23°21'1.89"E
 - AWS2 located at: 28°18'39.63"S and 23°22'24.87"E
 - AWS3 located at: 28°18'50.38"S and 23°21'50.19"E
- Two soiling stations, consisting of two PV panels each, measuring approximately 4m² in size each have been installed to monitor and determine operational efficiencies (Figure 14). GPS coordinates of the soiling stations are as follows:
 - Soiling Station 1 located at: 28°19'0.58"S and 23°21'1.89"E
 - Soiling Station 2 located at: 28°18'39.63"S and 23°22'24.87"E
 - Soiling Station 3 located at: 28°18'50.38"S and 23°21'50.19"E

A: AWS2 installed in Lesedi south solar field.

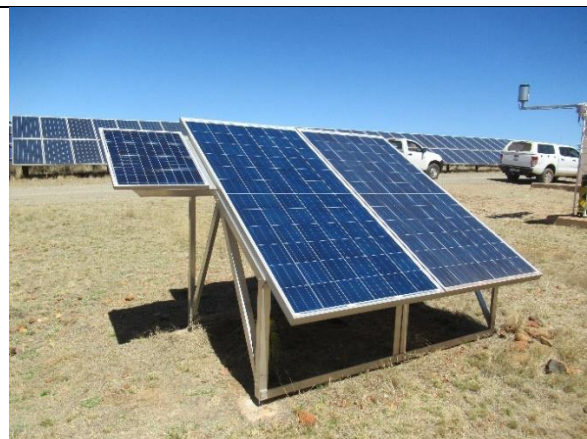
B: Soiling station installed to monitor and determine operational efficiencies in Lesedi south solar field.

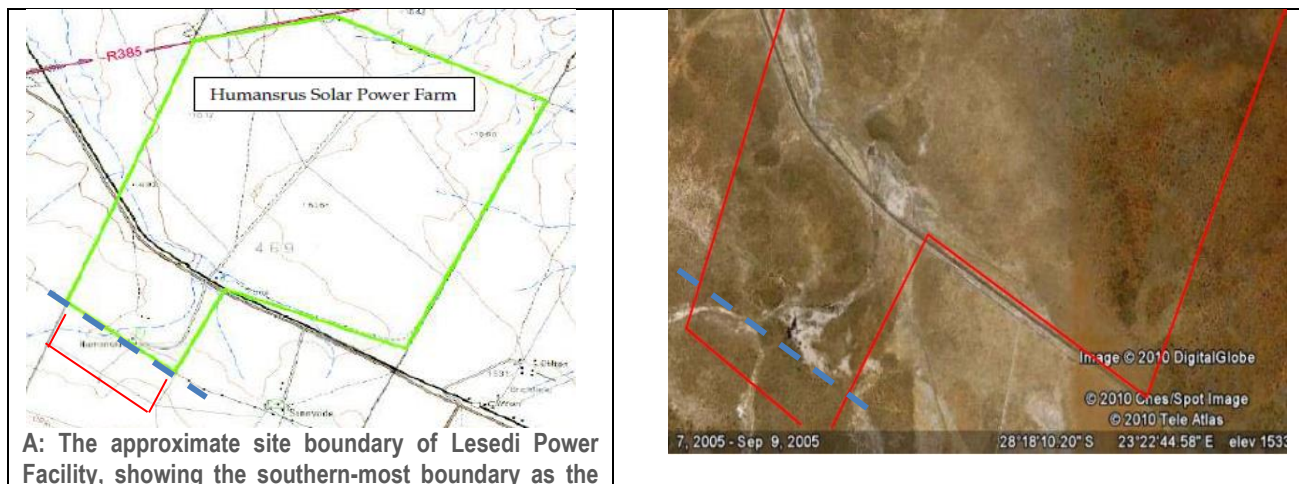
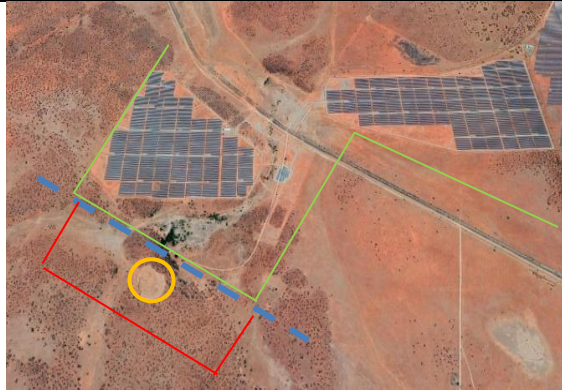
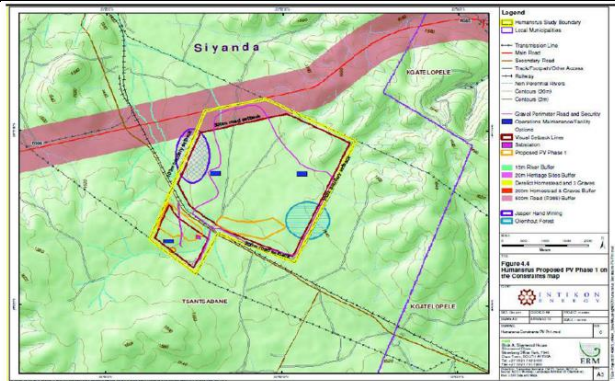
A: Eskom transmission line (blue dash-line) transecting the landowner's property; boundary fence shown by red line (Figure 1.1 in EIR, 2011).

C: Location of overburden stockpile (orange circle) in relation to Eskom powerline (blue dash-line) and owner's property boundary (red line). The green line shows the approximate site boundary as depicted in the 2011 EIR.

B: The property boundary (red lines) demarcated the study area of the 2011 Ecology Specialist Study. The blue dash-line shows the location of the Eskom transmission line (Figure 1 in 2011 Ecology Specialist Report).

D: Site Layout Plan (ERM, EIR 2011)

Figure 15 A - D summarises the activities outside of the authorised development footprint relating to the location of the overburden stockpile. The EA allowed for a small borrow pit to be established for construction activities. However, fill-material was not needed, and excess material (topsoil and overburden) was removed and stored. The location of the stockpile, south of the 132kV Eskom powerline and behind the old homestead is indicated by the orange circle in Figure 15C. The “approximate site boundary” was presented in Figure 1.1 of the 2011 EIR, which shows the southern boundary of the study area, as the Eskom transmission line (blue dash-line added to Figures16 A-C). The Eskom transmission line transects the landowner’s property (i.e. the proposed project area includes the old homestead). The 2011 Ecological Specialist Report shows the southern-most boundary of the study area as the boundary of the landowner’s property (see Figure 15B). The overburden stored on the landowner’s property is within the authorised property, namely Humansrus Farm (Farm 469) however not within the authorised development footprint, which was taken as the proposed “approximate site boundary”.

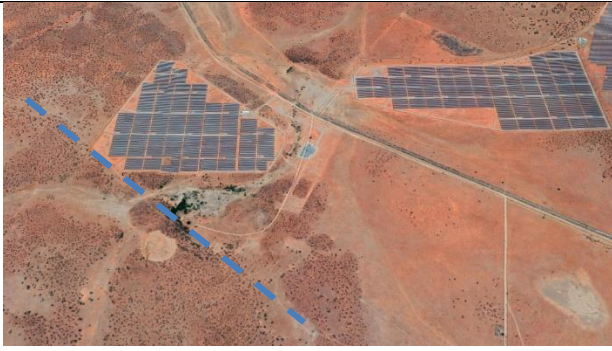
A: Location of Lesedi Solar Power Facility (south solar field on the left, and north solar field on the right), in 3D relief, showing Eskom transmission line (blue dash line) (Source: Google Maps, 2021).

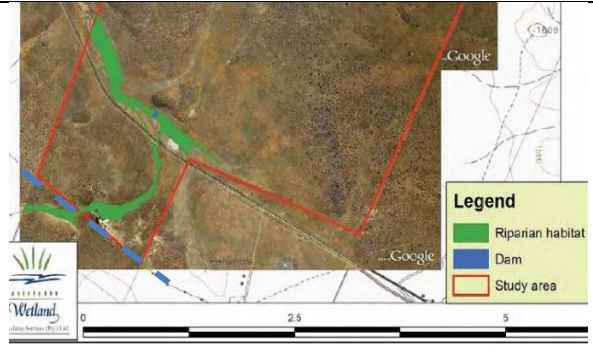
B: Delineated riparian habitat (Source: Figure 6 of the 2011 Wetland Delineation Assessment).

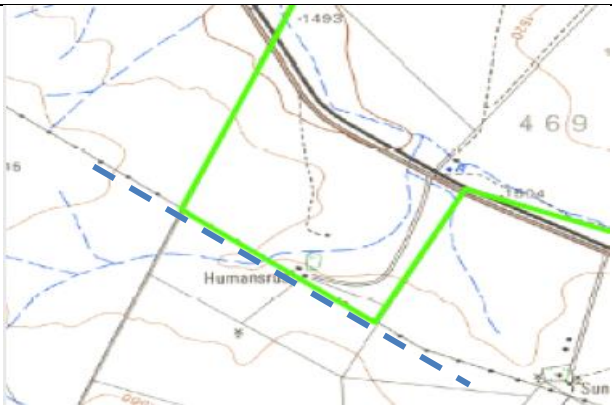
C: Topographical map, showing watercourses.

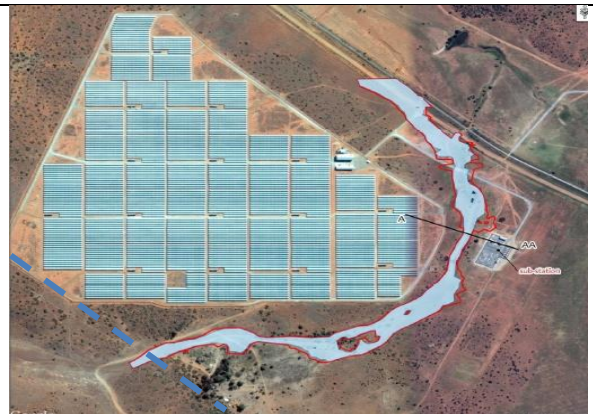
D: Floodline around Lesedi south solar field; blue shaded area shows 1:50-year floodline, and red border shows 1:100-year floodline (Source: Figure 3 of the 2018 Aquatic Assessment and Floodline Determination).

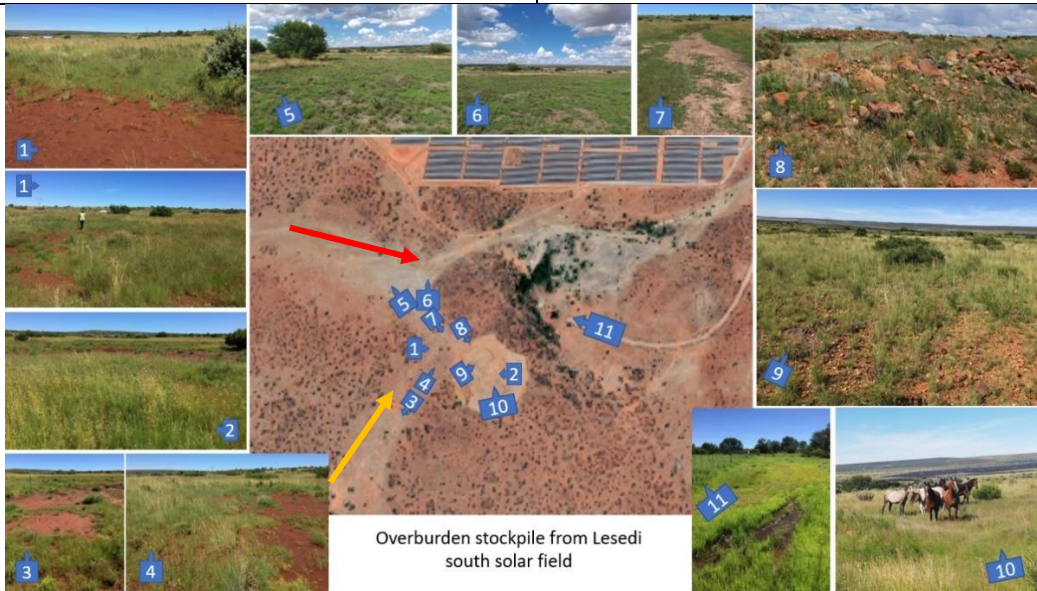
E: Site investigation of the overburden stockpile undertaken in January 2011.

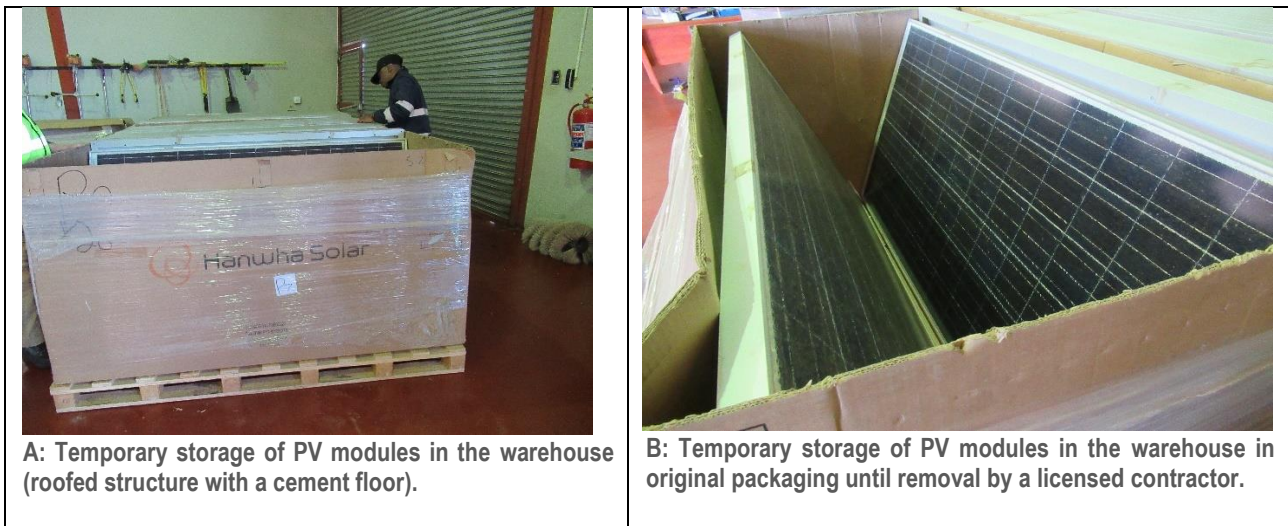
Waste PV modules are generated during operations. It is however not financially viable to remove waste PV panels from the facility within 90 days since generation. This is mainly due to high transport costs to licensed waste disposal facilities. Accordingly, an application will be lodged with the DFFE for the temporary storage of up to 300 waste solar PV modules on site, in compliance with the 2013 Norms and Standards for the Storage of Waste (NEM:WA 59 of 2008). Figure 17 A & B demonstrates the PV models and storage conditions.

Figure 17: Temporary storage of waste PV modules

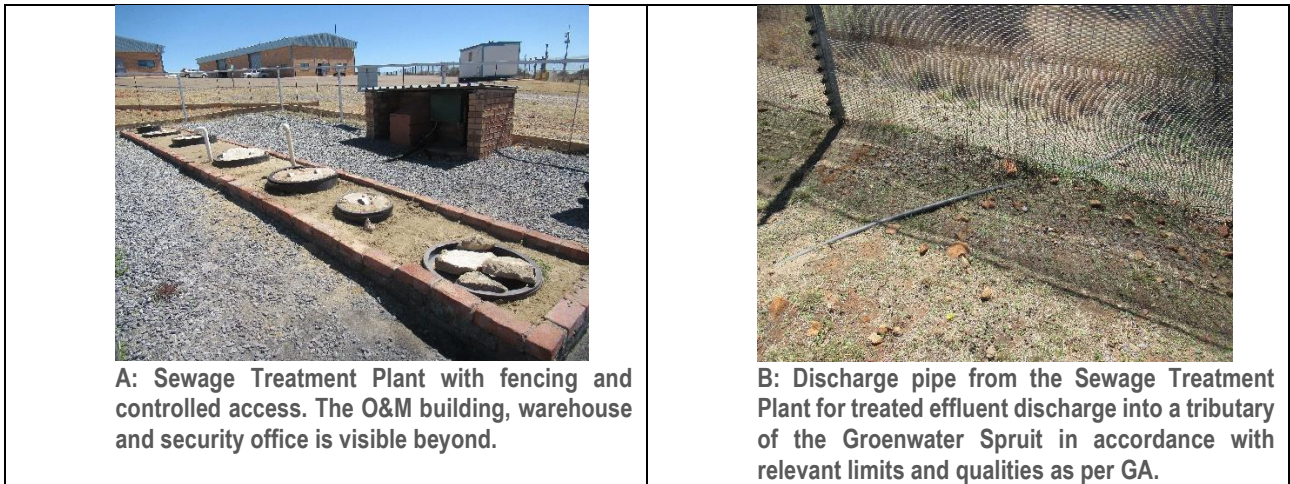
Figure 18: Sewage Treatment Plant

Supplementary information on the STP is attached to this report in Annexure Refer to C15_Sewage Treatment Design.

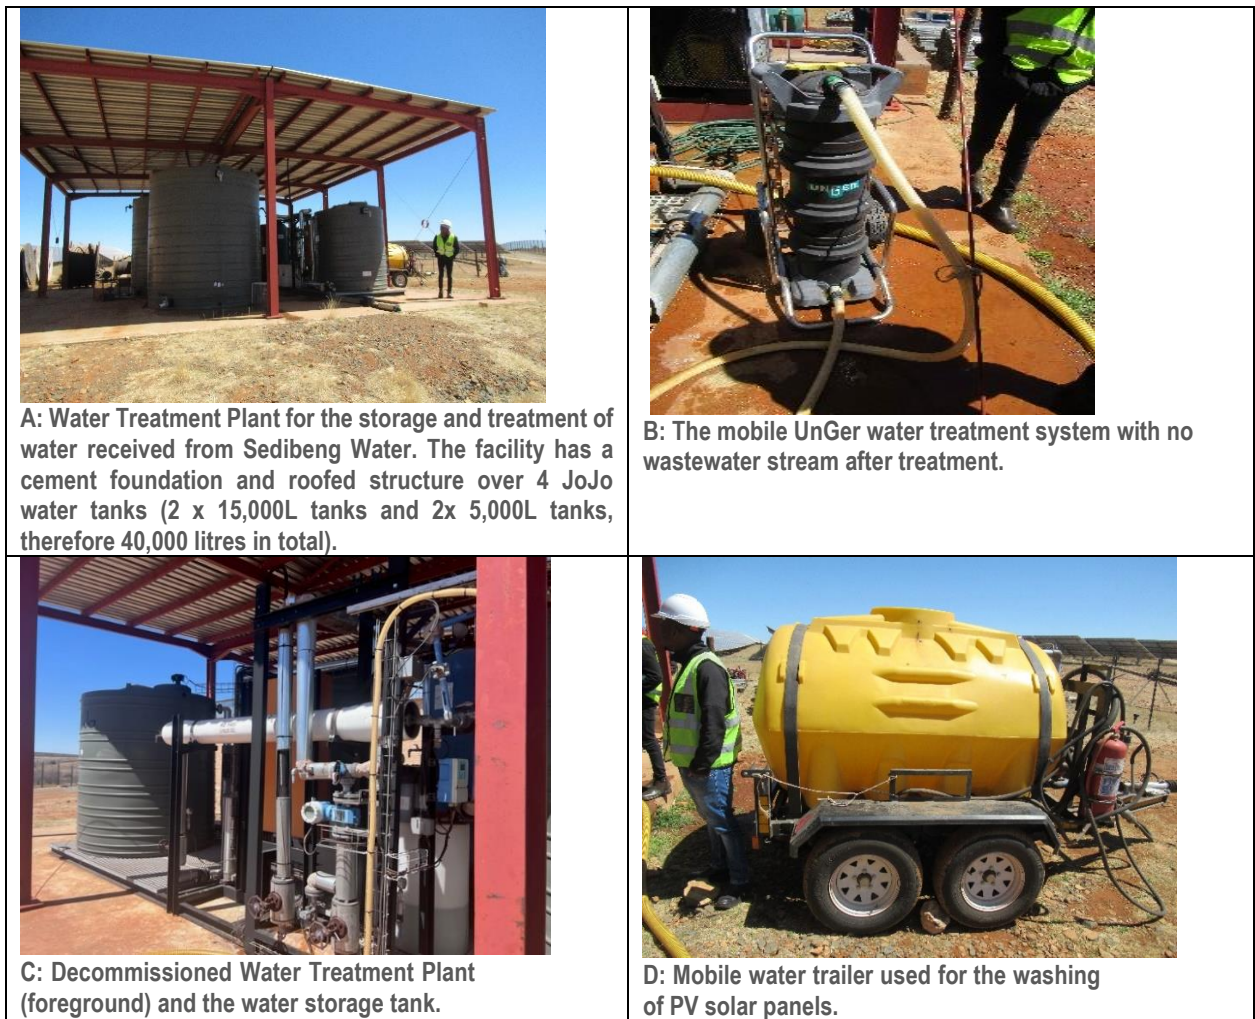
Figure 19: Water Treatment Plant

Supplementary information on the WTP is attached to this report in Annexure C12_Water Treatment Plant Location.

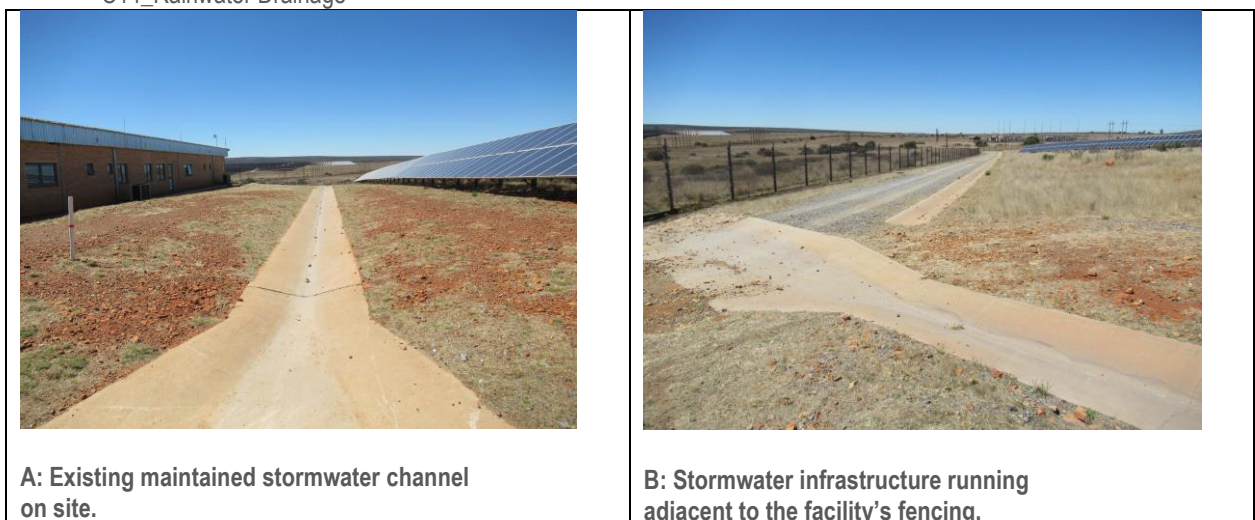
Figure 20: Stormwater infrastructure at Lesedi Solar Power Facility

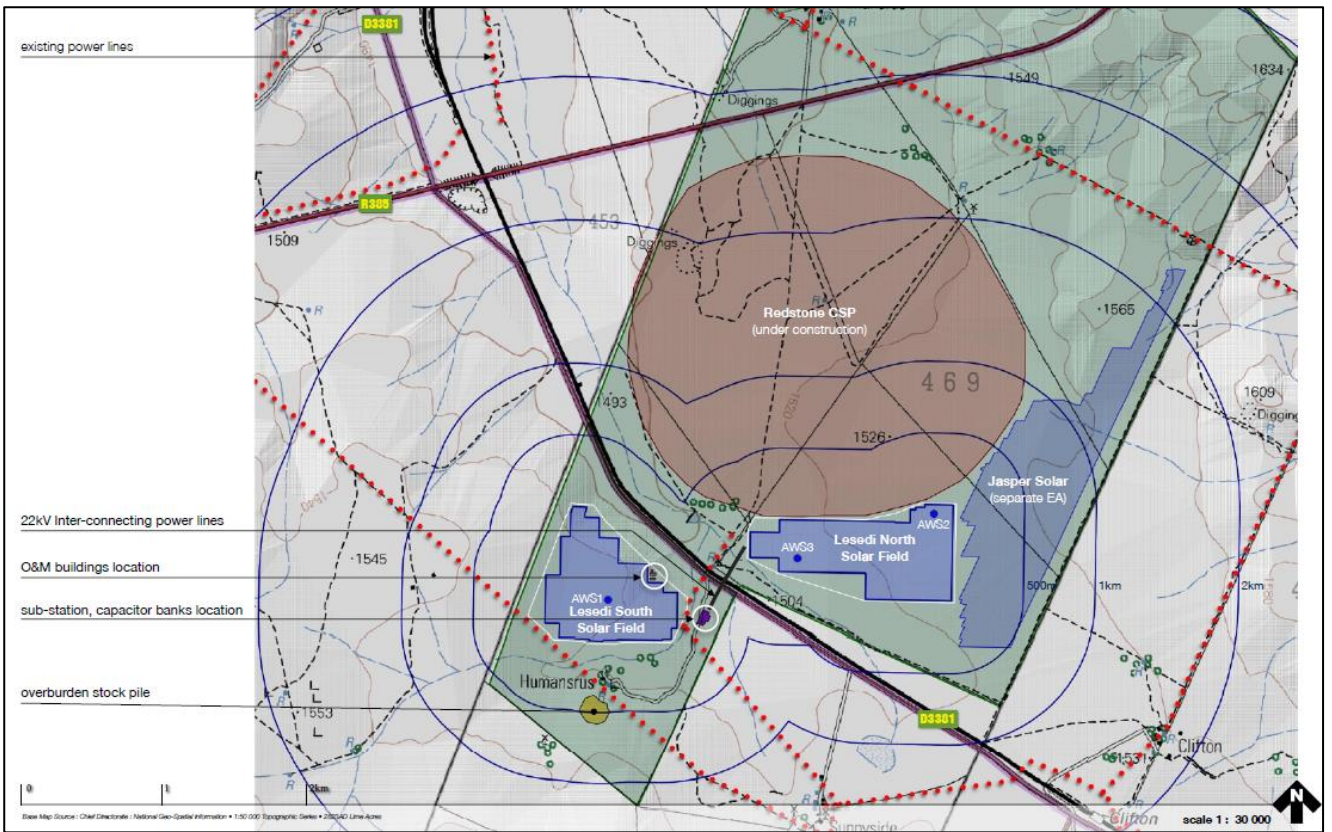
Figure 21: Lesedi Solar Power Facility layout (Visual Review, 2023)

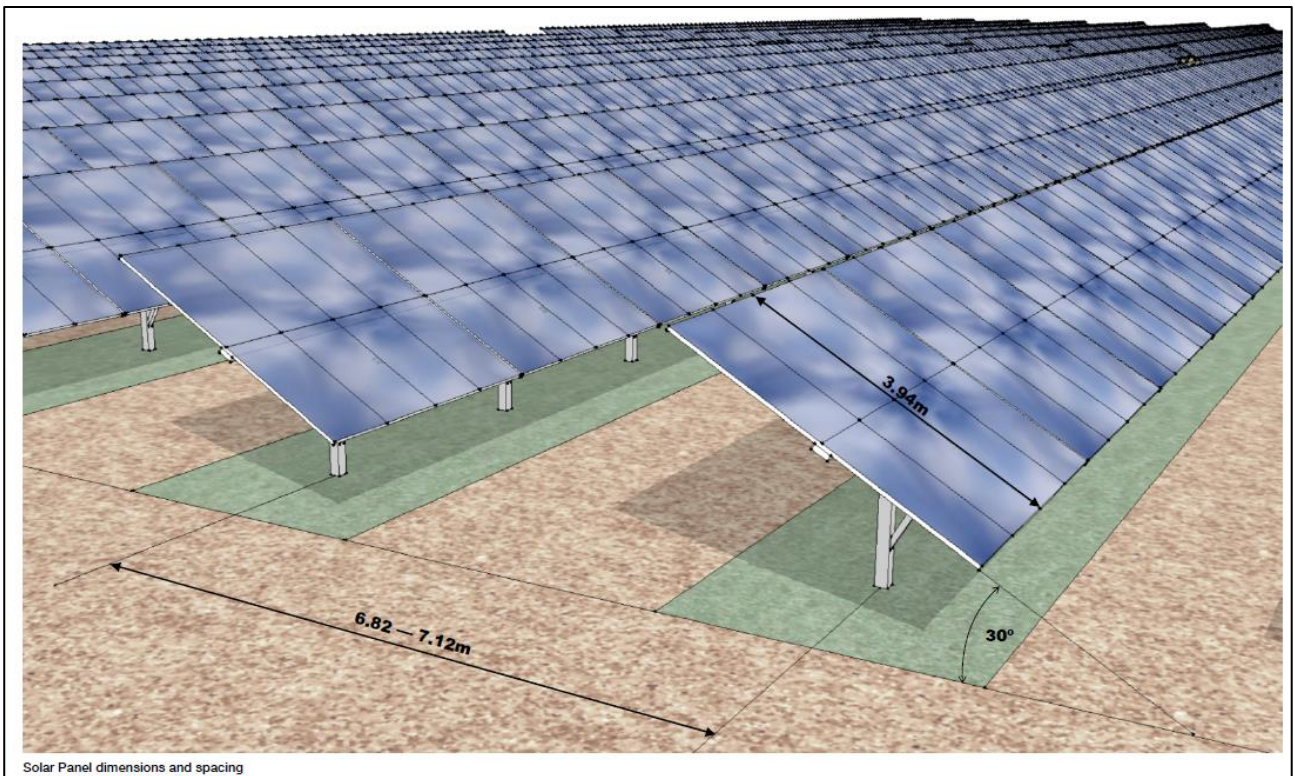
Figure 22: 3D Model solar panels dimensions and spacing (Visual Review, 2023)

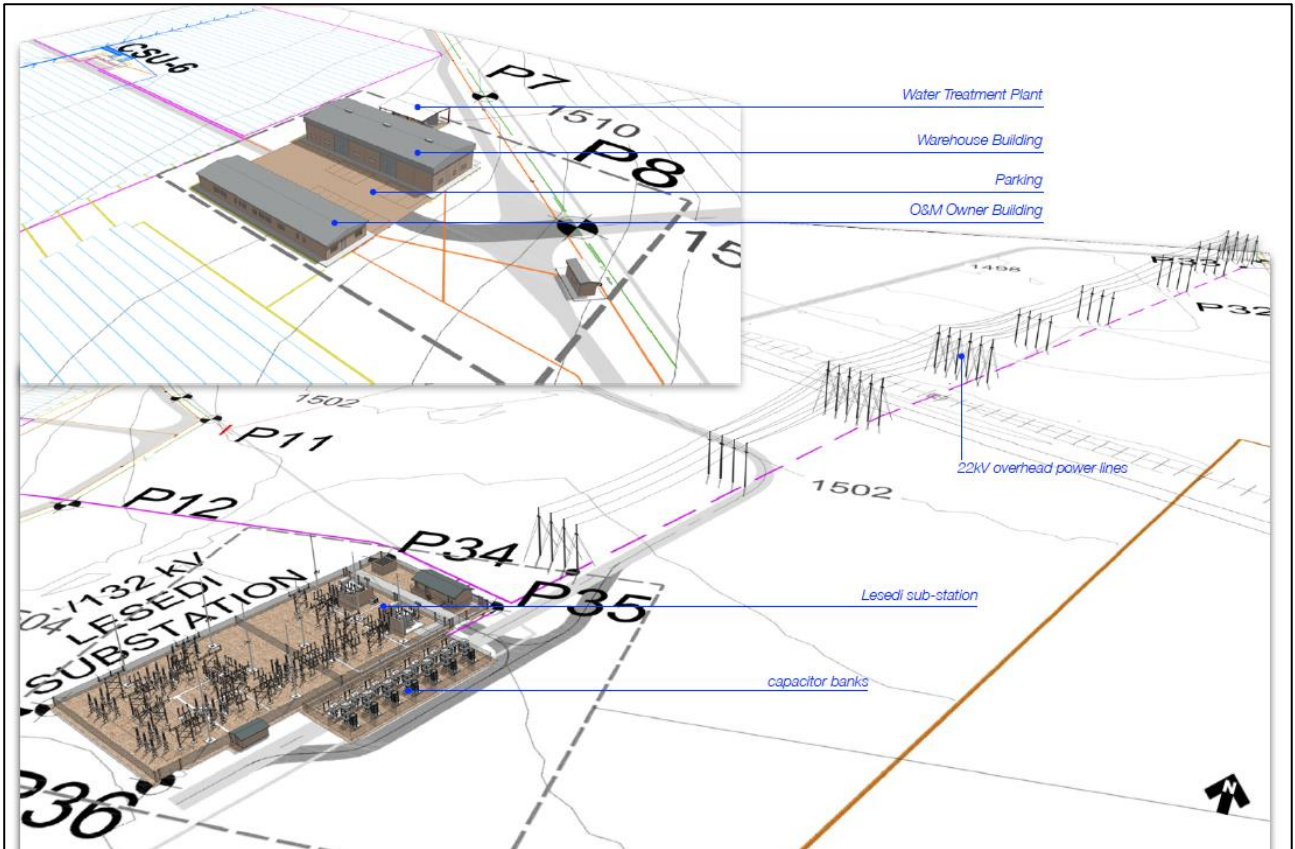
Figure 23: 3D Model of facilities (Visual Review, 2023)

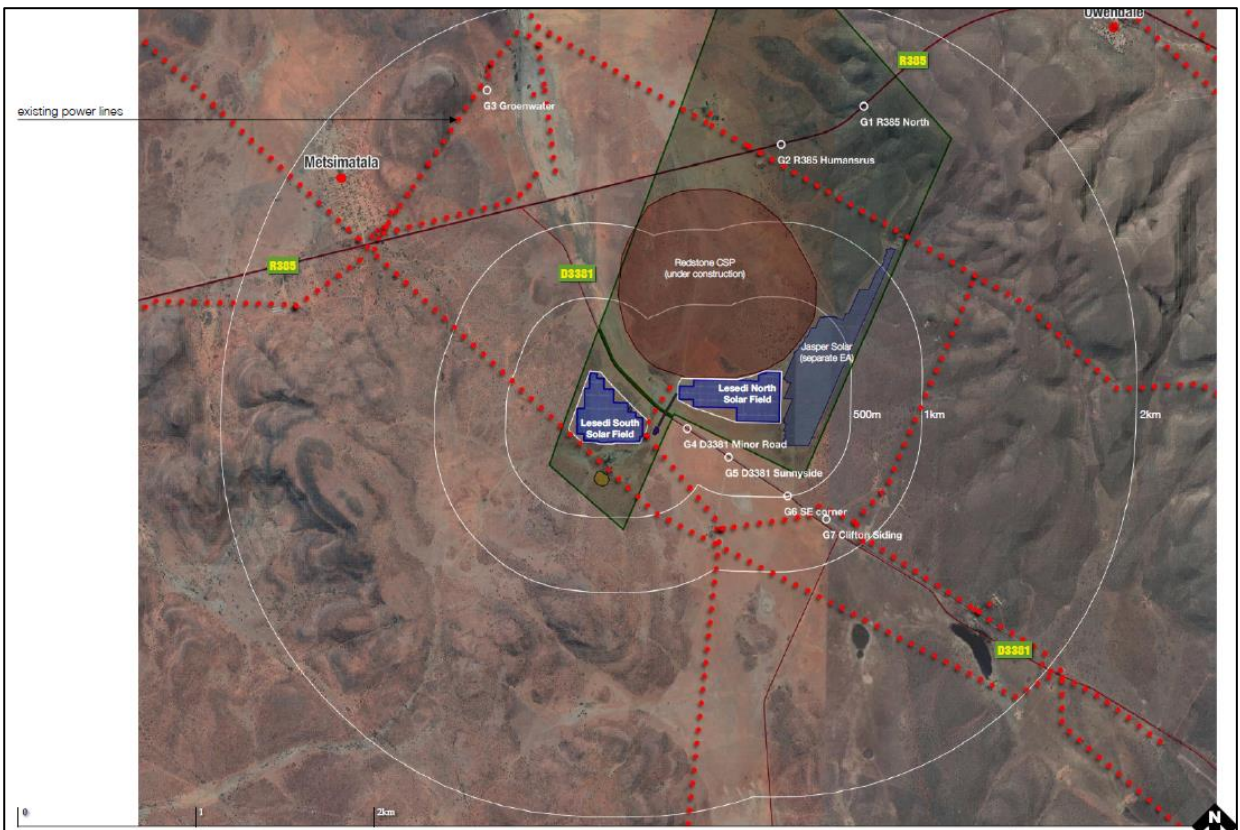
Figure 24: Lesedi Solar Power Facility viewpoints, distance radii (Visual Review, 2023)
