PART 2 ENVIRONMENTAL AUTHORISATION AMENDMENT APPLICATION: 75 MW HUMANSRUS PHOTOVOLTAIC (PV) 1 SOLAR POWER FACILITY

DFFE Ref: 2022-09-0038

MAY 2023

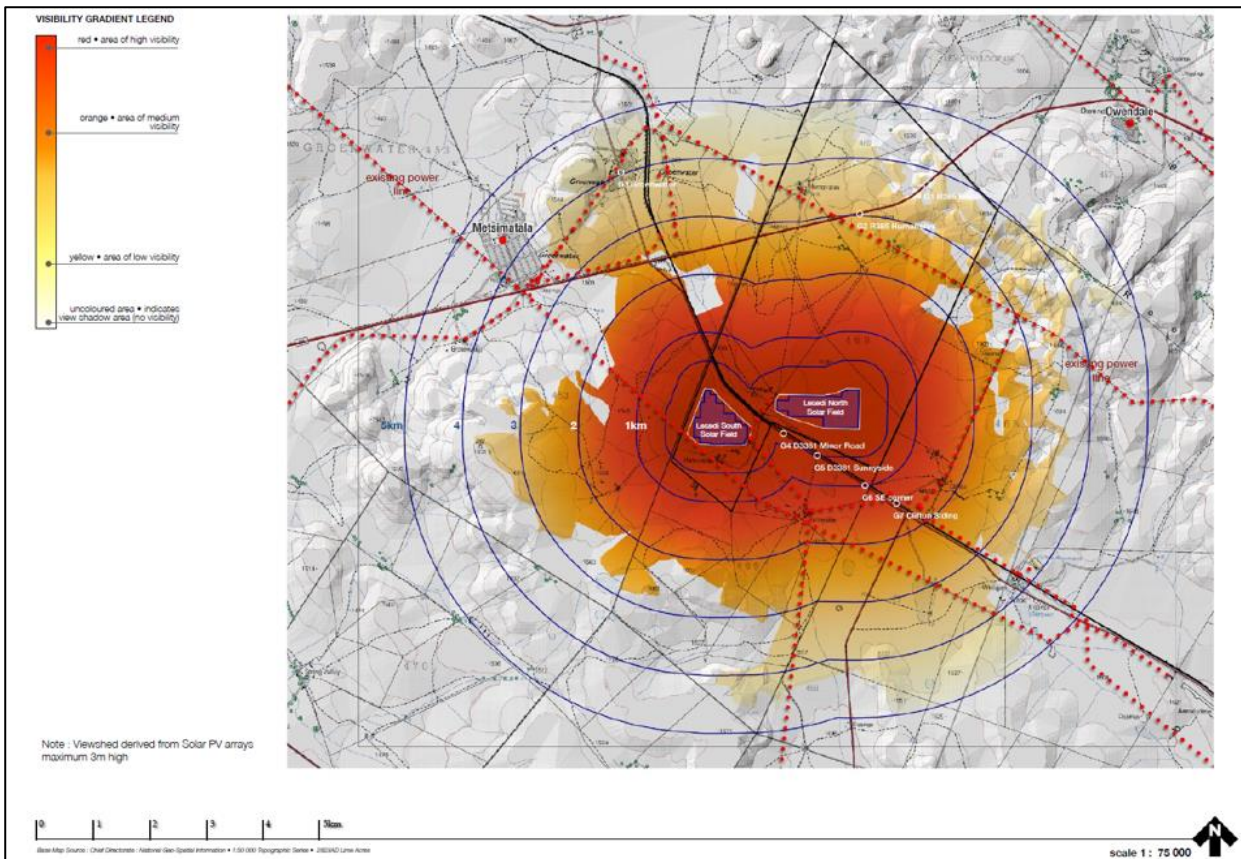
Figure 25: Lesedi Solar Power Facility viewshed and distance radii (Visual Review, 2023)

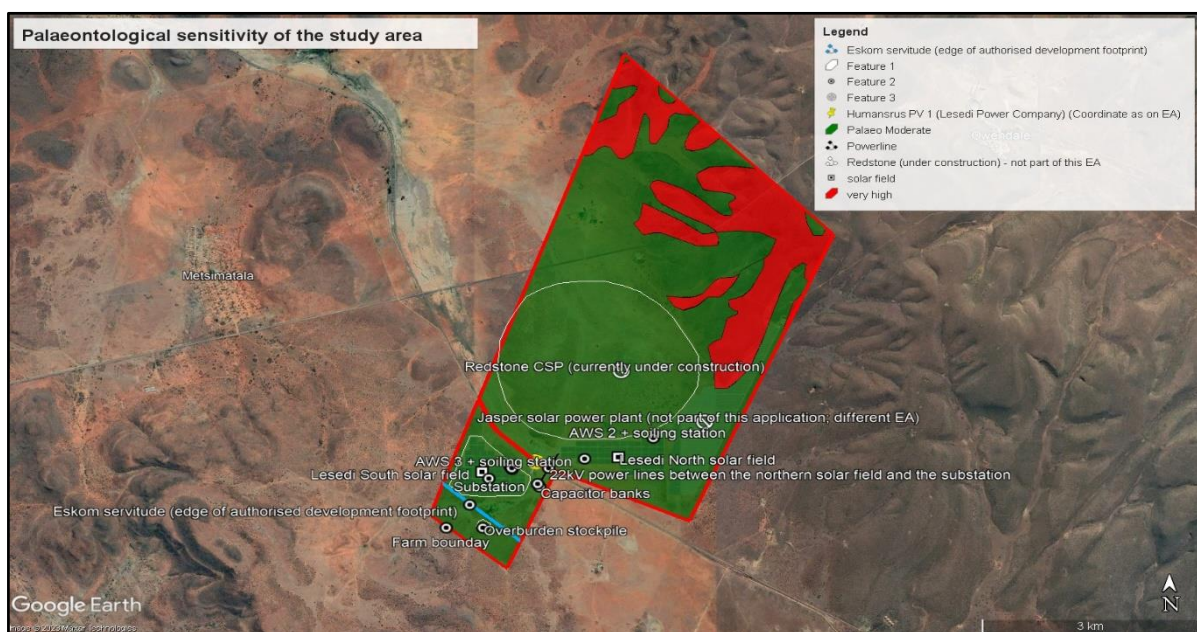
- Following a detailed desktop survey of existing data, we confirm the fact that only areas in the north and east of the study area are underlain by very highly sensitive (red colour) geological formations (Figure 27). Areas underlain by deep soil cover (colluvial plains) are indicated as moderately sensitive (green colour) since deep excavation (>1,5m) can expose significant fossils.

Figure 27: Very high paleontological sensitivity as indicated (Paleontological Review, 2023)

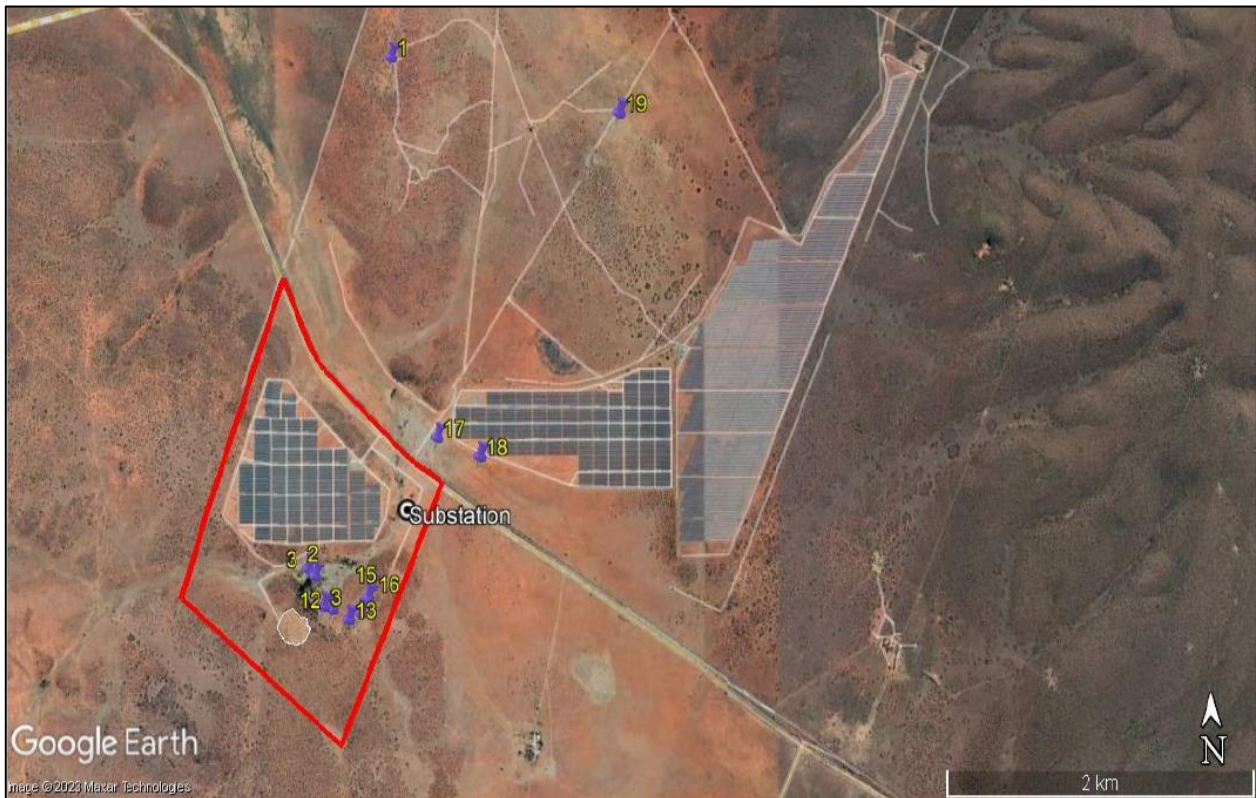
Figure 28: The location & distribution of the heritage sites of significance recorded in 2010 (Google Earth 2023) (Heritage Review, 2023).

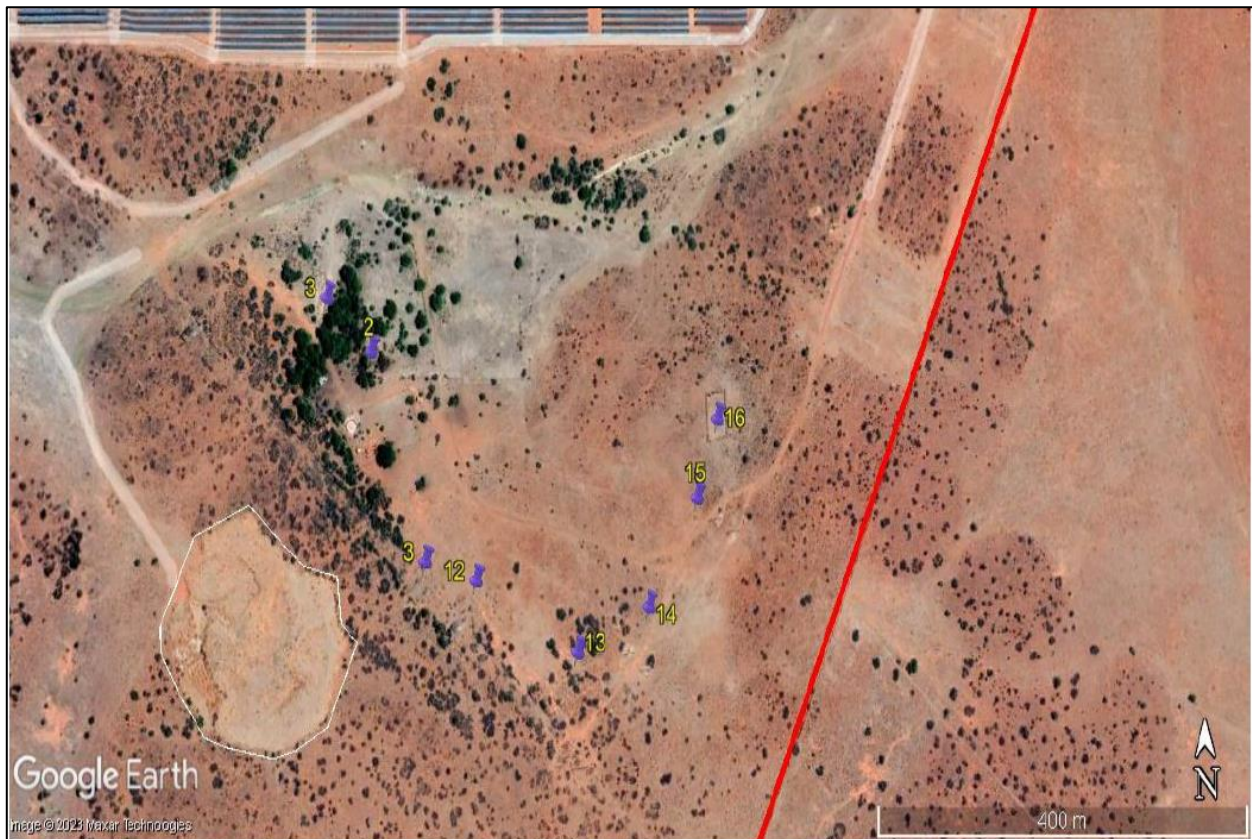
At the time of the 2010 assessment (for the planned Groenwater Solar Farm development) the sites were all still intact, with no development having commenced yet. From aerial images of the study and development/application area (Google Earth) dating to between 2006 and 2023 it is also clear that somewhere between the 2010 assessment and 2016, the Solar Farm development had been undertaken and completed. However, none of the recorded sites had been impacted and are still present (presumably) and intact as they were in 2010 (Figures 28 &29). The additional development work that has already taken place under this EA Amendment Application, and has been completed already, **did not impact on any** of the known and recorded sites.

Figure 29: Evidence of little to no impact on identified heritage sites of significance as a result of the development of the facility (Google Earth 2023) (Heritage Review, 2023).

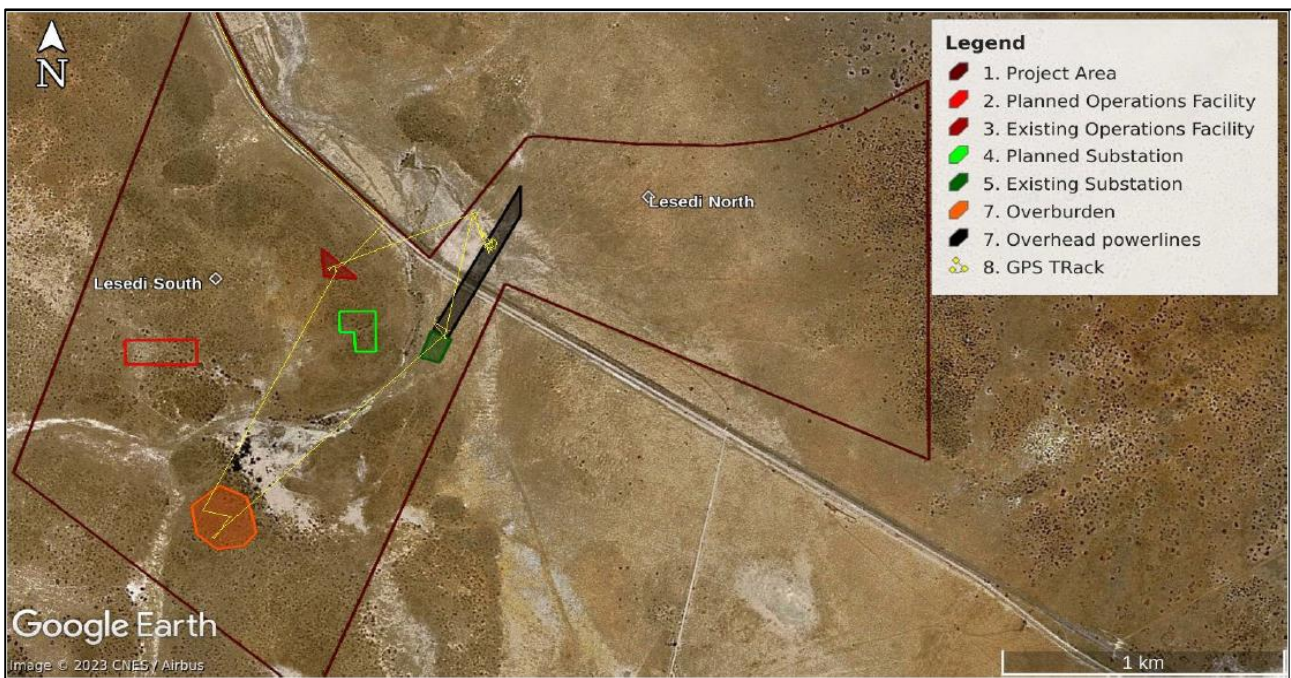
Figure 30: Google Earth (August 2005) of the project area indicating originally planned infrastructure and existing (as-built) infrastructure (Fauna Review, 2023)

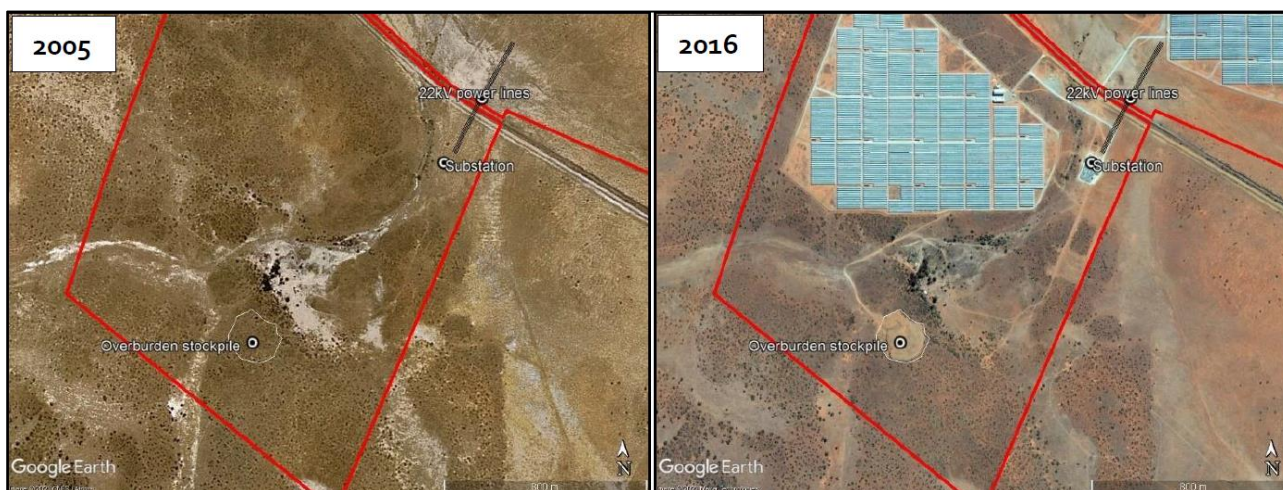
- *Landcover and land use:*
 - Figure 31 indicates that post construction, **the disturbances are contained**, and seemingly limited edge effects took place. The 2005 image shows that a tree-shrub layer is absent from the substation and powerline localities, prior to construction.

Figure 31: Historical Google Earth satellite images of the year 2005 prior to construction of the PV facility (left) and in the year 2016, after the construction (right) (Vegetation Review, 2023)

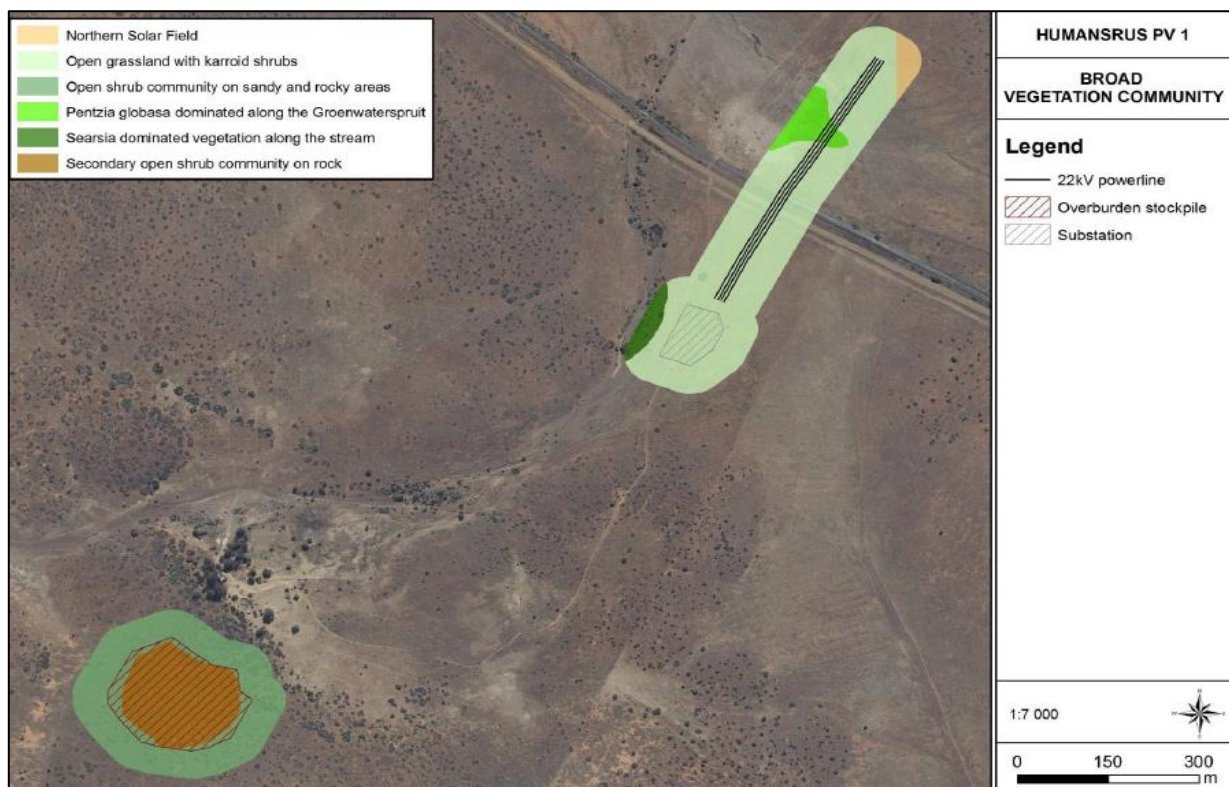
- *Vegetation Groups:*
 - Figure 32 indicates the vegetation observed on site within a 50m buffer around the substation, 22kV overhead powerline and overburden stockpile.

Figure 32: Vegetation groups on and around the infrastructure (Ecological Review, 2023)
