SITE SENSITIVITY VERIFICATION & AQUATIC BIODIVERSITY COMPLIANCE STATEMENT

Proposed construction and operation of the Battery Energy Storage System (BESS) and associated infrastructure for the authorised Dwarsrug Wind Energy Facility, located near Loeriesfontein in the Hantam Local Municipality, Namakwa District in the Northern Cape Province of South Africa.

October 2020

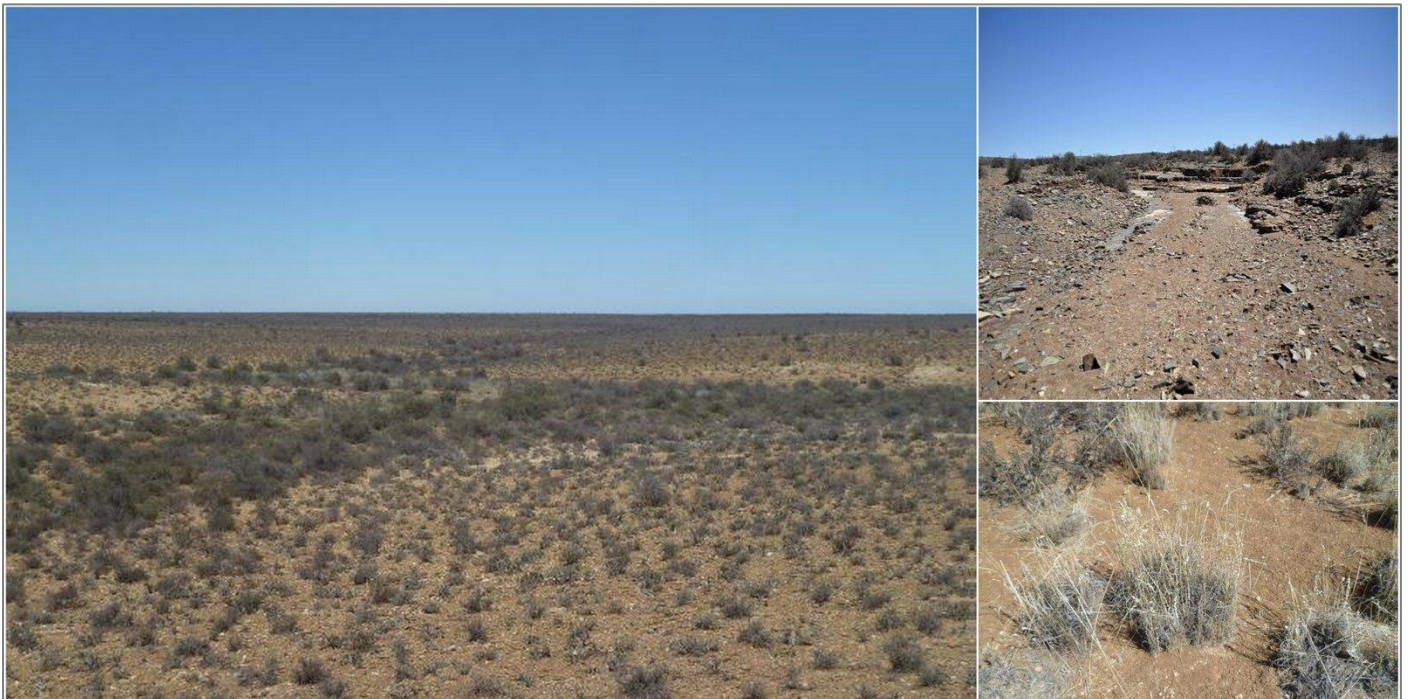
Figure 1 The Dwarsrug site prior to the Wind Energy Facility

The layout of the site is indicated in Figure 1.
