**GEO TECHNICAL AND
GEOHYDROLOGICAL
STUDY REPORT FOR
EAST 2 SOLAR PARK.
GCS-RP/06/2016**

**Report Prepared
for Palus Energy
(Pty)Ltd**

GCS-RP/06/2016

April 2016

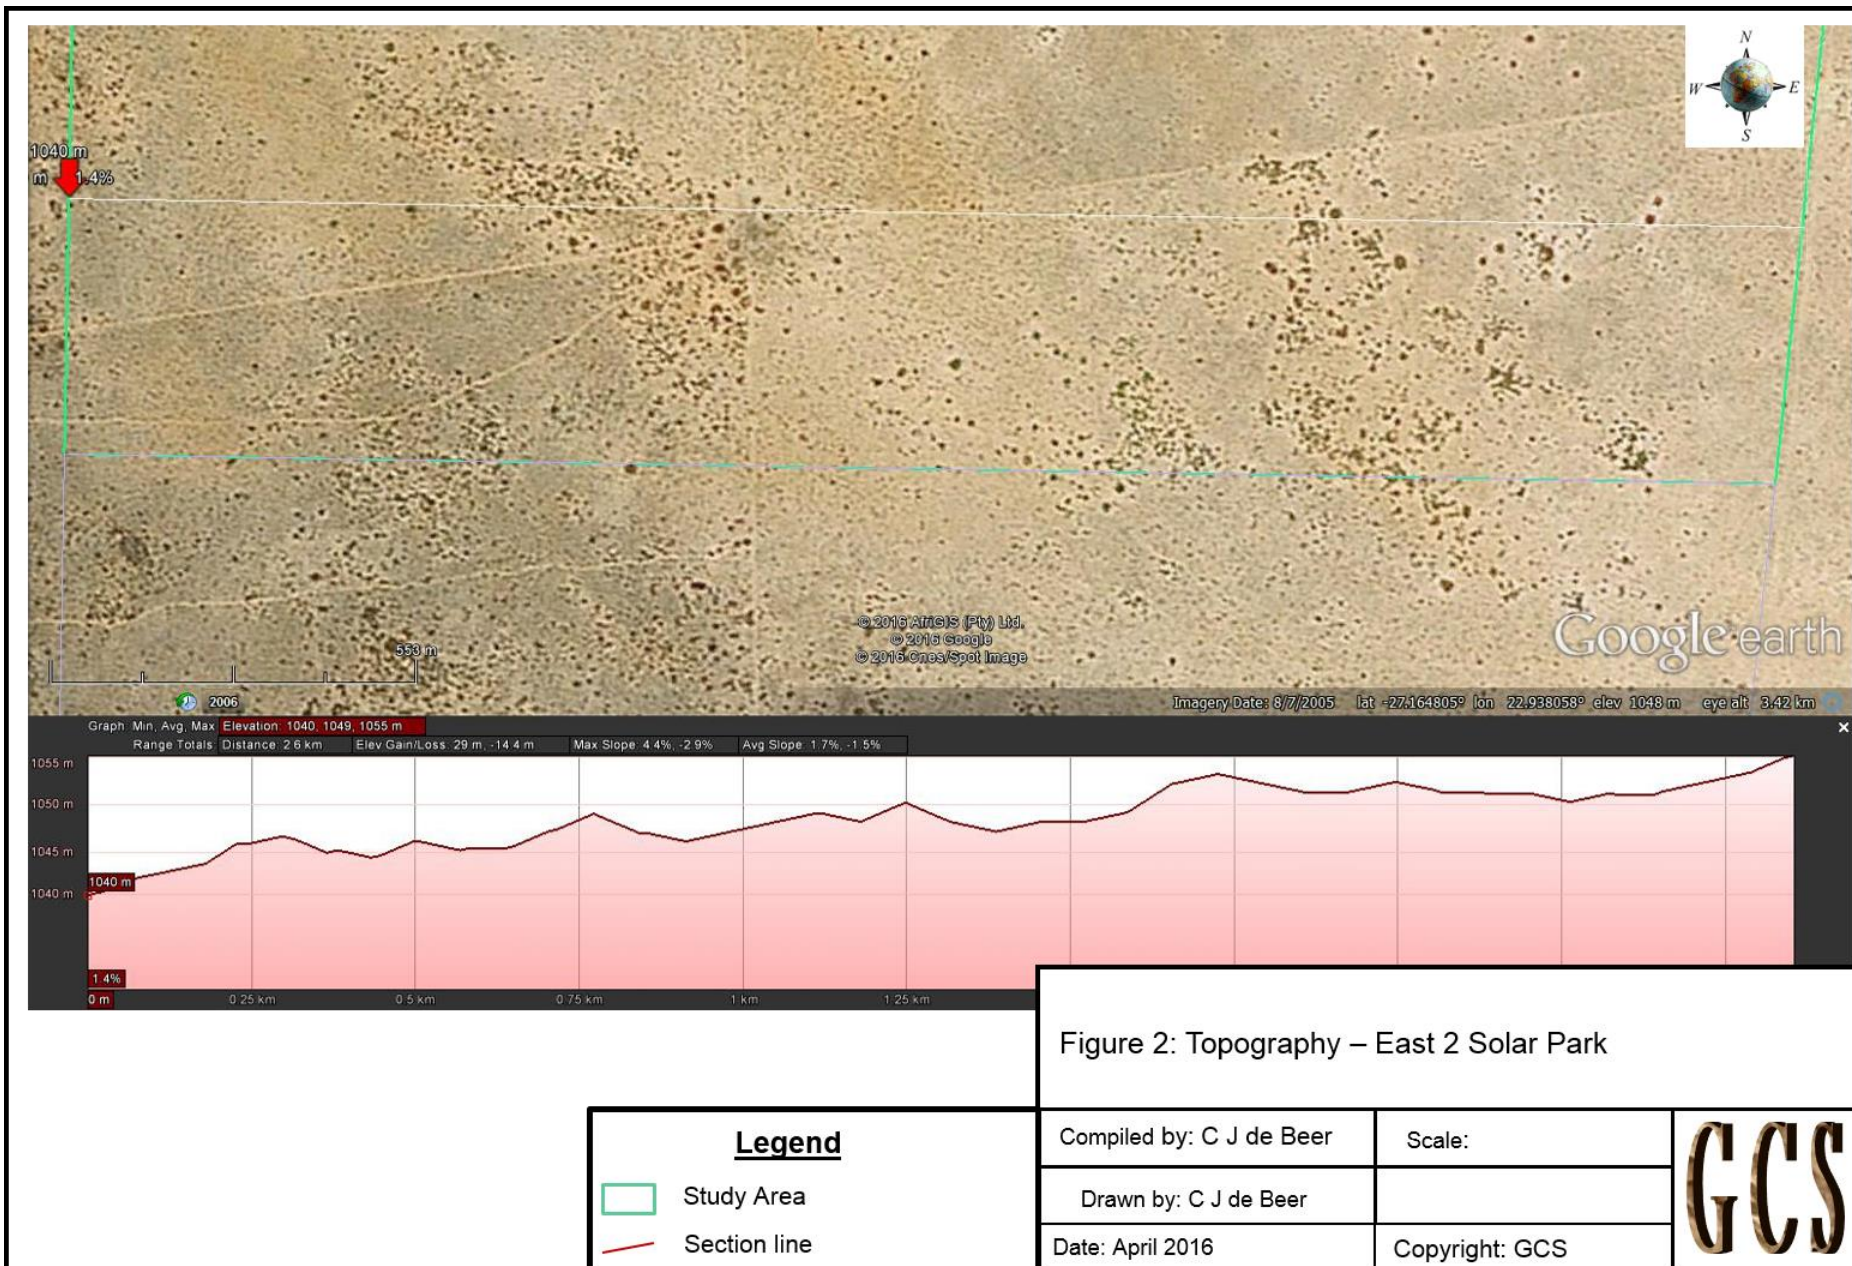
The study area is underlain by a plain land facet with a gentle undulating to flat topography with a gradient of 1.3%. The average elevation of the study area is 1047 mamsl with the lowest point 1040 mamsl and the highest point 1055 mamsl (figure 2).

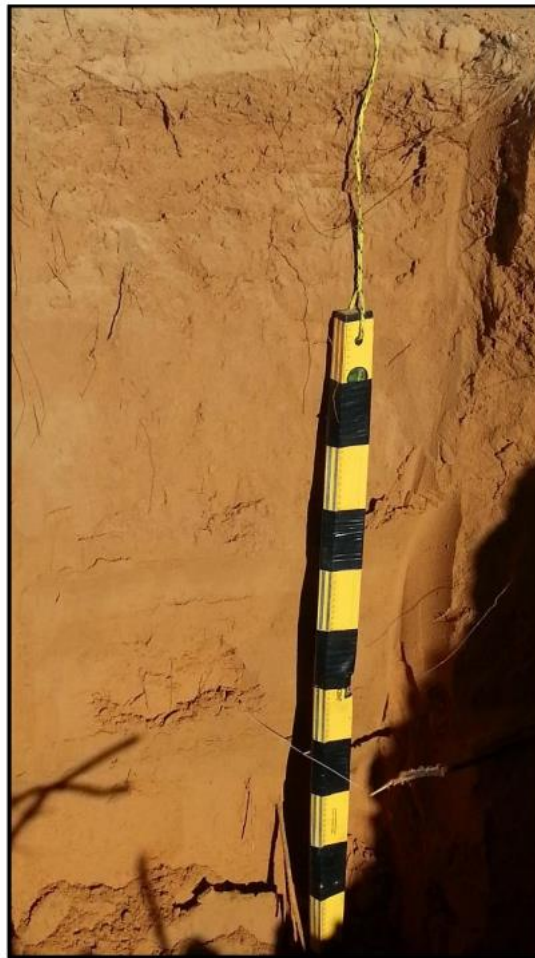
PHOTO 1: KALAHARI SAND

The site is underlain by unconsolidated recent aeolian sand of the Kalahari Formation (Qs) (figure 3). The unconsolidated recent deposits vary in thickness of as little as 3m to over 17m thick overlying calcrete and clay. Competent bedrock occurs at depths of 21m to 37m.

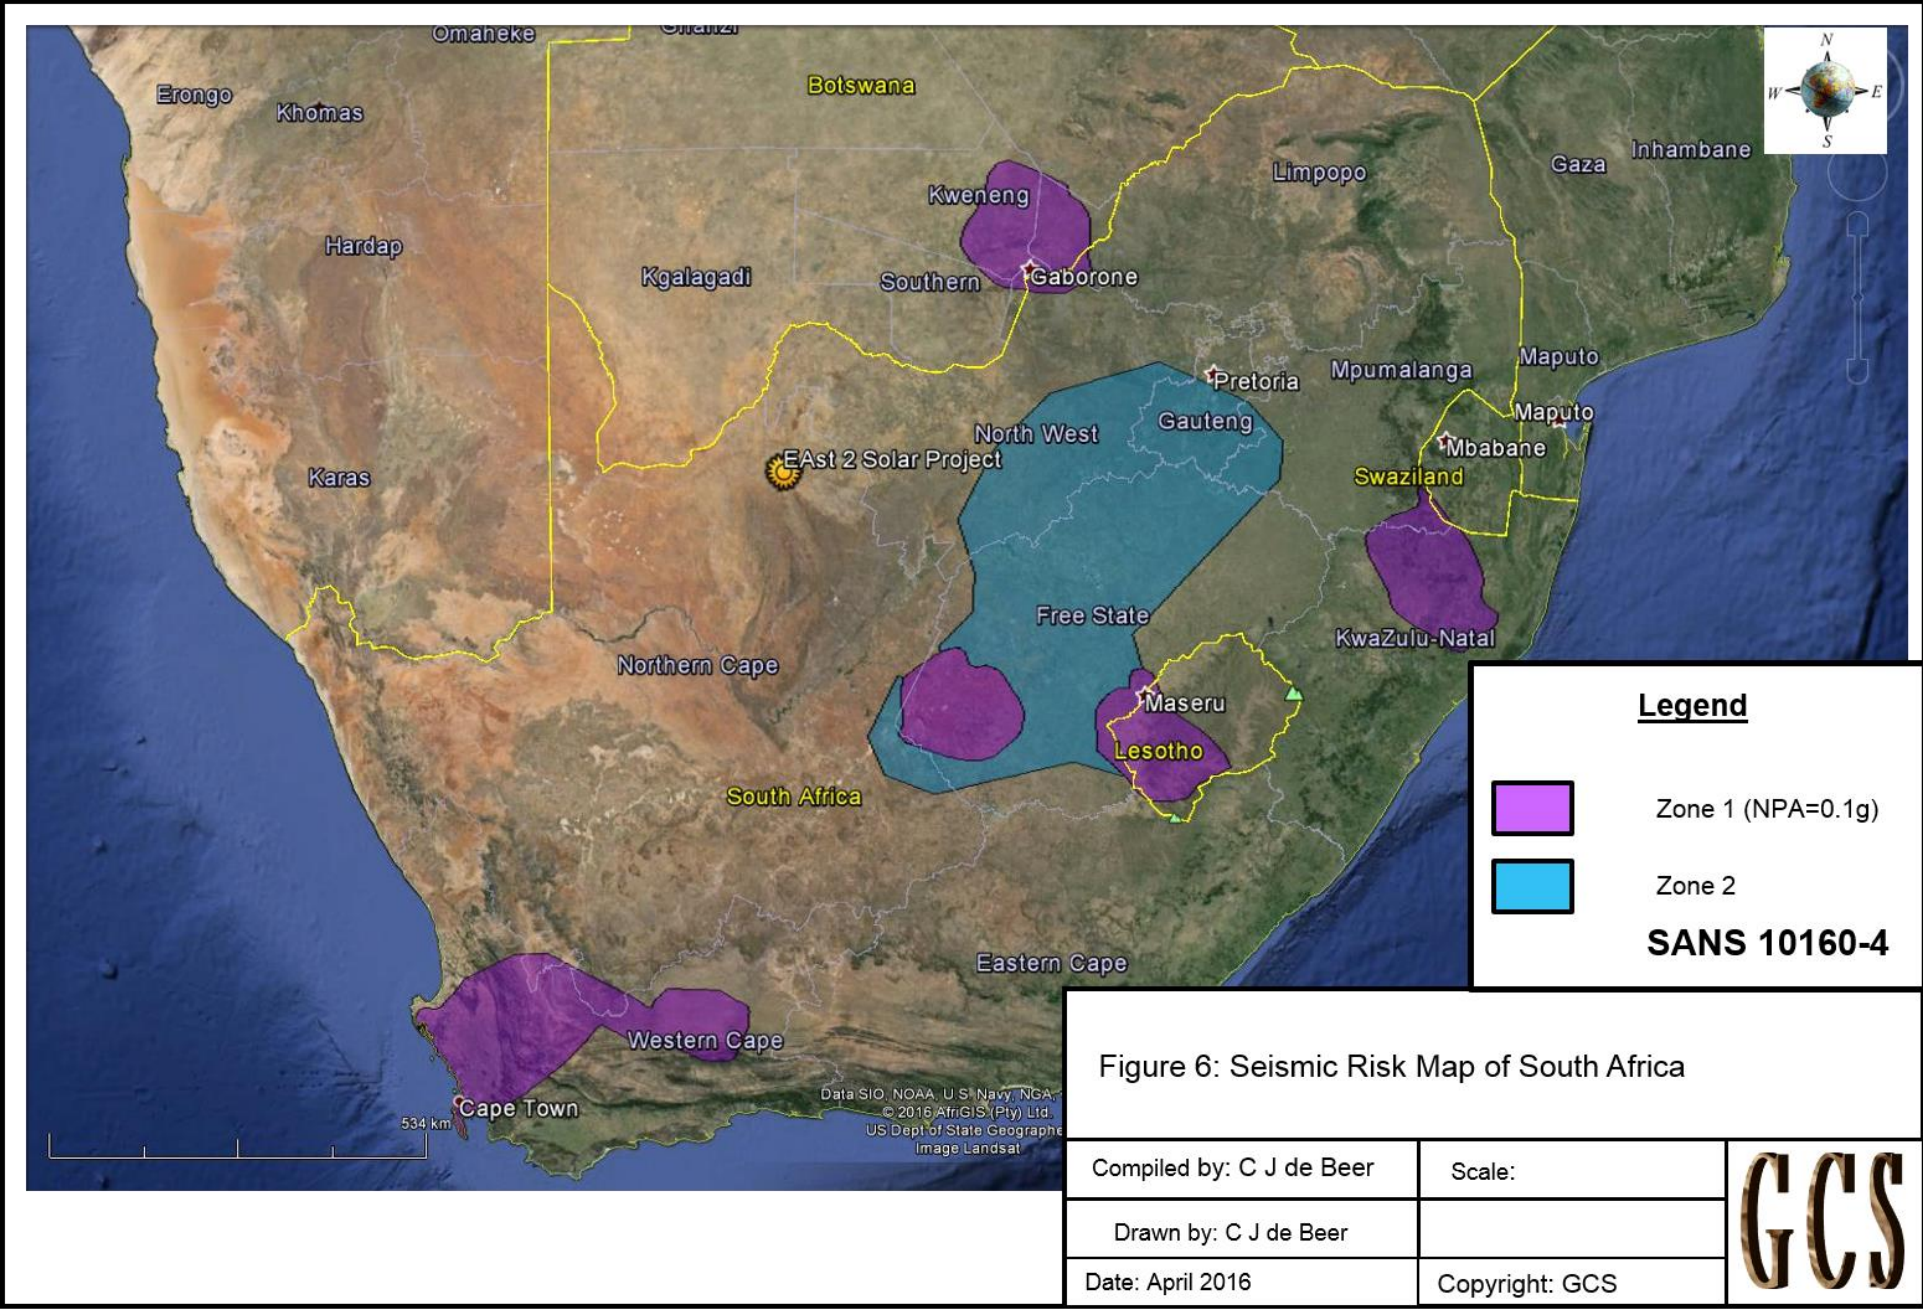
The SANS 10160-4 document define seismic zones applicable to South Africa Figure 1. Two zones are identified, namely:

- a) Zone I: Natural seismic activity and
- b) Zone II: Regions of mining-induced and natural seismic activity.

NOTE: The above zones are determined from the seismic hazard map which presents the peak ground acceleration with a 10% probability of being exceeded in a 50-year period. It includes both natural and mining-induced seismicity).

The East 2 Solar Park site is situated outside the risk areas (Zone 1 and Zone 2). Therefore, no provision has to be made for seismic loading in the design of the structures or foundations.

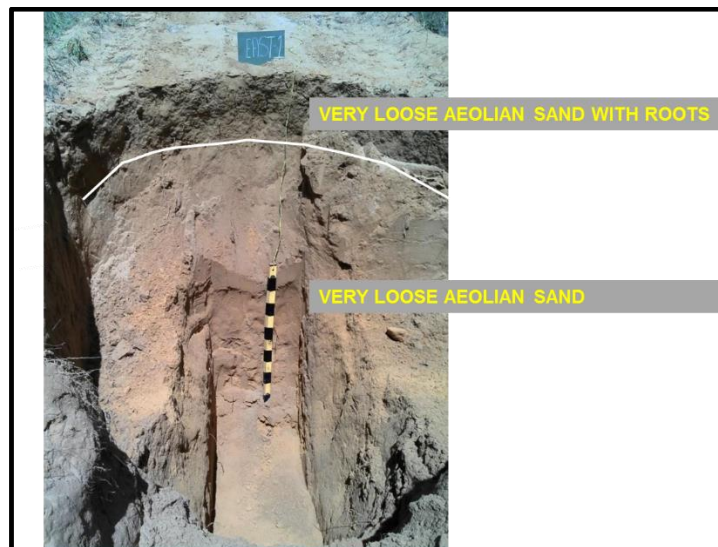
PHOTO 2: AEOLIAN SAND PROFILE

The soil profile underlain by dry to slightly moist, loose, uniform pale orange brown, intact, fine sand, of TRANSPORTED (AEOLIAN) origin with grass roots, overlying slightly moist, loose, uniform orange brown, intact, fine sand, of TRANSPORTED (AEOLIAN) origin. The sidewalls of the trial pits collapsed due to the loose consistent of the soil. No perched water table was encountered. The TLB excavated the soil with ease to reach limit (Table 5 and Photo 2).

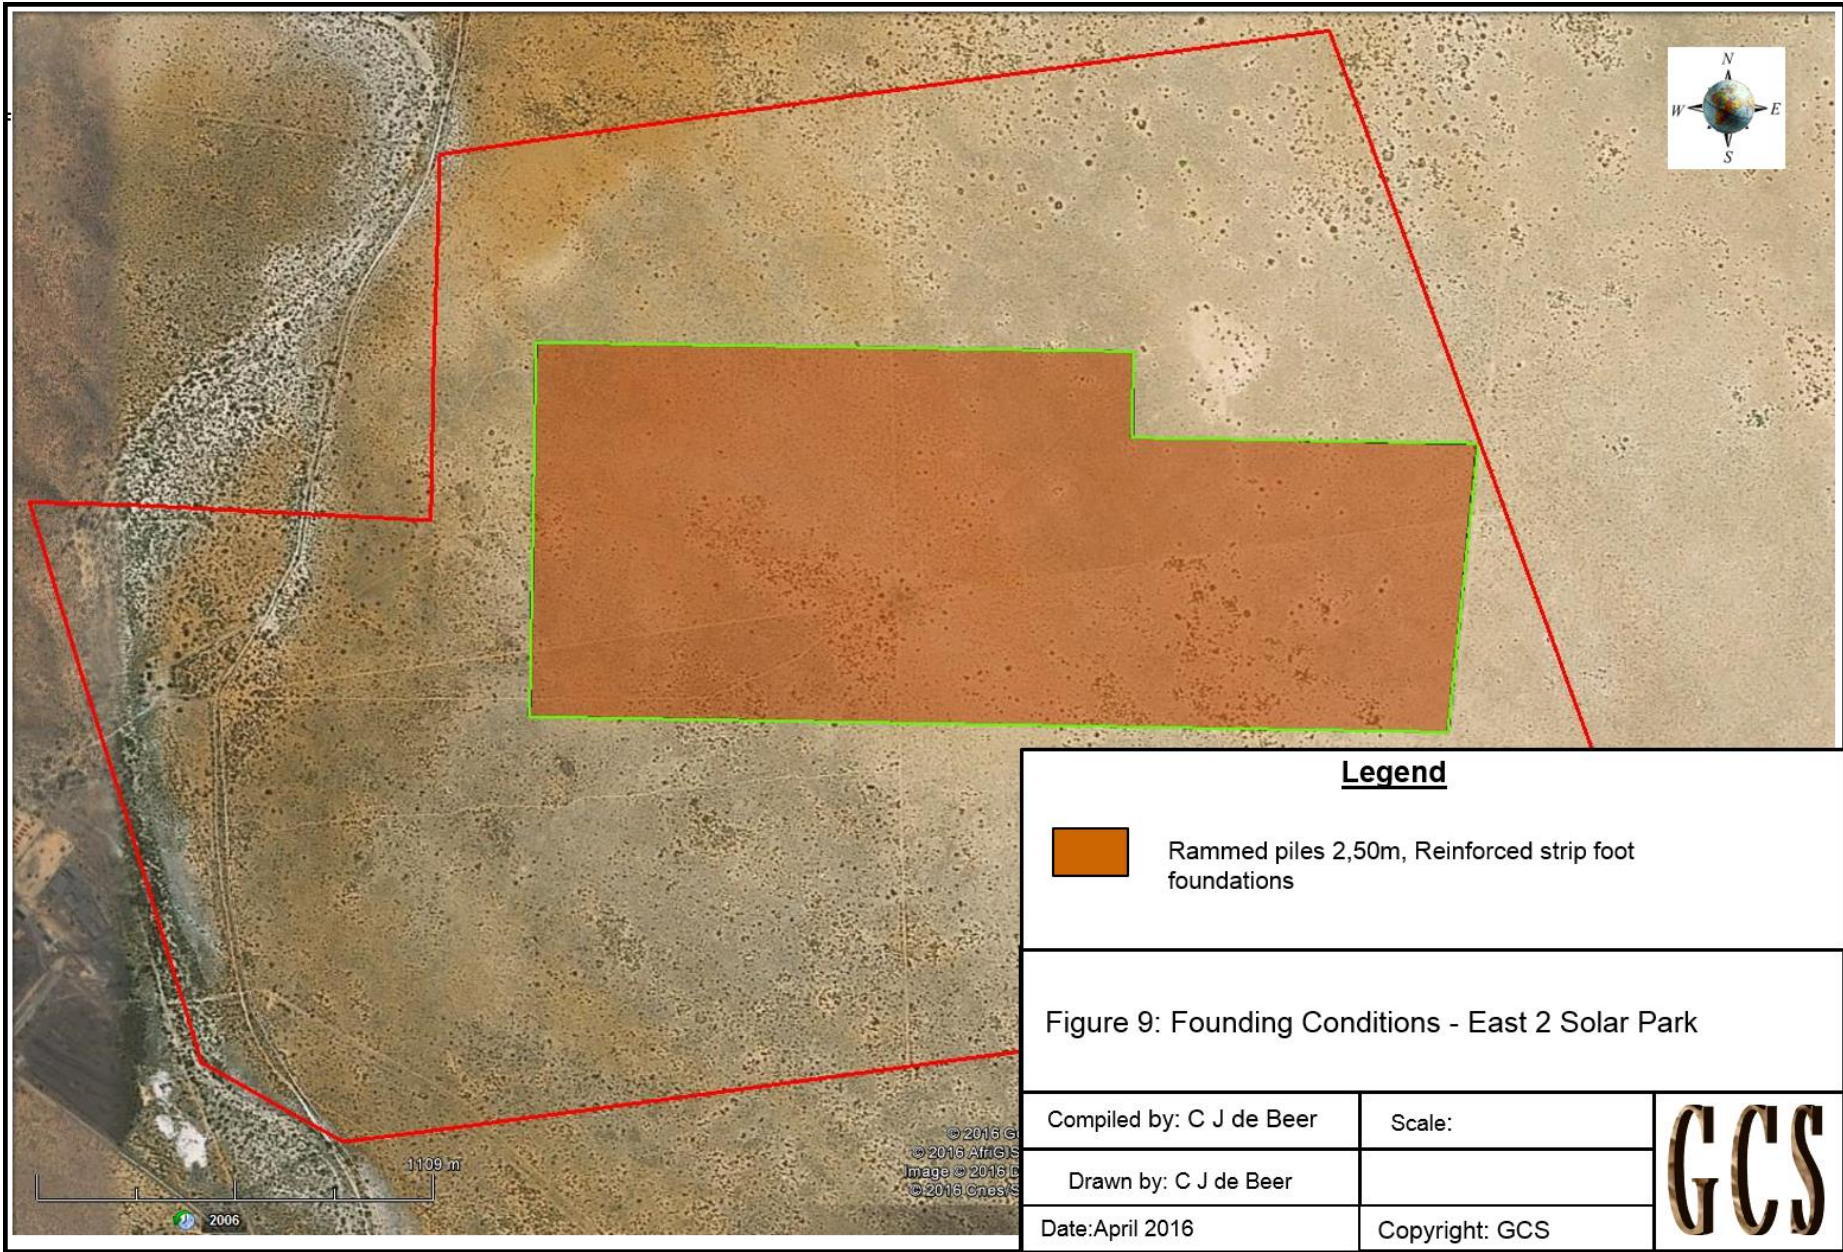
For the solar panel structures it is recommended that rammed piles be used as the depth of the loose sand allow sufficient shear resistance to be developed. The type and shape of the material used to manufacture the piles will determine the length of the piles as the material across the site fairly homogeneous. For the other conventional structures on site either normal strip foot foundations with compacted trenches is recommended. The trenches should be wetted during the compaction process. (Figure 9)

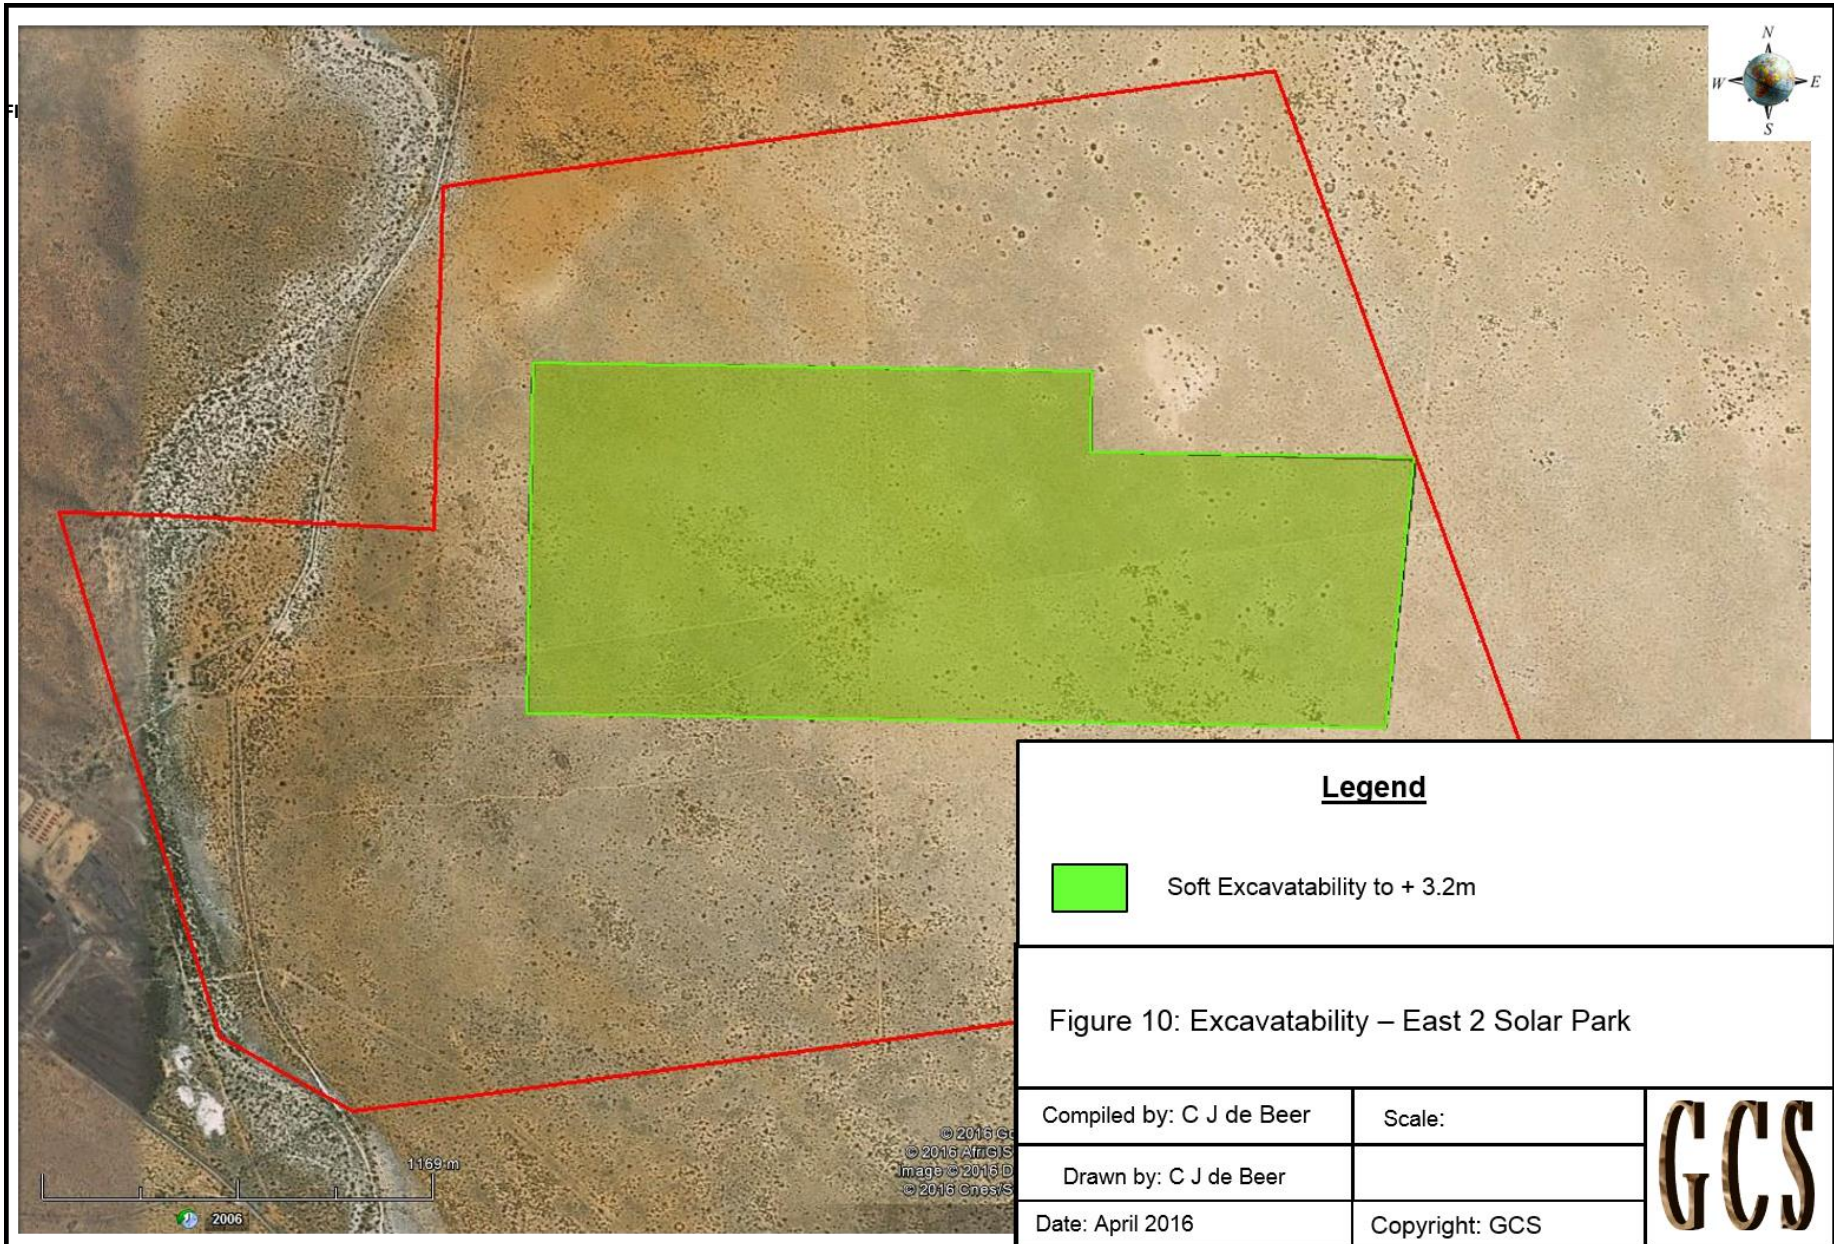
Using the COLTO Standard excavatability is classified as hard (boulders larger than 0.1m³, blasting or pneumatic and Mechanical rock breaking tools required) or soft (all other conditions) (Figure 10).

For this site the excavatability below surface is classified as soft to at least 2.5m below surface. Sidewall collapse occurred in all the trial pits excavated. The potential for collapse of side walls of deep excavations is high. It is recommended that the sidewalls of any excavation deeper than 0.8m be battered back to a 1:1.5 grade slope or shored.

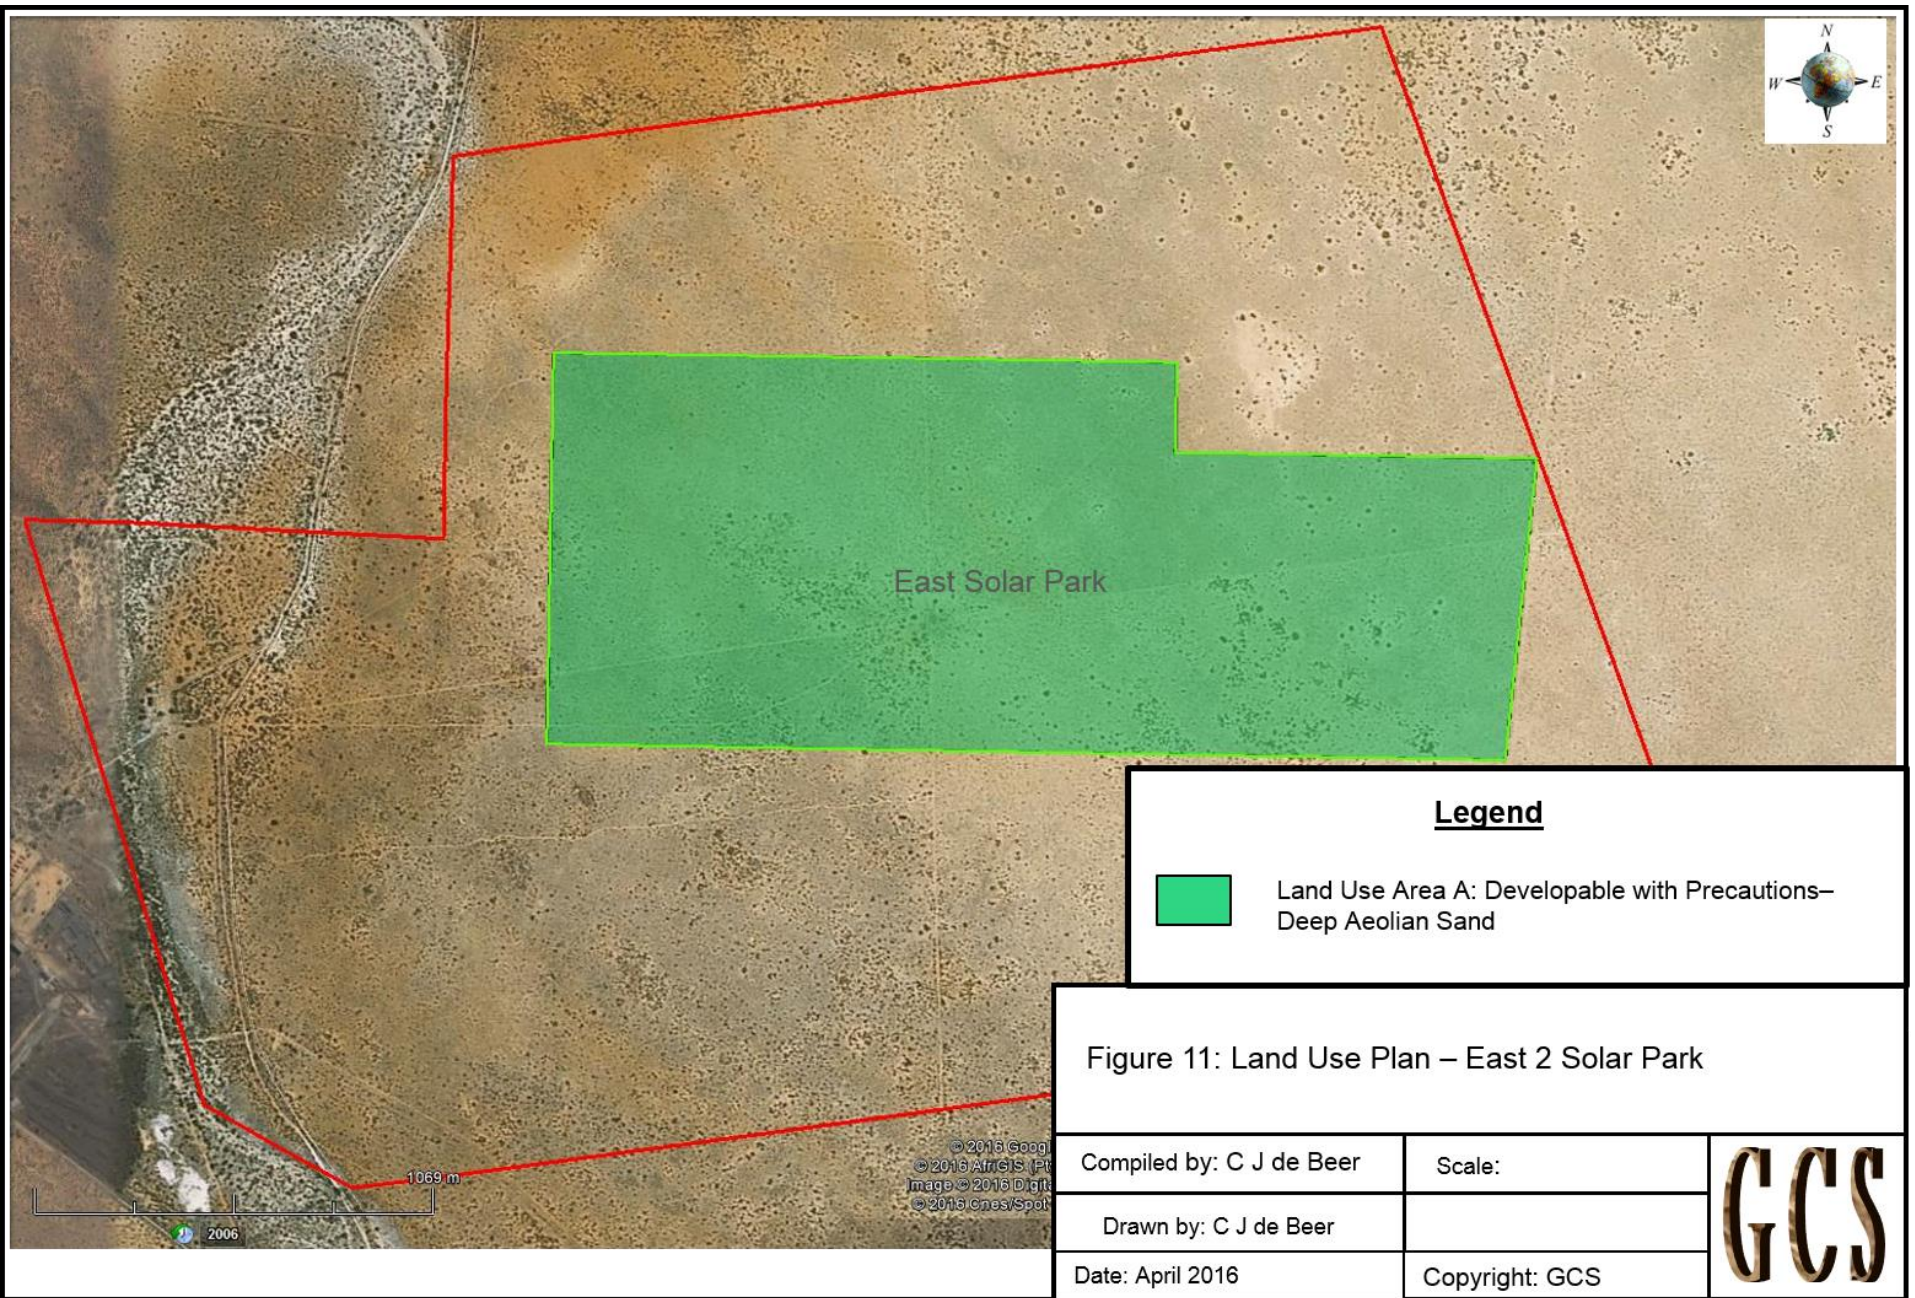
Land Use Area A covers the soil profile 1 and 2 areas and is classified as **DEVELOPABLE with PRECAUTIONS and is regarded low risk with respect to the intended development of the solar park**. The soil profile consists of transported aeolian soil of more than 3m thick. The excavatability is soft with the potential for sidewall collapse in trenches. The recommended foundation solution for tracker based and fixed solar panels is rammed, steel or wooden piles of approximately 2.5m long. For fixed frames, strip foot foundations founded at 0.6m is recommended. For conventional structures strip foot foundations founded with light reinforcing is recommended.

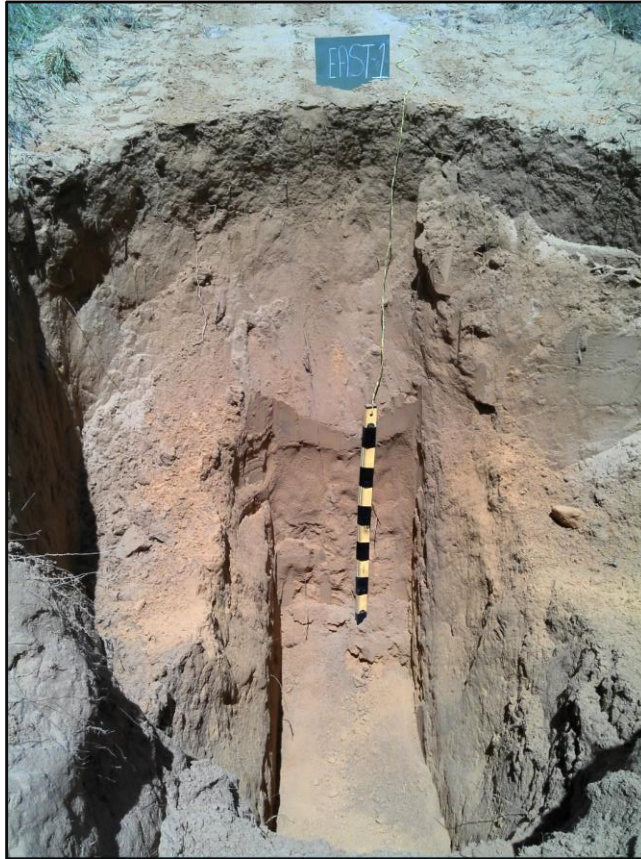
Profiled by C. de Beer
Diameter
Depth 3.20 m
Type: Trial pit

Profile	Depth to	Description
	0.50	VERY LOOSE SAND Dry, very loose, uniform pale orange brown, intact, fine sand with roots, of TRANSPORTED (AEOLIAN) origin
	3.20	LOOSE SAND Dry to slightly moist, loose, uniform orange brown, intact, fine sand, of TRANSPORTED (AEOLIAN) origin. Sidewall of trial pit collapsed
		EOH @ 3.2m. No Refusal. Reach limit

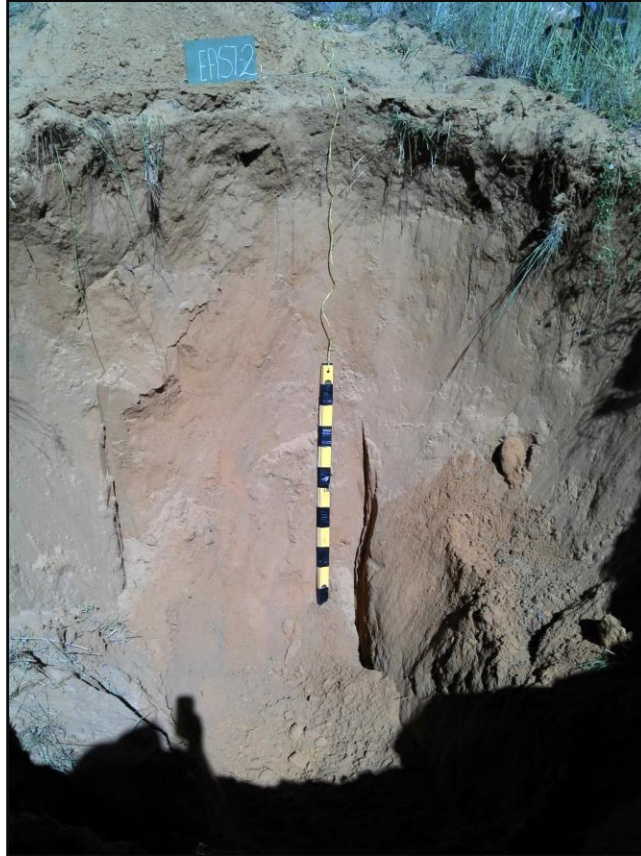
Co-coordinates:
X-coord -27.16984
Y-coord 22.94330
Z-coord m
 (WGS'84 decimal degrees)

Profile	Depth to	Description
	0.50	VERY LOOSE SAND Dry, very loose, uniform pale orange brown, intact, fine sand with roots, of TRANSPORTED (AEOLIAN) origin
	3.20	LOOSE SAND Dry to slightly moist, loose, uniform orange brown, intact, fine sand, of TRANSPORTED (AEOLIAN) origin. Sidewall of trial pit collapsed
		EOH @ 3.2m. No Refusal. Reach limit

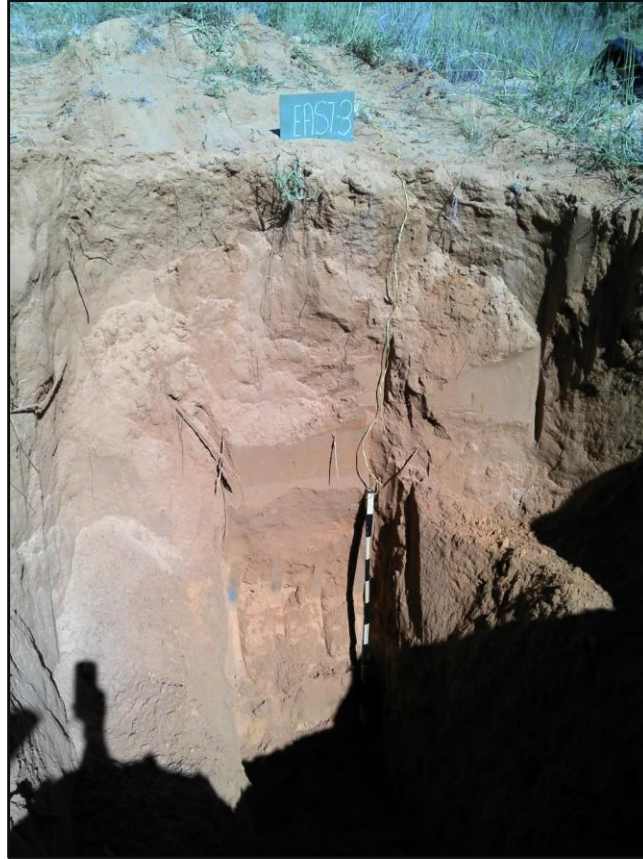
Co-coordinates:
X-coord -27.16711
Y-coord 22.93962
Z-coord m
 (WGS'84 decimal degrees)

Profile	Depth to	Description
	0.50	VERY LOOSE SAND Dry, very loose, uniform pale orange brown, intact, fine sand with roots, of TRANSPORTED (AEOLIAN) origin
	3.20	LOOSE SAND Dry to slightly moist, loose, uniform orange brown, intact, fine sand, of TRANSPORTED (AEOLIAN) origin. Sidewall of trial pit collapsed
EOH @ 3.2m. No Refusal. Reach limit

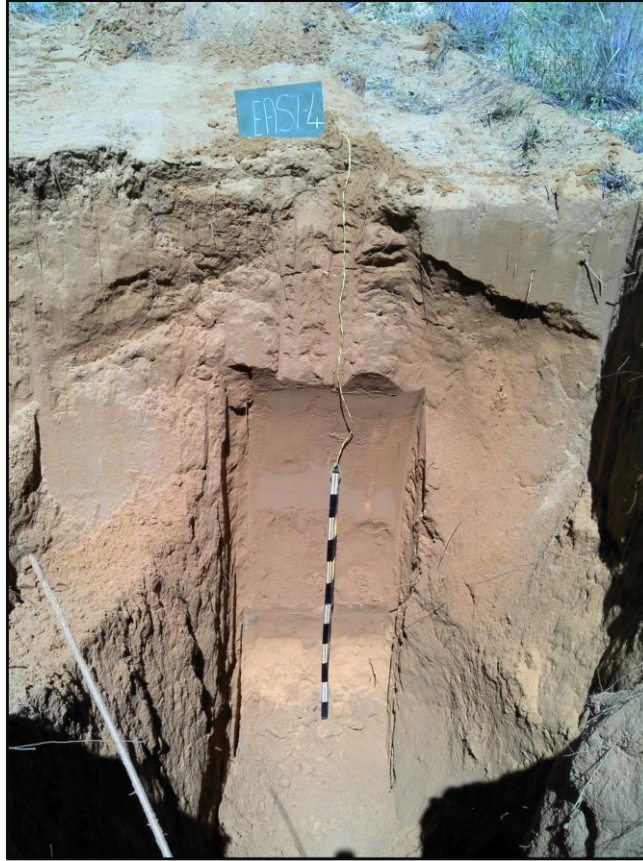
Co-coordinates:
X-coord -27.17309
Y-coord 22.93746
Z-coord m
 (WGS'84 decimal degrees)

Profile	Depth to	Description
	0.50	VERY LOOSE SAND Dry, very loose, uniform pale orange brown, intact, fine sand with roots, of TRANSPORTED (AEOLIAN) origin
	3.20	LOOSE SAND Dry to slightly moist, loose, uniform orange brown, intact, fine sand, of TRANSPORTED (AEOLIAN) origin. Sidewall of trial pit collapsed
EOH @ 3.2m. No Refusal. Reach limit

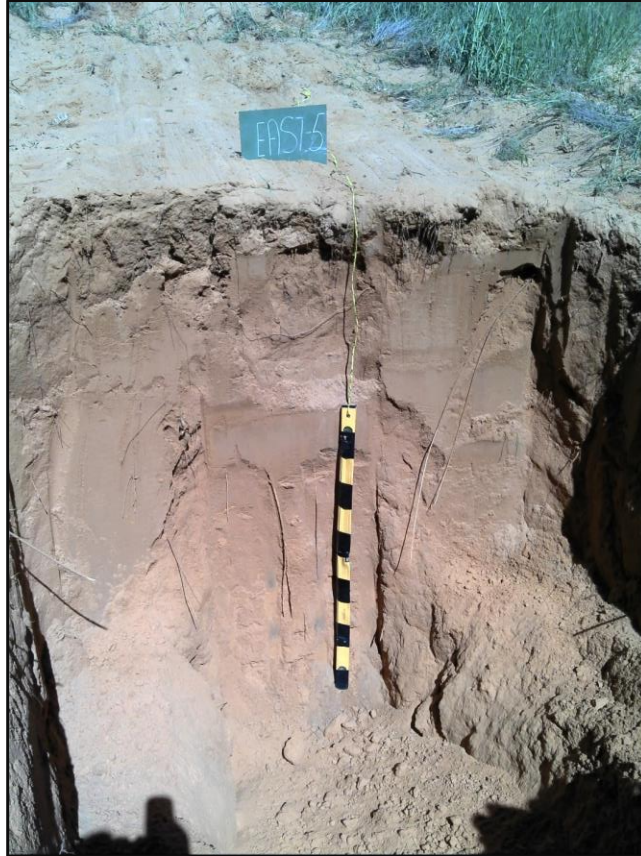
Co-ordinates:
X-coord -27.17243
Y-coord 22.94726
Z-coord m
 (WGS'84 decimal degrees)

Profile	Depth to	Description
	0.50	VERY LOOSE SAND Dry, very loose, uniform pale orange brown, intact, fine sand with roots, of TRANSPORTED (AEOLIAN) origin
	3.20	LOOSE SAND Dry to slightly moist, loose, uniform orange brown, intact, fine sand, of TRANSPORTED (AEOLIAN) origin. Sidewall of trial pit collapsed
EOH @ 3.2m. No Refusal. Reach limit

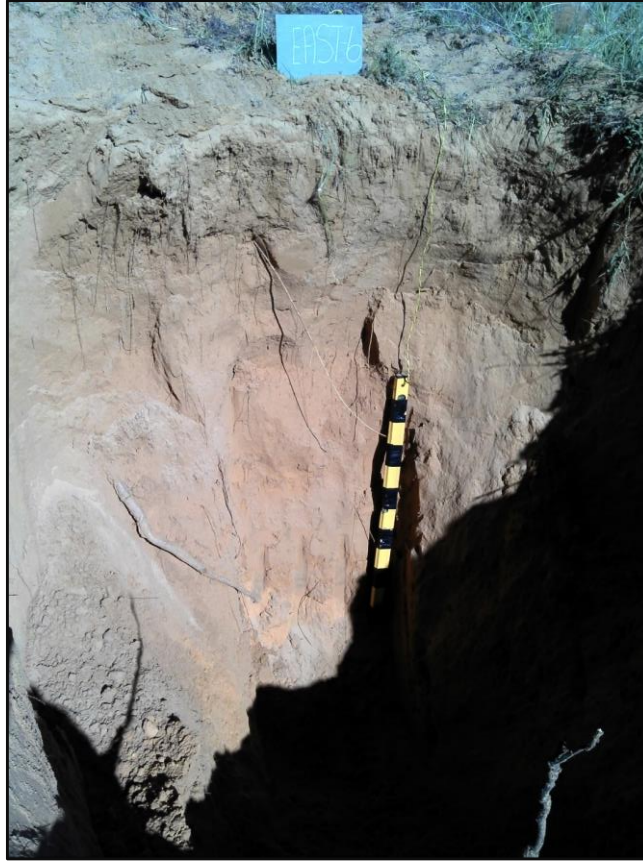
Co-coordinates:
X-coord -27.16590
Y-coord 22.94790
Z-coord m
 (WGS'84 decimal degrees)

Profile	Depth to	Description
	0.50	VERY LOOSE SAND Dry, very loose, uniform pale orange brown, intact, fine sand with roots, of TRANSPORTED (AEOLIAN) origin
	3.20	LOOSE SAND Dry to slightly moist, loose, uniform orange brown, intact, fine sand, of TRANSPORTED (AEOLIAN) origin. Sidewall of trial pit collapsed
EOH @ 3.2m. No Refusal. Reach limit

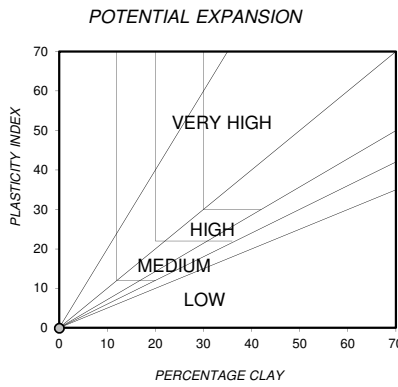
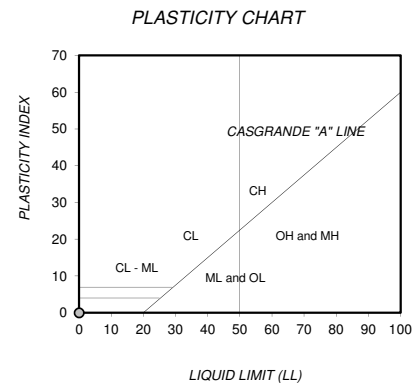
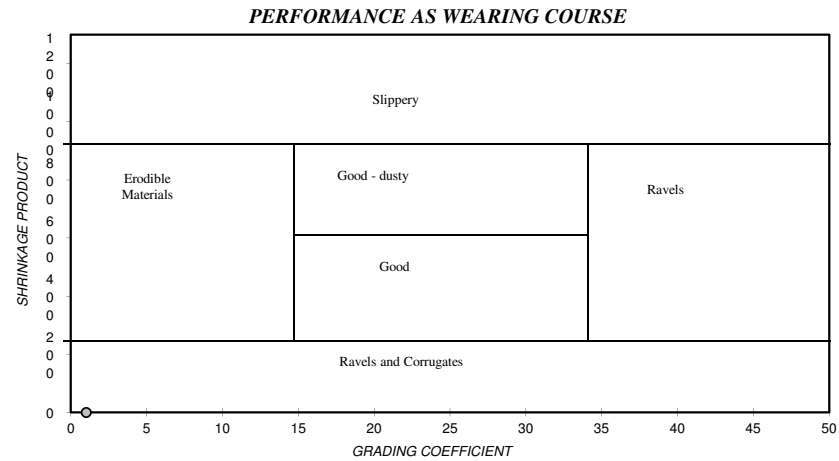
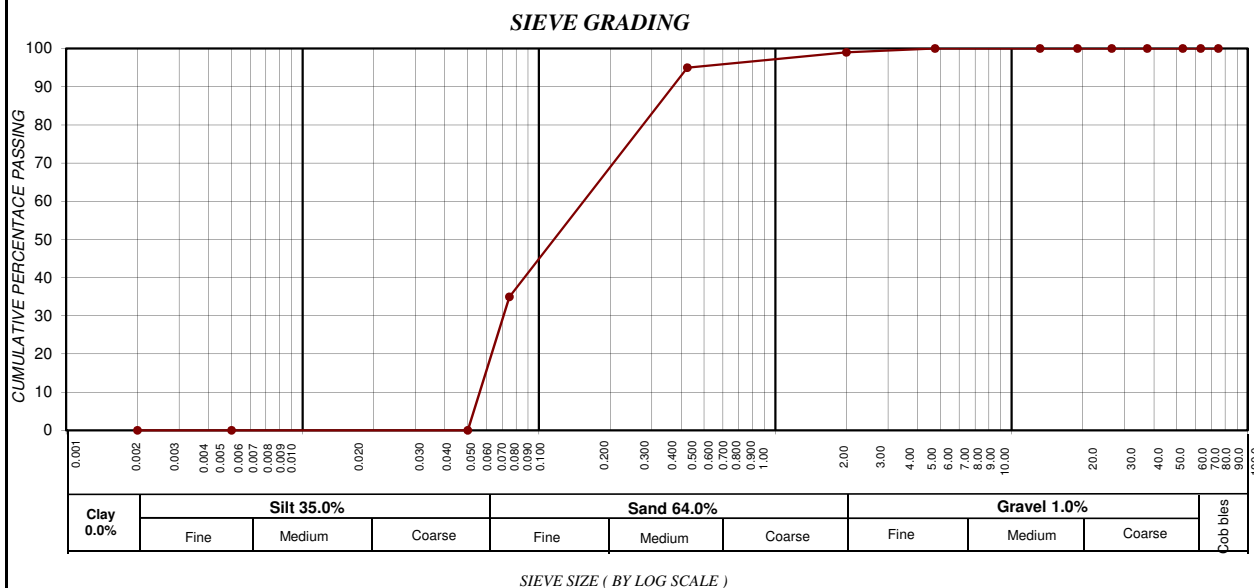
FOUNDATION INDICATOR TEST RESULTS

Sieve analysis Cumulative percentage passing (mm)	75.0	100
	63.0	100
	53.0	100
	37.5	100
	26.5	100
	19.0	100
	13.2	100
	4.75	100
	2.000	99
	0.425	95
	0.250	75
	0.150	55
	0.075	35
0.050	0	
0.005	0	
0.002	0

Soil Mortar Analysis % < 2.00mm	2.000 - 0.425	4.0
	0.425 - 0.250	20.0
	0.250 - 0.150	20.0
	0.150 - 0.075	20.0
< 0.075	35.4

Effective size	0.005	
Uniformity Coefficient	22.8	
Curvature Coefficient	7.4	
Oversize Index	0.0	
Shrinkage Product	0.0	
Grading Coefficient	1.0	
Grading modulus	0.71	
Atter-berg Limits	Liquid Limit	0
	Plasticity Index	NP
	Linear Shrinkage	0
Unified Soil Classification	SC	
U.S. Highway Classification	A-2-4(0)	
pH - Value	N/A	
Conductivity mS/cm	N/A

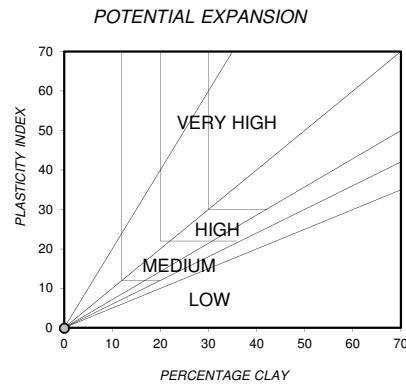
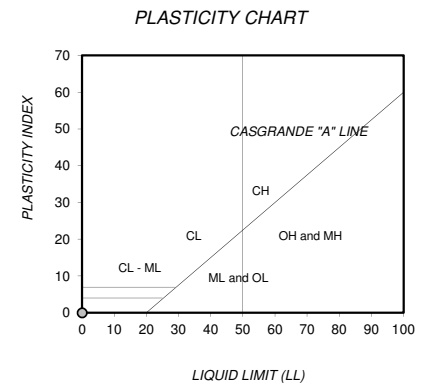
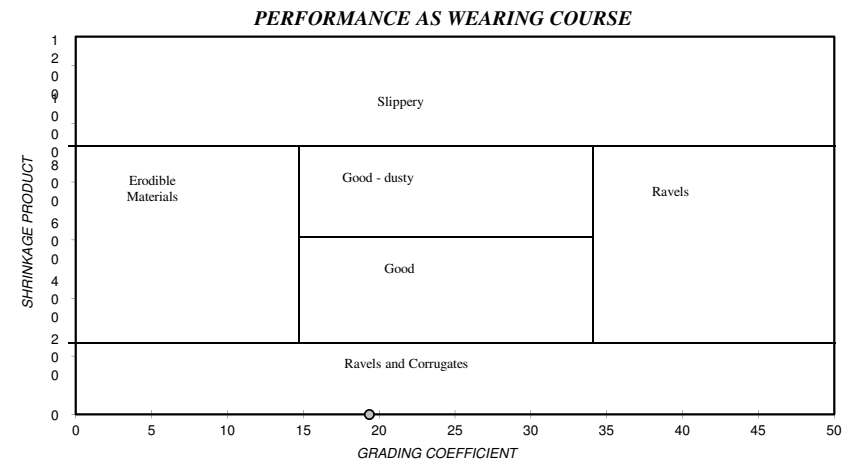
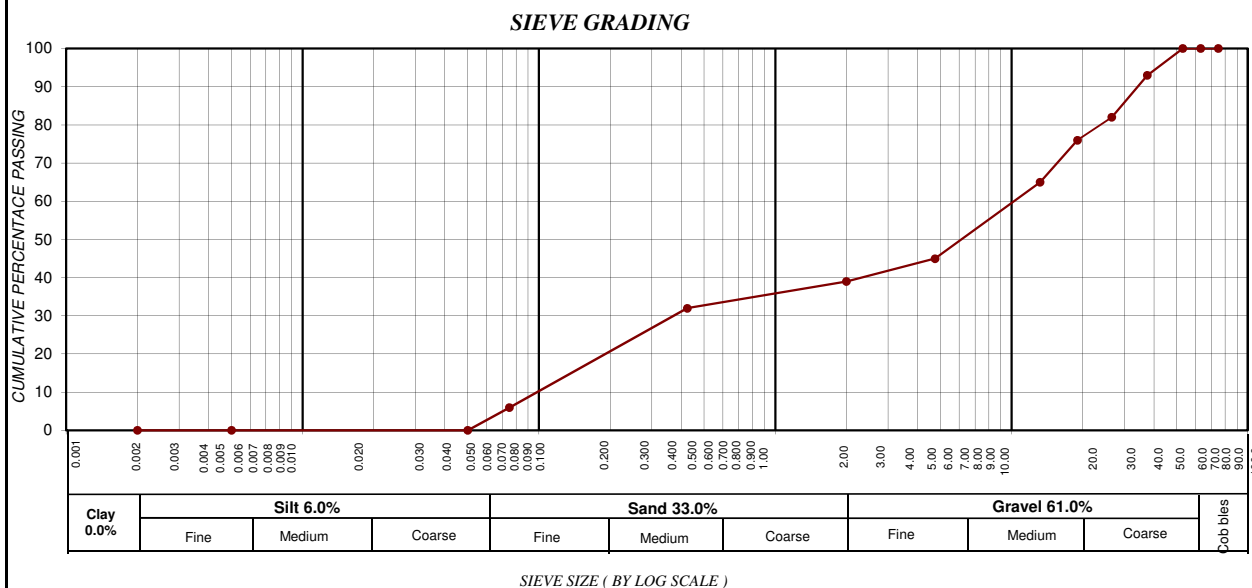
FOUNDATION INDICATOR TEST RESULTS

Sieve analysis Cumulative percentage passing (mm)	75.0	100
	63.0	100
	53.0	100
	37.5	93
	26.5	82
	19.0	76
	13.2	65
	4.75	45
	2.000	39
	0.425	32
	0.250	23
	0.150	15
	0.075	6
0.050	0	
0.005	0	
0.002	0

Soil Mortar Analysis % < 2.00mm	2.000 - 0.425	7.0
	0.425 - 0.250	9.0
	0.250 - 0.150	8.0
	0.150 - 0.075	9.0
< 0.075	15.4

Effective size	0.005	
Uniformity Coefficient	22.8	
Curvature Coefficient	7.4	
Oversize Index	7.0	
Shrinkage Product	0.0	
Grading Coefficient	19.4	
Grading modulus	2.23	
Atter-berg Limits	Liquid Limit	0
	Plasticity Index	NP
	Linear Shrinkage	0
Unified Soil Classification	GP	
U.S. Highway Classification	A-1-a(0)	
pH - Value	N/A	
Conductivity mS/cm	N/A
