NORTH BLOCK COMPLEX (PTY) LTD FINAL ENVIRONMENTAL IMPACT ASSESSMENT AND ENVIRONMENTAL MANAGEMENT PLAN IN SUPPORT OF A SECTION 102 CONSOLIDATION AND INTEGRATED ENVIRONMENTAL AUTHORITY PROCESS

FINAL ENVIRONMENTAL IMPACT ASSESSMENT REPORT

**FOR LISTED ACTIVITIES ASSOCIATED WITH MINING RIGHT AND/OR BULK SAMPLING
ACTIVITIES INCLUDING TRENCHING IN CASES OF ALLUVIAL DIAMOND PROSPECTING**

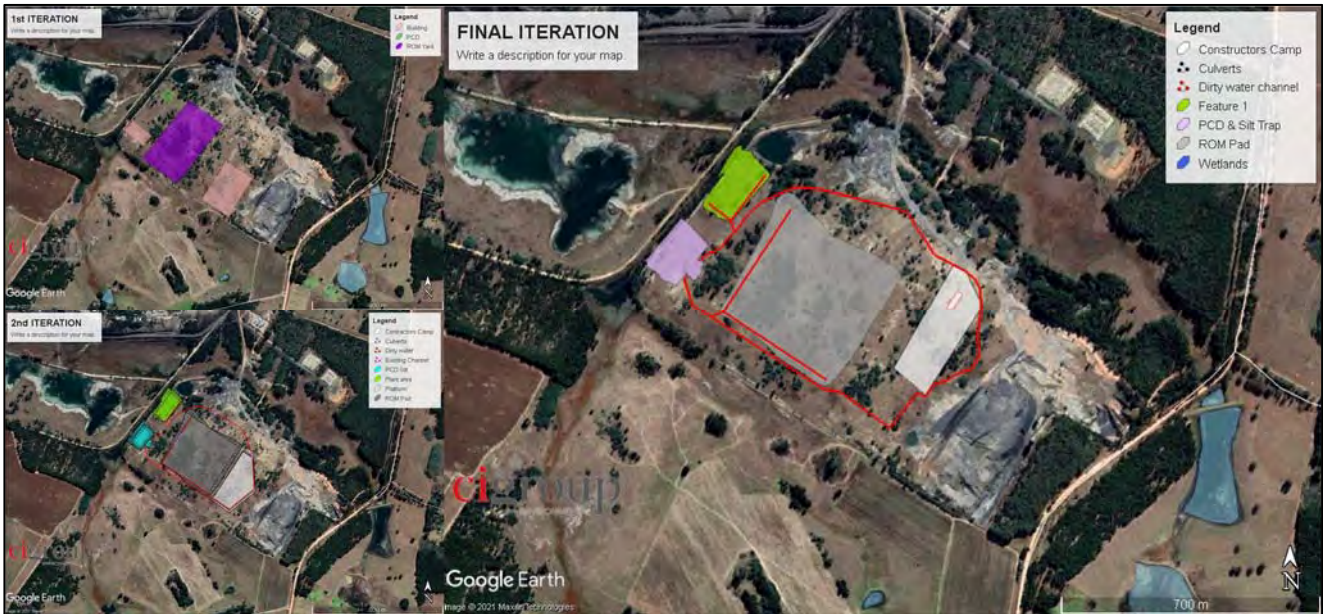
Figure 7.1: Portion 24 Infrastructure Layout Iterations.

The design of the PCDs, Portion 24 plant area, Portion 24 RoM pad and water management infrastructure were designed in terms of best practice guidelines and comply with the requirements of GN 704 and the NEM:WA. The proposed infrastructure area on Portion 24 went through various iterations to reach the final layout. Changes were ultimately made to align the infrastructure with the mining contractors plans, so the ROM pad and contractor's area was adjusted as indicated in **Figure 7.1**.

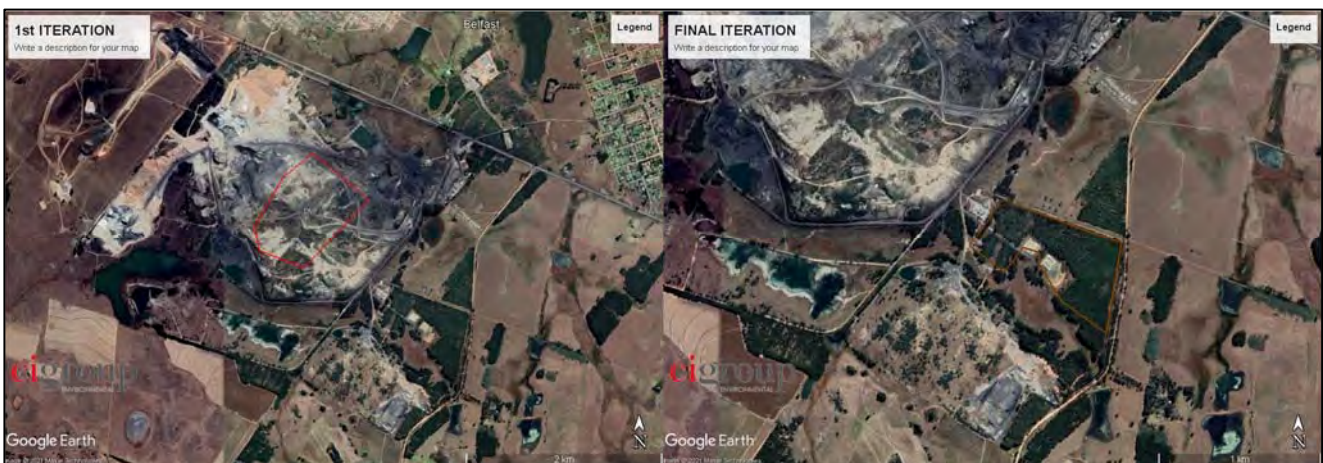
Figure 7.2: DMF Layout Iterations.

The location of the DMF also went through various iterations to reach the final layout. Changes were made to address initial concerns about seepage and rehabilitation and final landform design requirements at the Glisa Section, as as indicated in **Figure 7.1**. The DMF will be located on Potion 24 and will be developed in accordance with the requirements of GN 704 and the NEM:WA.

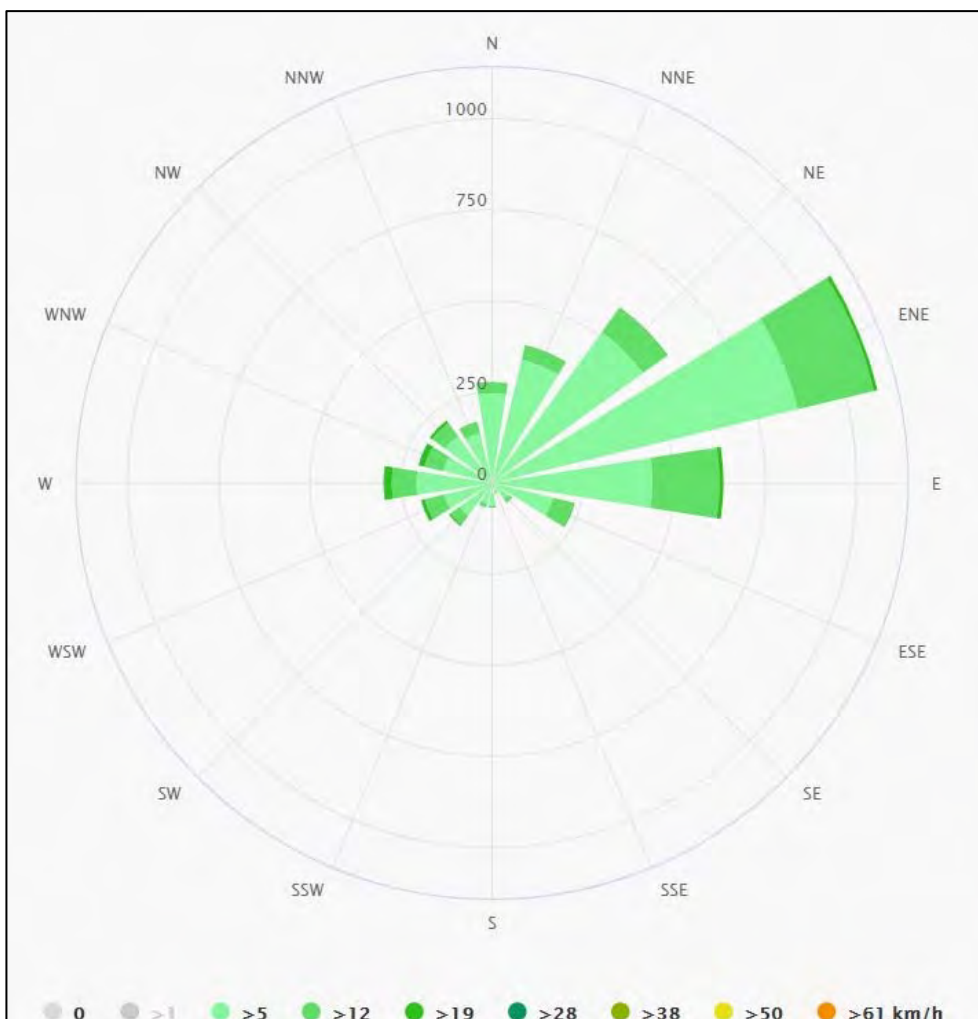
Figure 9.3: Predominant Wind Direction for the Integrated Paardeplaats Section.

A period wind rose for the Integrated Paardeplaats Section is presented in **Figure 9.3**. Wind roses comprise of 16 spokes which represents the direction from which winds blew during the period. The colours reflect the different categories of wind speeds. The dotted circles provide information regarding the frequency of occurrence of wind speed and direction categories. Based on an evaluation of the meteorological data simulations run from the global NEMS weather model at approximately 30 km resolution from 1985 to current of the project area, the following deductions can be made:

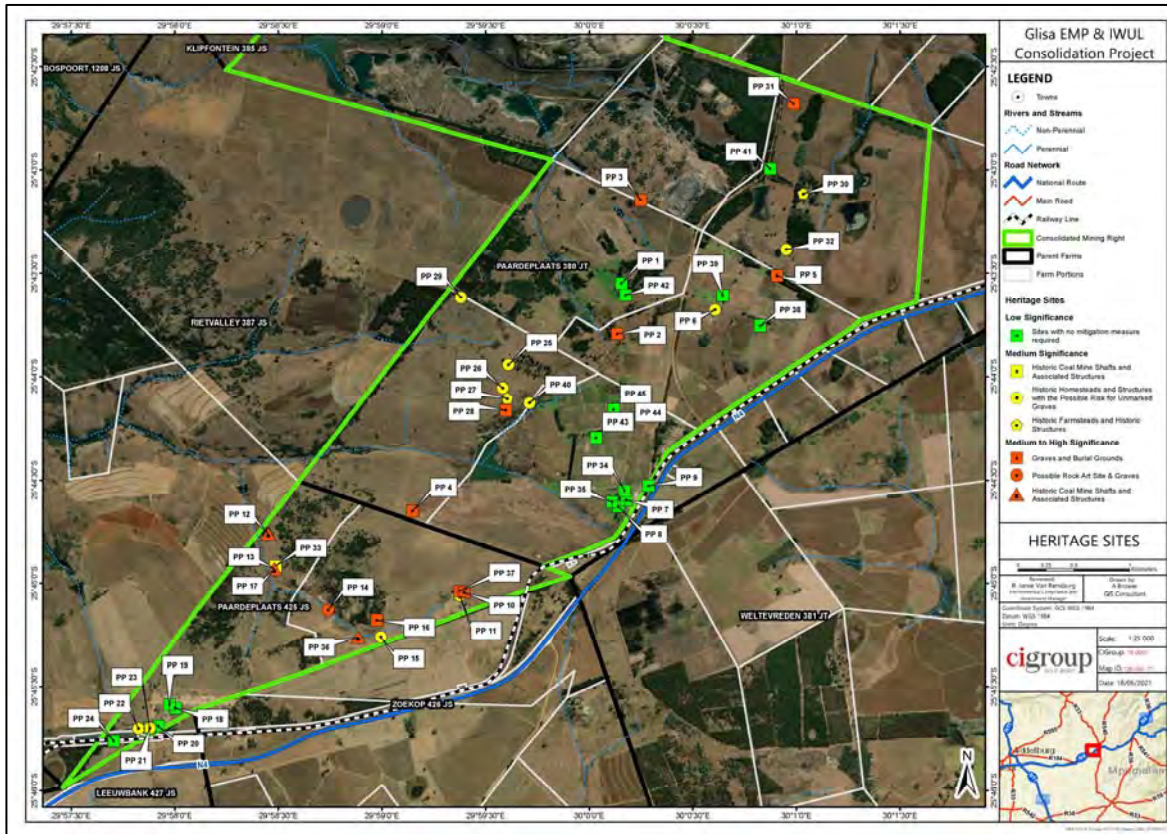
Figure 9.37: Identified Heritage Features within the Integrated Paardeplaats Section.

In 2012, a total of 32 heritage sites (PP 1 – PP 32) including 21 heritage structures, 7 cemeteries, 3 areas with historical mining shafts, and one possible rock art site were identified within the Paardeplaats Section of the Integrated Paardeplaats Section. In 2020 an additional 13 heritage sites (PP 33 – PP 45) were identified within the Paardeplaats Section and Portion 24 of the Integrated Paardeplaats Section. The detailed description of each heritage feature identified, including an updated description of the sites identified in 2012 to align with current conditions is presented in **Table 9.40** whilst the location of the sites is presented in **Figure 9.37**.
