NAME OF APPLICANT: Great Karoo Prospecting (Pty) Ltd

REFERENCE NUMBER: EC30/5/1/3/2/1010108MP – Tsitsikamma Borrow Pit 5

ENVIRONMENTAL MANAGEMENT PLAN

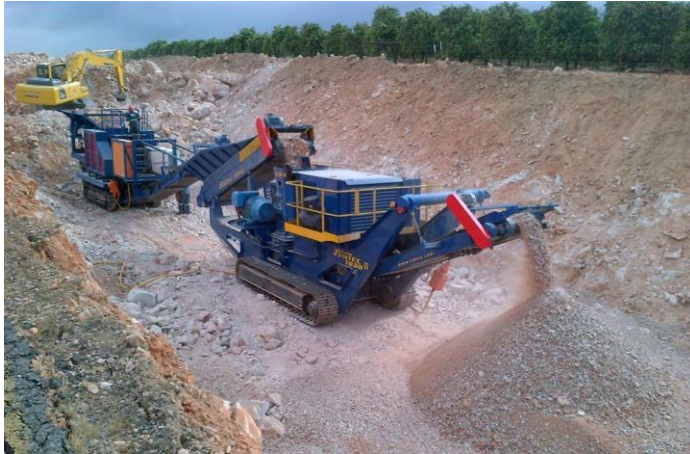
Photo 3: Typical mobile tracked in-pit crusher on another contract by the Applicant

- iii. Such plant will either simply screen the excavated material into oversize which is returned for crushing to provide the enhanced G4 grade material or stockpiled for loading as the finer G5 material. The screened and/or crushed material which is stockpiled by the mobile plant will continuously be loaded by front end loader to delivery trucks for delivery as in b)(i) above. The tracked mobile plant will move along on the newly developed excavation floor to facilitate direct loading by the excavator.

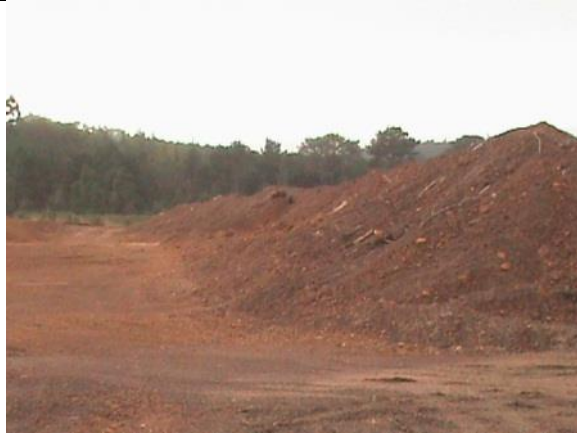
Photo 4: Example of temporary perimeter topsoil stockpiles (berms)

Given the existence of a good topsoil profile on site, topsoil dozing to perimeter topsoil berm stockpiles (photo 4) as prescribed in Figure 4 shall be undertaken in the establishment phase of the mining. Decommissioning rehabilitation as in Figure 4 and 5 prescribes the replacement of such topsoil together with its retained seed and bulb bank on the final perimeter slopes and floor of the excavation.

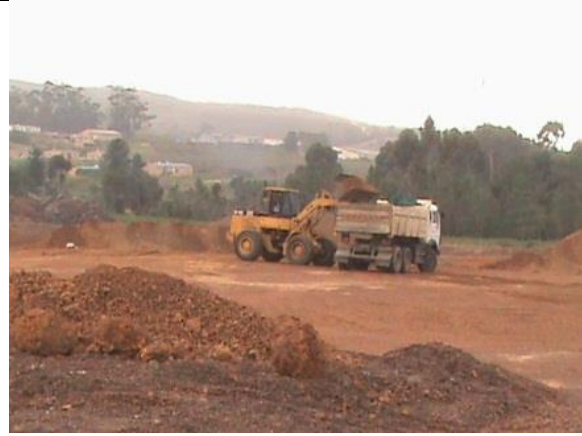
Photo 5: Example of product loading by front-end loader

- e) In the event of screening taking place on site, a front-end loader will continuously load product from the small product stockpile into delivery vehicles for transport to the wind farm construction site and there will be no bulk stockpiling on site. G4/G5/G6 material will be delivered directly onto the road or platform construction on the wind farm site.
- f) The Applicant (contractor to the wind farm project) will operate from a main contractor's yard on the wind farm where he will have all logistical facilities of project office, workshops and stores with diesel storage facility, to serve the contract site and provide service and maintenance to the external Borrow Pit sites. The only logistical facilities required in the Borrow Pit 5 Mining Area will be an office/stores container and mobile chemical toilet.

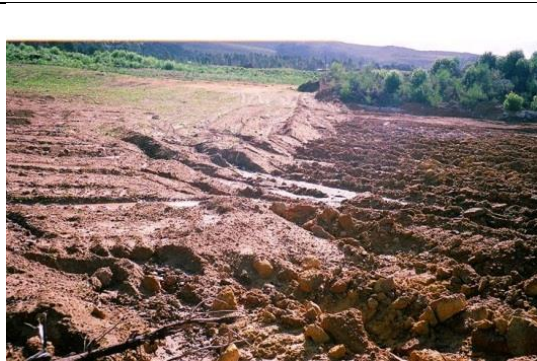
Photo 6: Example of growing medium/topsoil replacement in a gravel pit

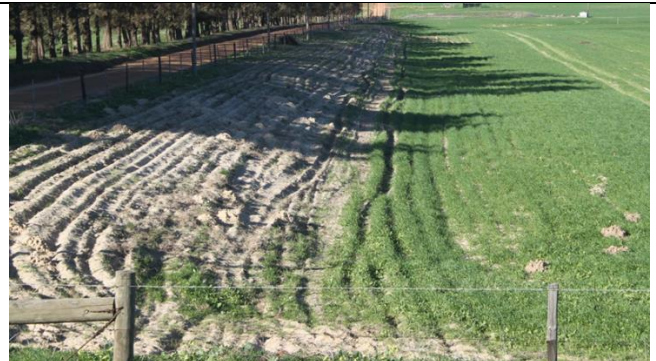
Photo 7: Example of perimeter sloping to 1:3 following retopsoiling and revegetation of a typical wedge-shaped excavation in "soft" materials

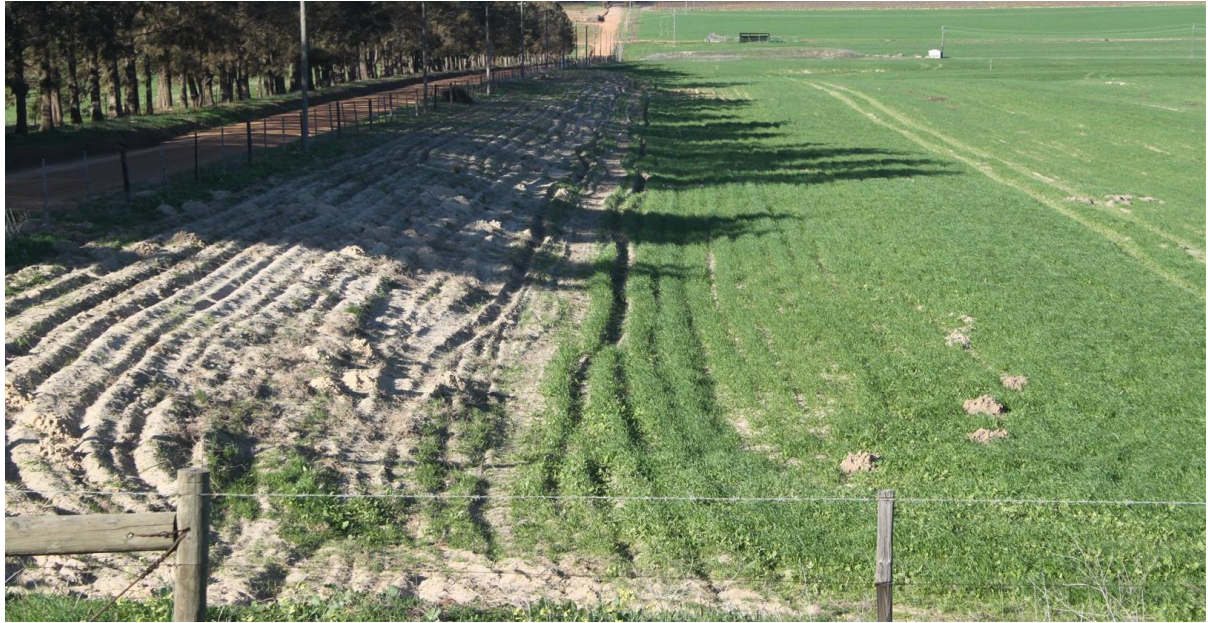
Photo 13: Typical Borrow Pit rehabilitation in process, with full topsoil replacement and revegetation by pasture seeding on the floor of the excavation, and scarification of 1:3 side slope ready for hand seeding.
