Environmental Impact Assessment (EIA) for the
Proposed Construction, Operation and
Decommissioning of a Sea Water Reverse Osmosis
Plant and Associated Infrastructure Proposed at
Lovu on the KwaZulu-Natal South Coast

FINAL EIA REPORT

CHAPTER 7: ESTUARINE ECOLOGY

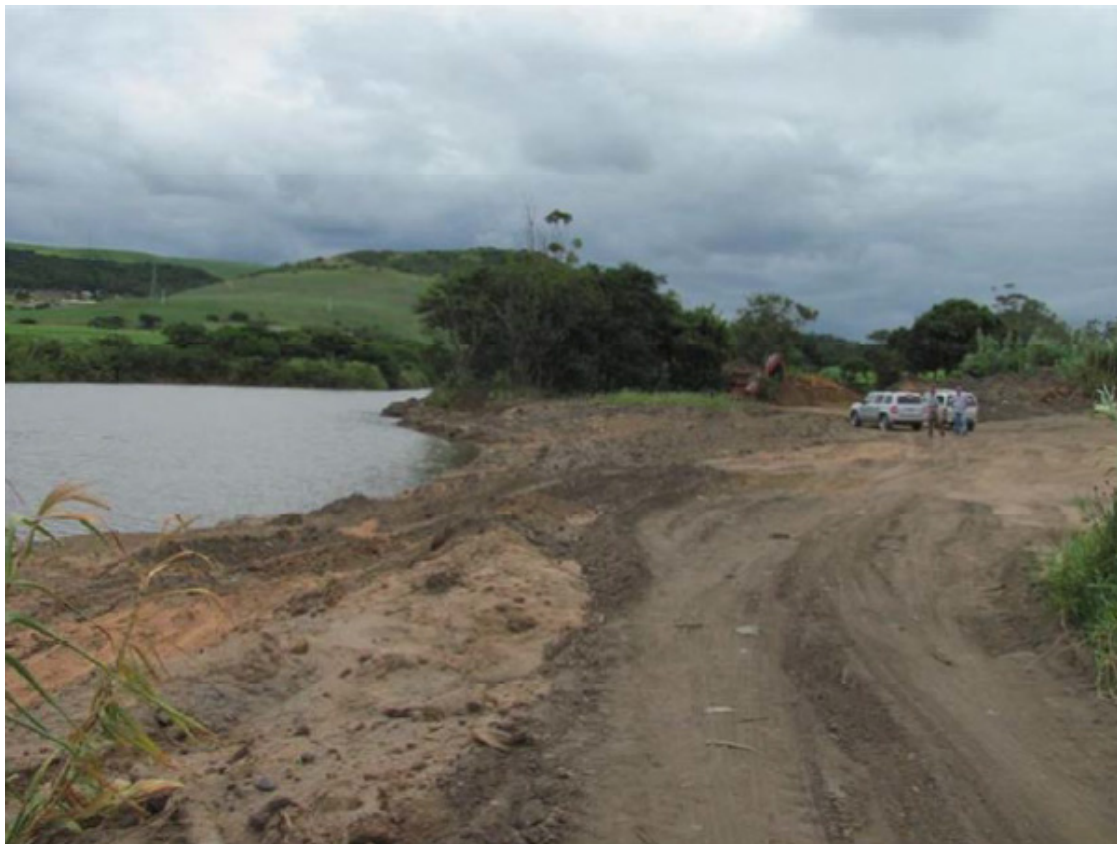
Figure 7.1a Disturbance from sand mining operations along the northern bank of the Lovu River

Surrounding urban and/or agricultural development has impacted the Lovu Estuary reduced the ecological goods and services that the system could provide. This is true of the vast majority of estuaries in KwaZulu-Natal, South Africa (and indeed worldwide). Major impacts on the system included causeways, road and rail bridges that impact both the floodplain and channel characteristics. Other impacts have also occurred historically, and continue in the present day. These include physical alteration and destruction of habitat, as well as pollution. Evidence of sand mining along the northern bank was observed in 2012 during a site visit by Aurecon (Figure 7.1a & b) and has also been reported

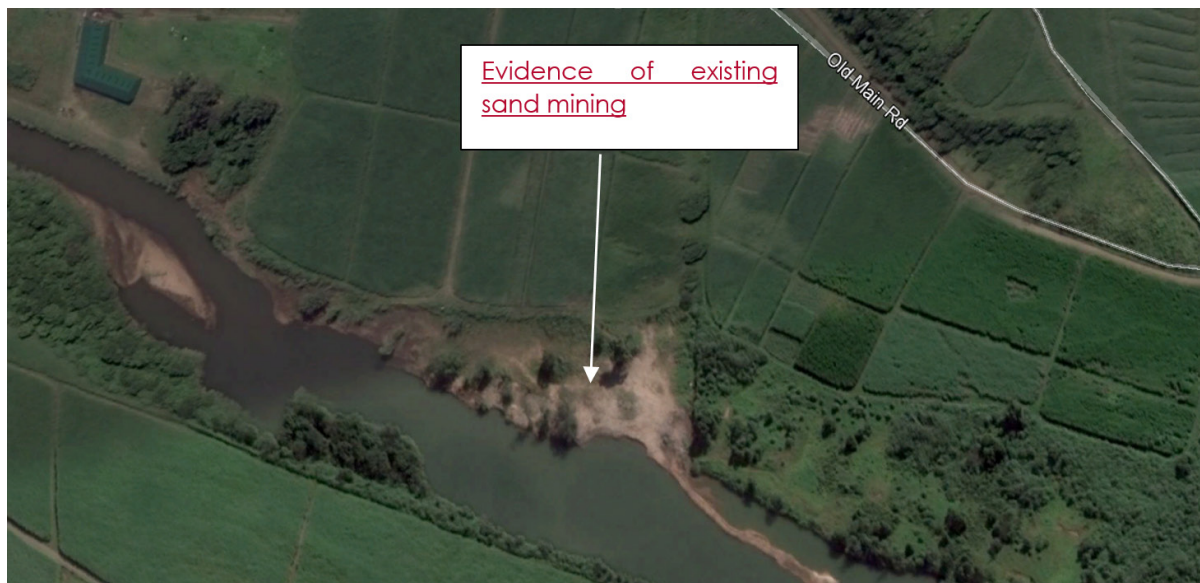
Figure 7.1b Evidence of sand mining along the northern bank of the Lovu River

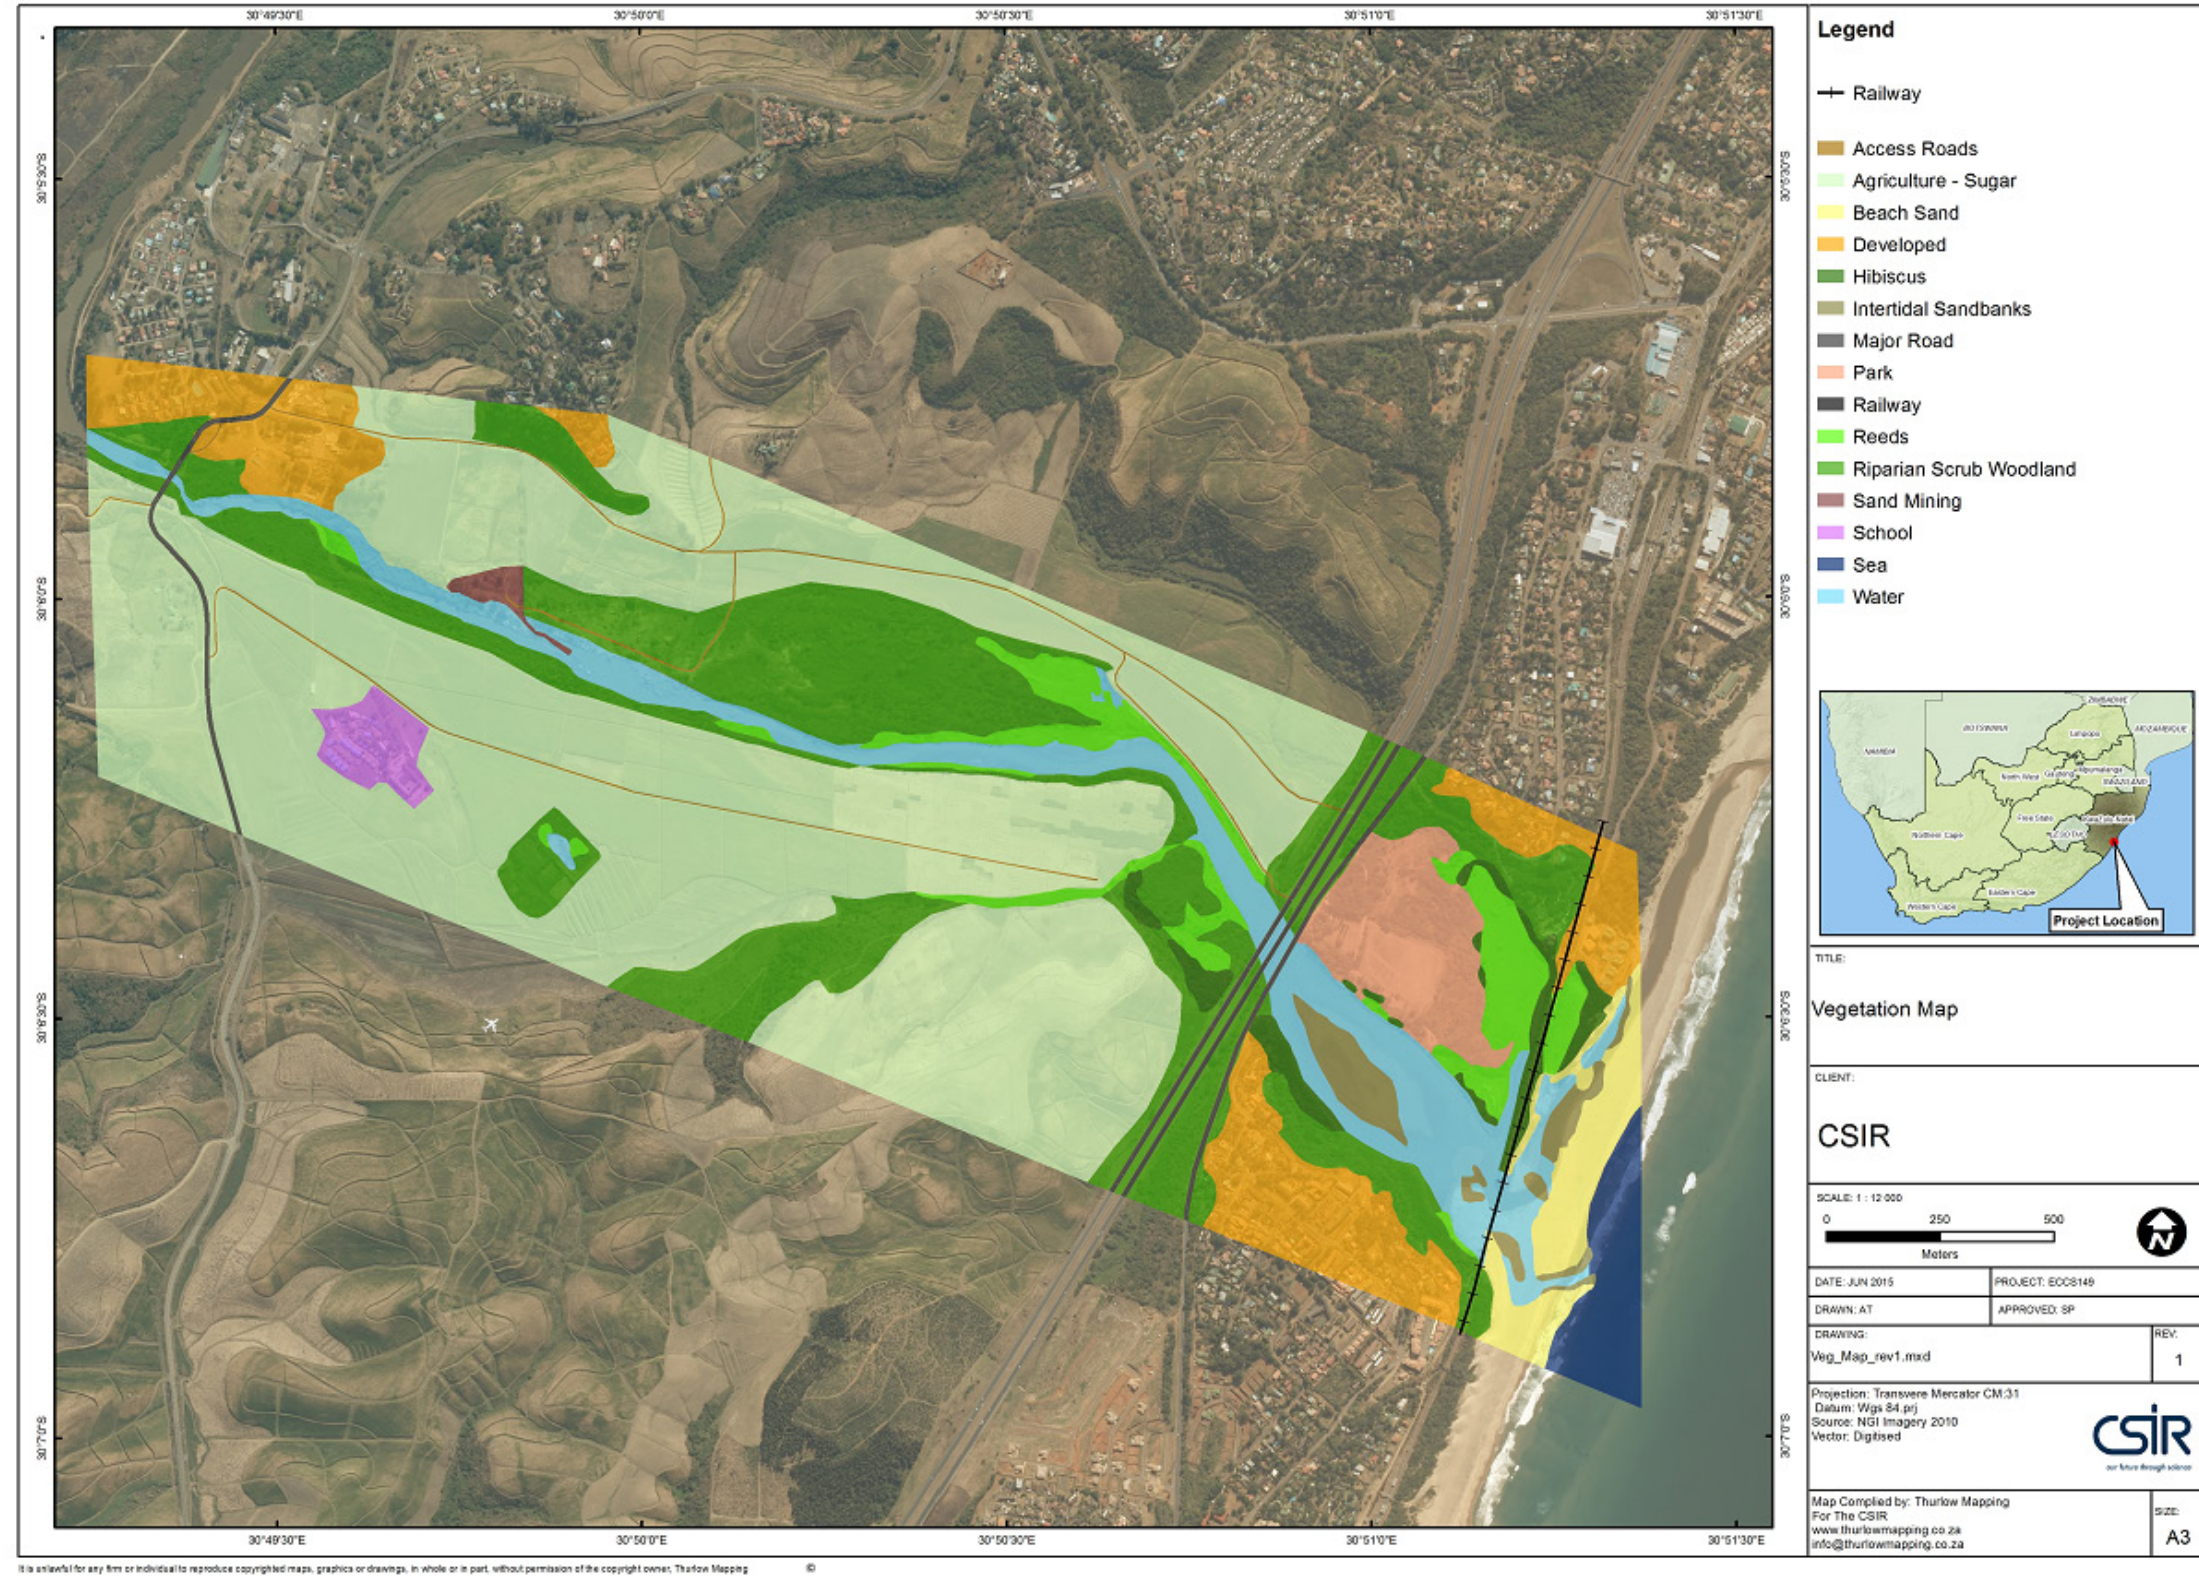
Figure 7.2 Land cover along the Lovu Estuary digitized in Google Earth to indicate distribution of estuarine vegetation along the floodplain

As illustrated in Figure 7.2 the only communities of relevance for determination of estuarine botanical importance of the Lovu Estuary are reeds, small stands of hibiscus (lagoon swamp forest), intertidal sandbanks (benthic algae) and the water body (phytoplankton). When determining the botanical importance of a particular estuary the scores obtained are compared to the highest scoring estuary regionally or nationally whichever is appropriate for the purpose. The development and use of botanical importance ratings have undergone various developments over the years (Coetzee *et al.*, 1997; Colloty *et al.*, 2000) to incorporate habitat degradation, community rarity etc. For the purpose of this study, the Lovu was compared to the uMgeni, the highest scoring and one of the larger estuaries within the eThekweni Municipality. This provided an importance rating in the context of the local region. Comparison with much larger estuaries such as the St Lucia and Kosi Bay systems (for reasons of the large size of these systems) would have resulted in a misleadingly low functional importance evaluation of smaller systems along this section of the coast.

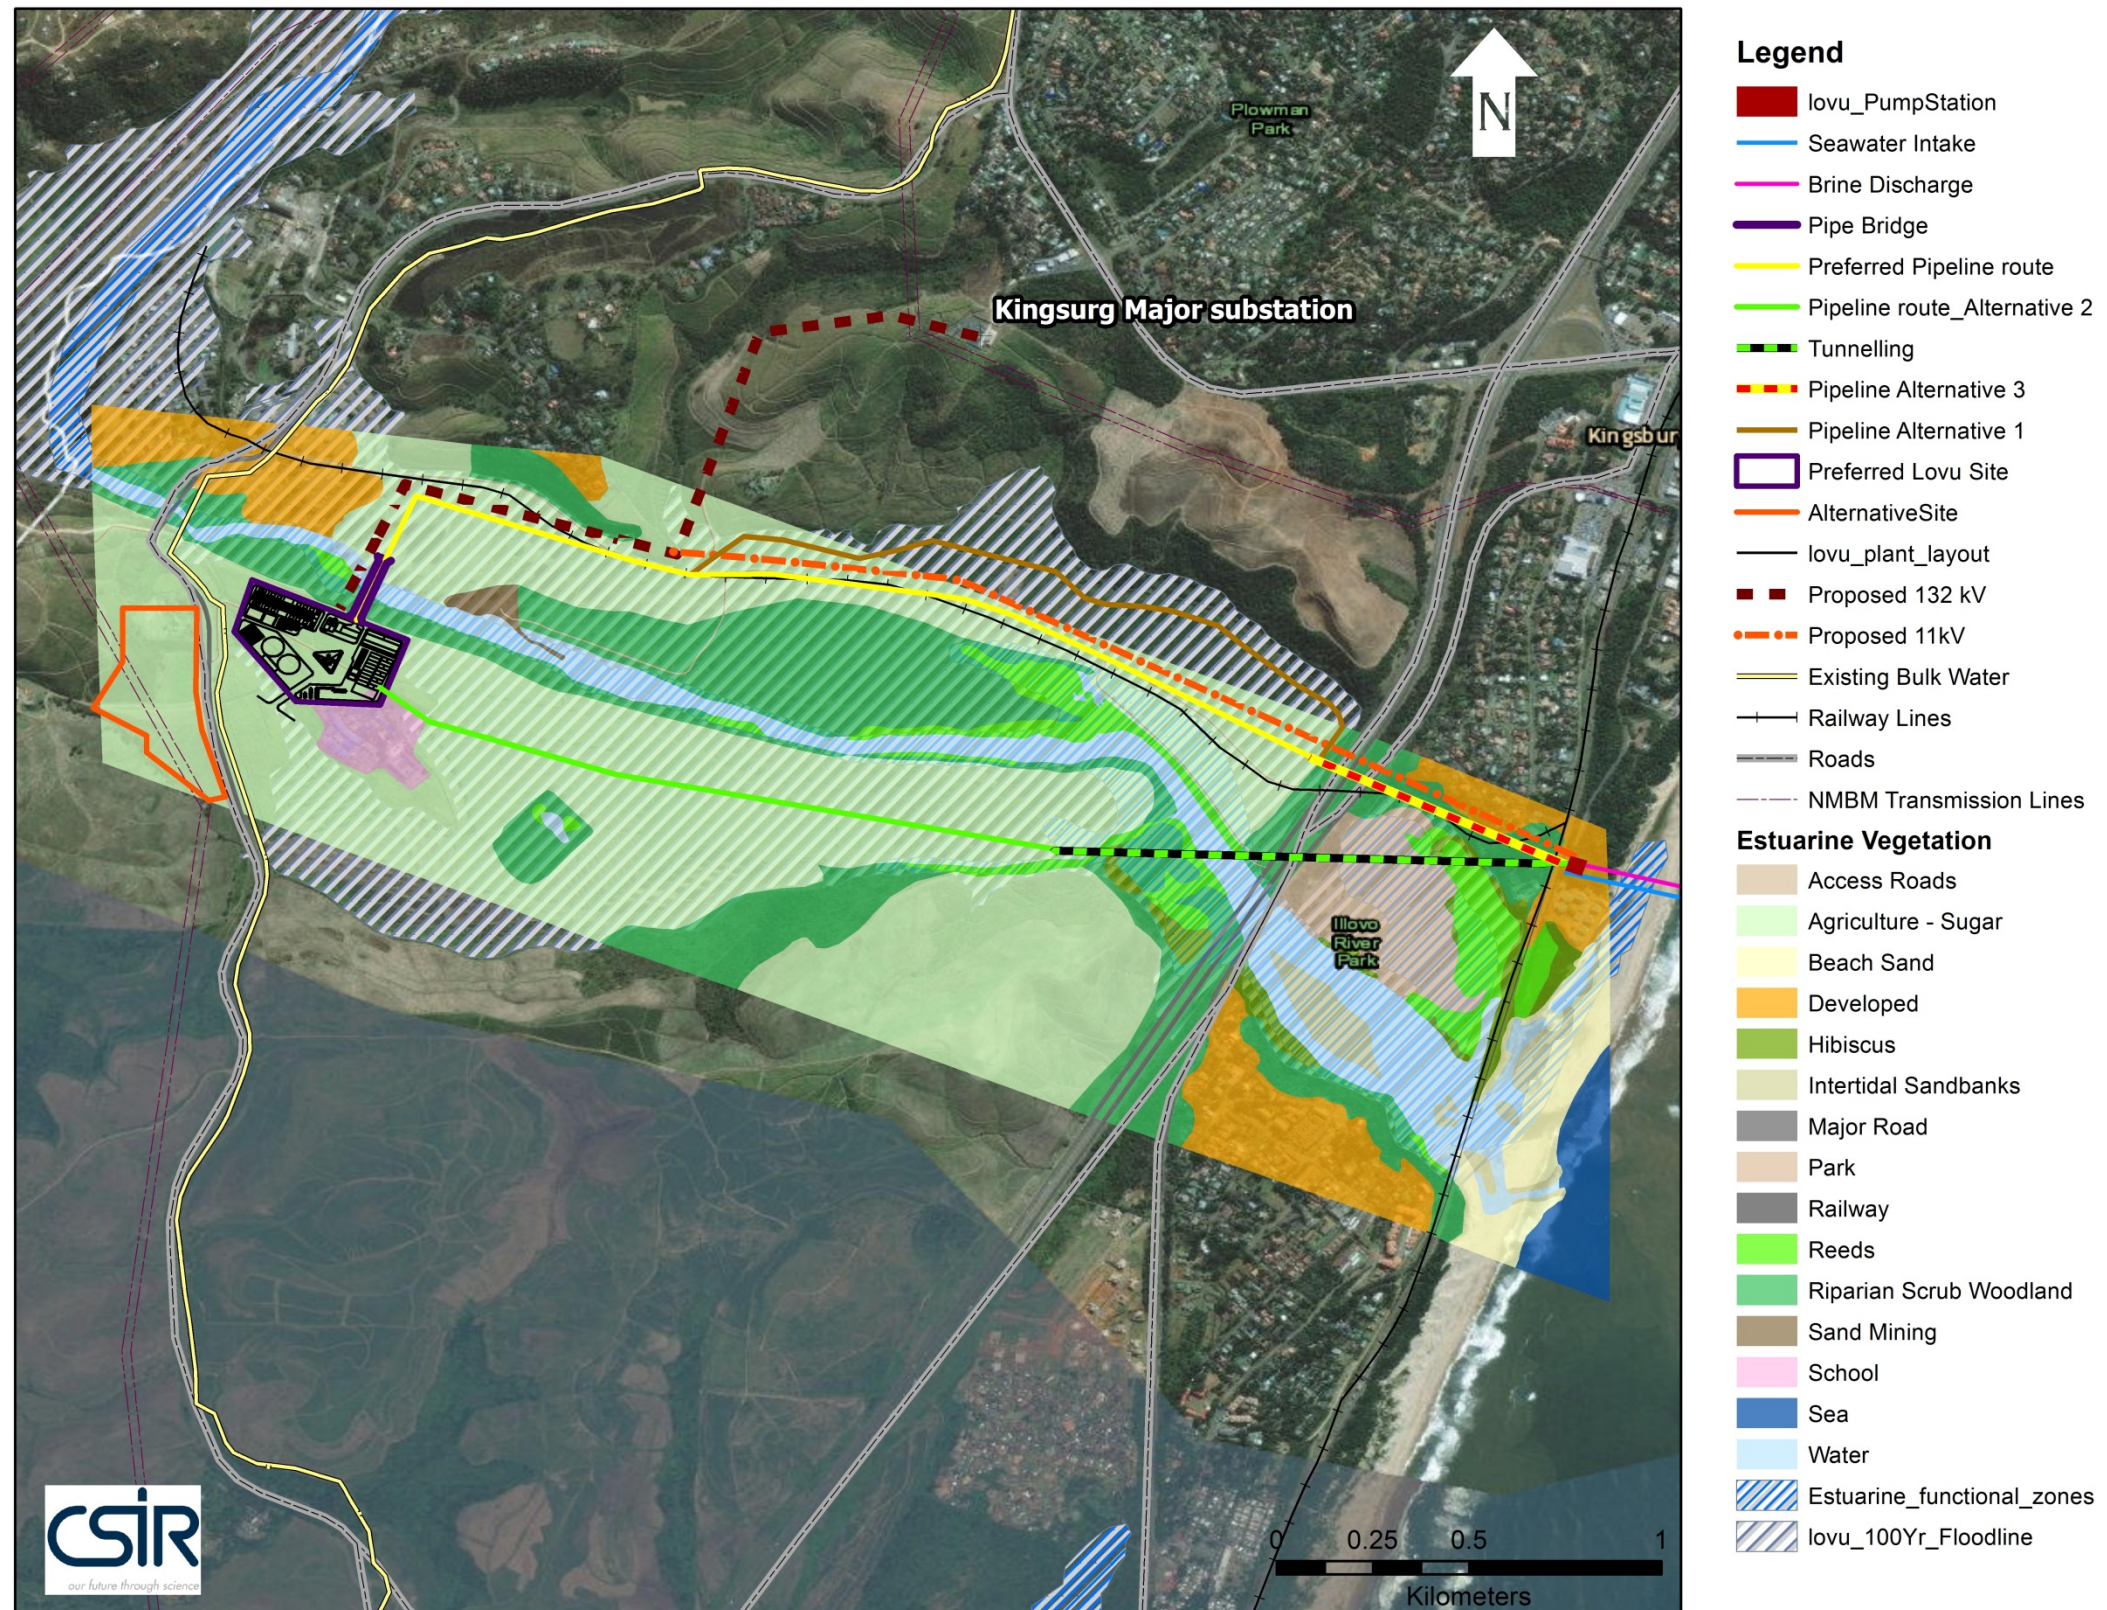
Figure 7.3 Planned infrastructure overlaid onto land cover map

Figure 7.3 indicates the planned siting of infrastructure for the proposed desalination project overlaid onto the landcover map for clarity regarding vegetation communities that may be impacted.

Excavation for installation of the proposed seawater intake and brine discharge pipelines along a current service line and bridging of these across the upper estuary, indicated as the Preferred Pipeline route (in yellow) in Figure 7.3, will cause similar risk of increased turbidity as described in section 7.6.1.1 above. The routing of Pipeline Alternative 1 (shown in brown in Figure 7.3) slightly north of the preferred option is not expected to have any significant reduction in impacts and for the purposes of this estuarine assessment hereafter both options are simply treated similarly in terms of envisaged impacts. Effects of increased turbidity on water quality and biota will be the same as described in section 7.6.1.1 above. The impact assessment is thus also the same and is predicted to have an overall **low** significance without the implementation of key mitigation measures. The level of confidence in the assessment is high.

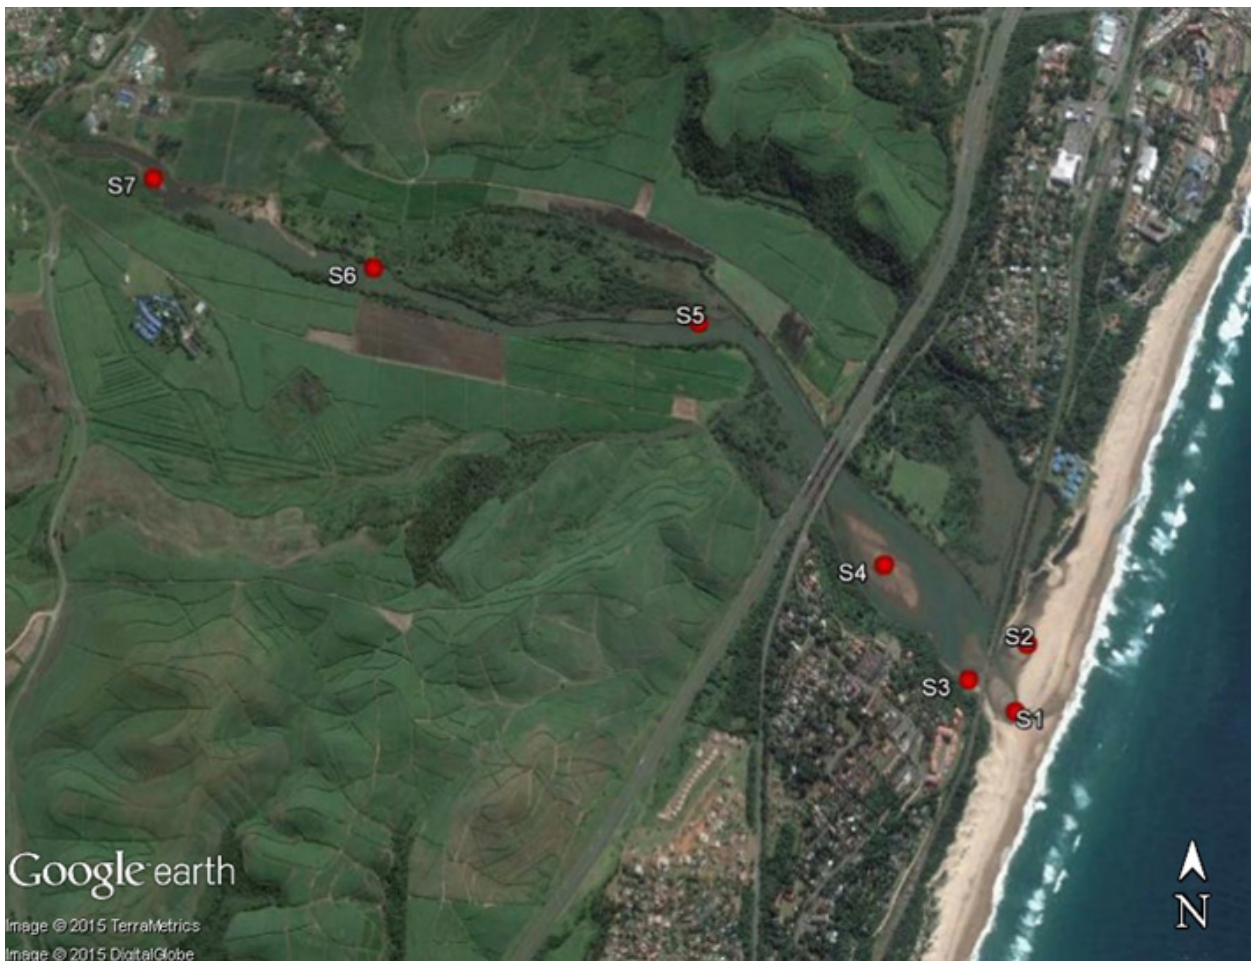
Figure 7.4 Physicochemical water quality and fish sampling sites (Google Earth, 2015)
