Appendix I1 – Stormwater Management Plan

PROJECT NAME: Duvha WULA Amendment

SUBJECT Duvha Power Station Stormwater Management Plan

Project Title: Duvha PS Stormwater Management Plan and Water Balance.

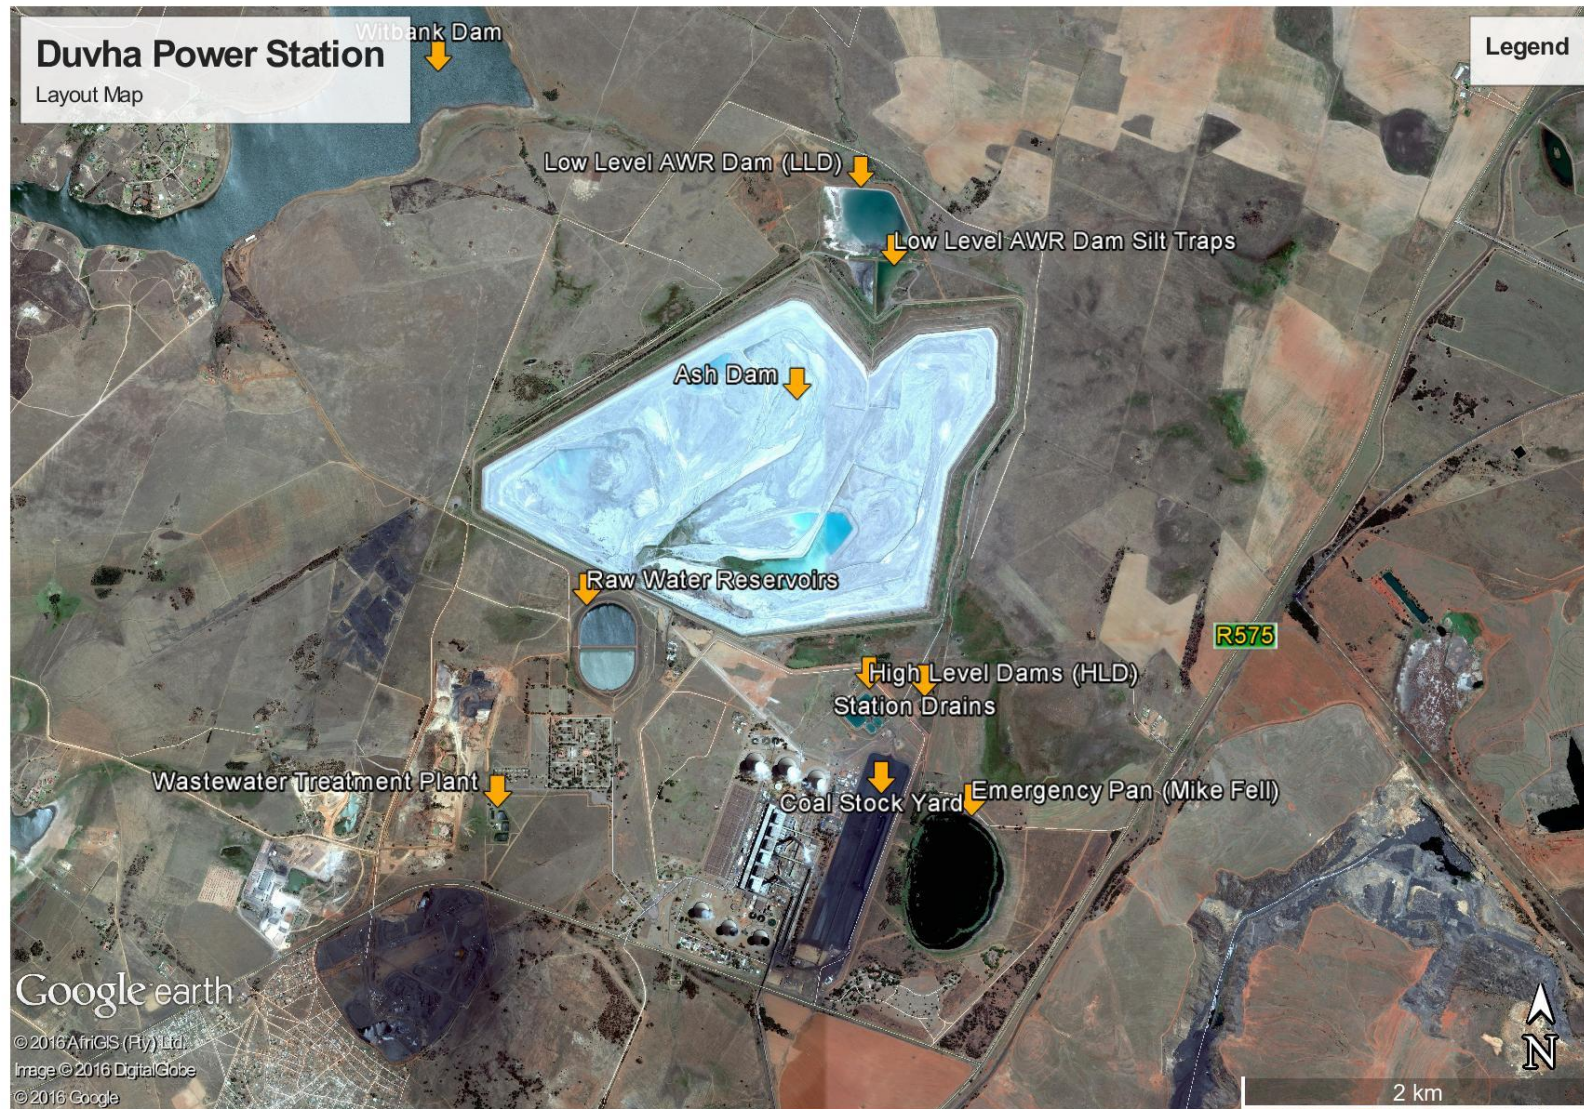
Figure 2: Layout of Duvha Power Station

The stormwater management system, grouped in the main areas as described in the previous section, is explained in the following sections. **Figure 2** shows the general arrangement of the infrastructure as discussed below.

The above areas are shown on **Figure 2**.

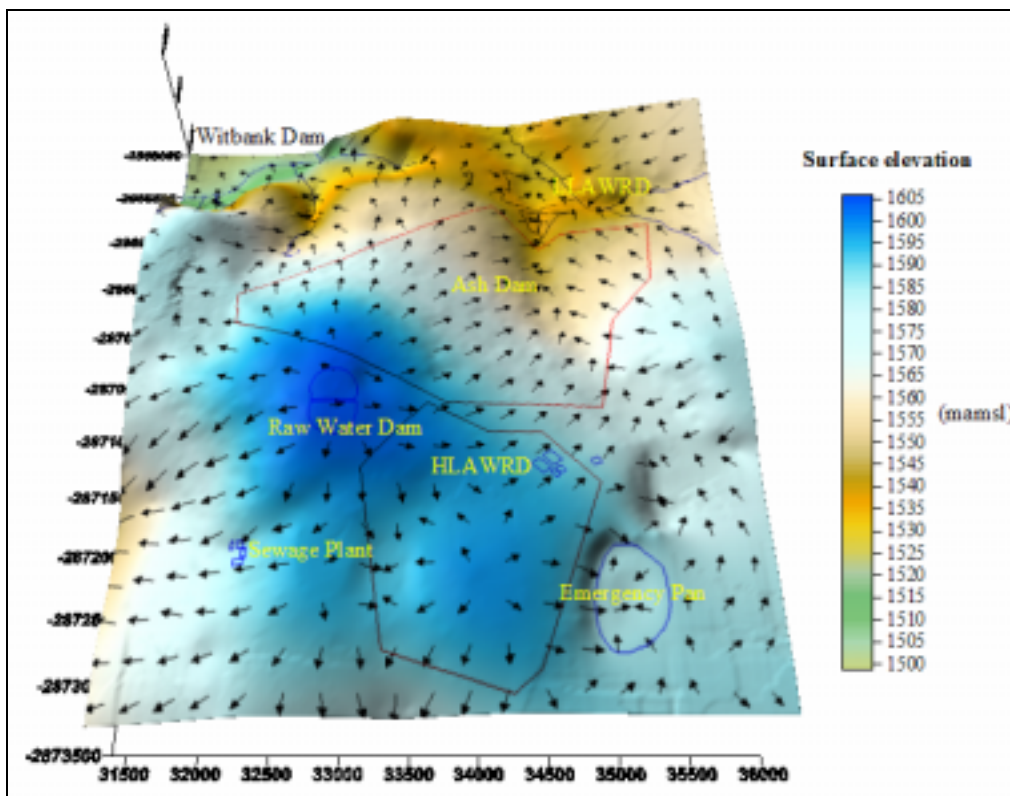
Figure 4. Surface topography and drainage prior to the commencement of power station activities.

The natural drainage to the west of the power station is in a westerly direction.

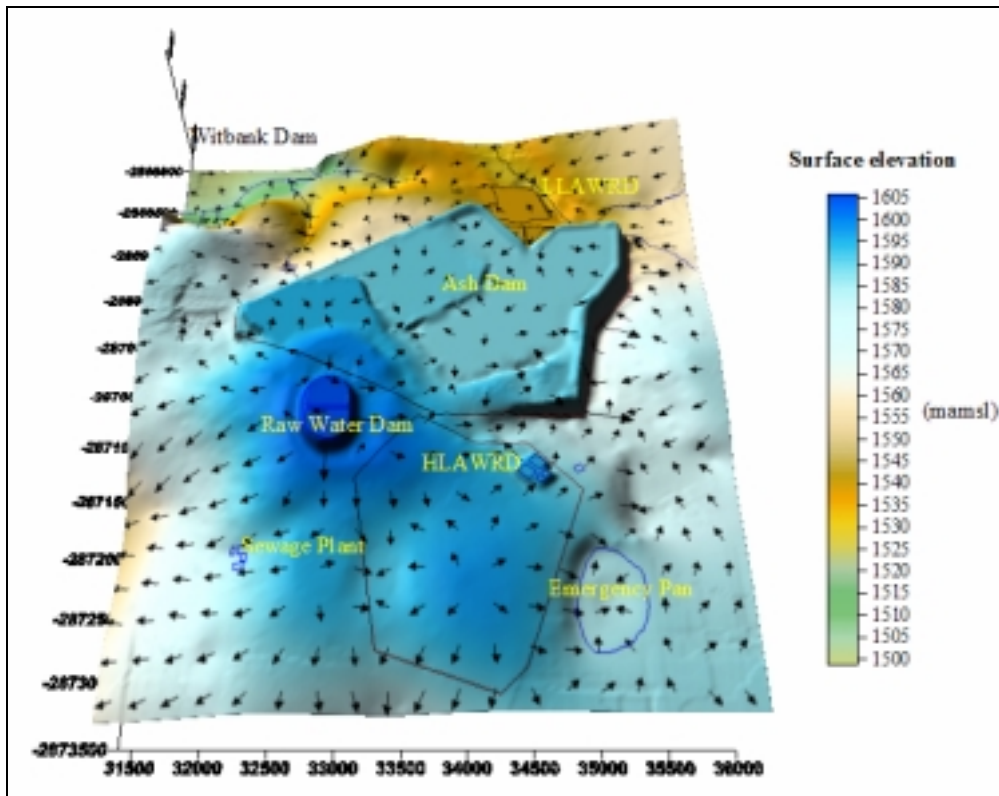
Figure 5. Current surface topography and drainage.

The current surface topography and drainage directions at Duvha Power Station are shown in Figure 5. Although the construction of the various dam systems at the power station has altered the local drainage patterns in vicinities of these dams, the regional drainage is very similar to the natural drainage that occurred prior to the construction of the power station.

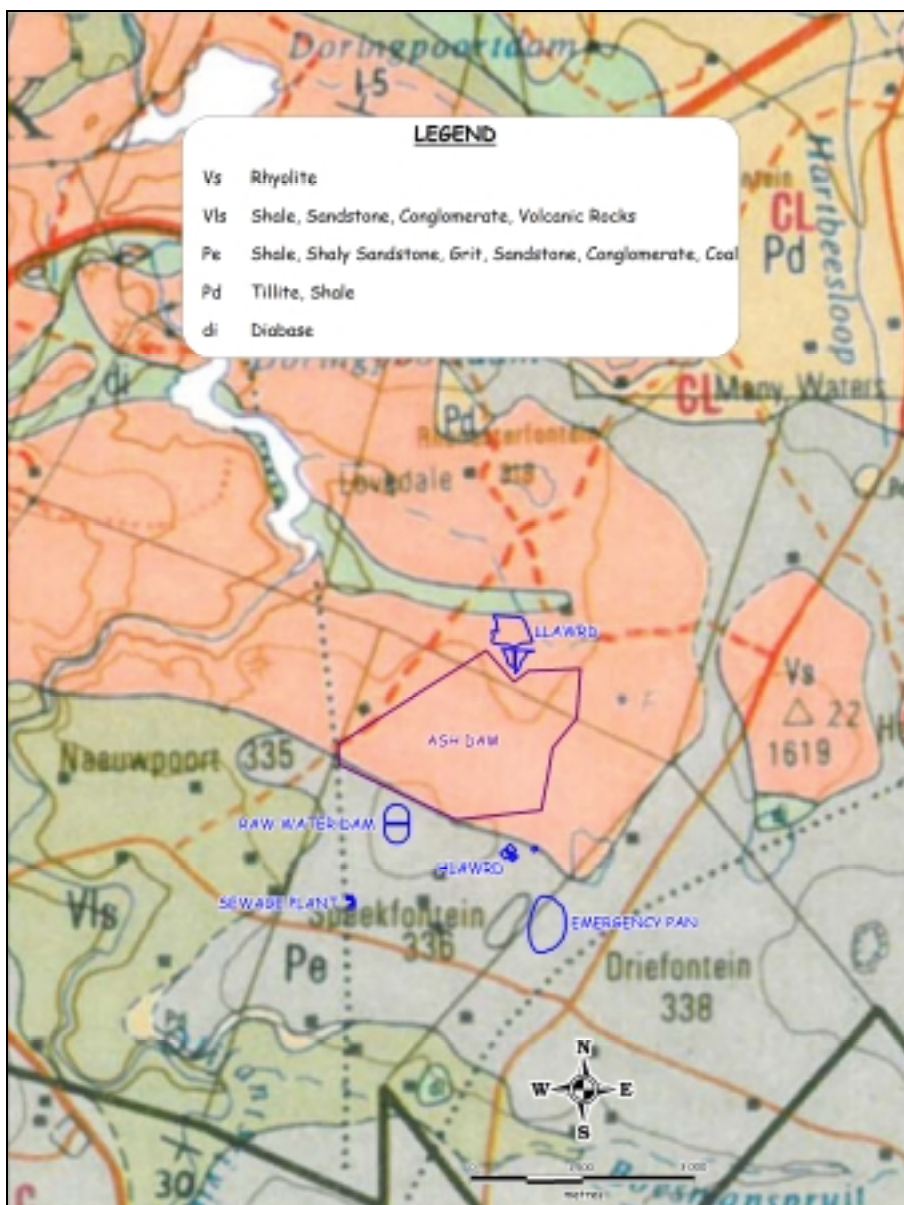
Figure 6. Geological setting of Duvha Power Station.

The Ash Dam and Low Level Ash Water Return Dam are almost completely underlain by rhyolites, with the contact between the rhyolites and the Karoo rocks running approximately parallel to the south-western border of the Ash Dam. Drilling results have shown that the contact occurs more to the south and that it in fact runs underneath the Raw Water Dam. The power station itself, as well as the High Level Ash Water Return Dams, Sewage Plant and Emergency Pan, occurs on Karoo sedimentary rocks.

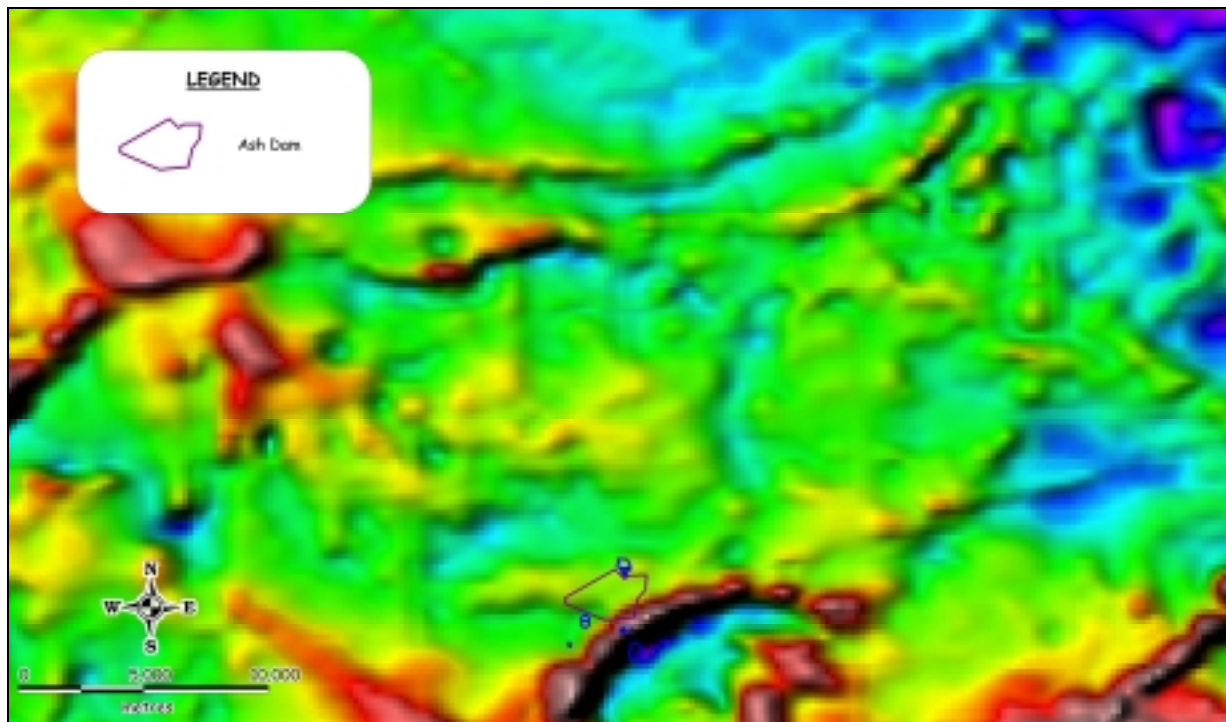
Figure 7. Airborne magnetic map of the area surrounding Duvha Power Station.

Airborne magnetic data were obtained from the Council for Geoscience and studied in order to identify large scale magnetic features that may influence the groundwater environment. A map of the airborne magnetic data is shown in Figure 7 and Figure A.10 of **Appendix A**.

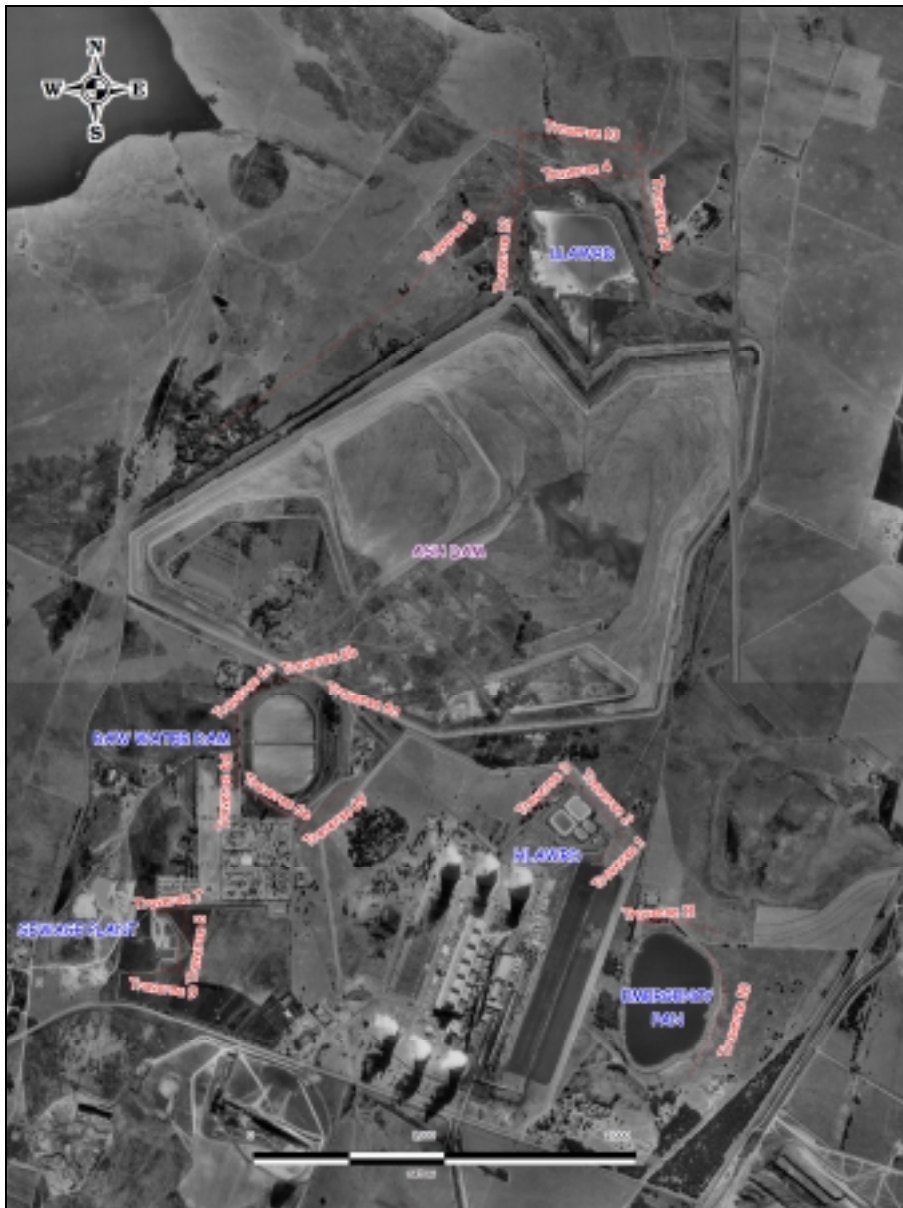
Figure 8. Positions and orientations of the magnetic traverses in relation to the dam systems at Duvha Power Station.

The positions of the 14 traverses on which magnetic data were recorded during the geophysical investigations are indicated in Figure 8 (as well as in Figures A04 and A05 of **Appendix A**). The profiles of the magnetic data recorded on the various traverses are presented in **Appendix B**.

Where possible, magnetic data were recorded on three perpendicular traverses around the different dam systems to ensure that any linear magnetic feature that cuts through the dam systems would be detected. The choice of traverse position and direction was, however, influenced by the presence of surface infrastructure. Metal objects, such as ash transfer pipes and pump houses, have a strong magnetic signature that may mask the magnetic signatures of geological units. Power lines and wires carrying current cause electromagnetic noise that may completely dominate the magnetic readings taken during a survey. Since metal objects and electric currents are ubiquitous at a power station, it was not always possible to avoid their negative influences on the recorded data. The results of the geophysical investigations are described below:

The only prominent magnetic anomalies observed in the profiles of Traverses 1, 2 and 3 are associated with surface infrastructure. No magnetic feature of a geological origin could be identified from the data recorded on these traverses.

The magnetic data recorded on Traverse 11 do not indicate the presence of a magnetic feature that could influence the groundwater environment. The lack of magnetic variation observed on Traverse 11 as compared to Traverse 10 suggests that Traverse 11 runs approximately parallel to the local strike of the magnetic feature that gives rise to the response observed along Traverse 10.

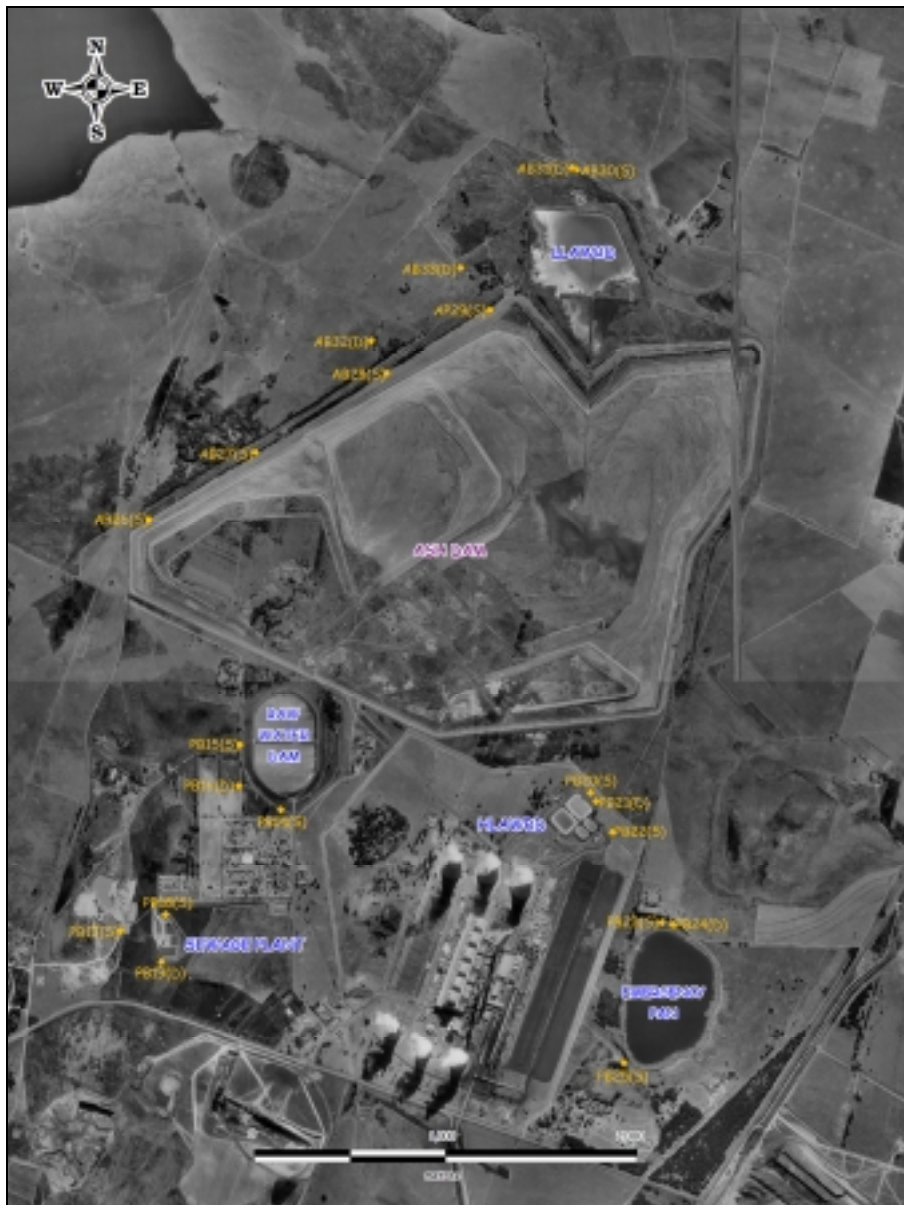
Figure 9. Positions of the 20 new monitoring boreholes at Duvha Power Station.

Twenty new monitoring boreholes were drilled at selected sites in the vicinities of the different dam systems that are included in the current seepage investigations. Both deep and shallow boreholes were drilled to allow investigation of the properties of both the shallow weathered formations and the deeper fresh rock units. The newly drilled boreholes have depths that vary from 10 to 30 metres. The positions of the newly drilled boreholes in relation to the different dam systems are shown in Figure 9 and in Figure A06 of **Appendix A**. The boreholes have been numbered according to the existing numbering system. Since 13 monitoring boreholes existed at the power station prior to the latest drilling programme, the 20 new boreholes are numbered PB14 to PB25 and AB26 to AB33. The “P” in the numbering system indicates that the specific borehole monitors groundwater of the Power Station Area, while the “A” indicates that a borehole monitors groundwater of the Ashing Area. In Figure 9 it is also indicated whether a borehole is a shallow borehole (S) with a depth of only 10 m or whether it is a deep borehole (D) with a depth greater than 15 m. Information on the 20 new boreholes is listed in Table 4.

Borehole PB16 was drilled to the south-west of the Raw Water Dam. Sandstones and siltstones were again encountered up to a depth of 10 mbgl. Light grey and olive grey clayey silts occurred at depths of between 10 and 20 mbgl. These silts are in all probability due to the decay of siltstones. The clayey material caused difficulties during drilling and it was decided to terminate drilling at a depth of 20 mbgl.

Boreholes PB20, PB21 and PB22 were drilled to the north-east and east of the High Level Ash Water Return Dams, in the expected direction of groundwater flow away from the dam system. Clayey sandstones and siltstones were encountered during the drilling of these three boreholes. No water was struck during drilling. However, the drill cuttings from boreholes PB20 and PB21 were moist at shallow depths (< 5 mbgl).

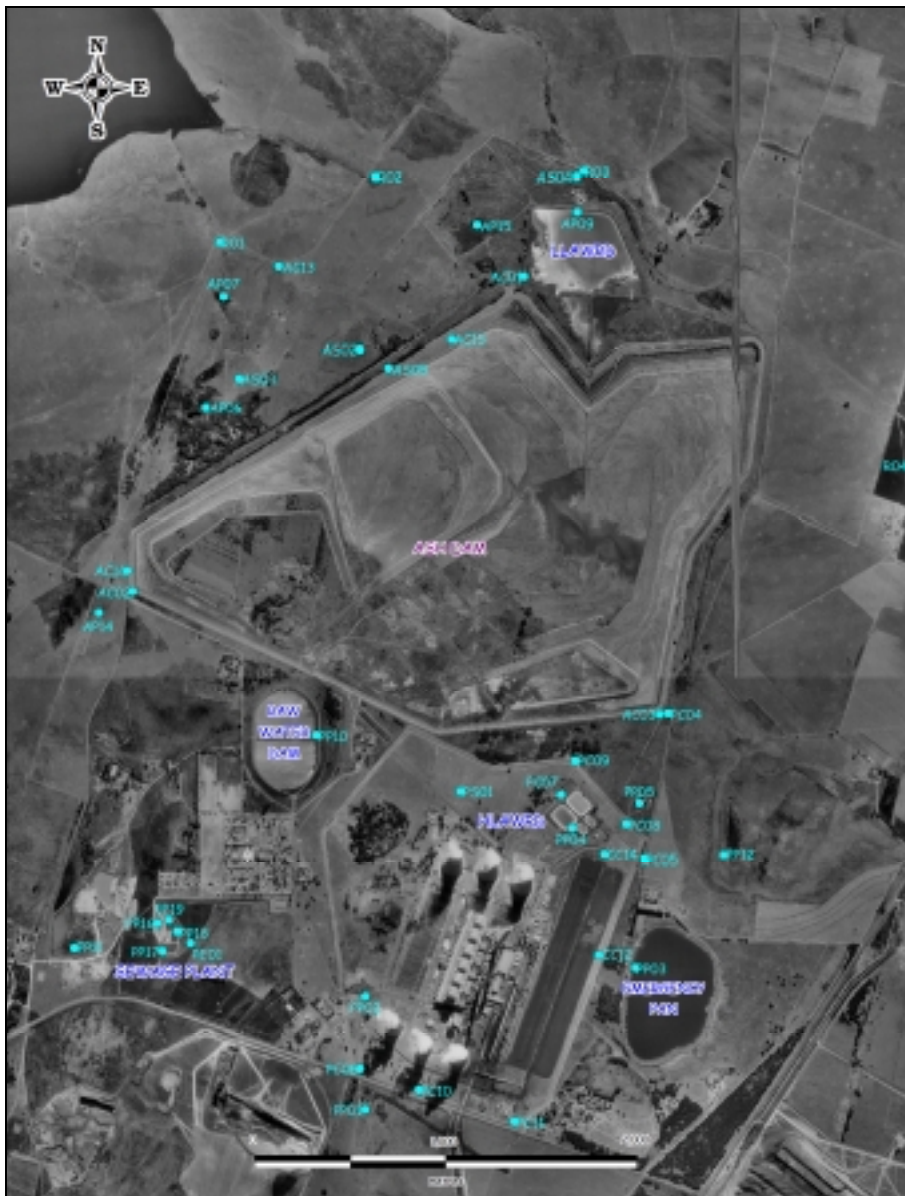
Figure 10. Surface water monitoring sites at Duvha Power Station.

The positions of the existing surface water monitoring sites at Duvha Power Station are shown in Figure 10 and Figures A07 of **Appendix A**. Information on these sites is supplied in Table 6.

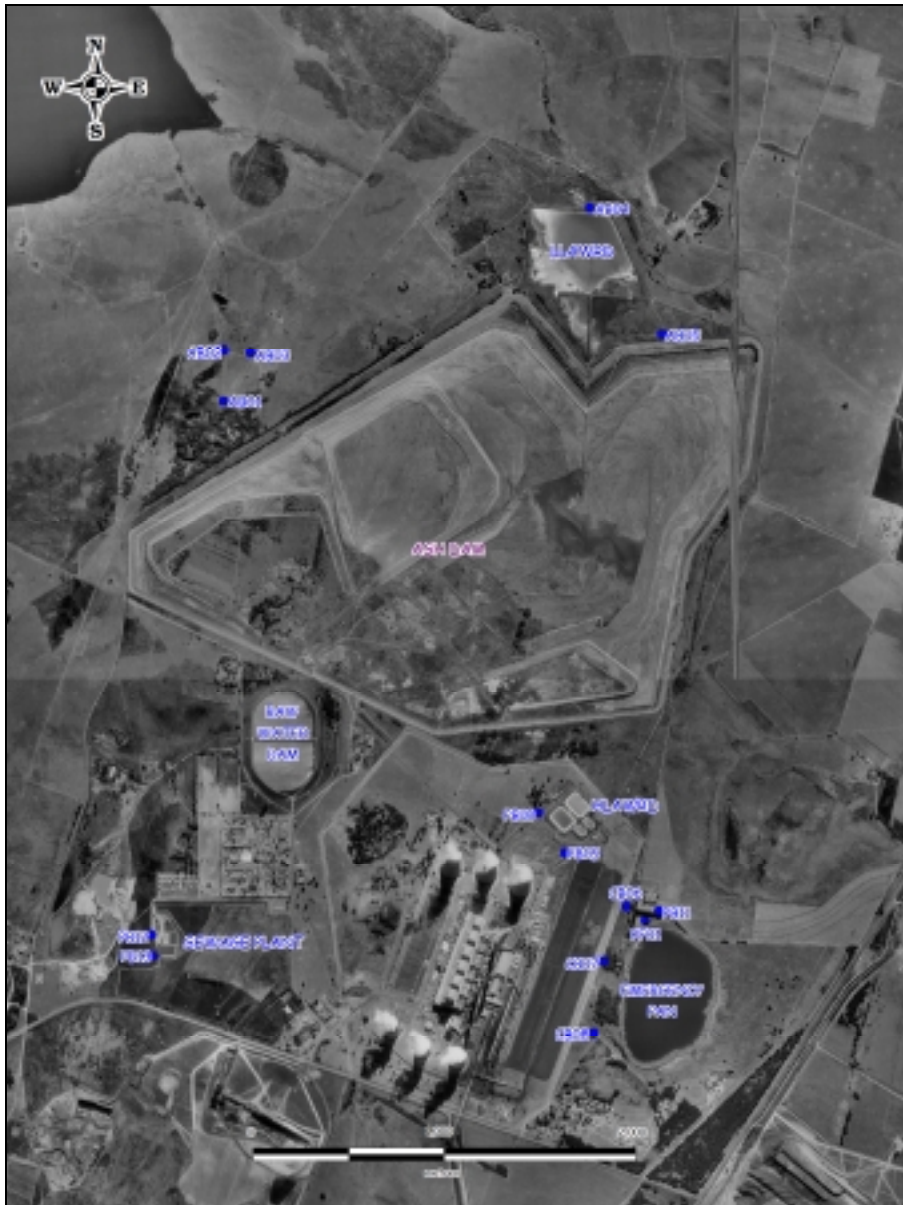
Figure 11. Groundwater monitoring sites at Duvha Power Station.

The positions of the groundwater monitoring sites at Duvha Power Station that existed prior to the drilling phase of the current investigation are shown in Figure 11 and Figures A08 of **Appendix A**. Information on these sites is supplied in Table 9.

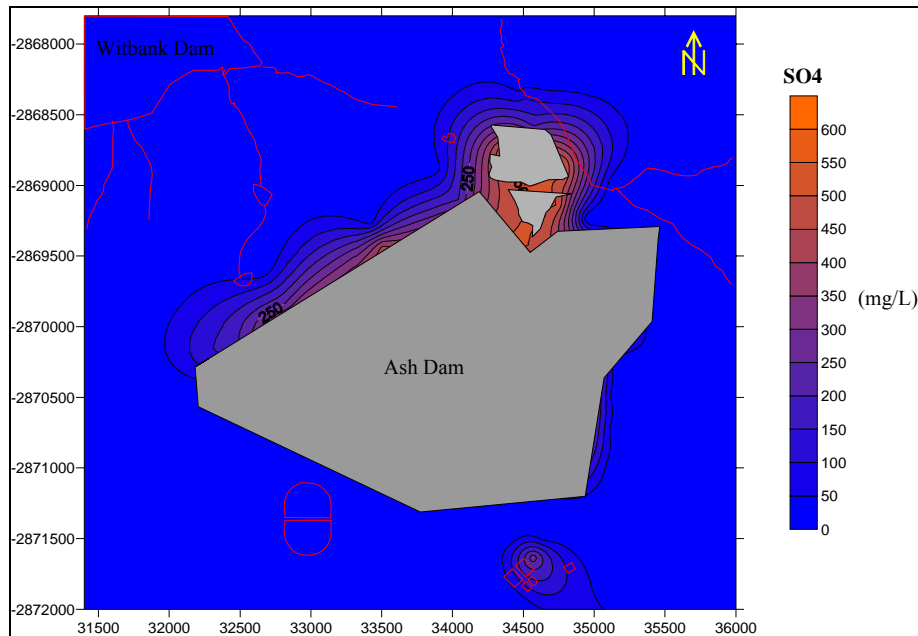
Figure 12. Contour map of the sulphate concentrations observed at the different groundwater sites.

From the data listed in Table 10 it is apparent that the sulphate concentration at a particular site can be seen as a good indicator of the contamination status of that site. To allow a first idea of the distribution of the sulphate pollution plume in the vicinity of the Ash Dam, the sulphate values recorded at the different groundwater sites are contoured and plotted in Figure 12. Note that Figure 12 only plots the contoured sulphate concentrations as observed at the groundwater sites and does not take the borehole depth or sampling depth into account. Contoured values at positions far removed from the groundwater sites should also not be seen as representative of the true concentrations.

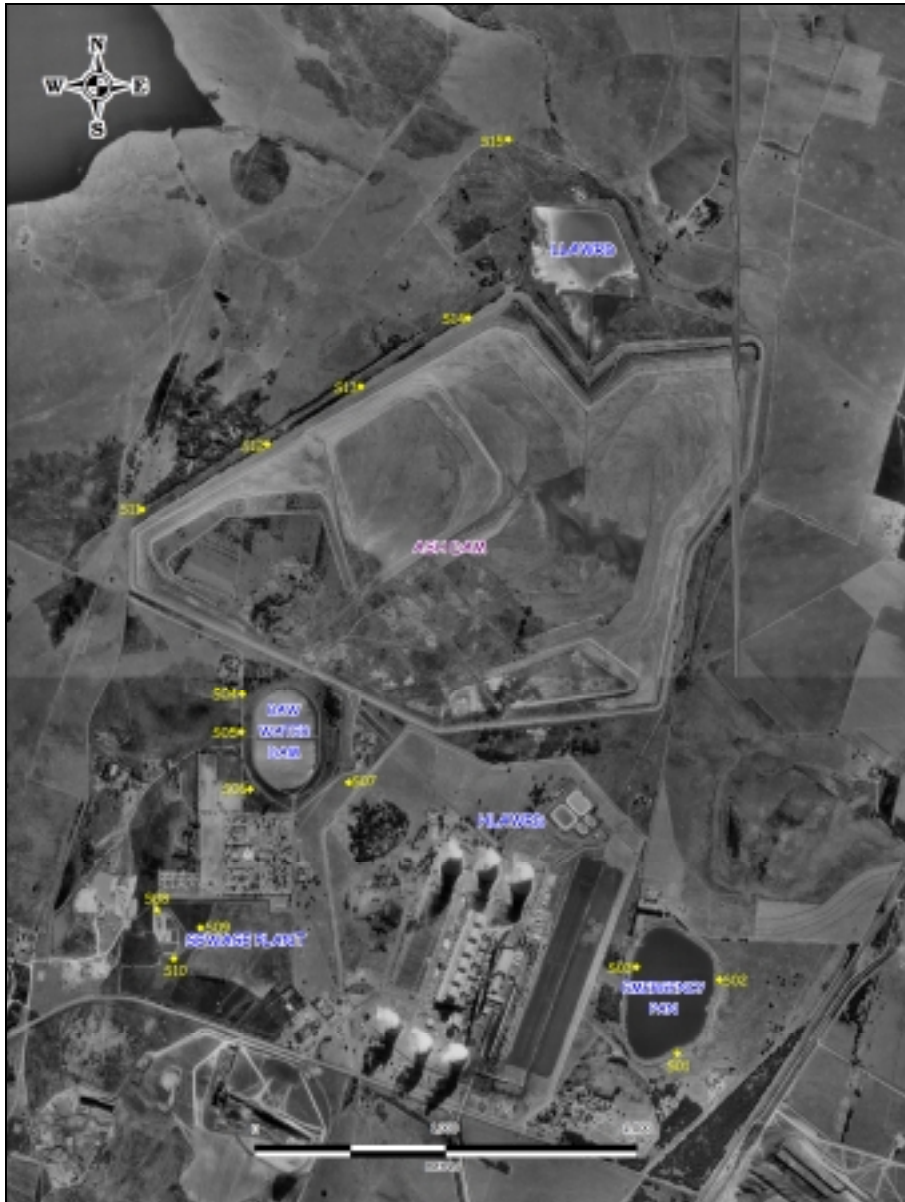
Figure 14. Soil sampling positions.

The positions from which soil samples were taken for chemical and granulometric analyses are shown in Figure 14 and Figure A09 of **Appendix A**. Apart from these samples, additional soil samples were taken from the drill cuttings during the drilling of the 20 new monitoring boreholes in an attempt to gain additional information on the soil properties. The drill cuttings were generally taken during the first couple of metres of drilling where only overburden or topsoil was encountered.

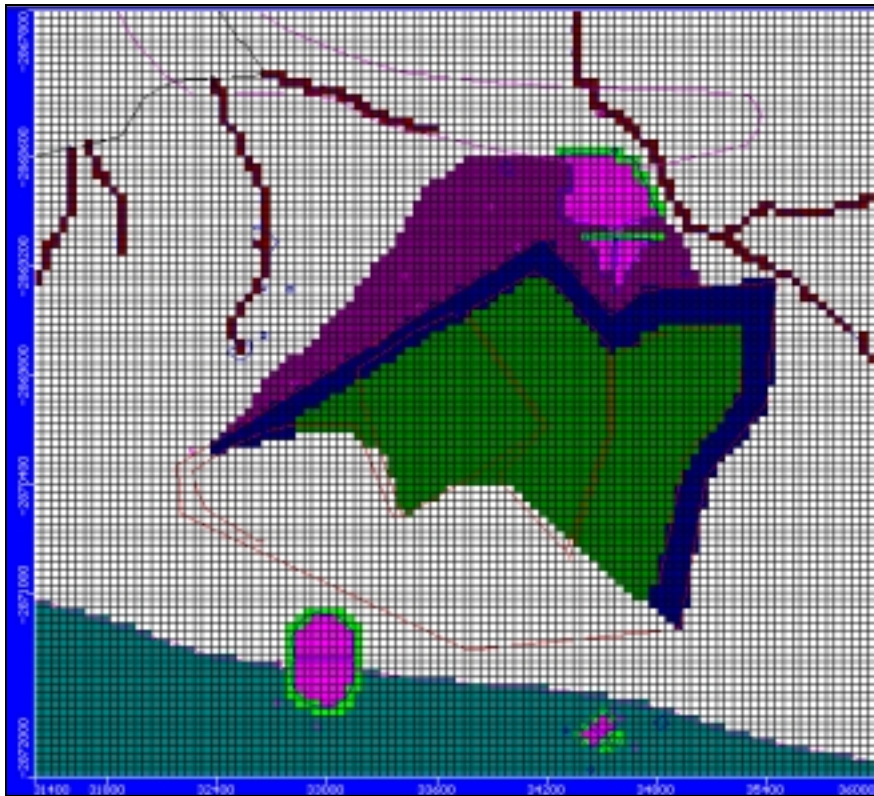
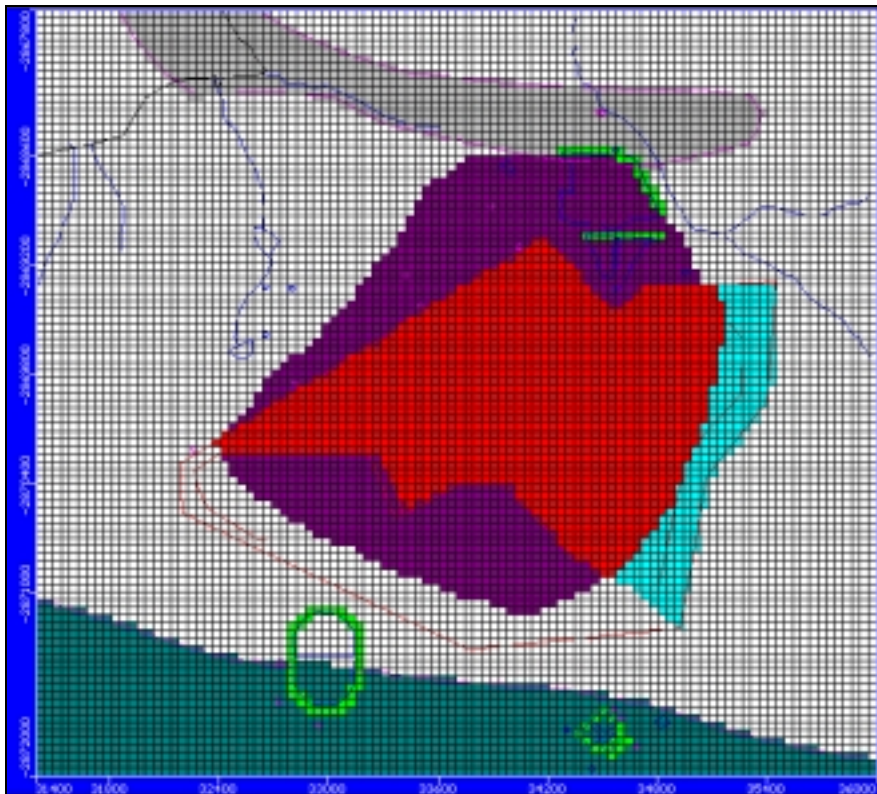
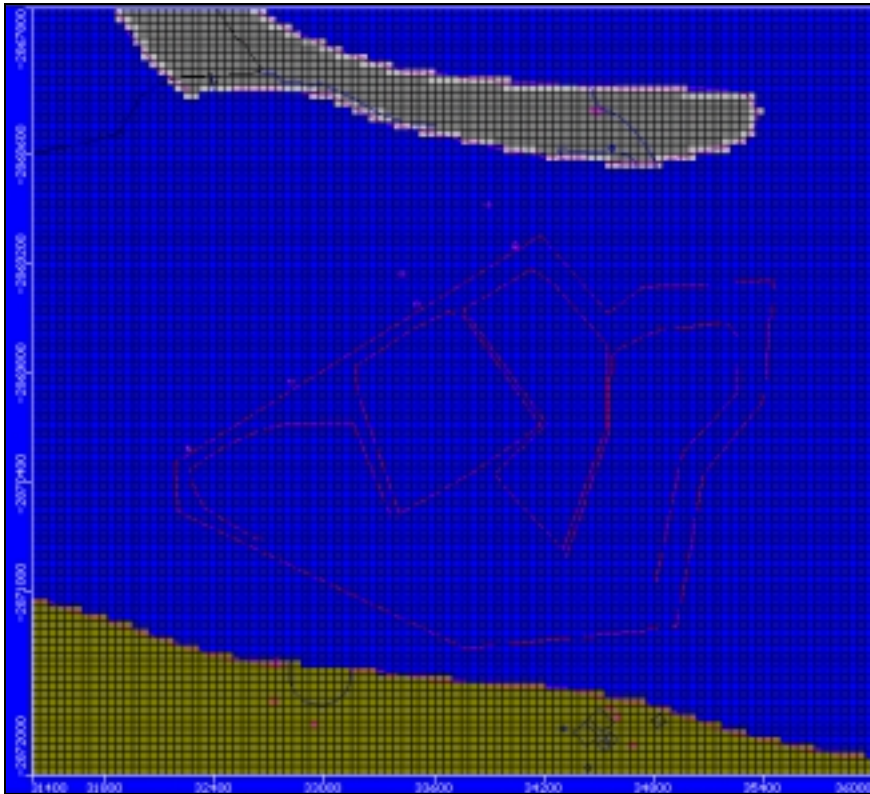
For the numerical model, a grid consisting of 210×230 cells (each cell 20×20 m) was constructed. Three layers were incorporated into the model. Layer 1 represents the dam systems, topsoil and shallow aquifer system. Layer 2 also represents the shallow aquifer system, but extends under the various dams to allow the investigation of seepage from these dams. Layer 3 represents the deep aquifer system. The distribution of the 13 geohydrological zones described above in each of these layers is shown in Figure 17, Figure 18 and Figure 19.

Figure 17. Geohydrological zone distribution in Layer 1.

Figure 18 Geohydrological zone distribution in Layer 2.

Figure 19. Geohydrological zone distribution in Layer 3.

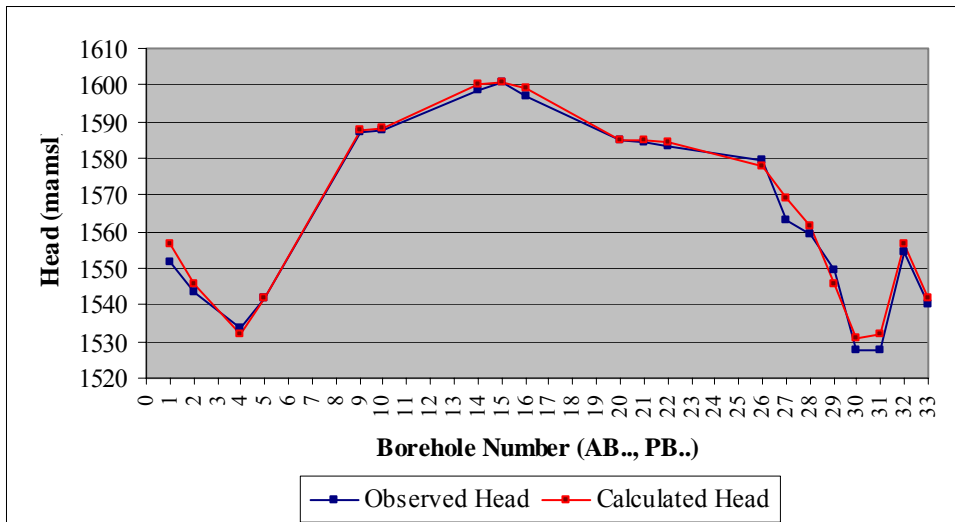
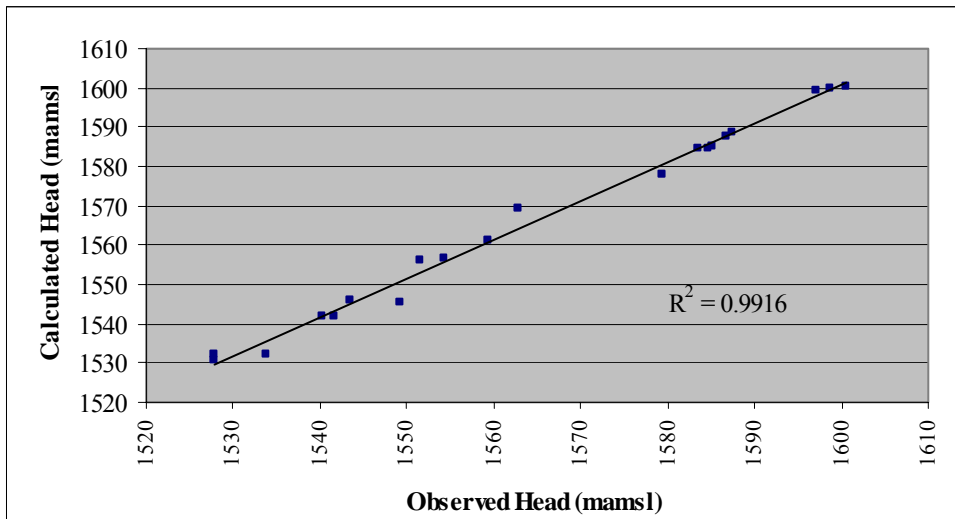
In order to assess the degree to which the model input parameters are representative of the actual field parameters, the model outputs may be compared with the actual measured values. In Figure 21 the observed and calculated heads at the different boreholes around the Ash dam for the current time (end 2006) are plotted. The calculated heads are seen to give good approximations of the actual heads. In Figure 22 the hydraulic heads modelled are plotted against the observed heads. A regression coefficient of 0.992 suggests that the hydraulic properties assigned to the different geohydrological zones give a fair representation of the actual field parameters.

Figure 21. Observed and Calculated Heads at the various boreholes – end 2006.

Figure 22. Model calibration: Calculated vs. Observed Head – end 2006.

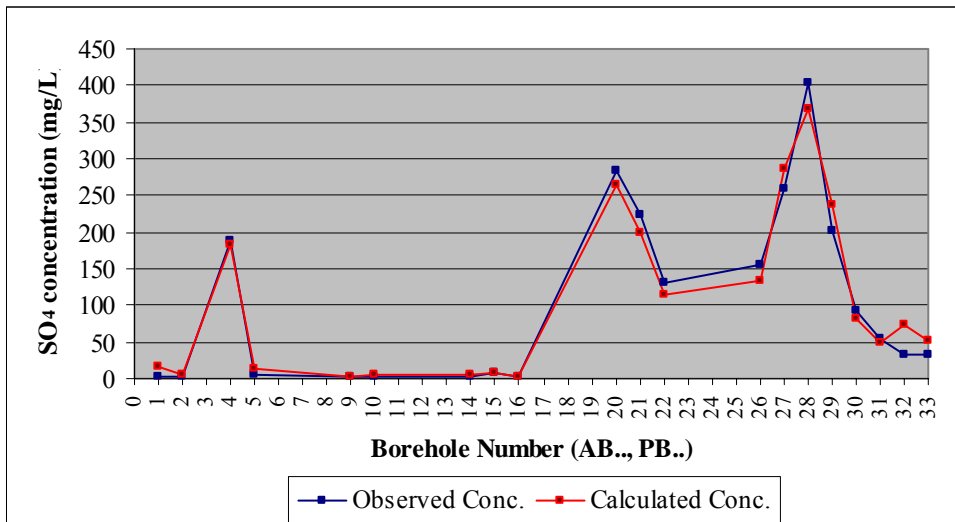
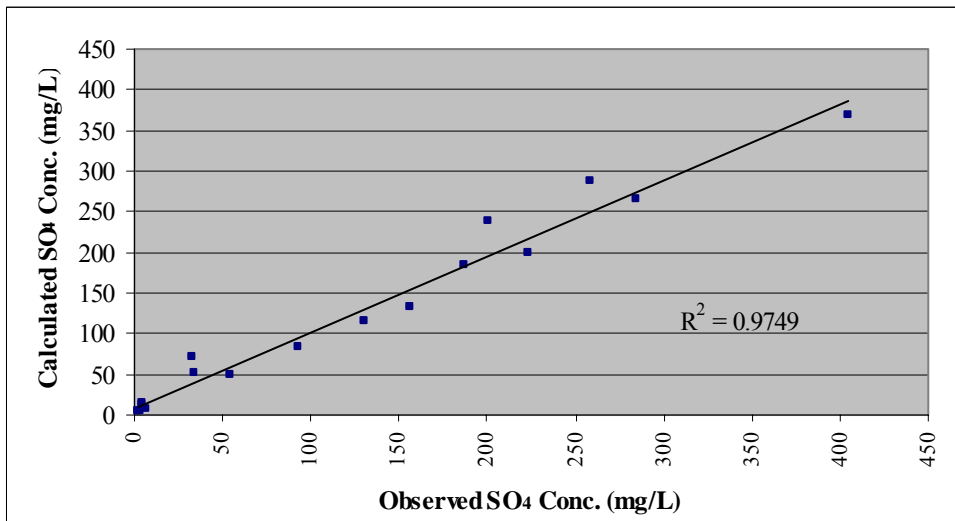
In Figure 23 the observed and calculated sulphate concentrations at the different borehole around the Ash dam for the current time (end 2006) are plotted. The calculated concentrations are seen to give reasonable approximations of the actual concentrations. In Figure 24 the modelled sulphate concentrations are plotted against the observed concentrations. A regression coefficient of 0.975 is obtained, again indicating that the hydraulic properties assigned to the different geohydrological zones are good approximations of the actual properties.

Figure 23. Observed and Calculated SO₄ concentrations at the various boreholes – end 2006.

Figure 24. Model calibration: Calculated vs. Observed SO₄ concentration – end 2006.

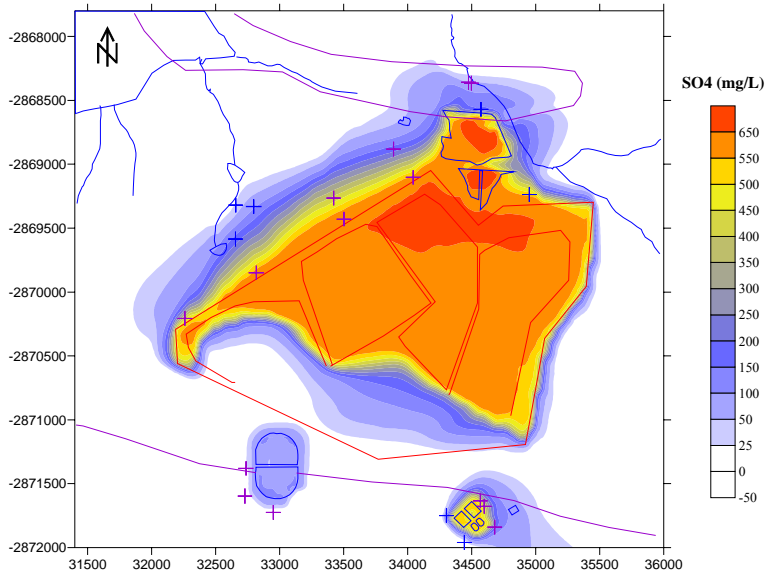
Figure 25. Modelled SO_4 concentrations in the shallow aquifer – end 2011.

The modelled sulphate concentrations as observed in Layer 2, representing the shallow aquifer, are shown in Figure 25 to Figure 29 as coloured contour plots for the following times: end 2011, end 2016, end 2021, end 2026 and end 2036 (when the Ash Dam is expected to reach its maximum height).

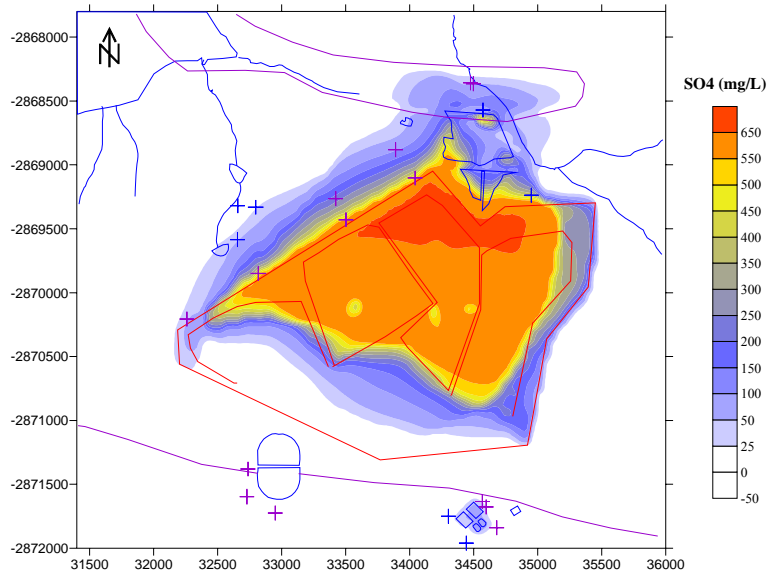
Figure 30. Modelled SO₄ concentrations in the deep aquifer system – end 2011.

end 2016, end 2021, end 2026 and end 2036 (when the Ash Dam is expected to reach its maximum height).

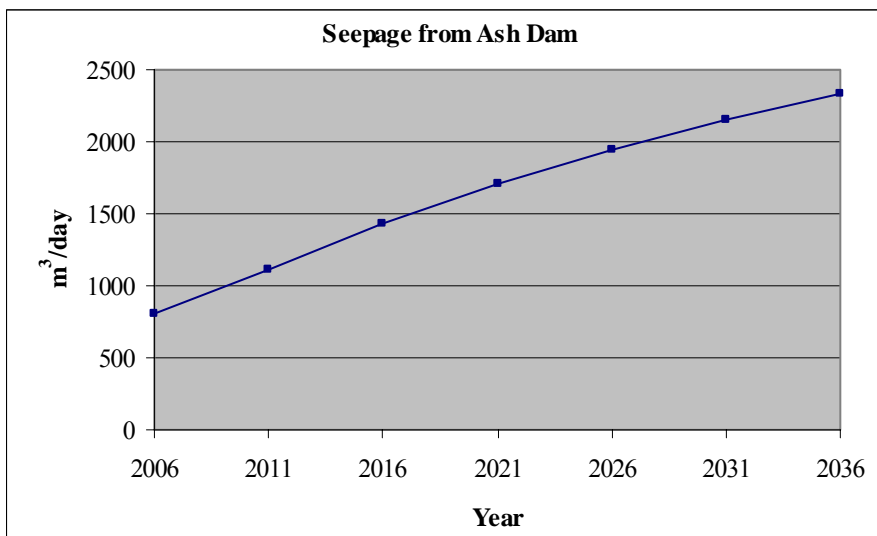
Figure 35. Estimated daily seepage volumes from the Ash Dam.

Seepage from Ash Dam (m ³ /day)			
Year	Total	Into Shallow Aquifer	Into Deep Aquifer
end 2006	805	796	9
end 2011	1109	1095	14
end 2016	1433	1410	22
end 2021	1708	1678	30
end 2026	1942	1905	37
end 2031	2156	2111	45
end 2036	2340	2289	52

The numerical modelling results indicate current seepage losses of approximately 805 m³/day (or 2.52 m³/ha/day) from the Ash Dam. This estimate is significantly lower than the estimate obtained by Mr. Hanekom of Eskom by means of water- and energy balance calculations. It should, however, be noted that for the water balance calculations performed by Mr. Hanekom, it was assumed that the average evaporation from the surface of Ash Dam is equal to the average evaporation measured at evaporation stations B1E001 located approximately 6.6 km away from Duvha Power Station. Mr. Hanekom showed that if the evaporation from the Ash Dam is 11% higher than at station B1E001 the seepage

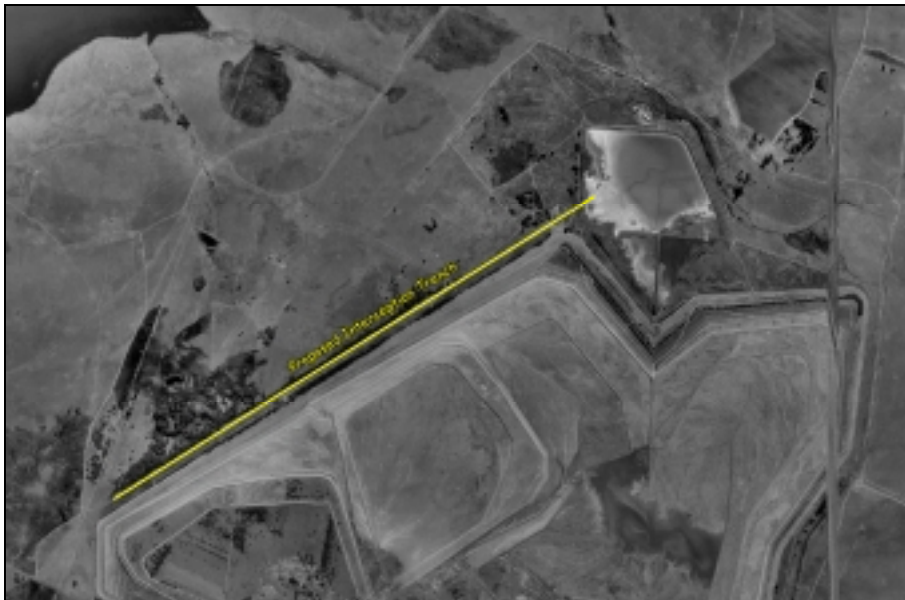
Figure 42. Location of the proposed seepage interception trench north of the Ash Dam.

The existing interception trench constantly carries water, indicating that it is intercepting seepage from the Ash Dam. However, since the depth of weathering in the rhyolites north of the Ash Dam is generally greater than 3 m, the interception trench is only effective in intercepting seepage that occurs at very shallow depths. In order to effectively intercept the seepage, it is recommended that an interception trench with a depth of at least 6 m be installed. It is recommended that this trench be constructed to the north of the existing interception trench, so that the trees that occur on the sides of the existing trench need not be removed. The new trench should, however, still be located close to the Ash Dam in order to minimise the impacts of the seepage on the groundwater regime. It is therefore recommended that the trench be installed 10 – 20 m north of the northern row of trees. The approximate location of the proposed trench is shown in Figure 42.

The numerical modelling results indicate that the installation of a seepage interception trench along the north-western wall of the Ash Dam could allow large volumes of water to be recovered. Different options for the depth and length of the trench were considered during modelling and it was found that an 8 m deep trench with a length of 2 km will be the most beneficial in terms of cost savings due to water recovery over the next 30 years while the Ash Dam is in operation.

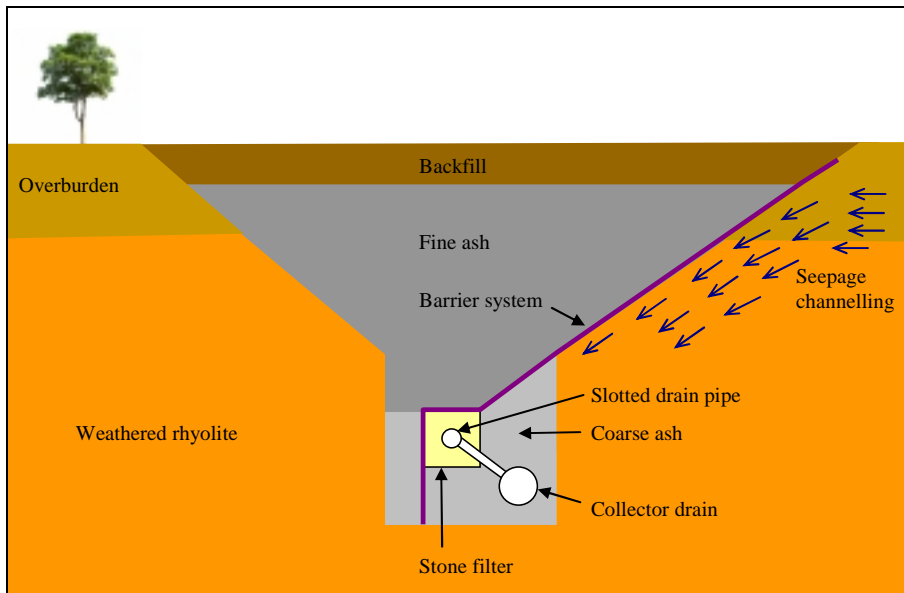
Figure 43. Conceptual design of the interception trench.

The designs of the interception trench and seepage barrier system are illustrated graphically in Figure 43 and Figure 44 (based on drawings by N Barnard).

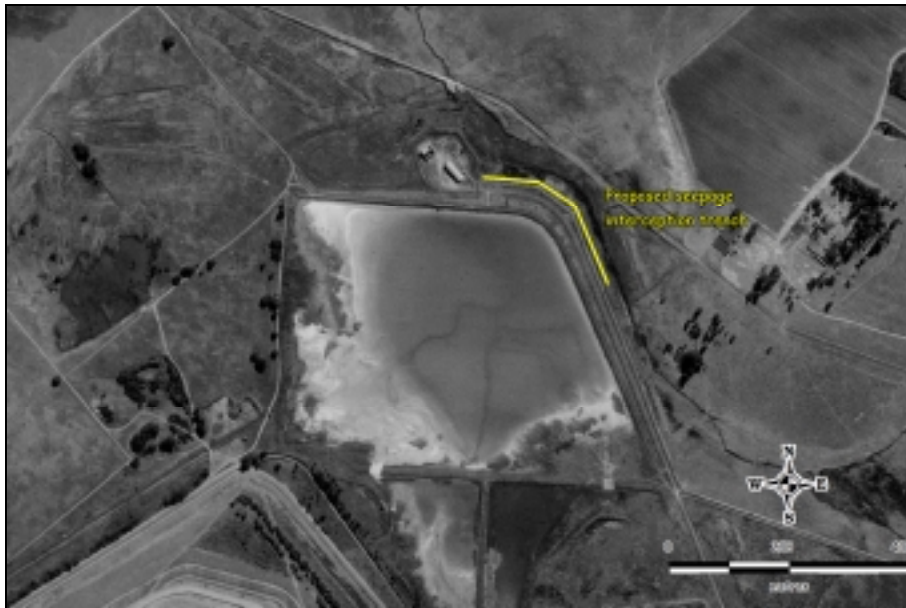
Figure 45. Position of possible seepage interception trench at the Low Level Ash Water Return Dam.

If future water quality monitoring reveals that contaminant impacts on the surface water and/or groundwater are occurring, a simple design for a seepage interception system could consist of a shallow unlined trench (3-4 m deep, ~300 m long) dug at a position near the north-eastern toe of the dam (see Figure 45). The trench could be fitted with gabions to prevent it from collapsing. A sump could be formed at the position of lowest floor elevation in the trench (near the elbow of the trench). From this sump, seepage water could be pumped back to the Low Level Ash Water Return Dam by means of pump equipped with a level switch. Such a system will, however, cause hydraulic gradients towards the trench which could increase the volumes of water seeped from the dam. The estimated costs of installing such a trench amount to approximately R700 000.

Due to the factors discussed above, it is at present not recommended that a seepage interception system be installed at the Low Level Ash Water Return Dam. However, regular monitoring of the water quality and surface- and groundwater sites north of the dam should be done. Any deterioration in the water quality could indicate that larger volumes of seepage have started to impact on the environment. Under these conditions it may be beneficial to install a seepage interception system.
