Appendix I1 – Stormwater Management Plan

PROJECT NAME: Duvha WULA Amendment

SUBJECT Duvha Power Station Stormwater Management Plan

Project Title: Duvha PS Stormwater Management Plan and Water Balance.

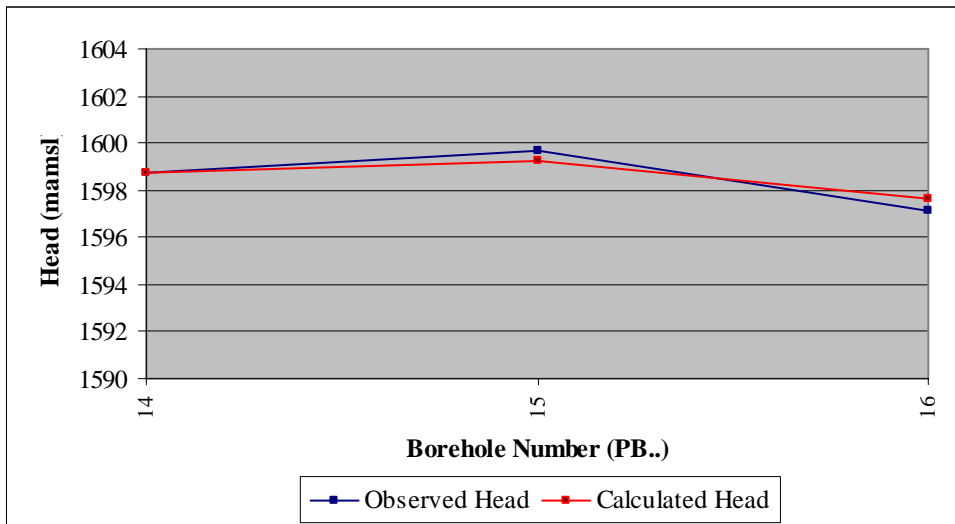
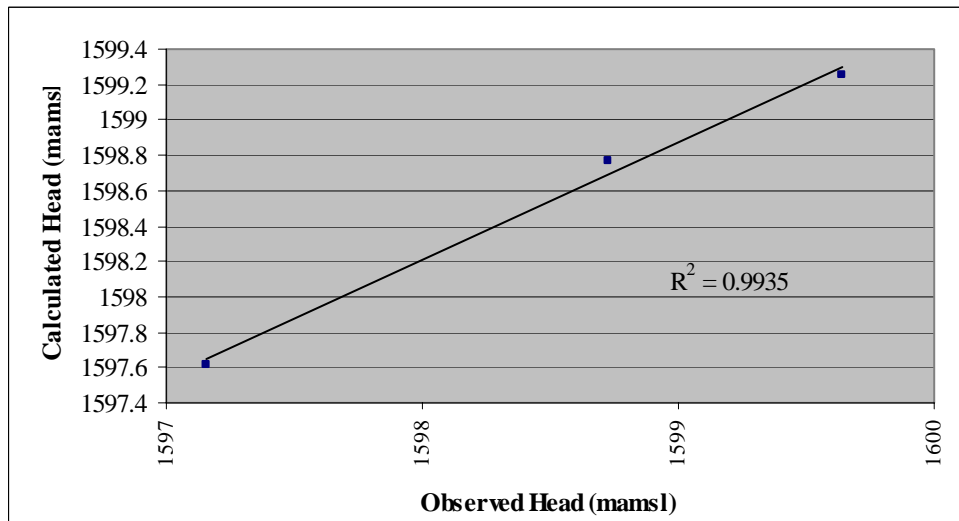
In Figure 52 the observed and calculated (modelled) heads at the three boreholes near the Raw Water Dam are plotted for a horizontal hydraulic conductivity of 0.65 and a vertical conductivity of 0.065 m/day. The calculated heads are seen to give fair approximations of the actual heads. In Figure 53 the hydraulic heads modelled are plotted against the observed heads and a regression coefficient of 0.994 is attained. It should, however, be kept in mind that only three groundwater level measurements were used to calibrate the model.

Figure 52. Observed and calculated heads at the boreholes near the Raw Water Dam.

Figure 53. Calculated vs. observed heads at the boreholes near the Raw Water Dam.

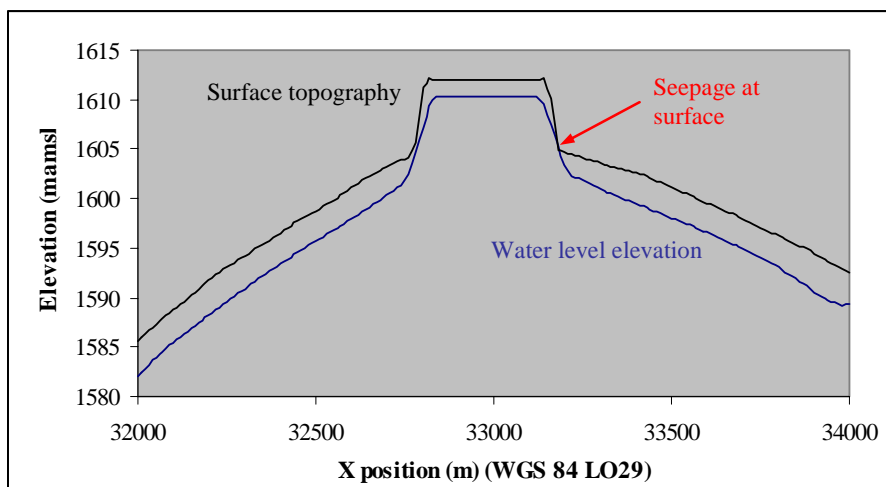
Figure 54. West/east cross-section through the Raw Water Dam showing the topographic elevation and water level elevation.

It should be noted that the water level depths in the three boreholes near the Raw Water Dam range from 2.48 to 5.24 mbgl, even though these boreholes occur close to the dam (66 – 118 m away). The results of the numerical model also suggest that seepage in the immediate vicinity of the Raw Water Dam is predominantly vertical through the weathered material that underlies the dam. This observation implies that the groundwater levels will become rapidly deep as one moves away from the dam. Seepage from the dam could, however, be expected to surface near the toes of the dam walls where the topographic gradient undergoes a rapid change. These observations are illustrated in Figure 54 where the surface topography and steady state water level along a west/east cross-section through the Raw Water Dam are plotted. The implications are that any seepage interception system should occur close to the dam wall and should be installed a relatively deep depth (> 4 m) to ensure that it is effective in intercepting seepage from the dam.

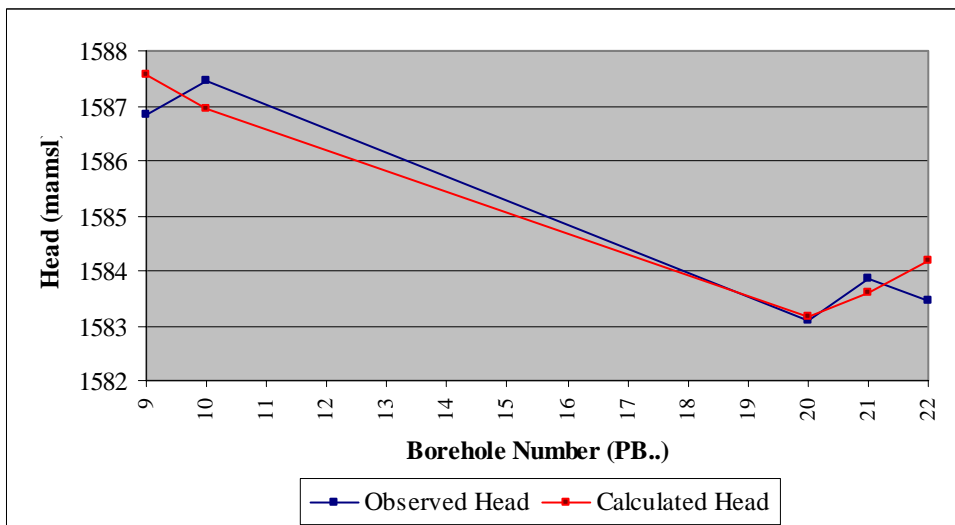
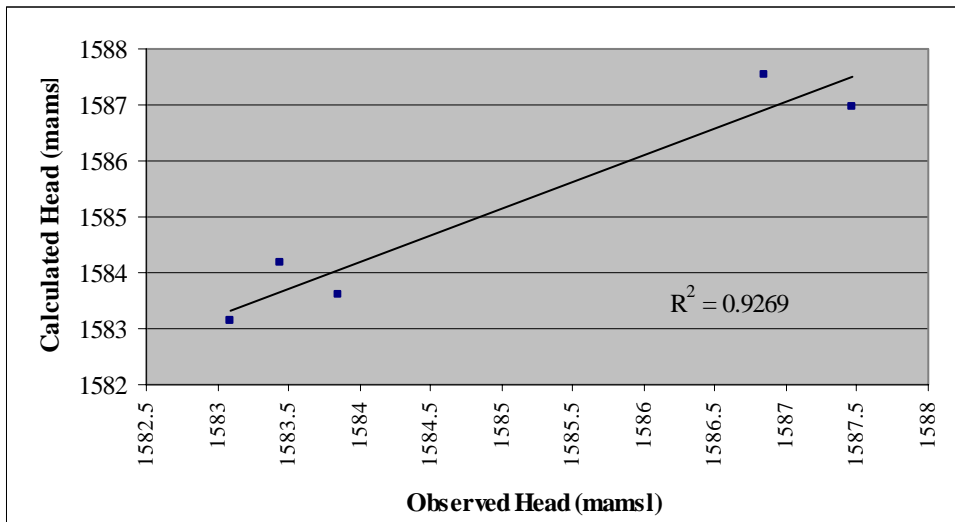
Figure 63. Observed and calculated heads at the boreholes near the High Level Ash Water Return Dams.

Figure 64. Calculated vs. observed heads at the boreholes near the High Level Ash Water Return Dams.

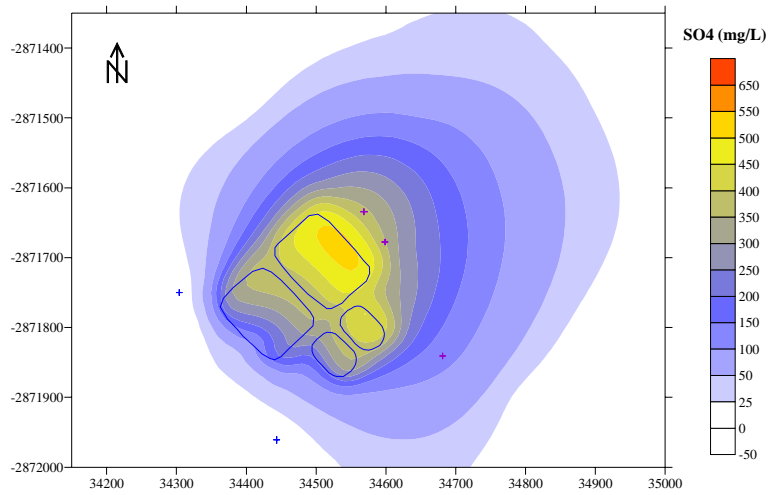
Figure 71. Modelled SO_4 concentrations in the deep aquifer – end 2011.

The modelled sulphate concentrations as observed in Layer 4, representing the deep aquifer, are shown in Figure 71 to Figure 75.

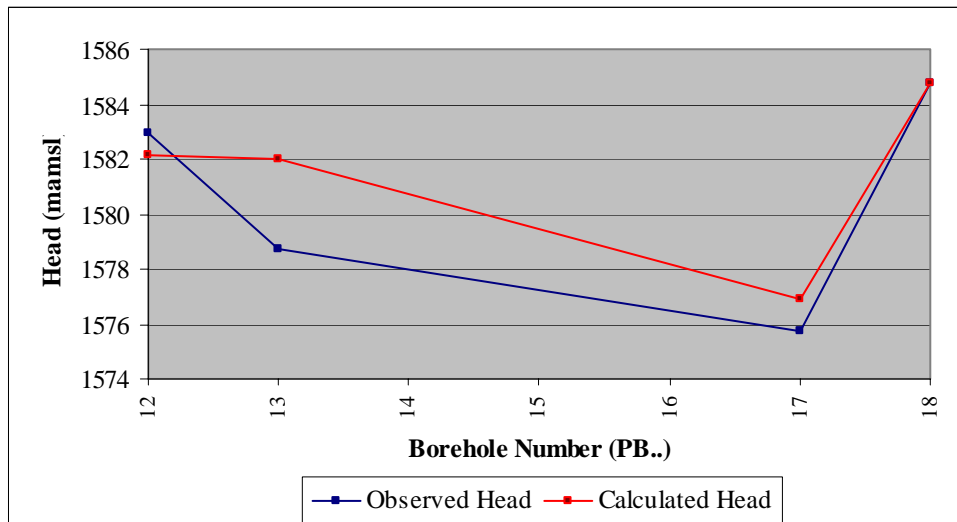
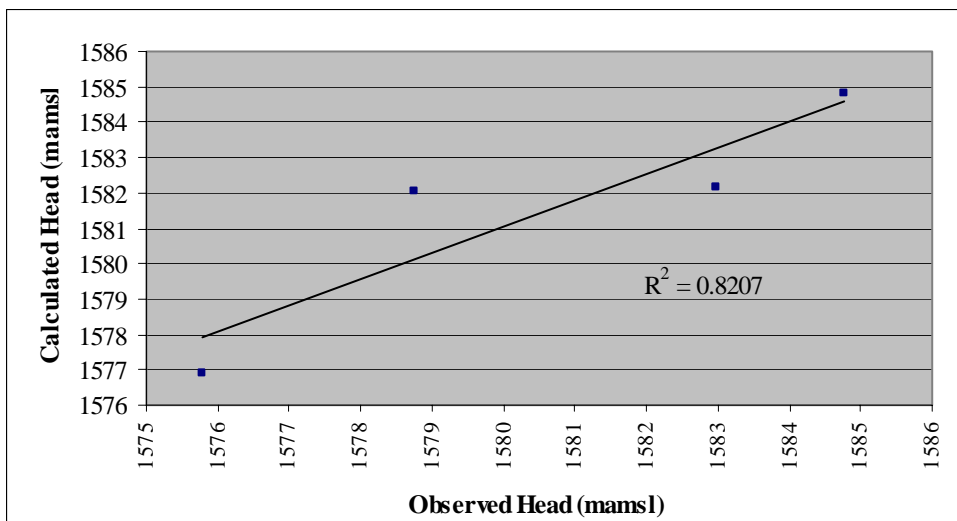
Figure 82. Observed and Calculated Heads at the various boreholes.

Figure 83. Model calibration: Calculated vs. Observed Heads.

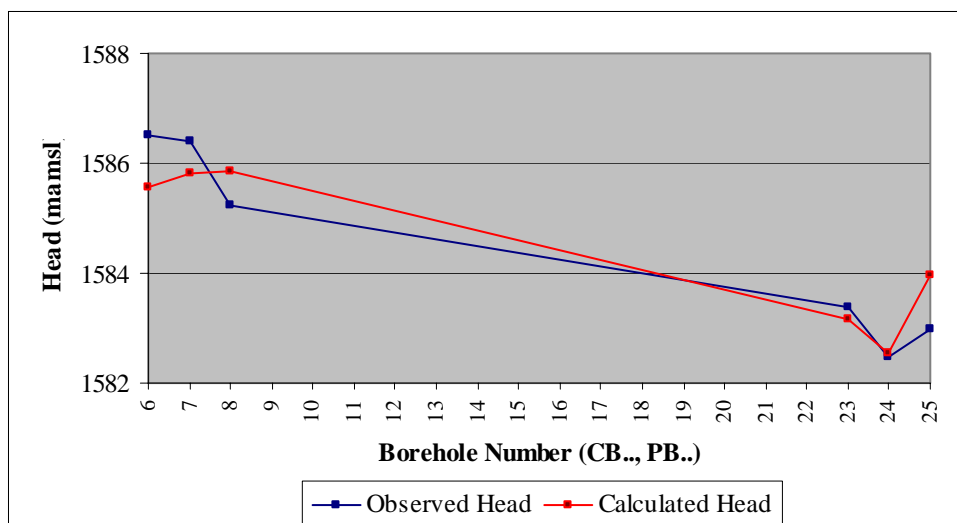
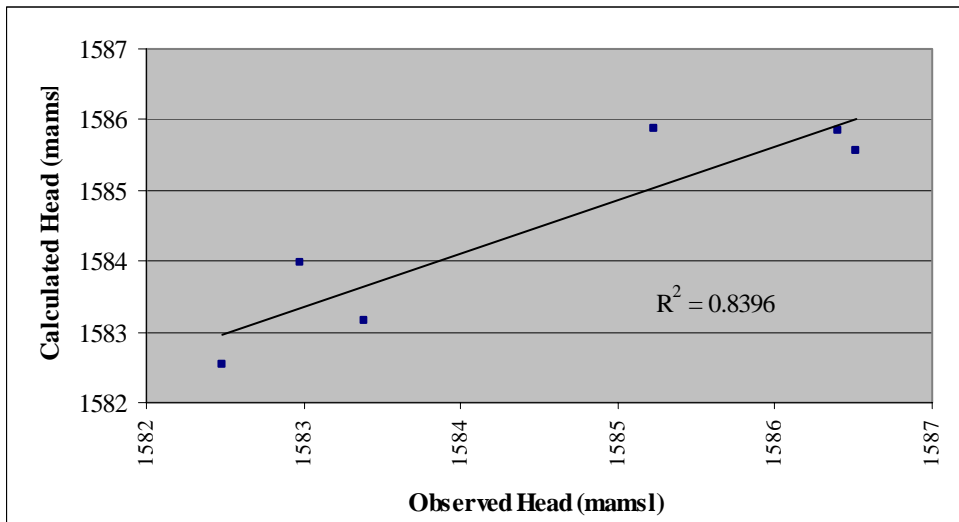
Figure 100. Observed and Calculated Heads at the various boreholes near the Emergency Pan.

Figure 101. Model calibration: Calculated vs. Observed Head.

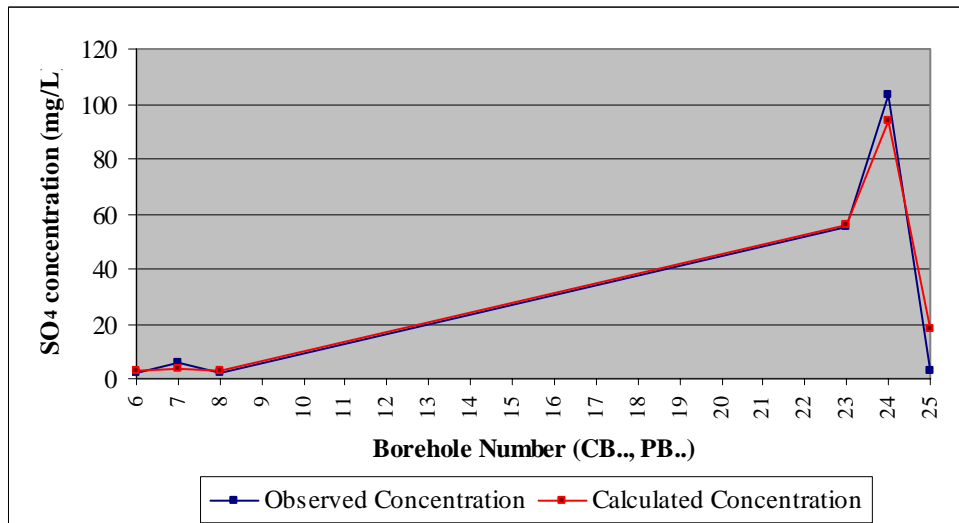
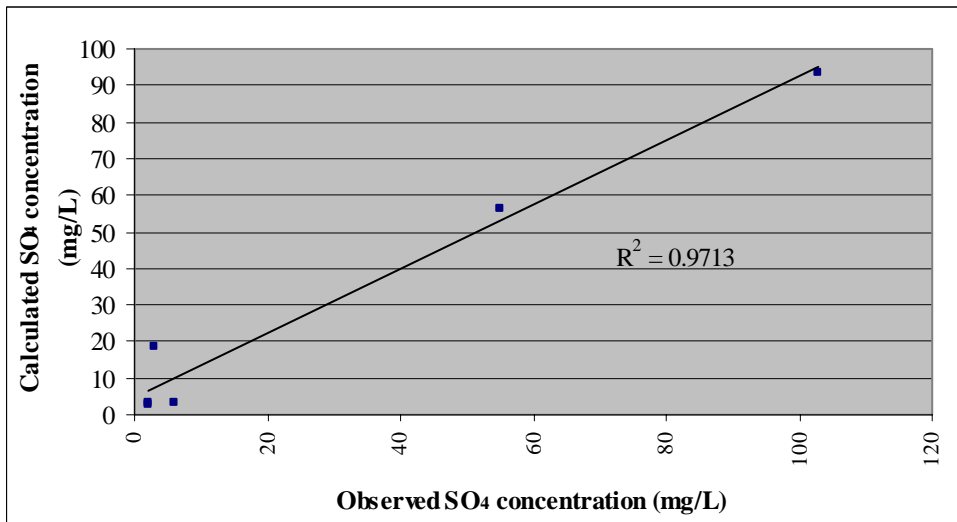
Figure 102. Observed and Calculated SO_4 concentrations at the various boreholes – end 2006.

Figure 103. Model calibration: Calculated vs. Observed SO₄ concentration – end 2006.
